Failure mechanism of boulder-embedded slope under excavation disturbance and rainfall

Abstract

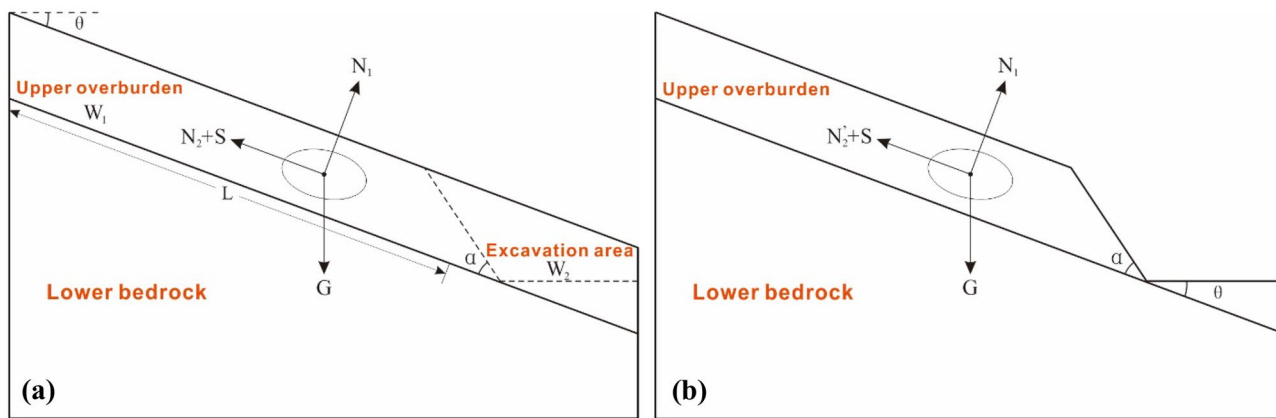
Since the boulder is firmly embedded in soil, it is assumed that the boulder is a rigid body and cannot deform or rotate within the overburden soil at the critical state of failure. According to Fig. 1a, the force equilibrium of the boulder before excavation can be expressed as follows:

Fig. 1 Force analysis diagram of boulder in a slope: **a** before excavation and **b** after excavation

After excavation, the earth pressure is partly released on the right of the boulder, resulting in the reduction of resistant force along the slope inclination to N'_2 , as shown in Fig. 1b. If the overall resistant force is less than the downslope component of gravity, N'_2 , may turn into a downward thrust, and the boulder will slide downwards along the bedrock. Meanwhile, when the rainfall is active, it will increase the soil weight and reduce the soil strength and the soil-boulder interface friction to S' which further intensifies the boulder

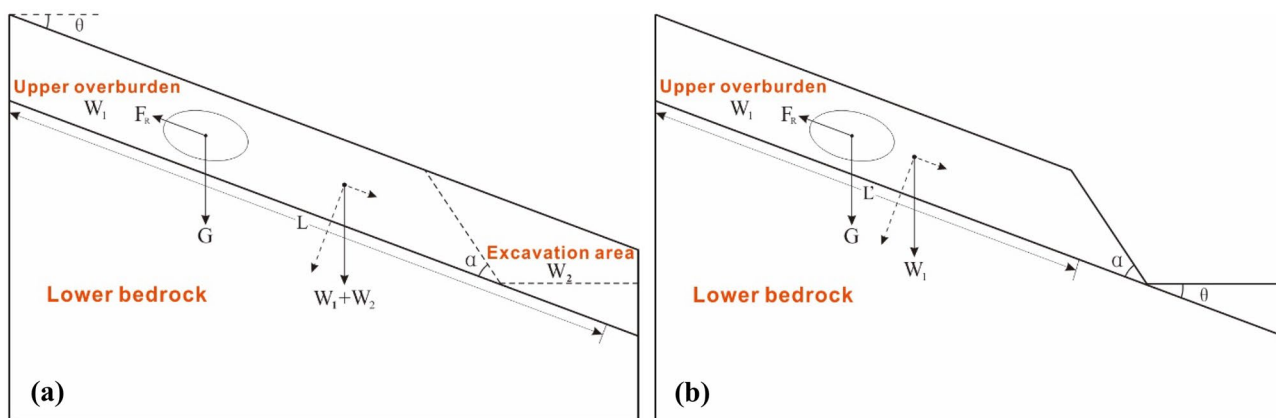
The straight-line fracture surface method has been employed to analyze the overburden soil stability, which assumes that the sliding surface is approximately straight, as shown in Fig. 2a. In this research, the fracture surface

Fig. 2 Stability analysis of the boulder-embedded slope: **a** before excavation and **b** after excavation

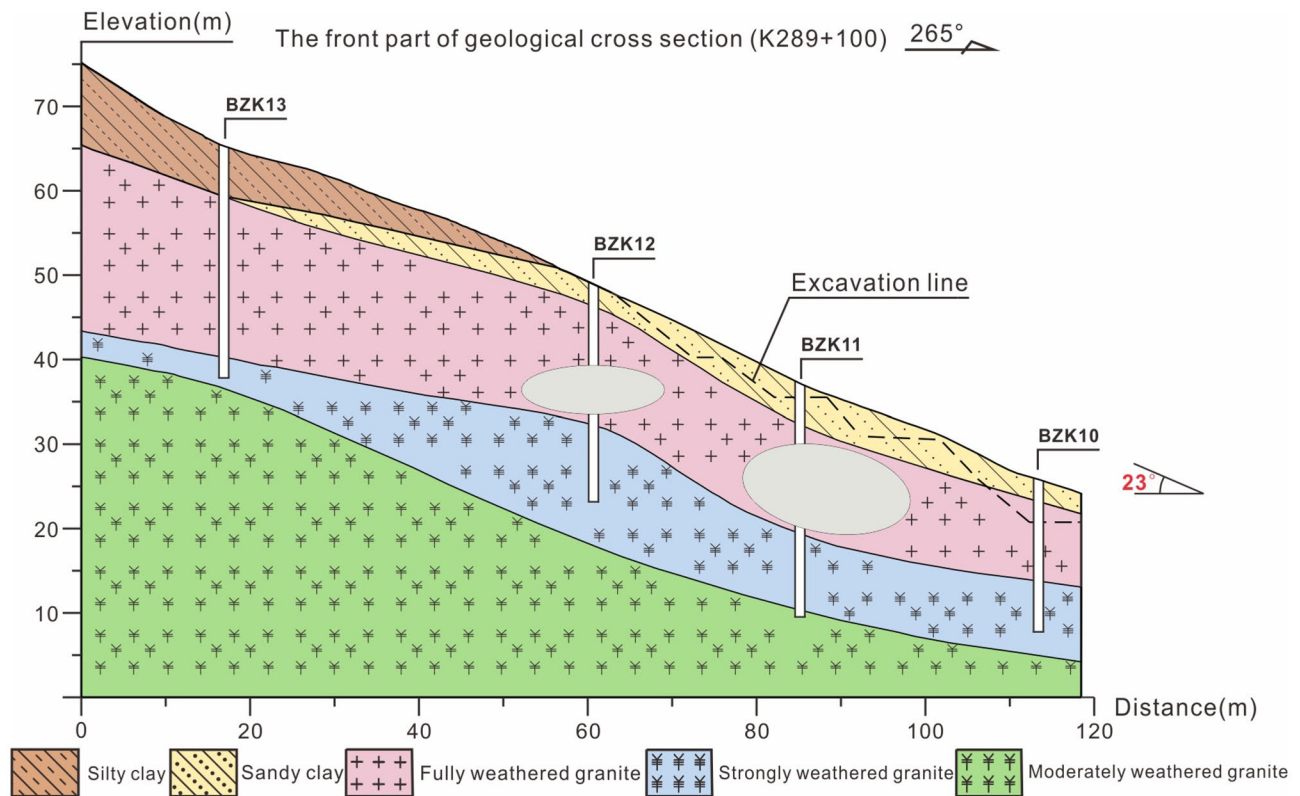
Since sliding failures occurred in the middle of the K288 + 980 ~ K289 + 180 slope section under excavation and rainfall and the boulders are mainly distributed near the K289 + 100 section, the K289 + 100 section is selected as the slope case for the study. The slope has a height of 54 m, an inclination of 265° , and a natural slope ratio of 1:2.5. The initial design involved the four-level excavations. The ratios of the lower first and second slopes are 1:1 and 1:0.8 with the height of 10 m and 4.7 m, respectively. The ratios of the upper third and fourth slopes are 1:1.2 and 1:1.3 with the designed height of 4.7 m and 7.2 m. The platforms are gradually narrowed from low to high with the widths of 9.5 m, 6.2 m, and 3.5 m. The slope morphological and geological conditions are shown in Fig. 5, in which the weathering degree of granite is classified according to the standard for engineering classification of rock mass (GB/T50218) published by the Ministry of Housing and Urban-Rural Development, of the People's Republic of China (2014). Two large elliptic boulders exist in the fully weathered layer. The upper one is smaller and close to the interface between strongly weathered granite and fully one. The lower one is twice times larger than the upper boulder and locates near the toe of the second slope.

Fig. 5 The K289 + 100 geological cross section (the gray filling represents granite boulders)

In this study, the two-dimensional finite element software Midas GTX (MIDAS Information Technology Co. Ltd. 2020) was used to analyze the slope failure. The numerical model consisting of 11,067 elements was configured according to Fig. 5. The vertical sliding bearings were applied to the left and right boundaries, and the fixed bearings were applied to the bottom boundary. The slope safety factor was calculated by the strength reduction method. Since the traditional failure criterion of numerical convergence or plastic zone penetration may cause infinite displacement or plastic zone discontinuity to the boulder-embedded slope, the displacement mutation was used as the failure criterion in this research. It is challenging to calculate the seepage analysis under rainfall conditions when affected by materials with

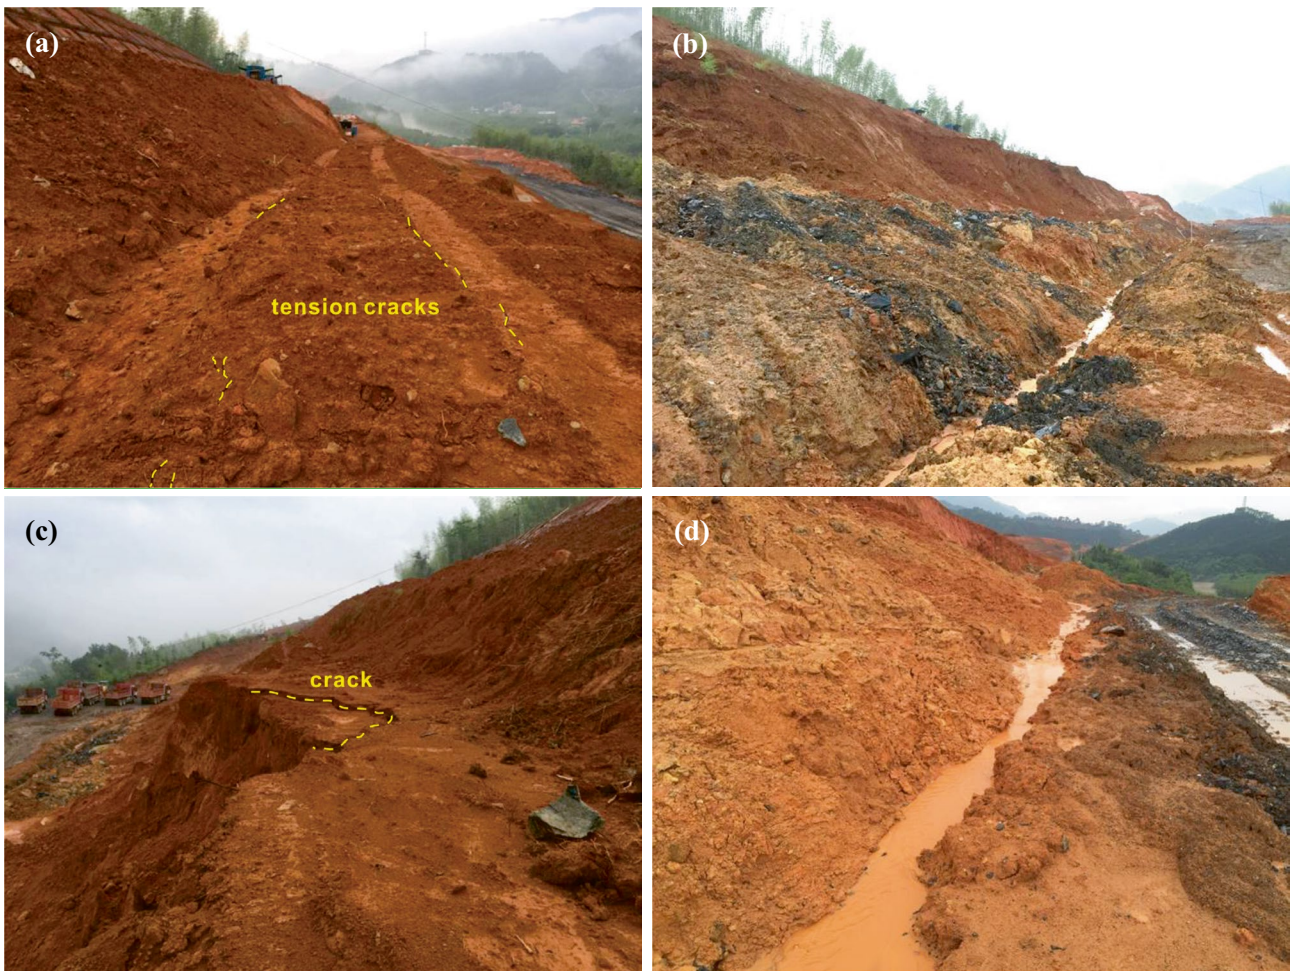
The K288 + 980 ~ K289 + 180 slope section exhibited a typical progressive failure induced by rainfall infiltration on the exposed slope after the excavation, which delayed the progress of slope supporting and protection. The slope construction started in December 2015, and all four slope excavations were completed at the end of February 2016. In mid-March of the same year, the continuous rainfall occurred. After 5 days of continuous rainfall, the slight tension cracks appeared on the first platform, as shown in Fig. 6a. On March 27, 2016, rainwater began to seep out at the slope toe and formed a small ditch, as shown in Fig. 6b.

saturated state, as shown in Fig. 6c. On April 18, a shallow landslide occurred in the first slope. The sliding area extended from the toe to the top platform, but did not reach the lower boulder, as shown in Fig. 6d. On April 20, the lower part of the second slope was dragged and damaged by the sliding bodies, with the cracks appearing on the second platform. By the end of the rainfall on April 30, the sliding area developed to the upper part of the second slope.

Fig. 6 Deformation and rain seepage of the first slope: **a** tension cracks (March 2016), **b** rain seepage at the slope toe (March 2016), **c** failure pattern (April 2016), and **d** rain seepage at the slope toe (April 2016)

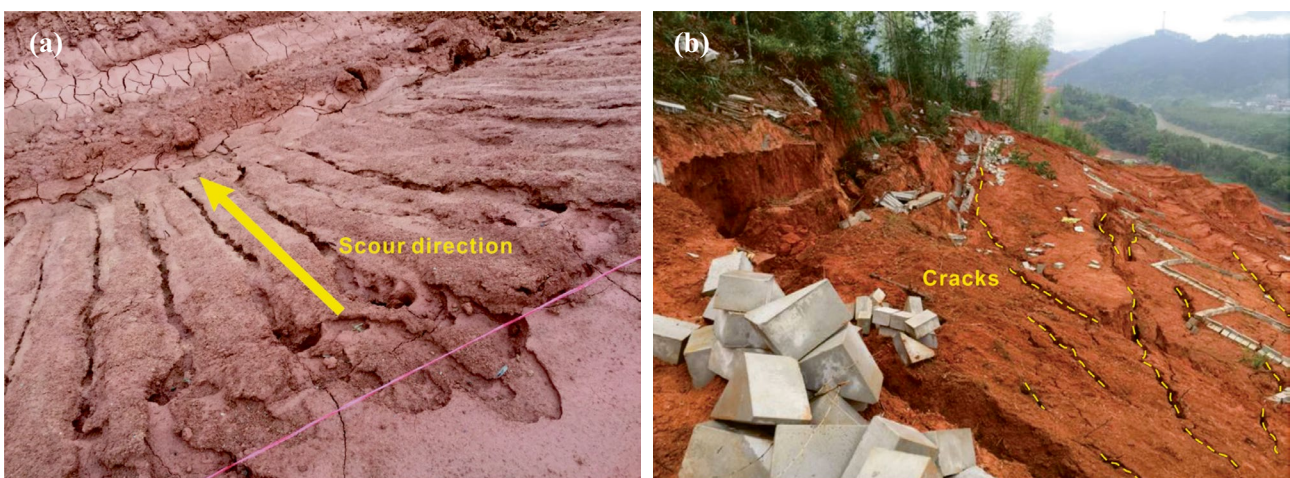
Landslides were also observed in the fourth slope. During rainfall, the surface runoff from the slope top continuously scoured the fourth slope. The field survey on March 25 showed that part of the soils had been washed away, as shown in Fig. 7a. Affected by continuous rainfall, many tension cracks appeared on the slope crest in April and continued to expand and develop. By April 21, the fourth slope slid as a whole. The sliding area started from the tension crack at the slope crest and extended to the toe of the fourth slope. The edge dislocation formed at the original tension crack, as shown in Fig. 7b. Simultaneously, the deformation and extrusion of the landslide body promoted the initiation of shear cracks on both sides of the slope.

Fig. 7 Deformation and sliding of the fourth slope: **a** rain erosion (March 2016) and **b** cracks at the slope crest (April 2016)

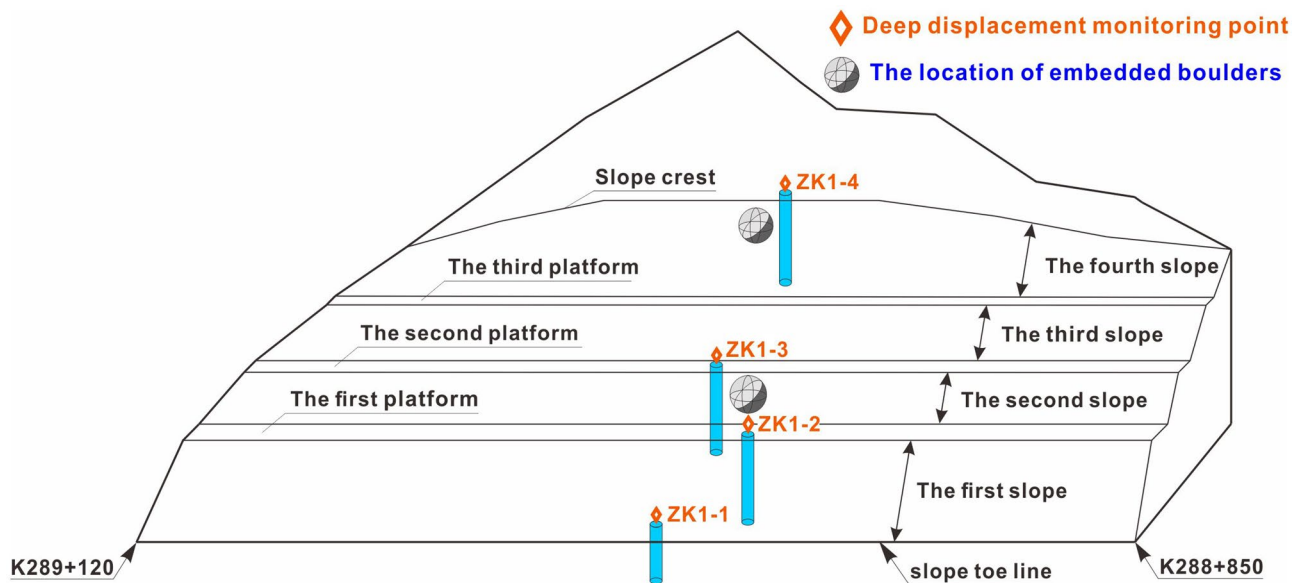
The slope monitoring was conducted from March 18 to April 29, 2016. The inclinometers were buried with the logging wells to investigate the stability of boulders and soil masses by measuring the horizontal displacement along the slope dip direction. Four measuring points were arranged at the K289 + 100 section, among which ZK1-1, ZK1-3, and ZK1-4 were located at the slope toe, secondary platform, and slope crest, corresponding to the BZK10, BZK11, and BZK12 logging wells, respectively. The lower boulder is situated at the south of the ZK1-1 pipe, with the depth of 6 ~ 16 m. The upper boulder is located at the north of the ZK1-4 pipe, with the depth of 10 ~ 15 m. ZK1-2 is an additional measuring point, and the inclinometer pipe was buried at the middle of the first platform. The four measuring points are used to monitor the displacement of slope toe, first slope, second slope, and fourth slope. The layout of the measuring points and the relative positions of boulders and pipes are shown in Fig. 8.

Fig. 8 Layout of the deep displacement-measuring pipes

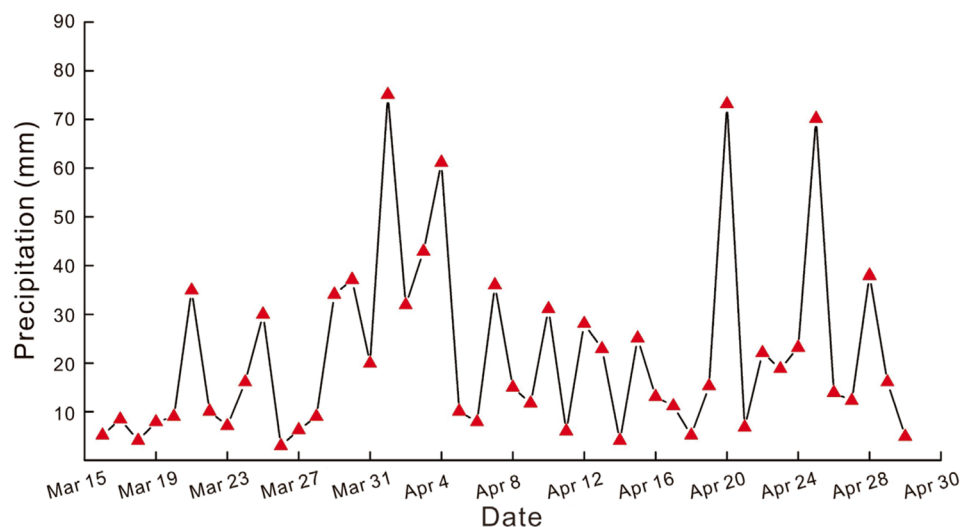
According to the steps of the developed simulation approach, the Midas GTX transient seepage module was used to analyze the rainfall process. The daily precipitation of the simulated rainfall was input into the software. Since no groundwater was found on site, the initial groundwater level was set at the bottom of the slope model to meet the transient seepage analysis conditions without affecting the results. The rainfall lasted for 46 days, and the accumulated

Fig. 10 The daily precipitation recorded from March 15 to April 30, 2016

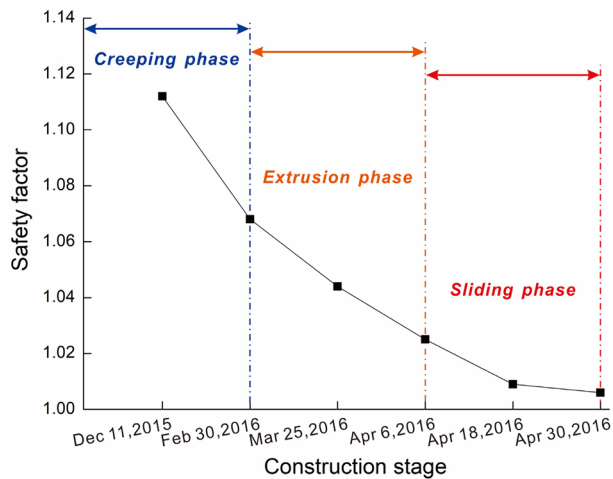
Figure 13 shows the variation of the factor of slope safety in each modeling stage. The slope stability gradually decreased under the influence of rainfalls. According to Wang et al. (2017), the slope deformation can be divided into the creeping phase ($1.05 < F_s < 1.1$), the extrusion phase ($1.02 < F_s < 1.05$), the sliding phase ($0.98 < F_s < 1.02$), and the sudden slip phase ($0.95 < F_s < 0.98$). Under the initial and excavation conditions, the slope was in the creeping deformation phase. Because of the rainfall infiltration, the slope transformed into extrusion deformation and finally slid.

Fig. 13 The factor of slope safety at each phase

After the rainfall infiltration, the slope reached the extrusion deformation stage, characterized by the rapid extension of the plastic zone in soils. On the March 25, 2016, the factor of safety was reduced to 1.044. Three deep sliding surfaces

As the rainfall continued, the slope eventually slid. The factor of slope safety on April 18, 2016, was 0.997, which means the sliding deformation phase. The deformation area of the first slope extended to its top and connected with the second slope, and a landslide occurred from the lower second slope to the slope toe. Meanwhile, the area of the slope crest expanded downward to the upper boulder, and soil masses slide along the fourth slope toe, as shown in Fig. 16a. The comparison between the simulated and actual failures shows that the simulated failure at this stage is basically consistent with the collapse of the first slope on April 18, 2016, the failure at the lower second slope on April 20, 2016, and the landslide of the fourth slope on April 21, 2016. The plastic zone at this stage further expanded significantly, as shown in Fig. 12d. The fracture surfaces connected along the bottom of the upper boulder, showing the third failure process of the soil instability where the sliding surface occurs under the boulder. However, the large-scale deep landslide did not occur because the sliding surface was still blocked by the lower boulder. The stress concentration belt shows that the soil masses have been destroyed and attempted to move the boulder when the bypass is impossible. At this moment, the slope shows the second failure process of the soil instability, i.e., the sliding surface intersects the boulder. Due to the large difference of the mechanical parameters, the boulder cannot be pushed. The plastic zone expanded to the slope surface, which eventually led to the damage of soil masses above boulder, and the failure process is similar to the first one for soil instability.

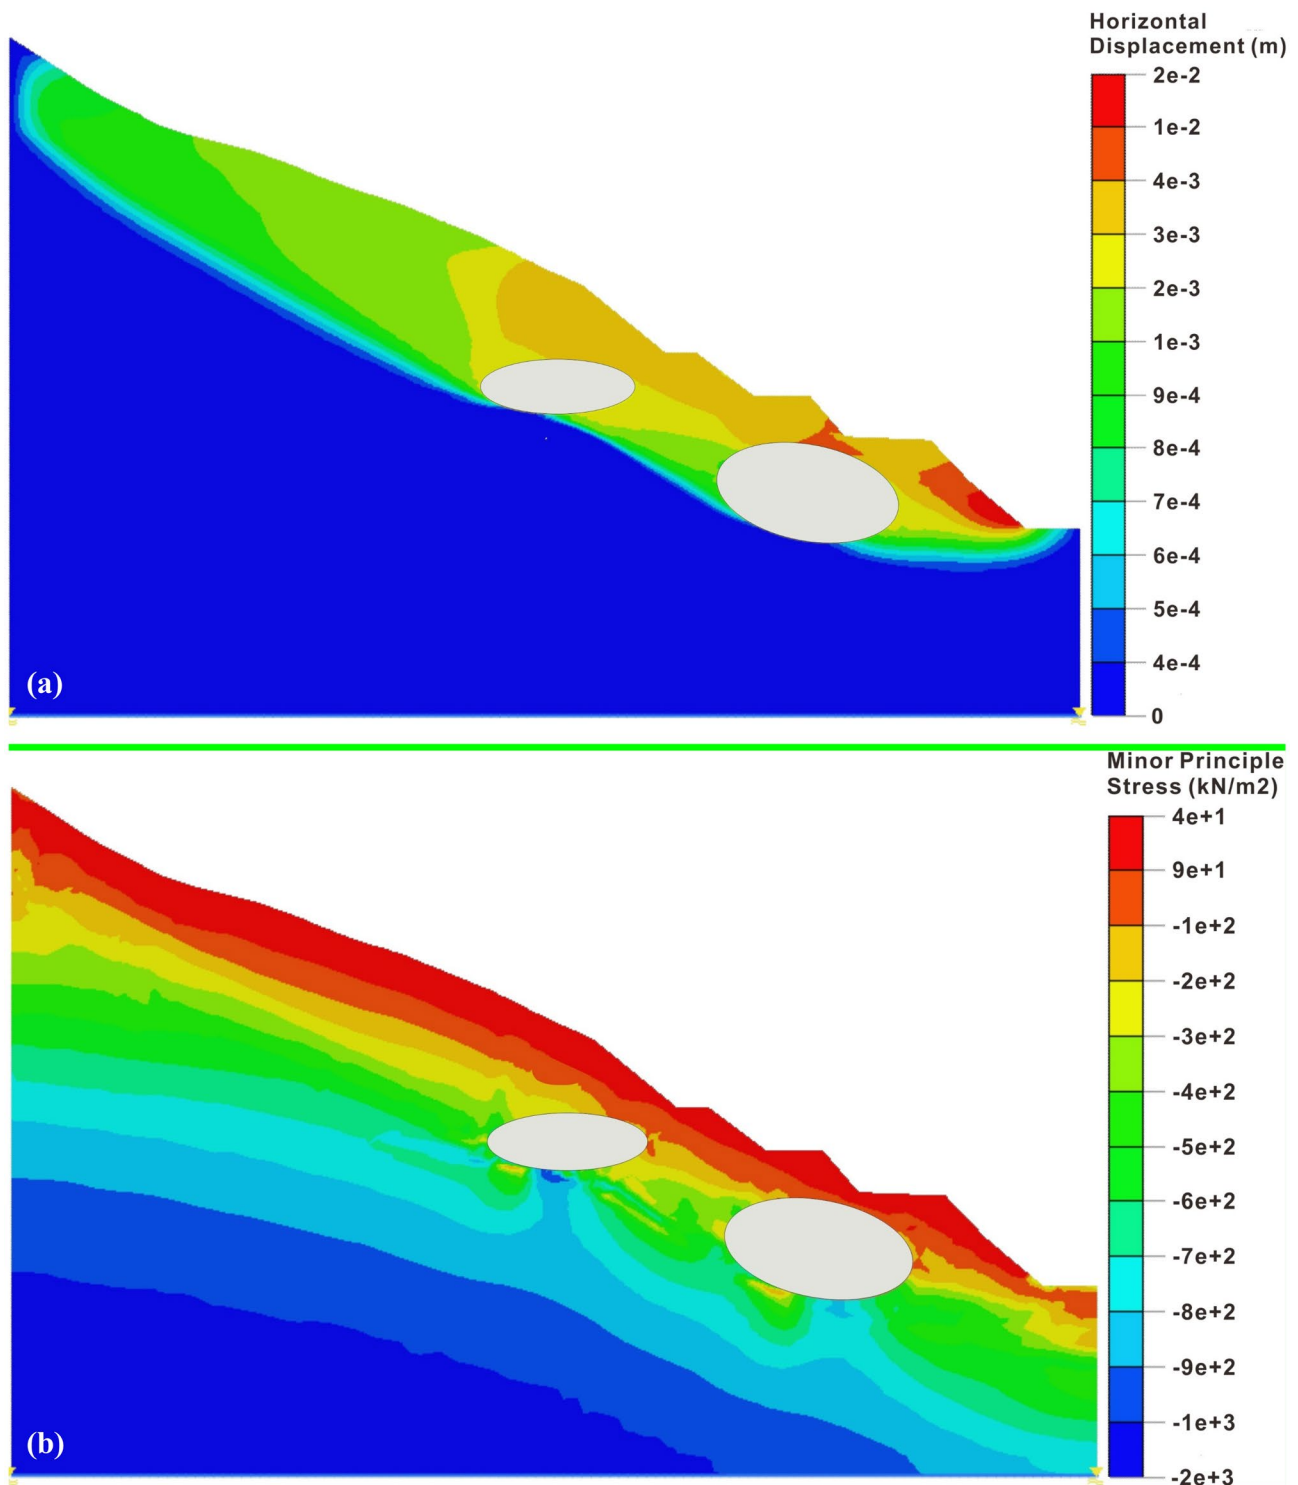
Fig. 14 Displacement and stress distribution after excavation: **a** horizontal displacement and **b** minor principle stress

masses makes the slope form a free face and lose effective mechanical support, causing the stress concentration at the excavated slope surface and the exposure of the weak zone at the slope toe and further resulting in the deformation of the middle-lower first and second slopes. At the early stage

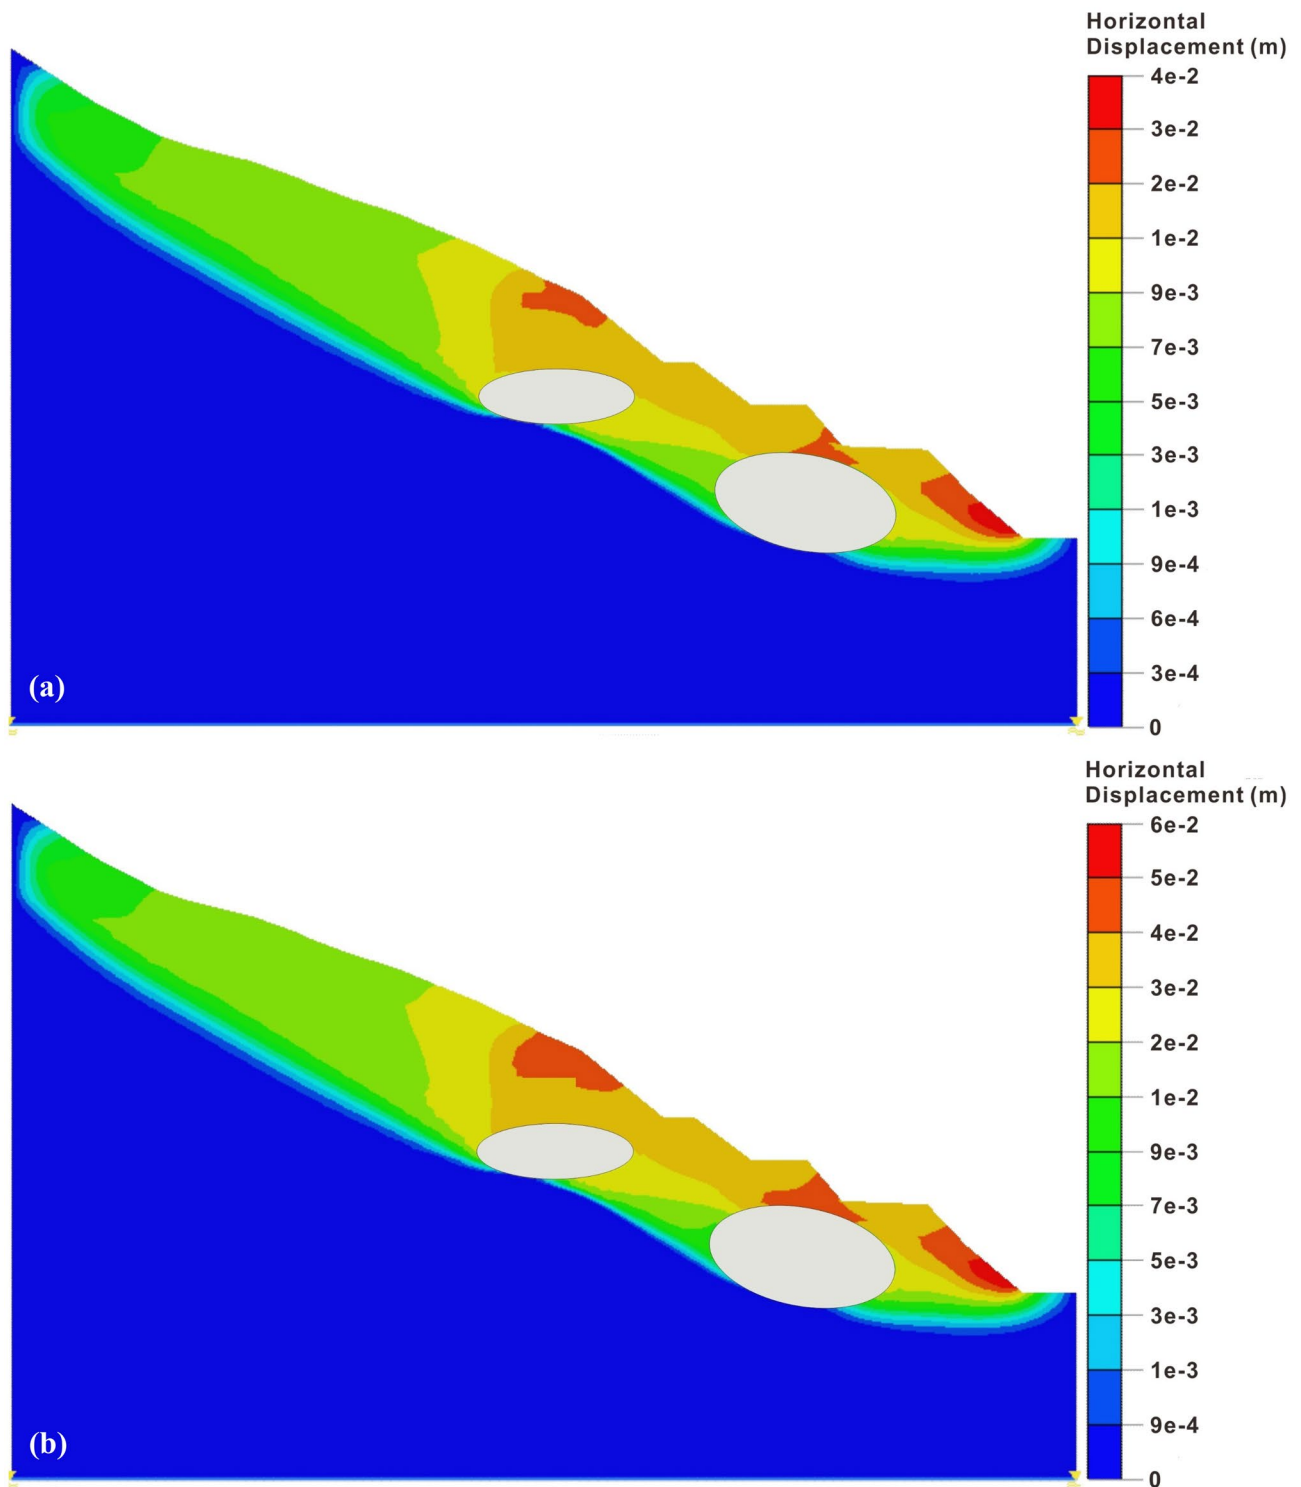
of rainfall, the rainwater infiltrates into the shallow areas and forms a transient saturation zone, which increases the unit weight of soil mass and reduces its effective stress and shear strength and therefore causes the deformation of the slope crest to the upper fourth slope. In the middle

Fig. 15 Horizontal displacement characteristics of the slope in the initial and middle rainfall stages: **a** rainfall on March 25, 2016, and **b** rainfall on April 6, 2016
