Observation of machined surface and subsurface structure of hinoki (*Chamaecyparis obtusa*) produced in slow-speed orthogonal cutting using X-ray computed tomography

Abstract X-ray computed tomography (CT) was applied to non-destructive observation of machined surface and subsurface structure of hinoki (*Chamaecyparis obtusa*) produced in slow-speed orthogonal cutting. The cutting experiments were conducted under several cutting conditions and the chip formations were observed with a high-speed camera to be classified into four chip types. The difference in the quality of the machined surfaces produced in four types of chip formation was investigated. During type 0 chip formation, the workpiece was cut almost exactly at the path of the cutting edge, so no deformation was found on and beneath the machined surface. During type I chip formation, the direction of the fore-split, which is dependent on the arrangement of cells, determined the machined surface. During type II chip formation, the cutting tool sometimes tore part of the workpiece below the path of the cutting edge and the tore part was then compressed by the tool, remaining on the machined surface. During type III chip for

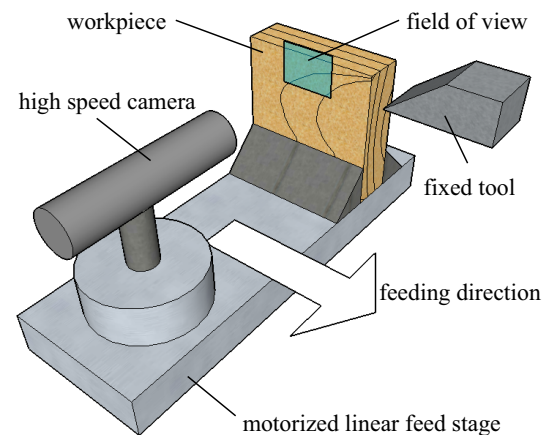
Orthogonal cutting experiment was conducted on a milling machine equipped with a motorized linear feed stage on the machine's table (Fig. 1). The workpiece was mounted on the feed stage, and was fed at a constant speed of 5 mm/s toward the cutting tool which was fixed to the overarm of the milling machine. The machined surface was RL surface normal to tangential direction, that is, quarter-sawn surface. The cutting tool was fed in the longitudinal direction (90–0 cutting) without bias angle.

Fig. 1 Schematic illustration on experimental apparatus

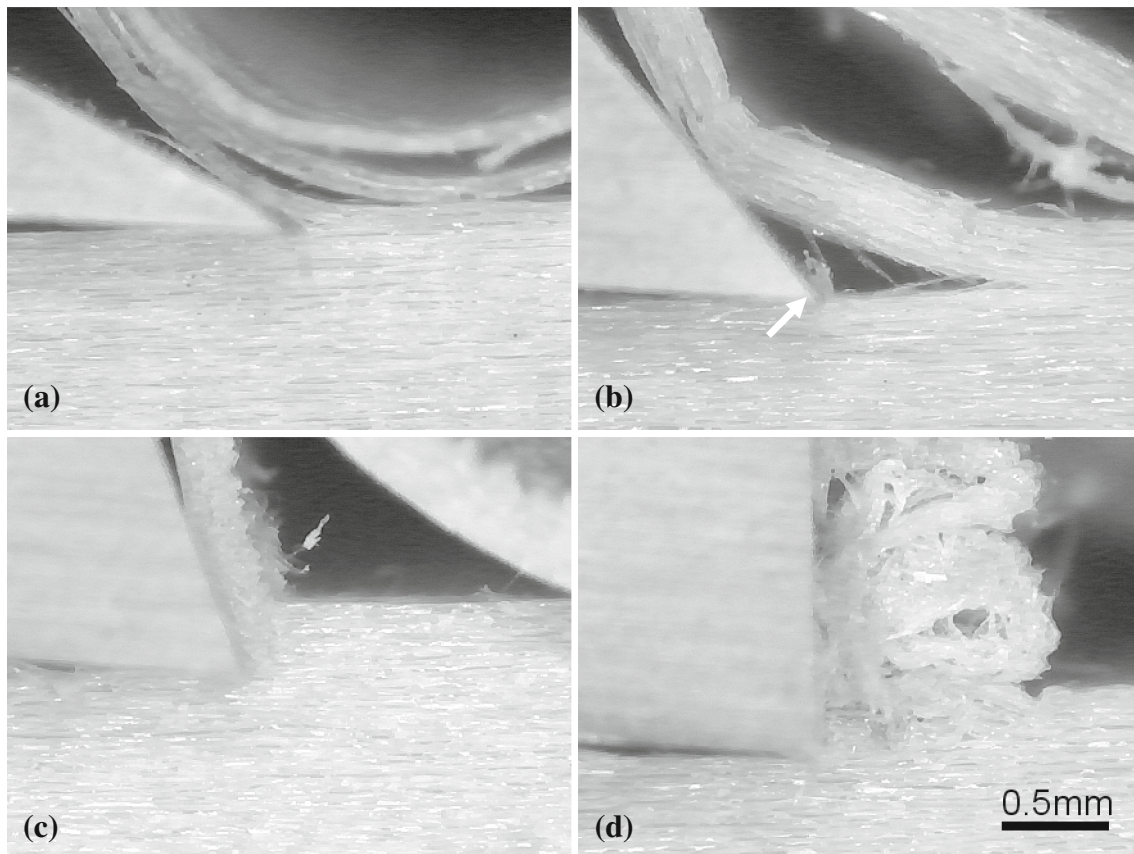
All chip formations found in this study were categorized into four chip types defined by Franz [12, 13] and McKenzie [14]. Figure 2 shows pictures of chip formation of each chip type taken by the high-speed camera. (a), (b), (c), and (d) in Fig. 2 represent type 0, I, II, and III, respectively. The cutting angles for (a) to (d) were 30°, 50°, 70°, 90°, respectively. The depth of cut was 0.1 mm for (a), while 0.3 mm for (b), (c), and (d). Table 1 shows the occurrence of the chip type for various combinations of cutting angle and depth of cut. The relationship between the chip type and the cutting condition was similar to those of previous studies [13, 16]. It was confirmed that only one chip type occurred for each cutting condition in the most of the cases. When the cutting angle was 50° and the depth of cut was 0.1 mm, however, chip type varied itself among the types 0, I, and II in the five repetitions. This cutting

Fig. 2 Chip formations of each chip types. **a** Type 0. **b** Type I. **c** Type II. **d** Type III. The *white arrow* indicates the secondary chip. Cutting angles for (a) to (d) were 30°, 50°, 70°, 90°, respectively. Depth of cut was 0.1 mm for (a), while 0.3 mm for (b), (c), and (d)

Type 0 chip was obtained when cutting angle was 30° and depth of cut was 0.1 mm, and also when the boundary condition was employed. In the video clip, the chip split at the distance of 0.01 mm or closer from the cutting edge, and no deformation could be observed on the workpiece beneath the path of the cutting edge (Fig. 2a).

Type I chip was obtained when the cutting angle was 30° or 50° and the depth of cut was 0.3 mm, and also when the boundary condition was employed. The chip split along the grain by cleavage and failed as if a cantilever beam bends and breaks down at its base, as shown in Fig. 2b. Splitting of workpiece near the cutting edge was in a larger scale than that of type 0, occurred at the distance of 0.1 mm or further from the cutting edge. This splitting is designated as “fore-split”. The generated chip slid up the rake face of the tool until the cutting edge reached the next contact point of the workpiece. This phenomenon repeated in the cutting process. In some cases, the split proceeded above the path of the cutting edge, and the uncut part above the path of the edge was removed as a secondary chip, as pointed by the white arrow in Fig. 2b. The secondary chip was thin and similar to the type II chip, as Franz mentioned [12].

cutting edge failed along a line extending upward from the edge, while the workpiece below seemed to be not deformed. This phenomenon probably induced by a shearing stress along the inclined line. In the video clip, no fore-split could be observed (Fig. 2c), and the cutting edge seemed to control the chip formation.

Type III chip was obtained when the cutting angle was 90° . The workpiece ahead of the tool was compressed by the tool and the compressed zone usually extended below the machined surface. The chip generated was also compressed and seriously damaged, and frequently stuck to the rake surface (Fig. 2d). Since the chip tended to stick ahead of the tool, the cutting was not only done by the cutting edge but also by the stuck chip, which made the cutting unstable. When the chip made the cutting angle larger than 90° , the workpiece above the path of the cutting edge seemed to be compressed and passed beneath the clearance face instead of removed along the rake surface. Those parts of the workpiece would be compressed and would be left on the machined surface.

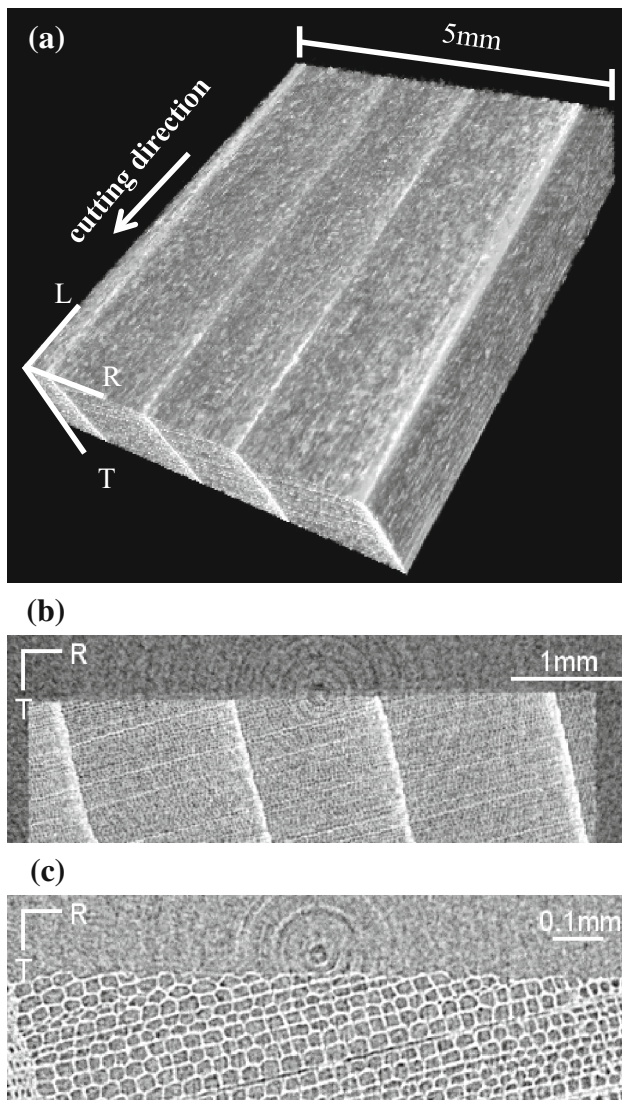
Figure 3 shows the CT images of one of the machined workpieces produced in type 0 chip formation. The cutting angle employed was 30° and the depth of cut employed was 0.1 mm for this workpiece. The intensity of a pixel in a CT image represents the density level of the pixel; the

Fig. 3 CT images of the machined workpiece obtained by type 0 chip formation. Cutting angle was 30° and depth of cut was 0.1 mm. **a** 3D view of the workpiece. **b**, **c** cross-sectional view (RT plane) of the workpiece

brighter the pixel is, the higher the density of the pixel is. Figure 3a shows a 3D rectangular prism image of a part of the workpiece. RL plane indicates the machined surface, while LT plane indicates the side surface of the workpiece. RT plane indicates a cross-sectional view, which is vertical to the cutting direction, of the workpiece. Figure 3b, c shows the cross-sectional views of the rectangular prism. Figure 3b was scanned by scanning condition (a), while Fig. 3c was scanned by scanning condition (b). The surfaces parallel to R direction in Fig. 3b, c are the machined surface. The two bright stripe-like zones running vertically from the machined surface in Fig. 3b are the latewood of the annual rings. The cells on the machined surface were cut almost exactly at the path of the cutting edge, as shown

in Fig. 3b. Most of the cells on and beneath the machined surface seemed to be neither compressed nor deformed, as shown in Fig. 3c. In addition, it was confirmed that the cut was mostly done along the intercellular layer. The characteristics of the surface and subsurface structure of type 0 observed with X-ray CT correspond to the fact that no deformation of the workpiece was observed in the video clip of type 0.

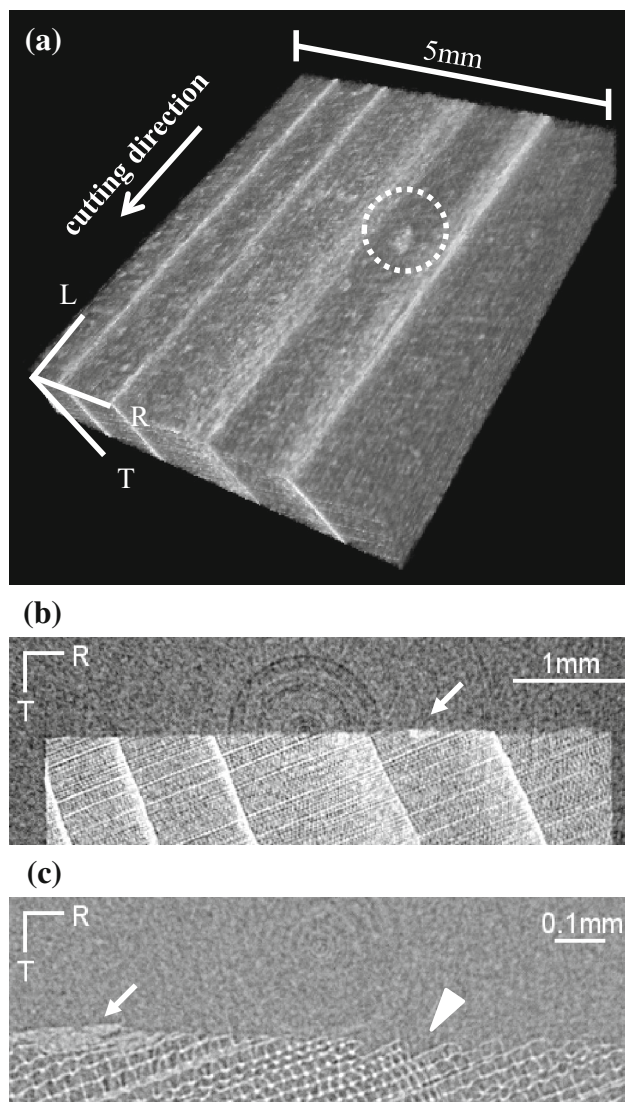
Figures 4 and 5 show the CT images of the machined workpieces produced in type I chip formation. The cutting angle was 50° and the depth of cut was 0.3 mm for the workpiece in Fig. 4, while the cutting angle was 30° and the depth of cut was 0.3 mm for the workpiece in Fig. 5. A couple of bright spots of higher density were found on the surface, as pointed by the white arrows in Fig. 4b, c. These bright spots must be the masses of the compressed cells. The cells were seriously deformed, and no cell lumens could be observed (Fig. 4c). These compressed areas were considered to be produced by the secondary chip formation of type II, since similar areas were also found on the machined surfaces of type II. For the workpieces whose contact angle of annual ring was smaller than the right angle, the fore-split tended to lead below the path of the cutting edge. Therefore, the machined surface seemed not to match the path of the cutting edge, as pointed by a white triangle in Fig. 4c. On the other hand, when the contact angle of annual ring was close to 90° , the machined surfaces were similar to those of type 0, and seemed to match the path of the cutting edge (Fig. 5b, c). In both cases, the chip tended to split along the intercellular layer. It was confirmed that the direction of the fore-split, which was dependent on the arrangement of cells, determined the machined surface.

Fig. 4 CT images of the machined workpiece obtained by type I chip formation. Cutting angle was 50° and depth of cut was 0.3 mm. The circled area in **a** and the bright areas pointed by white arrows in **b** and **c** indicate the compressed areas. White triangle in **c** indicates a poor surface

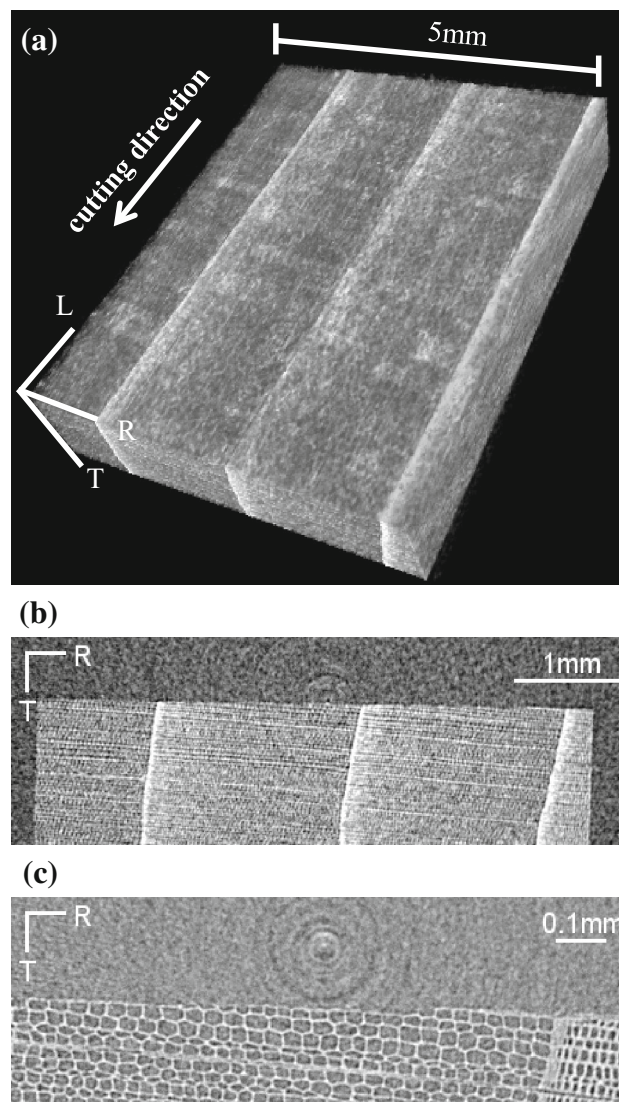
Fig. 5 CT images of the machined workpiece obtained by type I chip formation. Cutting angle was 30° and depth of cut was 0.3 mm

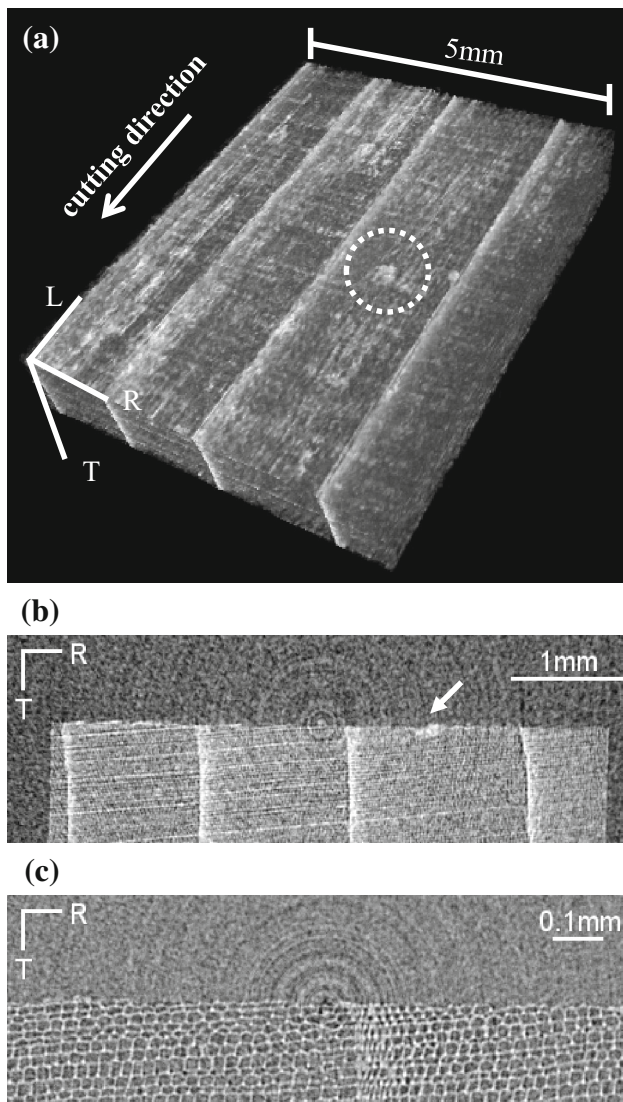
Figure 6 shows the CT images of one of the machined workpieces produced in type II chip formation. The cutting angle was 70° and the depth of cut was 0.1 mm. Most of the areas of the machined surface appeared to match the path of the cutting edge (Fig. 6c), as seen from the video clip. No torn grain or fuzzy grain was found (Fig. 6a). As

Fig. 6 CT images of the machined workpiece obtained by type II chip formation. Cutting angle was 70° and depth of cut was 0.1 mm. The circled area in **a** and the bright area pointed by white arrow in **b** indicate the identical compressed area

pointed by the white arrow in Fig. 6b, however, the bright spots were found.

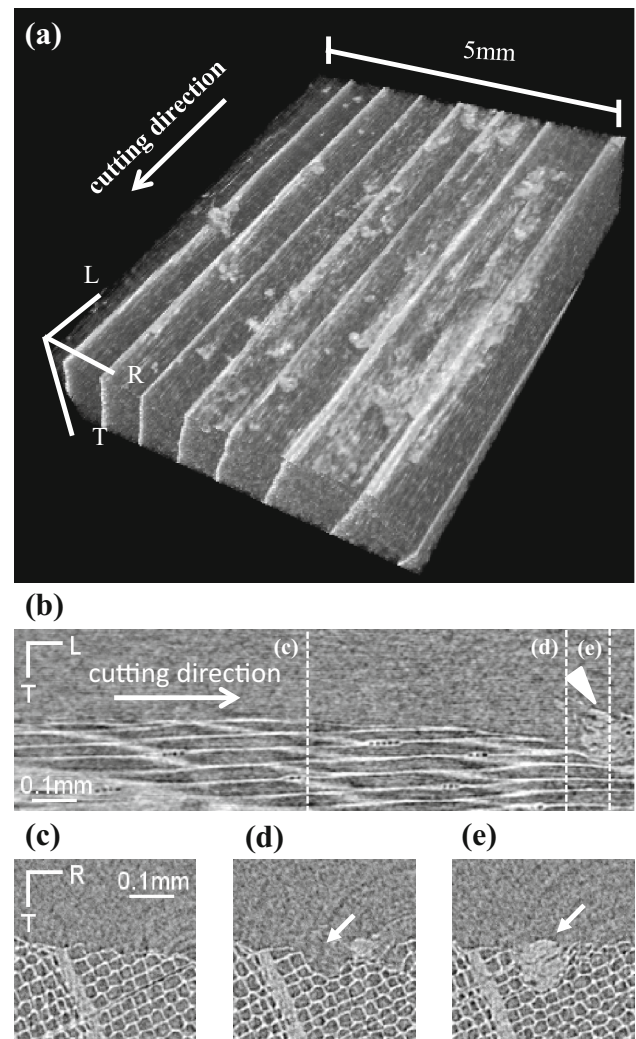
Figure 7 shows the CT images of another workpiece of type II. The cutting angle was 70° and the depth of cut was 0.3 mm. Figure 7b is a cross-sectional view (LT plane) of the workpiece, which was scanned by scanning condition (b). The cutting edge first passed across the dotted line (c), then across the dotted line (d), where the workpiece seemed to be torn, and finally the dotted line (e), where the compressed area was observed. This indicates that after the workpiece below the path of the cutting edge was torn, it was compressed and remained on the surface, instead of being removed as a chip. This compressed area accompanied with the tore area seems to be a characteristic of type II chip formation, although it should be investigated more in detail.

Fig. 7 CT images of the machined workpiece obtained by type II chip formation. Cutting angle was 70° and depth of cut was 0.3 mm. **b** a cross-sectional view (LT plane) of the workpiece. **c**, **d**, and **e** are cross-sectional views (RT plane) sliced at the dotted lines (**c**), (**d**), and (**e**) in **b**, respectively. White triangle in **b** and white arrow in **e** indicate the identical compressed area. White arrow in **d** indicates the accompanied tore area

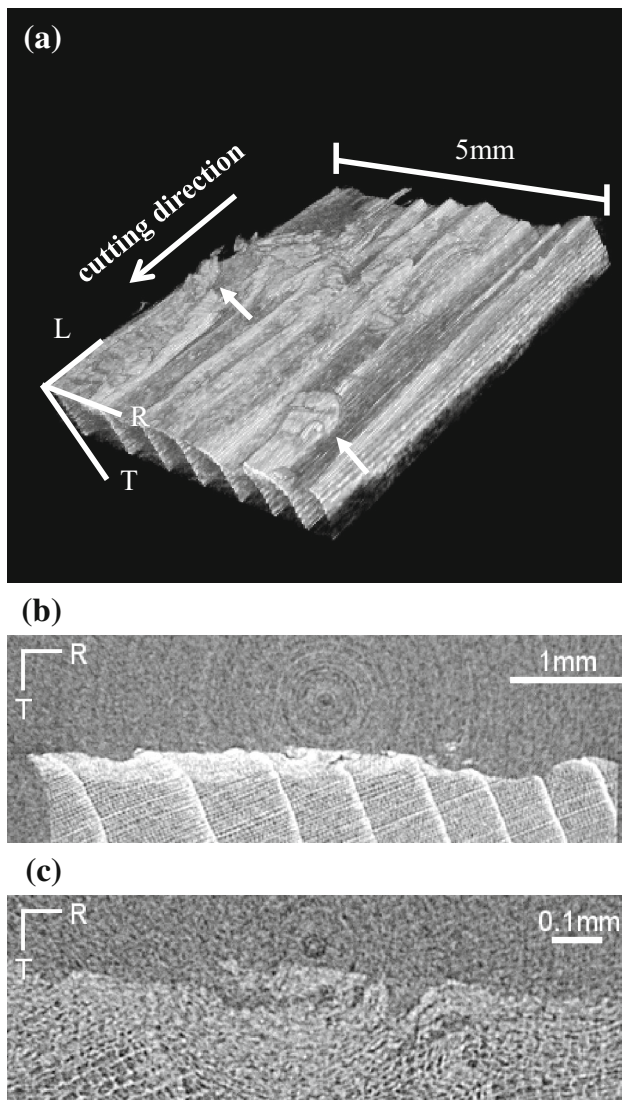
Figure 8 shows the CT image of one of the machined workpieces produced in type III chip formation. The cutting angle was 90° and the depth of cut was 0.3 mm. Occurrence of fuzzy grains was found in the most of workpieces, as pointed by the white arrows in Fig. 8a. The surface seemed not to match the path of the cutting edge. Wide area of the surface was covered with the compressed cells in the most of workpieces, as shown in Fig. 8b, c. The appearance of the compressed surface was typical to type III chip formation, as McKenzie [14] mentioned.

Fig. 8 CT images of the machined workpiece obtained by type III chip formation. Cutting angle was 90° and depth of cut was 0.3 mm. White arrows indicate fuzzy grains
