Landslides (2019) 16:533–549
 DOI 10.1007/s10346-018-1079-9
 Received: 15 March 2018
 Accepted: 9 October 2018
 Published online: 22 November 2018
 © The Author(s) 2018

A rockfall-induced glacial lake outburst flood, Upper Barun Valley, Nepal

Abstract On April 20, 2017, a flood from the Barun River, Makalu-Barun National Park, eastern Nepal formed a 2–3-km-long lake at its confluence with the Arun River as a result of blockage by debris. Although the lake drained spontaneously the next day, it caused nationwide concern and triggered emergency responses. We identified the primary flood trigger as a massive rockfall from the northwest face of Saldim Peak (6388 m) which fell approximately 570 m down to the unnamed glacier above Langmale glacial lake, causing a massive dust cloud and hurricane-force winds. The impact also precipitated an avalanche, carrying blocks of rock and ice up to 5 m in diameter that plummeted a further 630 m down into Langmale glacial lake, triggering a glacial lake outburst flood (GLOF). The flood carved steep canyons, scoured the river's riparian zone free of vegetation, and deposited sediment, debris, and boulders throughout much of the river channel from t

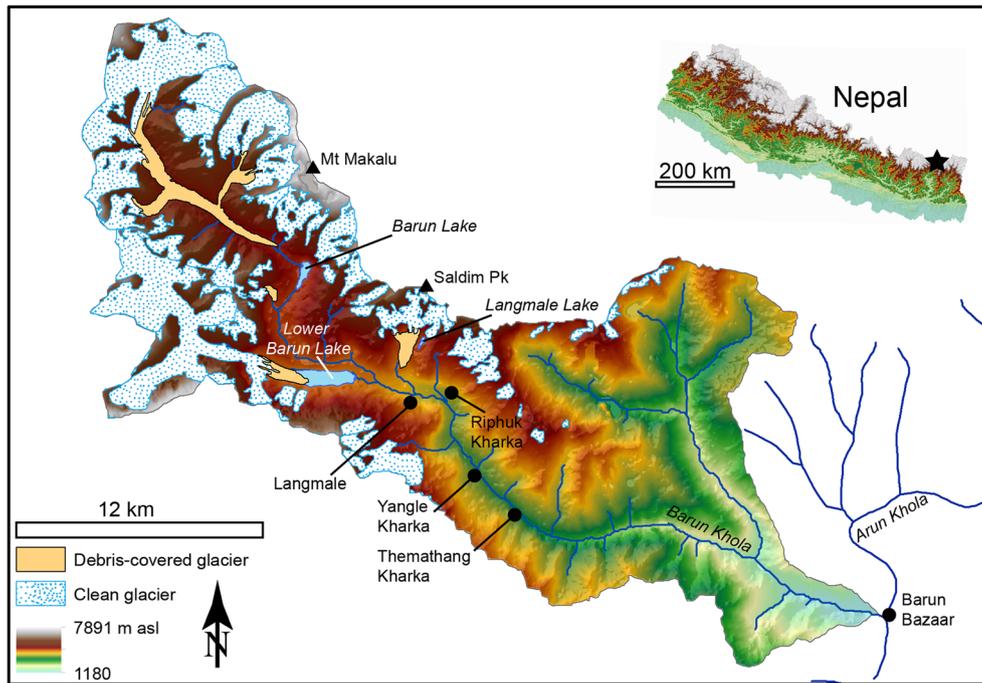
Fig. 1 Barun River catchment in eastern Nepal (star on upper right country inset) showing the location of Langmale, Barun, and Lower Barun glacial lakes, Saldim Peak, and *kharka* (grazing) areas impacted by the flood

At 4:00 p.m. on April 20, 2017, a flood from the Barun River, Makalu-Barun National Park (Fig. 1) was reported that formed a 2–3-km-long, 500-m-wide lake at its confluence with the Arun River (Kathmandu Post, April 21, 2017). Debris had dammed the floodwaters directly above the village of Barun Bazaar, which displaced 10 families from their homes, destroyed fields, and threatened to impact at least 80 families living within the immediate area in the event that the dam suddenly failed (Shakya 2017). The lake also threatened downstream villages that included Phaksinda, Diding, Chetabesi, Lumningtar, and other riverside communities in Bhojpur and Dhankuta districts (MyRepublica 2017), as well as construction activities of the recently approved Upper Arun hydropower project, located 2 km downstream (Kathmandu Post 2017a, b; USAID 2014).

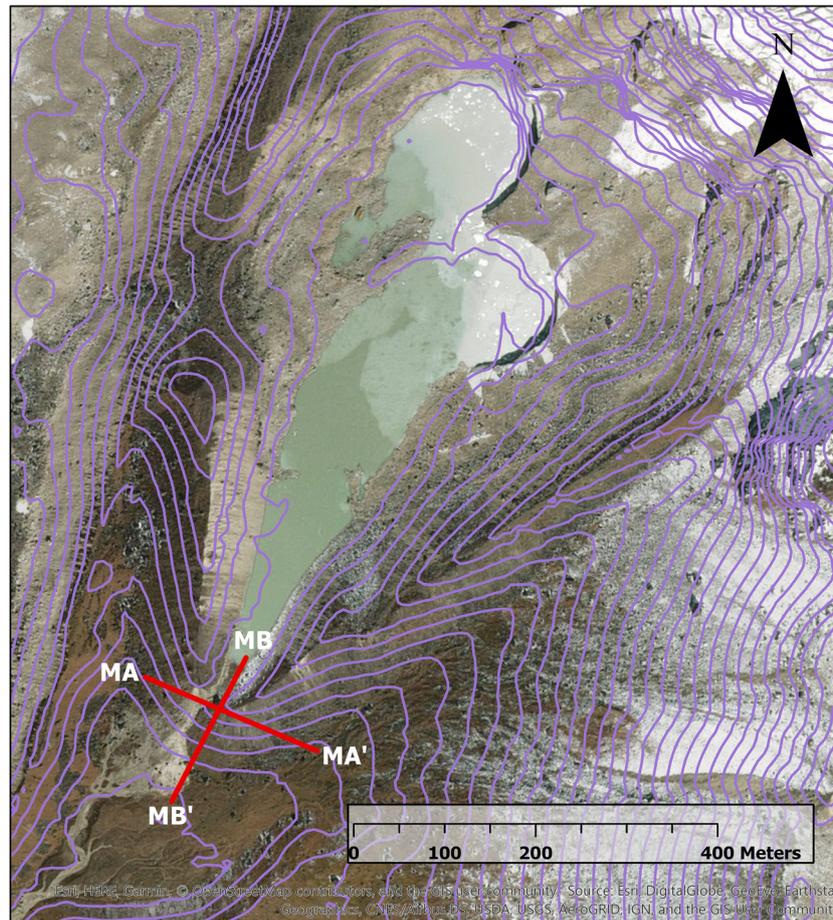
Fig. 2 Contour map of Langmale lake showing the geometry of the moraine and cross sections used to analyze erosion. Contour intervals are 10 m.

The moraine damming Langmale Lake was approximately 75 m wide, 100 m long, and 40 m high (Fig. 2). The moraine lacked vegetation, which is common for contemporary moraine-dammed lakes since they are typically young and located at high elevations (Costa and Schuster 1998). The moraine was assumed to not have an ice-core, since no ice was visible after the incision of the GLOF and no melt ponds or ice cliffs were observed on the moraine prior to the event. The lake’s relatively steep moraine and its close proximity to the steep glacier front and surrounding rock-walled cirques only increase its potential hazard. Two cross sections of the moraine—one along the moraine’s length and one along its width (Fig. 2)—were analyzed to assess the erosion resulting from the overtopping wave.

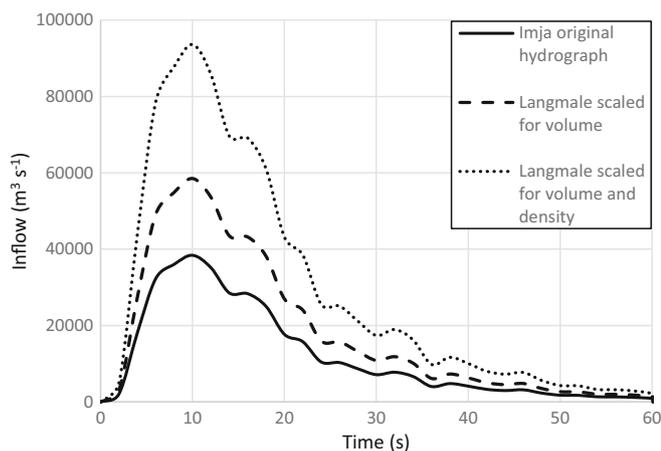
Fig. 3 Inflow hydrographs for BASEMENT simulation, showing the original hydrograph taken from Imja Tsho (Lala et al. 2018), and its adaptation for the Langmale GLOF model

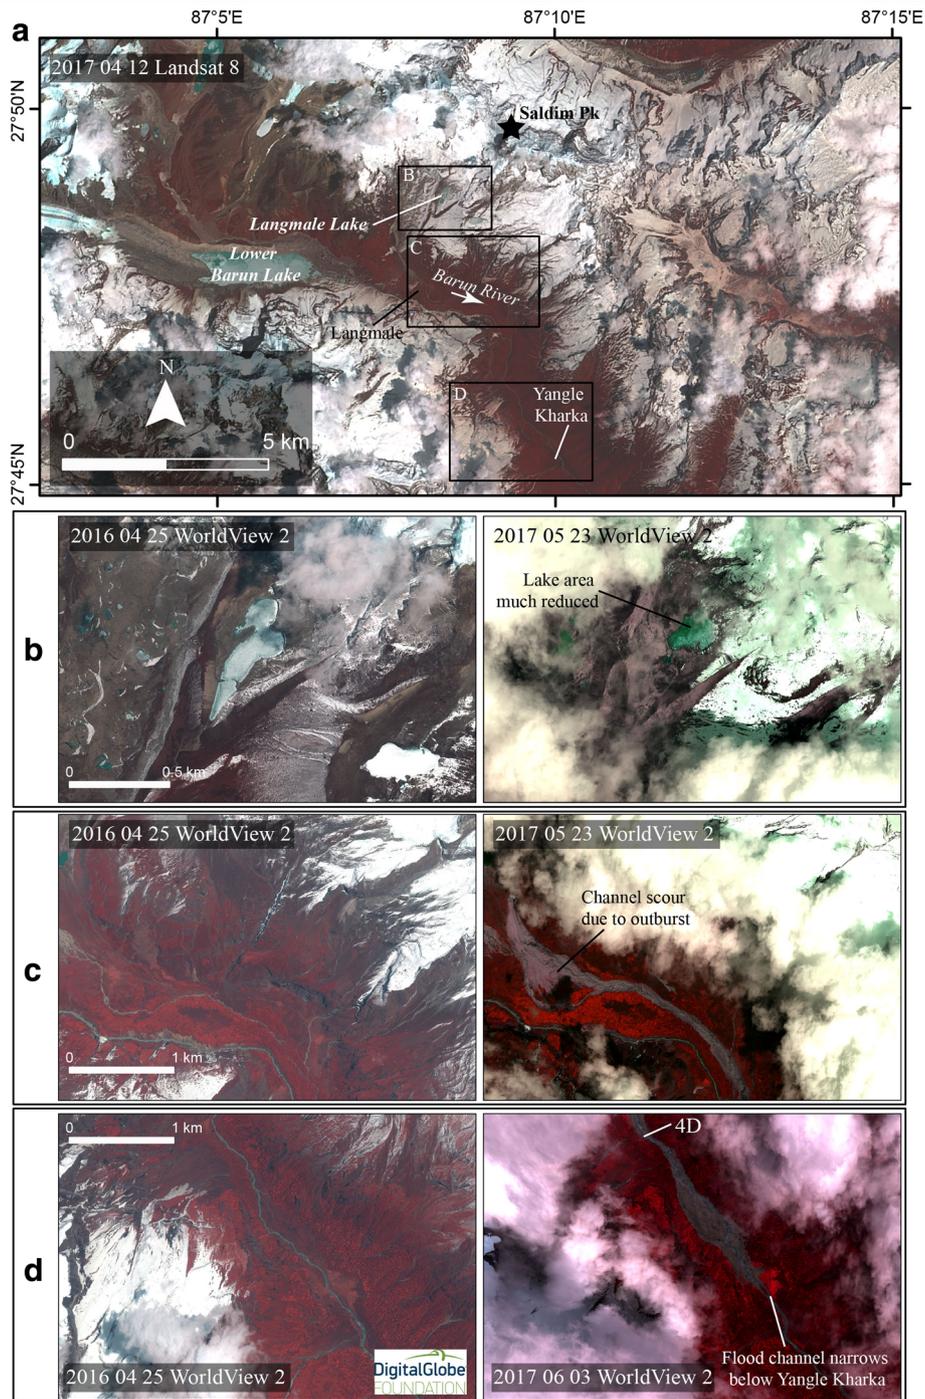
Fig. 4 Satellite imagery of the study area. (A) A Landsat 8 scene of the upper Barun River valley. Boxes show extents of (B), (C), and (D), which are high-resolution (2 m, WorldView-2) multispectral before and after views of key sites along the river. (B) A before and after pair showing the reduction in area of Langmale glacial lake. (C) The channel scour and deposition along the Barun River created by the outburst flood. (D) The flood impacts in the broad floodplain area of Yangle Kharka, followed by the abrupt narrowing of the flood channel below the bedrock constriction at the lower end of Yangle Kharka. Inset (D) shows the location of boulders (4D) deposited near Nhe Khaka (Fig. 12d) (imagery courtesy of the DigitalGlobe Foundation)

0.036 km² (Supplementary material: Fig. S1), which indicates that at least part of the flood's source was from the drainage of Langmale glacial lake (Fig. 4 (B)). Based on empirical volume-area equations for glacial lakes (Cook and Quincy 2015), the lake volume was estimated to have decreased from 1.1 million m³ on February 19, 2017 to 0.3 million m³ on May 8, 2017. Footage from the helicopter showed the terminal moraine was clearly breached and zones below the lake were scoured. Large areas of the flat pastures at Yangle Kharka were also destroyed by the scouring and deposition of the flood (Fig. 4 (C, D)). A short flight down the Barun River valley revealed that the flood became more channelized beyond Yangle Kharka, scouring the river bed to bedrock.

Inundation depth from BASEMENT (Fig. 11) also agreed with observed scouring (Fig. 4 (C)), although the resolution of the DEM may have contributed to excess spillover onto the western glacier, rather than confining more of the flood to the main eastern channel. This spillover likely accounts for the lower, delayed peak discharge at cross section D (Fig. 10) due to the water rejoining the main channel.

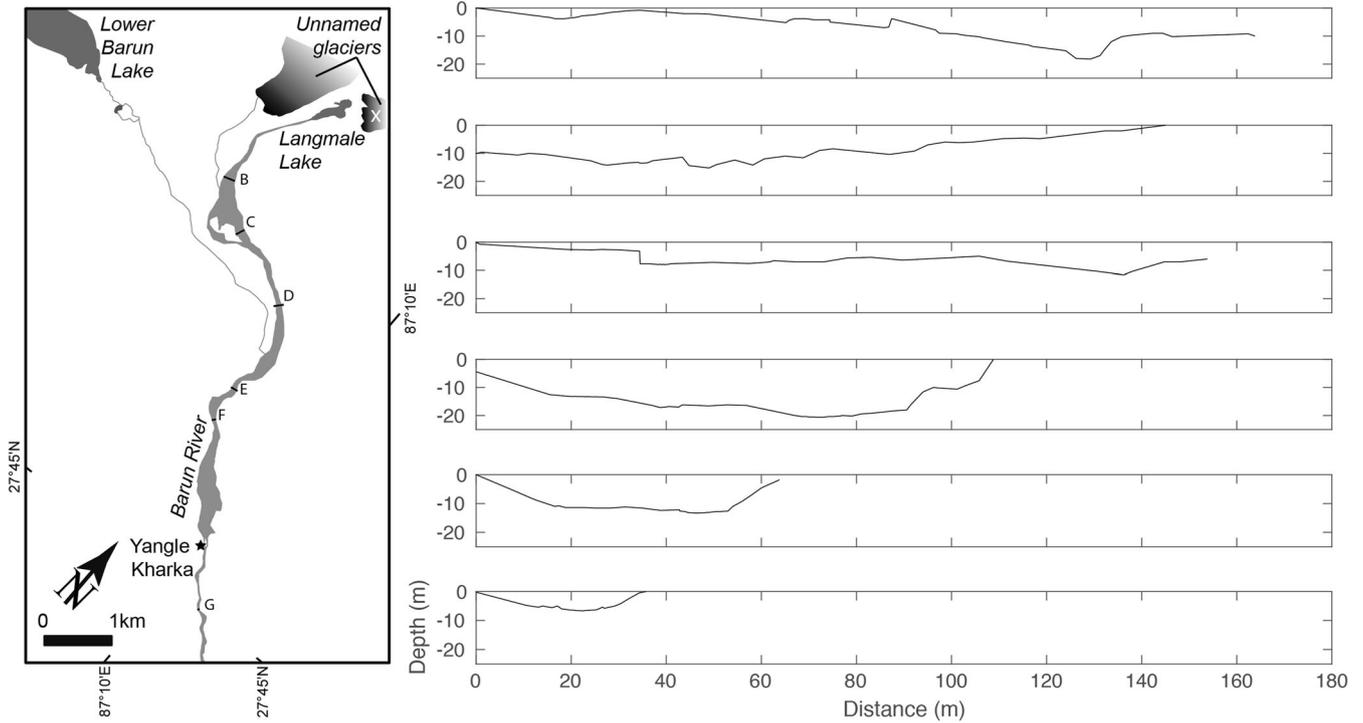
Fig. 6 Cross sections on the Barun River during peak flow based on high water marks between the banks of the river, which show the transition from highly non-uniform wetted channels near the source of the flood to more uniform channels further downstream. Map to the left shows location of the glacier that collapsed above Langmale glacial lake (“X”), cross-section sites, and width of scouring and deposition in the Barun River channel

Peak flood discharge was estimated at six locations along the Barun River (Fig. 6). Cross sections were chosen in relatively straight, stable reaches to avoid areas of significant erosion, deposition, or superelevation around bends. Measurement of multiple cross sections helped to address the large uncertainty that is

Flood channel cross sections were erratic near the source of the flood and became more uniform as the flood moved downstream (Fig. 6). A number of large remnant boulders upstream from Yangle Kharka, most likely deposited during a previous flood event (Chaudhary 2013; Byers et al. 2014; Carpenter 2017), appeared to be undisturbed by this event, i.e., they were still capped with moss, shrubs, and approximately 40-year-old fir trees. Bedload otherwise became smaller and more uniform in the vicinity of Yangle Kharka.

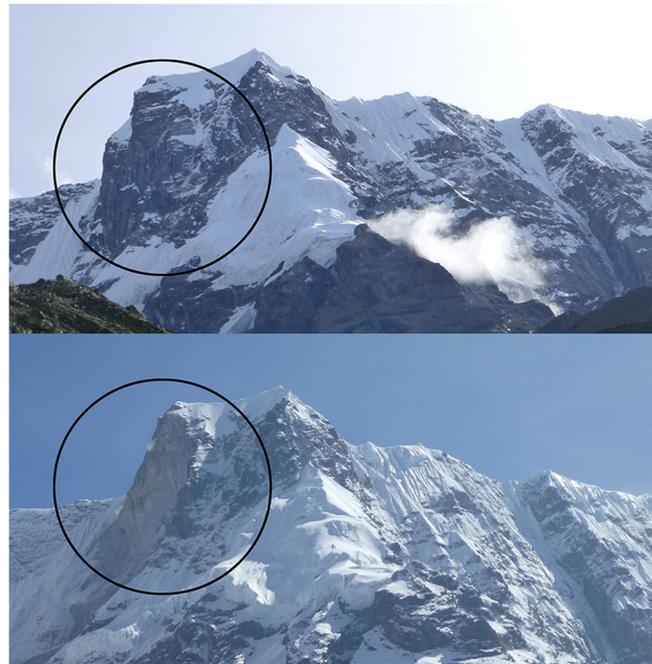
Fig. 5 Before (top) and after (bottom) photographs of the large rock face that collapsed on April 20, 2017 (top photograph: E. Byers, 2016; bottom photograph: A. Byers 2017)

Repeat oblique photography of the northwest face of Saldim Peak (6388 m) revealed the primary flood trigger, i.e., a large rockfall from the mountain's northwest face (Fig. 5). Langmale glacial lake was previously excluded from the hazard assessment conducted by Rounce et al. (2017a), since it was below the area threshold used in that study. However, the mass movement trajectories as calculated by the methods described in Rounce et al. (2017a) showed that Langmale glacial lake was susceptible to both avalanches and rockfalls entering the lake, which included a rockfall with a volume of 0.3×10^6 m³ from Saldim Peak. The terminal moraine did not appear to be ice-cored, but the steep lakefront area angle (Fujita et al. 2012), an indicator of the steepness of the moraine, of 16° indicated that the lake was susceptible to self-destructive failure. The combination of potential mass movement entering the lake and self-destructive failure classified this lake as very high hazard with a potential flood volume of 1.1×10^6 m³. The extent of a potential GLOF was modeled using the MC-LCP model (Watson et al. 2015) and revealed that 33 buildings, 4 bridges, and 0.76 km² of agricultural land could be impacted, which included the 4 buildings in Yangle Kharka that were impacted by the actual event. These downstream impacts were classified as high. The combination of the hazard and the downstream impacts retroactively suggest that Langmale glacial lake was a very high risk for a GLOF.

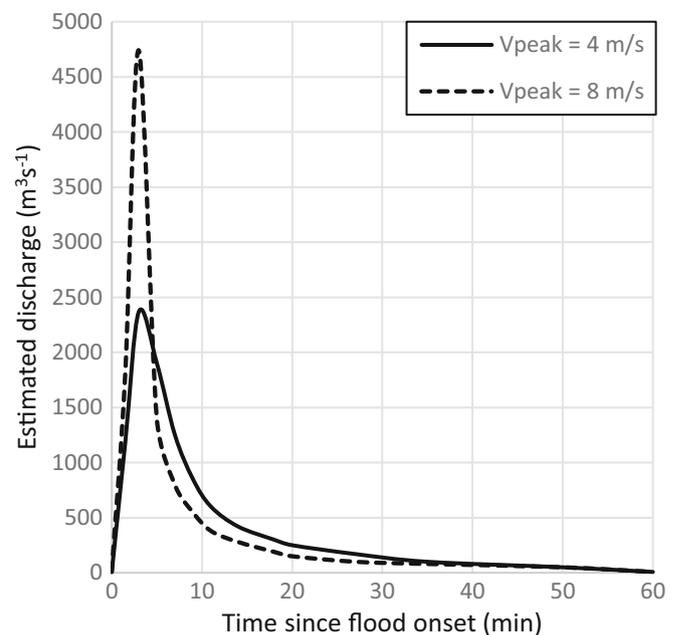
Fig. 7 Estimated flood hydrograph at Yangle Kharka based on the time since the start of the flood. Total flood volume shown is $1.3 \times 10^6 \text{ m}^3$ for upper and lower estimated peak velocities of 4 ms^{-1} and 8 ms^{-1}

be stored in Yangle Kharka, we estimate a total flood volume of no more than $1.3 \times 10^6 \text{ m}^3$. The minimum total flood volume is constrained by the estimated peak flow measurements and the shape of the hydrograph, i.e., the duration of the rising limb, peak flow, and falling limb of the event.

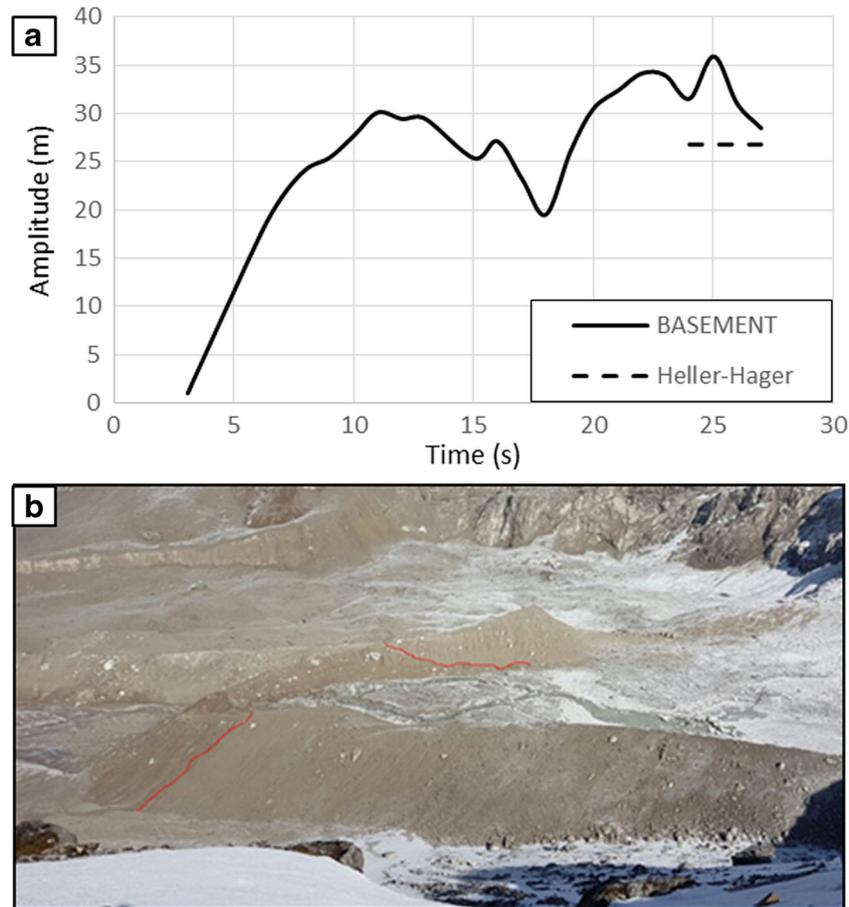
Fig. 8 a GLOF modeling results showing the wave amplitude as it traverses the lake from the BASEMENT simulation and the corresponding Heller-Hager amplitude at the point of overtopping and **b** field observations of the path of the surge wave (red lines) that overtopped the left lateral and terminal moraines of Langmale glacial lake (photograph by D. Sherpa)

BASEMENT was used to model the mass movement entering the lake, the propagation of the tsunami-like wave across Langmale glacial lake, and the ensuing erosion, scouring, and flow of the GLOF. The wave height at the point of overtopping for both BASEMENT and the Heller-Hager (see Supplementary material: Table S1) model agreed, indicating an amplitude of 27.0 m for the former and 26.8 m for the latter (Fig. 8a). This agrees with observed evidence of the wave, which left a mark on the moraine indicating a height of at least 25 m (Fig. 8b).

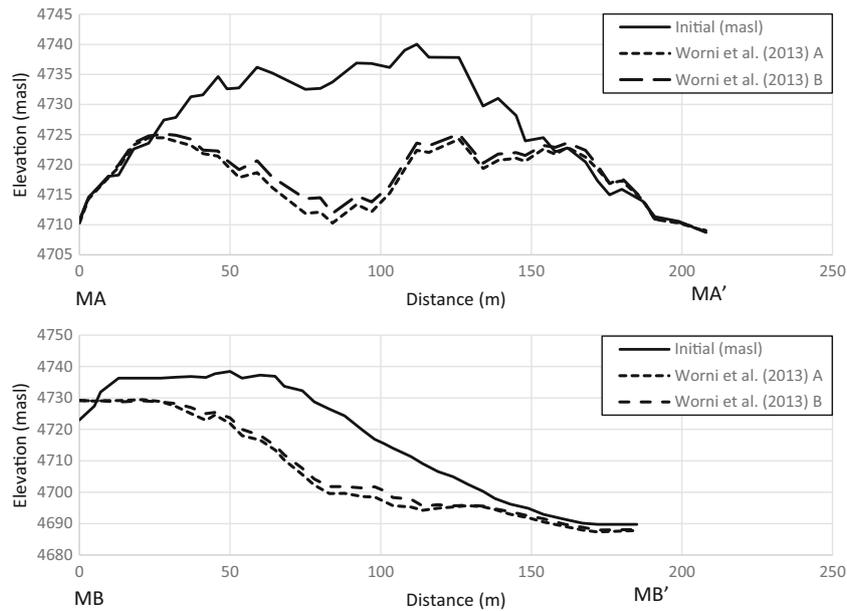
Fig. 9 Cross sections (see Fig. 2) along the width (MA-MA') and length (MB-MB') of the terminal moraine before and after the flood showing the erosion caused by the overtopping wave for two grain size distributions

The overtopping wave caused significant erosion of the terminal moraine, which was most severe along the lake's main outlet channel (Fig. 9). The maximum erosion lowered the outlet channel by approximately 22–25 m depending on the grain size distribution. This amount of erosion agreed well with field observations (Figs. 8b and 12e) and confirmed that the GLOF was triggered by the overtopping wave causing a failure of the terminal moraine.

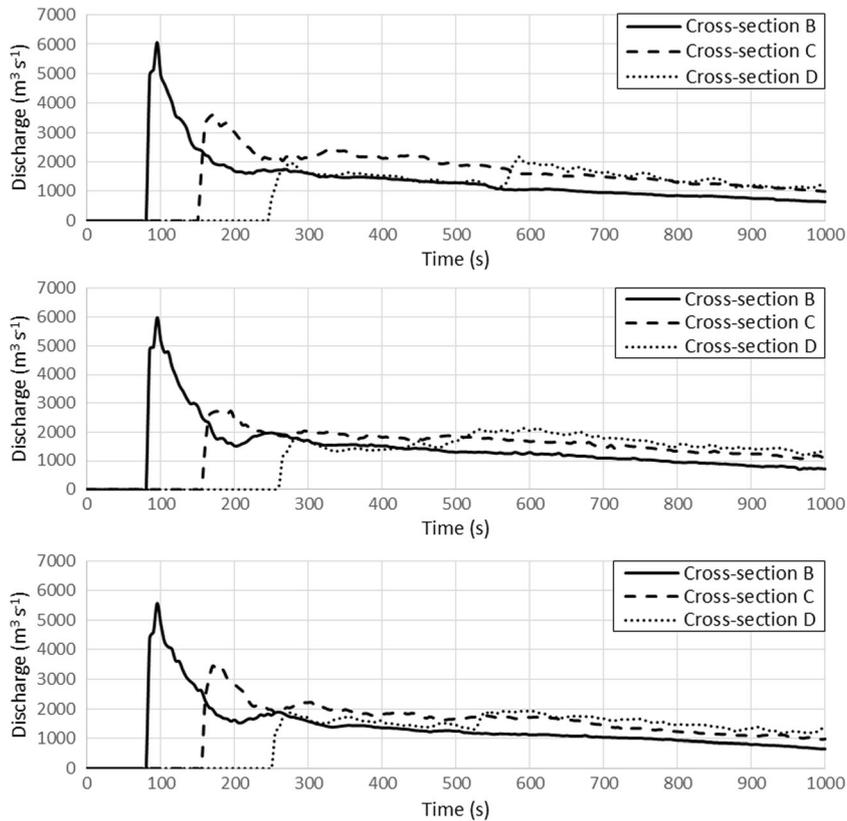
Fig. 10 GLOF modeling results showing discharge at cross sections B, C, and D (see Fig. 6) for grain size distributions from Worni et al. (2013) A (top) and Worni et al. (2013) B (bottom)

Peak discharge from BASEMENT, $5985 \text{ m}^3 \text{ s}^{-1}$, $3456 \text{ m}^3 \text{ s}^{-1}$, and $2152 \text{ m}^3 \text{ s}^{-1}$ for cross sections B, C, and D, respectively (Fig. 10), also agreed with observed estimates (Table 3). Due to the limited spatial extent of the DEM used for the GLOF model, cross sections E, F, and G were not analyzed. Despite these differences of up to 3 m in erosion at the moraine, the peak discharge at the

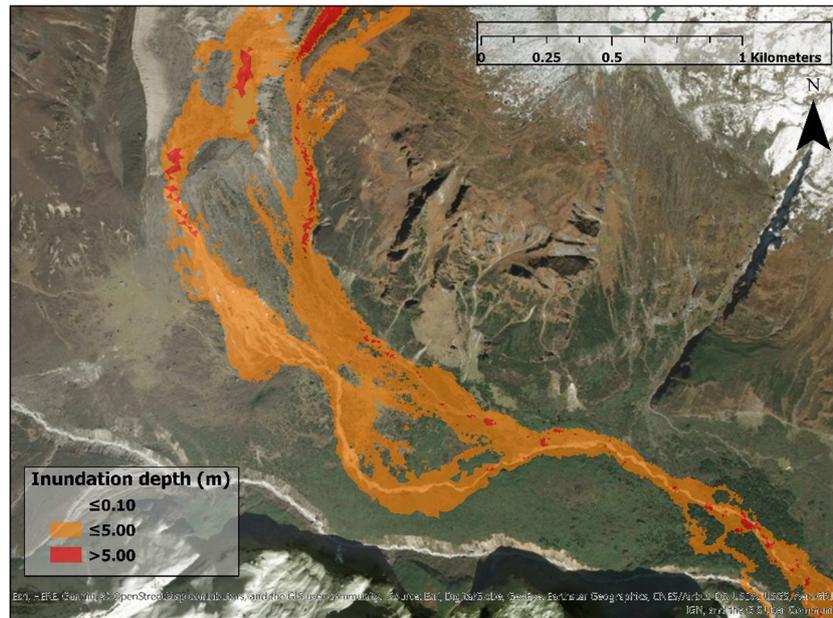
Fig. 11 Maximum inundation depth downstream of Langmale glacial lake from BASEMENT simulation

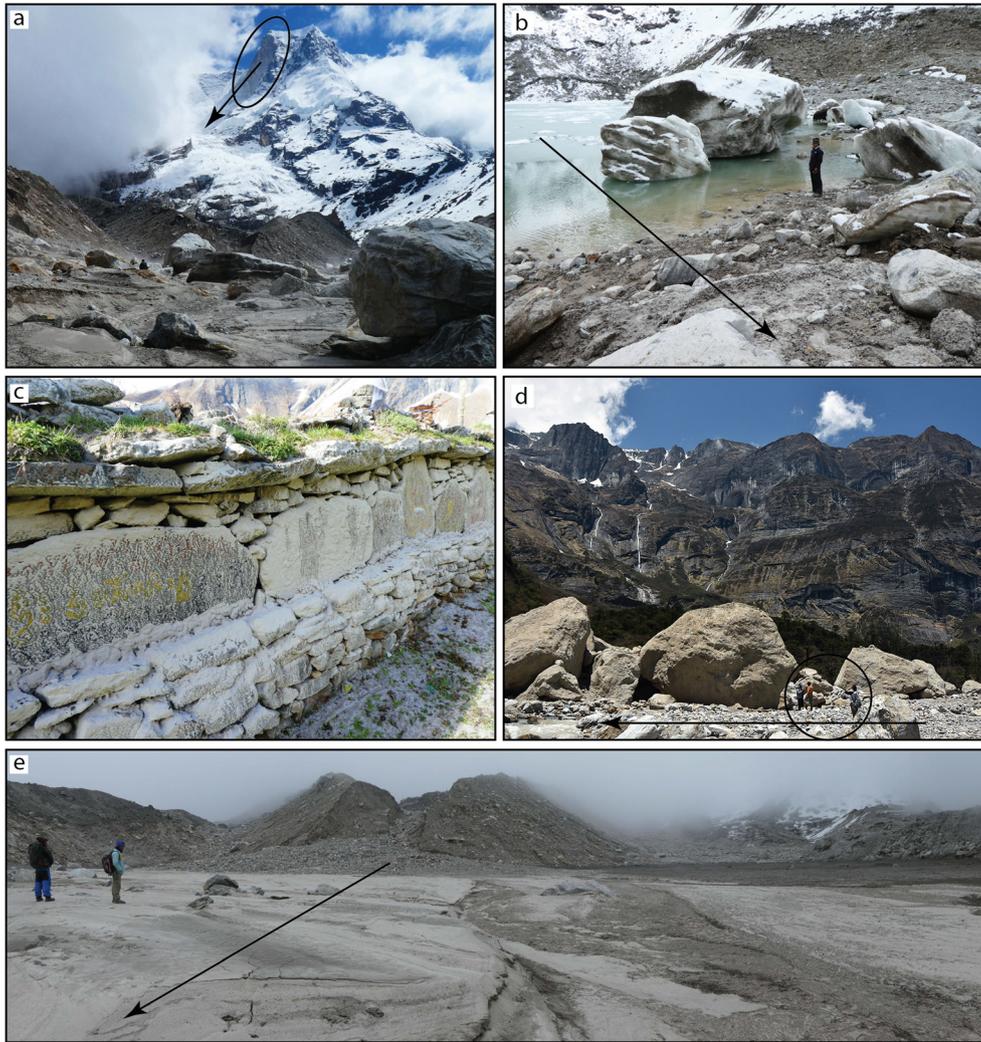
Fig. 12 a The rock face that fell from the upper slopes of Saldim Peak and newly deposited boulders in the foreground below the dam breach. b The large ice blocks from the avalanche that were deposited in the remains of Langmale glacial lake. c Sandy deposits from pulverized rock that settled over all surfaces for several kilometers. d The 10+-m-diameter boulders that were deposited by the flood near Nhe Kharka (photograph by C. Carpenter). e The lakebed sediment and debris that covered the basin below the Langmale terminal moraine as well as the basins to the west and east. The arrow in a shows the direction of rockfall from the west face of Saldim Peak; and arrows in b, d, and e show the direction of water flow (all photographs by A. Byers except for photograph d)

downstream from a steep section of the Barun river to the vicinity of Nhe Kharka (Fig. 12d).

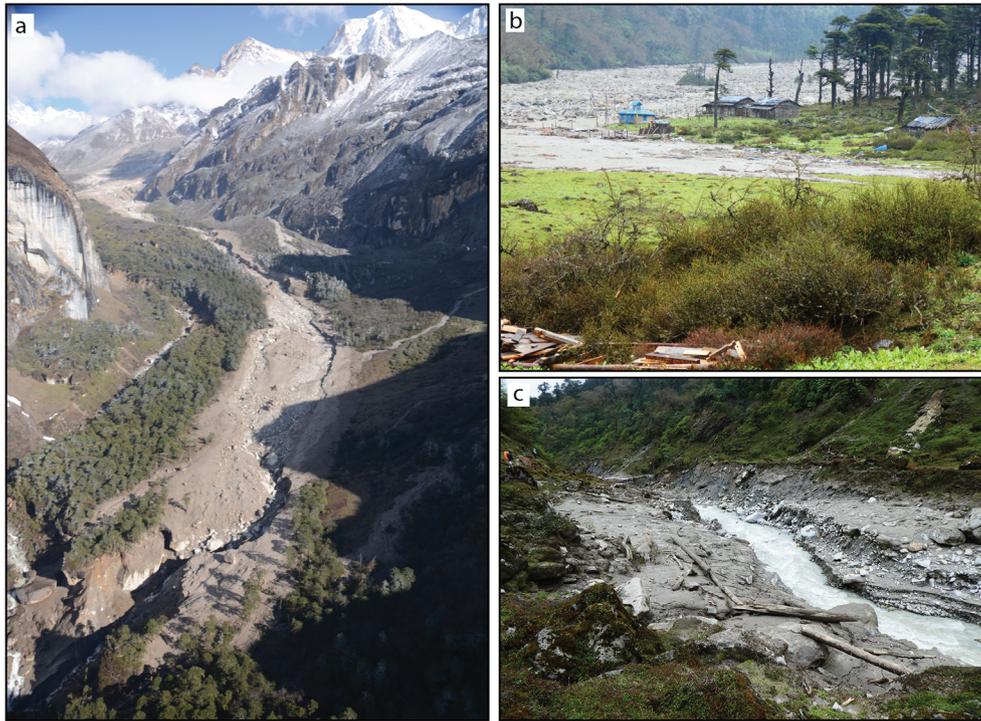
Fig. 13 a The flood path from the air. b The destruction at Yangle Kharka, where four buildings were destroyed. c The narrowed flood channel below Yangle Kharka
