Landslides (2019) 16:1681–1690
 DOI 10.1007/s10346-018-1110-1
 Received: 12 June 2018
 Accepted: 21 November 2018
 Published online: 19 December 2018
 © The Author(s) 2018

Understanding of landslide risk through learning by doing: case study of Koroška Bela community, Slovenia

Potoška planina landslide

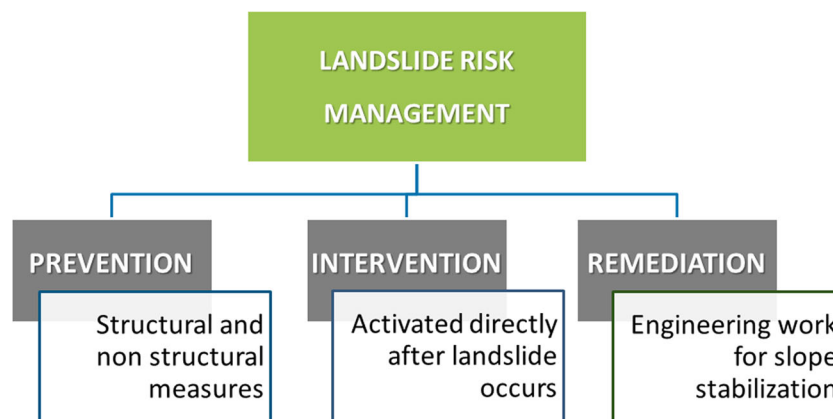
Fig. 1 The general concept of landslide risk management in Slovenia

The current protection strategy against landslides is a part of The Waters Act (Official Gazette of RS 2002), which follows the Water Frame Directive of the European Parliament and Council 2000/60/EC, where developments in landslide-prone areas are specified primarily in terms of adverse effects of water—meanwhile, spatial planning in areas that could be the source of or stand to increase the risk of landslides is entirely overlooked. However, landslide risk management in Slovenia generally follows the guidelines of the Sendai Framework for Disaster Risk Reduction 2015–2030 (Fig. 1).

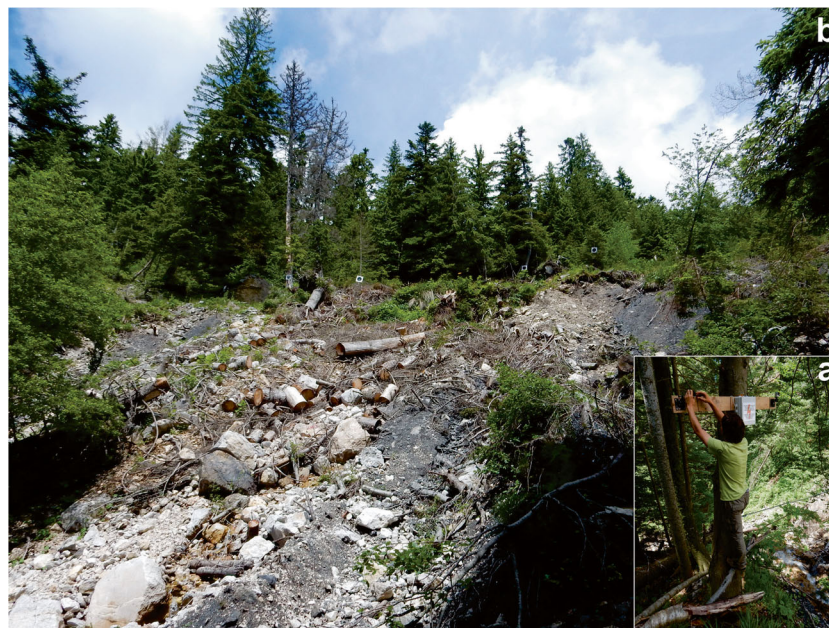
Fig. 5 a Installation of 3D cameras at the observing point 5 at the lower part of landslide (Fig. 4a). b The view of the lower part of landslide from the point, where cameras were placed

At the location of point 5, the 3D cameras were utilised for the real-time monitoring of the lower part of Potoška planina landslide where the Bela stream increases the possibility of mobilisation of the material into debris flow (Fig. 5). The local members of the cooperative team were responsible for camera performance and battery replacement, while the members from geodetic company provided cameras and software (Peterman 2018).
