## Structurally controlled rock slope deformation in northern Norway

**Abstract** Gravitational forcing of oversteepened rock mass leads to progressive failure, including rupture, creeping, sliding and eventual avalanching of the unstable mass. As the point of rupture initiation typically follows pre-existing structural discontinuities within the rock mass, understanding the structural setting of slopes is necessary for an accurate characterisation of the hazards and estimation of the risk to life and infrastructure. Northern Norway is an alpine region with a high frequency of large rock slope deformations. Inherited structures in the metamorphic bedrock create a recurring pattern of anisotropy, that, given certain valley orientations, causes mass instability. We review the geomorphology, structural mechanics and kinematics of nine deforming rock slopes in Troms County, with the aim of linking styles of deformation. The limits of the unstable rock mass follow either foliation planes, joint planes or inherited faults, depending on the valley aspect, slope angle, foliation dip and proximity to fault structures. We present an updated geotechnical model of the different failure mechan

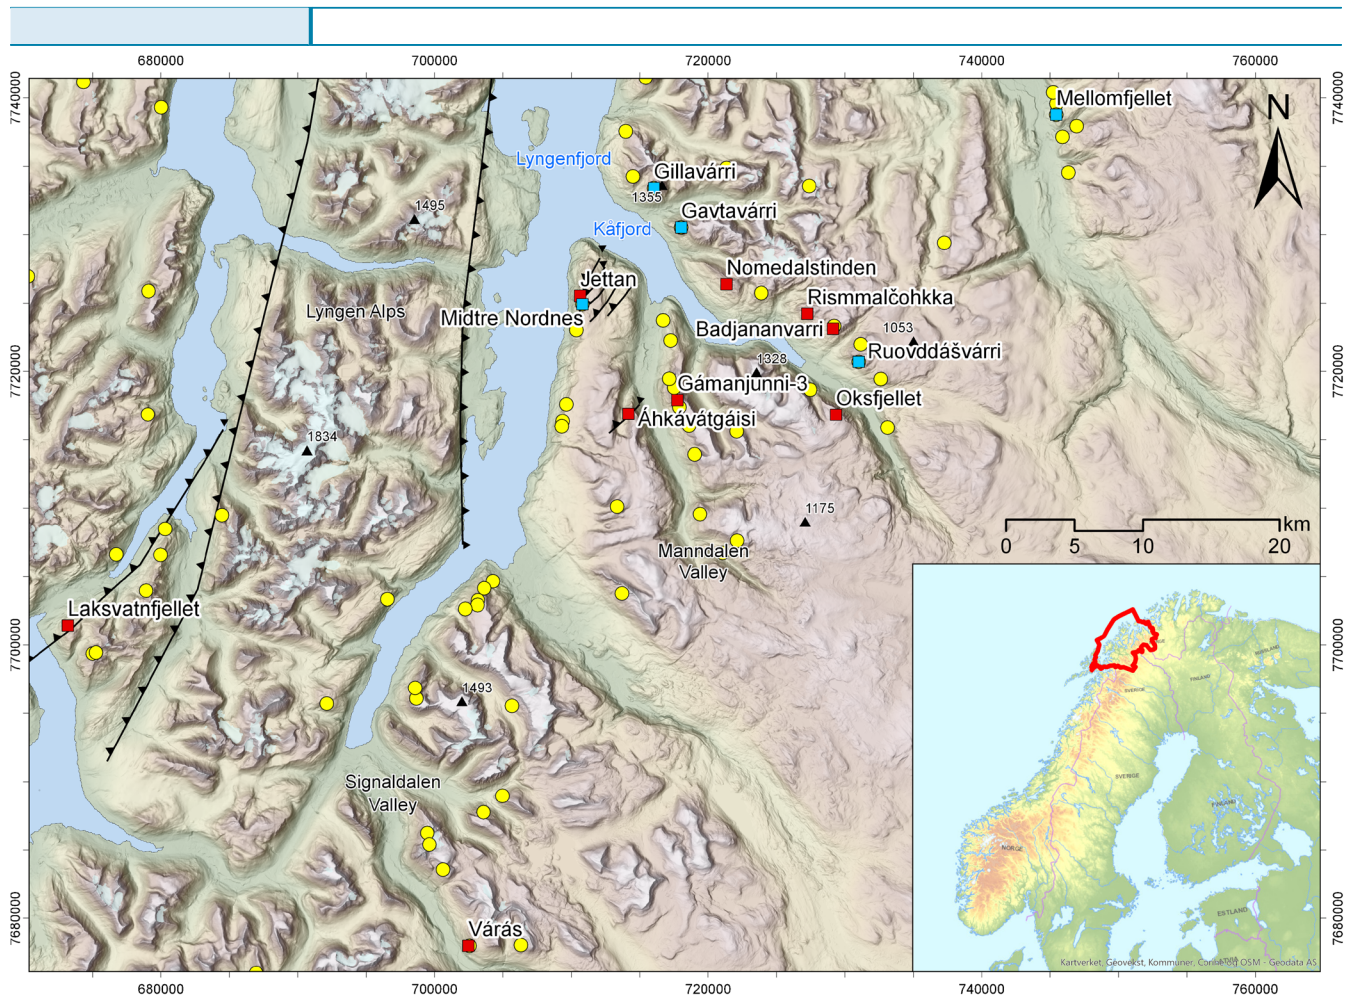
**Fig. 1** Relief map of central Troms. Map displays the location of mapped RSDs (yellow dots, NGU 2019a), sites discussed in this contribution (red squares) and other sites mentioned (blue squares). Faults presented here are only those discussed in this paper. The Lyngen Fault complex borders the Lyngen Alps (after Osmundsen et al. 2009), the Laksvatn Fault goes through Balsfjord and towards the western Lyngen Fault (after Davids et al. 2013) and the fault traces across Laksvatnfjellet and at Áhkávátgáisi (Bunkholt et al. 2013b). Inset shows the location of Troms County (red polygon) in Norway. Grid in UTM33

Deglaciation of the fjords in the map area (Fig. 1) occurred between 11 (western margin) and 9.7 ka (eastern margin; icemap.no; Patton et al. 2017). Subsequent paraglacial processes have reshaped the landscape (Ballantyne 2002; Jarman 2009). Extensive dating records across Norway indicate an instability response in rock slopes following ice retreat and again during the Holocene climate optimum. From then, landslide activity has remained consistent (Hermanns et al. 2017). The cluster of identified rock glaciers in the area (Lilleøren and Etzelmüller 2011) illustrates the cryo-conditioning of the landscape evolution (Berthling and Etzelmüller 2011). Exposure dating of the backscarp of an active RSD in this study (Gámanjunni-3) suggests displacement initiated between 6.6 and 4.3 ka (Böhme et al. 2019), indicating that rockslides in the area have a long deformation history conditioned by Holocene climatic events. Peaks in Holocene landslide activity have also been attributed to periods of seismic activity due to isostatic uplift (Bøe et al. 2004). The Baltic Shield is generally thought to be aseismic; however, some evidence of neotectonics have been reported in northern Norway. Associated earthquakes could trigger mass slope failure in the region (Olesen et al. 2004, 2013).

The three sites discussed in this category are found in the Kåfjord valley (Fig. 1). The valley aligns NW–SE, with a local foliation dip measured at the head of the mountains between 30 and 40° to SW, making the northern flank of the fjord ideal for foliation-controlled rear rupture.

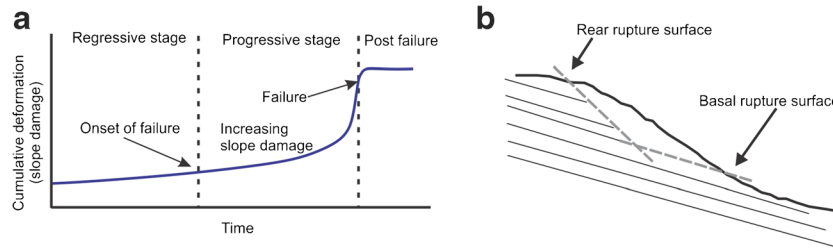
**Fig. 2** a Stages of slope failure modified after Stead and Eberhardt (2013) and Dick et al. (2015). The onset of failure occurs at the transition between the regressive and progressive stages at which time the rate of damage increases in the rock slope. b A compound rockslide model indicating the rear and basal rupture surface as the major bounding structures of a rockslide. Modified after Glastonbury and Fell (2010)

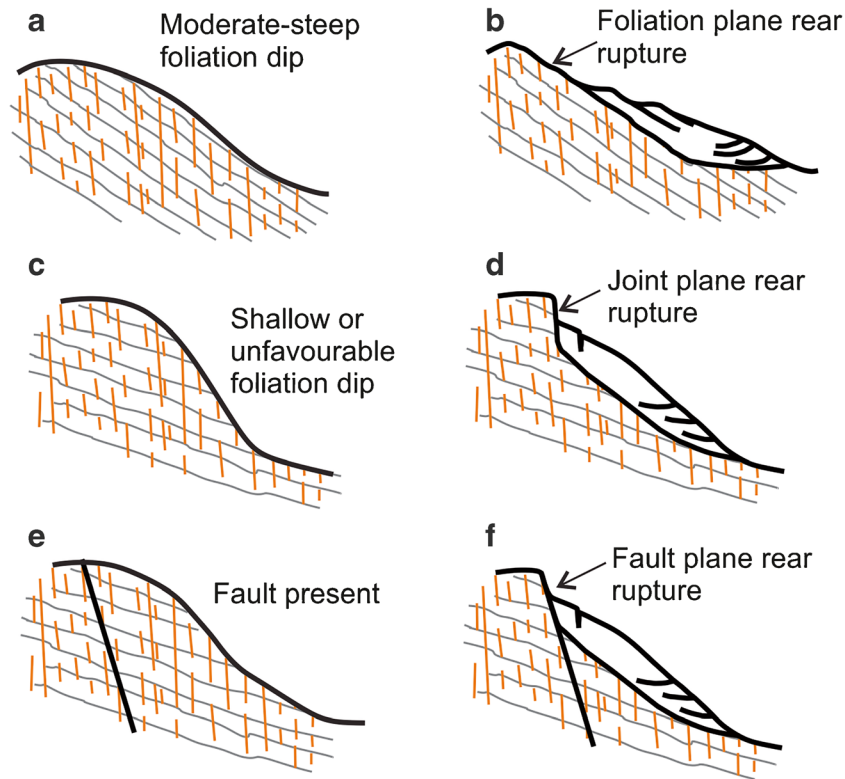
**Fig. 3** Schematic overview of foliation orientations and subsequent failure mechanisms. At all sites, joint sets are vertical to subvertical, but foliation varies. **a** Foliation dips moderately to steeply with the slope, this allows kinematically for foliation-parallel sliding at the head of the slope (**b**). In scenario **c**, the foliation dip is shallow; however, it could also be horizontal or dipping into the slope **e** Foliation dip is shallow and a fault is present, rupture at the head of the slope utilises the fault plane (**f**)

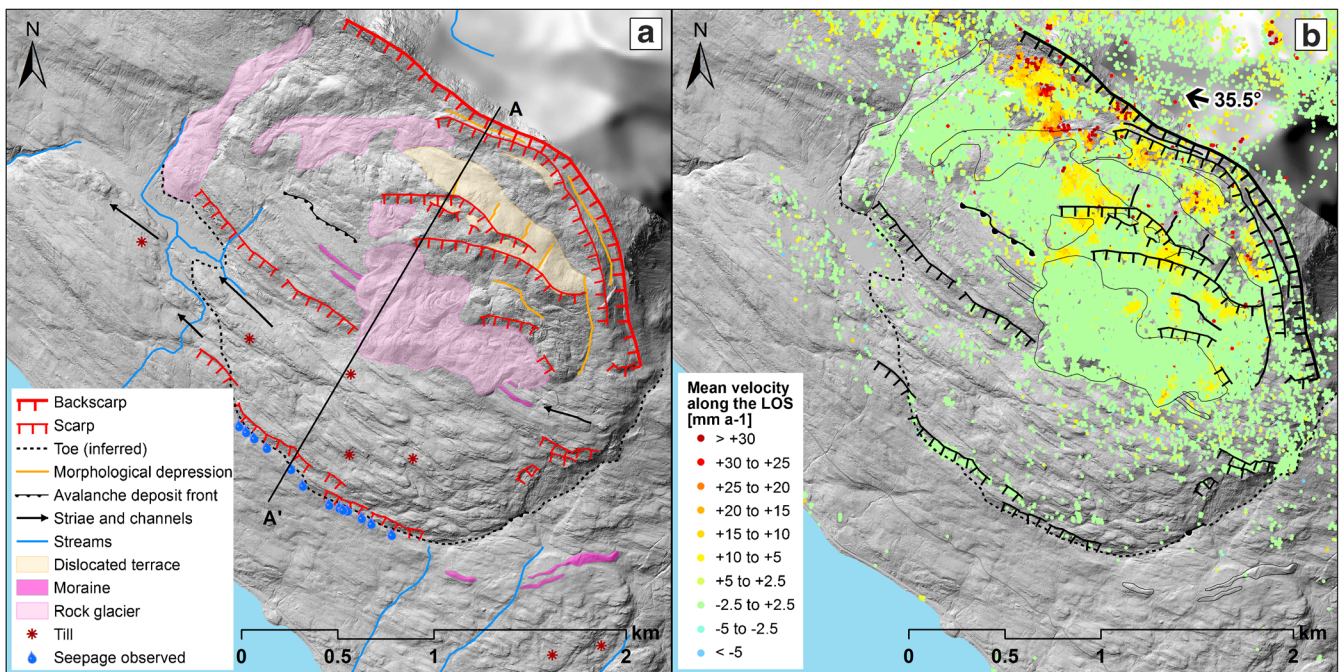
**Fig. 4** **a** Morphostructure and location of A–A' profile. **b** InSAR mean velocity [ $\text{mm a}^{-1}$ ] along line-of-sight (LOS) in descending geometry (orientation of black arrow: LOS azimuth angle, label: LOS incidence angle; NGU 2019b). Background: hillshade based on 0.5 m ALS-derived digital elevation model

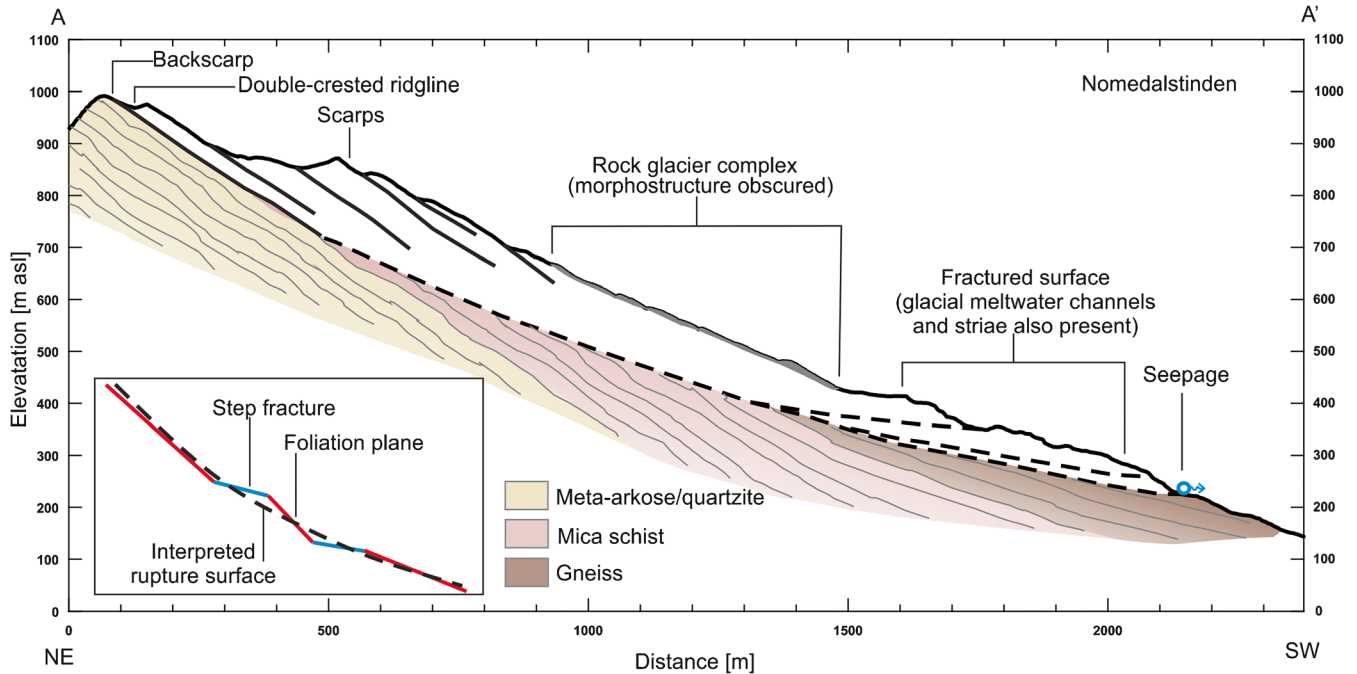
**Fig. 5** A–A' cross section of Nomedalstinden based on 0.5 m DEM (location on Fig. 4), showing exposed foliation-parallel sliding surfaces. Mapped rupture surfaces indicated by heavy black lines, and inferred rupture surfaces indicated by a dashed line. Inset is showing structural configuration of the rupture plane. Glacial geomorphology is based on Tolgensbakk and Sollid (1988) and geology on Zwaan et al. (2006)

Through the central section of the unstable area, the morphostructure is obscured by several rock glacier units, their presence indicating a supply of material from localised rock avalanche and rockfall events in the upper portion of the RSD. The lower portion of the slope contains some minor scarps, frequent open surface fractures, localised rockfalls and groundwater seepage. The toe of this slide is interpreted from buckling observed in the slope morphology and by following the clear line of the back scarp at the SE side downwards. Small streams seeping from the toe 'line' confirm that a dominant structure daylight here, and surface cracking and rockfall activity indicates localised deformation taking place. A compound slide mechanism is proposed, where the rupture surface follows steep foliation at the rear and shallow foliation at the base. Projecting the uppermost rupture surface to the inferred toe point indicates a transfer in the centre of the RSD to allow for load transfer from rear to base. This may be accommodated by low-angle step fractures, or locally varied foliation which cannot be mapped at the surface due to surficial material coverage (Fig. 5).

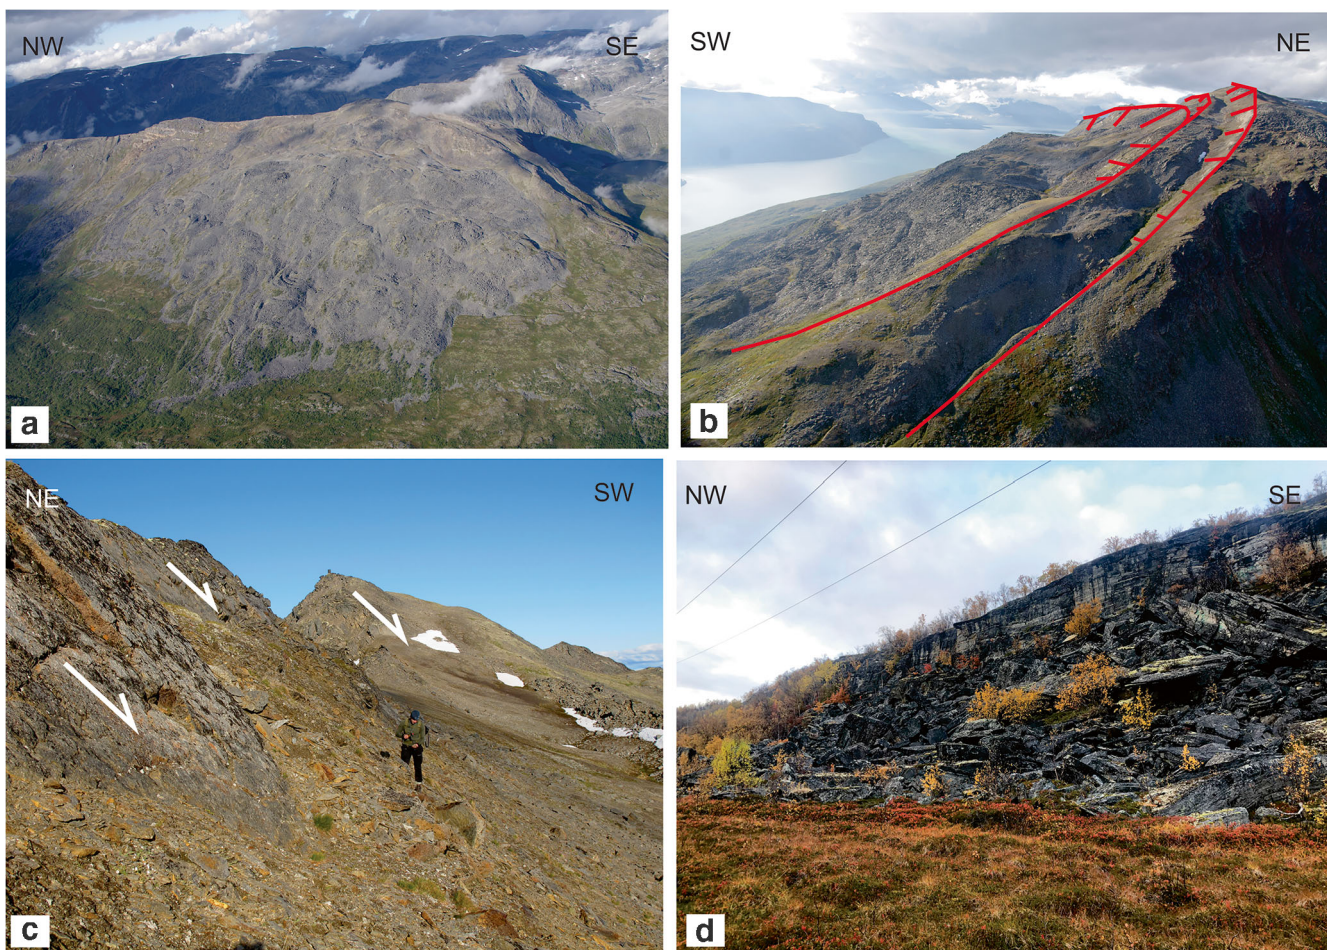
**Fig. 6** a Overview photo of Nomedalstinden (Hermanns 2016). b View across double-crested ridgeline (Hermanns 2016). c Headscarp structure as exposed foliation plane (Bergh 2010). d Cliff face representing inferred toe of the slide. Small streams were observed seeping from the base of the cliff (Vick 2019)

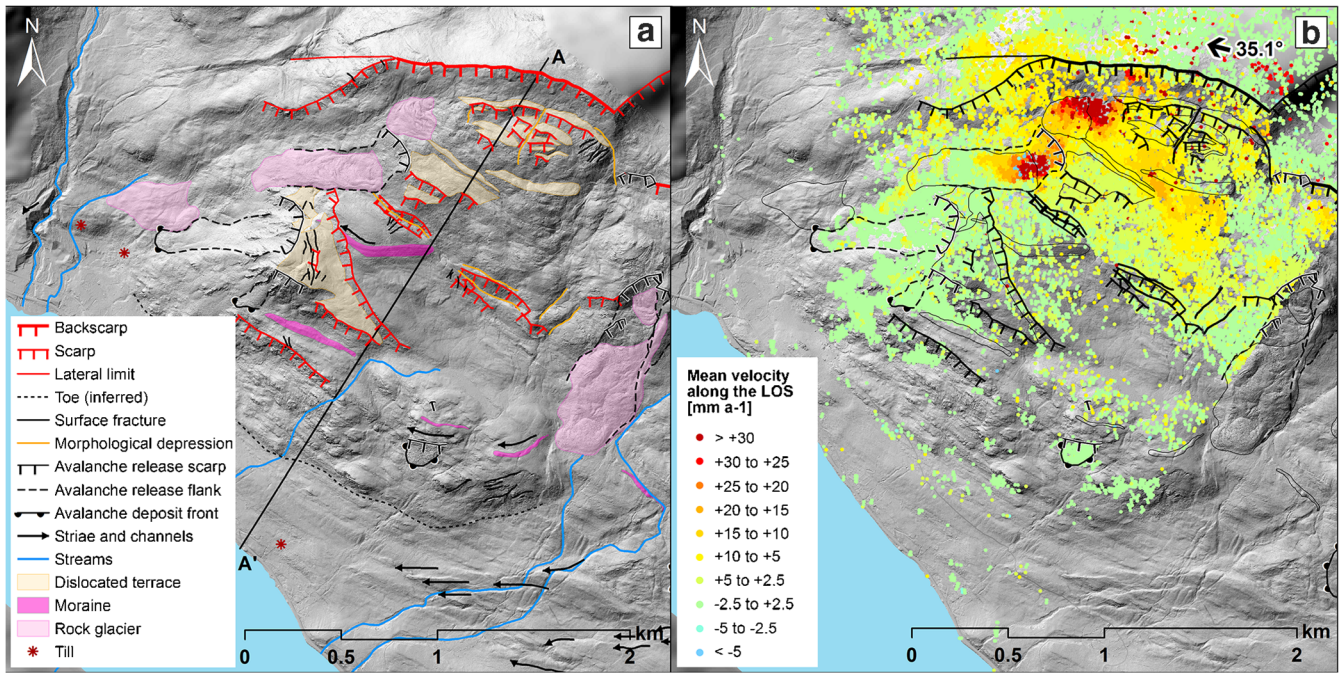
**Fig. 7** a Morphostructure and location of A–A’ profile. b InSAR mean velocity [mm a<sup>-1</sup>] along line-of-sight (LOS) in descending geometry (orientation of black arrow: LOS azimuth angle, label: LOS incidence angle; NGU 2019b). Background: hillshade based on 0.5 m ALS-derived digital elevation model

The NW end of the grabens delimits a bedrock knob below, the graben indicating slight dislocation of the knob has occurred. Slope damage is accumulating within the knob, evidenced by its fractured surface and small avalanche scars (Fig. 7a). In the lower SE section of the mountain, the terrain is smoothed, with glacial geomorphic features present including moraines and meltwater channels (Tolgensbakk and Sollid 1988). Some of the glacial features are dissected by morphostructure, confirming post-glacial deformation.

No clear toe has been mapped; however, some surface fracturing is apparent in the bedrock of the lower slope, and a slope break indicates that the surface is buckled (Figs. 7 and 8). The toe line has been inferred at the slope break and delimits the extent of observable deformation (Figs. 7 and 9d). It is possible that the basal rupture surface daylight in the fjord basin, or possible there is no clear toe at all, a diagnostic characteristic of DSGSD (Agliardi et al. 2012). The foliation shallows towards the inferred toe with respect to the slope direction ( $16^\circ$  apparent dip in cross section A-A', Fig. 8). Therefore, the rear rupture surface likely transitions to a basal rupture surface which follows the foliation (as mapped at the scarp) and some low-angled step fractures to achieve daylighting in the surface at the toe. A toe line has been inferred which divides rough hummocky terrain from smoothed flatter terrain near the fjord; however, no clear indications of a daylighting toe have been mapped.

As for Nomedalstinden, the InSAR LOS is not ideal for capture of SW horizontal movement (black arrow, Fig. 7b). However, areas affected by horizontal westward and vertical components of movement can be highlighted. The central upper part of the slope shows a homogeneous pattern of low velocities ( $2.5\text{--}15 \text{ mm a}^{-1}$  along LOS). The upper terraces show higher velocities ( $15\text{--}20 \text{ mm a}^{-1}$  along LOS). The moving areas align with the mapped structures;

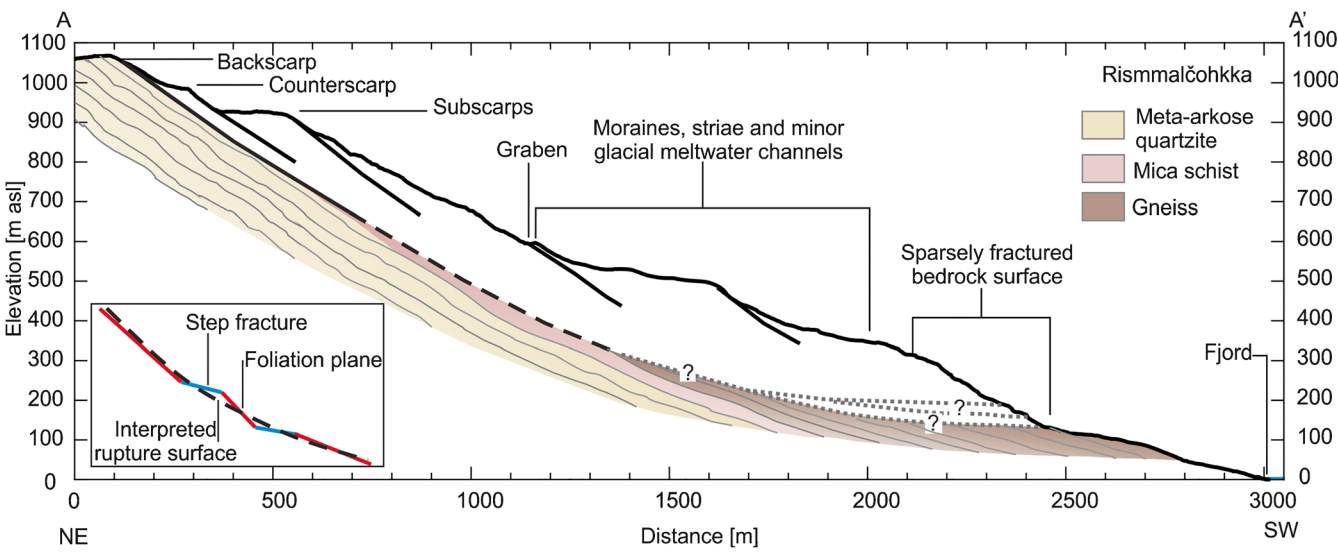
**Fig. 8** A–A’ cross section of Rismmalčohkka, based on 0.5 m DEM (location on Fig. 7), showing exposed foliation-parallel sliding surfaces. Mapped rupture surfaces indicated by heavy black lines, inferred rupture planes indicated by a dashed line, uncertain rupture surfaces by a dotted line. Inset is showing structural configuration of the rupture plane. Glacial geomorphology is based on Tolgensbakk and Sollid (1988) and geology on Zwaan et al. (2006)

high and 1.5 km long (Figs. 8 and 9a). The rupture surface contains downslope movement indicators and is heavily oxidised.

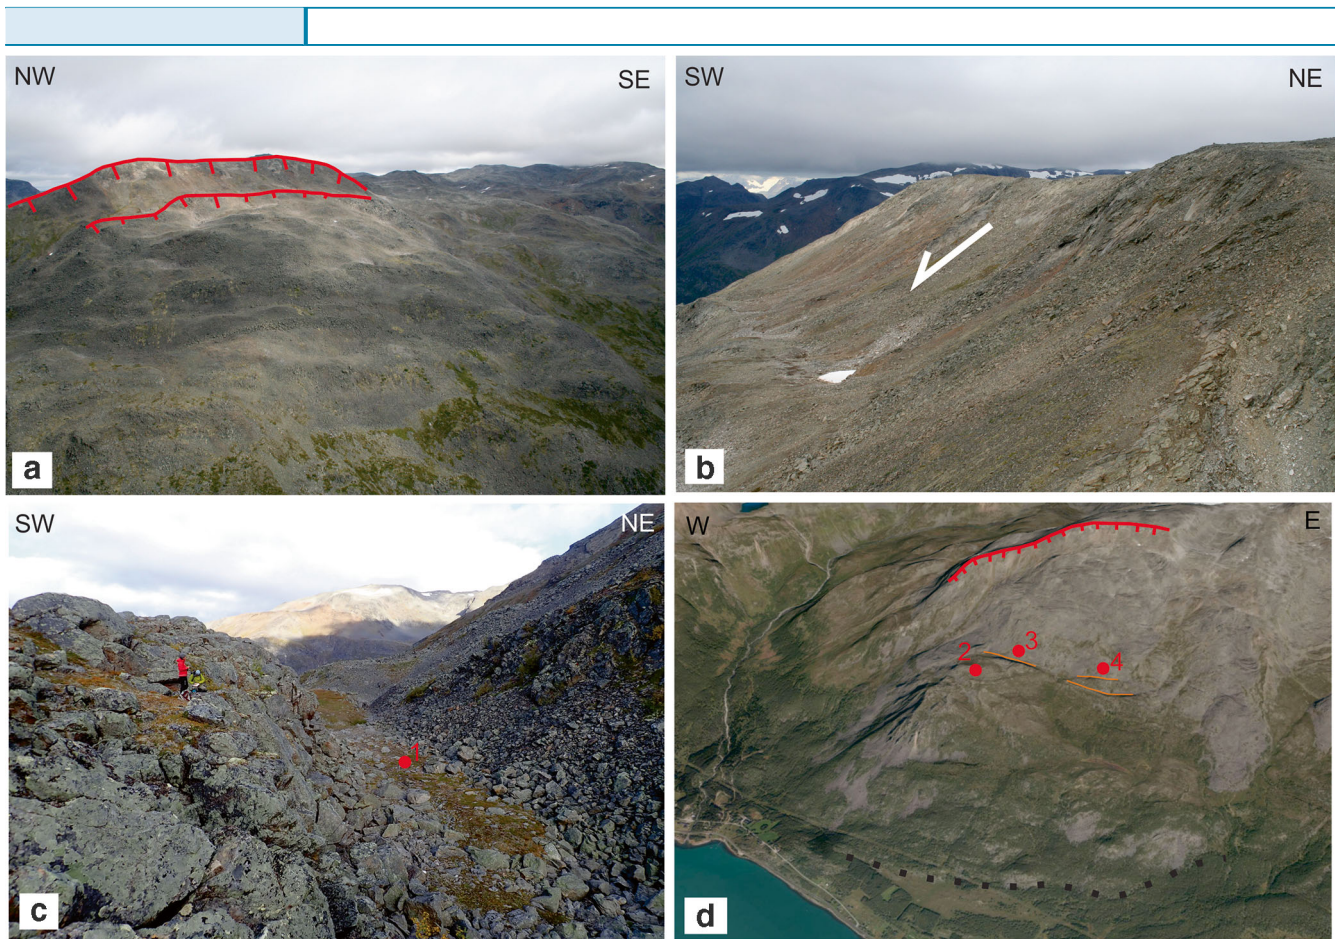
**Fig. 9** a Overview photo of Rismmalčohkka indicating the backscarp (Henderson 2007). b Looking across the exposed backscarp of Rismmalčohkka, indicating sliding direction and a thin dislocated terrace below (Henderson 2007). c A graben structure from the central slope, with the preserved surface of the graben indicated by 1 (Bredal 2018). d 3D overview of Rismmalčohkka. 2. Top of the bedrock knob, delimited by graben structures indicated by 3 and 4. Inferred toe indicated by dotted black line (Kartverket 2019b)

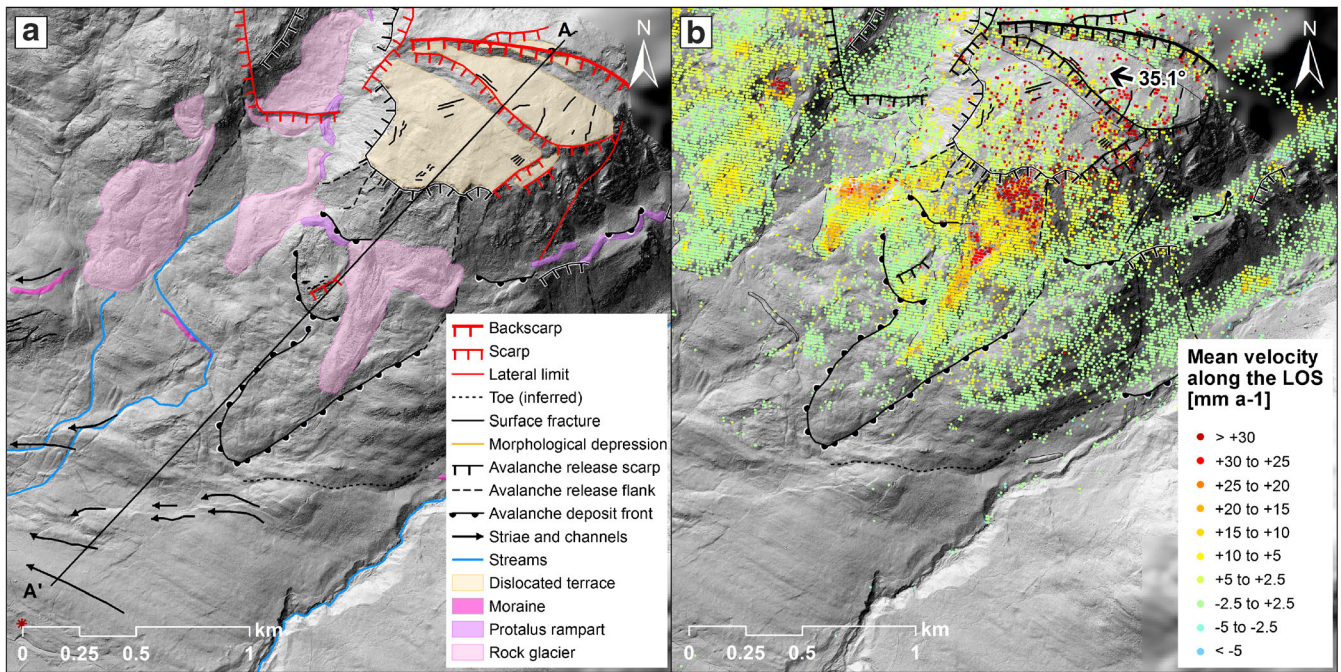
**Fig. 10** a Morphostructure and location of A–A' profile. b InSAR mean velocity [mm a<sup>-1</sup>] along line-of-sight (LOS) in descending geometry (orientation of black arrow: LOS azimuth angle, label: LOS incidence angle; NGU 2019b). Background: hillshade based on 0.5 m ALS-derived digital elevation model

While a toe line has been inferred (Figs. 10 and 11), surficial deposits make it difficult to delineate any evidence of compression. It is possible that the rupture path is less developed within the lower gneisses than the above schistose material. The slope surface is significantly shallower than the foliation dip, and therefore, the rupture surface would require a combination of foliation (as mapped at the scarp) and low-angled step fractures to achieve daylighting in the surface, regardless of where in the profile it may daylight.

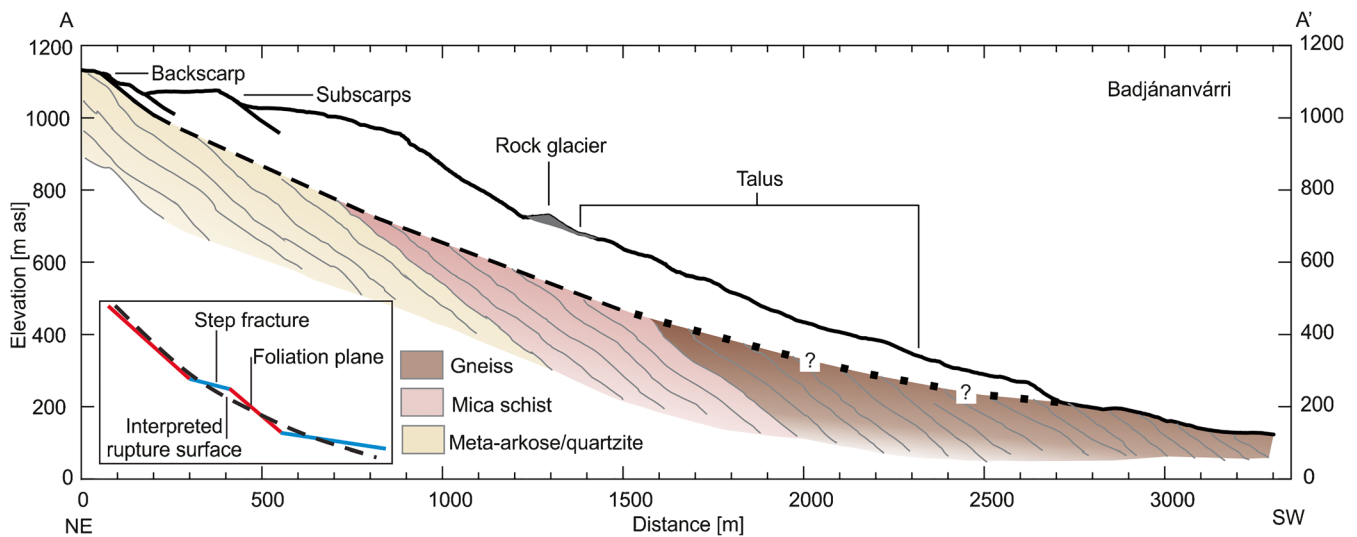
**Fig. 11** A–A' cross section of Badjananvarri, based on 0.5 m DEM (location on Fig. 10), showing exposed foliation-parallel sliding surfaces. Mapped rupture surfaces indicated by heavy black lines, inferred rupture planes indicated by a dashed line, uncertain rupture surfaces by a dotted line. Inset is showing structural configuration of the rupture plane. Glacial geomorphology is based on Tolgensbakk and Sollid (1988) and geology on Zwaan et al. (2006)

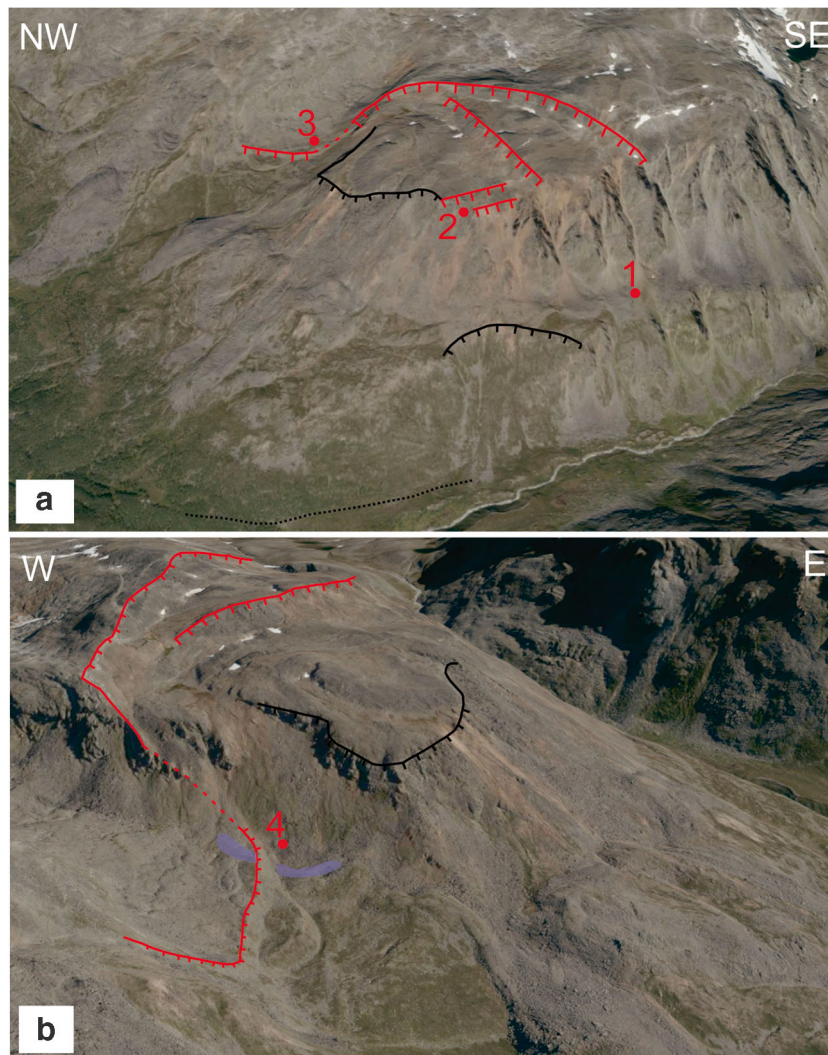
**Fig. 12** a A view of Badjånánvárri to the NE, showing scarps (red) and avalanche release areas (black). 1 indicates a ledge formed by the competence difference between the mica schist above and gneiss below. 2 indicates lateral spread of the main terrace into the valley E. 3 indicates the scarp which crosscuts the Litledalen valley towards Rismmalčohkka. The scarp offsets a rock glacier. b A view of Badjånánvárri to the N. 4 indicates a scarp offset of surficial deposits. Images captured from [www.norgebilder.no](http://www.norgebilder.no)

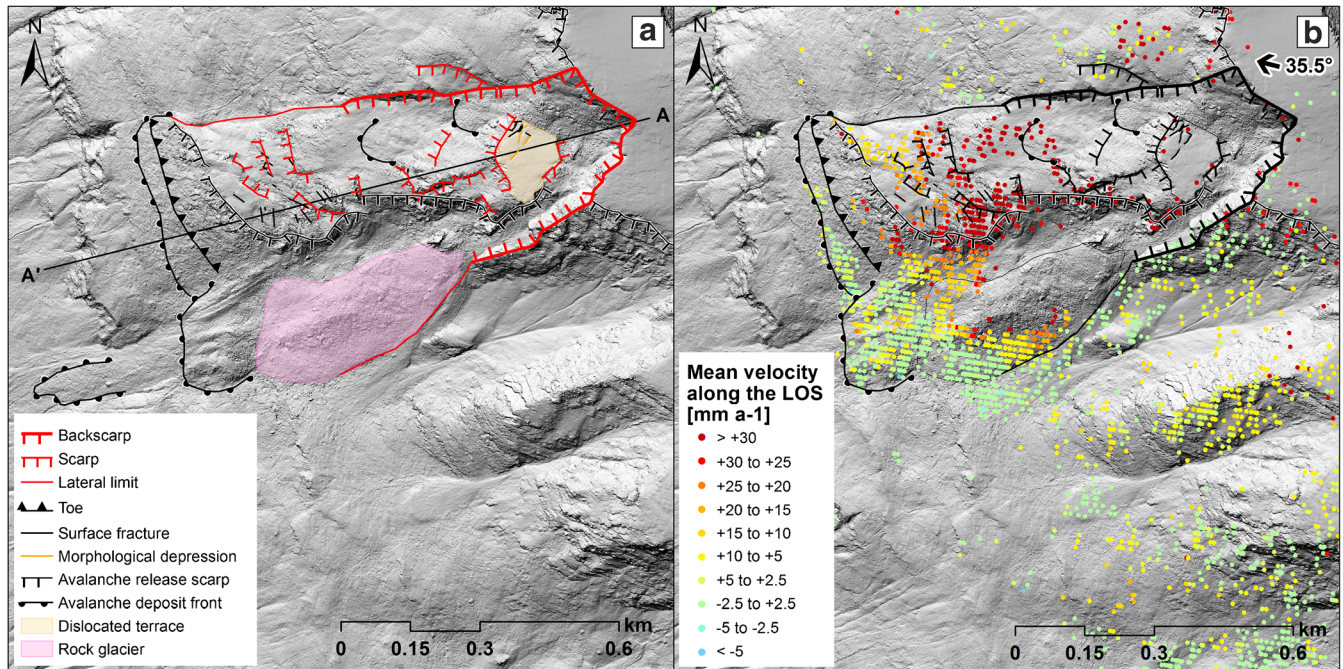
**Fig. 13** a Morphostructure and location of A–A' profile. b InSAR mean velocity [ $\text{mm a}^{-1}$ ] along line-of-sight (LOS) in descending geometry (orientation of black arrow: LOS azimuth angle, label: LOS incidence angle; NGU 2019b). Background: hillshade based on 0.5 m ALS-derived digital elevation model

The InSAR LOS is subparallel to the slope, good for movement detection (black arrow, Fig. 13b). However, parts are decorrelated due to fast and nonlinear displacement rates (e.g. the rock glacier in the

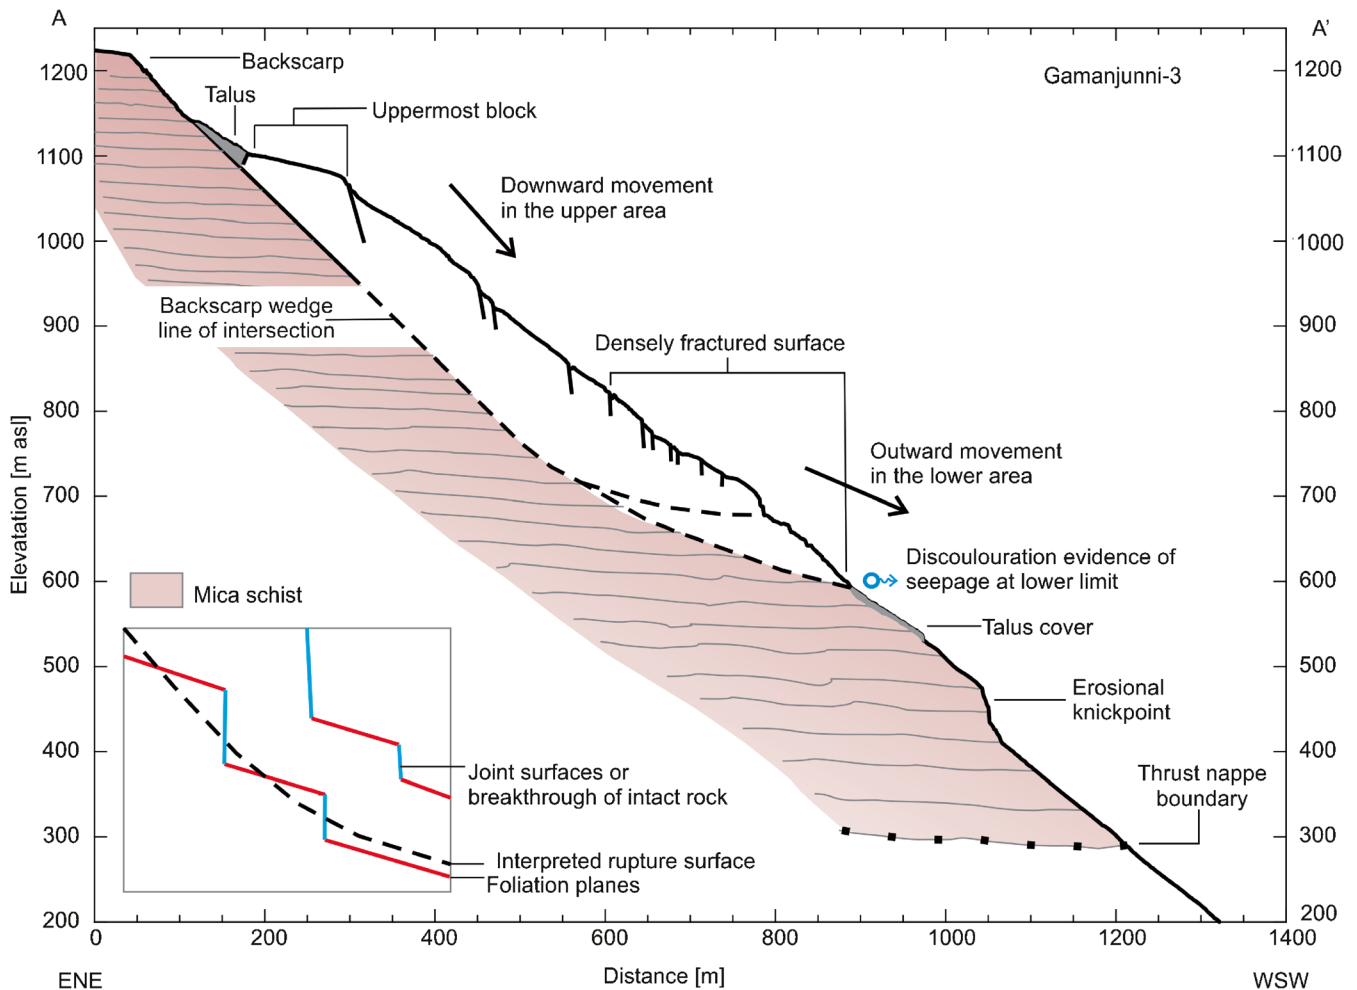
**Fig. 14** A–A' cross section of Gámanjunni-3, based on 0.5 m DEM (location on Fig. 13), showing exposed rupture planes. Mapped rupture planes indicated by heavy black lines, and inferred rupture planes indicated by a dashed line. Movement vectors (black arrow) derived from 2D InSAR (Eriksen et al. 2017b). Geology based on Quenardel and Zwaan (2008)

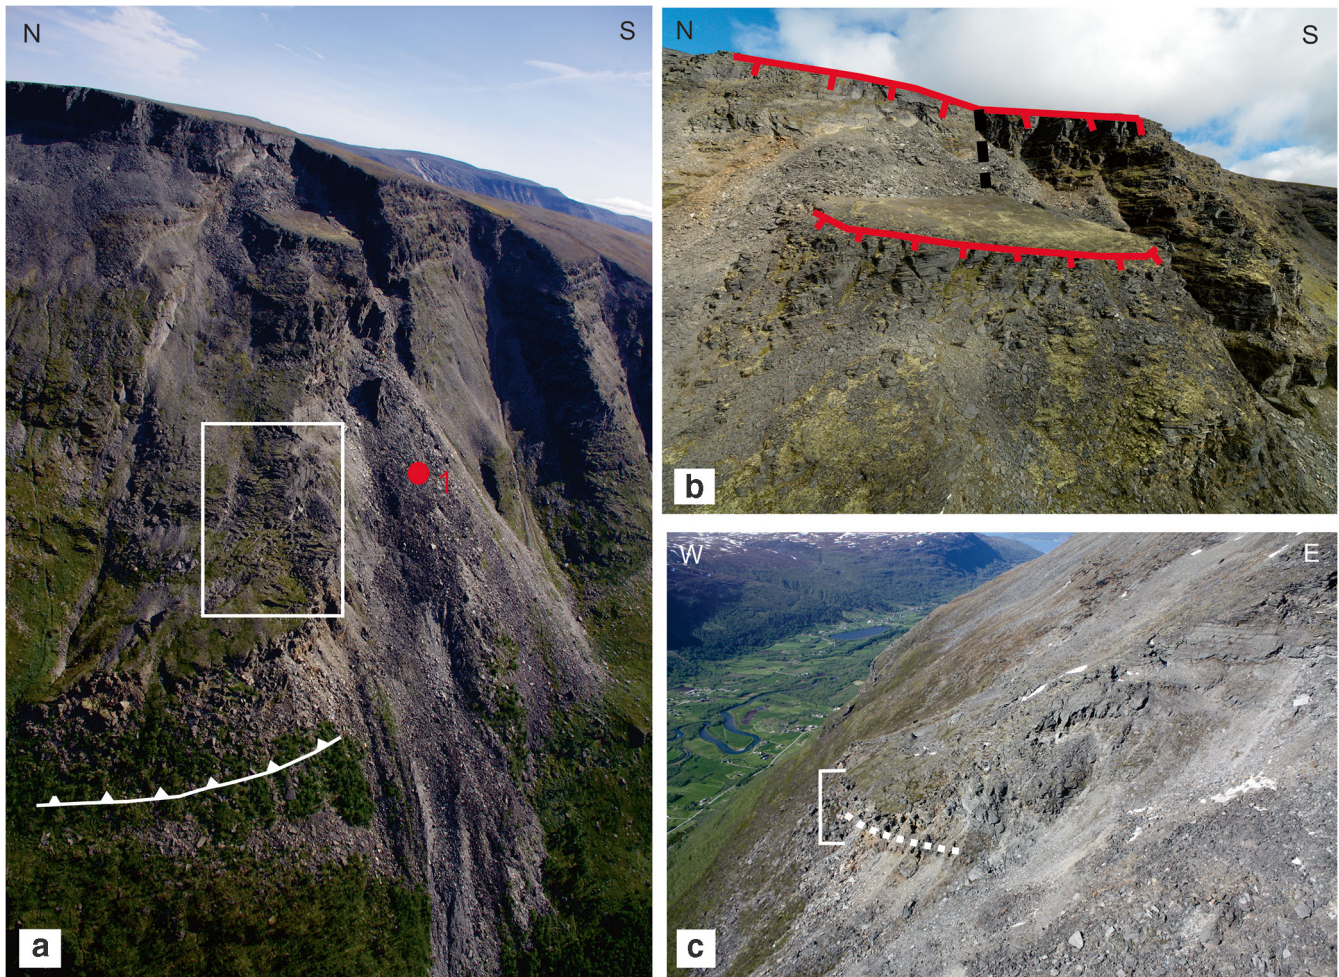
**Fig. 15** a Overview photo of Gámanjunní-3 from the south (Bunkholt 2010). White box indicates area of high surface fracture density, toe indicated by a white line. 1 indicates rock glacier. b Backscarps and uppermost block surface (Solberg 2013). Black line indicates daylighted wedge intersection of orthogonal backscarps. c Toe buckle/thrust of the rockslide indicated by bracket (Bunkholt et al. 2012). White dash indicates line below which rock material is heavily oxidised indicating channelisation of groundwater flow along the basal rupture

buckle and by upturned foliation. It is logical that the basal rupture surface traces around the base of this thrust material. Discolouration of the rock material is seen in the lower half of the exposed toe (Fig. 15c), indicating channelisation of groundwater along the basal rupture.

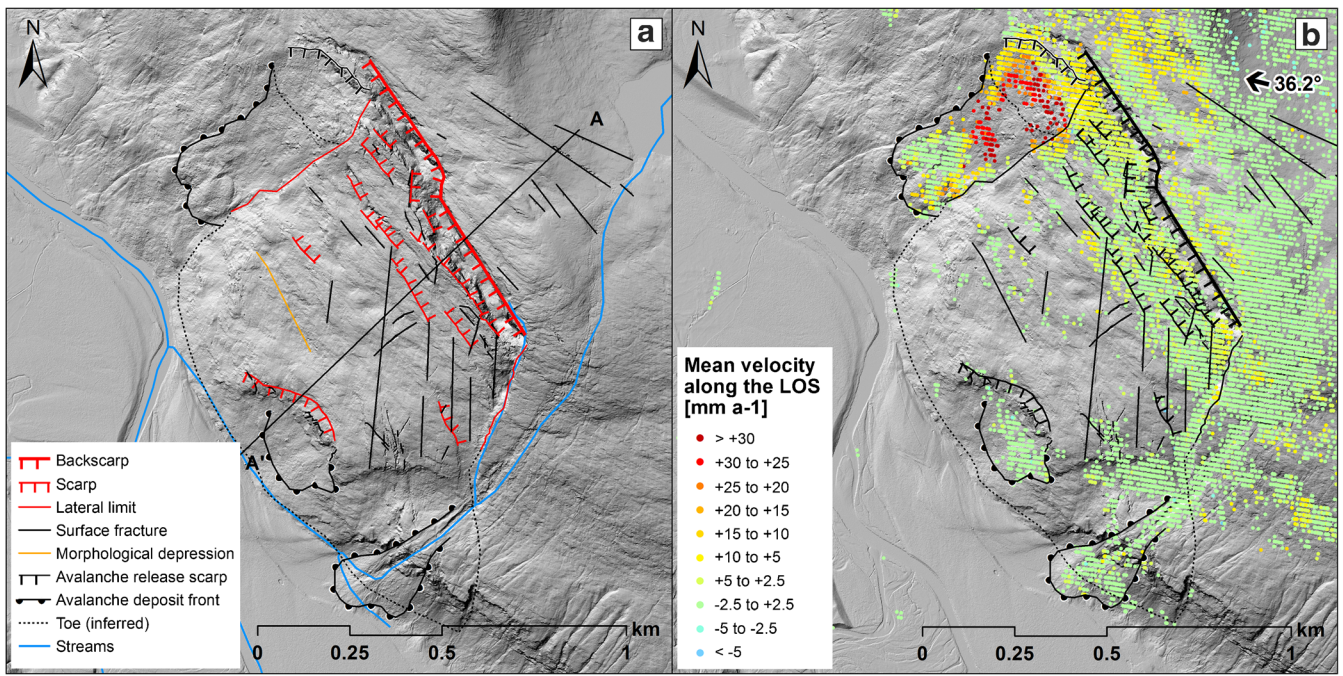
**Fig. 16** a Morphostructure and location of A–A' profile. b InSAR mean velocity [mm a<sup>-1</sup>] along line-of-sight (LOS) in descending geometry (orientation of black arrow: LOS azimuth angle, label: LOS incidence angle; NGU 2019b). Background: hillshade based on 0.5 m ALS-derived digital elevation model

There is a clear buckle in the slope morphology of the mountain, delimited by an inferred toe line at the break before the valley floor (Fig. 16a). Groundwater seeping from the bedrock around the toe has been observed in early summer (Hannus 2012). The inferred toe indicates a possible daylighting basal rupture surface; however, it could also be buried under fluvial sediments deeper within the valley. To daylight in either case, the rupture surface must transfer from steep surfaces at the rear, to low-angle surfaces at the base. The foliation is locally poorly developed, as well as irregular, folded and containing lenses and boudins (Hannus 2012). In some locations, foliation is mapped as horizontal or even dipping into the slope. It is therefore likely that the basal rupture surface comprises step fractures, as well as foliation and joint surfaces (Fig. 17 insert). Forward rotation of the unstable mass

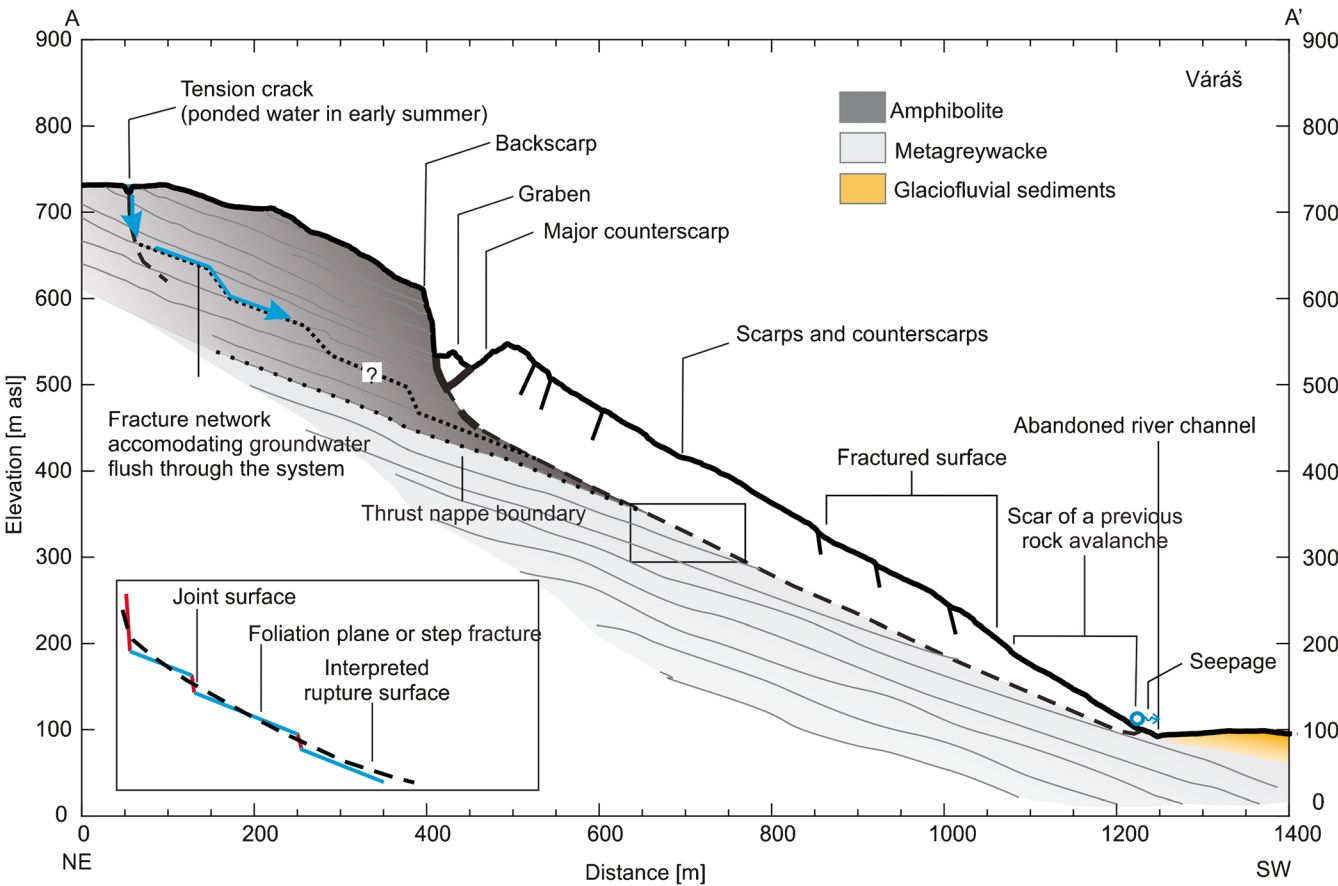
**Fig. 17** A–A' cross section of Várás, based on 0.5 m DEM, showing exposed joint-parallel backscarp (location on Fig. 16). Mapped rupture planes indicated by heavy black lines, and inferred rupture planes indicated by a dashed line. Inset is showing structural configuration of the rupture plane. Geology from Zwaan (1988)

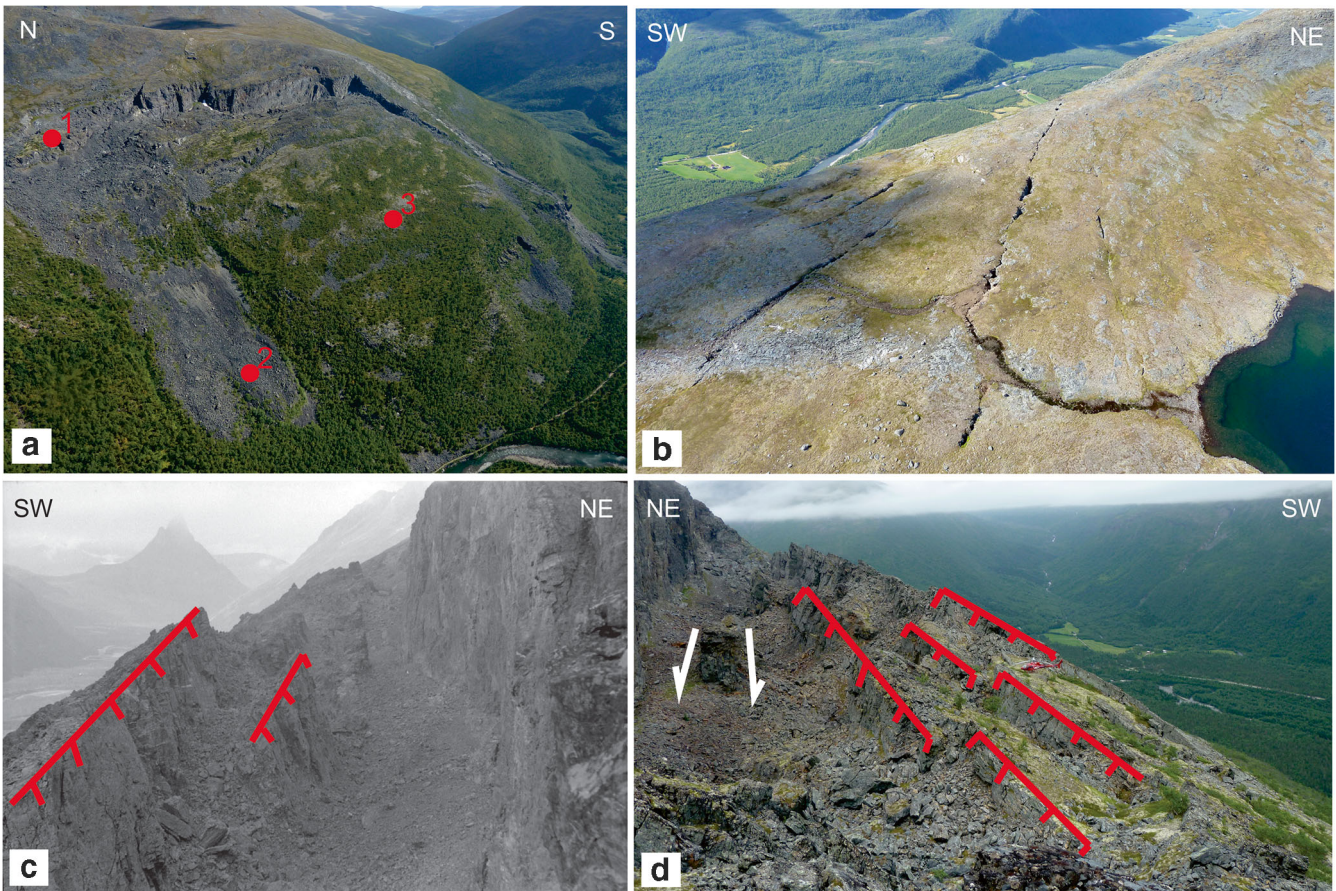
**Fig. 18** a Overview photo of Várás (Bunkholt 2011). Annotation indicates the smaller block of scenario B (1), and previous avalanche events below scenario B (2) and the main unstable area, scenario A (3). b Tension cracks upslope of the unstable area accommodate through-going drainage fed by the lake (Bunkholt 2011). c Backscarp and counterscarp (Corner 1969). d Backscarp, graben and counterscarps formed by downslope movement of unstable mass and subsidence of graben material (Bunkholt 2010)

failure of the entire unstable mass (scenario A), or failure of only the smaller block on the NW limit of the slide (scenario B; Fig. 18a). The volume estimate of A is  $70 \text{ Mm}^3$  and  $1.3 \text{ Mm}^3$  for B (NGU 2019a). Despite these volumes, the consequences connected to a potential failure are considered low (for A) to very low (B) due to the remoteness of the valley. The risk ranking for A is low and for B medium. The site has been investigated since 2008 (Henderson et al. 2010; Hannus 2012; Bunkholt et al. 2013a), and due to the proximity of the failure scenario to the river and dwellings, GNSS monitoring points were installed in 2010 (NGU 2019a).

cracks also align with the main scarp and reach up to 500 m in length (Fig. 18b). The back scarp delimits a large graben (ca 85 m wide) that contains disaggregated rock and subsided blocks (Fig. 18c, d). Below this, multiple subsidiary scarps and counterscarps cut through the unstable area, aligning NW–SE with the main scarp (Fig. 18d). Although the instability is crosscut with scarps, in general, the main body appears to have sagged/relaxed as a cohesive mass.

Flooding of the pond within the cirque valley (Fig. 18b) has led to episodes of debris flow and slush avalanches parallel to and outside of the lateral scarp (Hannus 2012). The tension cracks between the pond and the backscarp accommodate overflow drainage from the pond. Water fills the cracks until late summer, when the water rapidly draws down and both the cracks and the pond empty. Water can be heard flowing through the unstable area after drawdown of the cracks and pond, hinting at a fracture network linking the tension cracks and the unstable area accommodating groundwater flow. Pondered water and springs mapped at the toe in late spring are completely dry by late summer (Hannus 2012). It is likely there is some hydromechanical and seasonal control on the movement of the rockslide. Groundwater recharge is clearly seasonally controlled, and at times, the fracture network
