## Structurally controlled rock slope deformation in northern Norway

**Abstract** Gravitational forcing of oversteepened rock mass leads to progressive failure, including rupture, creeping, sliding and eventual avalanching of the unstable mass. As the point of rupture initiation typically follows pre-existing structural discontinuities within the rock mass, understanding the structural setting of slopes is necessary for an accurate characterisation of the hazards and estimation of the risk to life and infrastructure. Northern Norway is an alpine region with a high frequency of large rock slope deformations. Inherited structures in the metamorphic bedrock create a recurring pattern of anisotropy, that, given certain valley orientations, causes mass instability. We review the geomorphology, structural mechanics and kinematics of nine deforming rock slopes in Troms County, with the aim of linking styles of deformation. The limits of the unstable rock mass follow either foliation planes, joint planes or inherited faults, depending on the valley aspect, slope angle, foliation dip and proximity to fault structures. We present an updated geotechnical model of the different failure mechan

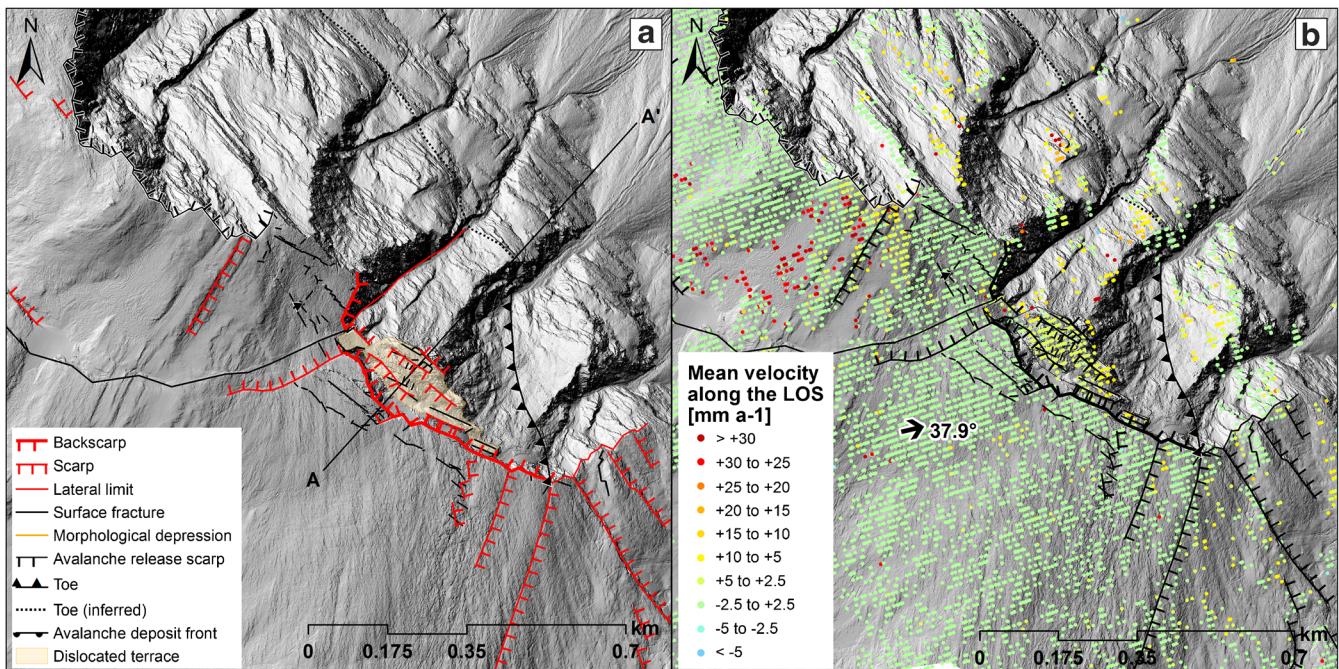
**Fig. 19** a Morphostructure and location of A–A' profile. b InSAR mean velocity [mm/year] along line-of-sight (LOS) in ascending geometry (orientation of black arrow: LOS azimuth angle, label: LOS incidence angle; NGU 2019b). Background: hillshade based on 0.5 m ALS-derived digital elevation model

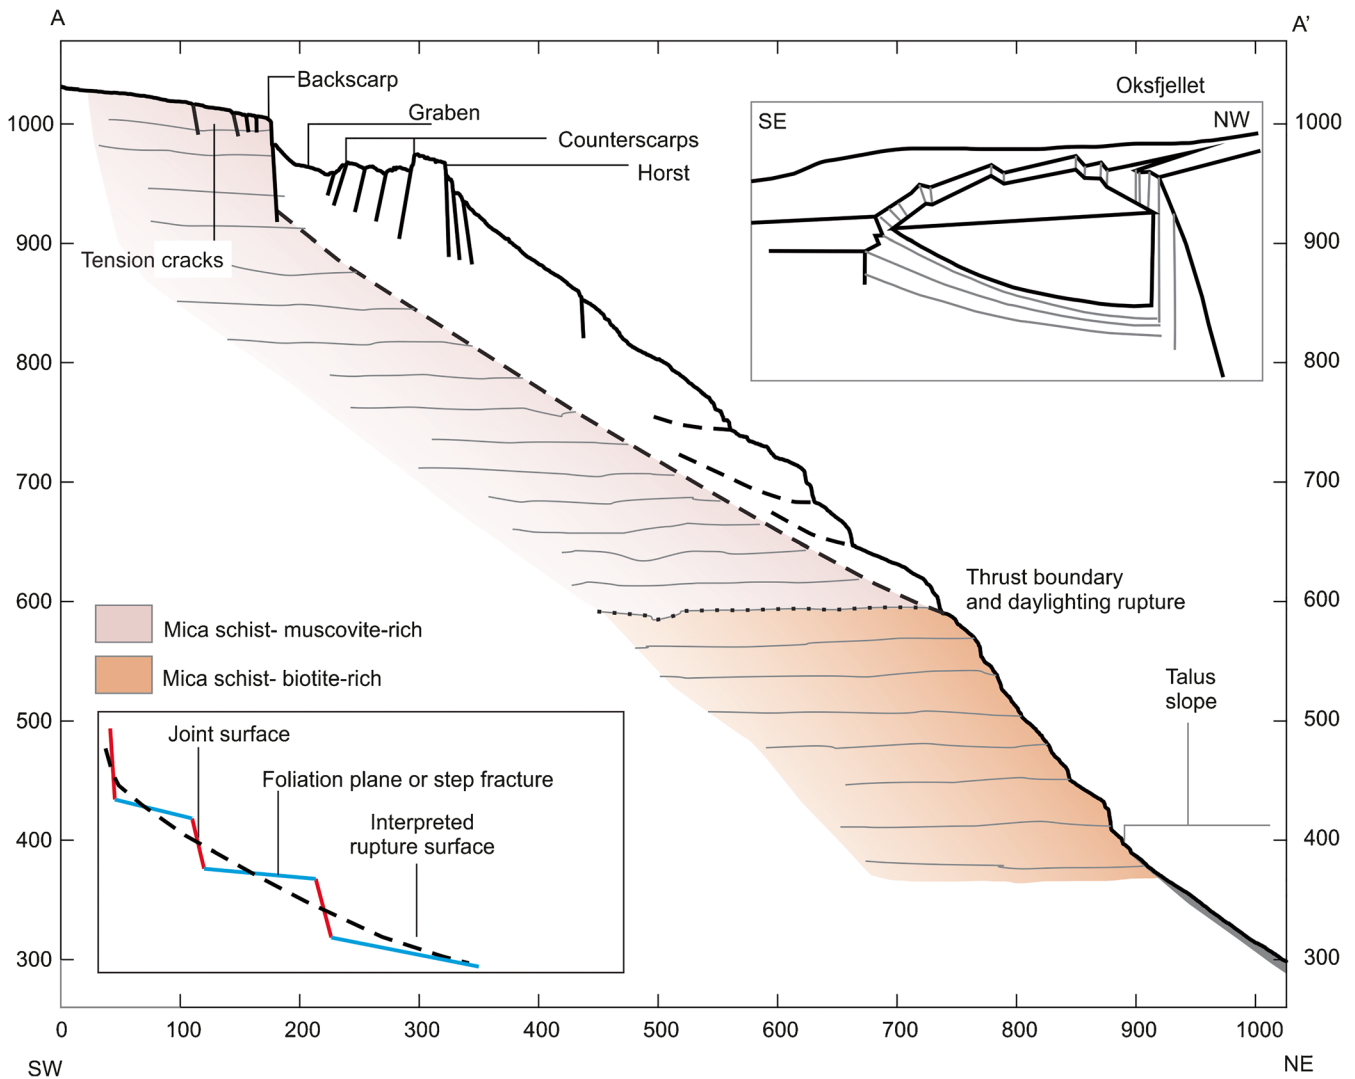
**Fig. 20** A–A' cross section of Oksfjellet, based on 0.5 m DEM (location on Fig. 19). Mapped rupture planes indicated by heavy black lines, and inferred rupture planes indicated by a dashed line. Inset is showing a simplified 3D model of the main sliding block and sliding planes, after Bredal (2016). Geology from Quenardel and Zwaan (2008)

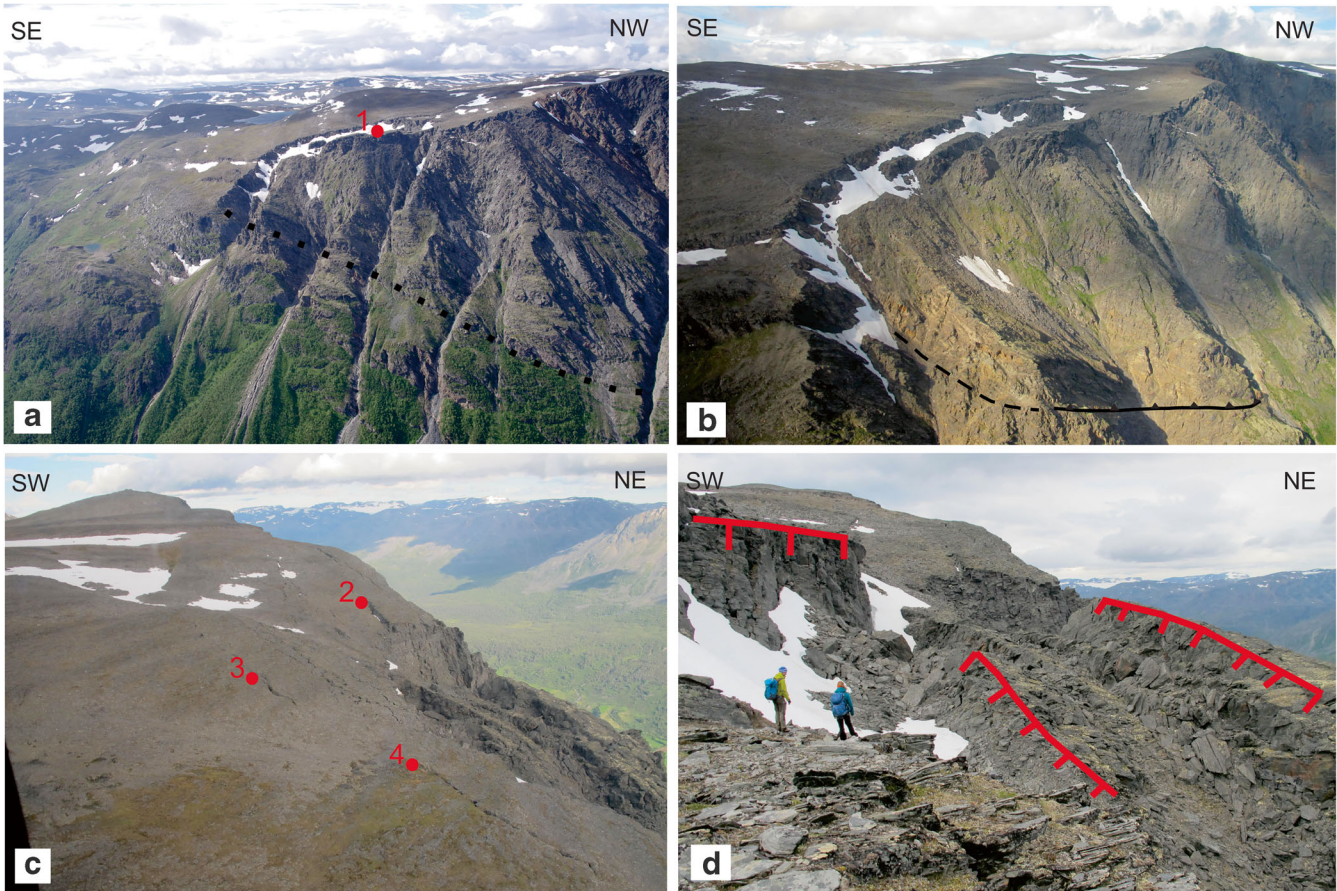
**Fig. 21** a Overview photo of the Oksfjellet cliff section showing approximate thrust nappe boundary and terrace of main displaced block (1) (Böhme 2015). b Overview of the active Oksfjellet block showing the basal rupture surface (Bergh 2015). c Looking down at the RSD (bottom right) and across the tension cracks (2–4) in the plateau (Bergh 2015). d Looking north along the backscarp of Oksfjellet, through the graben and across counterscarps (Bergh 2015)

The thrust boundary runs through the lower part of the unstable area. It follows a monocline structure ramping up to  $40^\circ$  at the SE boundary (Fig. 21a). A wedge slide is formed by this thrust and the NW lateral limit, while the back scarp forms the rear release structure. The toe line is defined based on GB-InSAR, which indicates deformation down to the underlying thrust plane, but not below.

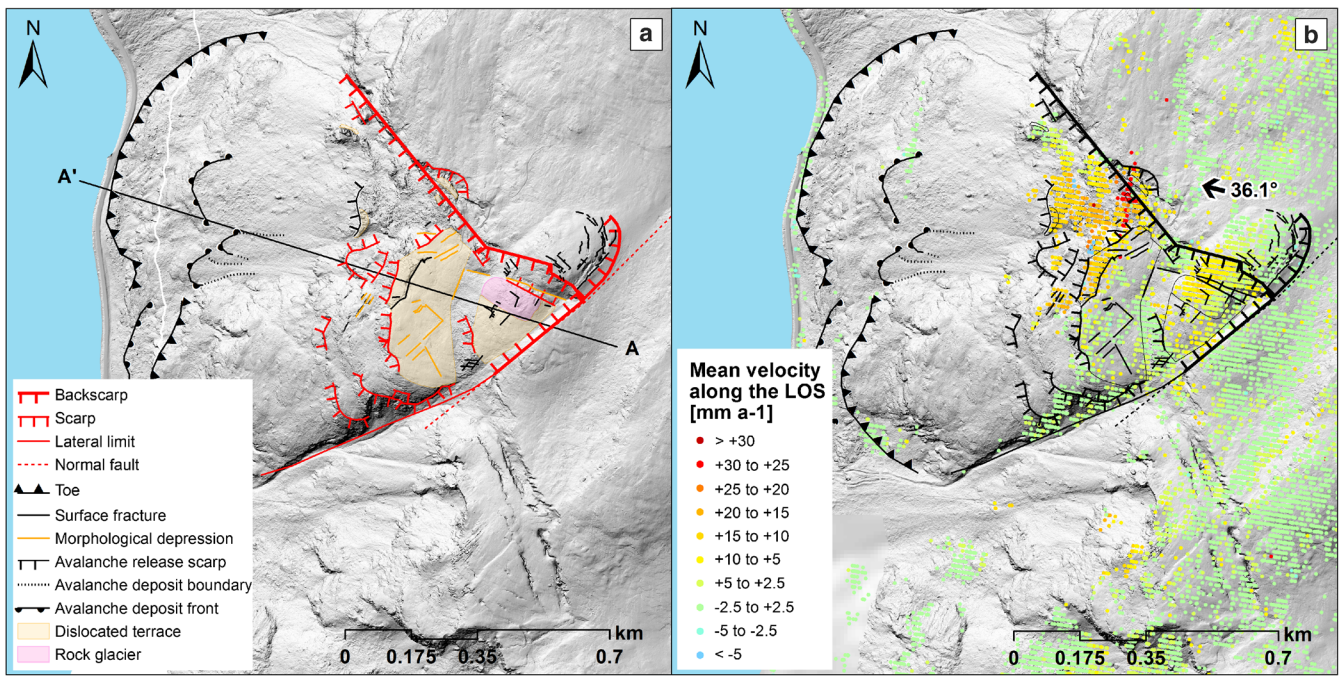
**Fig. 22** a Morphostructure and location of A–A' profile. b InSAR mean velocity [mm/year] along line-of-sight (LOS) in descending geometry (orientation of black arrow: LOS azimuth angle, label: LOS incidence angle; NGU 2019b). Background: hillshade based on 0.5 m ALS-derived digital elevation model

Some deformation is taking place above the backscarps (Fig. 22). The surface fractures are large open crevasses within a marble cap that sits on top of the RSD. Subsidence of the unstable mass (which

The InSAR LOS is subparallel to the slope, good for movement detection (black arrow, Fig. 22b). Velocities from 15 up to > 30 mm a<sup>-1</sup> along the LOS are detected. Other studies combining multiple SAR geometries highlighted a maximum of 50 mm a<sup>-1</sup> downslope movement. Displacement vectors obtained from 3D InSAR and validated by dGNSS show surface movement mainly oriented to the WNW (Eriksen et al. 2017a). Additionally, vectors display a deep downward dip in the upper slope and a shallow outward dip in the lower slope (Fig. 23), indicating that rupture surfaces become listric with depth. The velocity of the slide reduces downslope, indicating compression and thrusting.

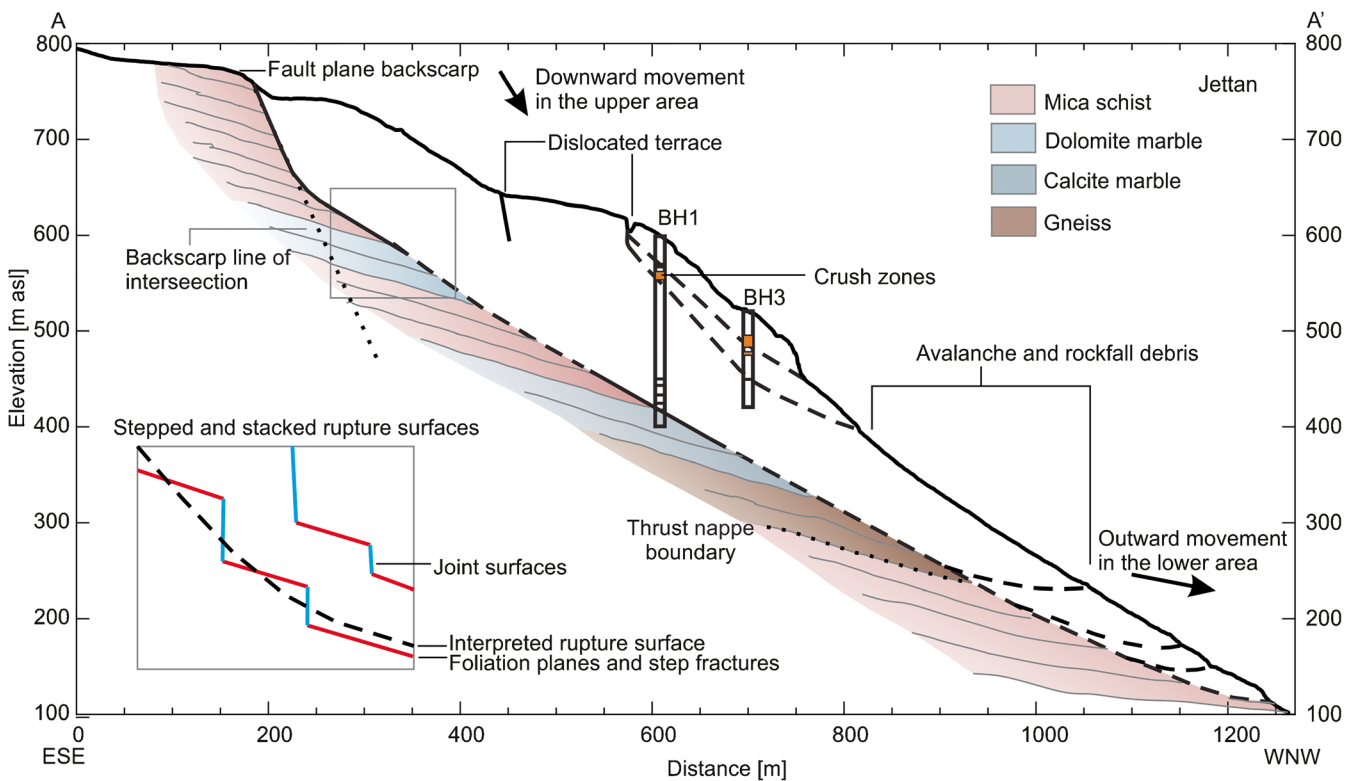
**Fig. 23** A–A' cross section of Jettan, based on 0.5 m DEM (location on Fig. 22), showing exposed fault in the backscarp. Mapped rupture planes indicated by heavy black lines, and inferred rupture planes indicated by a dashed line. Inset is showing structural configuration of the rupture plane. Subsurface crush zones from borehole data (Elvebakk 2013, 2014; Ganerød 2013a, b). Movement arrows depict average surface movement vector from 3D InSAR (Eriksen et al. 2017a). Geology from Zwaan et al. (2006)

There are likely multiple basal rupture surfaces at depth. Borehole data (Ganerød 2013a, b) and downhole geophysics (Elvebakk 2013, 2014) show multiple crush zones at irregular depths containing brecciated rock and clay material. The 'main zone of deformation' occurs as repeated layers of breccia and clay seams in mica-rich rock between 42 and 46 m below ground level (bgl) in BH1 and between 36 and 53 m bgl in BH3 (Ganerød 2013a). Swelling clays were recorded in the crush zones from X-ray diffraction analysis (110–145% free swelling of clay; Nystad 2015). Surfaces bounding crush zones dip between 19 and 81° out of the slope, but most dominantly dip between 20 and 40°. This aligns with rock mechanical testing which demonstrated a basic friction angle in the material of between 31 and 34° (Nystad 2015). It is likely that multiple levels of rocksliding have developed within the major bounding rupture limit (Fig. 23).

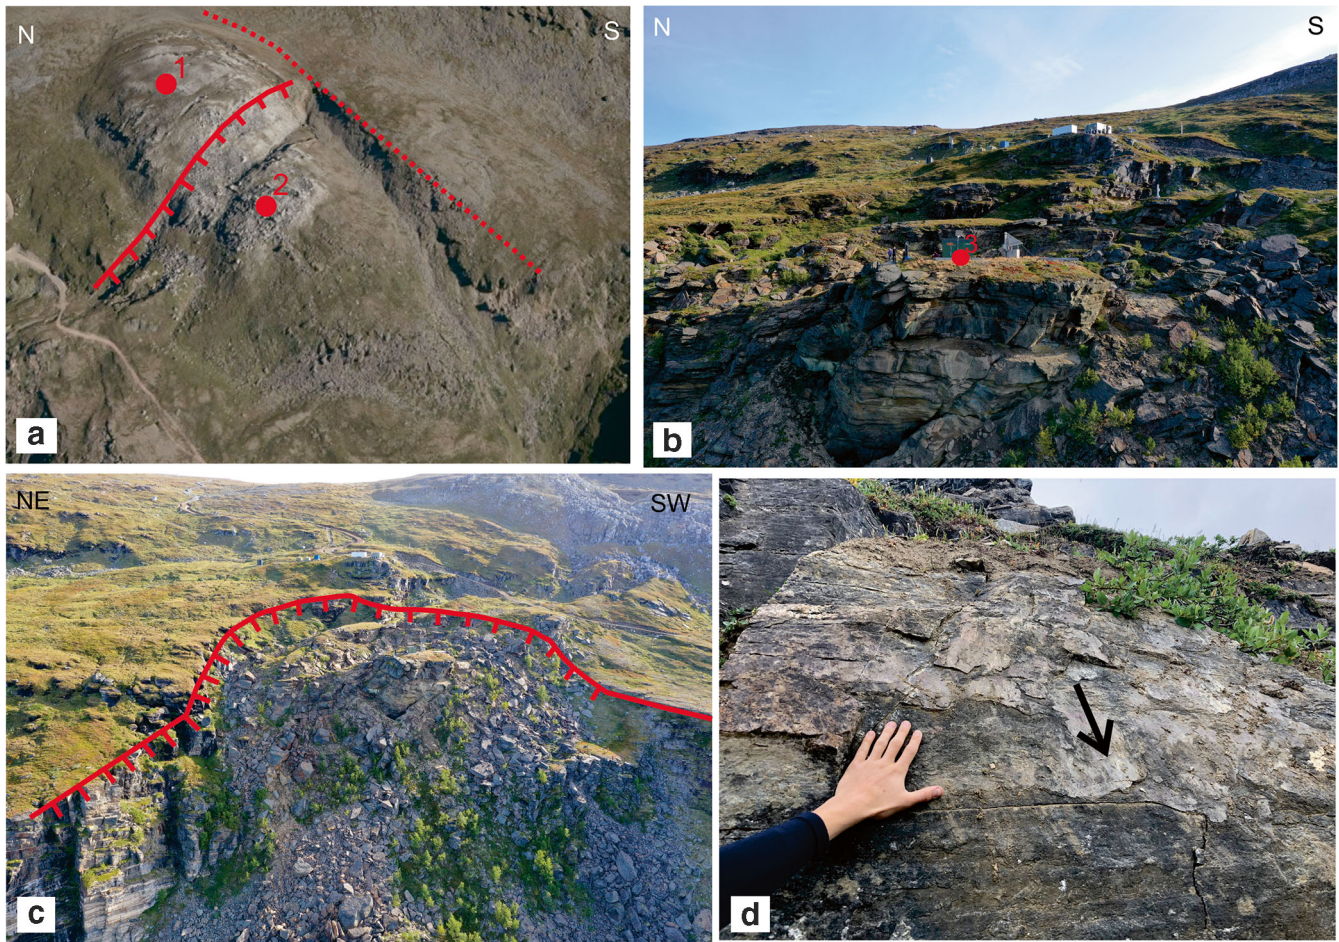
**Fig. 24** a Apex of the backscarp intersection—a fault plane on the southern border bounds an offset in the lithology (mica schist in the southern scarp, metasediments on the northern scarp; [www.norgebilder.no](http://www.norgebilder.no)) and intersects joint-controlled scarp on the N boundary. 1 indicates a marble dome sitting above the backscarp, 2 the active rock glacier (after Blikra and Christiansen 2014). b Stepped surface morphology of the RSD formed by a scarp-terrace assemblage (3. Location of borehole 2; Vick 2019). c Dislocated material/block field in the northern section of the RSD (outlined by red scarp) indicates some previous activity here, which has created space for material above to move (Vick 2019). d Slickenlines in the coating of the fault plane (Vick 2019)

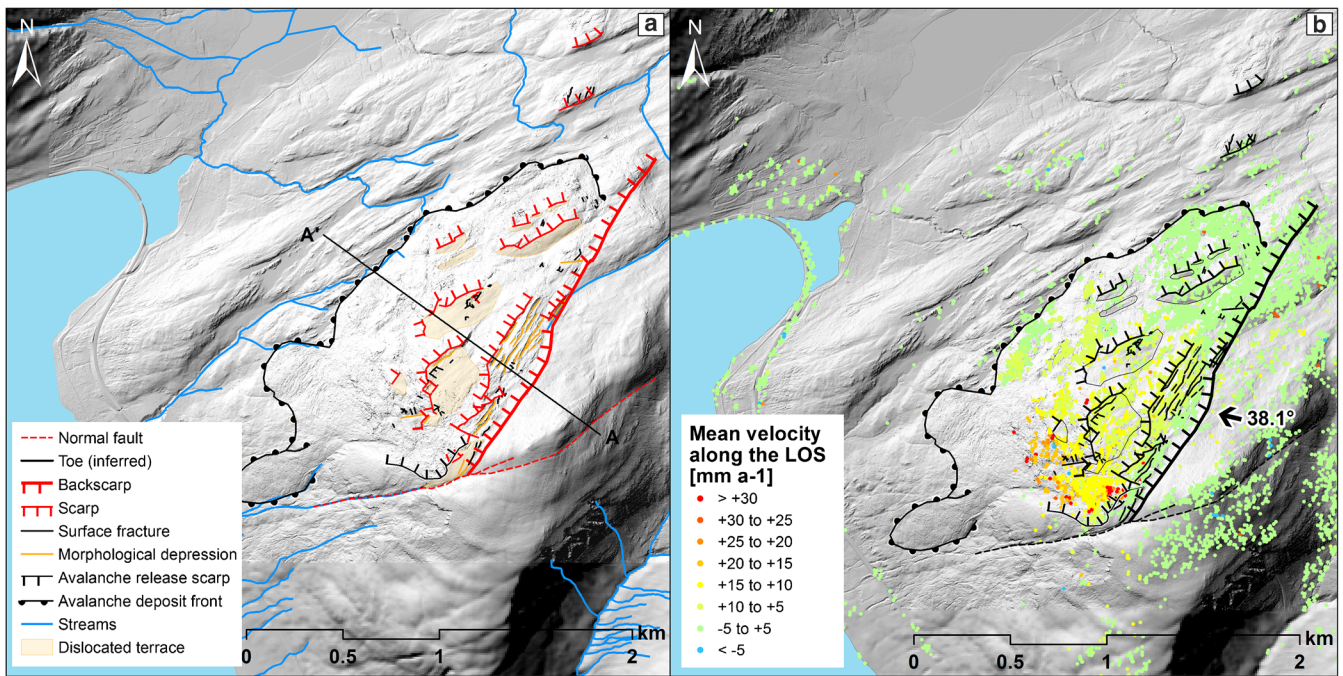
**Fig. 25** a Morphostructure and location of A–A’ profile. b InSAR mean velocity [mm/year] along line-of-sight (LOS) in descending geometry (orientation of black arrow: LOS azimuth angle, label: LOS incidence angle; NGU 2019b). Background: hillshade based on 0.5 m ALS-derived digital elevation model

The unstable area displays a complex surface geometry with disparate morphostructure across the slope (Figs. 25 and 26). In the upper central portion, a series of counterscarps are below and parallel to the backscarp (Fig. 27a). The counterscarps delimit ‘slabs’ of rock which are sliding on foliation surfaces dipping locally around 35° downslope. The foliation above the backscarp (in the stable area) has been mapped as on average 20°, and this steeper area could therefore be a result of localised folding. The slabs appear to be sliding on weaker layers of phyllite (Fig. 27e). These give way to dislocated and rafted terraces forming a stepped geometry (Fig. 27b). The terraces show break up and movement both directly downslope and laterally. They display open surface fracturing and sinkhole morphology from till draped over open

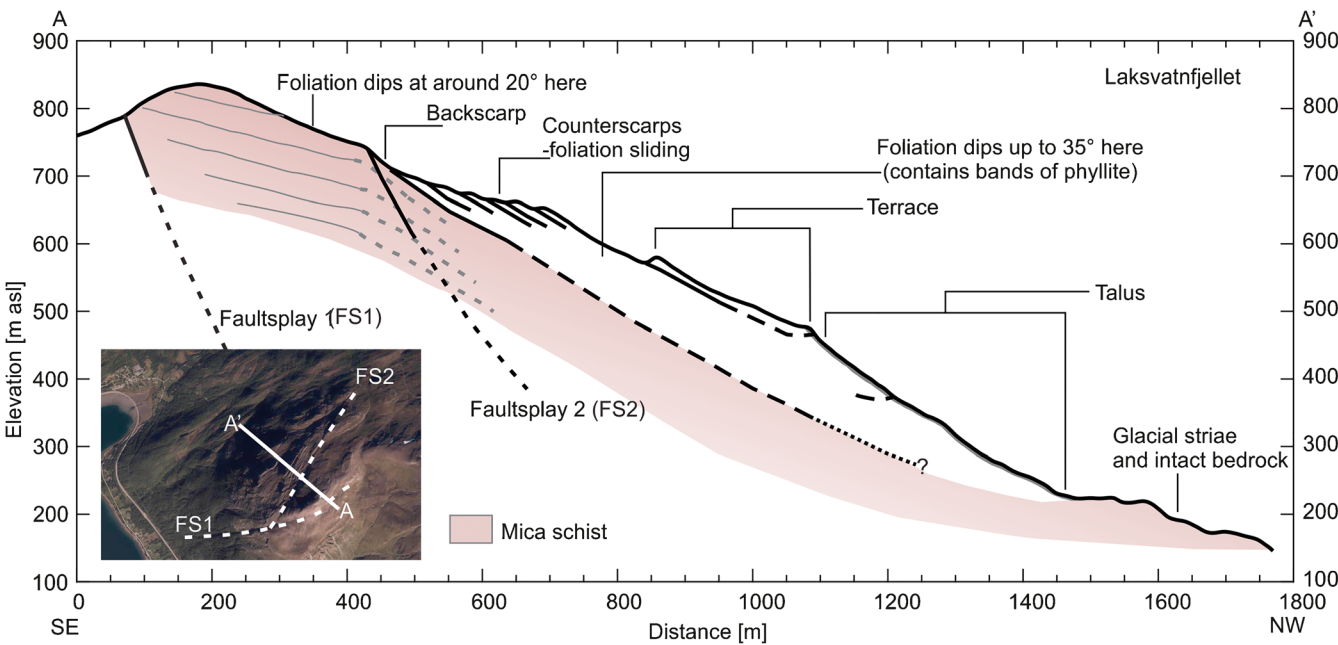
**Fig. 26** A–A’ cross section of Laksvatnfjellet, based on 0.5 m DEM (location on Fig. 25), showing exposed fault in the backscarp. Mapped rupture planes indicated by heavy black lines, and inferred rupture planes indicated by a dashed line. Basal rupture surfaces postulated (dotted line). Fault traces after Davids et al. (2013) and Rasmussen (2011). Geology from Zwaan et al. (1998)

The basal rupture surface is difficult to delineate and has been postulated based on the lack of observable surface deformation below the toe line (Fig. 26). It is unclear how much the rear rupture

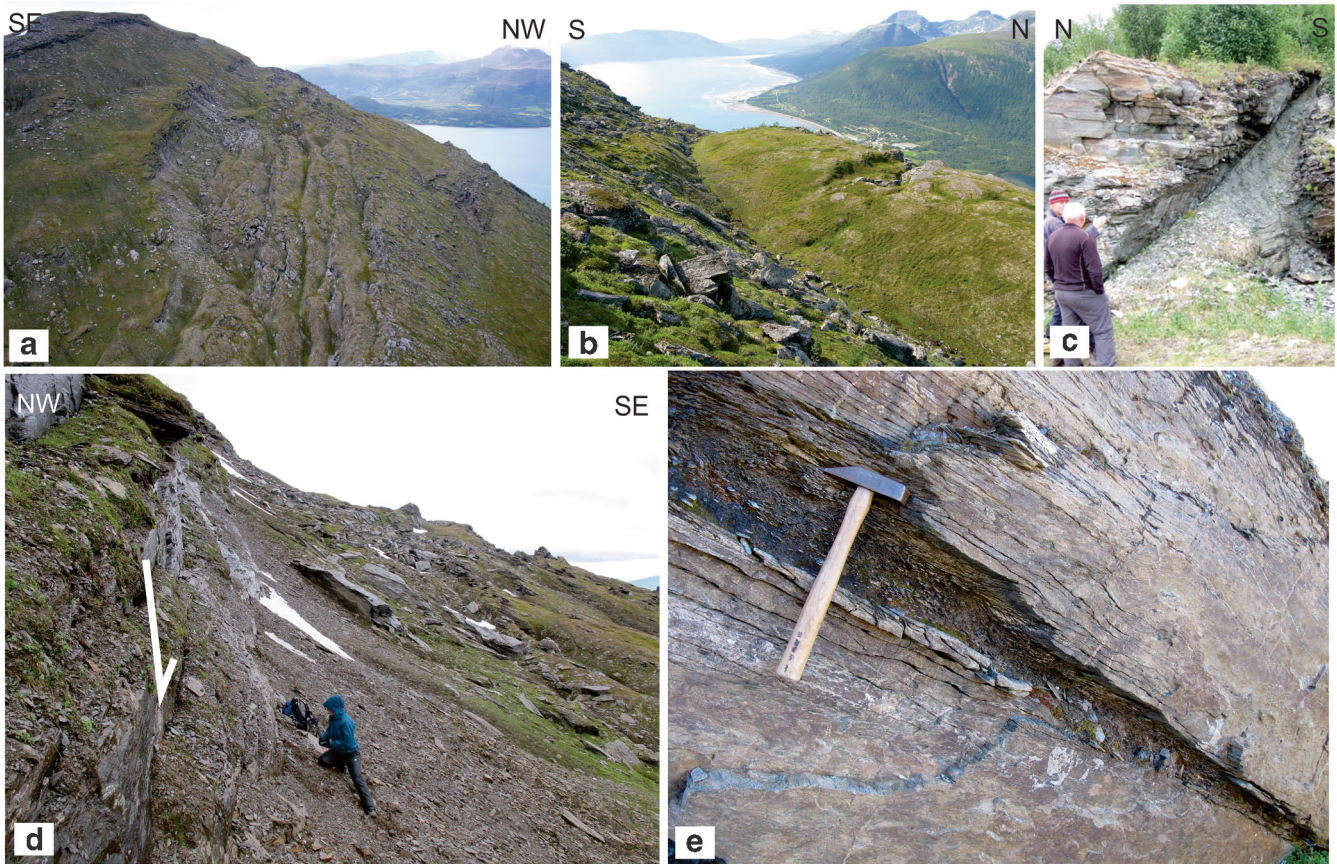
**Fig. 27** a Counterscarps sliding on overturned foliation surfaces (Henderson 2007). b Backwards rotation of a dislocated terrace. Note the transverse fractures in the terrace surface providing a lateral spread of the terrace (Bergh 2010). c Fault plane outcropping in the lower W limit of the RSD, showing gouge (Rasmussen 2010). d Fault plane backscarp (Bergh 2010). e Layers of weaker phyllite within the surrounding schist (Bergh 2010)

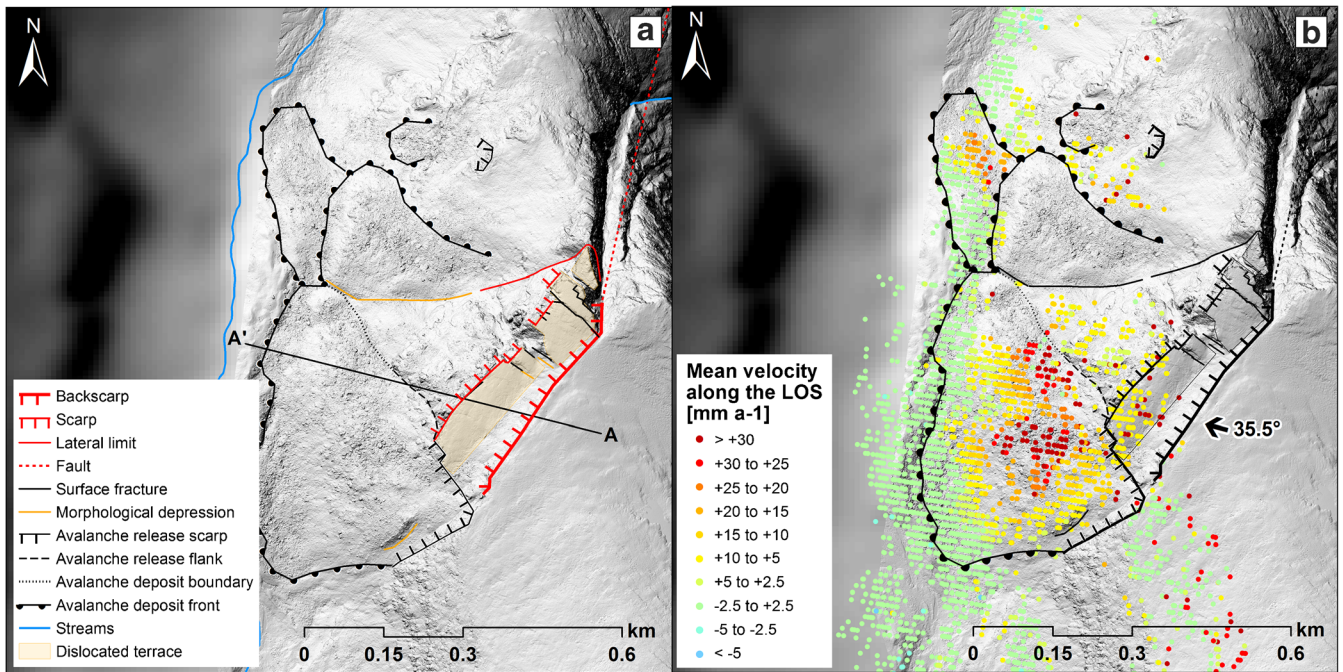
**Fig. 28** a Morphostructure and location of A–A' profile. b InSAR mean velocity [mm/year] along line-of-sight (LOS) in descending geometry (orientation of black arrow: LOS azimuth angle, label: LOS incidence angle; NGU 2019b). Background: hillshade based on 0.5 m ALS-derived digital elevation model

The morphostructure becomes difficult to constrain below the dislocated. At the N side, most of the slope is outcropping in situ bedrock, which displays no clear sign of deformation (Figs. 28 and 30a). Deposits from a series of rock avalanche events cover the entire flank at the SW lateral limit. The avalanche deposits may be degraded from fluvial erosion at river level.

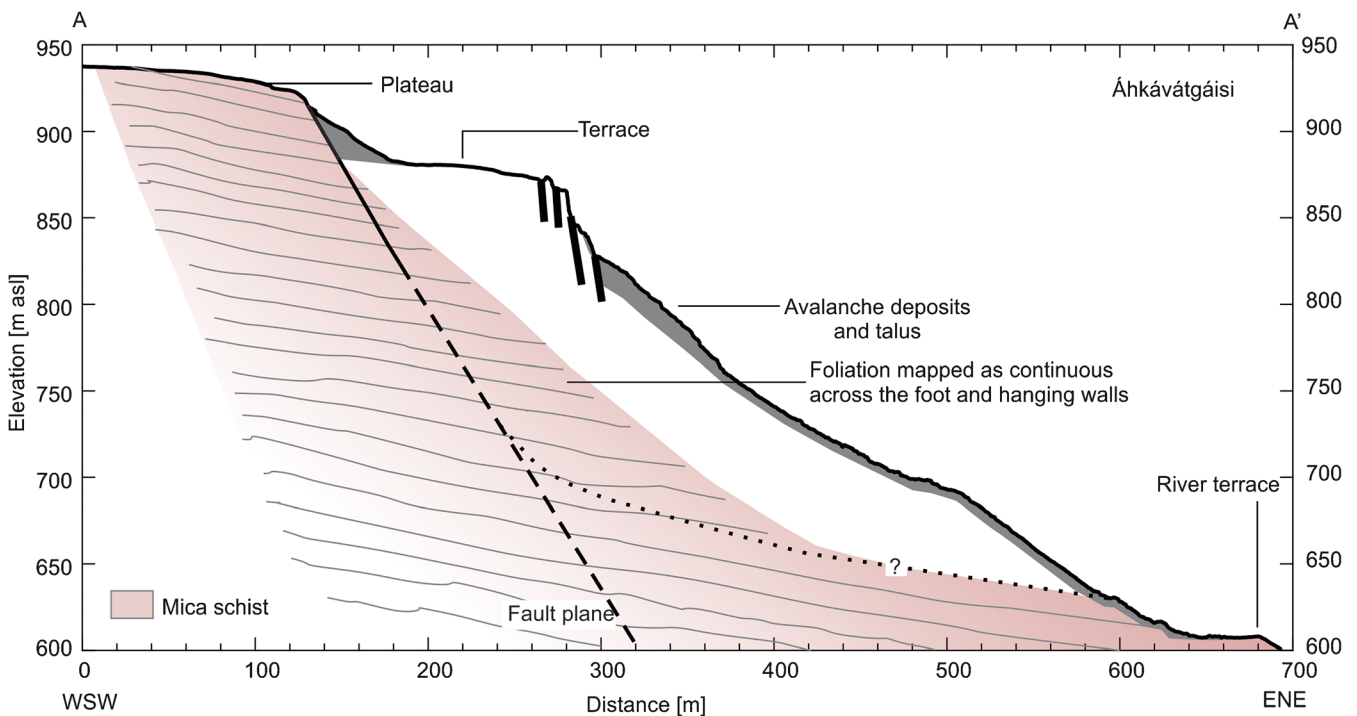
**Fig. 29** A–A' cross section of Áhkávátgáisi, based on 0.5 m DEM (location on Fig. 28), showing exposed fault plane in the backscarp. Mapped rupture planes indicated by heavy black lines, and inferred rupture planes indicated by a dashed line. Fault trace after Bunkholt et al. (2013a). Geology from Quenardel and Zwaan (2008)

therefore, a basal rupture surface has been indicated to follow foliation (Fig. 29).

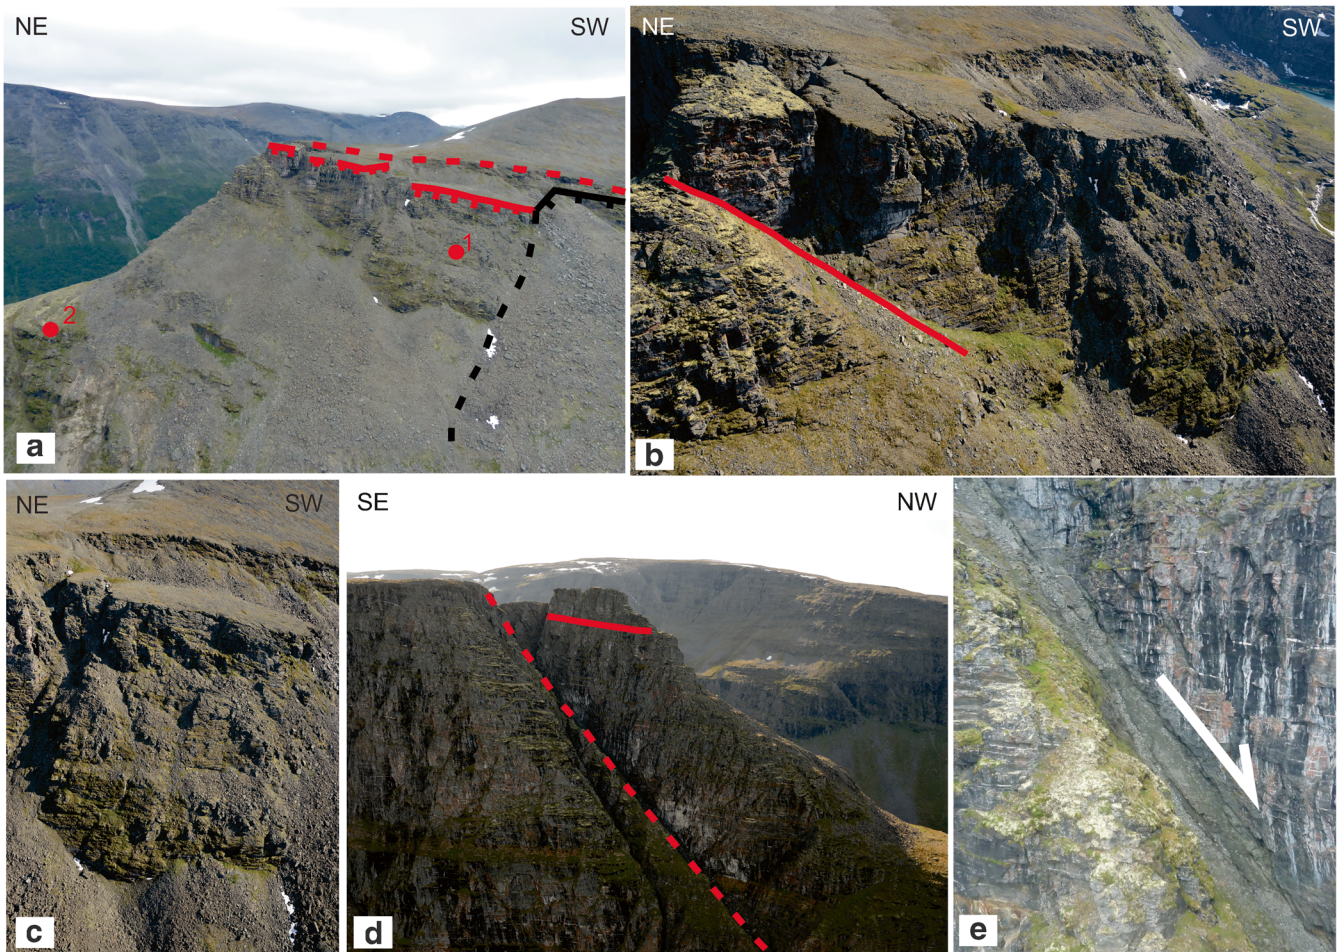
**Fig. 30** a Overview image of the RSD indicating fault plane (red dashed line) and displacing blocks (Bunkholt 2011). 1. Main terrace block, with increased subsidence to the SW end. 2. Intact bedrock. b Terraces at the NE end show signs of subsidence and sliding to the S at the SW end. Lateral limit of deformation indicated by a red line (Bunkholt 2011). c The large displacing block in front view. d Exposure of the Kjerringdalen Fault as seen from the W. Note the lateral limit indicated in b extends to this side of the column (Böhme 2019). e Closer inspection of the fault gouge material (Böhme 2019)

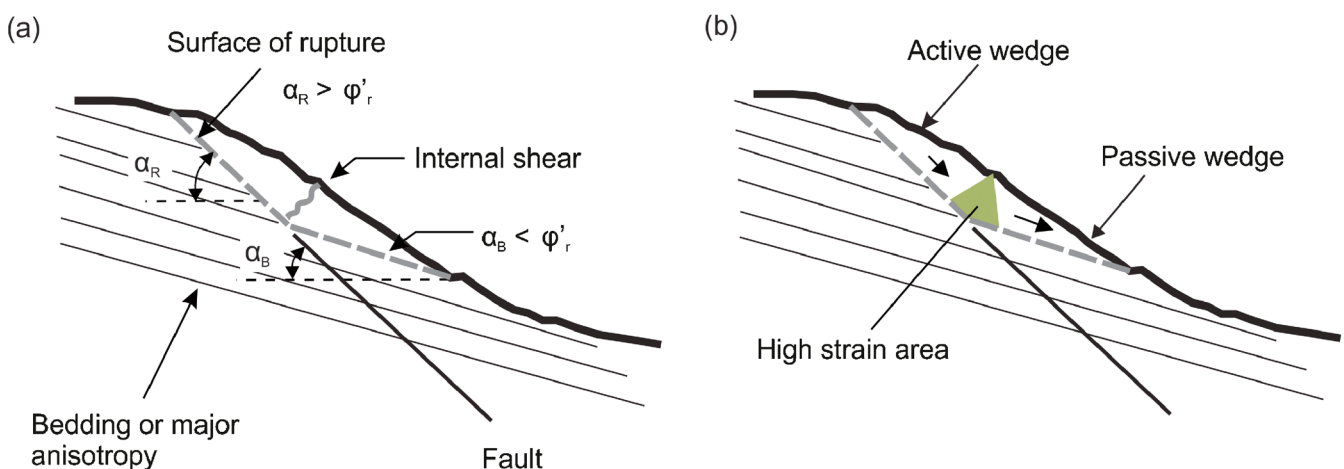
**Fig. 31** a Geotechnical characteristics of a (simplified) compound slide, where surface of rupture comprises a rear surface inclination ( $\alpha_R$ ) higher than the residual friction angle ( $\phi'_r$ ), and a basal surface ( $\alpha_B$ ) which inclination is lower than the friction angle ( $\phi'_r$ ) of the basal surface. Transformation between the upper active portion and the lower passive portion results in internal shearing. After Glastonbury and Fell (2010). b A compound slide showing transition zone as a high strain area (after Stead and Wolter (2015), modified from Glastonbury and Fell (2010))

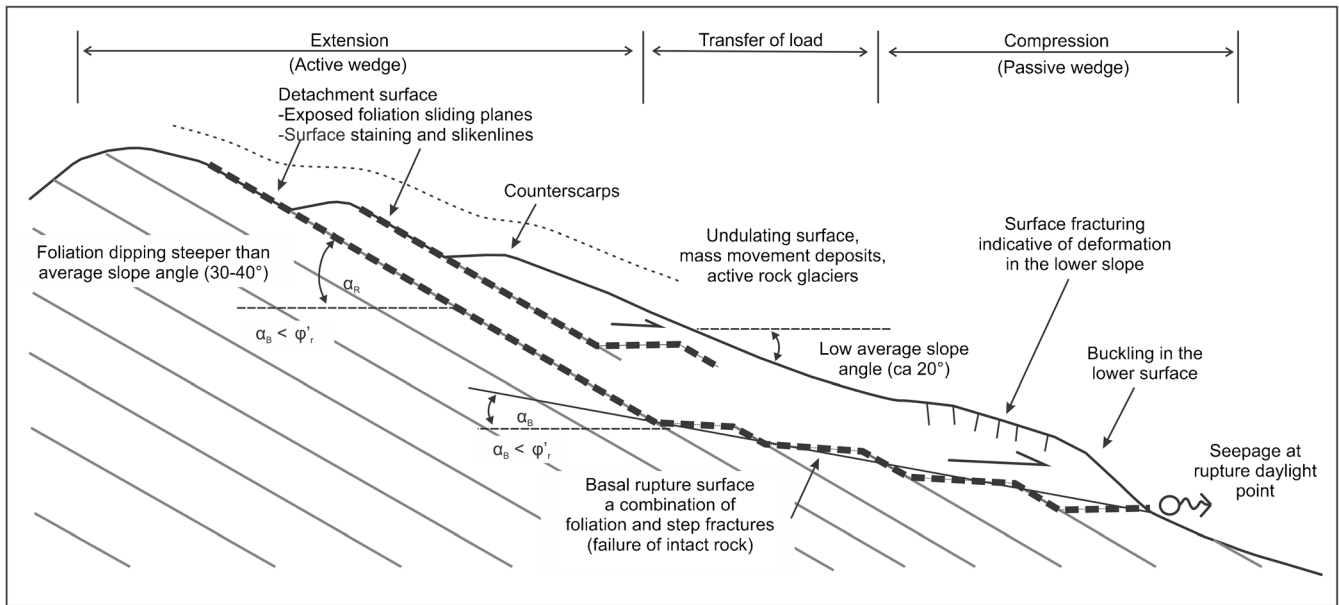
**Fig. 32** Geomorphological and geotechnical schematic of foliation sliding

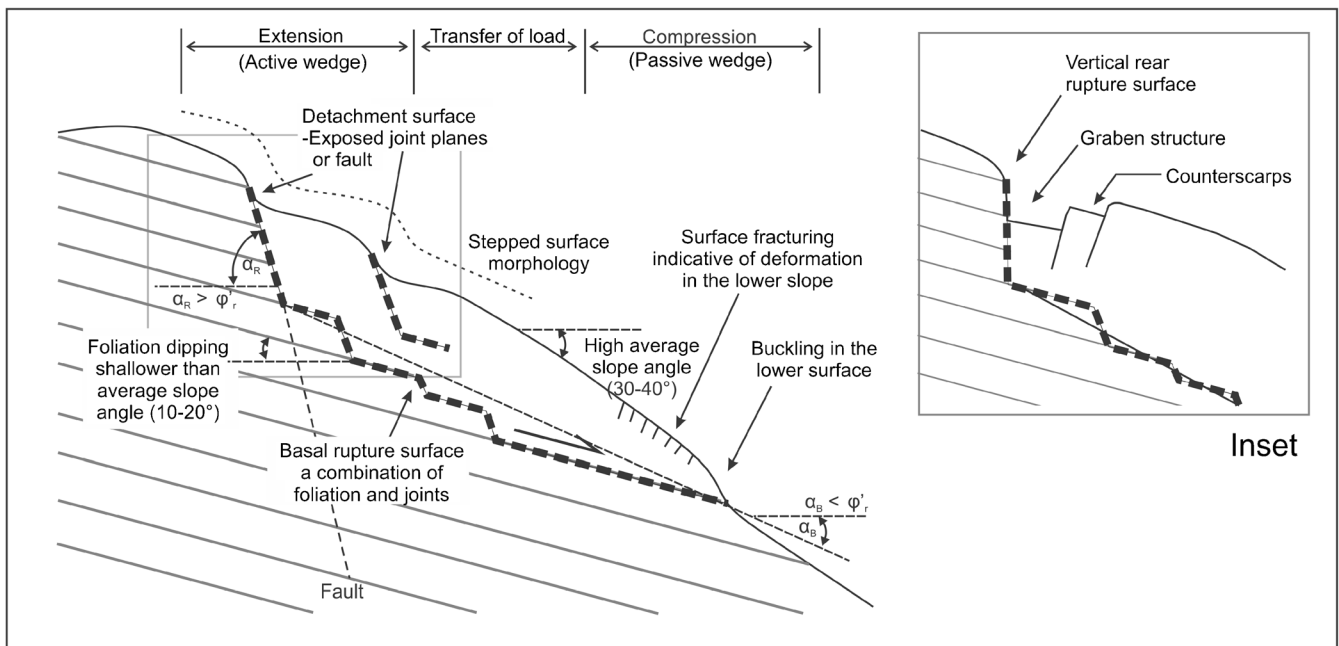
**Fig. 33** Geomorphological and geotechnical schematic of joint and fault rupture RSDs. Inset shows a variation of the same whereby the rear rupture is steep enough to allow a formation of a graben structure below the backscarp
