New insights into the catastrophic slope failures at Sau Mau Ping: the role of antecedent rainfall pattern

Keywords Rainfall-induced landslides · Antecedent rainfall · Rainfall temporal pattern · Landslide hazard

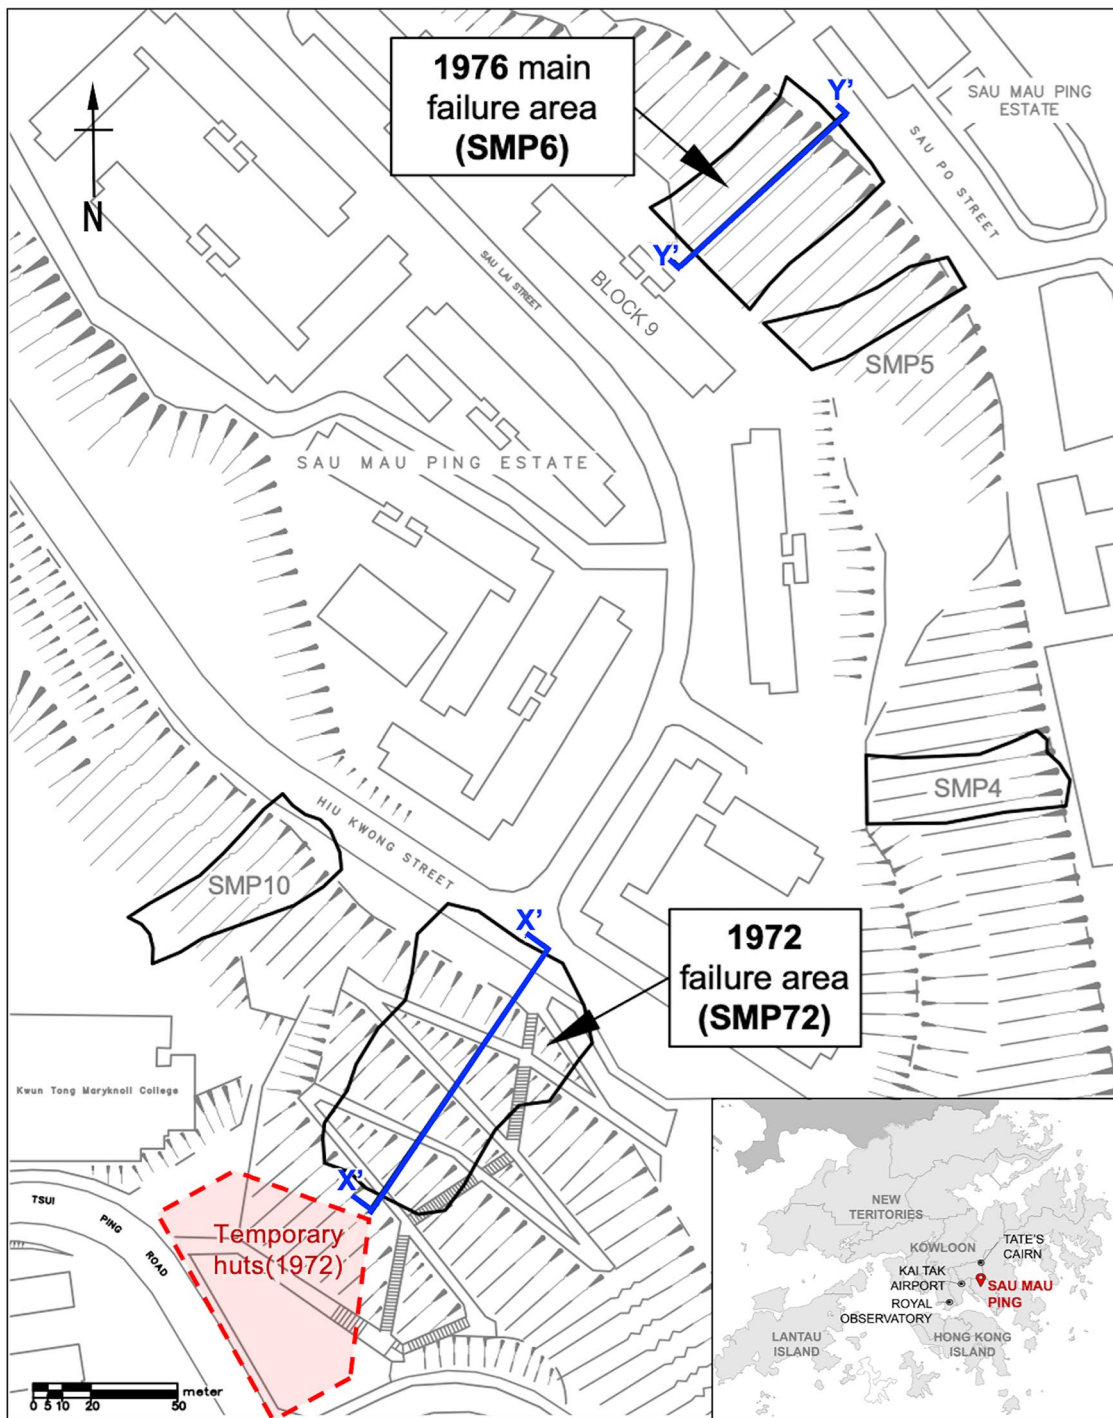
Fig. 1 Sau Mau Ping 1972 and 1976 landslide area

carried out by end-tipping in many places of Hong Kong, including the Sau Mau Ping area (Fig. 1). On June 18, 1972, after an extreme rainfall event with a maximum intensity of 98.7 mm/h, the slope SMP72 failed, releasing 4000 m³ of soil mass and causing 123 casualties. Following the failure, the slopes in the nearby areas were inspected, including the SMP6 slope. The SMP6 was classified as “reasonably safe” with minor works such as clearing the blocked drains and removing rubbish from the slope recommended in the evaluation. Nonetheless, four years later, in 1976, four embankment slopes that had successfully survived the 1972 extreme rainfall, including SMP6, failed, releasing 2000 m³ of soil mass and causing 42 casualties. However, the maximum rainfall intensity was only 51.5 mm/h, nearly half of the 1972 rainfall intensity.

Four years after the deadly landslides, on August 25, 1976, at 10.12 a.m., another disastrous failure happened in the Sau Mau Ping area. The failures were recorded at four locations, two at SMP6, one at SMP5, and another at SMP10 (Fig. 1). *What is intriguing is that all these slopes were examined right after the 1972 failures and were considered reasonably safe.* Remedial works following the suggestions of the inspectors also followed the examinations. In this study, we focus on the main failure site at SMP6, which formed a flowslide and impinged on Block 9 of the estate, inundating the ground floor, killing 18 people, and causing serious injuries to 24 others. Figure 3c, f shows the rainfall intensity prior to the failures.

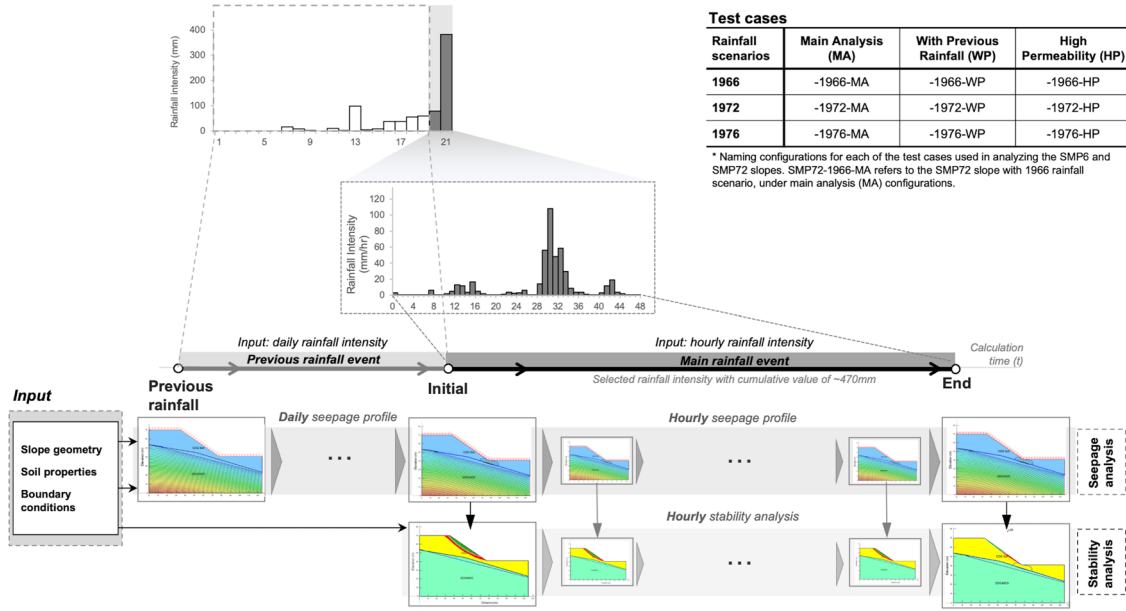
Fig. 2 Schematics of the methodology proposed in this study

Figure 2 presents the methodology for each analysis in this study. For each time increment, a two-step analysis is performed. First, a seepage analysis of the slope is performed to model the respective rainfall intensity. The pore water pressure obtained from the seepage analysis is then used as an input to the stability analysis to calculate the safety factor, FOS, of the

slope at the time. The pore water pressure is also used as an input for the subsequent seepage calculation. The process is repeated for each time increment. For the “main rainfall event,” which refers to the recorded rainfall that led to the failure event, hourly time increments are selected to match the actual rainfall records (Fig. 3d–f). In this study, the two-dimensional transient water flow theory (Fredlund et al. 2012), as defined below, is utilized to study transient water pressure resulting from the applied rainfall.

The “previous rainfall event” in this study (Fig. 2) refers to the 19-day rainfall prior to the recorded extreme rainfall. When no “previous rainfall event” is applied, the slope’s initial condition depends on the input parameters, and the calculation steps are the “initial to the end” steps in Fig. 2. The slopes have identical initial seepage. It is particularly useful to isolate the effect of the “main rainfall event” on the seepage and slope stability as in “Main Analysis” (MA) test cases. The “main rainfall event” is selected to have a cumulative rainfall intensity of approximately 470 mm based on considerations of the rainfall intensity and duration of the extreme rainfall events leading to the failure and the data availability. The previous and main rainfall events are represented as white and grey shaded bars, respectively, in Fig. 3a–c. The hourly rainfall patterns, which are used as input for the main rainfall events, are shown in Fig. 3d–f. The forensic reports have recorded substantial variability on the failure sites. Thus, another set of test cases with higher permeability input for the CDG fill is conducted as a parametric study in this study. The test cases are referred to as “High Permeability (HP)” cases. Additionally, in order to study the effect of previous rainfall and replicate the possible actual slope conditions that led to failures, a 19-day rainfall is applied to the slope prior to the “main rainfall event” as shown in Fig. 2. These cases will be referred as “With Previous Rainfall” (WP) cases. The summary of the test cases is shown in the table on the top right of Fig. 2. The bars located below Fig. 3d–f indicate the distribution of hourly rainfall intensity which are larger than 10, 20, and 30 mm/h.

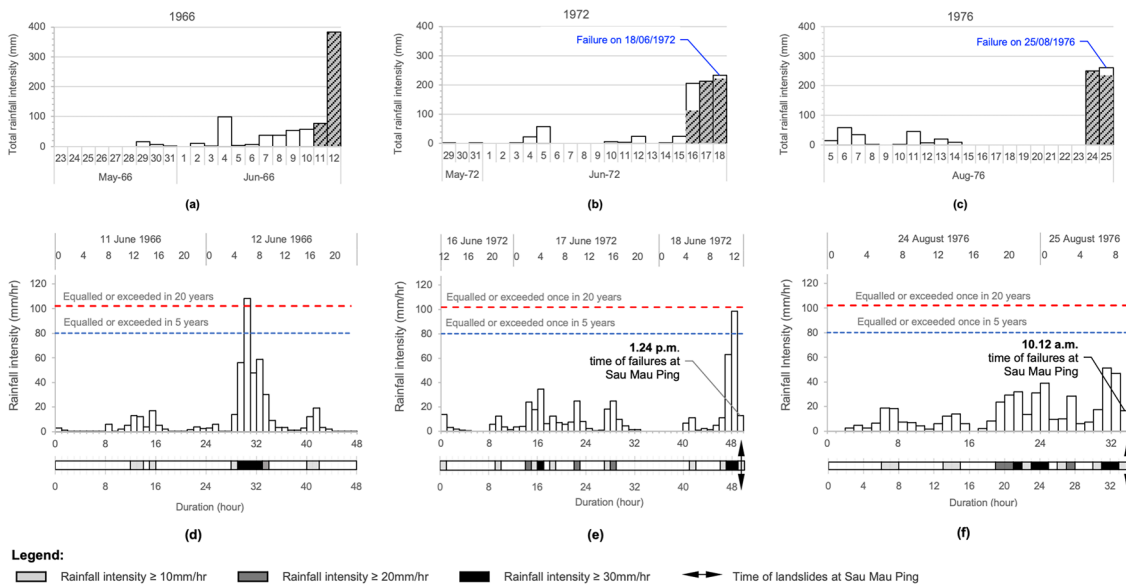
Fig. 3 Previous 19-days rainfall in a 1966, b 1972, and c 1976. Main rainfall loading in d 1966, e 1972, and f 1976, values are selected such that the cumulative intensity is approximately 470 mm

The slope SMP72, located between Hiu Kwong Street and Tsui Ping Road, failed on June 18, 1972, at 1.24 p.m. The failure was preceded by a series of extreme rainfall with a total rainfall of 650 mm, which started on June 16, 1972 (Fig. 3b, e). The maximum rainfall intensity of 98.7 mm/h was recorded around 1 h before the failure commenced. The failure was located right on top of the Sau Mau Ping Class II Licensed Area, a resettlement area proposed by the local government in 1964, which consisted of temporary huts to accommodate homeless refugees (see areas bounded by red-dotted lines in Fig. 1). The area was engulfed by the fallen earth and rocks almost immediately after the ground movement was noticed, causing 71 fatalities and injured 60 others.

Figure 3 summarizes all rainfall inputs used in this study. The “previous rainfall event” refers to the rainfall applied to the slope to simulate different initial conditions for WP cases. The 1966 “previous rainfalls” (Fig. 3a) tend to spread closer to the “main rainfall.” Four days before the “main rainfall,” the daily rainfall intensity is higher than 40 mm. The 1972 “previous rainfalls” (Fig. 3b) are relatively spread throughout the 19-day duration. However, to ensure the same cumulative rainfall intensity for the “main rainfall,” half of the rainfall intensity on 16/6/1972 is modeled as previous rainfall with rainfall intensity of approximately 100 mm/day. On the contrary, the 1976 “previous rainfalls” (Fig. 3c) are concentrated in the first half of the duration. The “main rainfall” is preceded by nine days without rainfall.

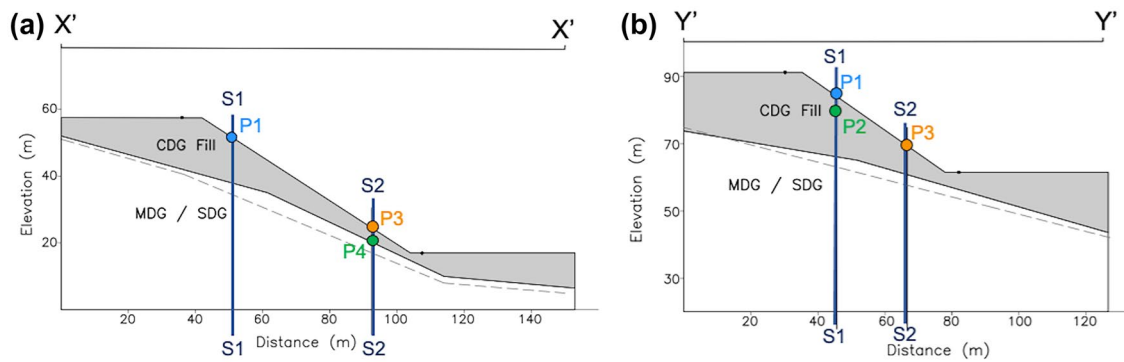
The slope profiles used for numerical modeling of SMP72 and SMP6 are shown in Fig. 4a and b, respectively, which are determined by referring to the available topography and water courses map, construction schedule of the slopes, drillholes, trial pits, and piezometer readings from the forensic reports (Binnie and Partners 1976; Knull et al. 1999; Vail 1984; Yang et al. 1972). These profiles are taken from cross-sections $X'-X'$ and $Y'-Y'$ in Fig. 1 (blue lines), which were located at the main failure area of SMP72 and SMP6, respectively. The slopes were comprised of CDG (completely decomposed granite) fill overlaying the MDG/SDG (moderately/

Fig. 4 Slope cross-sections of **a** SMP72 and **b** SMP6

slightly decomposed granite) bedrock. The inclination angle of SMP72 and SMP6 is taken as 32.83° and 34.62° , respectively. The groundwater table is approximated from the piezometer readings shown in Fig. 4a, b as dotted lines. The pore water is set to be hydrostatic with a maximum suction of 10 kPa, based on field measurements of Li (2003). Two cross-sections, S1 and S2, located 10 m from the slope's crest and toe, are drawn to observe the pore water development due to the rainfall. Four flux points are selected to observe the seepage and infiltration characteristics. Points P1 and P3 are located on the slope surface on the top of the S1 and S2 cross-sections, respectively. Points P2 and P4 are located at the depth of the critical slip of SMP6 and SMP72, respectively.

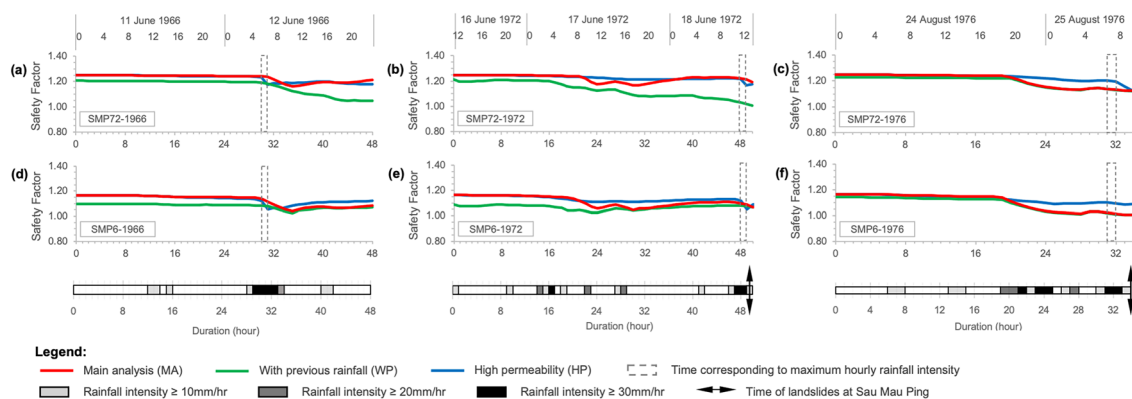
Figure 5a–c and d–f summarizes the safety factors of SMP72 and SMP6, respectively, at different calculation times after being subjected to different rainfall events. The red, blue, and green lines represent the main analysis (MA), high permeability (HP), and with previous (WP) rainfall cases, respectively. The bar charts at the bottom of Fig. 5d–f denote the distribution of rainfall intensity greater than 10, 20, and 30 mm/h. The initial safety factors for MA and HP cases are identical as they have identical initial seepage conditions. The initial safety factors of SMP72 and SMP6 are 1.249 and 1.165, respectively. Likewise, with different initial conditions, all the WP cases have different initial safety factors, depending on the rainfall cases. As shown in Fig. 5, the slope stability, quantified by the safety factor, increases and decreases with calculation time, depending on the rainfall loadings. Table 2 summarizes all the initial and minimum safety factors. The value inside the brackets refers to the calculation time at which the minimum safety factor is reached.

The 1972 failure happened on June 18, 1972, at 1.24 p.m., corresponding to the calculation time between 49 and 50 h of the 1972 rainfall event. As shown in Fig. 5b, the safety factor of the WP case constantly decreases and reaches the $FOS_{\min} = 1.004$ at calculation time $t = 50$ h. Likewise, the 1976 failure occurred on August 25, 1976, at 10.12 a.m., approximately corresponding to $t = 34$ h. The safety factor of the WP case is equal to 1.004 at calculation time $t = 34$ h (Fig. 5f). Hence, both failure cases are properly replicated by the WP cases.

Fig. 5 Summary of changes in factor of safety (FOS) with respect to time and applied rainfall

When comparing the MA cases, the 1976 rainfall results in the lowest safety factor for both SMP6 and SMP72 (Fig. 5c, f; Table 2). In fact, even without the influence of “previous rainfall,” the 1976 rainfall alone is able to cause SMP6 to fail; as shown in Table 2, the minimum safety factor of SMP6-1976-MA was 1.005 at $t = 34$ h. Despite the contradiction with the common assumption that the danger is related to high-intensity rainfall, it is generally consistent with the study of Fan et al. (2020), who concluded that relatively uniform rainfall leads to more water infiltration into the soil layer and subsequently introduces more substantial hazards compared to delayed high-intensity rainfall like the 1966 and 1972 events.

As previously mentioned, the MA and WP cases for SMP6 under the 1976 rainfall give almost an identical safety factor (Fig. 5f). Due to the 9-day no-rain period prior to the “main rainfall event,” the degree of saturation at the slope and slip surface only differ by a slight amount (Fig. 8b, d). The compacted pattern of the 1976 rainfall ensures that the slope is sufficiently saturated to facilitate water infiltrating deeper into the soil mass. A continuous reduction of the safety factor can be observed after calculation time $t = 19$ h, which leads to failure at $t = 34$ h for both MA and WP cases.

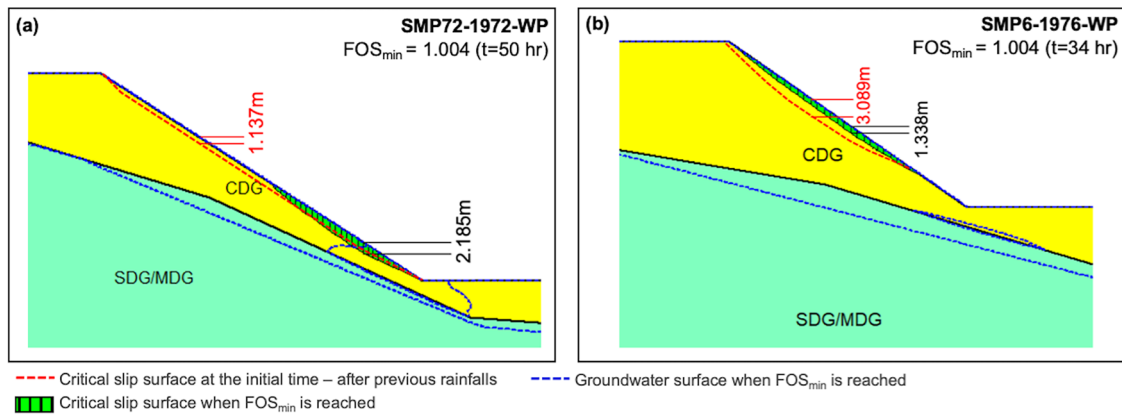
displays the critical slip surface for the WP cases at the initial time (dotted red line) and when the minimum safety factor is reached (green areas). The initial depth of the slip surface is 1.5 m and 3 m for the SMP72-1972-WP and SMP6-1976-WP, respectively. After the 1972 rainfall, at $t = 50$ h, the SMP72's slip surface is located at the lower half of the slope with a depth of 2.2 m (Fig. 6a). Likewise, the slip surface of SMP6 after the 1976 rainfall ($t = 34$ h) is found to be concentrated at the upper half of the slope with a maximum depth of 1.3 m (Fig. 6b). Hence, the numerical results agree with the field investigation.

Fig. 6 Summary of slip surface at the time of minimum factor of safety (FOS) for **a** SMP72 and **b** SMP6 with considerations of previous rainfalls (WP)

The less permeable layer of MDG/SDG bedrock introduces a semi-impermeable boundary to both slopes. The semi-impermeable boundary hinders the water from infiltrating the deeper layers of the slope. This behavior particularly affects the SMP72 slope as it has shallower fill layers. When the minimum FOS is reached, as shown in Fig. 6a, there is a significant amount of perched groundwater near the toe of SMP72. On the contrary, a lesser amount is

observed on SMP6 (Fig. 6b). It is also interesting to note that the slopes with more permeable fill layers do not directly translate to lower stability. In the MA and HP cases, the initial seepage and stability conditions are identical for slopes with the same geological and hydrological settings. The HP cases of SMP72 have safety factors slightly lower than the MA cases. On the contrary, for SMP6, the HP cases relatively have a higher safety factor than MA cases. This is potentially due to the slope geometry, which in the case of SMP72, facilitates the formation of a perched water table. This highlights the role of the combined geological and hydrological settings as facilitating factors for rainfall-induced failure.

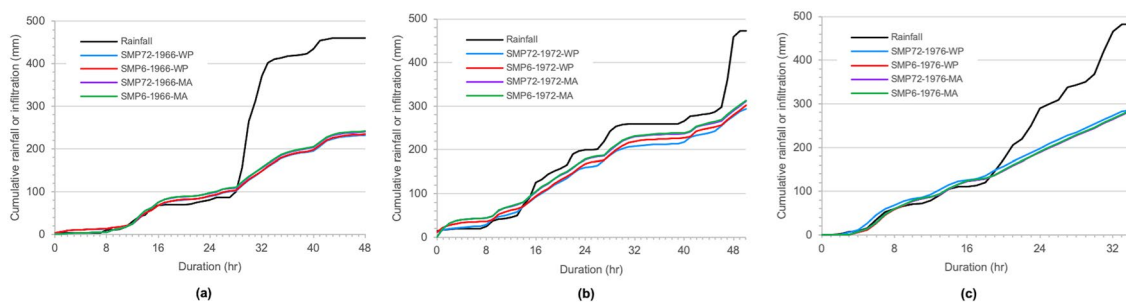
Fig. 7 Cumulative rainfall intensity and cumulative water infiltration under **a** 1966, **b** 1972, and **c** 1976 rainfall

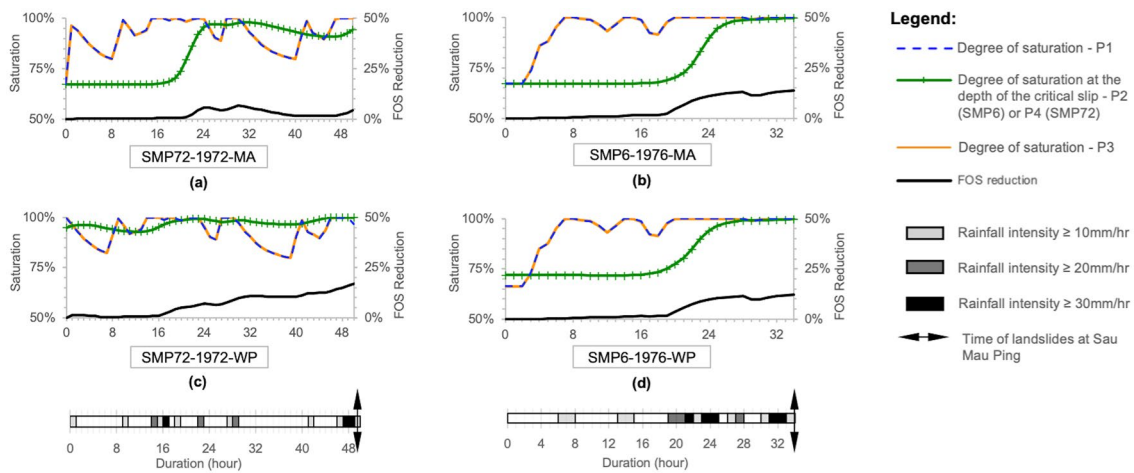
Fig. 8 Changes in degree of saturations at flux point P1, P2, P3, and P4 and reduction of factor of safety with time and applied rainfall

On the contrary, by comparing Fig. 8a, b, it can be observed that the influence of the previous rainfall events is substantial for the 1972 case. The degree of saturation at the slope's surface and slip surface is almost fully saturated after the “previous rainfall.” In both MA and WP cases, the FOS reduction can be observed after continuous rainfall at $t = 8$ – 32 h. However, the FOS increases in the MA case throughout the following 7-h no-rainfall period, while the FOS seems to be constant in the WP case (Figs. 5b and 8a, b). As a result, when the extreme rainfall intensity happened at $t = 48$ – 49 h, the WP case failed at a similar time recorded on the forensic report ($t = 50$ h). It should be noted, however, as shown in Fig. 5, the high-intensity rainfall is still related to the significant reduction of safety factors. The dotted grey lines in Fig. 5 correspond to the highest rainfall intensity, and most of the substantial reduction of the stability occurs during or not long after that.

When comparing the 1976 rainfall with the other, it seems that the variations of the degree of saturation at the slip surface, the safety factor reduction, and the cumulative infiltration caused by the 1966 and 1972 rainfalls generally occur in steps (Figs. 5, 7, and 8), which might be credited to the compacted nature of the 1976 rainfall that resembles a “uniform” distribution. Likewise, from the 1966 and 1972 rainfall, it can be concluded that when there is only rainfall of low intensity or no rainfall, the slope regains its suction strength and stability, although by slight amounts.

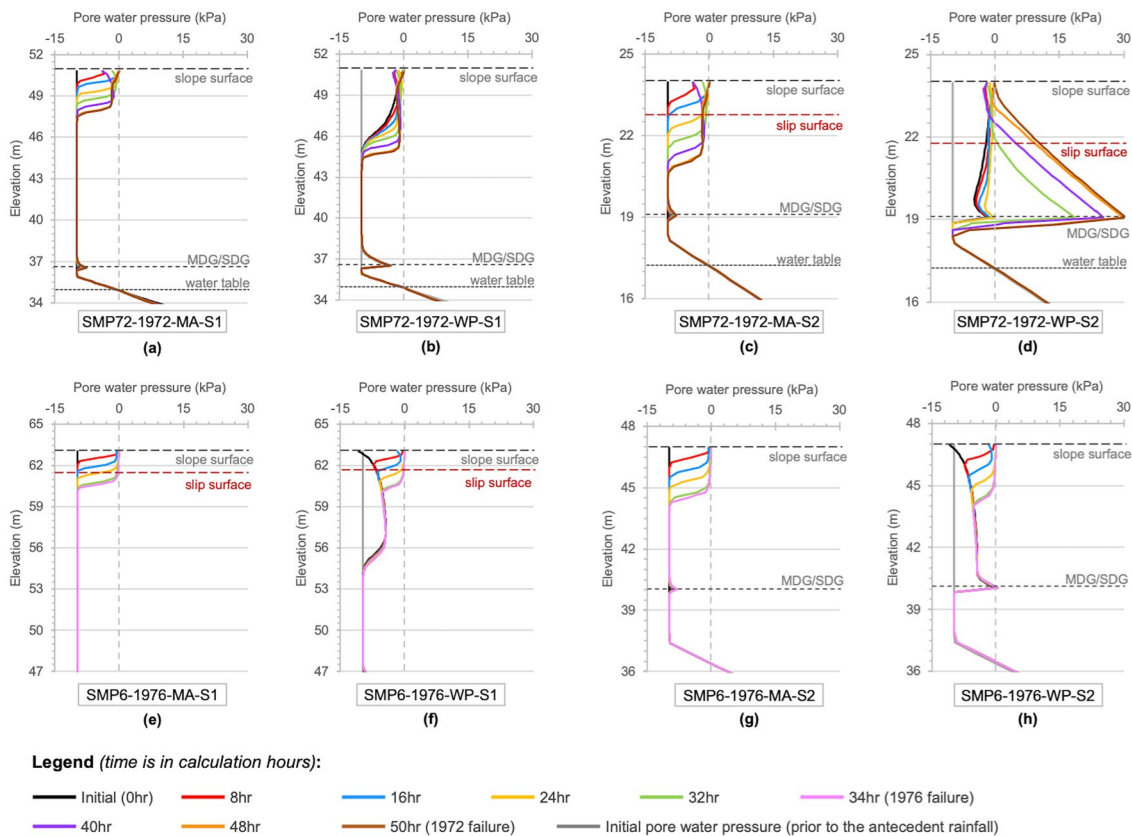
Figure 9 summarizes the pore water pressure profile at cross-sections S1 and S2 for SMP72 under 1972 rainfall and for SMP6 under 1976 rainfall. The general behavior agrees with previous studies (Collins and Znidarcic 2004; Lu and Godt 2008; Godt et al. 2012). As the rainfall event commences, the suction will gradually reduce, and the wetting front will be developed deeper. The contribution of previous rainfall towards initial seepage conditions can be observed by comparing MA and WP cases in Figs. 8 and 9. The previous rainfall is shown to infiltrate further to the slope, facilitating a deeper wetting front (Fig. 9). In the case of SMP72 (Fig. 9d), it further facilitates the formation of perched groundwater. From all test cases, there is no significant change in the initial groundwater table. This finding agrees with the previous observation that only 2% of slope failures in Hong Kong were attributed to the rise of groundwater level (Wong and Ho 1993). There is an interesting observation between $t = 32$ – 40 h for the SMP72 (Fig. 9a–d) cases: as the rainfall intensity occurring at that duration is low, the upper portion of the suction seems to regain slowly before it diminishes under the afterward high-intensity rainfall ($t = 48$ – 50 h). A similar observation can also be seen in the pore water pressure after the previous rainfall events for SMP6 (Fig. 9e, h). Again, this observation highlights the effect of the temporal pattern of antecedent rainfalls; in this case, the absence of rainfall between the events allows the suction strength to regain in the slope.

Fig. 9 Pore water pressure profile at the cross-section S1 (near crest) and S2 (near toe) at **a–d** SMP72 and **e–h** SMP6
