# Nonlinear dynamic behaviour of severely corroded reinforced concrete columns: shaking table study

## Abstract

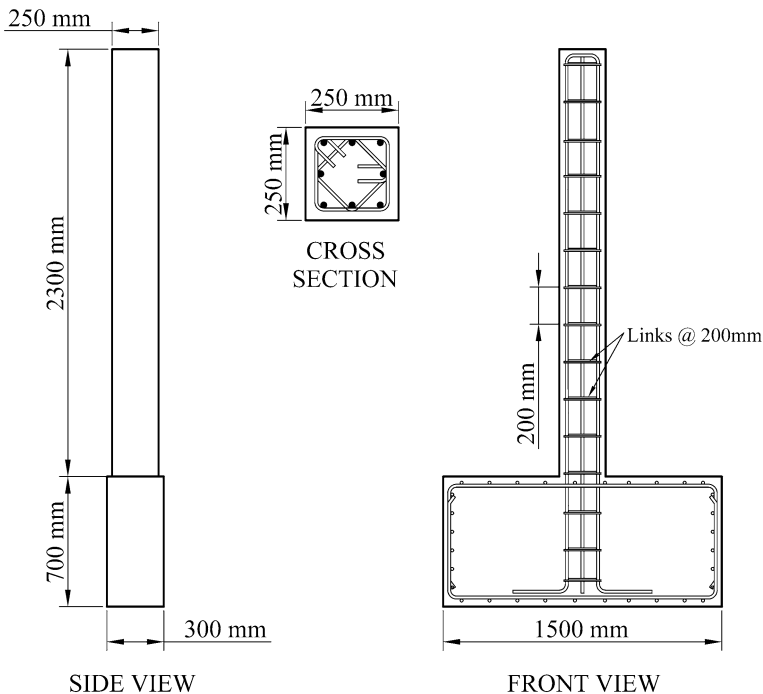
**Fig. 1** Reinforcement details of experimental test specimens

aspect ratios. Eight reinforcing bars with a diameter of 16 mm are used in the vertical reinforcement. The transverse reinforcements are made of 8 mm diameter bars with 200 mm spacing along with the column height (as shown in Fig. 1). The ratio of the transverse bar/tie reinforcement spacing (confining reinforcement) and the diameter of the vertical reinforcement is 12.5, which are more spaced than recommended value of 6 in Eurocode 8 (CEN.EN 2010). The insufficient spacing of tie reinforcement makes the three specimens represent non-code conforming RC columns. The average concrete strength of 40 MPa is derived by compressive tests conducted on three concrete cylinders. All steel reinforcement used in these tests is manufactured under the requirement of the British standard B500 (2005). Three tensile, compressive and cyclic tests are conducted on sample longitudinal bars to characterise their mechanical properties including their stress–strain relationships. The mechanical properties of the longitudinal bars are summarised in Table 1. The identification of the three specimens is given in Table 2.

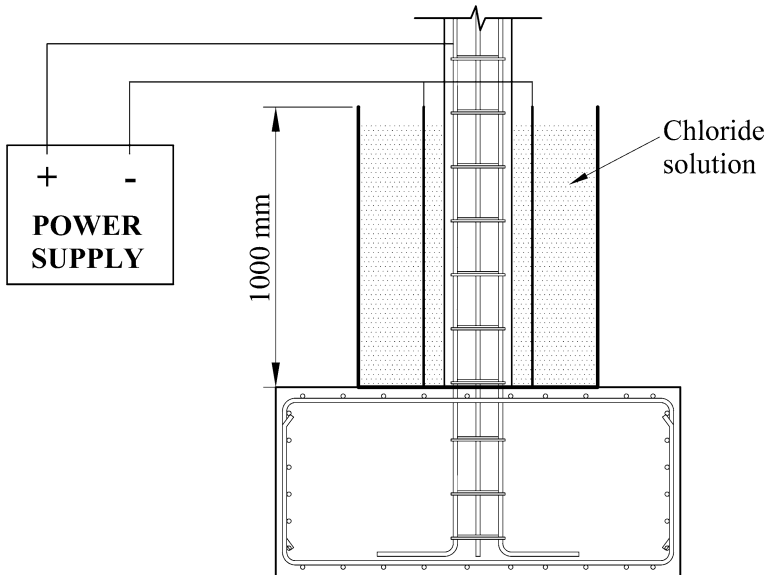
**Fig. 2** Accelerated corrosion procedure setup

A polyethene pipe with 500 mm diameter and 1000 mm height was mounted on the top of the foundation to create a bath for the sodium chloride solution. Four 250 mm × 1000 mm stainless plates are connected around the column as the cathode. Reinforcing bars and stainless plates are connected to the power supply by cables respectively. The sodium chloride solution contained 10% sodium chloride (i.e. salt). It is worth clarifying that no additional load (other than its own weight) is applied on the specimens during the procedure. The ACP setup is shown in Fig. 2.

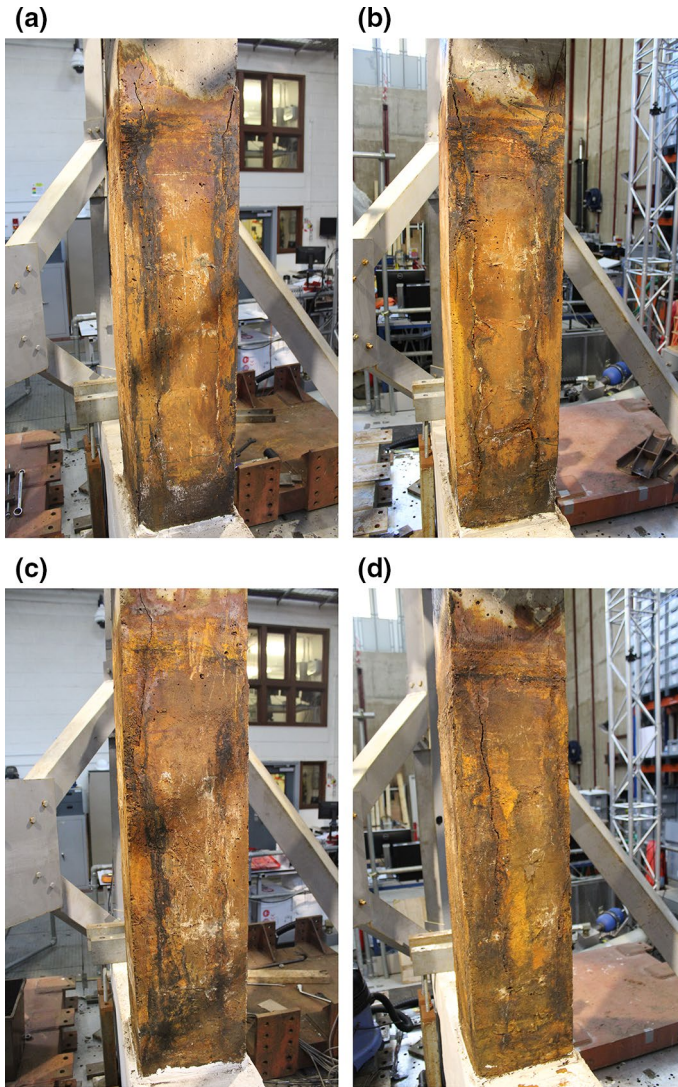
**Fig. 3** Corrosion-induced cracks in Corr1 and Corr2 specimens: **a, b** front and back of Corr1, and **c, d** front and back of Corr2

This is because the additional corrosion in the corner bars results in further corrosion-induced concrete cover cracking (as shown in Fig. 3), and hence, a significant reduction in concrete strength. Therefore, concrete cover crushes earlier on one side of the column,

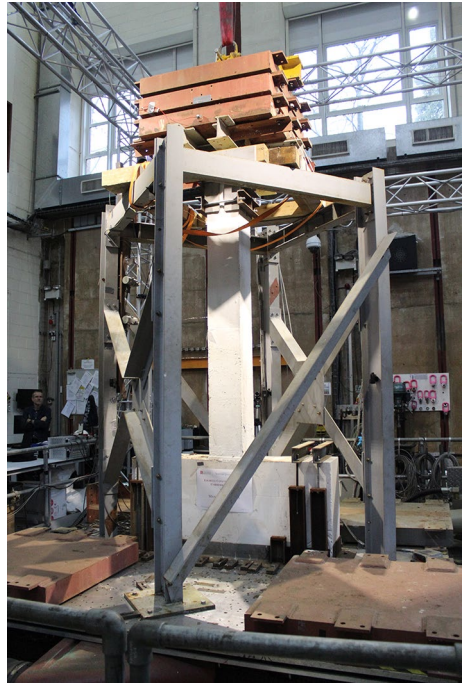
**Fig. 4** Experimental test setup

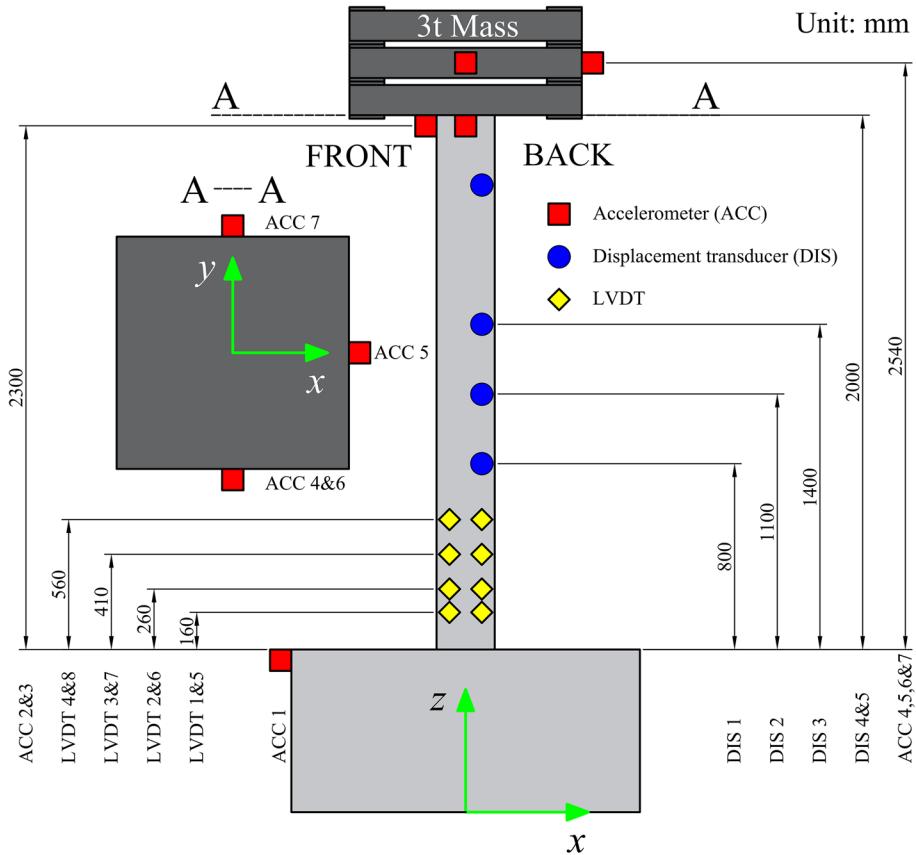
Fig. 5 Instrumentation layout

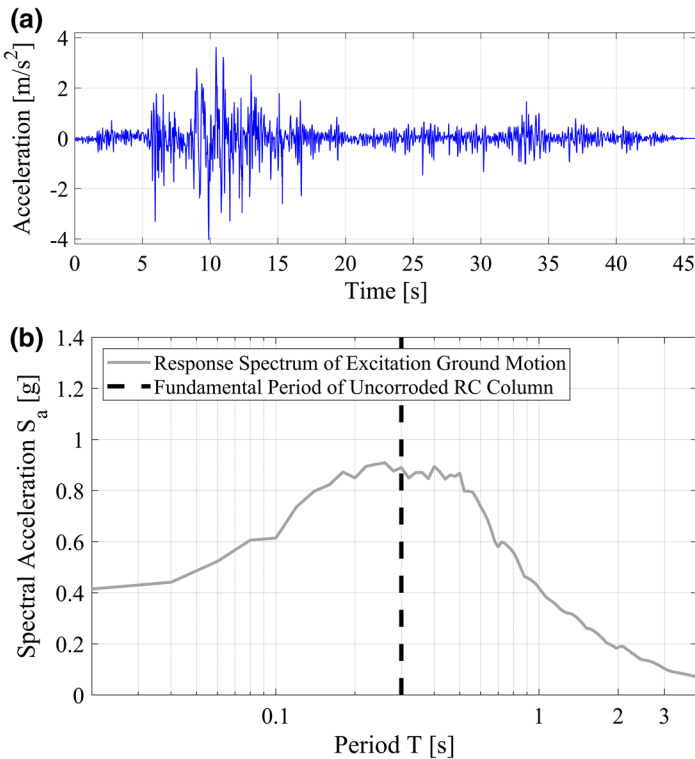
**Fig. 6** Spectrally matched Manjil earthquake ground motion record: **a** acceleration time-series, and **b** elastic total acceleration response spectrum

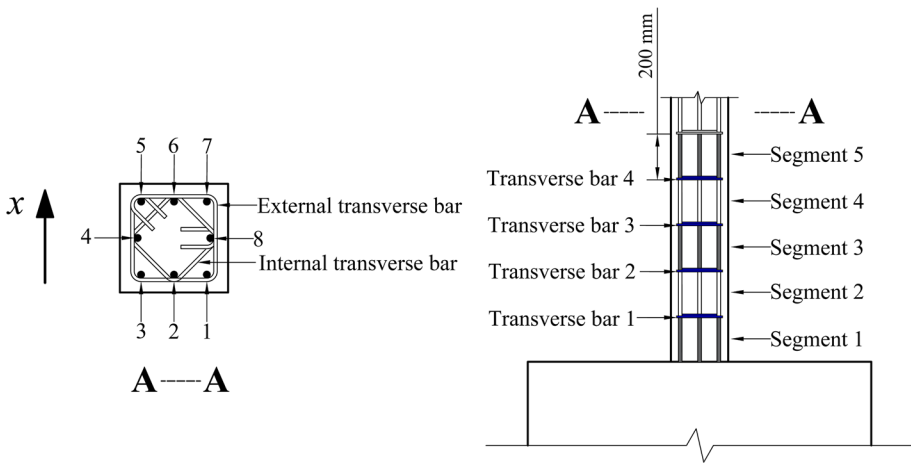
**Fig. 7** Physical segments to investigate the spatial variability of corrosion

Figure 8 indicates clearly that the mass loss in the corner bars (bars 1, 3, 5 and 7 in Fig. 7) is larger than mid-face bars (bars 2, 4, 6 and 8 in Fig. 7). This is because the corner bars are exposed to bi-directional chloride diffusion, while the mid-face bars are exposed to unidirectional chloride diffusion. The synergistic effect of two-sided chloride ingress accelerates the corroding process, which leads to more deterioration and even earlier failure of the corner bars. This phenomenon is reported by other researchers (Lee et al. 2003; Khan et al. 2017). Zhang et al. (2011) conducted an experiment on fly ash concrete with two and three-dimensional chloride ingress. This finding is consistent with those summarised by Zhang et al. (2011).

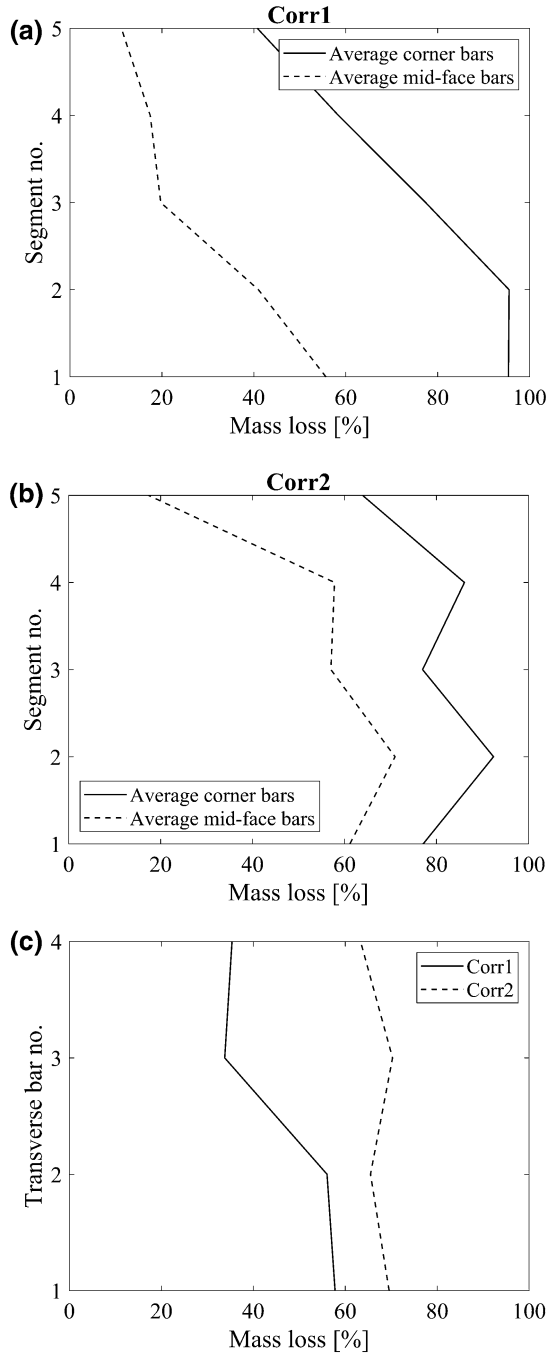
**Fig. 8** Spatial variability of corrosion damage at the lowest 1 m of corroded columns: **a** vertical bars in Corr1, **b** vertical bars in Corr2, and **c** transverse ties in both columns

As mentioned before, the designated part of the column to be corroded is 1 m above the foundation. It can be observed that the corrosion level reduces with increasing height

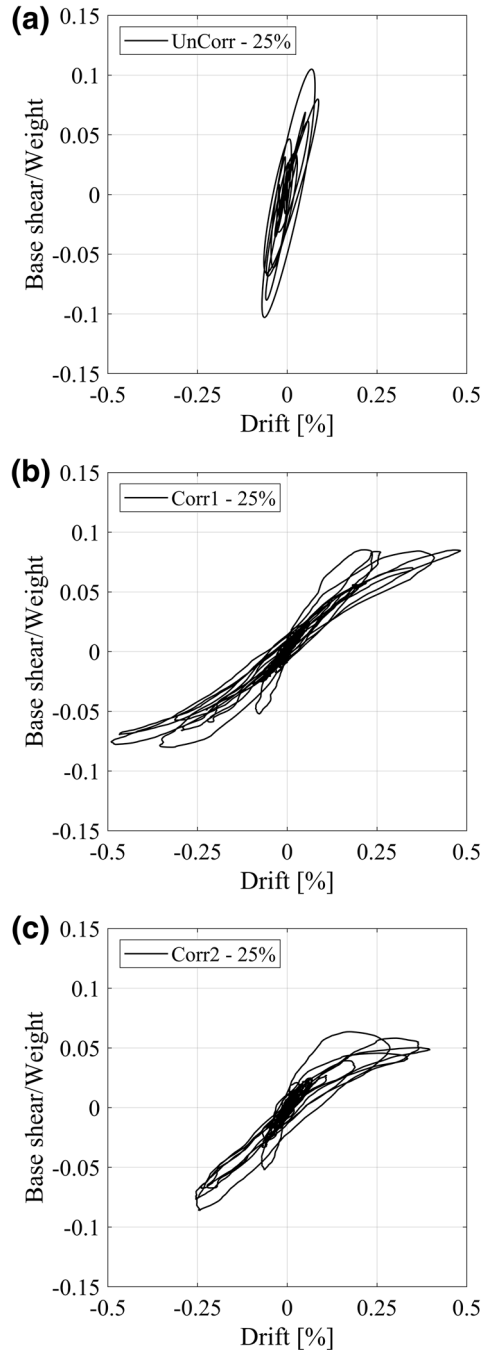
**Fig. 10** Force-displacement hysteretic response of all three columns at 25% excitation (slight damage): **a** Corr1, **b** Corr2, and **c** UnCorr

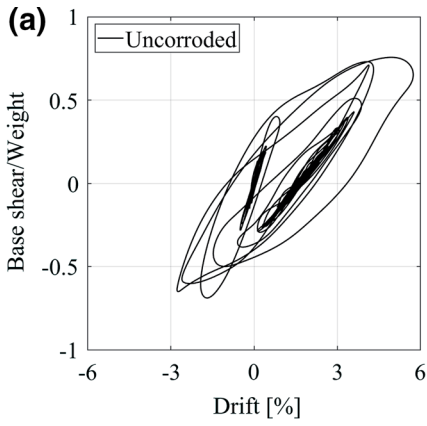
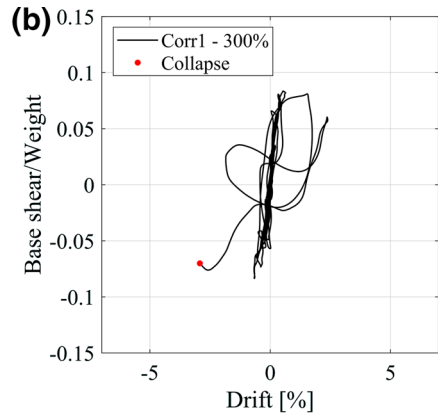
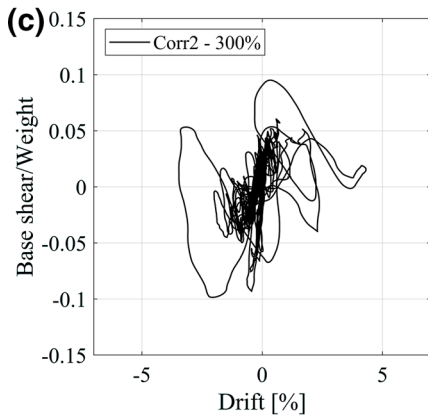
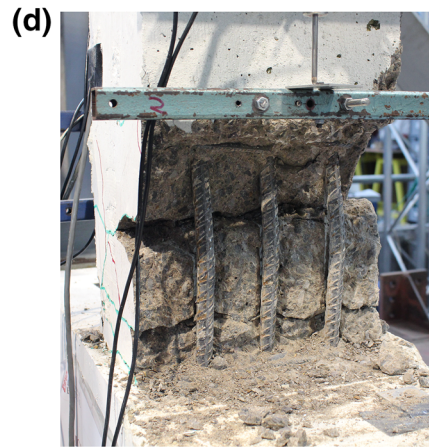
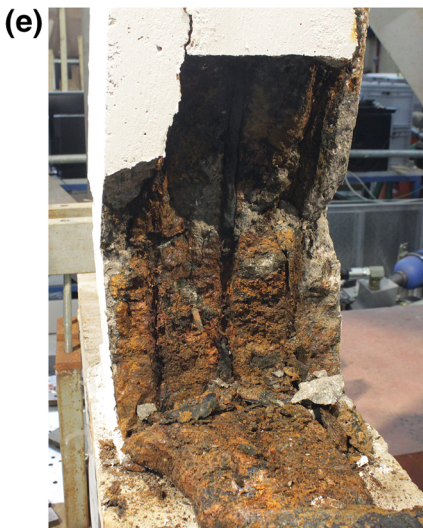
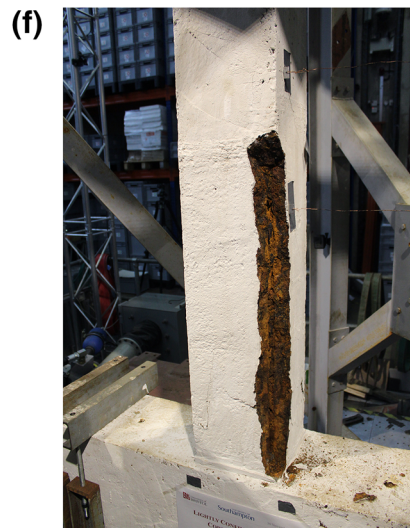
**Fig. 11** Force-displacement hysteretic response and observed damage of all three columns at 300% excitation (extensive damage): **a** hysteretic response of UnCorr, **b** hysteretic response of Corr1, **c** hysteretic response of Corr2, **d** observed damage in UnCorr, **e** observed damage in Corr1, and **f** observed damage in Corr2

Figure 11 shows the force–displacement response of all three columns together with observed visual damage on tests specimen at this 300% excitation level. Figure 11a shows that the Corr1 column collapses completely at the time of 10 s. About 90% of lateral strength reduction is observed compared with the UnCorr control specimen. The Corr2 column (Fig. 11b), despite a slightly higher corrosion level (in terms of mass loss),

The force–displacement response of the Corr2 column at 300% does not show the typical hysteretic response of RC components such as Lehman et al. (2004) and Kashani et al. (2019). During the test, at 300% excitation, some of the vertical bars fractured (due to a combination of pitting corrosion, tensile strain level, and low-cycle fatigue). Therefore, the response of Corr2 does not show the hysteretic response of a typical RC column. It was observed that the column was pivoting between the edges similar to a rocking column, and hence, resulting in concrete crushing in compression. In the hysteretic rocking response (Fig. 11c), force increases without an increase in displacement until it rocks, and as soon as the joint opens force significantly drops; i.e. negative stiffness (Makris and Vassiliou 2014). A rocking column system is typically characterised by a linear negative slope (negative tangent stiffness) of the force–deflection response (during the rocking phase). This negative tangent stiffness is observed in Fig. 11c in the high amplitude loops (for positive displacements). Furthermore, Fig. 11c shows that the hysteretic response is not symmetrical, which is due to a single-sided opening rocking which contains both in-plane and out-of-plane components. Figure 11d shows the observed damage in the UnCorr column, which is mainly due to inelastic buckling of vertical bars and premature crushing of core concrete. Figure 11e, f shows the observed damage in Corr1 and Corr2 columns. Figure 11e shows that the complete collapse of Corr1 column is due to a severe loss of vertical reinforcement due to corrosion as well as corrosion-induced damage to the surrounding concrete. Figure 11f shows that the damage in Corr2 column is mainly at one side of the column, which justifies the unsymmetrical hysteretic response in Fig. 11c.

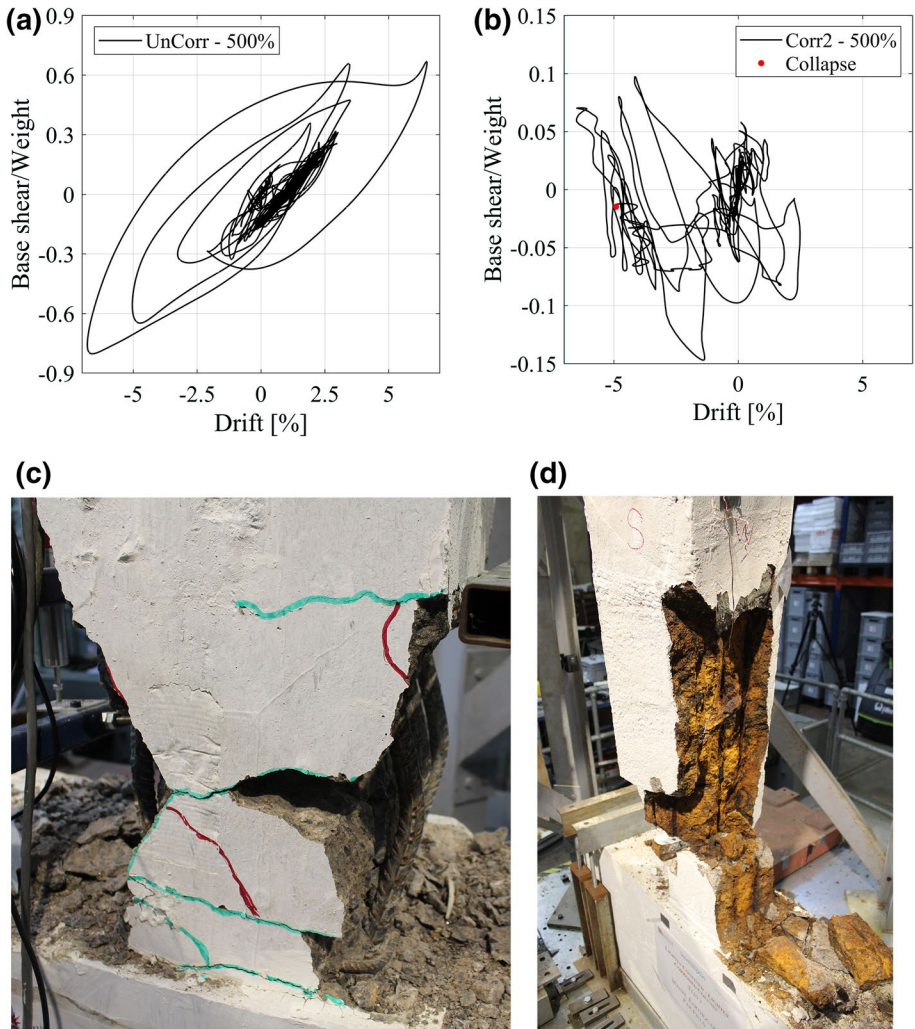
**Fig. 12** Force-displacement hysteretic response and observed damage of UnCorr and Corr2 columns at 500% excitation (complete damage): **a** hysteretic response of UnCorr, **b** hysteretic response of Corr2, **c** observed damage in UnCorr, and **d** observed damage in Corr2

Figure 12 shows the force–displacement response of UnCorr and Corr2 columns (the Corr1 column collapsed at 300% excitation) together with observed visual damage on tests specimen at 500% excitation level. Figure 12a shows the force–displacement response of the UnCorr level at the 500% excitation level. The hysteretic response shows severe cyclic degradation, which is due to the inelastic buckling and low-cycle fatigue of vertical reinforcement. Figure 12b shows that at the 500%, the Corr2 column exhibits an erratic force–displacement response, which includes an increasing residual tilting until the complete collapse at a time of 13 s. 80% lateral strength reduction is observed compared with the UnCorr control specimen. This is before it is subjected to the largest-amplitude pulse of the ground motion. Figure 12c shows the observed damage in UnCorr column after the 500% excitation. The visual inspection of damage indicates that severe buckling of vertical bars in lightly confined columns which resulted in the premature crushing of core concrete previously at 300% excitation level results in severe buckling and large residual drift in the UnCorr column after the experiment. This consequently results in severe degradation in the hysteretic response of the column. Figure 12d shows the completely collapsed Corr2 column at 500% excitation, which shows the unsymmetrical failure of the column. This is due to the unsymmetrical corrosion of vertical bars.

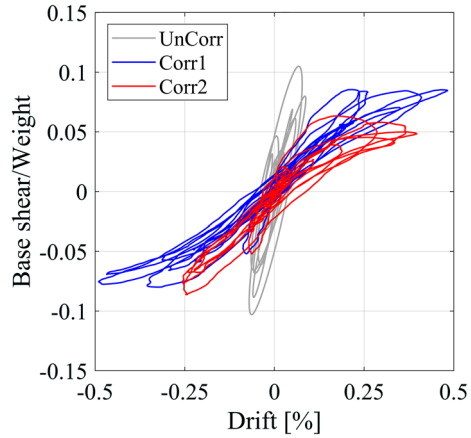
**Fig. 13** Comparative force–displacement responses of all columns at 25% excitation level

A further comparison of the results is provided in Fig. 13. It shows the hysteretic curves of all three columns at 25% excitation amplitude for the strong motion part of the response. It is evident from Fig. 13 that severe corrosion can result in a significant reduction in effective stiffness of RC columns. The severe reduction in stiffness results in an increase in drift, which subsequently results in the premature yielding of the longitudinal reinforcement and crushing of the cover concrete (as shown in Figs. 11, 12). The effective stiffness of the column greatly influences the dynamic properties of the structure as well as the strength and plastic deformation capacity, which all have a significant influence on the energy dissipation capacity of RC columns under earthquake loading. In the following sections of this

compression. As it is qualitatively shown in Fig. 13, corrosion has a significant negative impact on effective the stiffness of RC columns. Here, we will quantitatively show the stiffness degradation of test specimens during the earthquake excitation.

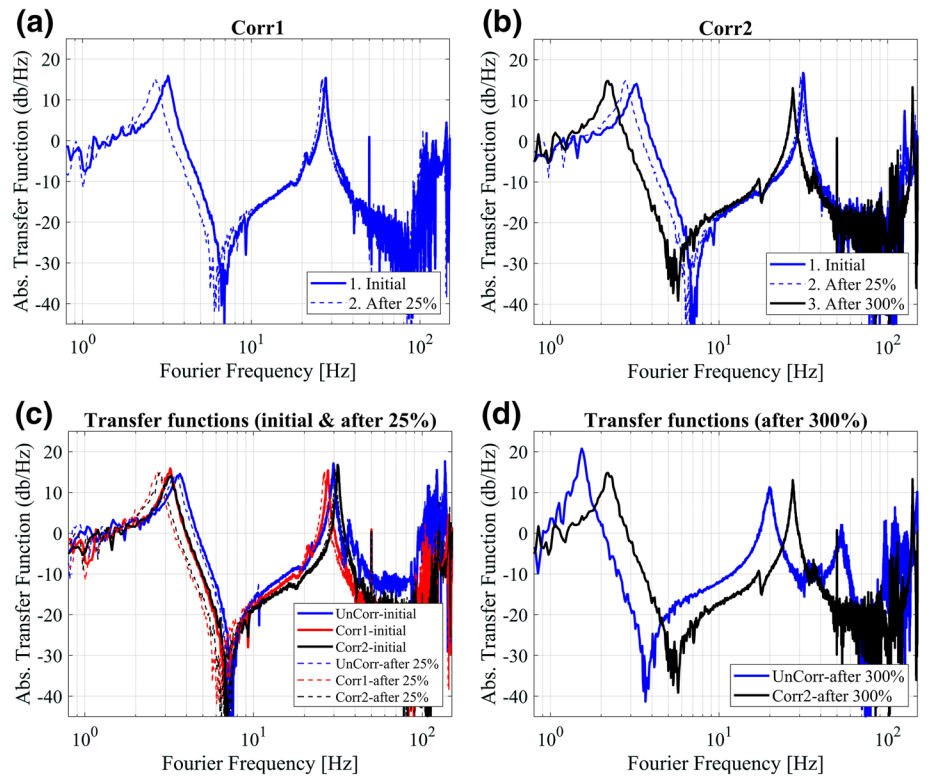
**Fig. 14** Transfer function estimate of test specimens using the low-amplitude white noise excitation: **a** Corr1, **b** Corr2, **c** all three columns, and **d** UnCorr and Corr2 after 300% excitation

Power Spectral Density (PSD) of structural time-history records can extract structural characteristics in the frequency-domain (Cryer and Chan 2008). The transfer function (based on input and structural response accelerations time-series) are estimated using a MATLAB (1994–2018) toolbox (Vold et al. 1984), which employs Welch's algorithm (1967). Large peaks of the transfer function estimate modal frequencies. In this study, only the first and second modes are considered as shown in Fig. 14. Since the Corr1 specimen collapsed at 300% excitation, the white-noise tests data are not available at and beyond 300% excitation for this column.

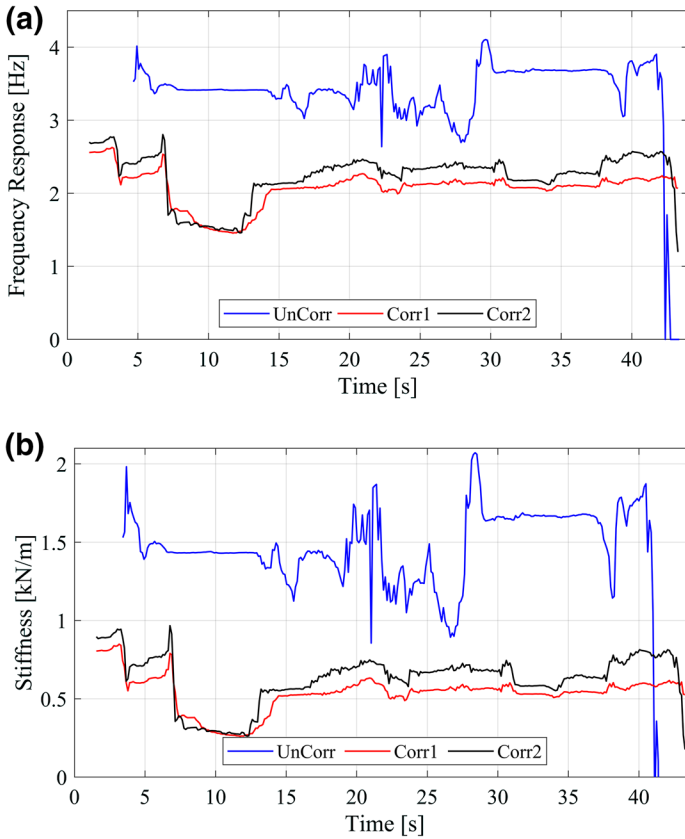
**Fig. 15** Time-varying frequency and stiffness responses of all columns: **a** time-frequency response, and **b** time-stiffness response

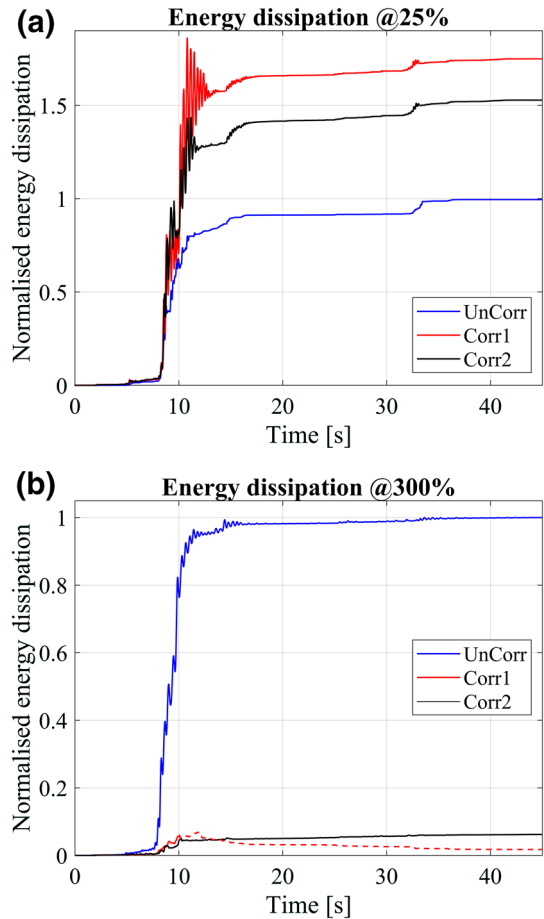
**Fig. 16** Normalised cumulative energy dissipation of the uncorroded and corroded columns: **a** slight damage excitation (25%), and **b** extensive damage excitation (300%)

The cumulative energy dissipation is an important quantitative indicator of cyclic degradation of a structure subjected to seismic excitation. Cumulative energy dissipation is defined as the integration of the area inside hysteretic force–displacement loops (Chopra 2007). In this study, the cumulative energy dissipation of two corroded RC columns and the UnCorr control column at slight (25%) and extensive (300%) damage excitation levels are estimated. The results are normalised by the total dissipated energy of the UnCorr control specimen in each round of the test (shown in Figs. 10, 11, 12). Corroded columns Corr1 and Corr2 exhibit 1.53 and 1.75 times the energy dissipation of the UnCorr column at (25% of PGA). At the 300% of PGA level, both corroded columns are highly damaged and appear to dissipate much smaller energy than the UnCorr column. Column Corr1 technically fails at 10 s and would completely collapse if not for the support frame. Column Corr2 as previously discussed has transited from a flexural to a rocking typology and is also very near to collapse. This shows, that corrosion results in premature plastic deformation in the corroded columns and hence higher energy dissipation at low-amplitude excitation (Fig. 16a). However, owing to the corrosion-induced reduction in strength and plastic deformation capacity, there is a severe reduction in energy dissipation capacity at large amplitude excitation (Fig. 16b).
