Field survey of the 30 October 2020 Samos (Aegean Sea) tsunami in the Greek islands

Abstract

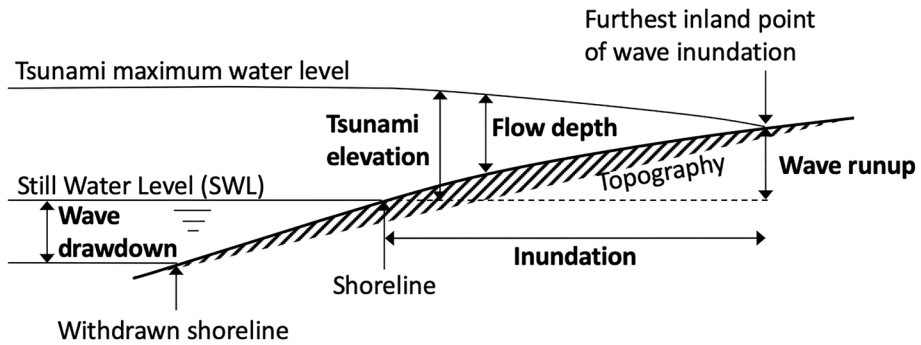
Fig. 2 Diagram showing the terms used for the quantitative measures of tsunami intensity (boldface text) collected at coastal locations during the post-tsunami field surveys

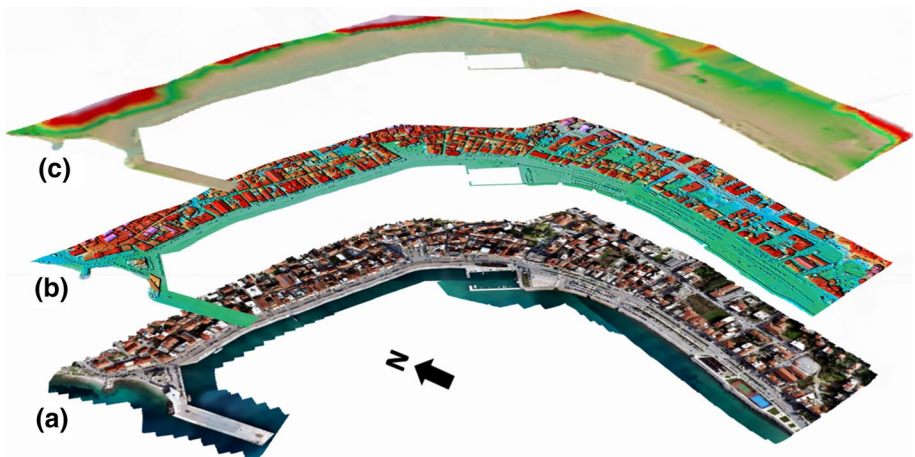
Fig. 3 The orthophoto (a), DSM (b) and bare earth DEM (c) of Vathi created using drone aerial images

Photoscan software to produce high-resolution point clouds, and the data were georeferenced using well-distributed ground control points (GCPs, in the form of targets on the ground) of known world coordinates. The final products were a 5.3 cm resolution orthophoto and DSM of the waterfront of Vathi (Fig. 3), and a 1.7 cm resolution DSM of the Samos Library and its surroundings (Fig. 4). The mean total (xyz) errors of the two DSMs are 3 and 3.7 cm, respectively. The DSM of the waterfront of Vathi was post-processed using ArcGIS Pro tools to create a (bare earth) Digital Elevation Model (DEM) (Fig. 3).

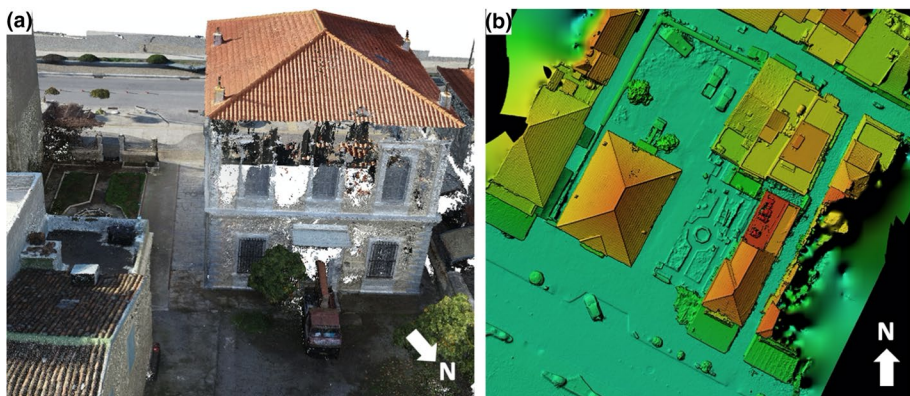
Fig. 4 The point cloud (a) and DSM (b) of Samos Library in Vathi created using drone aerial images

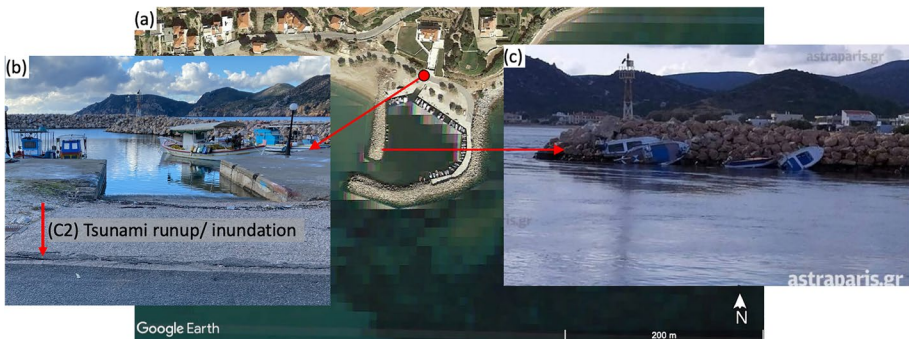
Fig. 6 **a** Google Earth satellite picture of Komi and the location of the runup/inundation measurement. **b** A picture from the field showing the maximum runup/inundation point measured north of the harbour slip. **c** A picture from a news article showing the fishing boats that were dragged by the tsunami-induced currents to the side of the breakwater (source: Astraparis 2020)

to eyewitnesses was the largest observed, the water overtopped the harbour dock and reached the coastal road at ~ 1.46 m of elevation (Fig. 6b). The mooring lines of some of the fishing boats broke or came off and the tsunami-induced currents dragged and deposited them on the harbour side of the breakwater (Fig. 6c). While the tsunami impacted the harbour, the waves didn't reach any of the houses sitting on the beach adjacent to the harbour.

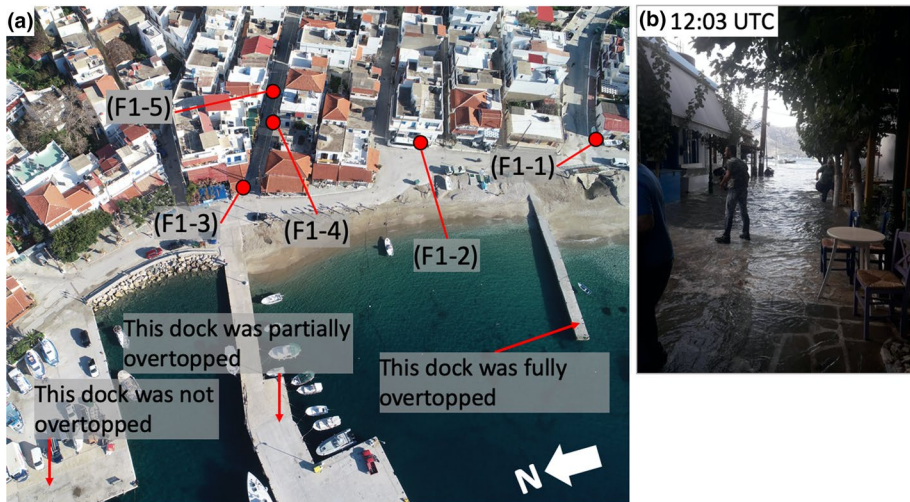
Fig. 7 **a** Aerial picture of the town of Fourni showing the locations where tsunami field measurements were collected and revealing the coastline features described in the text. **b** A timestamped eyewitness picture of the main commercial street of Fourni being flooded by the first and largest wave (photo credit: A. Chalaros)

Maximum runup was measured along the main commercial town street (data point F1-5), which at the time of writing did not appear to have a name. An additional runup and three tsunami elevation points were collected in the town of Fourni as indicated by eyewitnesses. The residents mentioned at least two additional floods in Fourni, but that the first was the largest. A timestamped video captured at 12:14 UTC shows that the water level was rising and had already flooded the coastal road, while a picture taken at 12:31 UTC shows another flood event. There was no substantial damage due to the tsunami in the town of Fourni, which was described as a fast-rising tide with no significant overland flow velocity. The data points collected in other locations along the northern part of the island of Fourni (data points F2-F4) show consistent runup/tsunami elevation values above 1 m, but no flooding of any coastal buildings was reported.

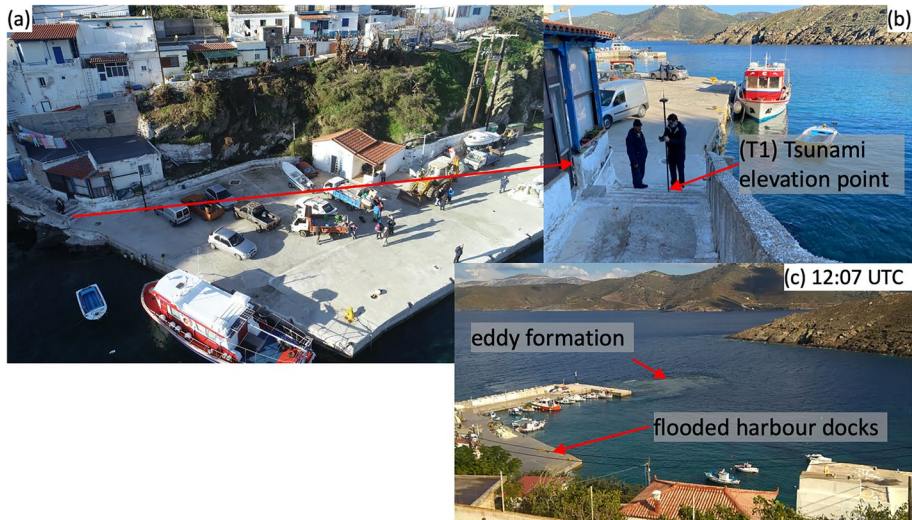
The town of Thimena (location T1) on the namesake island features a small harbour (Fig. 8a) and is located ~2.3 km to the west of the town of Fourni. According to several eyewitnesses, the tsunami arrived as a leading depression wave, and during the drawdown phase some fishing boats touched the sea floor. The (first) flood that followed was described as being the largest. An eyewitness video shared with us that was filmed at 12:07 UTC,

Fig. 8 **a** Aerial picture showing the harbour of Thimena, and the tsunami elevation data point measured on the first step of the staircase connecting the harbour to the town (**b**). **c** A frame from an eyewitness video showing an eddy forming at the corner of the harbour dock during the second drawdown phase and the harbour docks being already flooded

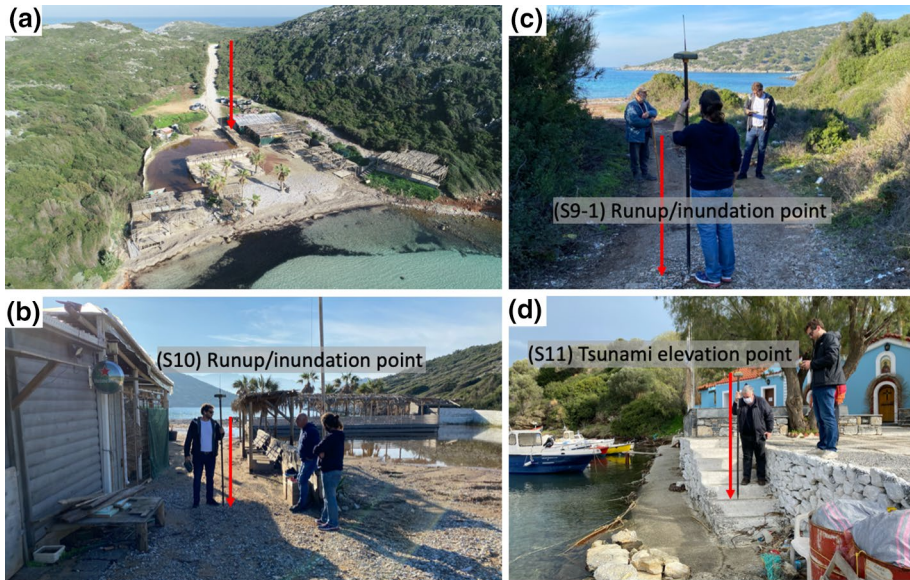
Fig. 9 **a–b** Aerial and ground picture of the runup/inundation point collected in Livadaki, Samos. **c–d** The runup/inundation and tsunami elevation points collected in Asprochorti and Ag. Paraskevi, respectively

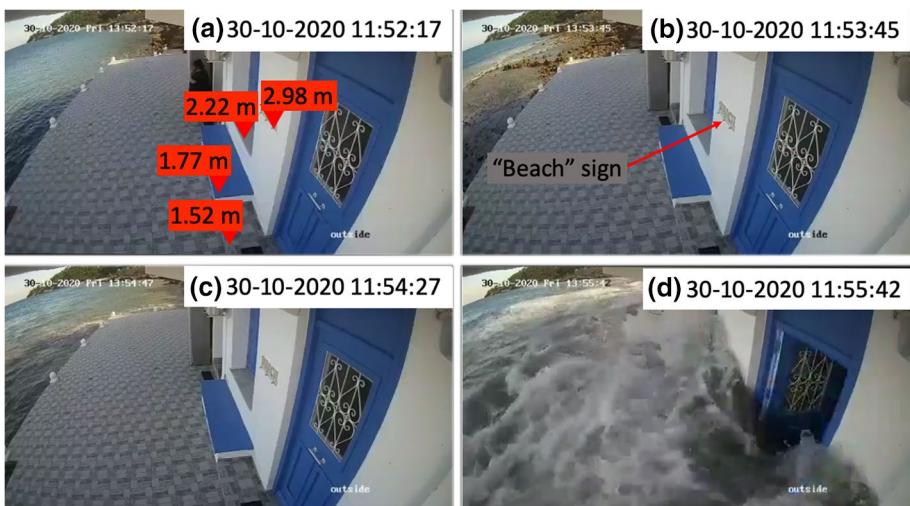
Fig. 11 **a–d** Frames from a CCTV video captured in a coastal residence of Ag. Nikolaos, Samos; date and time displayed is UTC. The elevations (above SWL at the time of measurements) of various features of the building facade are displayed in (a)

information for the timing of impact: the shoreline withdraws (Fig. 11b), the sea level rises and peaks (Fig. 11c), and the last frame (Fig. 11d) shows the impact of a subsequent flood. The steep wave front that impacts the coastal residence appears more violent compared to any other coastal location for which video footage is available for the Samos (Aegean Sea) tsunami, and is seen arriving from the east, propagating westward along the coast. Upon visiting this location and measuring the elevation of the distinct features on the house's facade (Fig. 11a), it can be safely said—excluding the water splash—that the tsunami elevation in this location reached at least 2.22 m above SWL (windowsill), and was below ~3.0 m (the lower side of the “Beach” sign).

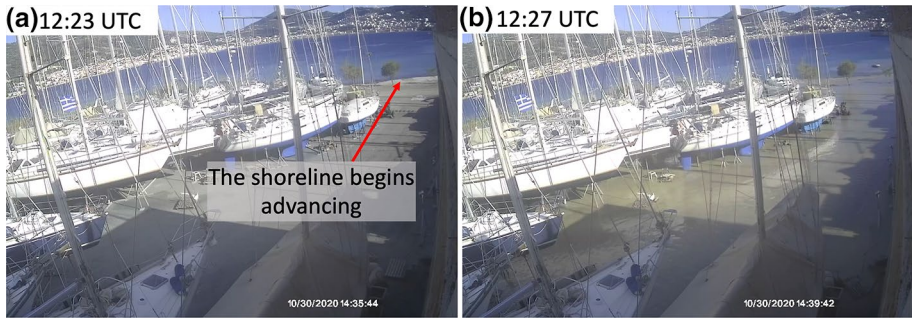
Fig. 12 CCTV footage frames from the boat parking area in Malagari, Samos, showing the moments when (a) the shoreline started advancing and (b) when the flood peaked (UTC times shown were corrected based on the earthquake shaking initiation)

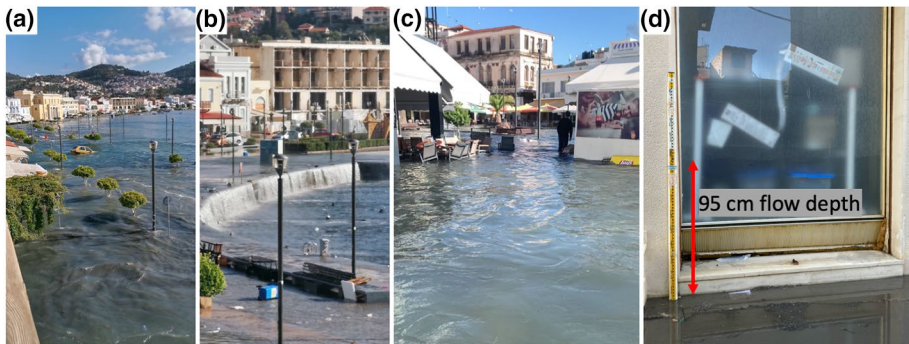
Fig. 13 a–c Eyewitness pictures from the second and largest flood in Vathi, Samos. d A characteristic flow depth point identified on a dusty shopping window the day after the tsunami along Tompazi St. in Vathi (data point S7–12)

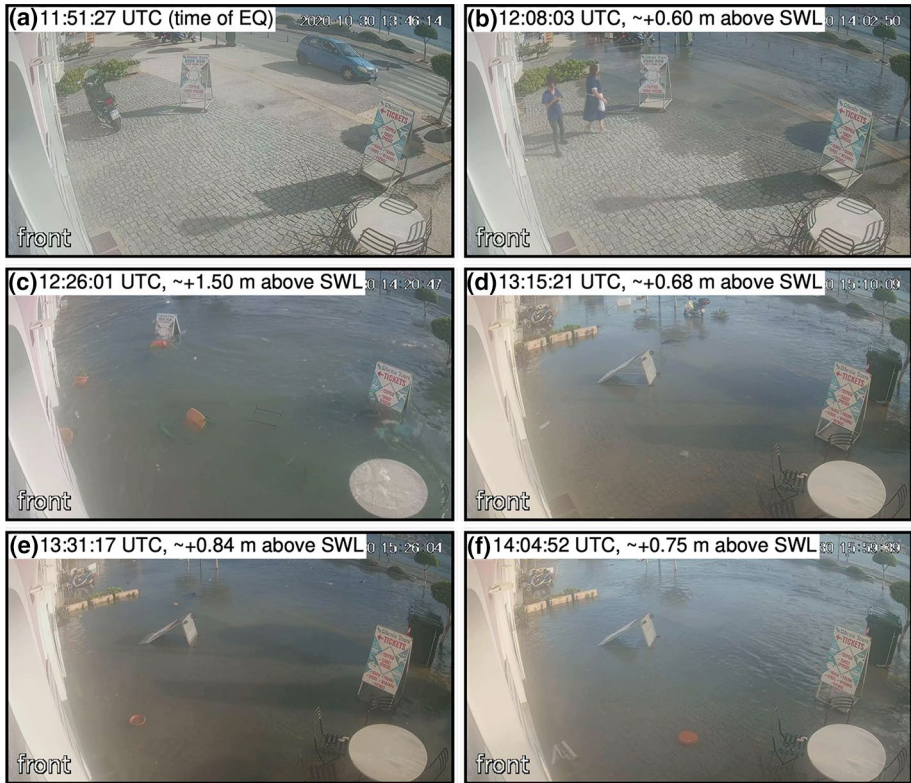
the time each flood event reached its maximum elevation. The maximum water elevation reached in each flood displayed in Fig. 15 was inferred through objects seen in the image whose elevations were surveyed, in combination with the high-resolution DSM of Vathi created using the drone images. It is important to stress that in this location only the second and fourth waves overtopped the concrete structure located between the harbour quay and the street, while in the other events the water flooded the street and pavement through areas of lower topography and the storm drains (located at ~ 0.44 m above SWL). As a result, for the flood events that didn't overtop the concrete structure, flooding was delayed, and the maximum water level was deficient compared to other locations impacted directly through wave overtopping.

Fig. 15 Video frames extracted from the travel office CCTV footage showing the (corrected) times and maximum elevations reached by the individual tsunami-induced floods in this location of Vathi, Samos

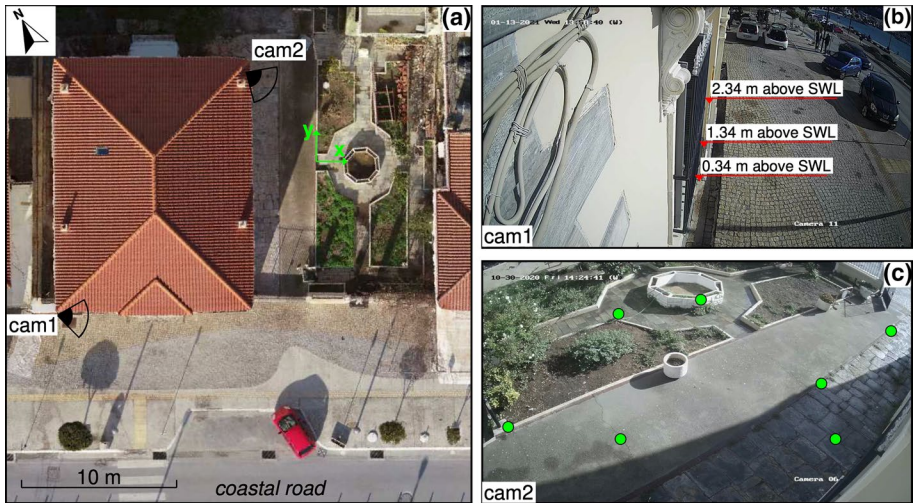
form $\mathbf{A} \cdot \vec{x} = \vec{b}$ and using the seven non-coplanar ground control points (GCPs) shown in Fig. 16c whose world coordinates were obtained from the Library high-resolution DSM (Fig. 4). Reconstructing the world coordinates of the GCPs from their (undistorted) image coordinates using the best-fitting DLT coefficients yields a mean horizontal error of 1 cm.

Fig. 16 **a** The location and orientation of the two cameras (*cam1* and *cam2*) used to extract overland tsunami heights and free surface velocities overlaid on an orthophoto of Samos Library; the local coordinate system used with the free surface velocities overlaid is shown with the green arrows, x and y being the shore-parallel and shore-normal directions, respectively. **b** The field of view of *cam1* showing the levelling rod placed on the corner of the building facade to extract water level information; reference heights are provided. **c** The field of view of *cam2* and the ground control point (green circles) through which the camera extrinsic parameters were determined

the flood peaked, was inferred through features of known dimensions that were partially flooded. For the world coordinates (x , y), a local coordinate system was defined where the x and y axes are parallel and normal to the shoreline, respectively (Fig. 16a).

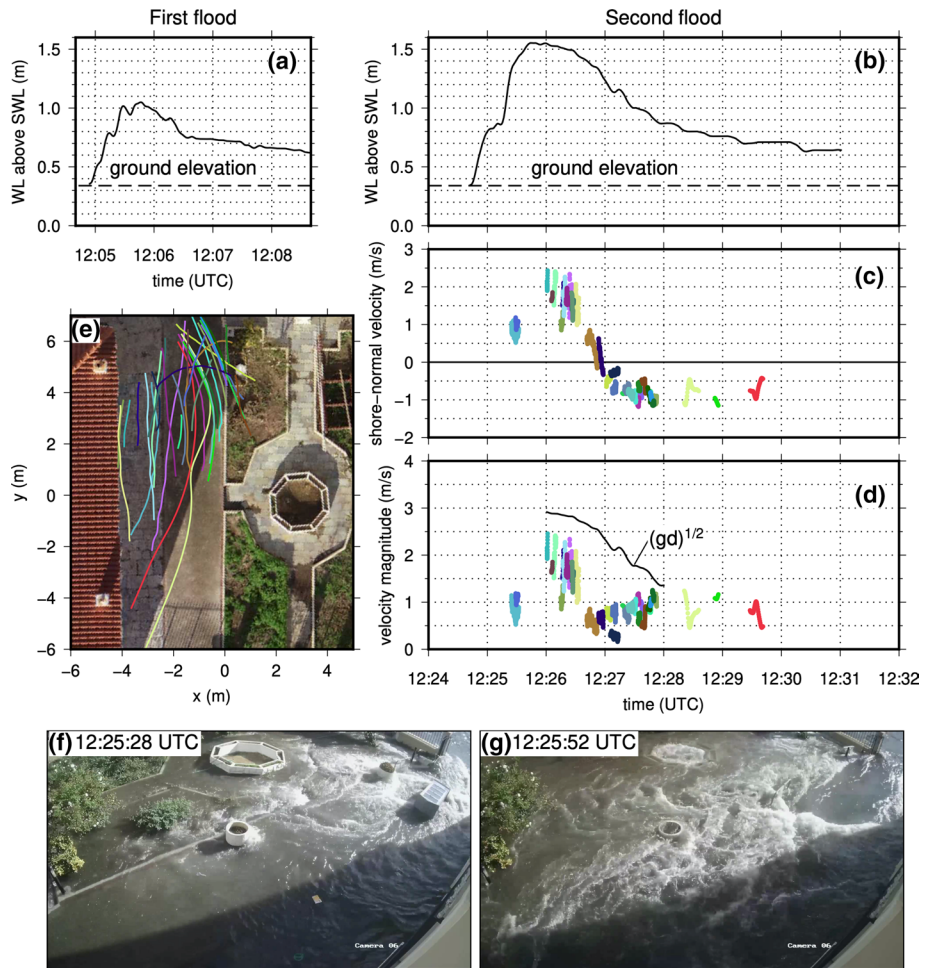
The tracer paths in world coordinates extracted with the 25 Hz sampling frequency were first filtered using a low-pass Butterworth filter with 2.5 Hz cut off frequency to remove high frequency fluctuations due to optical tracing errors and local water level fluctuations. The filtered paths (Fig. 17e) were then translated to velocities using the first order central difference scheme. The resulting shore-normal velocities and corresponding velocity magnitudes are shown in Fig. 17c–d. Each tracer, plotted using a different colour, experienced high acceleration/deceleration as it moved through the camera field of view in regions of varying velocity as is evident from the steep individual velocity curves. Free surface velocities as high as 2.5 m/s were measured as the flow depth reached ~ 0.83 m, which corresponds to a subcritical flow according to the Froude number ($Fr < 1$) using the mean ground elevation in the optical field of view $h = 0.68$ m. The video frames shown in Fig. 17f–g indicate supercritical flow conditions before the second flood peaked.

Fig. 17 **a–b** Tsunami elevation time series of the first two floods in Vathi extracted from the *cam1* Samos Library CCTV video. **c** Shore-normal free surface velocities for the second flood in Vathi extracted from the *cam2* Samos Library CCTV video through particle tracking; each colour corresponds to a different particle. **d** Same as (c), but showing the velocity magnitude; the black curve corresponds to the shallow water speed \sqrt{gd} , where d is the flow depth computed by subtracting the mean ground elevation in the optical field of view ($h = 0.68$ m) from the water level d extracted from (b) after the flood peaked. **e** The paths of the objects optically tracked, projected on top of an orthophoto. **f–g** Two frames of the *cam2* footage for the second flood showing the flow conditions during the flood rise stage
