Shaking table test and numerical analyses of a full scale three-leaf masonry wall

Abstract

Keywords Three-leaf masonry walls · Weak lime-mortar joints · Full-scale shake table test · Old masonry buildings

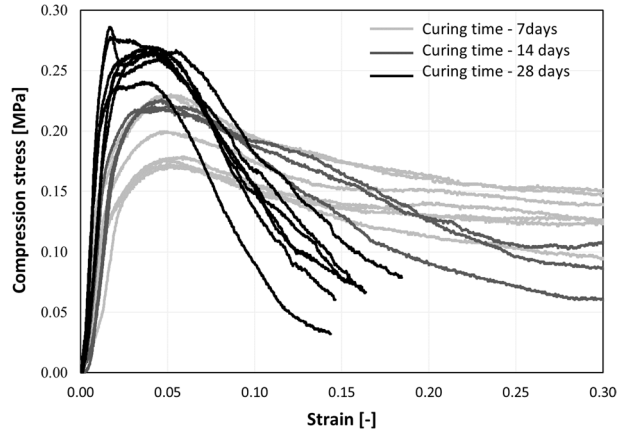
Fig. 2 Mortar stress–Strain diagrams for uniaxial compression tests at different curing times

tested. However, issues related to the consistency of some specimens arose when they were removed from the mould and the number of specimens had to be reduced. Figure 2 shows the resulting stress–strain diagrams. The curing process induced an increase of the compressive stress which returned a mean value $f_{c,M,28}$ around 0.18 MPa at 7 days, 0.24 MPa at 14 days and approximately 0.29 MPa at 28 days. A reduction in the ultimate strain was also observed. The average mortar Young’s modulus $E_{c,M}$ was estimated equal to 25 MPa.

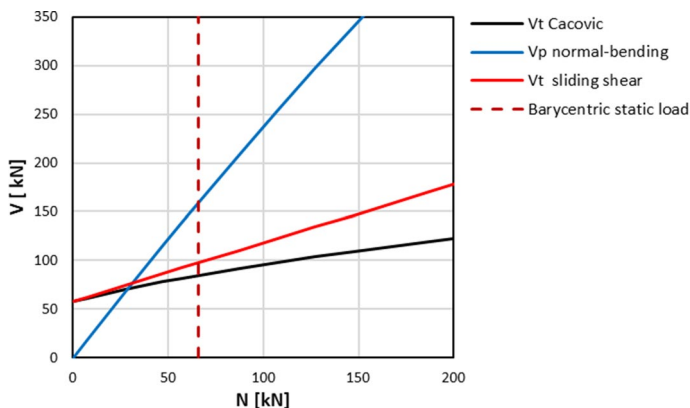
Fig. 3 Strength domain envelope of the test wall specimen

The previous equations lead to the strength domain envelope given in Fig. 3 in terms of shear strength vs. axial force. Based on the above calculations and to facilitate the development of shear failure with diagonal cracks, a total vertical load of 66 kN was imposed on the wall top. It is noted that this load, added to the wall weight, was also deemed optimum for the shaking table as it did not exceed the permissible payload, while still allowing accelerations higher than 1 g to be achieved.

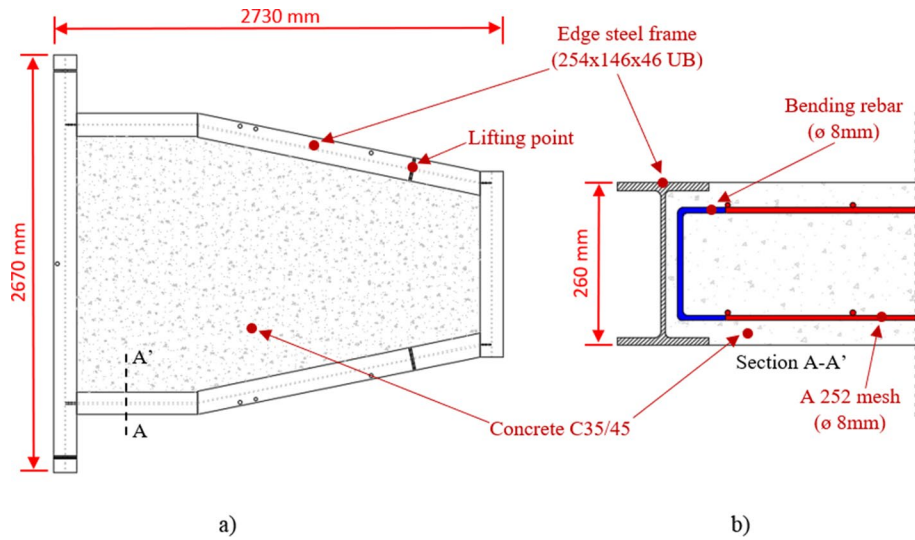
Fig. 4 Specimen foundation system: **a** plan view and **b** section near the foundation edge

The foundation system, schematically shown in Fig. 4, consisted of a reinforced concrete (RC) slab confined at its edges by 254×146×46 UB steel members. It was designed to support the wall and the additional top mass during the dynamic tests, as well as to withstand the forces and deformations that developed during the construction stages, particularly when the slab was lifted and positioned on the shaking table. The foundation shape was necessary to accommodate additional tests on T-shape walls, that are not discussed in this paper but will be the subject of future publications.

The RC slab was made of a C35/45 concrete and was reinforced, both top and bottom, with A252 steel ($f_y = 460 \text{ N/mm}^2$) 8 mm-diameter square mesh sheets with a 200 mm on-center. Figure 5 shows selected working phases during construction.

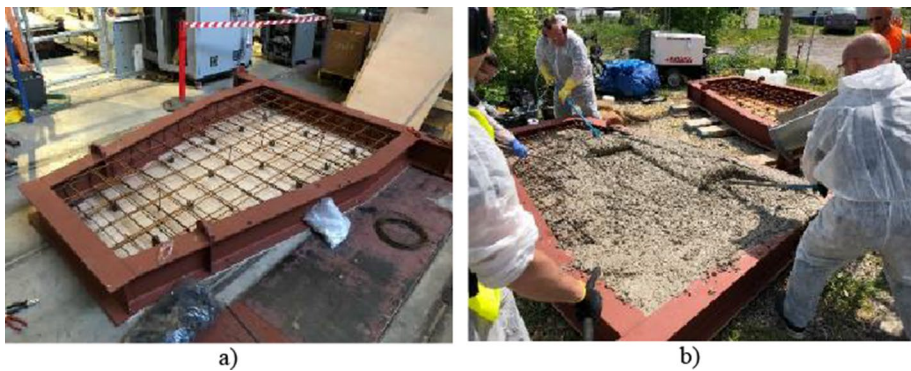
Fig. 5 Selected images from construction of the foundation system: **a** edge steel frame with rebar mesh and **b** concrete casting

To summarize, construction followed the following sequence. The foundation system (Fig. 5) was built outside the laboratory. Once finished it was transported inside the lab next to the table. The wall specimen was then built on the foundation before lifting foundation and wall specimen onto the shaking table. Once on the table, the lateral support system was added first, followed by the additional top frame and top weights. The total specimen weight was 13.5 tons: 3 tons for the foundation system, 3.3 tons for the wall, 6.5 tons for the roof system, including the additional masses, and 0.7 tons for the two external frames.

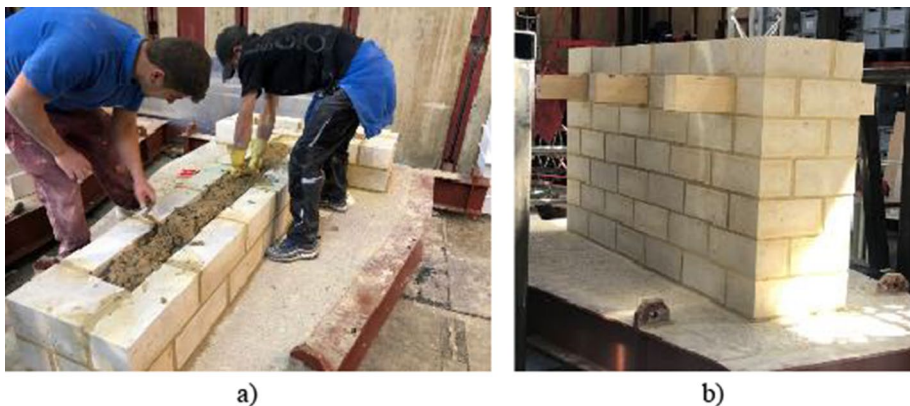
Fig. 7 Wall construction phases: **a** infilling between the outer leaves; **b** finished three-leaf wall

2640×1900 mm. The two 1900 mm-long longitudinal timber beams had a 140×200 mm rectangular cross section. Figure 7 shows relevant working phases of the wall built-up.

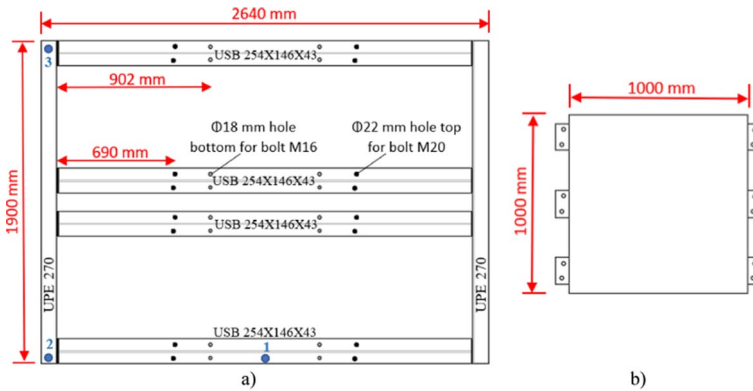
Fig. 8 **a** Horizontal steel frame mounted on top of the wall; **b** 130 mm-thick 1000×1000 mm plate used as additional mass (1-ton weight for a single plate). Numbered and coloured blue dots indicate position of accelerometers shown in Fig. 12

The roof system consisted of the steel horizontal frame shown in Fig. 8 connected to two longitudinal timber beams that were, in turn, supported by the three transversal timber beams built into the masonry wall. The two longitudinal timber beams were connected to the three transverse timber beams using 12 mm-diameter steel treated rods. The steel frame was made of four longitudinal UB 254×146×43 profiles connected to two UPE 270 profiles in the orthogonal direction. The total in-plane dimensions of the frame were

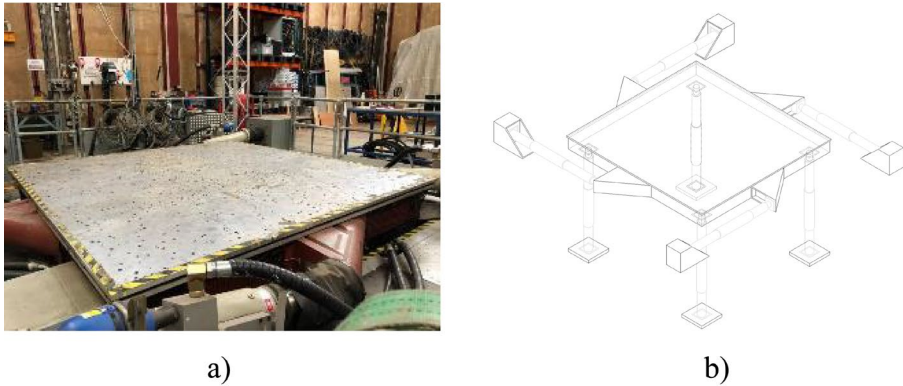
Fig. 10 The shaking table of the EQUALS laboratory at the University of Bristol

The 6DOF (Degrees Of Freedom) shaking table (i.e., Earthquake Simulator, ES) of the EQUALS Laboratory was used to carry out the dynamic test on the wall. The table is made of a 3 m×3 m cast aluminium platform (Fig. 10a), capable of carrying a maximum payload of 15 tons, but no more than 10 tons at a maximum acceleration of 1.6 g. The platform surface is an arrangement of five superimposed aluminium plates with a regular grid of holes that serve to mount the specimens to the platform through M12 bolts. The platform is supported by eight hydraulic actuators (four horizontal and four vertical, Fig. 10b) that allow all six degrees of freedom to be controlled.

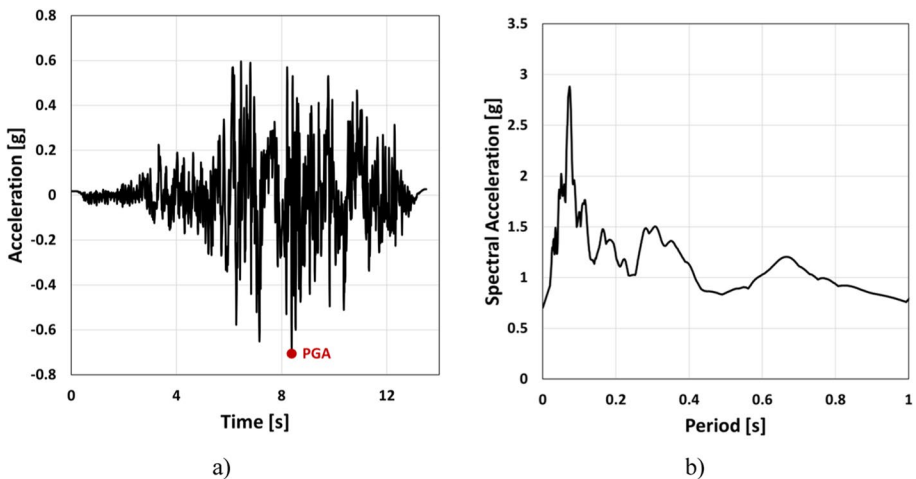
Fig. 11 May 17, 1976 Gazli earthquake: **a** recorded Horizontal (H) component and; **b** corresponding elastic pseudo-acceleration spectrum (for 5% damping)

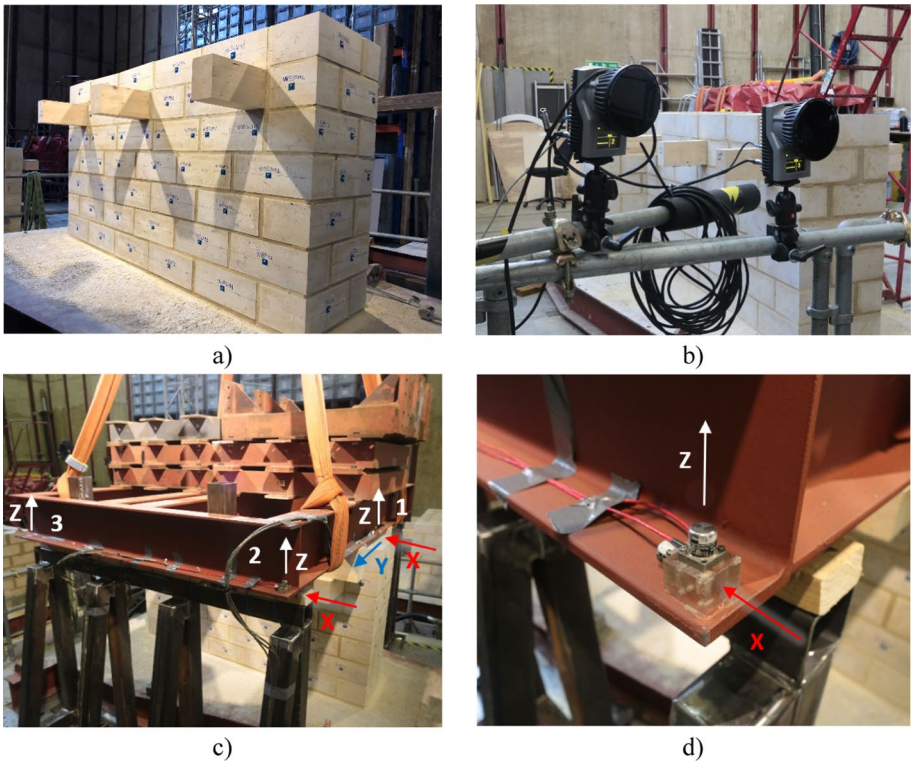
Fig. 12 Main features of the data acquisition system: **a** markers on the masonry faces for displacement measurements; **b** infrared cameras; **c** accelerometers on the top steel frame; **d** close-up of accelerometer 2 on the top steel frame

Displacements in the three directions (X, Y and Z) were recorded with five infrared Oqus400 cameras as shown in Fig. 12b. Accelerations were recorded using nine accelerometers around the specimen (Fig. 12c). Three of the accelerometers were arranged on the shaking table to measure the acceleration imposed on the wall and six on the top horizontal steel frame, as shown in Fig. 12c, d. The accelerometers work in a range of ± 10 g with a sensitivity of the order of 10^{-14} g. Acceleration data was recorded at intervals of 2×10^{-4} s.

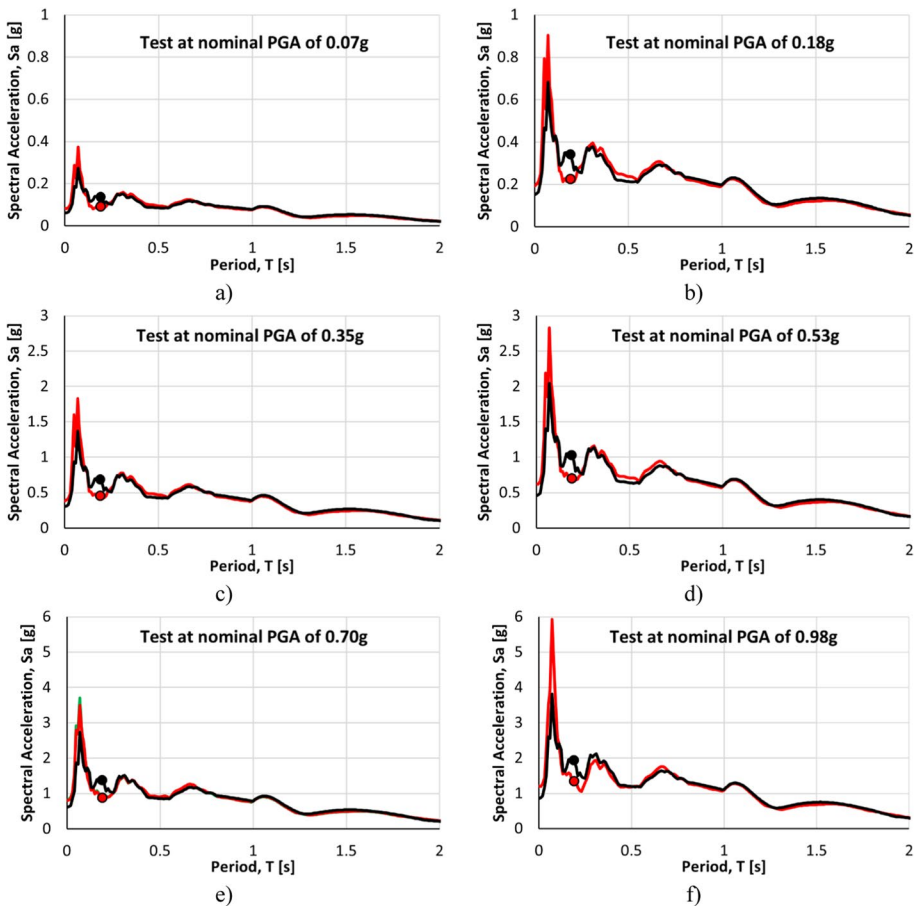
Fig. 13 Comparison between elastic acceleration response spectra (for 5% damping) of the input nominal records (black) and of the records measured on the shaking table (red)

The maximum accelerations recorded on the shaking table (corresponding to zero natural period in Fig. 13) were, on average, 13% higher than those of the input signals. The spectral acceleration values near the initial fundamental period in the specimen longitudinal direction (which the white noise tests identified as $T_1=0.18$ s) calculated from the shaking table signals were always lower than those of the input signals (see the black and red bullets in Fig. 13), with a maximum difference of 32%. It should be pointed out that when damage occurs for higher ground/spectral accelerations, the period of the structure increases significantly, and this should lead to the conclusion that the actual and the nominal ground/spectral accelerations tend to diverge for higher shaking intensities.

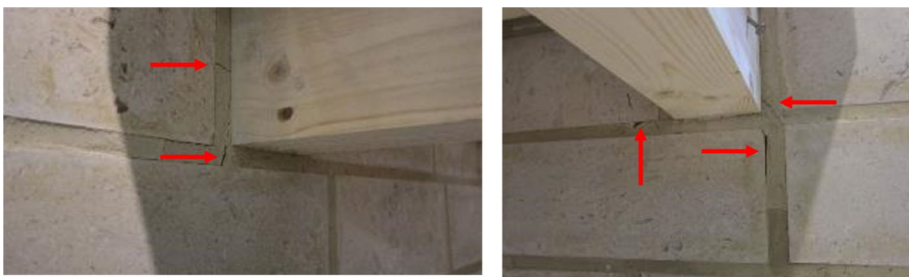
Fig. 14 Mortar cracks due to shrinkage near a timber beam

The evolution of the wall damage for increasing accelerations was carefully monitored during the tests. The specimen developed minor cracks during lifting and transportation onto the shaking table due to the low strength of the weak mortar and possibly to the difference in stiffness between the external leaves and the more flexible inner core. Following a check of these cracks, they were not considered of structural significance. Additional small cracks due to shrinkage appeared near the timber beams (Fig. 14), where the timber locally absorbed water from the mortar, thus affecting its curing. These small cracks may have affected the response of the specimen in the first runs with low accelerations by slightly reducing the wall initial stiffness.

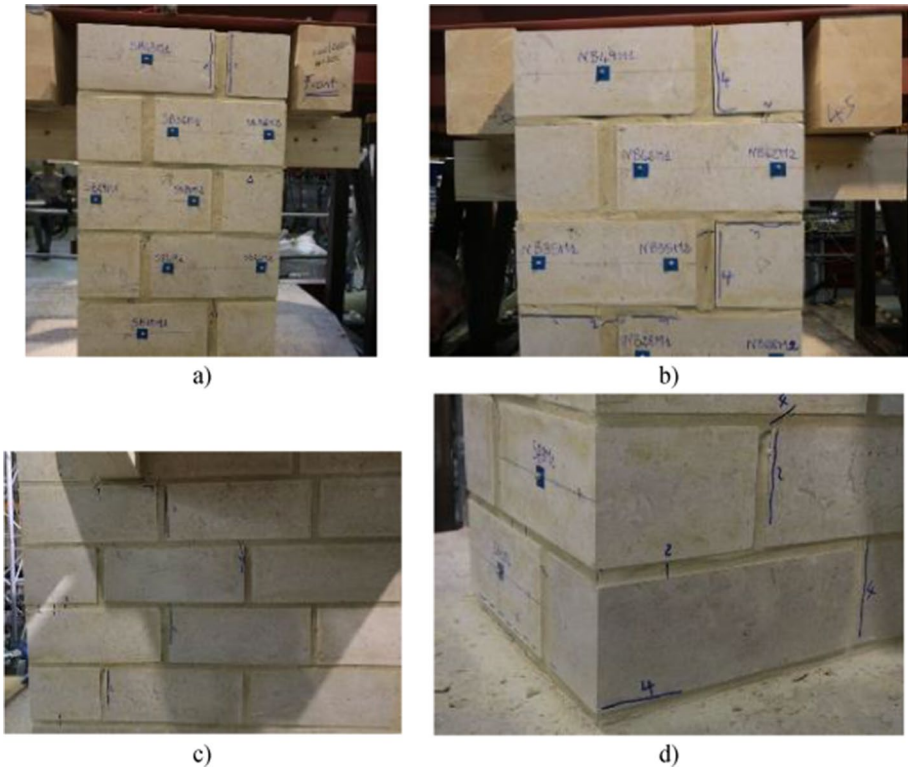
Fig. 15 Damage at the end of test A6 (nominal PGA=0.53 g) on: **a**, **b** S and N leaves; **c** E leaf; **d** SE corner. Major cracks are marked and numbered in blue

The specimen did not show any remarkable damage before test A6 [nominal PGA=0.53 g], when small—mostly vertical—cracks were detected at the mortar joints, more specifically below the external timber beams (Fig. 15). These in plane cracks on the two external W and E leaves slightly widened during test A8.

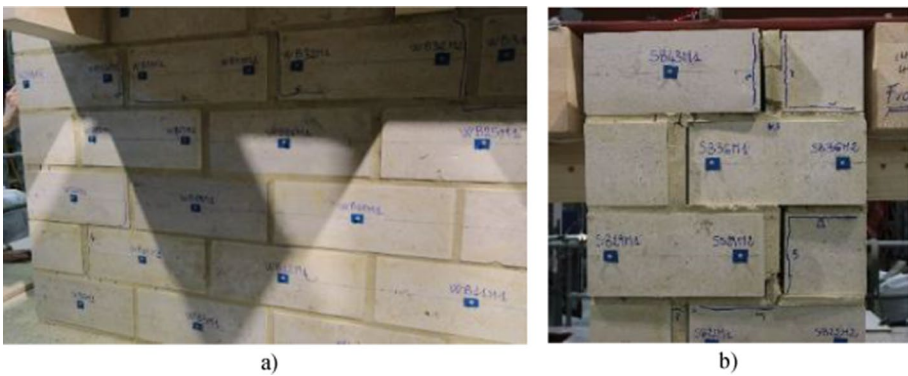
Fig. 16 Damage at the end of test A10 (nominal PGA=0.70 g) on: **a** W leaf; **b** S leaf. Major cracks are marked and numbered in blue

At the end of test A10, corresponding to a nominal PGA=0.70 g, delamination of the two outer N and S leaves started, with important vertical cracks developing (Fig. 16b). Moreover, narrow in-plane shear cracks appeared on the two W and E leaves (Fig. 16a). An incipient

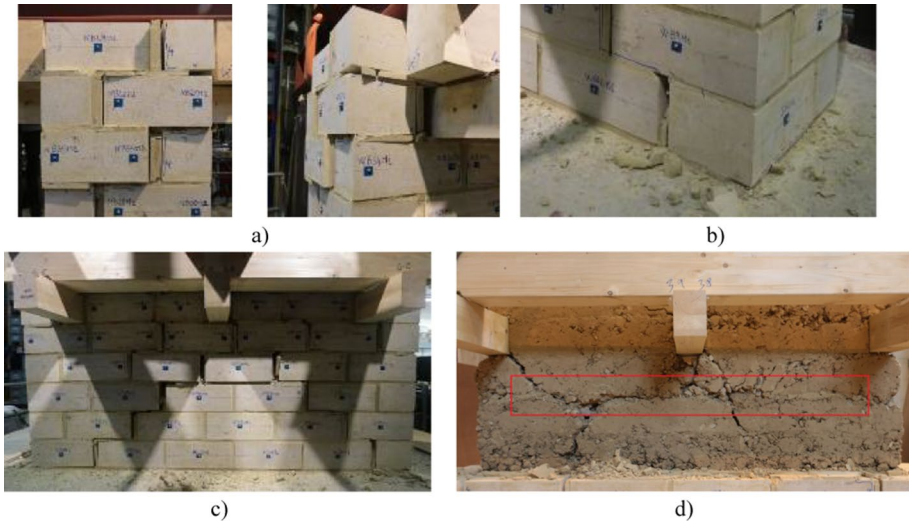
Fig. 17 Damage at the end of test A14 (nominal PGA = 0.98 g): **a** at the wall top; **b** at one of the lower corners; **c** on one of the two lateral sides; **d** in the infill following removal of the stone units of one of the outer layers (the longitudinal, out-of-plane plastic hinge crack is schematically shown inside the red box)

At the end of test A14 (nominal PGA of 0.98 g), damage was visible throughout the wall, with different mechanisms activated. On the wall two lateral sides, detachment of the two N and S leaves was evident (Fig. 17a). Sliding damage also took place in the lower end corner (Fig. 17b). Diagonal shear cracks (30–40 mm wide) were clearly visible (Fig. 17c). The out-of-plane flexural mechanism of the outer leaves was observed. This mechanism became more evident when the blocks below the timber crossbeams were removed (Fig. 17d). The infill had horizontal cracks pointing to the formation of a horizontal cylindrical plastic hinge. The outer leaf was, however, constrained by the timber beams at the top and by the foundation at the bottom. The leaf basically had two cylindrical hinges parallel to the wall lateral side, one at the top and one at the bottom. The out-of-plane displacements of the outer leaves indicate that a thrusting force in the out-of-plane direction pushed the leaves outward. The poor quality of the infill and the lack of through connections between the two external leaves (typical of poor quality three-leaf walls) are the major causes for the delamination and the undesired out-of-plane bulging of the outer leaves that result laterally unrestrained.

There are significant maximum displacement increases between the two tests. The green blocks below the two shear cracks showed little displacement, even during the A14 test. This is in line with the diagonal shear crack pattern clearly visible in Fig. 17c at the end

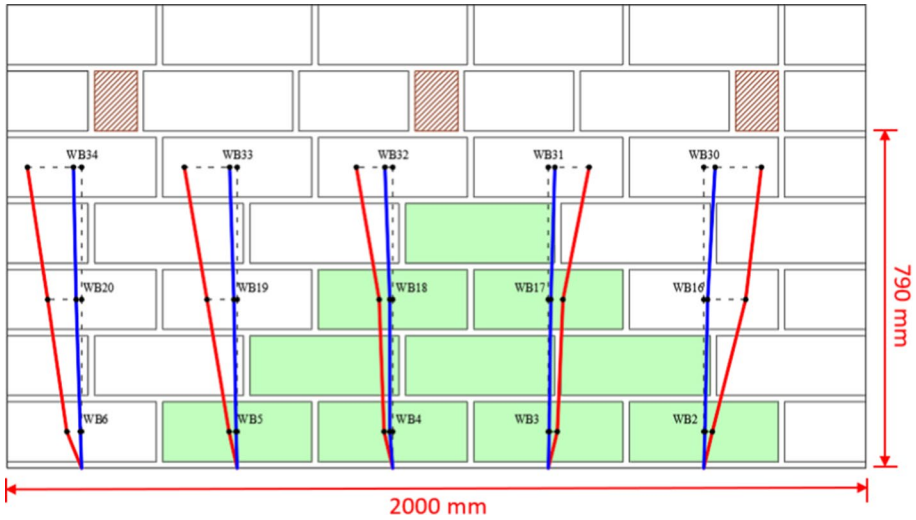
Fig. 20 Maximum horizontal displacements recorded during tests A10 (blue line) and A14 (red line). Displacements are scaled by a factor of 3

The results show that significant damage was triggered by the A14 test (140%) with maximum and residual drifts of about 3.24% and 0.30%, respectively. Figure 20 shows the maximum horizontal displacement profiles (including their direction) measured for the two seismic events A10 (100%—blue line) and A14 (140%—red line).

of test A14. The two diagonal shear cracks limit the forces applied to and, therefore, the displacement of the lower green blocks. The white blocks above the two diagonal cracks tilted and slid along the cracks with displacements significantly larger than those of the green blocks.

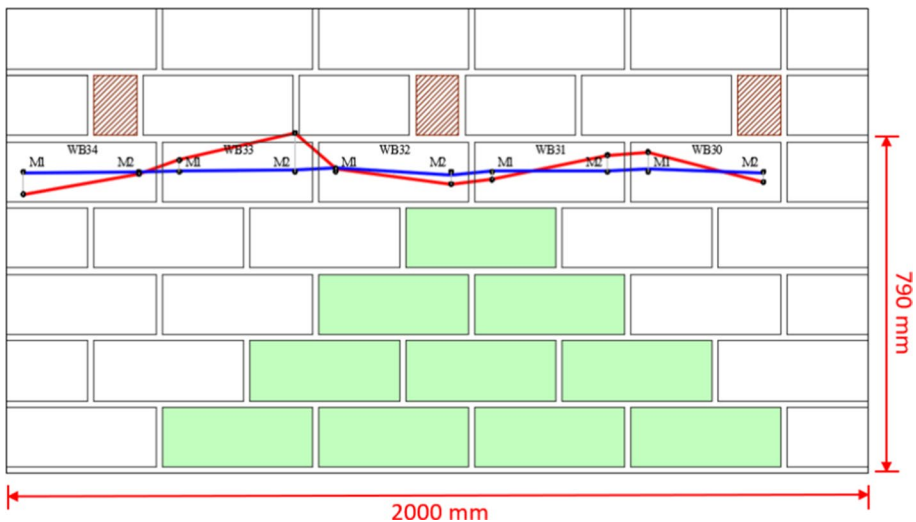
Fig. 22 Maximum vertical displacements recorded on the top of the wall for test A10 (blue line) and A14 (red line). Displacements are scaled by a factor of 10

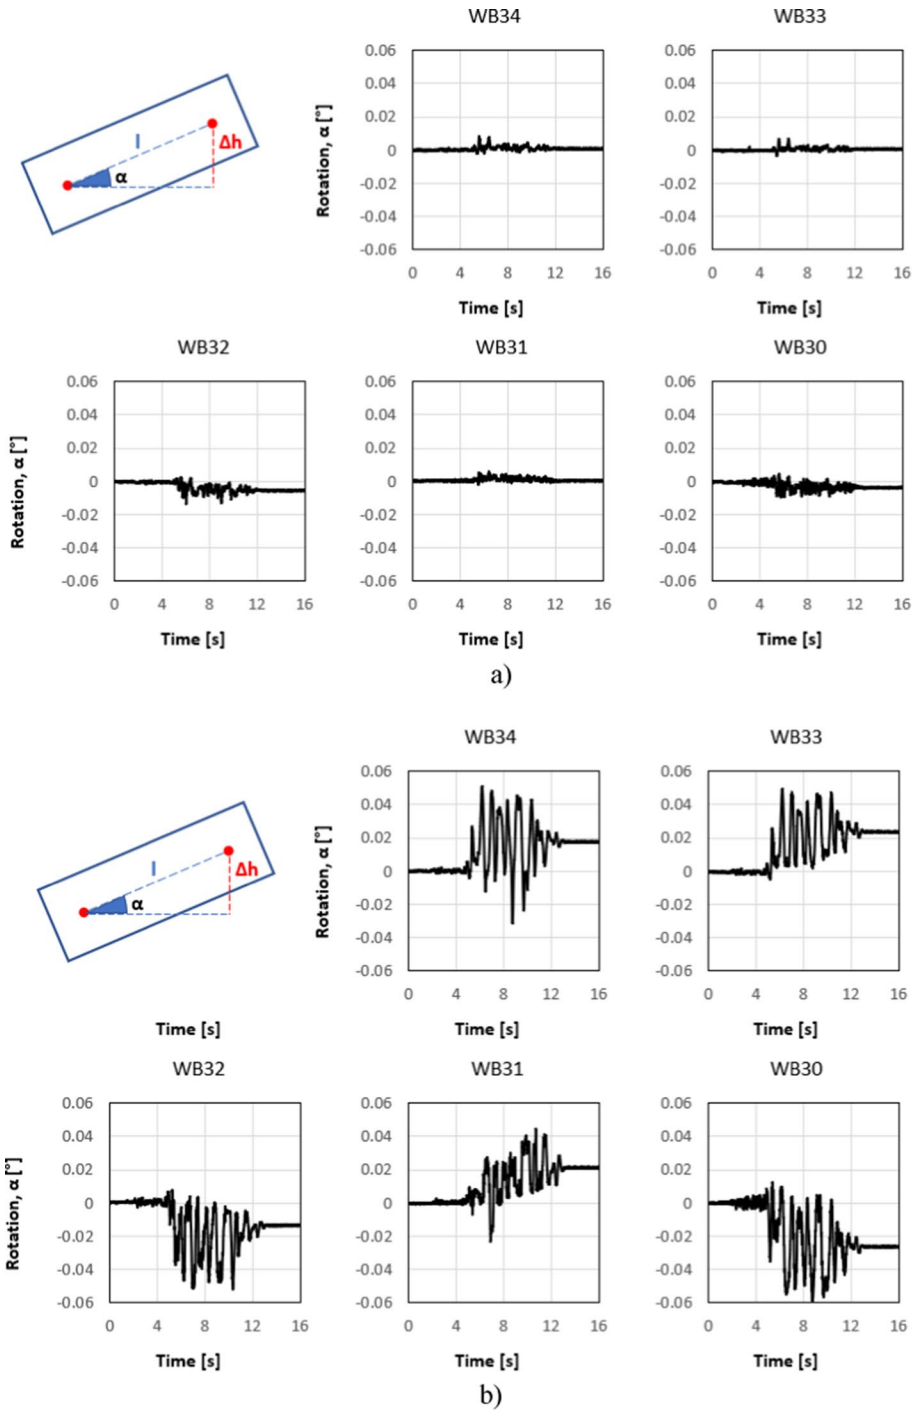
Fig. 23 Rotations of blocks at the wall top during tests a) A10 and b) A14

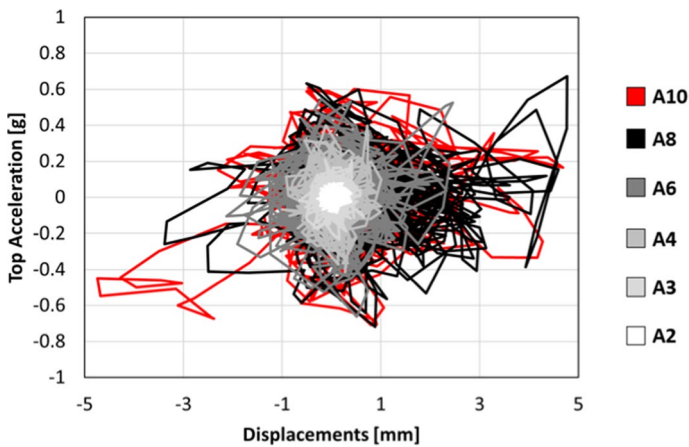
Fig. 27 Filtered acceleration versus lateral displacement at the wall top

Figure 27 shows the cyclic response of the wall top in the longitudinal X direction in terms of filtered accelerations vs. top displacement. The responses obtained for the different tests are plotted in different colours. It is observed that during test A10 (red line), the displacements reach almost 5 mm while the maximum strength is lower than that of test A8, thus indicating that the specimen is near failure since its strength is decreasing. Results for test A14 are not reported in Fig. 27 since they are out-of-scale with respect to the previous tests, further indicating that complete collapse was reached in test A14.

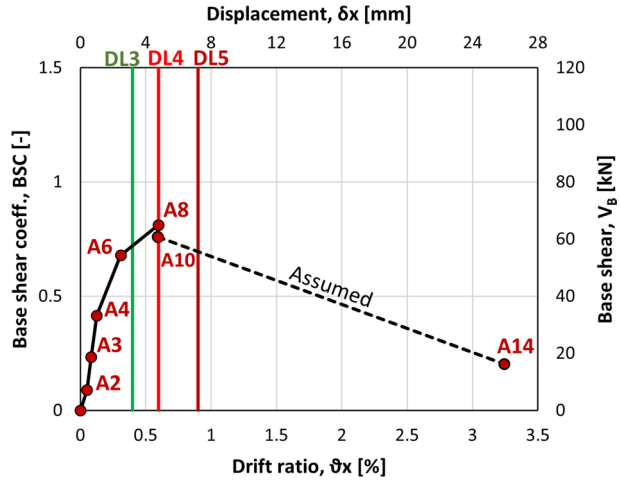
Fig. 28 Maximum base shear versus maximum drift ratio for test sequence A2 to A14. Vertical coloured lines indicate upper values of drift ratios corresponding to damage limit states DL3, DL4 and DL5 defined by CNR-DT 212 (2013) for shear critical walls

The specimen force–displacement response is represented by the maximum base shear coefficient (BSC) vs. drift (or displacement) plot in Fig. 28. The maximum BSC, i.e. the maximum base shear V_B normalized with respect to the total weight, is:

The results are those already shown in Table 4. Test A6 is within the DL3 drift range, tests A8 and A10 are at the upper limit of DL4, while A14 is represented by a drift way beyond DL5, confirming full failure. A point within the DL5 range is missing because

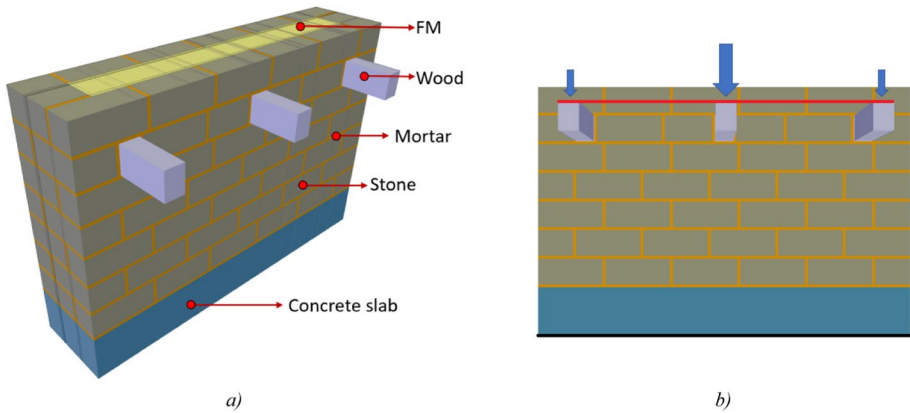
Fig. 29 **a** Micro-model with brick elements identification; **b** front view of the micro-model with vertical static loads applied on the top of cross-timber beams, Beam Solid Coupling constraint (red line) and fix constraint (black line)

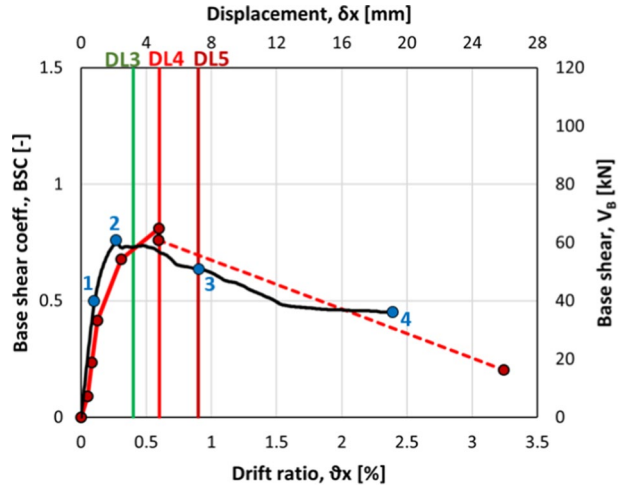
Fig. 31 Base shear versus displacement results of the experimental (red line) and numerical results (black line) for the wall specimen

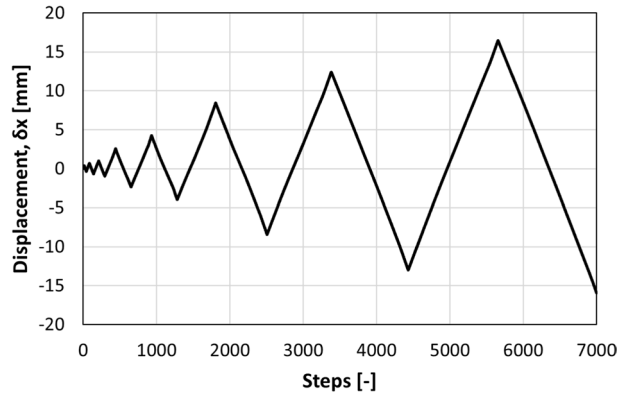
Fig. 33 Imposed cyclic displacements imposed at the wall top vs number of increments

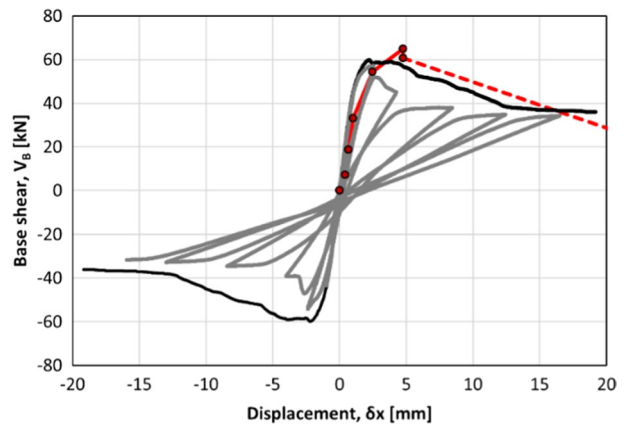
Fig. 34 Base shear vs displacement results of monotonic (black line) and cyclic (gray line) pushover analyses compared with the experimental results (red line)

simulation, an additional crack at approximately 45° forms when the specimen is pushed in the negative direction. The crack pattern of the cyclic simulation is consistent with that observed during the experiment.

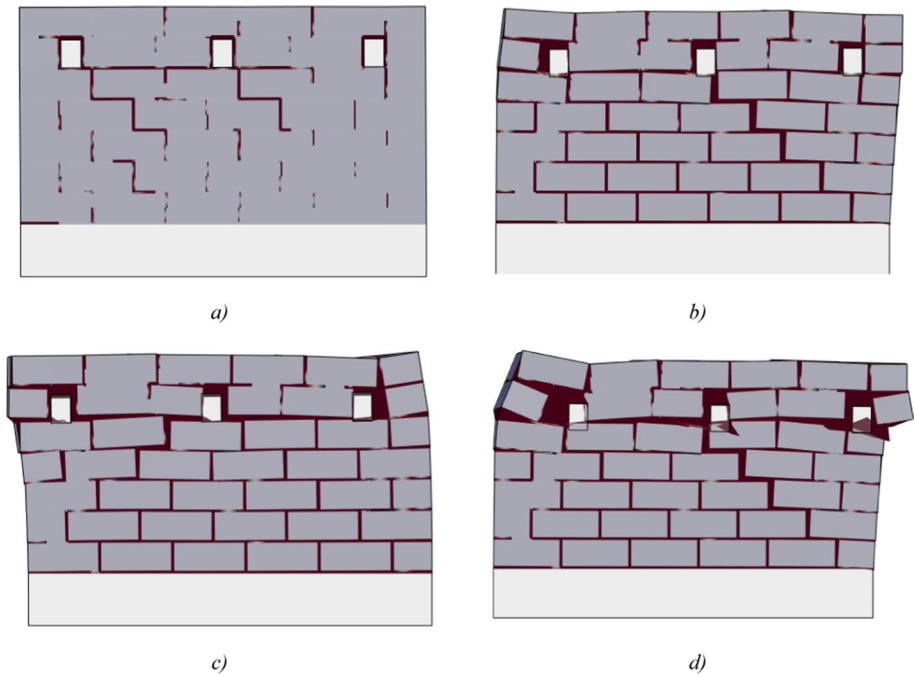
Fig. 35 Material damage and cracking at different steps of the cyclic pushover analysis: **a** step 250; **b** step 1000; **c** step 1300; **d** step 1800 (steps refer to Fig. 33)

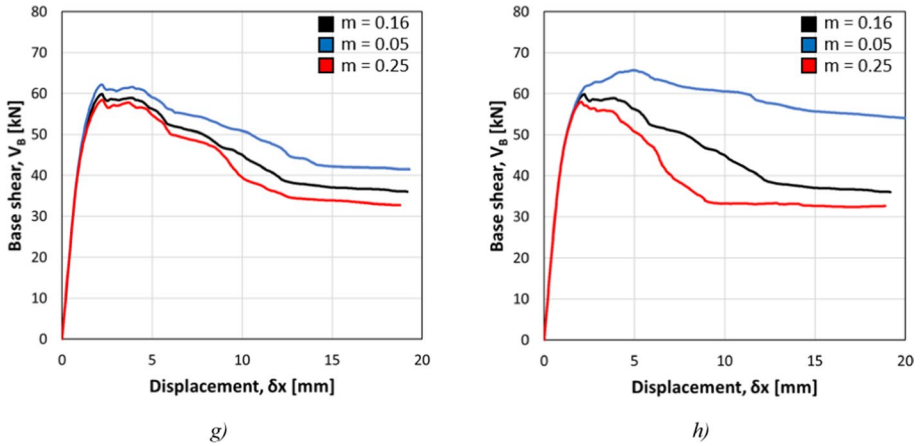
Fig. 36 Parametric results of monotonic pushover analyses with varying **a** mortar f_c ; **b** f_c infill; **c** mortar f_t ; **d** infill f_t ; **e** mortar E ; **f** infill E ; **g** mortar m and **h** infill m

Parametric monotonic pushover analyses were then carried out to check the main parameters affecting the capacity curve obtained with the micro-model. Pivotal parameters were changed one at a time to highlight the parameters that influence the response of the wall the most, mainly: compressive strength f_c , tensile strength f_t , Young's modulus E and the material parameter m . The materials considered in the parametric analyses were the mortar and the infill material, as they are the most flexible and least-resistant wall components. The stone units are assumed not to affect the response of the wall as no stone damage was observed during the experiments. Figure 36 shows the pushover curves for different parametric analyses. For each graph the black curve is the original pushover curve of Fig. 31. The results show an increase in the peak strength when the compressive strength of the mortar is increased, while the compressive strength of the infill material has no significant impact on the pushover curves. The fracture energy in compression was kept constant during the parametric studies. An increase in the tensile strength for both materials has a

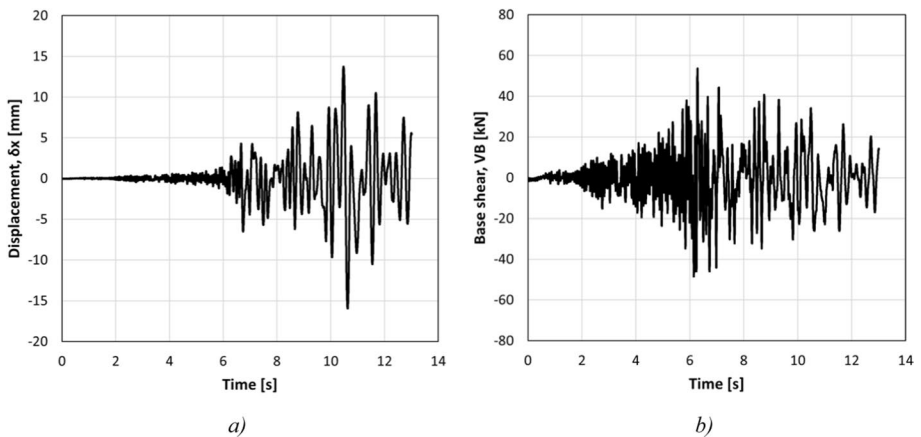
Fig. 37 Time histories of: **a** wall top displacement response and **b** base shear (Input is 100% of horizontal component of the Gazli ground motion as recorded on the shake table during the experimental tests)

The horizontal seismic input for the first dynamic analysis was the 100% scale earthquake recorded on the shake table test of the experimental campaign with nominal horizontal PGA of 0.70 g. The time step of the input signal is $dt=0.0066$ s. The analysis was carried out with 13,000 increments with fixed time step for a total of 13 s. The time step of the post-processor results is $dt=0.001$ s, a good compromise between computational times and accuracy of the results. Figure 37 reports the results of the displacement demand and the base shear during the seismic simulation. At approximately 6 s the model reached the peak strength of about 50 kN for a top displacement of 6–7 mm, similarly to the experimental dynamic test. After reaching the base shear peak the main frequency clearly shortens and the displacement demand increases.

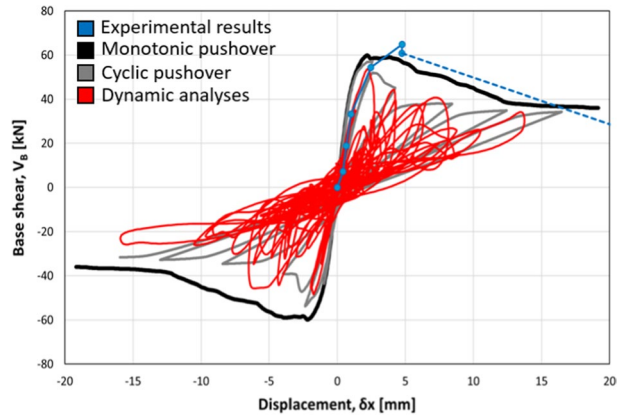
Fig. 38 Base shear vs displacement results for dynamic analysis at 100% scale of the selected ground motion (red line) and comparison with the same results for unidirectional (black line) and cyclic (blue line) pushover analyses

Figure 38 reports the hysteretic curve of the dynamic analyses. The numerical dynamic test red curve shows a good match with the results of the pushover analyses (monotonic and cyclic) in terms of initial stiffness, strength and displacement demand. The strength reached with the dynamic analysis is lower than the peaks obtained with the pushover analyses (monotonic and cyclic) because of more random cyclical actions and cyclic damage. The final pattern of the specimen damage corresponds to the mechanisms activated and observed during the experimental tests. Shear diagonal cracks are clearly visible in Fig. 39.

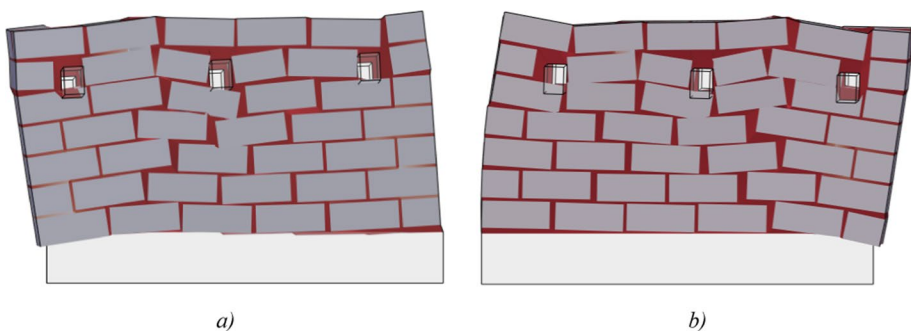
Fig. 39 Maximum Damage and crack patterns during non-linear dynamic analysis in **a** – X and **b**+X direction
