Environmental fluid mechanics of minimum energy loss weirs: hydrodynamics and self-aeration at Chinchilla MEL weir during the November–December 2021 flood event

Abstract

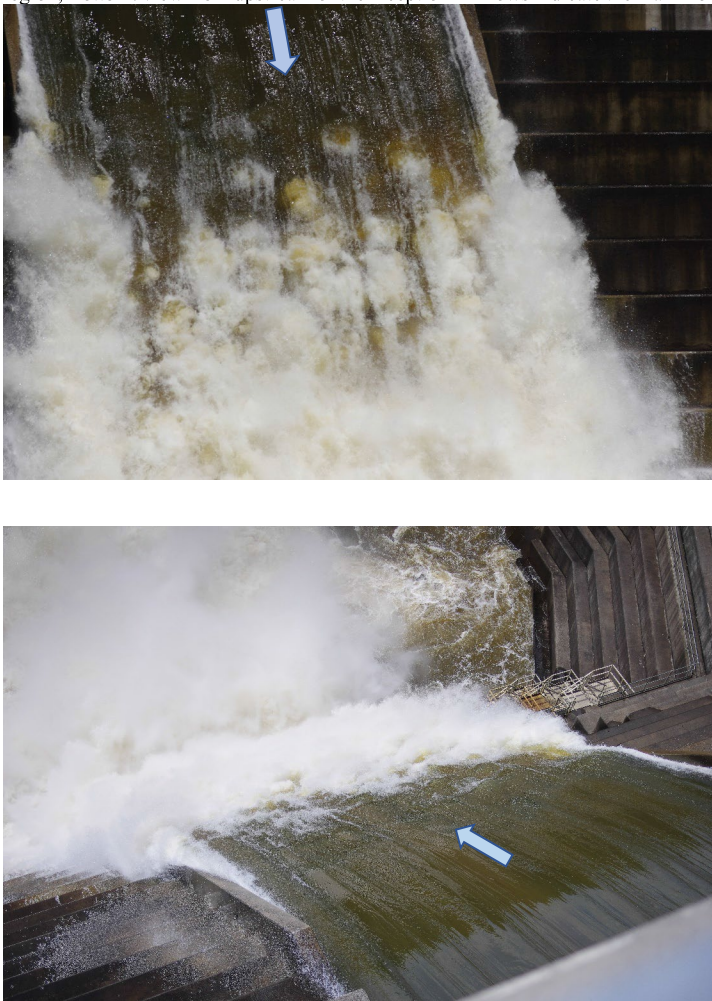
(A) Inception region on a steep chute: Hinze Dam Stage 3 spillway (Australia) on 24 March 2021 ($\theta = 45.9^\circ$ [at inception], $Re = 5.6 \times 10^7$, Shutter speed: $1/8,000$ s) - Top: view from downstream of the inception region; Bottom: view from upstream of the inception - Arrows indicate the main flow direction

Fig. 1 Onset of self-aeration on overflow spillways

In most overflow spillways, the upstream flow region is brown and non-aerated, and a strong air–water mixture develops downstream of the onset region of air entrainment [30, 37]. At the upstream end of the spillway, the flow is accelerated in a relatively smooth manner [29, 36]. A turbulent boundary layer develops along the invert from the upstream end [32, 34]. On a steep overflow spillway, the inception of free-surface aeration typically occurs when the outer edge of the bottom boundary layer starts to interfere with the water surface [31, 36, 50]. The interactions between boundary layer turbulence and free-surface can be explosive accompanied by strong projections of air–water packets [16, 21, 57]. In contrast, on a flat chute, the onset region exhibits a free surface with the gradual development of small ripple and surface instabilities, and the water surface tends to present a choppy appearance when self-aeration starts to occur [11, 12, 46]. Levi [40, 41] and Anwar [1] argued that the inception conditions then combine the effects of longitudinal vortices' breakdown and of gravity waves produced by boundary irregularities and roughness. Recently, Toro et al. [54] and Chanson [19, 21] demonstrated that the two theories are not exclusive using two different approaches. That is, three-dimensional Computational Fluid Dynamics (CFD) computations [54] and detailed prototype observations [19, 21] respectively. The inception region of free-surface aeration is illustrated on two prototype spillways in Fig. 1, using high-shutter speed (1/8000 s) photographs of the onset region in relatively steep and flat overflow chutes, i.e. Figure 1A, B respectively. The location of both structures is shown in Fig. 2.

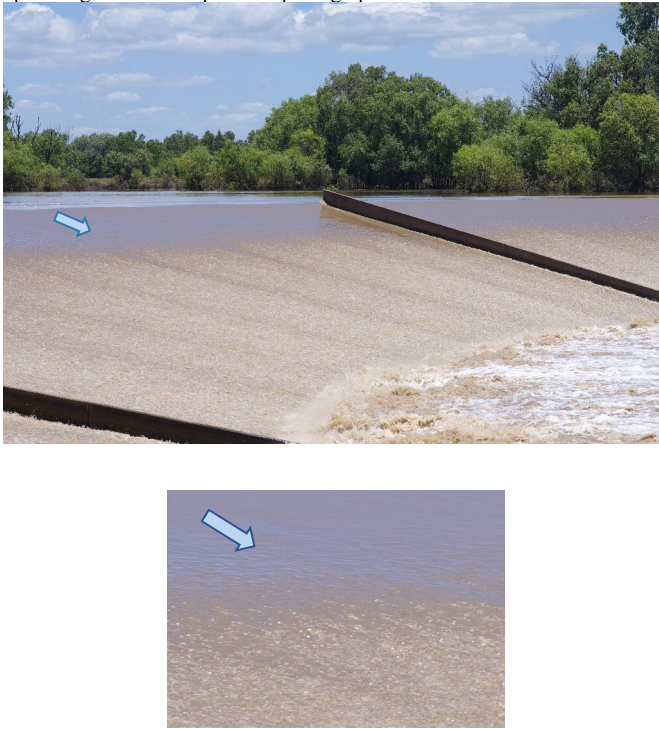
(B) Inception region on a flat chute: Chinchilla MEL weir (Australia) on 27 November 2021 ($\theta = 11.3^\circ$, $Re = 2.3 \times 10^6$ [at inception], Shutter speed: 1/8,000) - Top: General view from the right bank; Bottom: details of inception region from the previous photograph - Arrows indicate the main flow direction

Fig. 1 (continued)

The Chinchilla minimum energy loss weir (QLD, Australia) (Figs. 1B, 5) is located in the Western Downs, along the Condamine River to provide both town and irrigation water supply [49]. The longitudinal river bed slope is $S_o = 0.215\%$ in average between Brigalow and Chinchilla weir. Completed in 1973, the weir provides irrigation water, and it is listed as a "large dam". With a catchment area of 19,192 km², the weir is a 14 m high earth fill embankment with a 410 m long dam crest including abutments. The overflow spillway (Fig. 1B) has a design capacity is of 850 m³/s corresponding to bank full at a design head 1.83 m. The spillway system consists of a broad crest that is 214 m long, followed by a smooth converging chute with a 1 V:5H slope. There is no stilling basin. After completion, grass was planted in the top soil and protective mesh that had been placed on the subsidiary earth embankments on each bank. Before this had time to grow, the weir was subjected to a major out-of-bank flood of order 1,130 m³/s, one of the highest on record, and that overtopped the embankments [55]. At the peak of the flood, it was difficult to see where the weir was, because it was completely drowned out. As the flood receded, it was wonderful to see the structure emerge from the flood waters relatively unscathed. The top soil and grass planted over the plastic mesh and gravel on the top of these embankments were washed away for the most part, but the mesh

As the flow accelerated down the smooth converging chute, the glassy free-surface became rough and choppy, before becoming self-aerated, i.e. the inception region. The inception region showed a progressive transition of the surface roughness, from a smooth glassy surface to a rough, coarse-sand-paper-like appearance and further downstream to a very-rough choppy surface (Fig. 6). The self-aerated region presented a beige colour, evidence of a three-phase air–water sediment motion. Such an observation was well-documented visually on both 27 November and 15 December 2021, as well as during an earlier overflow on 8 November 1997 [53].

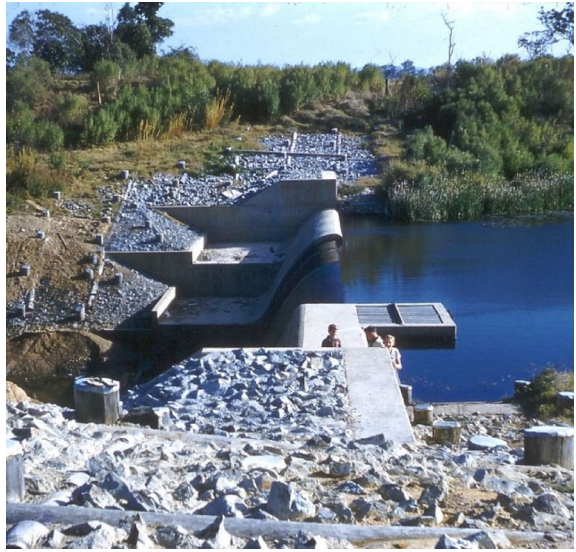
Fig. 3 In-stream weir on Wararba Creek weir near Caboolture (Australia) in the 1960s (Photographer Roy Dobson. Image courtesy of Moreton Bay Regional Council, reference number CLPC-P2299)

scour protection for the embankments to prevent scour there. An example of such a design is the weir on Wararba Creek near Caboolture, Queensland, Eastern Australia (Fig. 3). However, eventually it proved impossible to develop a satisfactory design based on these principles for the site on Sandy Creek, despite a large number of attempts. The competing requirements for this weir and for many others constructed in streams with erodible banks are: (1) maximum in-stream storage, (2) protection against erosion of the stream banks at the abutments of the weir and downstream and (3) no increase in the frequency of out-of-bank flooding. The conventional type of weir caused excessive afflux and over-bank flow and massive erosion of the alluvial banks at the abutments and downstream, even for flows considerably less than the design flow. When Apelt [4] was invited to observe the performance of the last of these unsatisfactory model tests, it was clear that the weir was causing too much constriction of the flow with large energy losses. He noted that the flow over the weir was analogous to that past an orifice plate in a pipe and suggested an approach analogous to a Venturi tube. The idea was to minimise the energy loss across the structure by using a more streamlined geometry everywhere and a gradual expansion downstream to recover as much as possible of the kinetic energy of the flow at the weir crest. A large number of trials finally produced a satisfactory design for the site on Sandy Creek, Clermont and the first MEL weir was built there in 1962 (Fig. 4) [4].

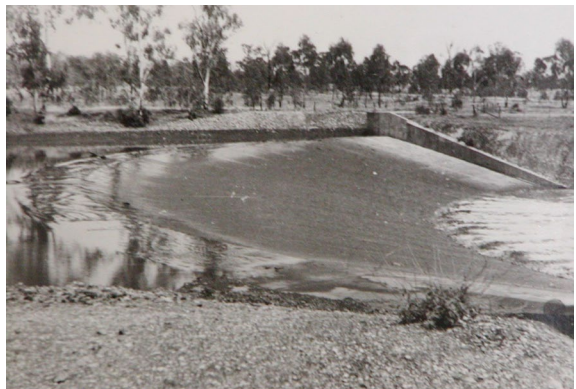
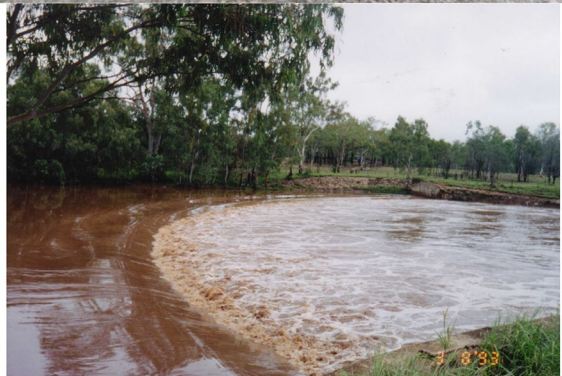
Fig. 4 Sandy Creek MEL weir at Clermont—Top: discharging a small flow about 142 m³/s (Collection of late Professor G.R. McKay); Bottom: large flood event on 3 August 1993 (Courtesy of A.J. Holmes)

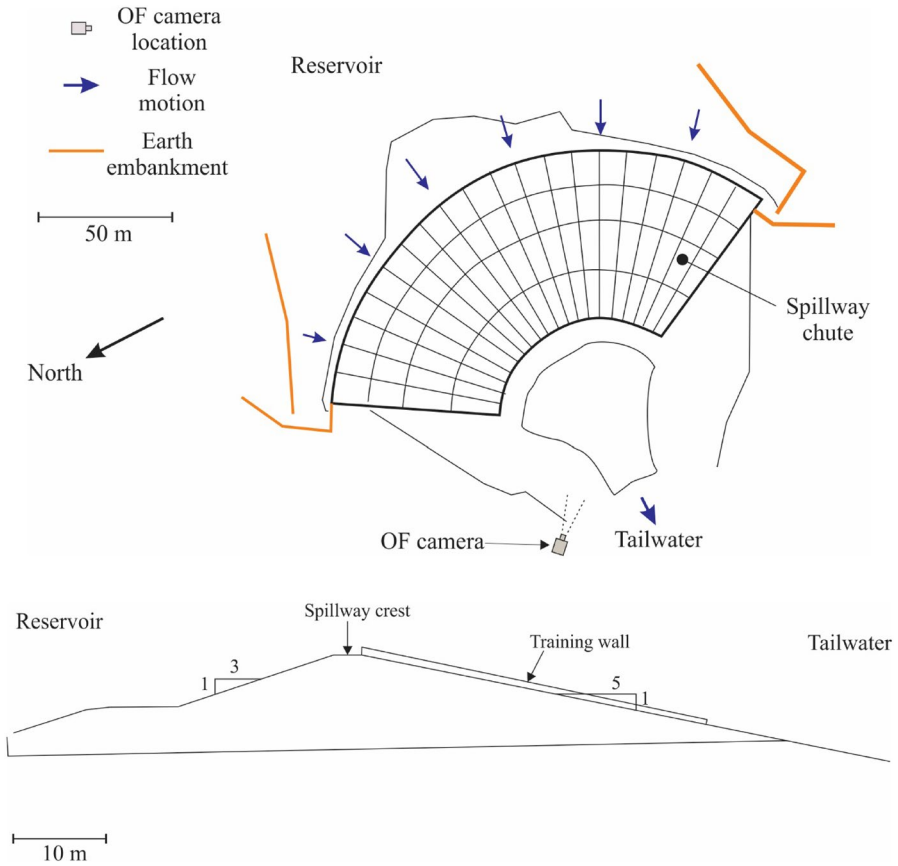
Fig. 5 Plan view and cross-section of Chinchilla MEL weir (redrawn after [55])

from the weir crest are excavated sufficiently to provide for efficient flow normal to the crest, uniformly distributed along its full length. Figure 5, based on the design drawings of the Chinchilla MEL weir, illustrates these principles.

The water discharge was deduced from the measured reservoir elevation, using the predicted discharge coefficient, based upon the drawings as constructed (Fig. 5) [33]. Visual, photographic and cinematographic records were undertaken from the right bank of the spillway and from the right river bank downstream of the spillway toe. Figures 1B and 6 present hand-held photographs taken from several locations. The observations were conducted using three dSLR Pentax™ cameras with sensor resolutions between 12 and 24 Mpx, a digital camera Sony™ RC100VA and an iPhone XI. The dSLR cameras were equipped with full-frame prime lenses producing photographs and movies with negligible barrel distortion. The dSLR camera movies were recorded in high definition (1920×1080 px) at 30 fps and 60 fps.

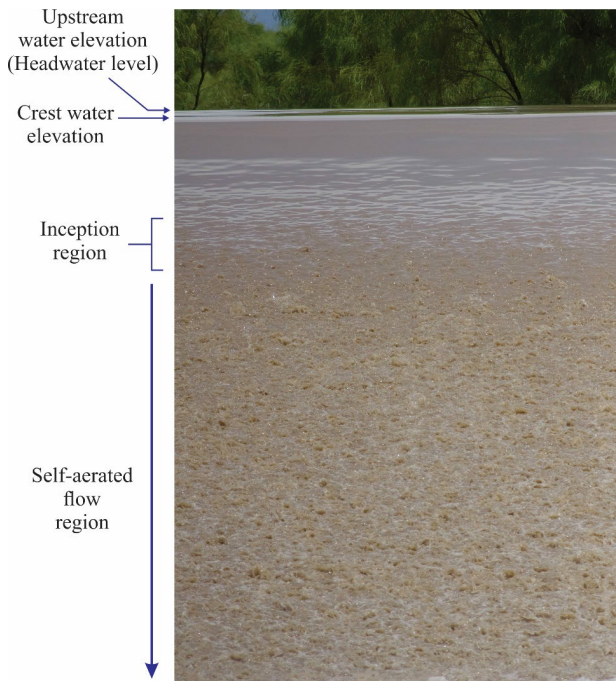
(A) Upstream flow viewed from downstream on 27 November 2021 (Shutter speed: 1/8,000 s) - View of the left spillway chute from the OF camera shown in Figure 5A

Fig. 6 Photographs of the spillway operation at Chinchilla MEL weir (QLD, Australia) during the major flood in Nov./Dec. 2021

Based upon the video movies of the left chute centreline, taken from downstream, the surface velocity field was measured in the plane parallel to the invert using the optical flow (OF) technique. Both the streamwise velocity V_s and transverse velocity V_t components were extracted. First, the present data provided physically meaningless results in the upstream non-aerated flow region. This was most likely caused by the shiny surface glare, seen in Figs. 1B and 6, upstream of the inception region. Second, physically meaningful

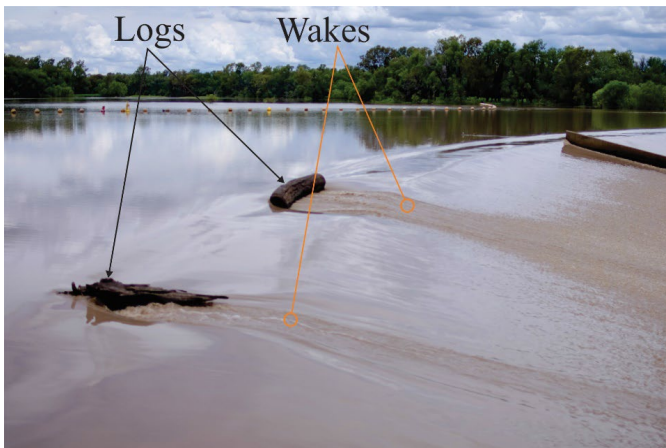
(B) Timber logs blocked at the spillway crest on 27 November 2021 (Shutter speed: 1/8,000 s)

On both occasions (Table 2), the approach flow was very smooth, and this was confirmed by aerial footages on 21 December 2018 and on 3 December 2021. The reservoir flow converged smoothly towards the weir crest and the water surface was waveless and almost still. On both 27 November 2021 and 15 December 2021, the flow was critical at the spillway crest which acted as a broad-crested weir, with a ratio of crest length to upstream head over crest of 6.2 and 5.54 respectively. The smooth change on water surface elevation between the upstream reservoir and spillway crest was nicely documented with photographs (Fig. 6A). Immediately downstream of the broad-crest, the water surface was smooth and glassy (Figs. 1B, 6). On 27 November 2021, a few logs were trapped at the crest, and their wake was clearly seen at the surface of the non-aerated flow. Further downstream, the wake progressively disappeared in the self-aerated air–water flow region (Fig. 6B).

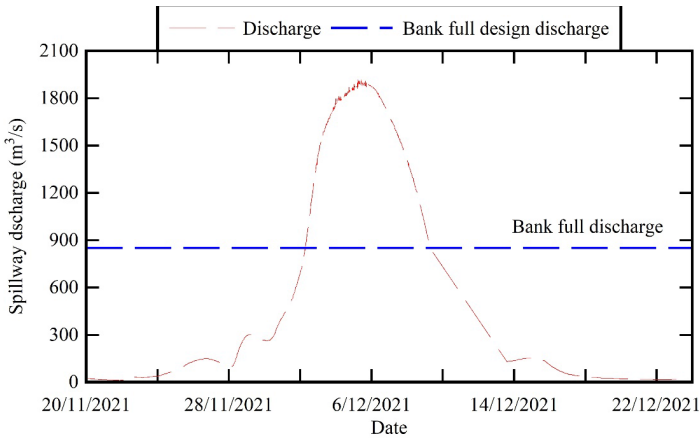
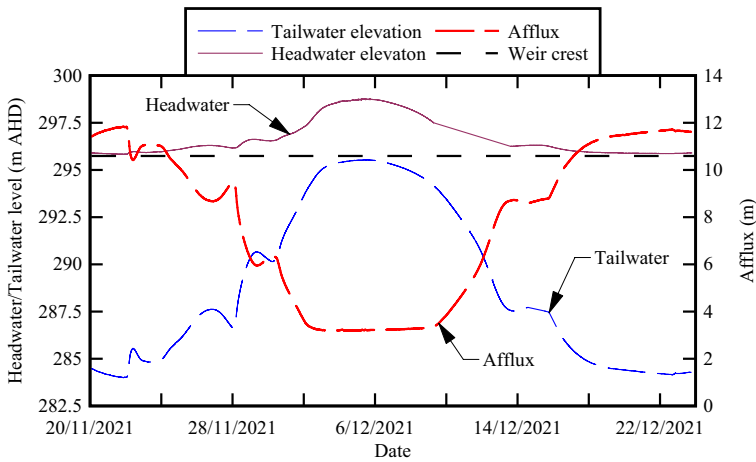
(A) Water discharge over the spillway excluding the abutment overflows

(B) Measured headwater levels, tailwater levels and afflux - the afflux being defined as the difference between the headwater level (H.W.L) and tailwater level (T.W.L.)

Fig. 7 Spillway operation at Chinchilla MEL weir (QLD, Australia) during the major flood in Nov./Dec. 2021: water discharge over the spillway and afflux

The Chinchilla weir overflow was documented on 27 November 2021 and 15 December 2021. The first data set was obtained at the start of the flood event, while the second took place after the peak of the flood (Fig. 7). The flow conditions at the time of observations are detailed in Table 2. Note that the weir overflow could not be witnessed at the peak of the flood by the authors, because the access road become submerged when the tailwater elevation exceeds about 290–291 m AHD. The afflux, difference between recorded High Water Rating Level (HWRL) and Tailwater Rating Level (TWRL), was 3.23 m at the peak of the flood event (Fig. 7B), which was somewhat consistent with some photographic observation by a local on 5 December 2021 morning. The maximum tailwater elevation and afflux during the 2021 flood event is compared with several documented major floods, including several major floods in 2022 in Table 1.

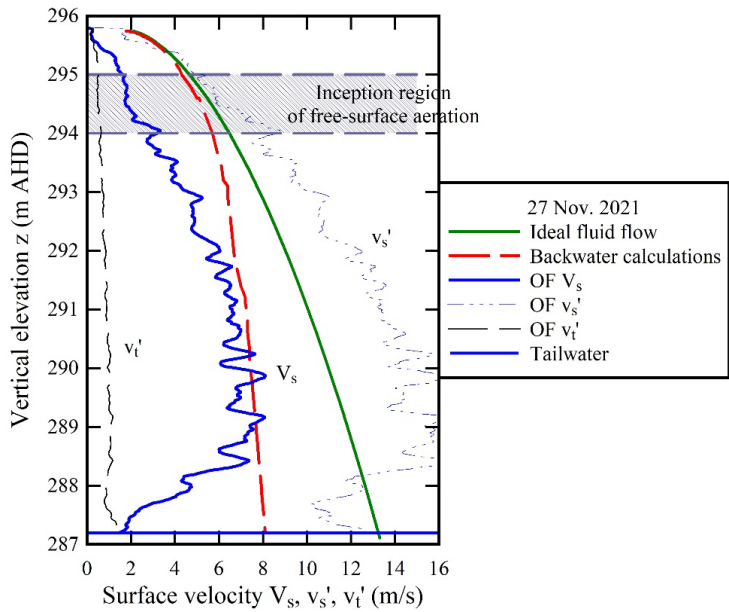
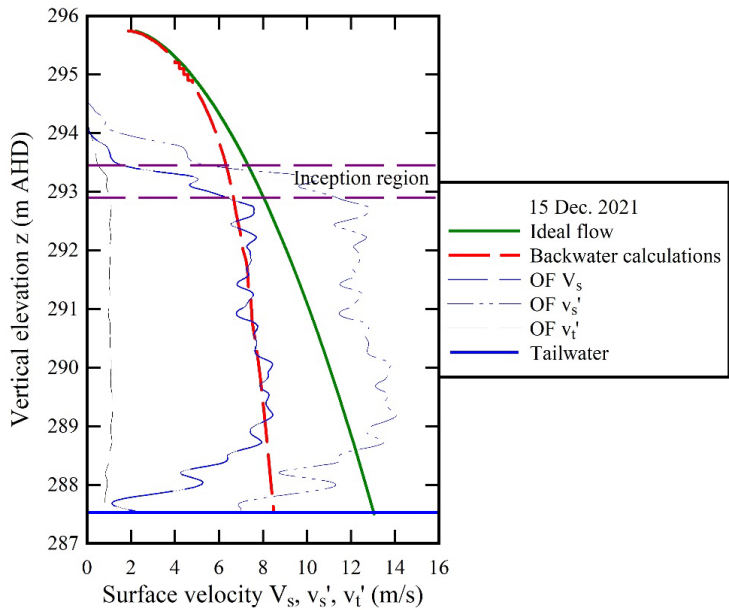
(A) On 27 November 2022 ($Q = 121 \text{ m}^3/\text{s}$)

(B) On 15 December 2022 ($Q = 144 \text{ m}^3/\text{s}$)

Fig. 8 Time-averaged OF surface velocity: comparison between time-averaged optical flow (OF) surface velocity data, ideal fluid flow velocity and backwater calculations at Chinchilla MEL weir

The surface velocity data showed a relatively close agreement between the time-averaged streamwise OF surface velocity and the backwater-calculated velocity downstream of the onset region, both qualitatively and quantitatively (Fig. 8). Figure 8 presents some typical comparisons in terms of streamwise surface velocity component V_s , with each graph corresponding to one movie. In Fig. 8, the ideal fluid flow estimates are shown with a solid green curve and the backwater calculations are the dashed red curve. For completeness, the streamwise surface velocity standard deviation v_s' and transverse surface velocity standard deviation v_t' are added in Fig. 8. In Fig. 8, the vertical axis is the vertical elevation in m AHD, where AHD stands for Australian Height Datum, and the horizontal axis is the surface velocity data in a dimensional form.

As seen in Figs. 8, 9 and 10, the results were unreliable in the upstream non-aerated flow. Further, the surface velocity data were not reliable below elevation 288 m AHD, because of the splashing above the hydraulic jump roller. In the self-aerated flow region, the surface velocity data implied some regions of high-velocity and others of low-velocity. That is, longitudinal "canyons" of faster flowing water, with streaks of lower surface velocities in between, in the self-aerated flow region downstream of the inception region. The same data sets highlighted regions of high- and low-streamwise velocity fluctuations. The observations were similar to recent field observations at the Hinze Dam Stage 3 [19, 21] and in a relatively large-size spillway model [6]. The findings are important in terms of the design and operation of energy dissipators, e.g. hydraulic jump stilling basins and ski jumps. Indeed, these regions of high velocity are associated with concentrations in kinetic energy that must be dissipated safely in the stilling structure.

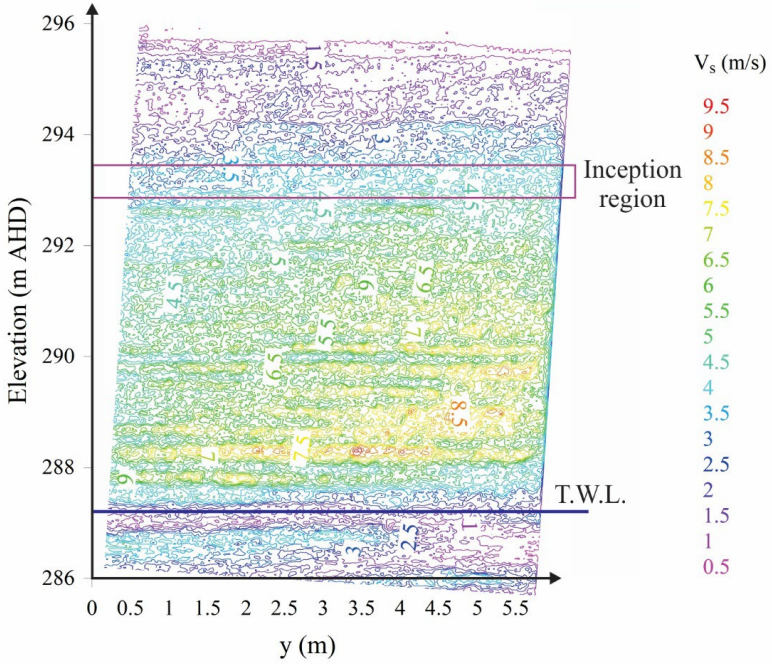
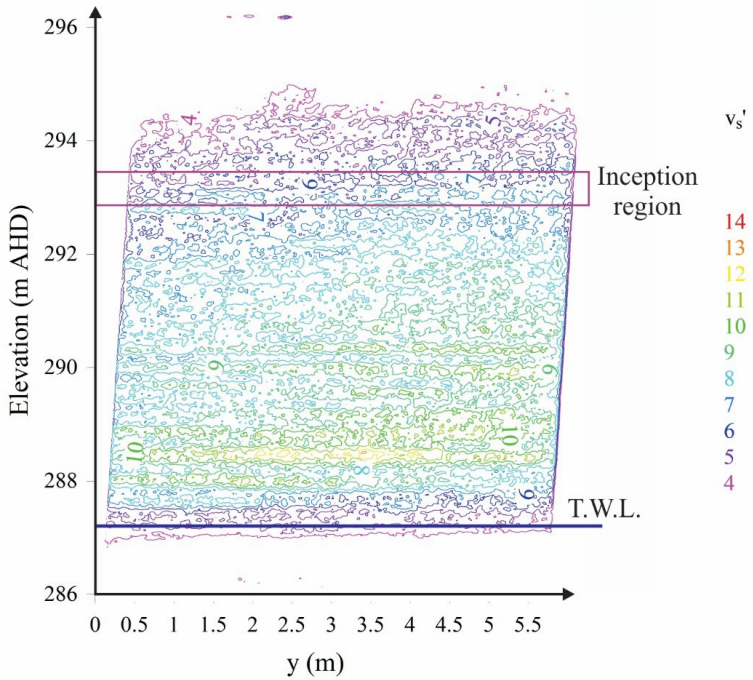
Fig. 9 Contour map of time-averaged surface velocity and standard deviation of longitudinal velocity at Chinchilla (MEL) weir on 27 November 2021—Location: middle of left spillway bay, Time: 14:18, Number of analysed frames: 840, Resolution: 0.00515 m/px, Frame rate: 30 fps. **A** Time-averaged longitudinal surface velocity. **B** Standard deviation of longitudinal surface velocity

(A) Time-averaged longitudinal surface velocity

(B) Standard deviation of longitudinal surface velocity

The OF surface velocity characteristics were analysed in the self-aerated flow region, in terms of the contour maps of time-averaged longitudinal velocity component, standard deviations of the longitudinal and transverse surface velocity. Typical contour maps of the time-averaged longitudinal velocity component V_s and standard deviations v_s' of the longitudinal surface velocity are shown in Figs. 9 and 10. In Figs. 9 and 10, the horizontal axis is a transverse coordinate, the vertical axis is the vertical elevation in m AHD, and the contour data are the velocity data measured parallel to the invert. The legend on the right of Figs. 9 and 10 explains the colour coding of the contour maps. In the contour maps, the tailwater level is shown as well.

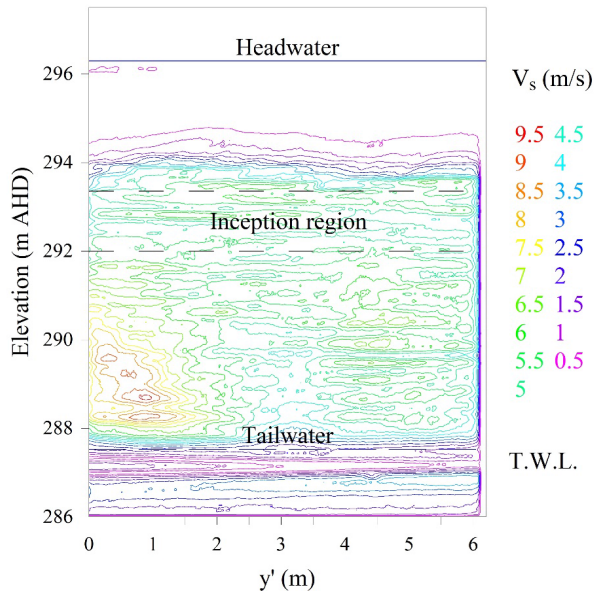
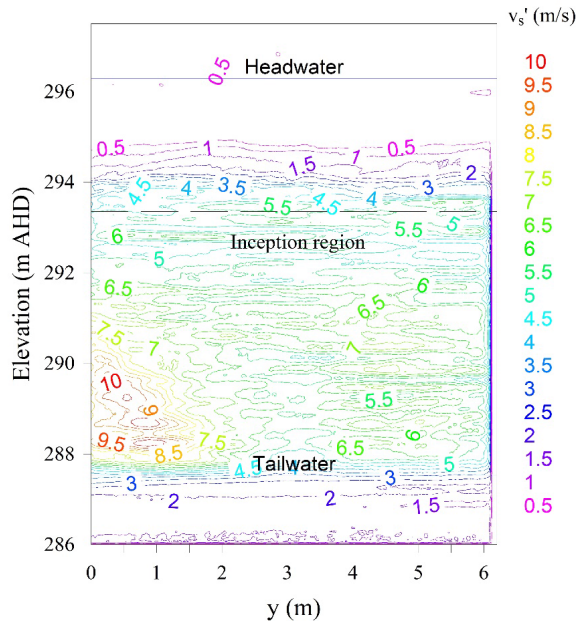
(A) Time-averaged longitudinal surface velocity

(B) Standard deviation of longitudinal surface velocity

Fig. 10 Contour map of time-averaged surface velocity and standard deviation of longitudinal velocity at Chinchilla (MEL) weir on 15 December 2021—Location: middle of left spillway bay, Time: 12:31, Number of analysed frames: 18,090, Resolution: 0.00579 m/px, Frame rate: 60 fps. **A** Time-averaged longitudinal surface velocity. **B** Standard deviation of longitudinal surface velocity
