Assessing the effectiveness of landslide slope stability by analysing structural mitigation measures and community risk perception

Abstract

Keywords Landslides · Slope stability · Countermeasure · Disaster risk perception · Structural mitigation measures

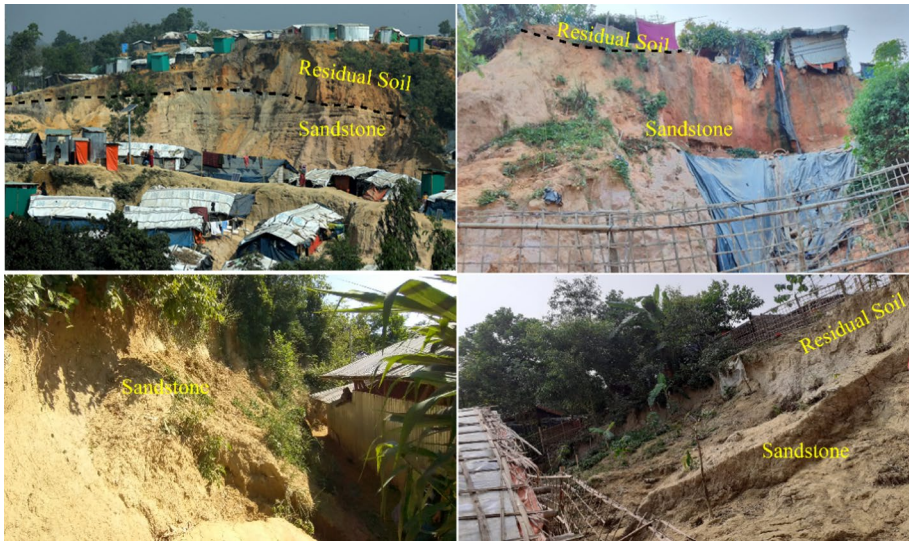
Fig. 2 Landslides in the Kutupalong Rohingya camp

The entire KRC area has been affected by hundreds of landslides from 2017 to the present (Figs. 1 and 2). To characterise them for overall slope stability and reliability analysis, average values of the shear strength parameters and four dominant and representative slope angles (40°, 45°, 50°, and 55°), where most landslides occurred, were considered. The area is also composed of almost monotonous lithology and structural setup. Three different slope stability analysis methods were used: geographic information system (GIS)-based infinite slope stability, limit equilibrium method (LEM), and finite element method (FEM). The factor of safety (FoS) determined using these methods was correlated and described the stability state of the slopes. Reliability or sensitivity analysis also assessed uncertainty in the geotechnical properties of the slope materials. The unstable slopes identified from the comparative analysis were further investigated by incorporating the existing landslide mitigation measures. In this way, the performance of the countermeasures to protect the slope was assessed, and the pitfalls of current measures were evaluated (He et al. 2022; Jiang et al. 2022). The results obtained from different slope stability analysis methods can be used in the future to select and implement proper landslide countermeasures in the KRC area.

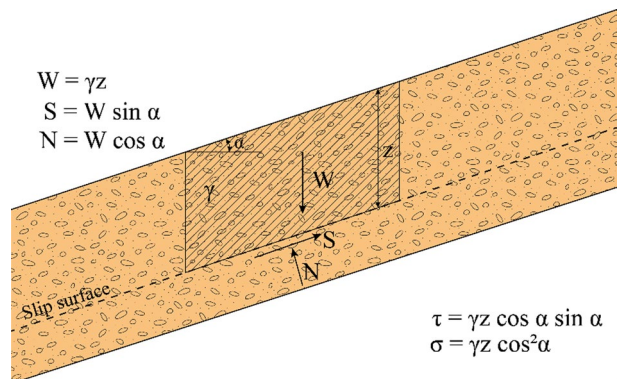
Fig. 4 Infinite slope model for the spatial factor of safety determination

where τ_f is the shear strength based on the Mohr–Coulomb failure criterion, and τ_d is the shear stress acting in the tangential direction of the slip surface due to the gravity load of the soil mass. A schematic illustration of the infinite slope is shown in Fig. 4.

The shear and normal stress acting on the slip surface of the infinite slope (Fig. 4) is constant and is expressed as:

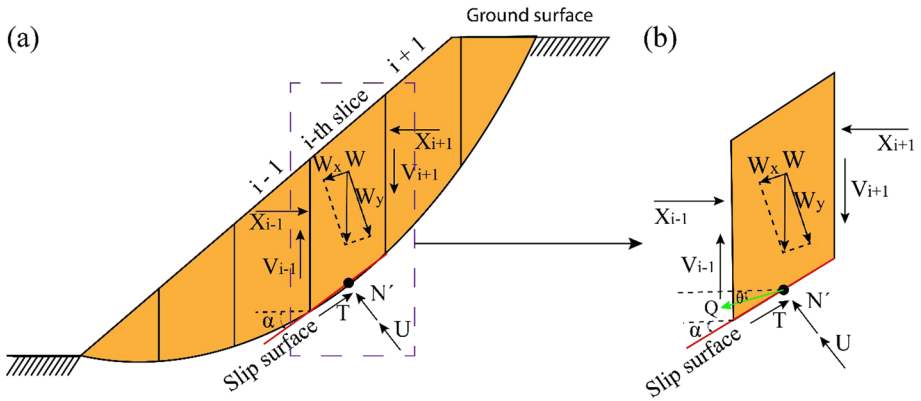
Fig. 5 The 2D stability analysis using Spencer's limit equilibrium method. **a** Forces act on a single slice of a slope, **b** Spencer's method assumption in which interslice forces X_{i-1} , X_{i+1} , V_{i-1} , V_{i+1} are replaced by a single force Q acting at the midpoint of the slice's base

The factor of safety (FoS) for the limit equilibrium method (LEM) was determined by Spencer’s method (Spencer 1967). It satisfies both the moment and force equilibrium and considers parallel interslice forces. In Spencer’s method, the interslice forces (Fig. 5) are substituted by an equivalent resultant force Q inclined by a constant angle of θ .

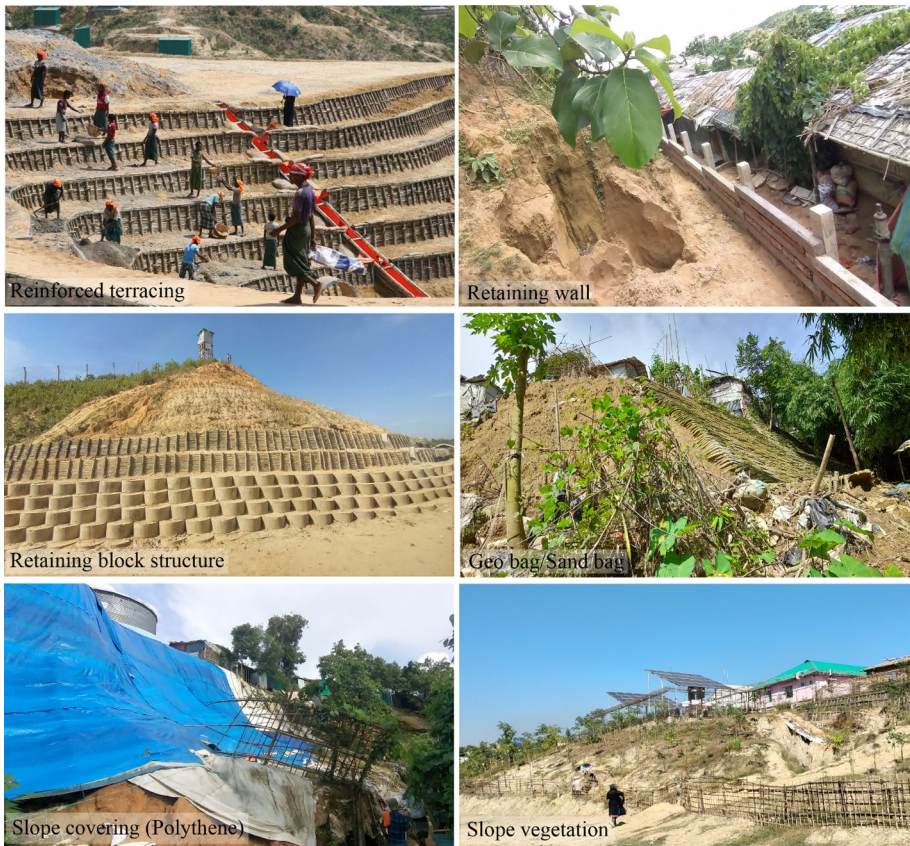
Fig. 6 Different landslide mitigation measures implemented in the KRC area

To protect the critical settlement and makeshift temporary shelters against landslides or slope failures, different mitigation measures were implemented in the Kutupalong Rohingya Camp (KRC). The essential measures of mitigation observed during the fieldwork in March 2022 were the reinforced terrace (benching) slope, concrete retaining wall, reinforced concrete block structure, slope covering by geo/sandbag, and nature-based slope stabilisation using tree plantation (Fig. 6). Immediate measures to prevent rainfall infiltration slope covering with polythene were also implemented in some vulnerable slopes. During fieldwork, it was found that the landslide mitigation measures successfully protected against slope failure. But in the various location, it was observed that the slope failed, although mitigation measures were present. A performance evaluation of the existing landslide mitigation measures was done to investigate the actual cause and pitfall of the slope stabilisation measures. The performance evaluation of the mitigation measures was carried out by the limit equilibrium method. The necessary data, such as retaining wall strength, slope terrace geometry, and geobag strength, were collected during the fieldwork (Supplementary Table S1). The strength of the concrete retaining structures was measured by the Schmidt hammer rebound process, and the geobag strength was measured by laboratory investigation of the filling sand materials.

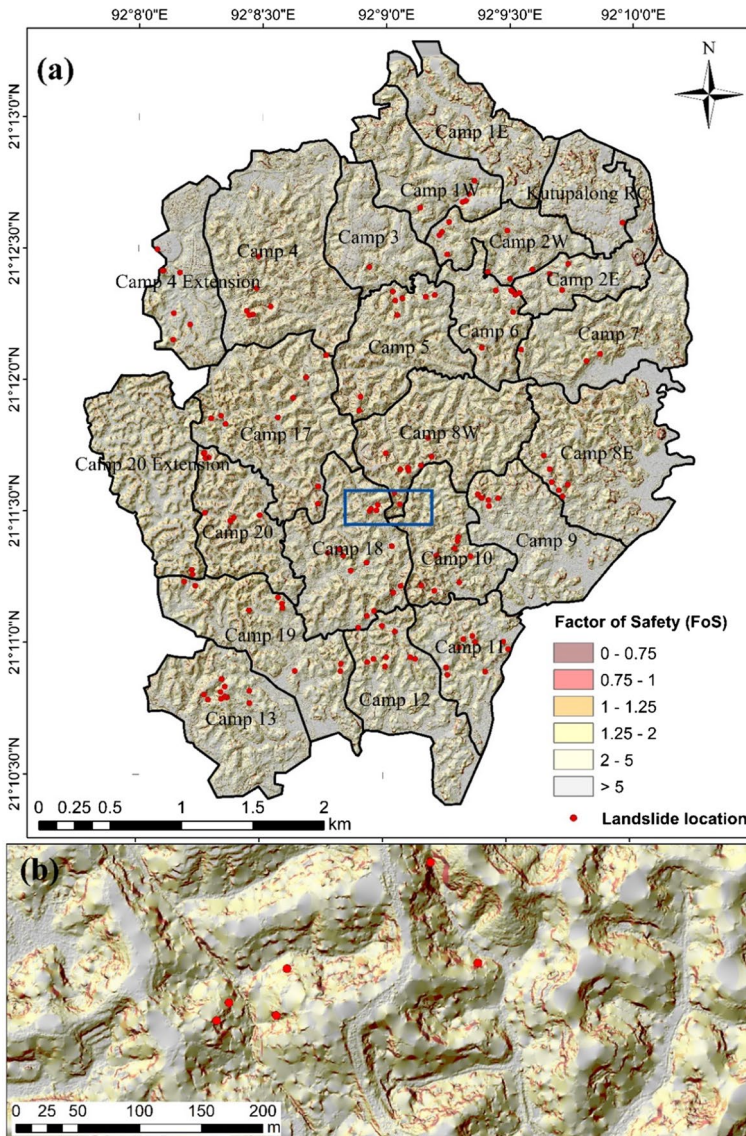
Fig. 7 a Distribution of factor of safety (FoS) calculated using deterministic slope stability (infinite slope) method; b enlarged view

The distribution of the factor of safety (FoS) determined by the infinite slope stability method in a spatial grid is shown in Fig. 7. Stability of slopes is classified into three categories based on FoS, e.g. unstable ($FoS < 1$), critically stable ($1 < FoS < 1.5$), and stable

($FoS > 1.5$). The FoS distribution follows the pattern of elevation and slope. It decreases exponentially with slope angle (Fig. 8). Several authors also reported the exponential decrease of FoS with slope angle (Löfroth et al. 2021). The visual inspection of the model result shows that the unstable slopes are concentrated along the steep slopes. Significant slope destabilisation is observed when the slope angle is higher than 40° and critically stable between 28 and 40° (Figs. 7b, 8). In KRC, the abundance of slope angles more elevated than 40° is much smaller, also reflected in the unstable (< 1) FoS value. Although the unstable slope's abundance is less, critically stable slope abundance is much higher in the KRC area. A qualitative comparison of the previous landslide inventory with the produced instability map agrees with the spatial distribution of the FoS values determined using the infinite slope stability framework. Landslide locations were mainly confined within unstable and critically stable areas. The unstable area suggested by the FoS value is frequently concentrated in camps no 4, 5, 8W, 8E, 10, 13, 17, 18, and 20.

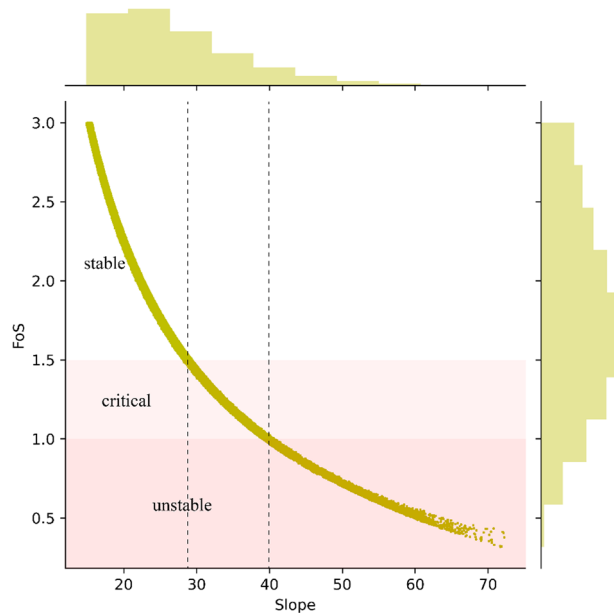
Fig. 8 Correlation of slope angle and factor of safety (FoS) calculated from the enclosed area of Fig. 7b

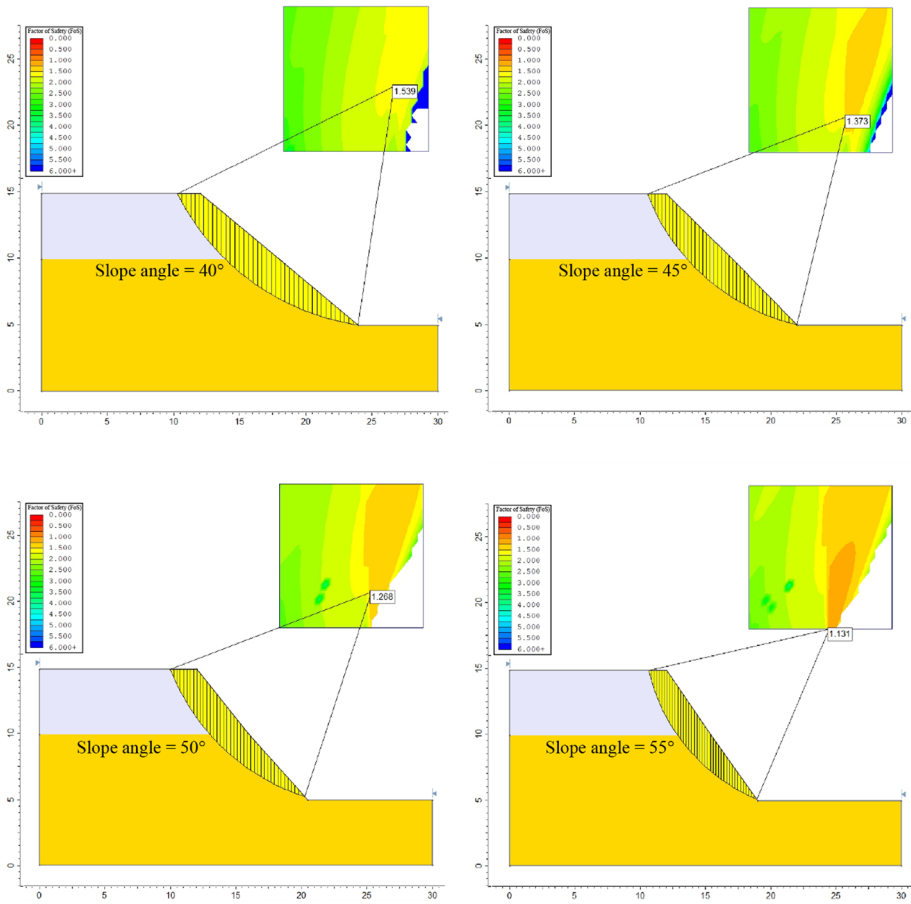
Fig. 9 Safety factor determined for different slope angles under natural conditions without anthropogenic overburden load using the LE method

Limit equilibrium slope stability is determined for 40° , 45° , 50° , and 55° slope angles, and with overburden loads of 0, 50, and 100 kN/m^2 are illustrated in Fig. 9 and Table 2. The factor of safety (FoS) decreases with increasing slope angle. FoS value of 1.54, 1.37, 1.27, and 1.13 is obtained for 40° , 45° , 50° , and 55° slope angles, respectively, without any overburden load. The slip surface is semicircular and extends from the top of the slope to the base. With increasing slope angle, the base of the slip surface shifted a little distance (Fig. 9) upward. When an overburden load is applied to the ground surface, the FoS value decreases. For 40° and 45° slope angles, the factor of safety value linearly reduces with increasing overburden load but does not attain unstable conditions ($FoS < 1$). But in the case of a 50° slope angle, the unstable condition is reached for 100 kN/m^2 loading, whereas

the unstable condition for a 55° slope is run on both 50 and 100 kN/m² loading. A particular slope angle safety factor value was reduced with increasing load from 0 to 100 kN/m². The radius of the slip surface also decreased (Supplementary Fig. S1). The safety factor (FoS) values determined using LEM are always higher than the FoS values determined using the infinite slope stability method in the GIS grid.

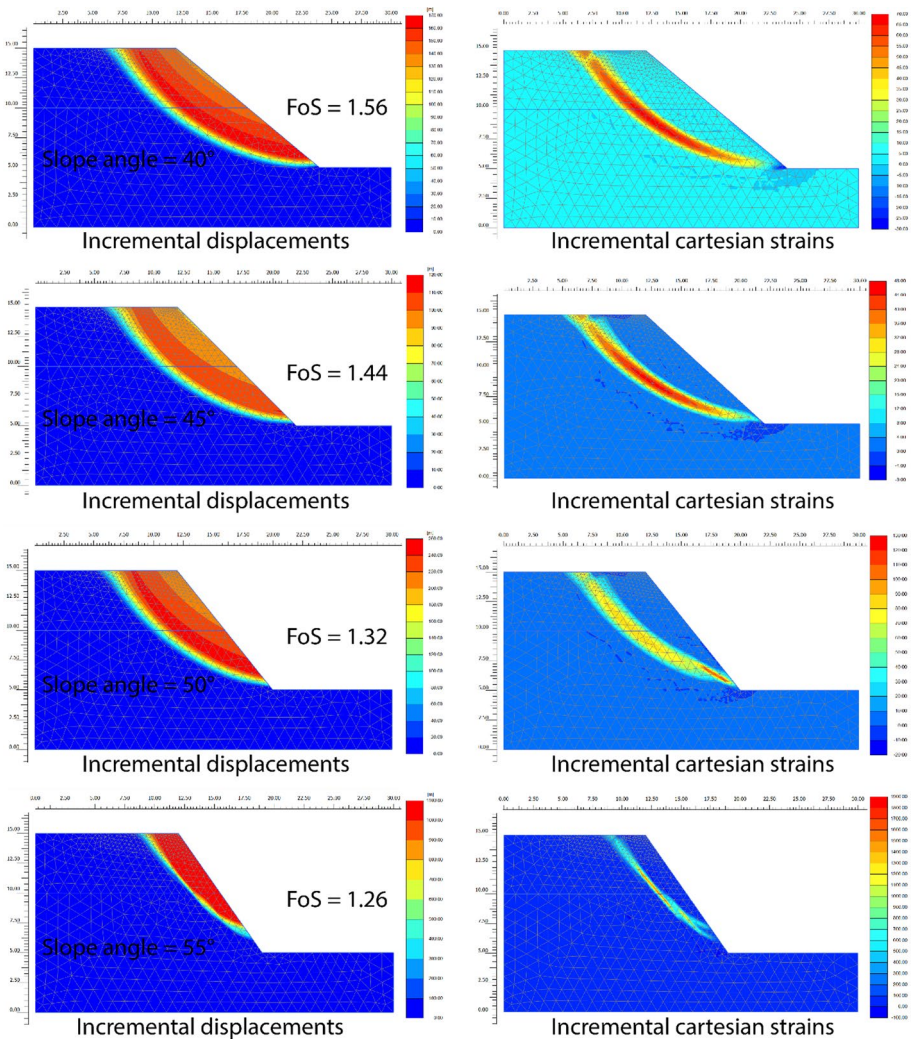
Fig. 10 Safety factor determined for different slope angles under natural conditions without anthropogenic overburden load using the FE method

The distribution of incremental displacement and strain with increasing slope angle is shown in Fig. 10. The FoS value obtained for a 40° slope angle is 1.56 under natural conditions without any stable overburden load. But when an anthropogenic load is applied, the FoS value decreases to 1.28 and 1.12 for 50 and 100 kN/m² loads, respectively. Decreasing trends of FoS with anthropogenic overburden loading occur for all the slope angles and are illustrated for the 45° slope angle in Supplementary Fig. S2. The displacements of slope materials are highest along a narrow semicircular zone which is also attributed to

maximum strain (Fig. 10). These are possible locations of the slip surface during the slope failures. These slip surface configurations are in good agreement with the LEM-derived slip surfaces.

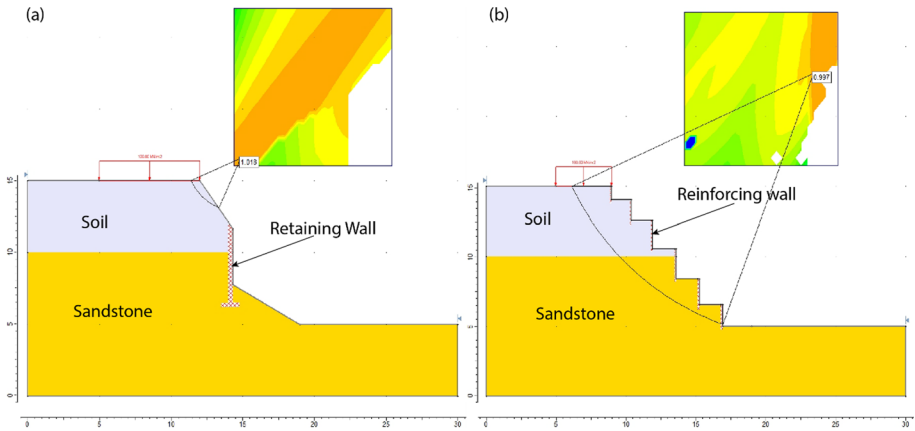
Fig. 13 Safety factor determined for slopes protected against landslide by **a** concrete retaining wall and **b** terrace with the reinforced bamboo wall

The terracing of the slopes with the reinforced bamboo wall increases the factor of safety to a safe limit for 50° and 55° slopes with 100 and 50 kN/m² loading, respectively. Also, the failure probability is significantly low, and the reliability index is close to 3 (Table 2). But for the 55° slope with ≥ 100 kN/m² loading, the slope remains unstable with

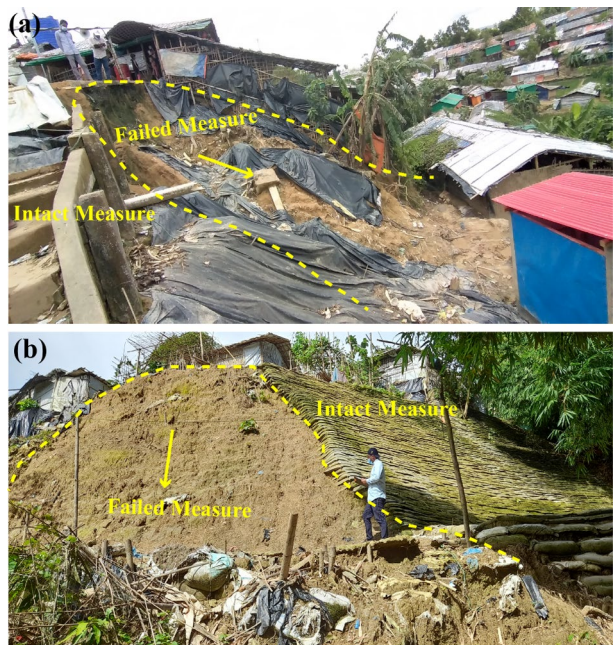
Fig. 14 Examples of landslide mitigation measure failure in the Kutupalong Rohingya camp—**a** retaining wall failure and **b** geo/sandbag cover failure

Implementing slope covering with geo/sandbag (Fig. 14b) protects the slope marginally ($FoS \approx 1$) with a fair share of failure probability for the high slope and loading. For the geo/sandbag-type mitigation measures, it was observed during the fieldwork that the failure of the mitigation measure (geo/sandbag cover) itself causes disaster and fatalities. For example, a 20-year-old woman died in camp 21 (Chakmarkul) in 2021.
