Fireside Corrosion of Heat Exchanger Materials for Advanced Solid Fuel Fired Power Plants

Stefano Mori¹ · Andy Pidcock¹ · Joy Sumner¹ · Nigel Simms¹ · John Oakey¹

Abstract

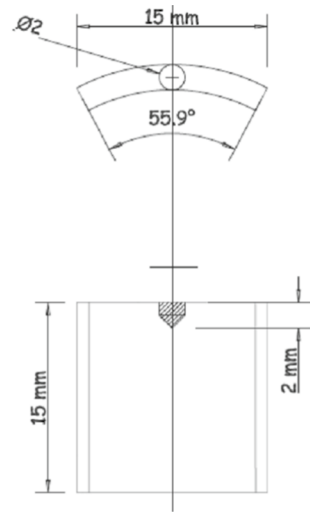
Fig. 1 Example of a tube segments used for corrosion exposures

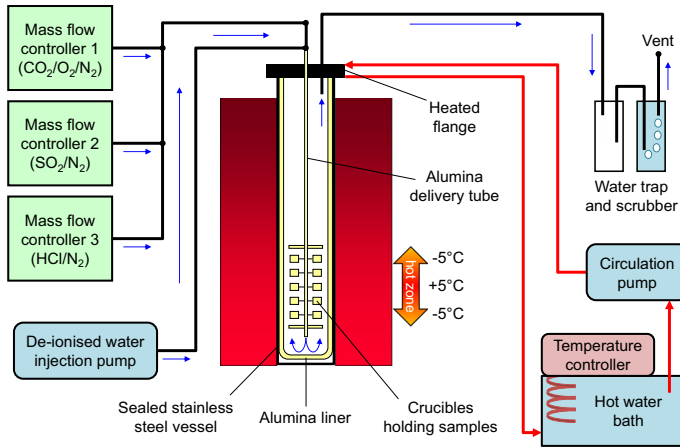
Fig. 2 Schematic diagram of the controlled atmosphere furnaces used for high temperature exposure [23, 25, 28]

Fireside corrosion tests were carried out in an alumina-lined, controlled-atmosphere, vertical tube furnaces (Fig. 2). These furnaces could accommodate 24 samples at a time, in individual alumina crucibles. Each test was run for 1000 h, in 200 h cycles, using the well-established ‘deposit recoat’ technique [22, 23].

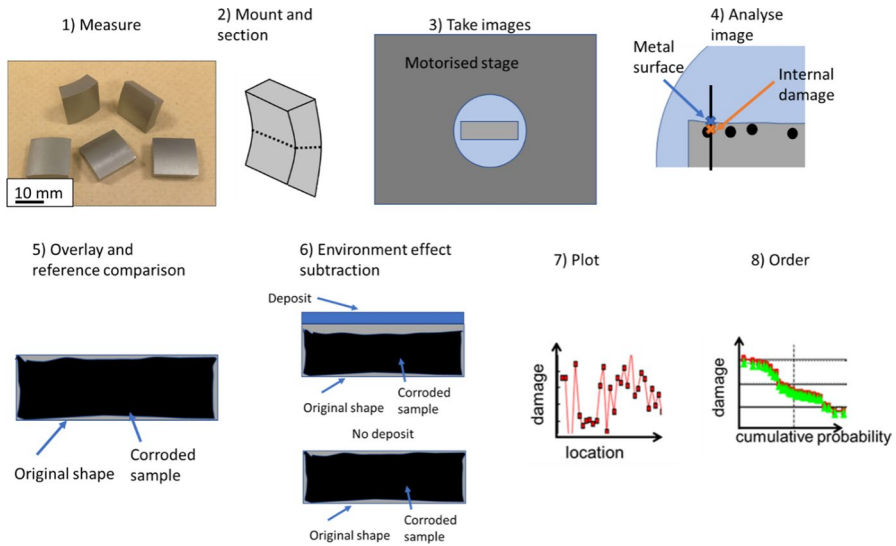
Fig. 3 Schematic diagram of the dimensional metrology process (Color figure online)

Dimensional metrology was used to generate statistical distributions of corrosion damage data for each exposed sample [31–34]. Pre-exposure metrology data were collected before exposure. In this methodology after exposure, polished sample cross sections were measured using an image analyser to record the locations of any remaining metal and internal damage. The x – y coordinates of the metal surfaces and internal damage were obtained from the image analyser. The coordinates were then compared with the damage of the sample without deposit, exposed to the same environment to isolate the damage specifically caused by the deposit; this is a necessary step as the corrosive deposit was only applied to one face of the samples. The data showing the extent of metal change at the sample surfaces were then plotted and ordered to produce cumulative probability curves showing damage distributions associated with each material/deposit/gas/temperature combination. A schematic diagram of the process is given in Fig. 3. Unexposed reference samples were also measured for each alloy to check the differences between pre- and post-exposure metrology processes.

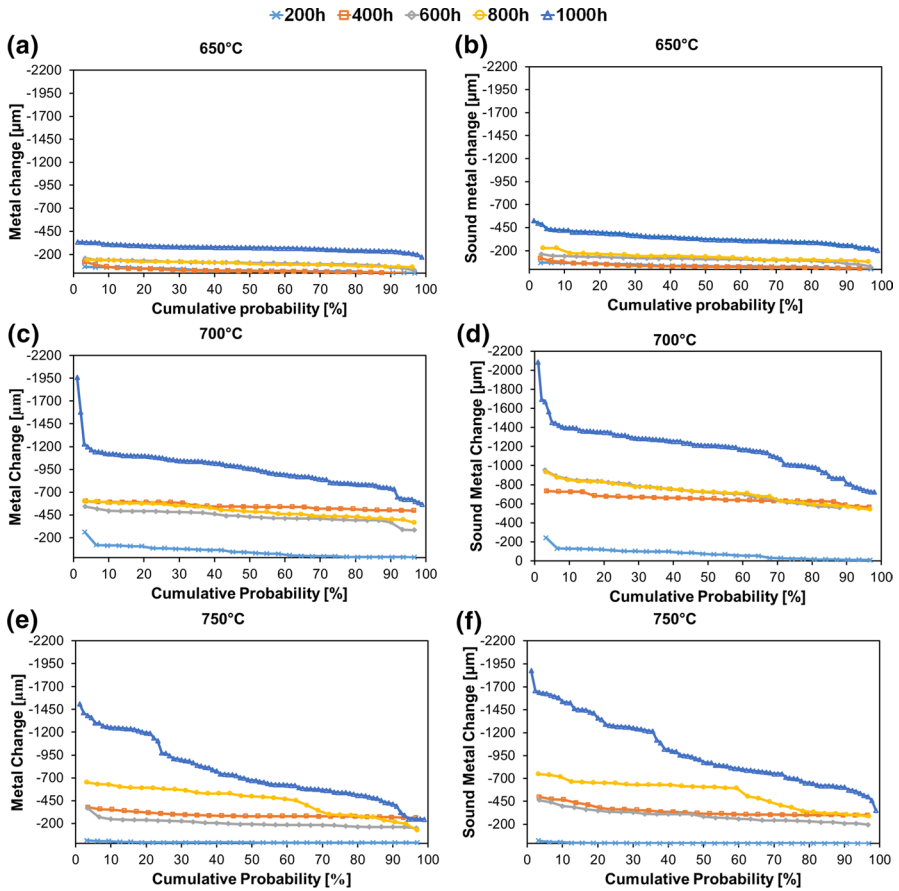
Fig. 4 Fireside corrosion-induced metal change and sound metal change for Sanicro 25 at the three different temperatures and exposure times; **a, c, e** show metal change for 650 °C, 700 °C and 750 °C, respectively, while **b, d, f** sound metal change for 650 °C, 700 °C and 750 °C, respectively (Color figure online)

For Sanicro 25 at 650 °C (Fig. 4a, b), it can be seen that, until 600 h exposure, relatively low damage is present on the samples. The median metal change for 200 h and 400 h exposures is, respectively, $-26 \mu\text{m}$ and $-20 \mu\text{m}$, while the median sound metal changes are $-37 \mu\text{m}$ and $-27 \mu\text{m}$. These values suggest little metal loss or internal damage on the deposit coated sides of the samples. Between 600 and 800 h, there is a significant increase in the fireside corrosion damage, with a metal change of $-109 \mu\text{m}$ and $-102 \mu\text{m}$, respectively. The median metal change at 800 h is 4 times higher than the damage observed at 200 h and at 400 h. The sound metal change (Fig. 4b) shows a median value of $-110 \mu\text{m}$ by 600 h and $-137 \mu\text{m}$ by 800 h (Fig. 4a, b). The amount of median damage observed after 1000 h exposure is $-275 \mu\text{m}$ for metal change and $-325 \mu\text{m}$ for sound metal change. The curves in

Fig. 4a, b suggest that, at this temperature, the alloy is not into the incubation stage anymore, but with a low level of internal damage recorded, as indicated by the small or almost negligible difference between metal change and sound metal change values, which could indicate that the attack is not fully developed yet.

In Fig. 4c, d, the metal change and sound metal change, respectively, are shown for 700 °C. In the figures, it can be seen that the damage propagation for Sanicro 25 starts sooner (at 200 h and 400 h) than for the comparable samples exposed at 650 °C, where the increase in the damage was seen at 400 h-600 h. Sample exposed for 200 h shows a median metal change of $-34 \mu\text{m}$, while the samples exposed for 400 h showed a median metal change of $-540 \mu\text{m}$. Looking at the sound metal

In Fig. 4e, f, the distribution of metal and sound metal change at 750°C is reported. From the figures, it can be observed that the amount of damage after the first 200 h exposure is low but increases after 400 h of exposure with median metal change of $-279 \mu\text{m}$ (which represent about half the amount of damage shown at 700°C , but is higher than the one at 650°C). At 600 h, the Sanicro 25 shows a similar median metal change ($-190 \mu\text{m}$) to that found at 400 h, but the spread of the values is higher than the one at 400 h, meaning a less homogenous distribution of the damage. A further increase in the amount of metal lost has been observed at 800 h. After 1000 h exposure, the distribution of the damage is less uniform around the surface of the metal, as can be seen in the cumulative probability plot, which shows a higher slope. The median value of the metal change increases to $-673 \mu\text{m}$. Similar observations can be made for sound metal change. The slope of the curves shown in Fig. 4f increases with the time; the increase is more evident after 800 h and 1000 h exposure. This is related with a less homogenous distribution of both, the surface recession and the internal damage, around the samples. Comparing this with the data for the 650 and 700°C samples (for the same alloy; Fig. 4), the amount of median change (both metal and sound metal) appears to be lower than at 700°C , and higher at 650°C , before dropping again at 750°C . This behaviour is consistent with moving across the corrosion peak.

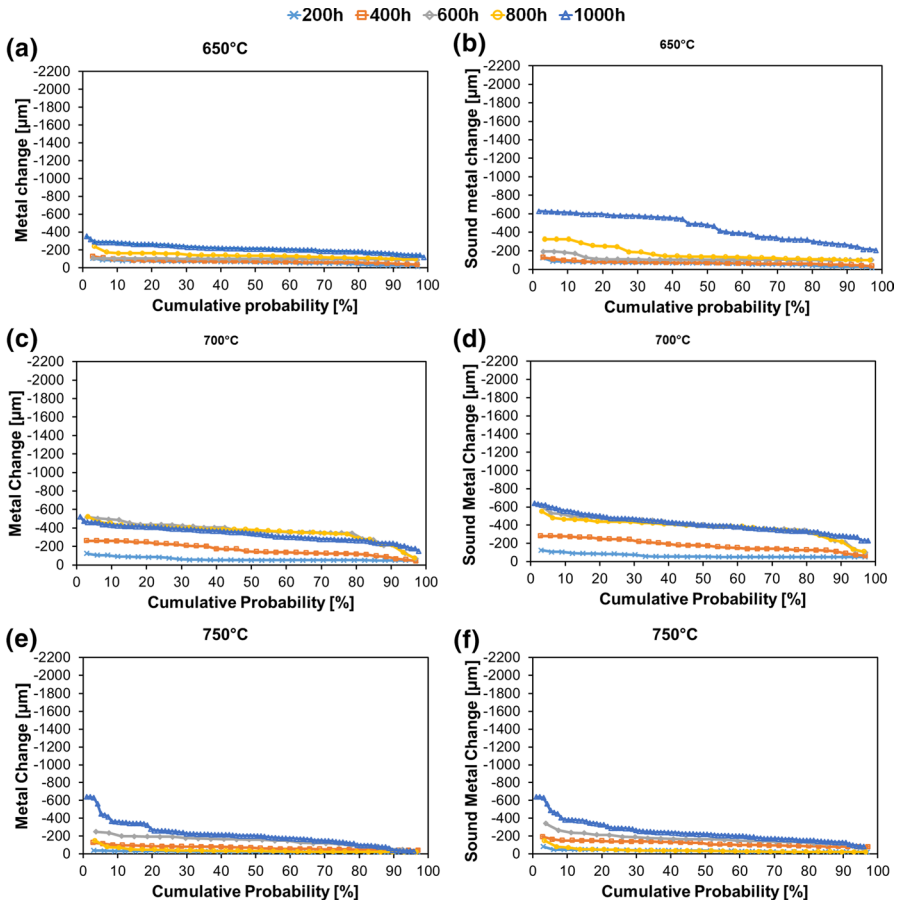
Fig. 5 Fireside corrosion-induced metal change and sound metal change for IN740 at the three different temperatures and exposure times: **a, c, e** show metal change for 650 °C, 700 °C and 750 °C, respectively, while **b, d, f** sound metal change for 650 °C, 700 °C and 750 °C, respectively (Color figure online)

In Fig. 5a, b, the data for metal and sound metal change at 650°C are shown. At an early stage of exposure (200 h), the alloy seems to suffer low damage (median metal change $-67 \mu\text{m}$), but still greater than Sanicro 25 (median $-26 \mu\text{m}$). Similar behaviour has been found after 400 h, with a median metal change of $-72 \mu\text{m}$ and small portion of the metal showing a higher damage. At these times of exposure, little presence of internal damage was observed. The amount of surface damage undergoes a small increase for both 600 h and 800 h exposure, with a median metal change of $-101 \mu\text{m}$ and $-137 \mu\text{m}$, respectively. For these exposure times as well, the amount of internal damage was small and only small portions of the samples experienced it, with a maximum value of the sound metal change

Cumulative probability distributions of corrosion damage for the different times at $700\ ^\circ\text{C}$ exposure are shown in Fig. 5c, d. These distributions of metal damage are mostly even after all exposure times, with the exception of samples after 600 h and 800 h, where small fractions of the sample surfaces show lower damage with respect to the rest of the sample.

Lower damage (both metal and sound metal change) was recorded at $750\ ^\circ\text{C}$ than at $700\ ^\circ\text{C}$, as can be seen in Fig. 5e, f, for metal change and sound metal change, respectively. The amount of damage after 200 h exposure was below $-100\ \mu\text{m}$ (median metal change $-24\ \mu\text{m}$) which is lower than the median damage recorded at both $650\ ^\circ\text{C}$ and $700\ ^\circ\text{C}$. The distribution of the damage on the surface is mostly homogeneous at this exposure time. After 400 h exposure, there is an increase in the damage, with a median metal change of $-62\ \mu\text{m}$. The sound metal change distribution starts to increase compared to the metal change, with median values of $-35\ \mu\text{m}$ and $-108\ \mu\text{m}$ for 200 h and 400 h exposure, respectively. After 600 h exposure, a bigger increase in the damage was measured, with the damage increasing by about 6.5 times compared to the sample exposed for 200 h (median metal change $-157\ \mu\text{m}$). At this exposure time, small areas with higher levels of damage started to appear, as can be seen from the metal change distribution in Fig. 5e.

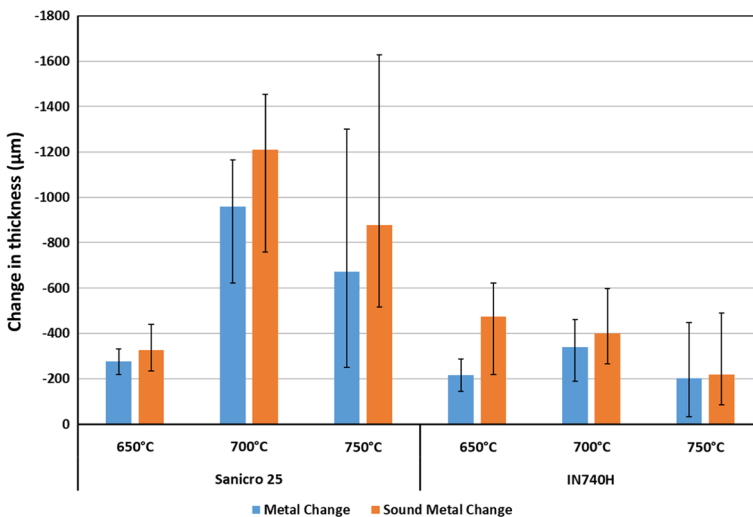
Fig. 6 Median, maximum and minimum metal changes for the two alloys, comparing different temperatures after 1000 h exposure under the simulated fireside corrosion conditions (range bars represent 95% and 5% probability) (Color figure online)

In Fig. 6, the median, 95%, and 5% values for both metal change and sound metal change at the three different temperatures are reported for Sanicro 25 and IN740. The two materials show a peak in metal change around 700 °C, highlighting that this is a critical metal temperature for both materials in these exposure conditions. At 750 °C, both alloys show a decrease in damage relative to the values recorded at 700 °C. Similarly, a drop in damage relative to 700 °C is recorded at 650 °C. In the case of the IN740, the amount of damage recorded at 750 °C is even lower than that observed at 650 °C (for both metal change and sound metal change). This peak at 700 °C for both alloys illustrates the bell-shaped curve temperature dependence of fireside corrosion damage (originally found for austenitic stainless steels [16, 22–24]). The bell-shaped curves for the fireside corrosion damage is related to the deposit flux for the lower temperature, and the ratio between SO₃ and SO₂, which influences the stability of the deposit. The temperature occurrence of these peaks is

strictly dependant on the combined effect of the chemistry of the gas environment, the chemistry of the deposit and the chemistry of the alloy substrate. For this reason, changing one of the three could result in a shift in temperature for the maximum corrosion damage observed. This is true for both metal change and sound metal change.

However, for median sound metal change, the two alloys show different behaviours; for Sanicro 25, the peak is still at 700 °C, while for IN740 the maximum is at 650 °C and decreases with increasing temperature (Fig. 6). The amount of median sound metal change in IN740 is lower than in Sanicro 25 at temperature above 650 °C (three times lower at 700 °C and up to 4 times lower at 750 °C), see Fig. 6.

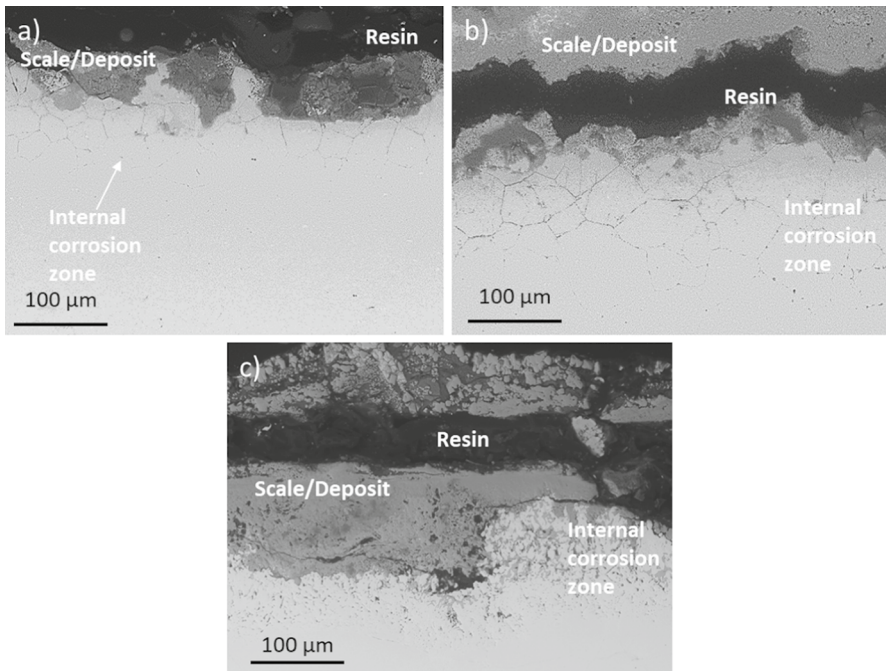
Fig. 7 SEM backscattered micrograph showing typical damage for Sanicro 25 at **a** 650 °C, **b** 700 °C, **c** 750 °C after 1000 h exposure. In the images, three regions can be clearly seen, scale/deposit, internal damage and alloy (brightest area). The black area is due to the resin used for the mounting

Samples for SEM/EDS were cross-sectioned and polished, but they were not etched to highlight the grain boundaries. In Fig. 7, SEM micrographs of the alloy Sanicro 25 are shown at the different exposure temperatures, after 1000 h. It has been chosen to report only cross sections after 1000 h exposure, to highlight clearly what happens to these alloys when they are in their propagation stages (i.e. information about the propagation rate). The typical morphologies of the three samples are different from each other. At 650 °C (Fig. 7a), the sample shows a relatively thin scale/deposit on it, which is in accordance with its low metal change data. On the other hand at 700 °C and 750 °C (Fig. 7b, c, respectively), thicker scale/deposit layers are present. For these latter two samples, the scale/deposit layers cannot entirely be shown on these micrographs, due to their thicknesses. The presence of these thicker

Another feature that can be seen is the different extent and morphology of the internal damage at the three different exposure temperature. At 650 °C and 700 °C (Fig. 7a, b), the deepest damage is shown to be intergranular corrosion; however, this is not seen at 750 °C. The sample at 700 °C also showed deeper internal damage than the sample exposed at 750 °C.

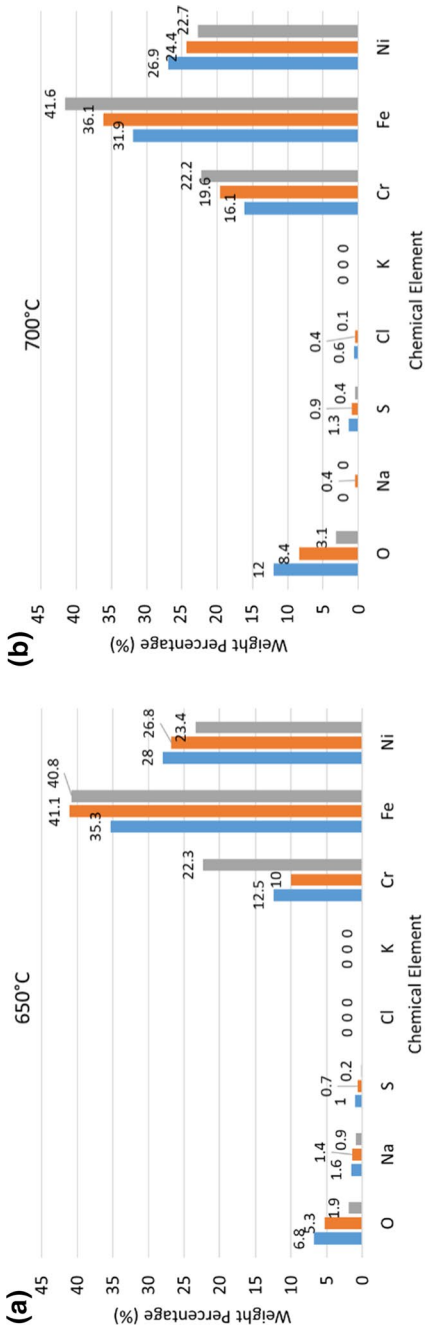
Fig. 8 EDS analyses for the Sanicro 25 at the three different temperatures; key elements only in scale/deposit, internal corrosion zone and alloy (Fig. 7) (Color figure online)

The samples were analysed by EDS; the results of the analysis are shown in Fig. 8. For each sample, spectra were collected using area scans from three areas (i.e. scale/deposit, internal corrosion and underlying alloy). All the samples showed a variable range of compositions in the scale/deposit areas and internal corrosion zones. In the internal corrosion zones, there is a depletion of chromium, but the scales were enriched in chromium. This can be because the Cr diffuses into the scale from the internal corrosion zones; and the Cr-rich scale reacts with the deposit. The Cr depletion seems to be greater in percentage terms at 650 °C and 750 °C, where, in the depleted area, it was found that there was ~12 wt% decrease in Cr. At 700 °C the depleted areas showed a decrease in ~2 wt%. Sub-surface Cr depletion in Sanicro 25 has previously been observed and identified as an indication of selective oxidation to form Cr₂O₃ [26]. Iron and nickel were also found in the scale; the iron could either come from the alloy, or from the deposit itself.

In Sanicro 25, nickel shows a different behaviour compared to Cr. The amount of Ni increases (in percentage terms) on moving from the metal, to the internal corrosion zone and then into the scale/deposit. In all the samples, a diffusion of sulphur can be seen going from both the gaseous atmosphere and the scale/deposit, into the internal corrosion zones. The amount of S in the scale/deposit of the samples increases with temperature, going from 1 wt% at 650 °C to 7.8 wt% at 750 °C (Fig. 8). In the same way, the depth of the diffusion (i.e. internal corrosion zone) seems to be higher at 750 °C. The composition of the samples return to the same values as the unexposed samples (see Fig. 8 and Table 1). The width of the internal corrosion zone shows a peak at 700 °C, in accordance with the internal corrosion data that is included in the sound metal change data (compare Figs. 4, 7 and 8). In this sample, the extension of the internal corrosion zone is about 300 µm; three times higher than at the other two temperatures (Fig. 7). From Fig. 8 can also be seen the presence of Cl at 700 °C, which could have contributed to the increase of the corrosion damage, this has been already reported in literature [36]. The presence of Na has been found as well, only at 650 °C and 750 °C, while K has not been seen in any of the temperatures. That could be due to the spallation of the deposit or the deposit reacting with the gaseous environment.

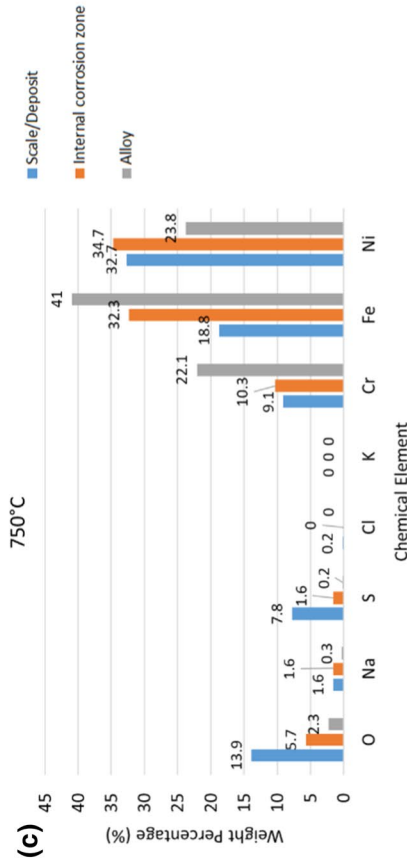
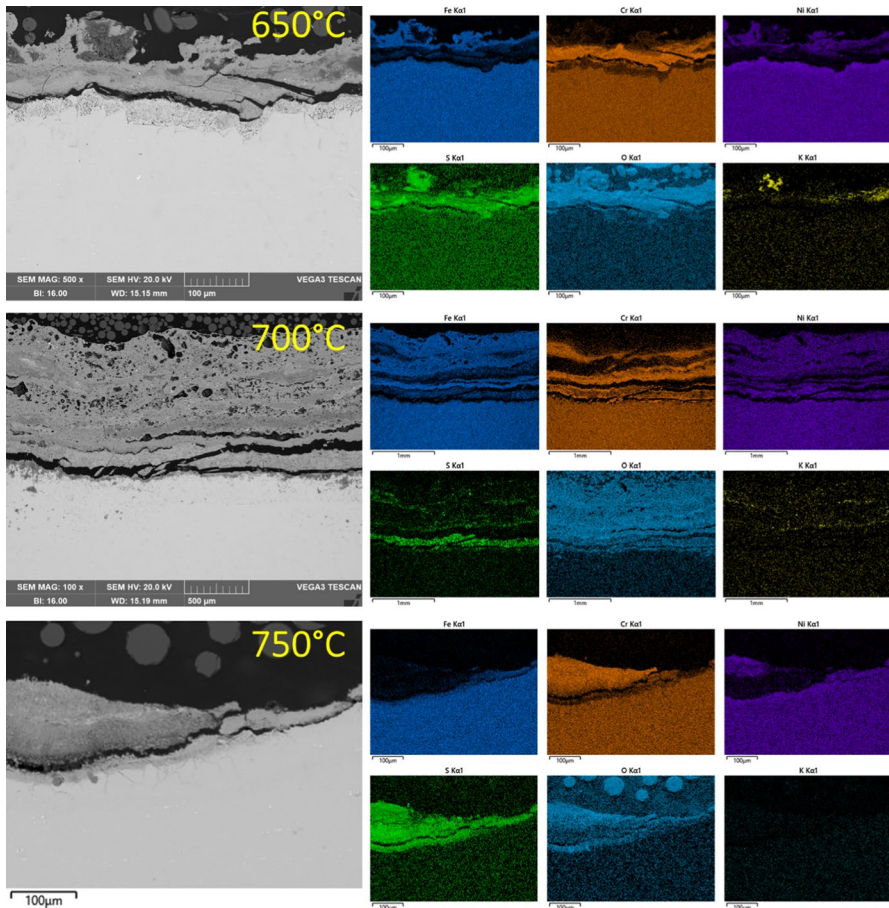
Fig. 9 SEM backscattered images and EDS maps analyses for the Sanicro 25 at three different exposure temperatures after 1000 h. The image for the sample exposed at 700 °C has been taken at lower magnitude, to allow a complete scan of the scale/deposit region (Color figure online)

In Fig. 9, EDS maps of the Sanicro 25 samples exposed at the three temperature are shown. It is worth noticing that the sample exposed at 700 °C required acquisition at lower magnification, due to the thickness of the the scale/deposit region. In all cases, the scale/deposit region appears detached from the metal surface, but a difference in morphology in the three case can be seen. This might be responsible of the damage recorded for Sanicro 25 (see median metal and sound metal change in Fig. 6). Looking at the morphologies, it can be noticed that the scale/deposit region for the sample exposed at 700 °C appears more porous and less dense than that

observed at the other temperatures. This could be due to the interactions between the substrate, gas and deposit, which results in the most aggressive fluxing of protective scales at this temperature, and hence a less protective scale. This would have given rise to the higher metal and sound metal change observed at this temperature (see Fig. 6). Furthermore, the scale/deposit appears to be composed of a thick outer layer of an Fe-rich porous oxide layer, which is expected to give lower protection from corrosion than a Cr-rich oxide layer [37]. On the other hand, for both higher and lower temperatures (650 °C and 750 °C, Fig. 9), a compact Cr-rich oxide has been found, just above the Sanicro 25 surface. Cr-rich scale is usually responsible of enhanced corrosion protection. As the sulphate deposits first increase in reaction rate with temperature, and then destabilise, their ability to inhibit the formation of the protective Cr-rich scale will peak, here showing the most aggressive resonance at 700 °C, as already reported [21], this destabilisation is due to the change in ratio between SO_3/SO_2 . At lower temperature, the amount of SO_3 is higher, leading to a more stable deposit on the surface. On the other hand at higher temperatures, the amount of SO_2 can be found, which is responsible of the deposit destabilisation. The crossover between the two behaviours is around 700 °C, which give rise to the bell-shaped curve peaked around 700 °C observed. The change in the deposit could explain the lower metal and sound metal changes observed for Sanicro 25 at both, 650 °C and 750 °C (see Fig. 6). It is important to notice the presence of S in the scale/deposit region in all of the Sanicro 25 samples. This could come from the deposit used (which was composed of sulphates) and/or the moreover SO_2 present in the gaseous environment.

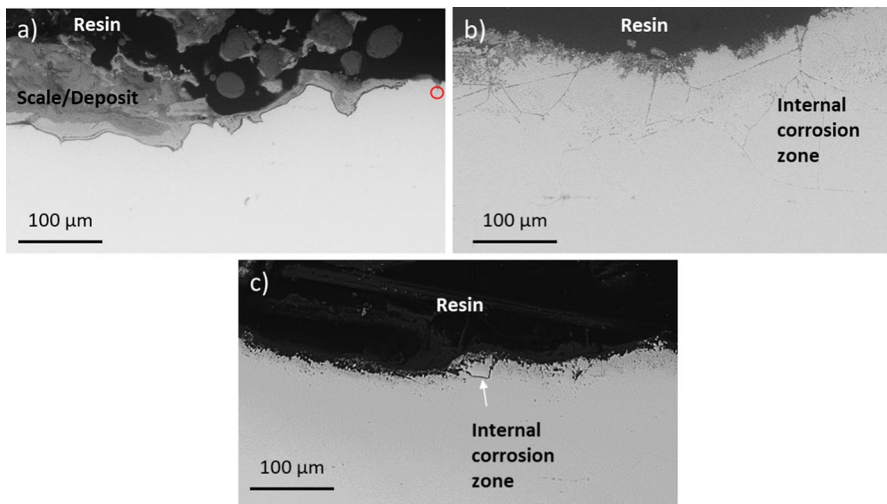
Fig. 10 SEM backscattered micrographs showing typical damage for IN740 at **a** 650 °C, **b** 700 °C and **c** 750 °C. In picture (a) the red circle shows the internal damage (Color figure online)

In Fig. 10a–c, typical images of IN740 samples exposed for 1000 h at 650 °C, 700 °C and 750 °C, respectively, are shown. From these images, different damage morphologies can be seen. The 650 °C image shows also presence of a large pit-like damage morphology, with further damage at the bottom of the peak spreading further into the metal (Fig. 10a).

The image in Fig. 10b shows the presence of internal damage areas, in particular, of grain boundary attack, even if a thick scale was not observed across the whole sample's exposed surface. The morphology of the metal surface looks irregular. This is reflected in the dimensional metrology, where the amount of metal change initially increased with the temperature. In the sample at 750 °C (Fig. 10c), the amount of internal damage shown is almost negligible. This feature was inline with the dimensional metrology data, where small amounts of internal damage were only observed in small areas.

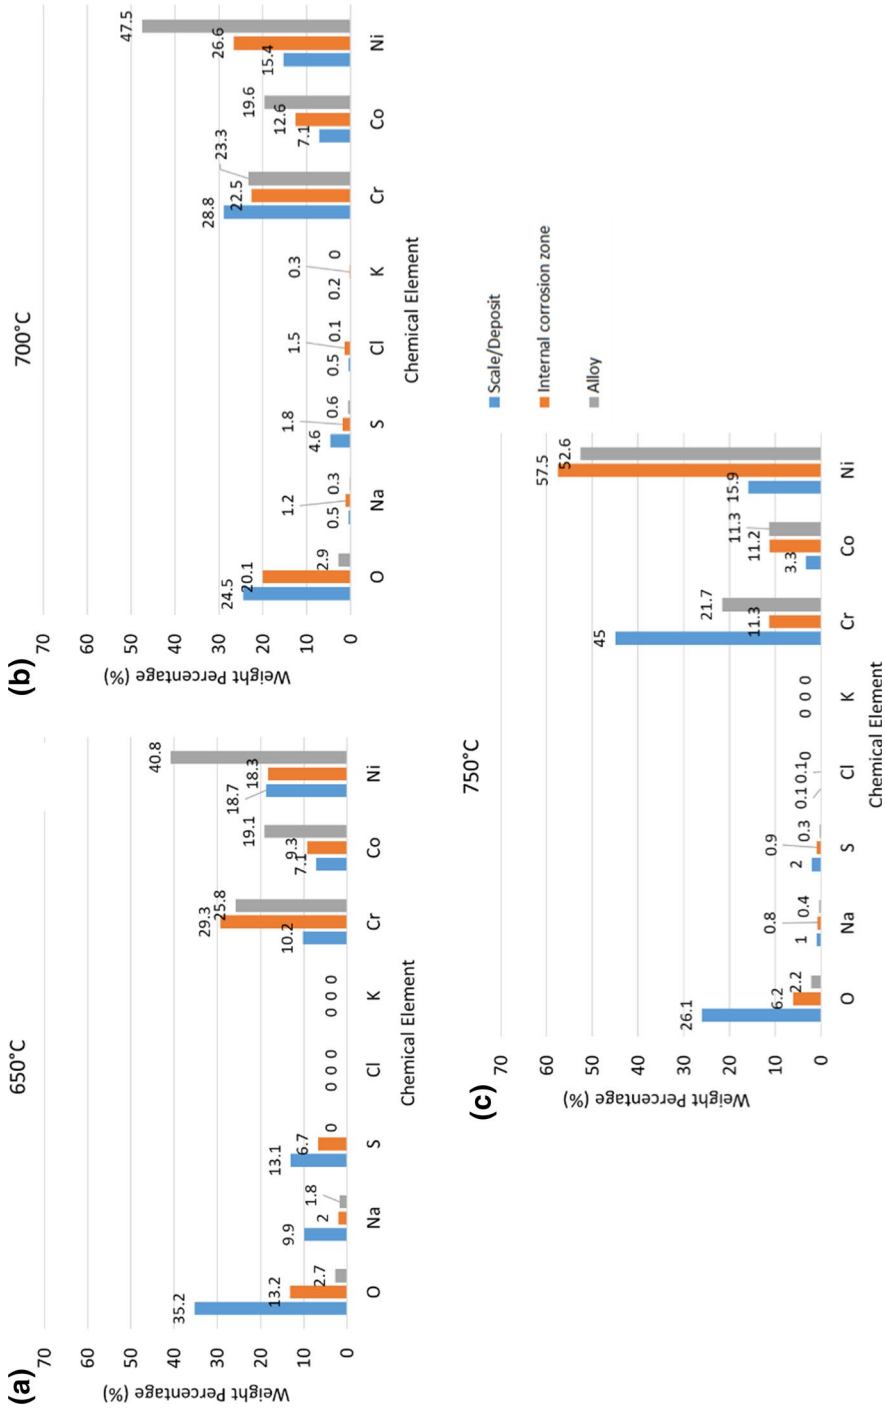
Fig. 11 EDS analyses for the IN740 at the three different temperatures; key elements only in scale/deposit, internal corrosion zone and alloy (Fig. 10) (Color figure online)

corrosion zone is not clearly visible in the sample exposed at 650 °C (Fig. 10a), but from the data shown in Fig. 11, a difference in concentration of nickel, chromium and cobalt has been observed. The area at the interface between scale/deposit and alloy seems to be enriched in Cr, while is depleted in Ni and Co. Data in Fig. 11, linked to Fig. 10b, c, show that at 700 °C and 750 °C the alloy shows an internal corrosion zone. In such area, a change in composition has been observed. The scale/deposit seems to be rich in chromium, and the content then decreases in the internal corrosion zone.

Figs. 10 and 11). In contrast, the sample at 750 °C the concentration of Cr and Co observed was below the typical value of the alloy (compare Fig. 11 with Table 1), especially for cobalt, that was observed in 11% weight rather than 20%. This could be due to a bigger extension of the damaged area, even if the pictures do not show clear evidences of corrosive attack below the internal corrosion zone. Looking at the contaminants' concentrations, a more extensive sulphur presence was found in the sample exposed at 700 °C; this is reflected in the data collected by dimensional metrology, where the peak in metal change damage is shown at a temperature of 700 °C for IN740 (Fig. 6).

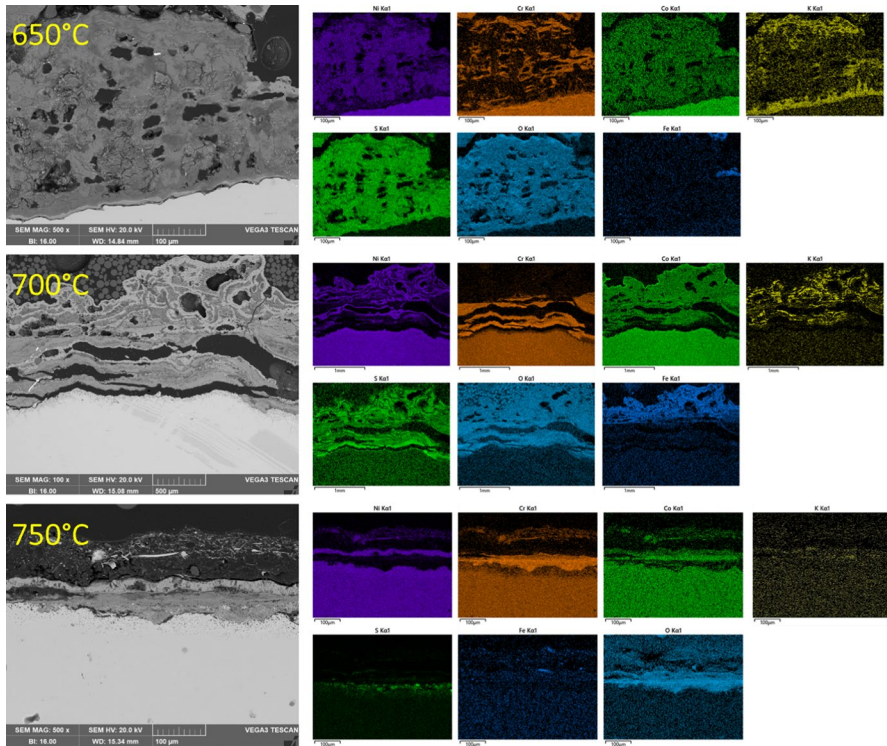
Fig. 12 SEM backscattered images and EDS maps analyses for the IN740 at three different exposure temperatures after 1000 h. The image for the sample exposed at 700 °C has been taken at lower magnitude, to allow a complete scan of the scale/deposit region (Color figure online)

Figure 12 reports EDS maps from IN740. Particular attention has been paid to assessing the scale composition. It is worth to be noted that the composition of the area indicates that the scale is not formed only by the oxides, but it comprehends, also, elements from the deposits. As can be seen, going from 650 °C to 750 °C, a progressively denser scale has been recorded, even if at 700 °C the scale appears to detach from the metal surface. A difference in composition can be observed as well, especially for the sample exposed at 700 °C (the sample that showed highest median metal change for IN740; see Fig. 6). This shows a significant part of the scale/deposit is formed by Fe-oxide, which is a more porous and less protective oxide than the Cr-rich oxides [38]. This scale formation could be due to the higher stability of the deposit at this temperature, leading to a more aggressive environment, causing a higher flux of more protective elements from the alloy to the surface, leaving the Fe as the remaining element to be oxidised. The greater presence of deposit elements (K, S) at 700 °C could be an indication of this deposit stability and have led to the higher median metal change for IN740 at 700 °C than at the other temperatures (see Fig. 6). At the other temperatures, as seen in Fig. 12, the presence of dense Ni-, Co-, Cr-rich oxide layers

(starting from top to bottom of the image) can be noted, which acted as a barrier between the environment and the samples. The presence of the Cr-rich scale is due to the increased instability and a more reactivity of the deposit at 750 °C, and a more stability and less reactivity at 650 °C, leading to a lower corrosion damage in both cases. This could explain the decrease in the median metal change, as well as median sound metal change, observed for the IN740 samples exposed at 750 °C, see Fig. 6. The reason for this frequently reported bell-shaped peak in corrosion damage is related to the stability of the deposits generated under these exposure conditions. The deposit used for this work reacts with the gaseous environment to give an alkali iron tri-sulphate; this has a melting point of ~550 °C [21], but becomes unstable above ~680–700 °C due to the decrease in SO₃ species in the gaseous environment with increasing temperature. Such changes in the deposit lead to a peak in corrosion damage between 650 °C and 700 °C (which has been reported by many authors, e.g. [21, 27]). The peak damage depends on the alloy chemistry as well. It should be noted that this kind of behaviour has been observed previously in both nickel-based alloys (i.e. 263, 617 and 740) [27] and stainless steels (e.g., 347HFG and HR3C) [21]. Hussain et al. [21] showed in the paper that the peak in metal change was observed at lower temperature for similar conditions (gas composition N₂ 73.8%, O₂ 4%, CO₂ 14%, H₂O 8%, SO₂ 1300 vppm, HCl 400 vppm [21], compare to Table 2), but the paper investigated the behaviour of other steels (i.e. T92, 347HFG and HR3C), not Sanicro 25. On the other hand, it has been reported the ability of the IN740 to create an effective barrier to sulphur penetration, at temperature equal or above 700 °C [27]. In the current study, the two alloys exhibit similar trends, with peak of median metal change at 700 °C, but with different level of damage; the median metal change in the Ni-based alloy being about three times lower at both 700 °C and 750 °C than the damage showed by Sanicro 25 (Fig. 6). From Fig. 11, it can also be seen that Cl has been found at 700 °C, corresponding to the peak in metal change for both alloys (Fig. 6), suggesting that the gas would have had access to the metal surface. It has been observed by Jonsson [39] and Olivas-Ogaz [40] that Cl plays a crucial role in high-temperature corrosion, especially HCl coupled with O₂. In this case, the Cl has the ability to form transition metal chlorides, which will decompose and leave a rough and porous, and hence unprotective, scale [40].

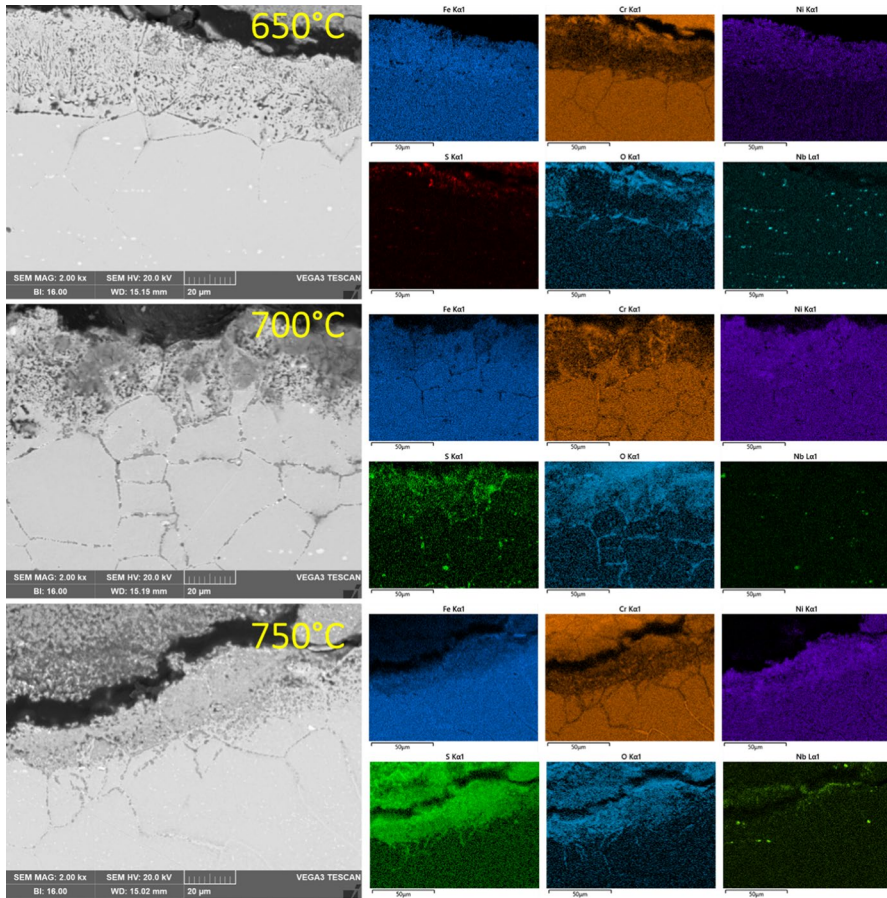
Fig. 13 SEM backscattered images and EDS maps analyses for the Sanicro 25 at three different exposure temperatures after 1000 h. Images have been taken at higher magnitude with respect to Fig. 9 (Color figure online)

Figure 13 shows the internal damage recorded for Sanicro 25 at the three different temperatures examined (650 °C, 700 °C and 750 °C). It can be seen clearly that below the surface, there is a clear Cr depletion zone. Below the depletion zone, there is grain boundary attack, which is characterised by a different Cr-content with respect to the grain itself. Starting from the sample exposed at 650 °C, the absence of Cr at the grain boundaries can be noted. This is not followed, at this temperature, by the inward diffusion of S or O along the grain boundaries (within the resolution

Figure 13 shows also Sanicro 25 exposed at 700 °C for 1000 h. The EDS maps are different with respect to Sanicro 25 exposed at 650 °C. At grain boundaries, Cr presence has been found inside the depletion area at 700 °C. This is followed by an inward diffusion of S and O, which is similar to what has been already found for IN740 [27], where the Cr interacts with S, forming Cr/S-rich areas, that, upon enclosing the grains, limit the ability of the Cr to diffuse from the bulk alloy (below the internal grain boundaries attack) to form a protective scale. This phenomenon is known as a “diffusion cell” and has been reported in literature for different materials exposed at high temperatures [41, 42]. At 750 °C, the grain boundaries show depletion of Cr, with almost absent S and O inward diffusion. This could be explained by the deposit different stability at those temperature, which is dependant on the SO_3/SO_2 ratio in the environment [21, 27]. This gives rise to the bell-shaped curve for the metal change found in this work.

As can be seen by Figs. 13 and 14, the alloys used in this work seem to be susceptible to grain boundary corrosion under the exposure conditions used. The contrast changes around the grain boundaries in the micrographs indicates localised corrosion attack there. Since the grain boundaries were clearly visible (Figs. 7 and 10), there was no need to etch the alloys cross sections. To measure the grain boundaries size, several lines of known length were drawn on the BSE images of the alloys, and the number of grains intercepted by the lines counted, to derive an average grain size (known as Heyn method [44]; (in line with ASTM standard ASTM E112 – 13 [45]). Cross sectioning of samples will result in 2D representation of the 3D grain structure, as such it is very unlikely to hit the maximum grain dimension in a single cross section. Calculating the average with this methodology could result in an under-estimation of the actual grain size. This is exacerbated when grains are not equiaxed [39]. For these reasons, the averages were used as a tool for discussion, rather than accurate grain size measurements. Measurements from BSE image of the corroded area, although not homogeneous, show that attacked grains have an average size of about 41 μm , with a standard deviation of 6 μm for Sanicro 25 and 46 μm and a standard deviation of 9 μm , for IN740.

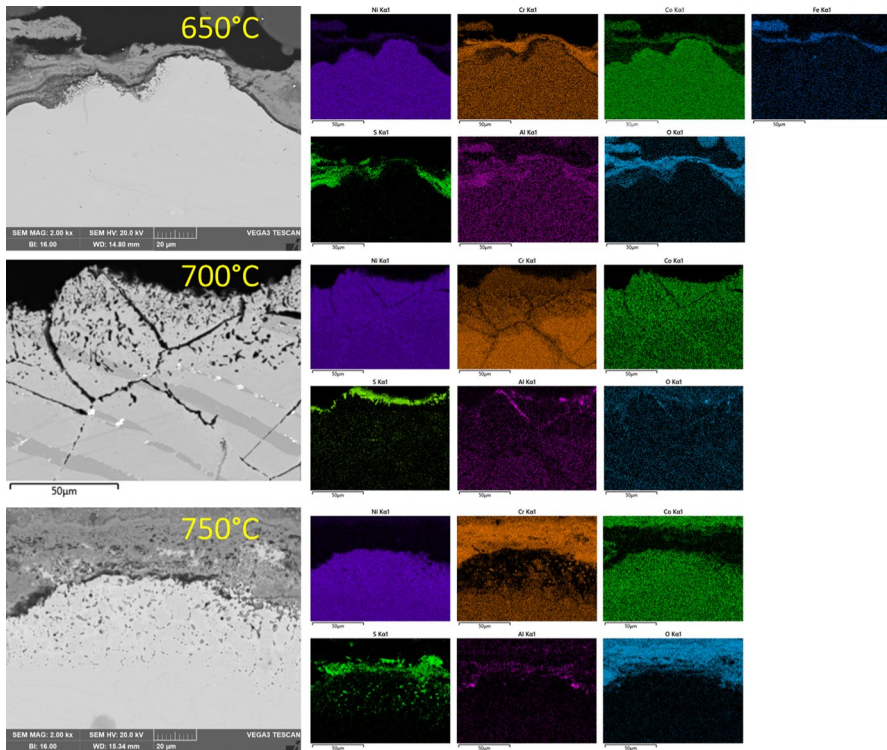
Fig. 14 SEM backscattered images and EDS maps analyses for the IN740 at three different exposure temperatures after 1000 h. Images have been taken at higher magnitude with respect to Fig. 12 (Color figure online)

In Fig. 14, areas with internal damage for IN740 at 650 °C, 700 °C and 750 °C are shown. The grain boundary attack is not as evident as in the Sanicro 25

samples, which is consistent with the dimensional metrology analysis (Fig. 6). The Cr depleted area is clearly visible only at 700 °C and 750 °C. At 700 °C, presence of Al and O is observed at grain boundaries. This could suggest the formation of Al oxide, which could potentially stop the diffusion of other species from the bulk alloy to the surface, preventing the formation of a protective Cr-rich oxide layer, as already observed [43]. It should be noted that the EDS data are in contradiction with the dimensional metrology data (Fig. 6), where the highest median sound metal change was found at 650 °C. This could be due to the fact that the feature highlighted by SEM backscattered images, cannot be seen by optical microscopy images and not everything can be resolved with the resolution limit of the optical microscopy. Furthermore, in the SEM images, there cannot be a clear indication on where the original surface, so no indication of what the sound metal change would be in the presented surface point.
