## Results from InSight Robotic Arm Activities

The InSight lander carried an Instrument Deployment System (IDS) that included an Instrument Deployment Arm (IDA), scoop, five finger “claw” grapple, forearm-mounted Instrument Deployment Camera (IDC) requiring arm motion to image a target, and lander-mounted Instrument Context Camera (ICC), designed to image the workspace, and to place the instruments onto the surface. As originally proposed, the IDS included a previously built arm and flight spare black and white cameras and had no science objectives or requirements, or expectation to be used after instrument deployment (90 sols). During project development the detectors were upgraded to color, and it was recognized that the arm could be used to carry out a wide variety of activities that would enable both geology and physical properties investigations. During surface operations for two martian years, the IDA was used during major campaigns to image the surface around the lander, to deploy the instruments, to assist the mole in penetrating beneath the surface, to bury a portion of the seismometer tether, to clean dust from the solar arrays to increase power, and to conduct a surface

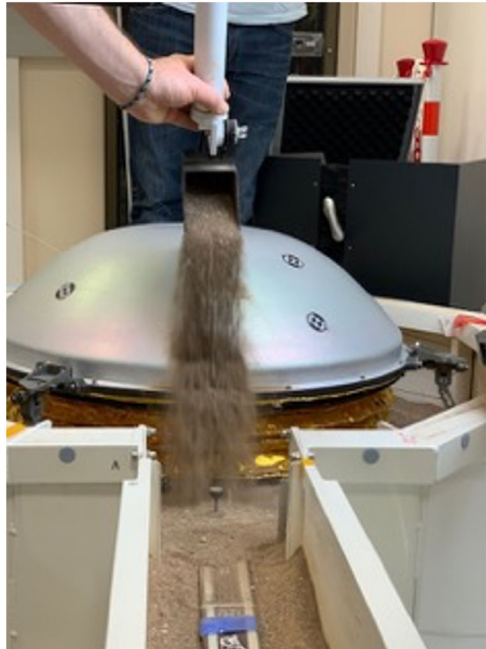
**Fig. 9** Dump test on the WTS and SEIS tether in CNES testbed, using a hand-held three dimensional model scoop. Note the ball on the post of the pinning mass of the tether upon which soil is being dumped

scoop onto the tether. There were two techniques for dumping soil on the tether. The first poured soil directly on the tether. The second poured the soil on the dome of the WTS so it slid off onto the tether close to the WTS. Dumping soil on the WTS was carried out to reduce the chance of soil pushing against the WTS skirt and potentially breaking its seal with the ground.

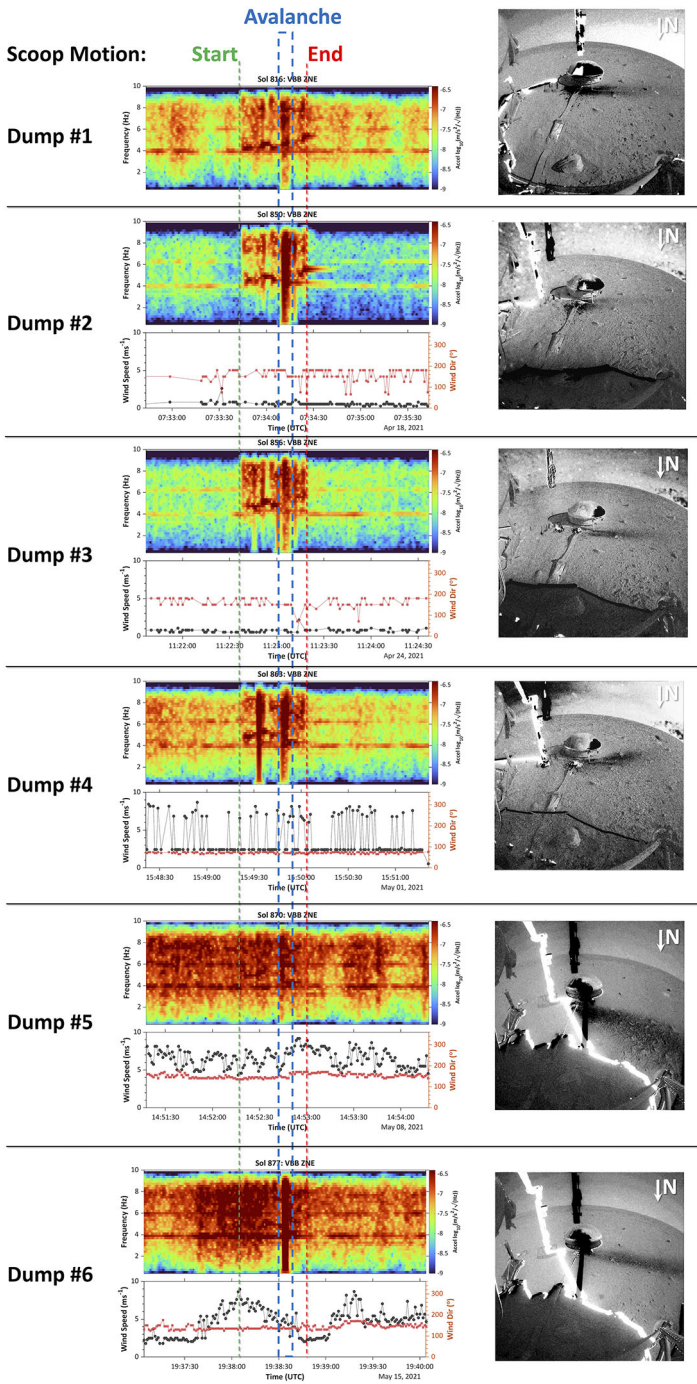
**Fig. 15** Summary of six tether burial dumps showing SEIS acceleration frequency response with the start, end and main avalanche indicated, wind speed and direction, and before-after differenced ICC images showing darker areas of the pile and dispersed soil

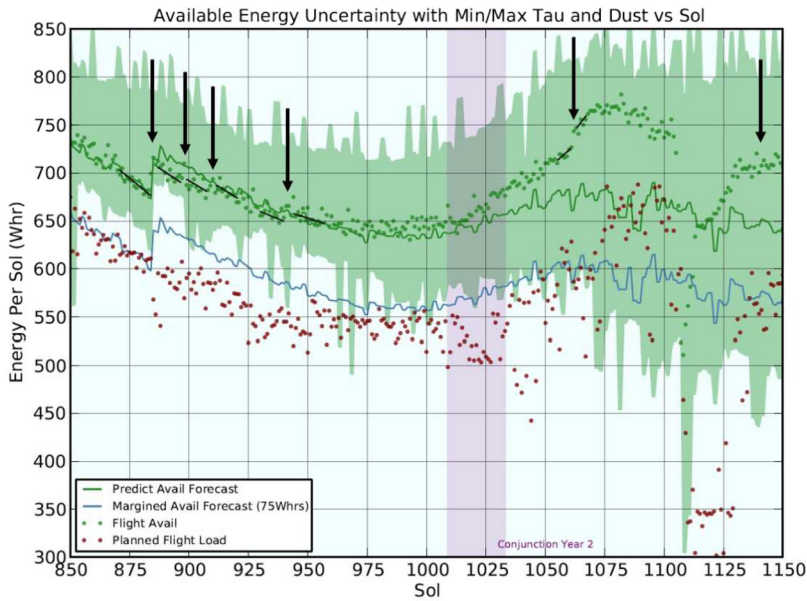
**Fig. 17** Plot of InSight energy from sol 850 to sol 1150 with the first six solar array cleaning experiments marked (black arrows). The energy low centered around sol 975 is near aphelion and conjunction (in purple) when the spacecraft was out of communication with Earth. The green shaded region is the power expected bounded by maximum and minimum atmospheric opacity based on the compilation of previously measured and extrapolated tau developed for InSight (Lisano and Bernard 2014). The green dots are the energy per sol produced by the solar cells. The red dots are the energy per sol planned to be used by the spacecraft. The blue line is the modeled margined energy provided to the operations team for planning and is 75 Whrs below the modeled energy. Black lines show trends in energy per sol on either side of the first five solar array cleaning events to emphasize the jumps in energy. The largest increases occur from the first and fifth cleaning experiments. More modest increases occur at the others

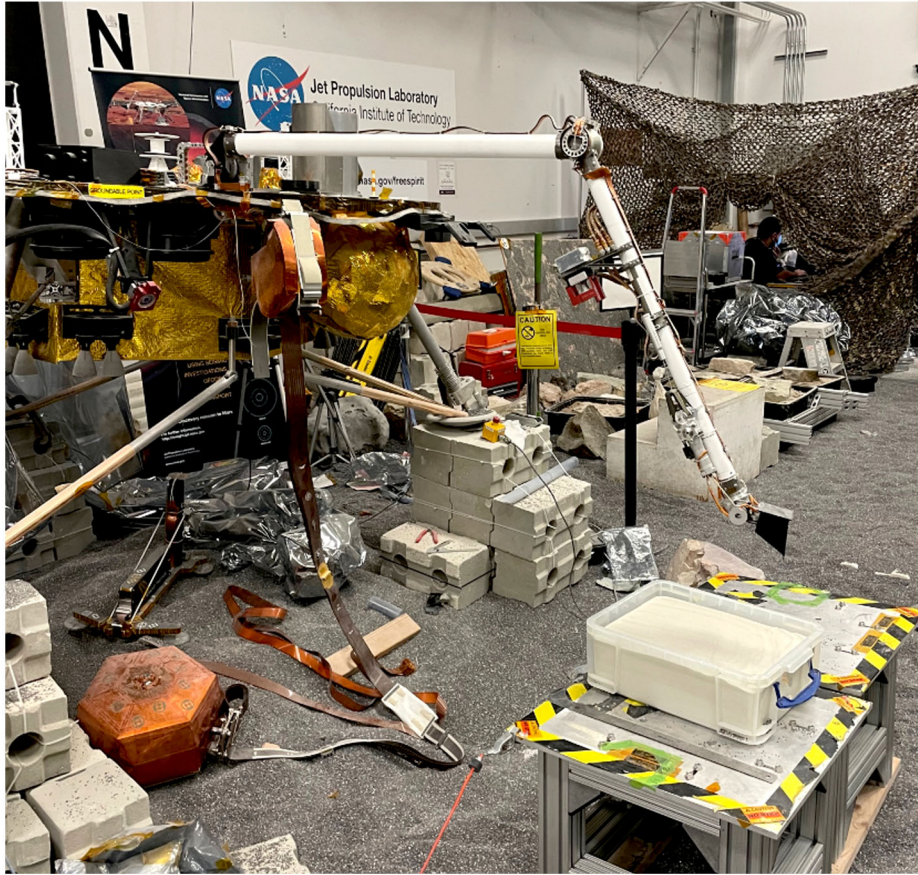
**Fig. 27** Picture of the engineering model lander, robotic arm, and scoop in the JPL testbed. Note the container of simulant below the arm as well as the SEIS and HP<sup>3</sup> models on the surface to the left. The IDC is on the forearm of the IDA and the ICC is mounted beneath the deck to the left (with red around the lens). Note the lander feet were placed on cinder blocks to enable end to end testing of arm activities that assisted the HP<sup>3</sup> mole and interacted with the surface

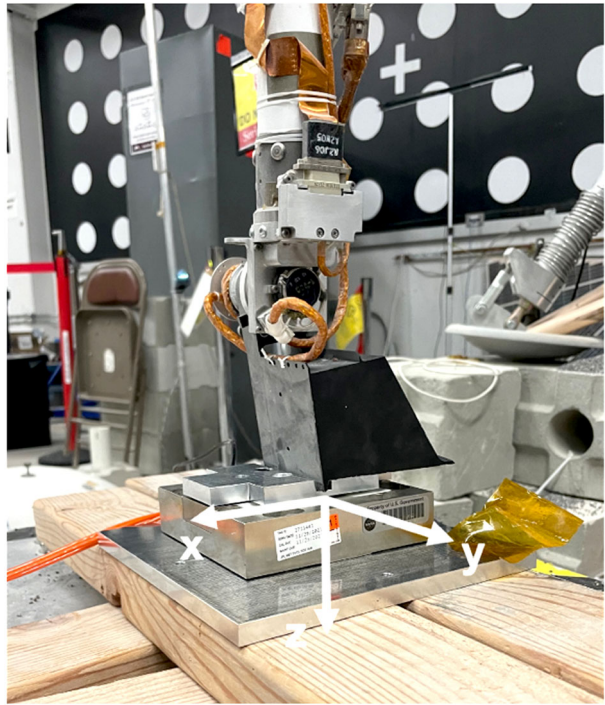
(Keysight DAQ34972a). A top plate is mounted on the load cell and designed with a groove to fit the scoop when pushing with its tip or flat bottom. The load cell is also bolted to a base plate that remains parallel to the top plate. Figure 28 shows the IDA scoop pressing with its flat bottom on the multi-axis load cell setup. Tests were run at three different locations to match those done at Mars near the HP<sup>3</sup> hole, at the Indentation and first Elastic Properties location, and at the second Elastic Properties location. Near HP<sup>3</sup>, the scoop external loads are measured for both the flat and tip pushes.
