The Evolution of White Etching Cracks (WECs) in Rolling Contact Fatigue-Tested 100Cr6 Steel

A. D. Richardson¹ · M.-H. Evans¹ · L. Wang¹ · R. J. K. Wood¹ · M. Ingram² · B. Meuth¹

Abstract

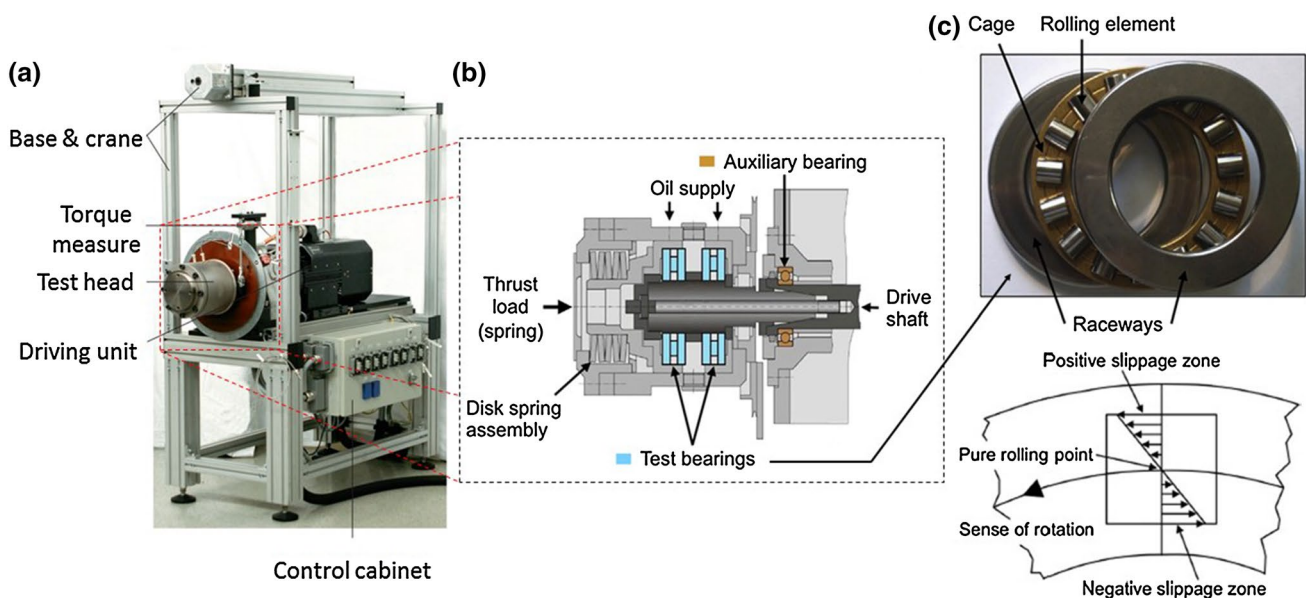
Fig. 1 **a** FAG-FE8 test rig, **b** schematic of test chamber (side on view), and **c** CRTB used in the RCF testing and slippage condition experienced. Adapted from [24]

the bearing, contact zone exists a pure rolling condition with rising slip to the edges of up to $\pm 12.5\%$ SRR along the contact major axis (see Fig. 1c, [45]). On the rollers, the slip zones experience both – ve and + ve directional slip, due to the roller being sandwiched between two raceways. Eight tests were conducted from 0 to 18 h, two of the tests (at 16.5 and 18 h) were shut down due to a vibration threshold limit being reached; other tests were shut down manually at pre-determined running durations (0 h control, 2 h, 4 h, 6 h, 6 h repeat and 12 h). The calculated maximum Hertzian contact pressure P_{max} is in the range of $\sim 1.5\text{--}1.9$ GPa, this being in accordance with the contact length used for a range of lengths between 7 and 9 mm (this dependence taking into account the profile of the rolling element geometry and where roller/raceway contact is assumed to start based upon bearing drawings and software). The test conditions are shown in Table 1.

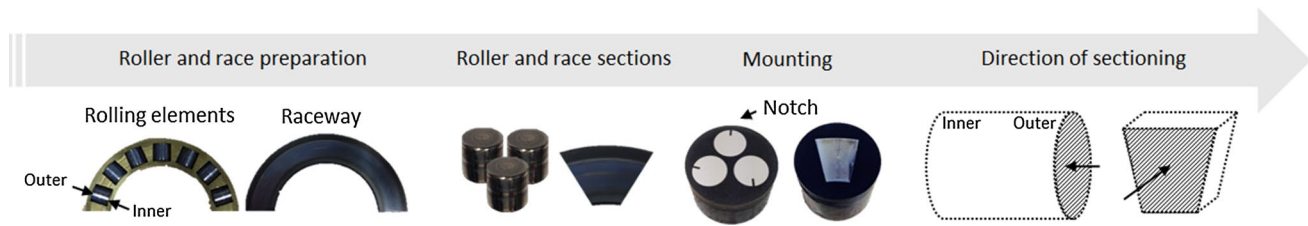
Fig. 2 Stages of sample preparation for rollers and raceway sections

interval around the circumference, individual WECs, when recorded, being numbered in regard to the numbers around a clock face, the notch representing 12 o'clock. Rollers were mounted such that they were sectioned in the axial direction from the outer roller edge through to the inner. Raceway washers were mounted such that the contact surface was sectioned, material removal being performed in the radial z-direction. See Fig. 2 for sample preparation.

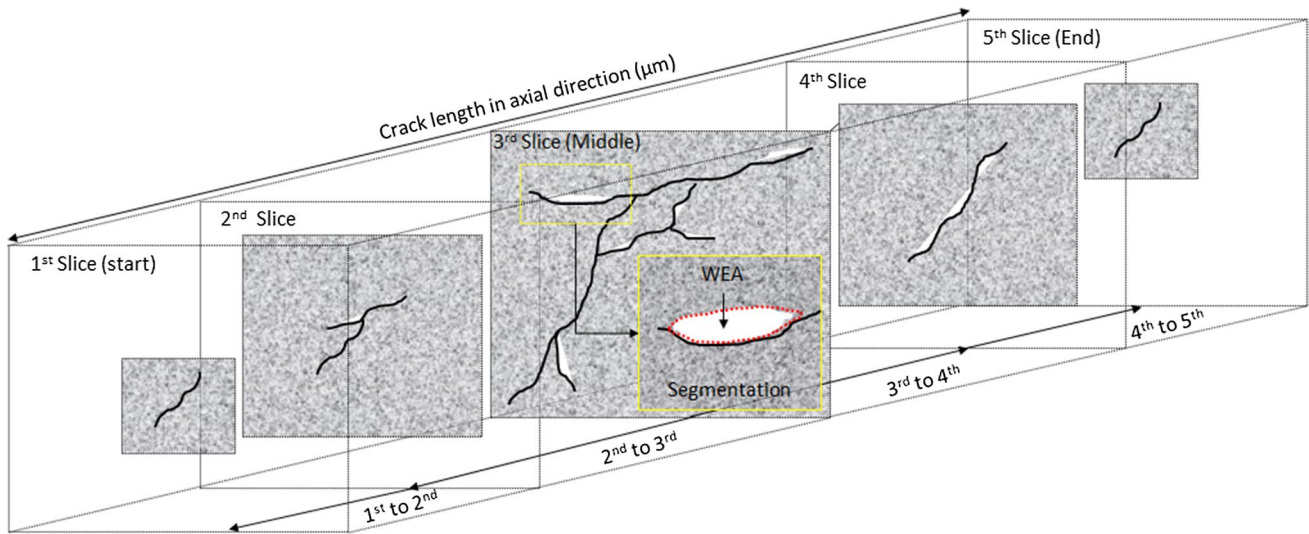
Fig. 3 Schematic illustrating the methodology of WEA volume measurements

(see Fig. 17d) for 5 individual WECs from the 18-h test. For each WEC, one plane from the sectioning analysis has been taken (approximately the middle slice, see Fig. 3). Individual WEAs have then been segmented out in the same way as described above and in Fig. 3. However, in addition the angle of the WEC w.r.t the axis of compression associated with the segmented WEA region is recorded. Cracks are recorded between 0° (a crack that is perpendicular to the compression) and ± 90° (a vertical crack in the same direction as the compression).

Results show the average amount of WEA volume increases with test duration (see Fig. 14a). The total ‘white etching area’ (μm^2) when quantifying the WEA at five individual positions within the WEC (see Fig. 3) shows that the 3rd slice (middle zone) of the WEC network has on average the greatest amount of WEA associated (see Fig. 14a). Total WEA volume versus respective WEC axial length for the WECs analysed shows that for an axial crack length over $500\ \mu\text{m}$ a significant increase in total WEA volume exists (see Fig. 14b). Analysis of 5 individual WECs has shown that a greater amount of WEA is associated with a crack that propagates nearer to 0° (perpendicular w.r.t to the axis of compression). Vertically propagating cracks nearer to 90° (parallel to the axis of compression) showing far less WEA (see Fig. 14c).

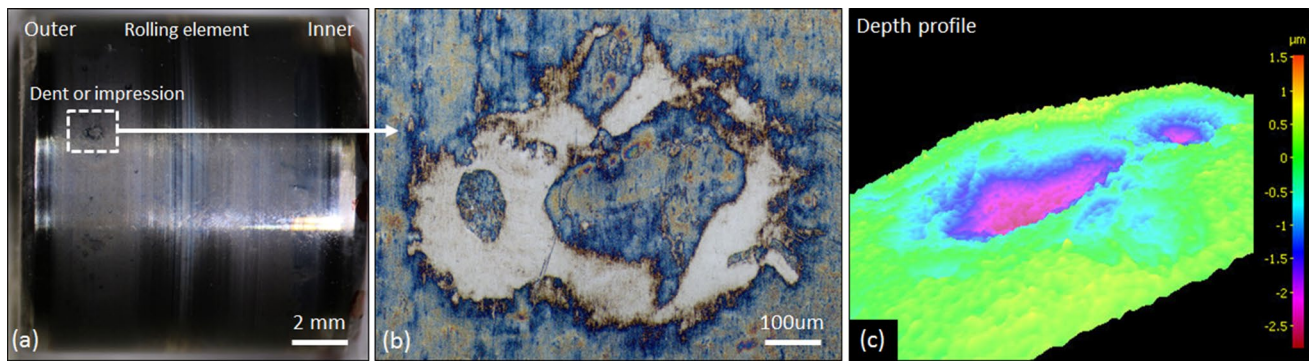
Fig. 4 Surface analysis of a typical indent found on the 18-h rollers. **a** Optical macroimage of roller indicating location of indent on the contact surface. **b** Magnified optical image of the indent. **c** Depth profile analysis of the indent

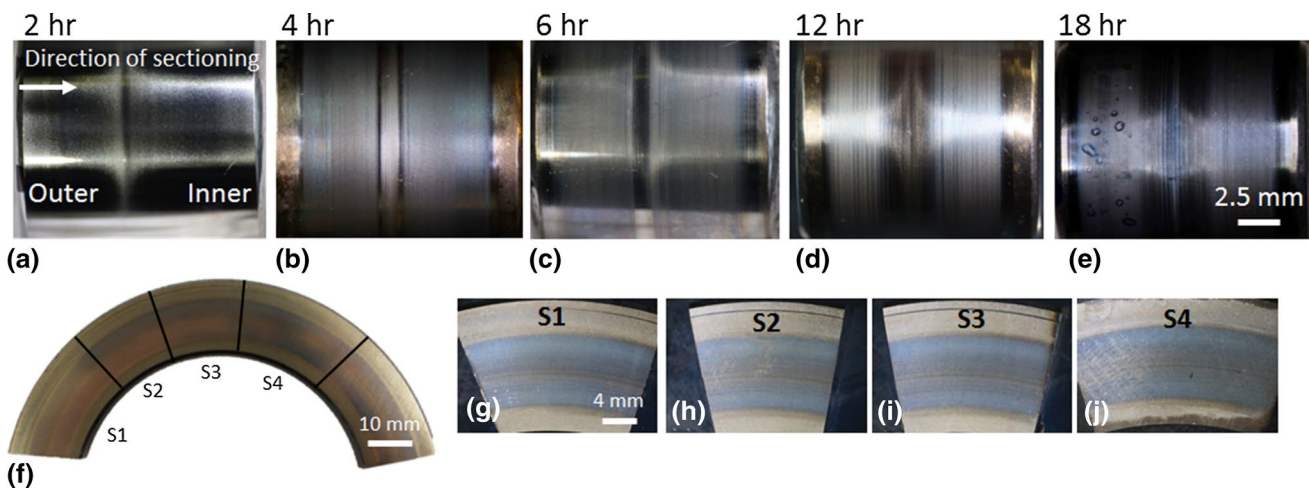
Fig. 5 Optical microscope images of a single roller from each RCF test duration (2–18 h) and 18-h raceway sections chosen for subsequent sectioning. Images **g–j** are optical macroimages of the corresponding sections (S1–S4) shown in **f**. S denotes sample number

around the circumference of the roller. **f** Overview image of raceway sections (S1–S4). Images **g–j** are optical macroimages of the corresponding sections (S1–S4) shown in **f**. S denotes sample number

Wear across the rollers for increasing RCF test durations has been observed on both sides of the central pure rolling region corresponding to the outer and inner zones (see Fig. 5). RCF test durations of 2–12 h showed very little surface damage. The 18-h test showed visible signs of damage on the outer half in the form of dents/impressions, but conversely little surface damage on the inner (see Figs. 4a, 5). Surface analysis of a typical indent using SEM (JEOL JSM-6500F) and optical profilometry (Alicona InfiniteFocusSL) revealed the indent to have a width of $\sim 800 \mu\text{m}$ and maximum depth of $\sim 2 \mu\text{m}$ (see Fig. 4). No signs of spalling were found on the rollers that were subsequently sectioned; however, spalling was observed on other rollers from the same bearing. Figure 5 shows the wear and damage across the 2–18-h rollers. Inspection of the raceway washer sections

at 18 h revealed little surface damage. Again wear zones can be seen on either side of the central pure rolling region, see Fig. 5.

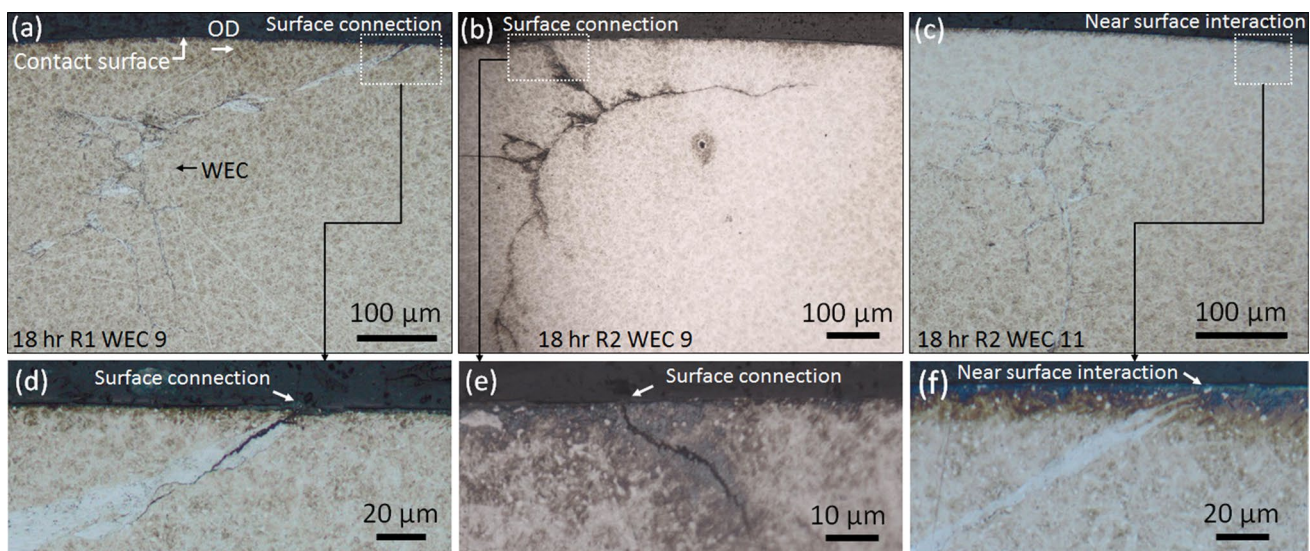
Fig. 6 Optical images of 18-h surface connections and near-surface interactions. **a** WEC-9 R1 surface connection, surface connection length in axial sectioning direction $< 30 \mu\text{m}$. **b** WEC-9 R2 surface connection, surface connection length $\sim 500 \mu\text{m}$. **c** WEC-11 R2 near-

surface interaction. **d–f** $\times 500$ optical images of the surface connections and near-surface interactions shown in (a–c). Over-rolling direction (OD) left to right

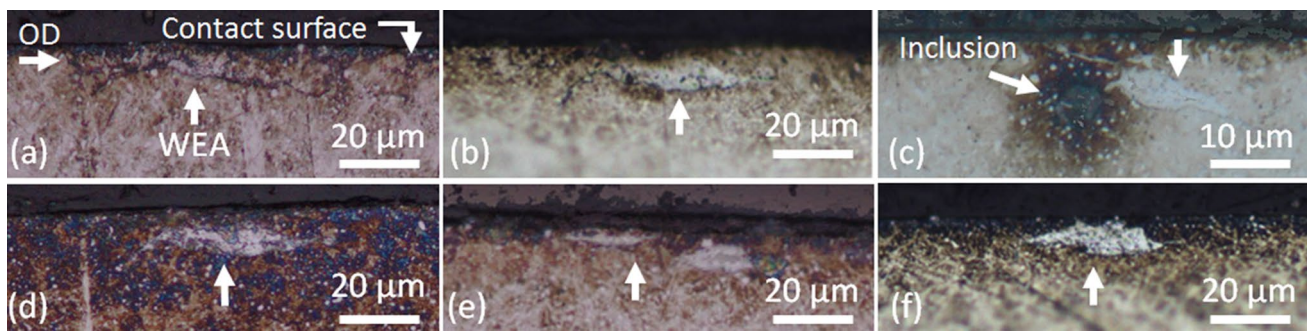
Fig. 7 Optical images of typical 18-h near-surface WEA/WEC features (a–f). Over-rolling direction (OD) left to right

Serial sectioning analysis of 18-h rollers revealed a large number of small near-surface (< 25 μm zone) WEC/WEAs (see Fig. 7). These were rarely seen with connection to the contact surface, limited interaction with inclusions, and it

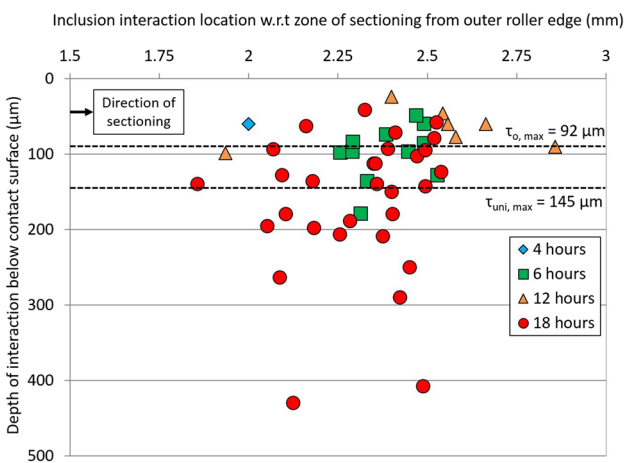
Fig. 10 a Spatial distribution and depth of inclusion–WEC interactions w.r.t the depth of maximum subsurface shear stresses judged to have a high likelihood of crack initiation (rank 1 or 2). See Fig. 8 and ‘Appendix B’ for more information on the inclusion ranking system

oxide inclusions (D). At the early infant stages of WEC formation (4 and 6 h), D_{Dup} and D -type inclusions were found to interact with the WECs, EDX analysis of inclusions at these stages being either Al_2O_3 or MnS surrounding Al_2O_3 . Inclusion types found to interact with the large WEC networks found at the later stages of RCF duration (18 h) are consistent with those found at the early infant stages. This agrees with the findings found from the 18.5-h RCF test in [24] that found 49 NMIs and 41 rank 1 or 2 NMIs in 5 fully mapped WECs, these predominantly being small sized ($\sim 2\text{--}15 \mu\text{m}$) D_{Dup} , $D_{\text{DupTi(C,N)}}$ and D -type inclusions. The oxide encapsulations are responsible for hardness discrepancy with the martensite matrix, induced tensile residual stresses due to differing coefficients of thermal expansion and weak coherence/de-bonding of the oxide and matrix [9, 68, 69]. The majority of the inclusion–WEC interactions were recorded at a depth of $\sim 50\text{--}200 \mu\text{m}$, this being consistent with the depth of high subsurface shear stresses ($\tau_{0, \max} = 92 \mu\text{m}$, $\tau_{\text{uni}, \max} = 145 \mu\text{m}$) (see Fig. 10).

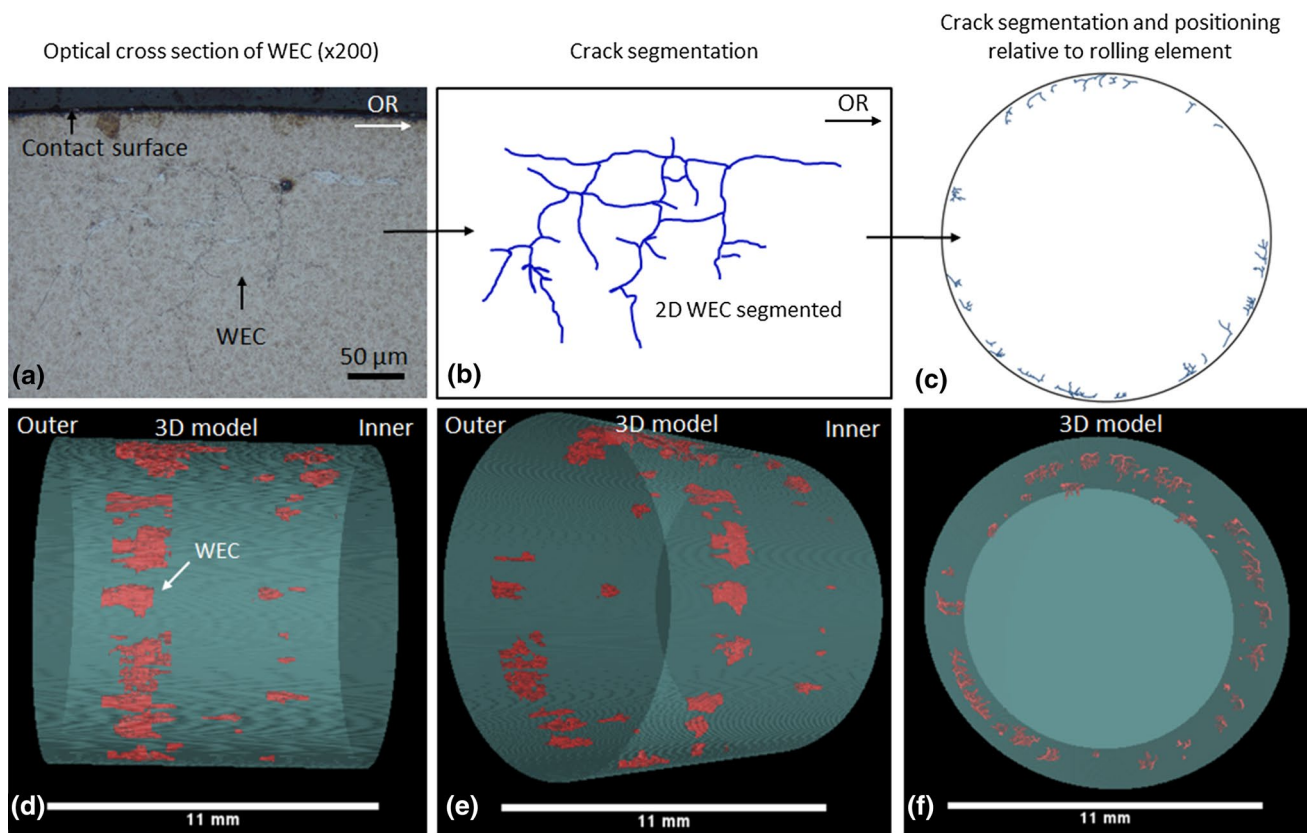
Fig. 11 3D model of total WEC damage recorded across 18-h R1. **a** Optical cross-sectional image of a WEC. **b** 2D segmentation of WEC from optical image in **(a)**. **c** Placement of 2D segmented WEC into its

relative position across the roller. **d–f** 3D model with all WECs highlighted in red across the roller from outer to inner edge. See Video 2

The total WEC damage recorded across roller 1 from the 18-h test has been modelled in 3D. This is to visualise the extent, density and distribution of damage seen typically at the late stages of RCF before failure, see Fig. 11 (see Video 2 for a 2D segmentation, 3D orthoslice sweep through the entire volume of the roller representing each individual WEC recorded across the roller from outer to inner edge). Figure 11a shows an example of an axial slice cross-sectional image of one of the WECs recorded in 18-h R1 that was subsequently segmented in 2D and placed in its relative position in the roller (see Fig. 11b, c). Figure 11d, e, f shows three views of the 3D model.

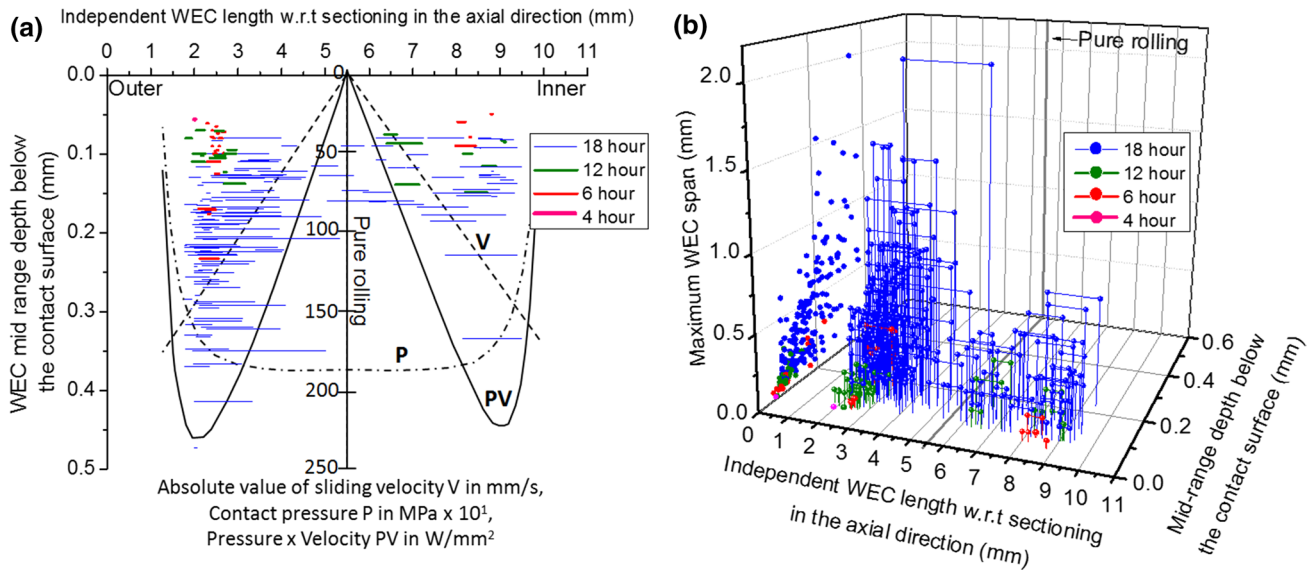
Fig. 12 a Distribution of individual WECs recorded in 4–18-h rollers across the entire axial length (x-axis) of rollers from outer to inner edge and corresponding mid-range depth below the contact surface (0.00 mm) (y-axis). Pressure P, absolute sliding velocity V and slip energy PV are also represented (adapted from [49]). b 3D plot of all independently recorded WECs across 4–18 h. X-axis represents the

entire axial length of the roller from outer to inner edge. Y-axis represents the mid-range depth below the contact surface (0.00 mm). Z-axis represents the maximum span (see ‘Appendix C’ for details). The dots on the YZ-projection represent the position of each independent WEC in the Y-axis and Z-axis. The distances between spheres for each WEC represent the total length in the X-axis

Analysis has shown that the propensity and average size (see Fig. 13) of WECs recorded in the rollers increase with RCF test duration (see Table 3, and Fig. 12, 13) no WECs being found in the raceway. Two factors to explain this could be: (1) steel cleanliness has shown that the raceway is ‘cleaner’ than the roller (see Sect. 2.3.1); (2) a lack of hydrogen being available to accelerate WEC formations [44]; and (3) the raceway is ~ 23% softer (590 HV) than the rollers (765 HV); therefore, the raceway is less prone to cracking due to an

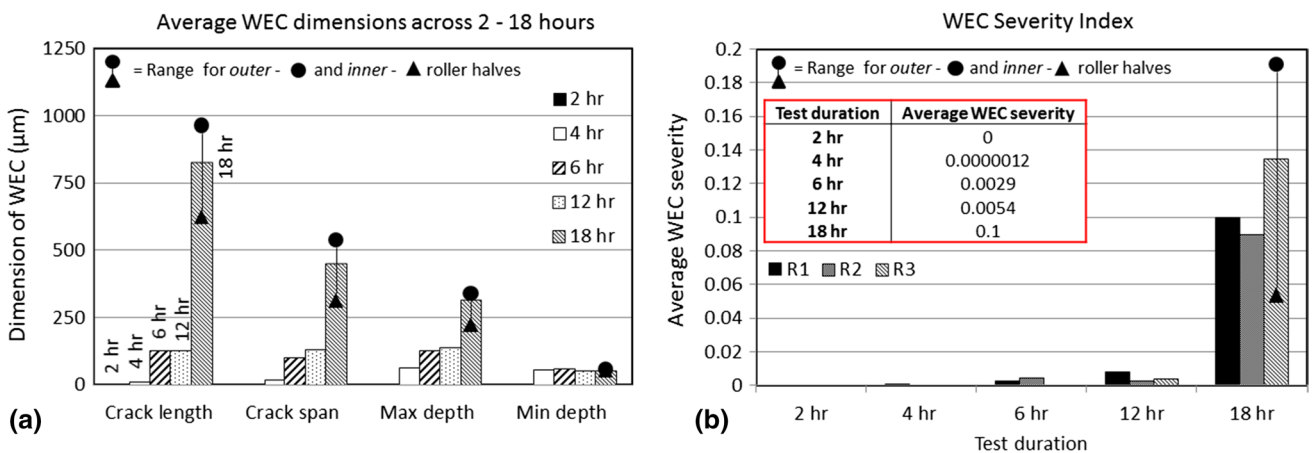
Fig. 13 a Average WEC dimensions in the rollers across 2–18-h tests, see ‘Appendix C’ for details on measurement of relevant crack dimensions. b WEC severity index in the rollers for the 2–18-h tests

A WEC severity index has been calculated based upon the WEC length in the axial sectioning direction, the radial length of the WEC (maximum depth minus minimum depth) and the maximum WEC span, see Fig. 13. The average

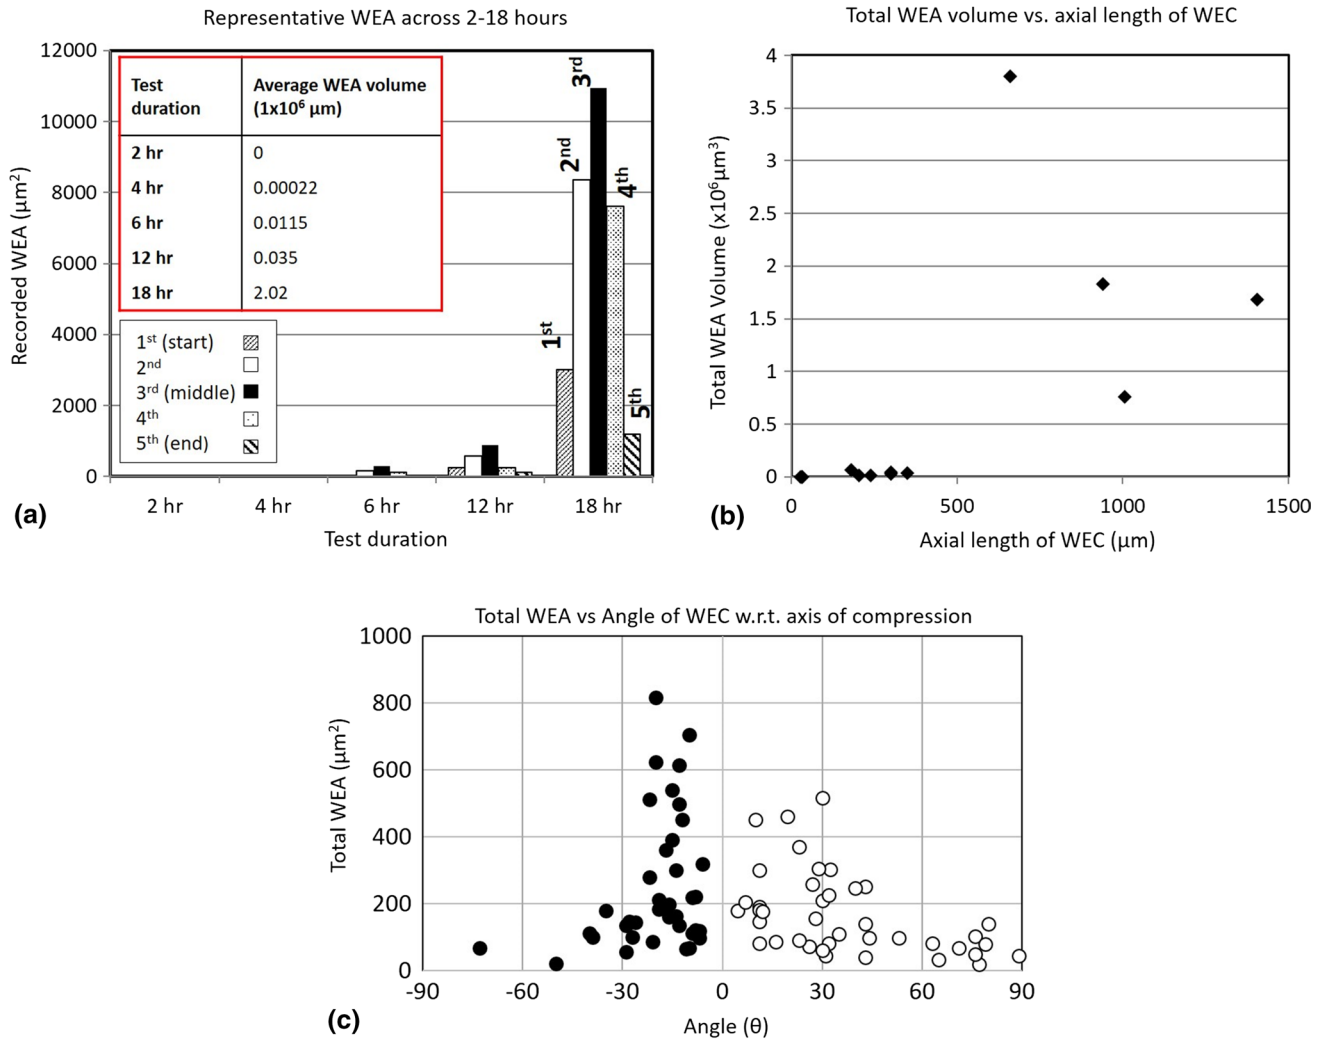
Fig. 14 WEA volume and area analysis. **a** Representative average WEA across 2–18 h. **b** Total WEA volume versus axial length of WEC. **c** Total WEA measured vs the respective angle of the WEC for 5 different randomly chosen WECs at 18 h

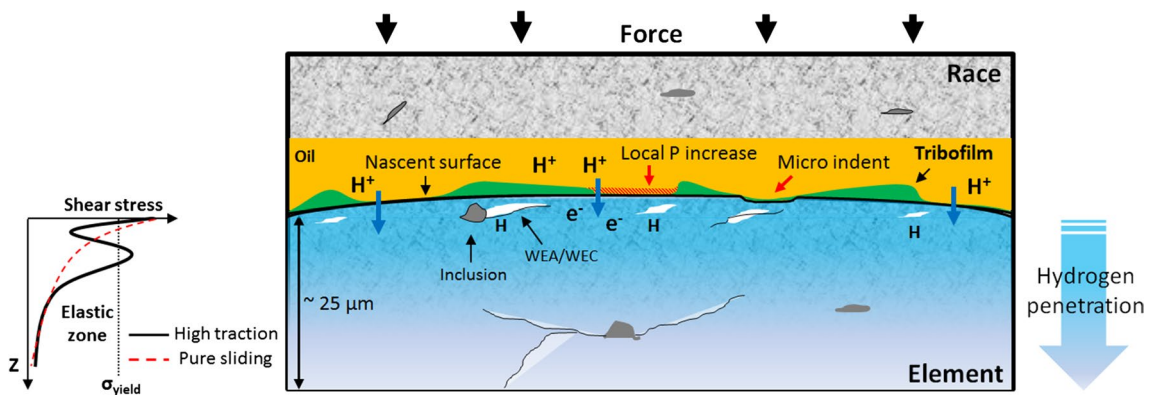
Fig. 15 Hypothesised mechanisms of near-surface ($< 25 \mu\text{m}$) WEA/WECs formation. H^+ denotes molecular hydrogen, H denoting monoatomic hydrogen diffused into the bearing steel. e^- denotes free elec-

trons at the fresh nascent surface. ‘P’ and ‘ σ ’ denote pressure and yield stress, respectively

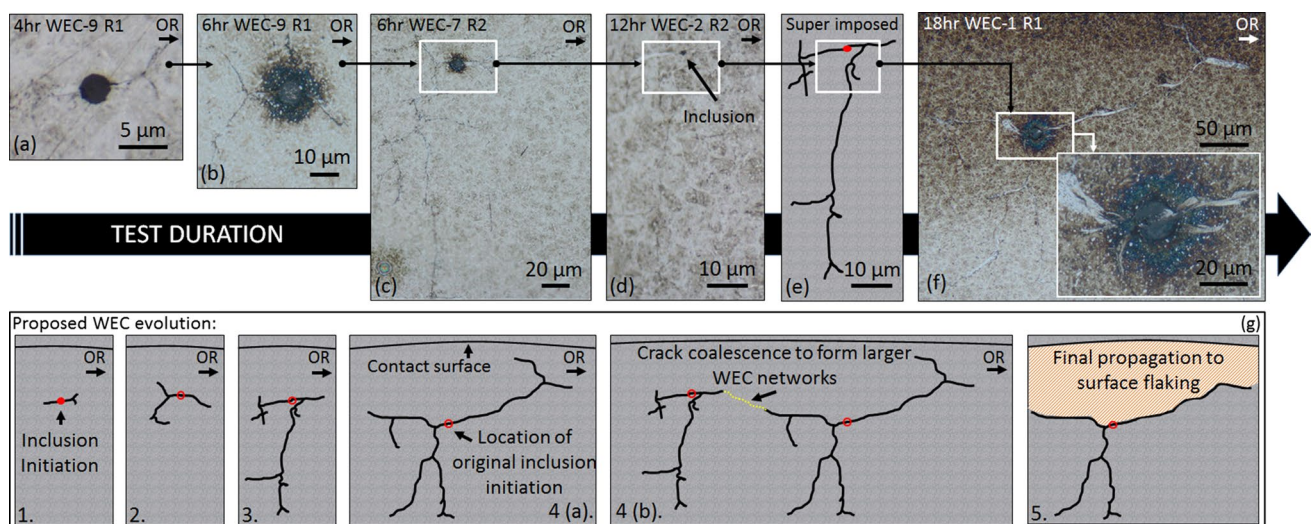
Fig. 16 Optical images of WECs recorded at 4–18 h. **a–f** show examples of typical WECs recorded between 4 and 18 h. **e** Super-imposed image of the 12-h WEC shown in **(d)**, the inclusion highlighted in red. **g** Proposed stages of WEC evolution; (1) initiation via inclusion in the subsurface, (2) propagation into ‘star-like’ WEC (see

b), (3) further propagation in radial and over-rolling direction, (4a) continued propagation, (4b) coalescing of independent WECs to form larger WEC networks and (5) final propagation to the surface resulting in flaking. Over-rolling direction (OR) is from left to right (Color figure online)

found to initially resemble butterfly cracks, which propagate into ‘star-like’ cracks with forking of the butterfly crack tips. This ‘star-like’ crack shape can be seen to fit a number of the WECs found at 12 and 18 h as shown in Fig. 16. It is thus proposed that the WECs recorded at 4 and 6 h are the early initiation stages of WECs that subsequently propagate and evolve into the large WEC networks recorded at 18 h. The proposed evolutionary stages of WEC initiation are shown in Fig. 16g.

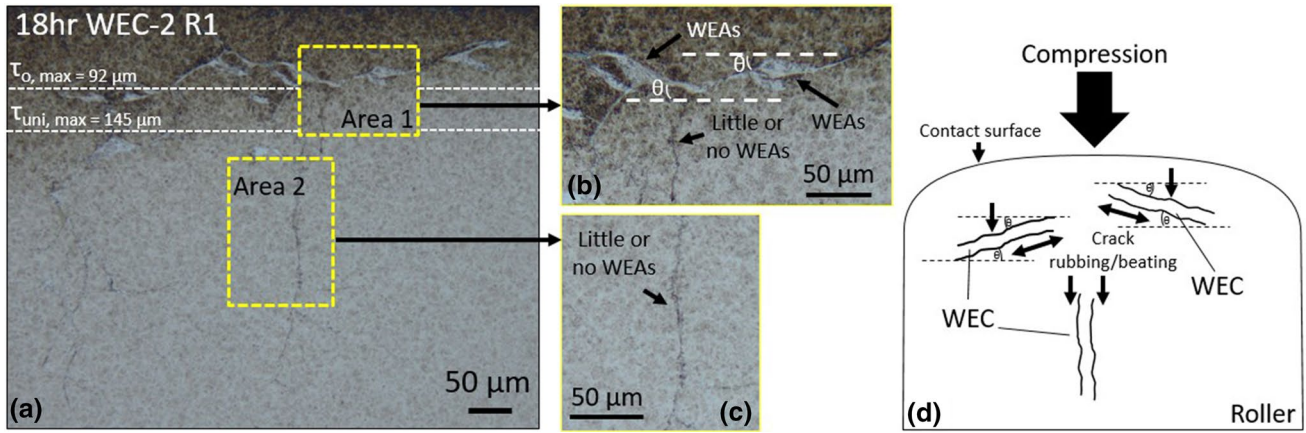
Fig. 17 Optical image of a WEC demonstrating the influence of crack angle w.r.t the axis of compression and depth of maximum subsurface shear stresses ($\tau_{o, \max} = 92 \mu\text{m}$, $\tau_{uni, \max} = 145 \mu\text{m}$) on the formation of WEAs. **a** Areas 1 and 2 show two different orientations of crack propagation, Area 1 shows cracks at an angle θ to the axis of compression along with a vertical crack parallel to the compression axis,

and the zones of maximum subsurface shear stresses are also shown. Area 2 shows a vertical crack parallel to the compression axis. **b**, **c** show magnified $\times 500$ images of the two areas, respectively. **d** is a schematic demonstrating the influence of crack orientation angle w.r.t the direction of compression and the associated action of crack rubbing/beating

Through metallographic analysis, it is indicated that the angle of crack propagation, crack width and zone of maximum subsurface shear stresses can influence the degree of WEA generated. WEA analysis has shown that the amount of WEA associated with a crack increases the nearer to 0° or perpendicular to the axis of compression a crack propagates (see Fig. 14c). A vertical crack $\pm 90^\circ$ parallel to the axis of compression is found to have very little WEA associated (see Fig. 14c). This is also exhibited clearly in the 18-h crack shown in Fig. 17. As suggested by others [36], it is proposed

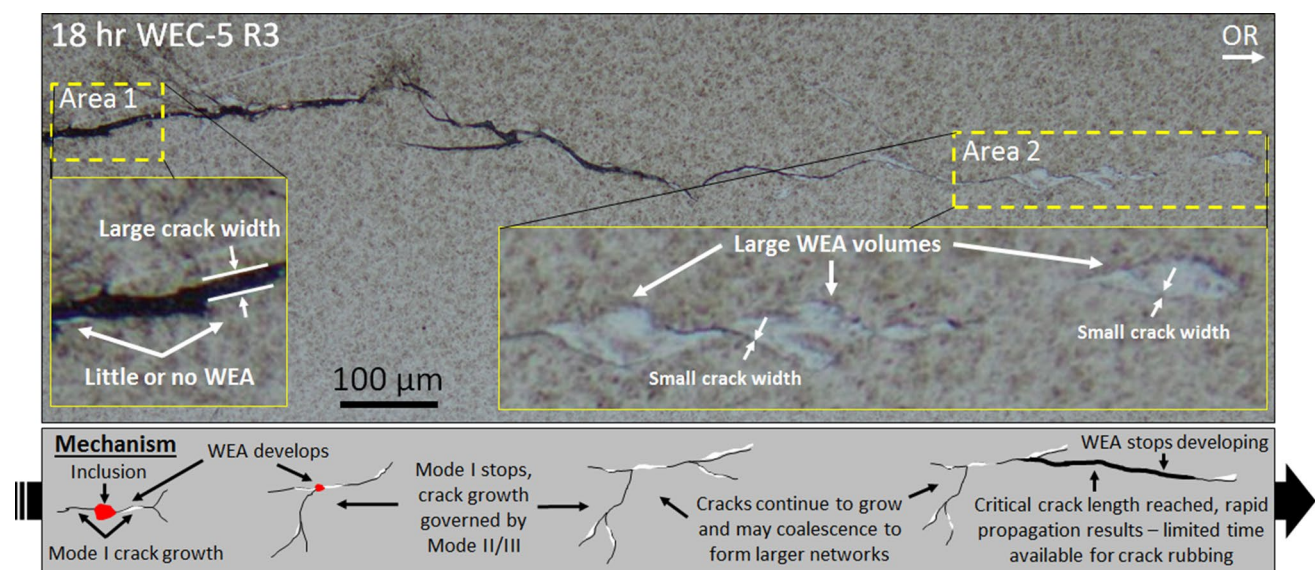
Fig. 18 Optical image of a WEC demonstrating the influence of crack width on the generation of WEAs. Area 1 shows a large crack width, and Area 2 shows a small crack width, with respective magni-

fied optical images. The proposed mechanism for the development of WEA w.r.t crack width is shown. Over-rolling (OR) direction left to right

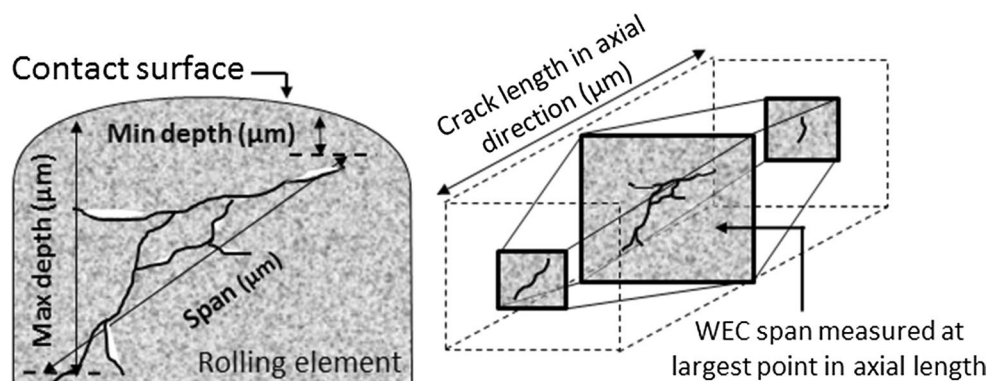
Fig. 19 Schematic illustrating the measurements of WEC dimensions
