# Managing Cold Temperature and Brittle Fracture Hazards in Pressure Vessels

Daniel J. Benac · Nicholas Cherolis · David Wood

**Abstract** Brittle fractures of pressure vessels can be both catastrophic and costly. The intent of this article is to provide guidance in avoiding such failures by identifying some of the causes for cold embrittlement hazards and brittle fracture in pressure vessels. Selected examples will help illustrate the main factors that contribute to brittle fracture, through identifying brittle fracture features, and demonstrating the importance of coordination of materials and potential operating condition. This article also discusses how to assess existing equipment pressure vessels subject to cold conditions and brittle fracture concerns using the guidelines of API 579-1/ASME FFS-1, Part 3.

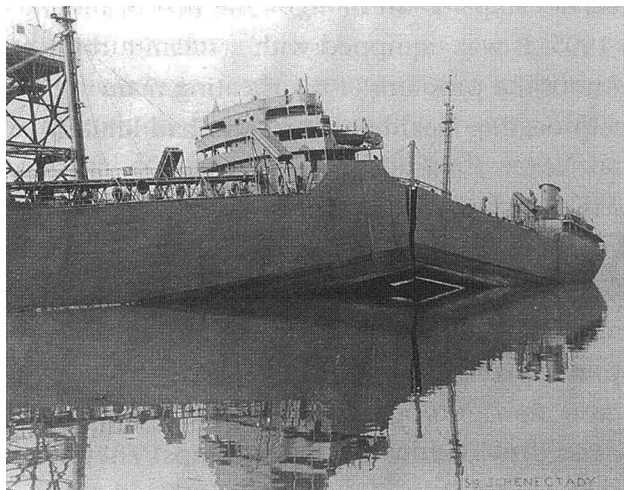
**Fig. 1** Liberty ship Schenectady in the Portland shipyard split in two while still under construction in 1943

Historic brittle fractures include the brittle fracture of 160 World War II liberty ships, which caused them to break in half during the winter months between 1943 and 1944, Fig. 1. Catastrophic failures of molasses storage tanks also occurred on two separate occasions, in 1919 and 1978. In 1919, on a cold day, just 4 years after it was built, a giant storage tank ripped open, releasing a flood of molasses in the city of Boston, Fig. 2. Poor fabrication practices, low material toughness, and design practices contributed to the failures [1, 2].

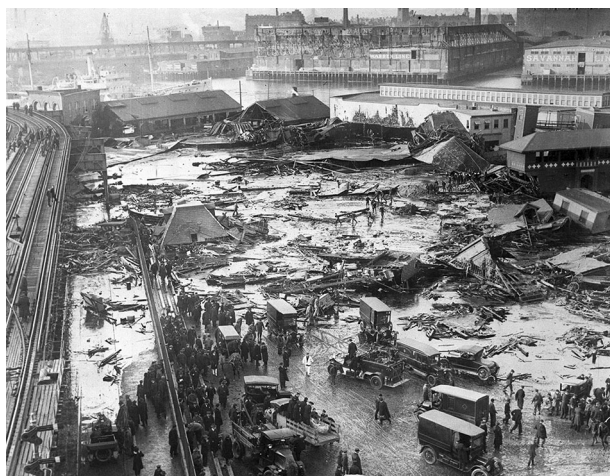
**Fig. 2** Boston Molasses tank failure wrecked an entire neighborhood in January 1919

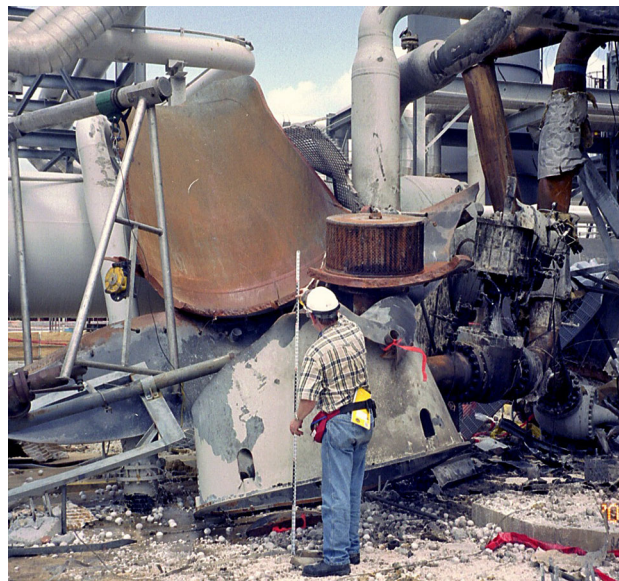
**Fig. 3** Brittle fracture of a pressure vessel is sudden and catastrophic, resulting in loss of containment of product and energetic fragmentation

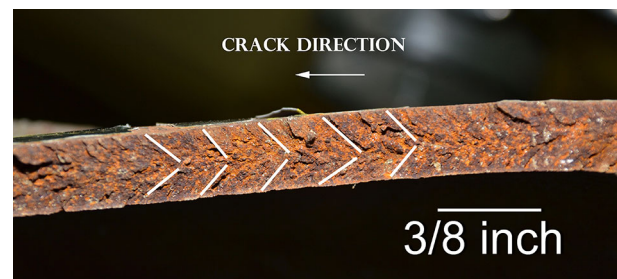
**Fig. 6** V-shaped chevron marks found on a pressure vessel brittle fracture surface indicating the direction of crack propagation

Figure 6 shows the directional V-shaped chevron markings that point back to the origin of the fracture. Also notice the flat fracture and the absence of a shear-lip and no elongation or stretching, indicating a brittle fracture. Often there is a crack-like flaw or defect or feature at the origin of a brittle fracture that would be of little or no consequence,

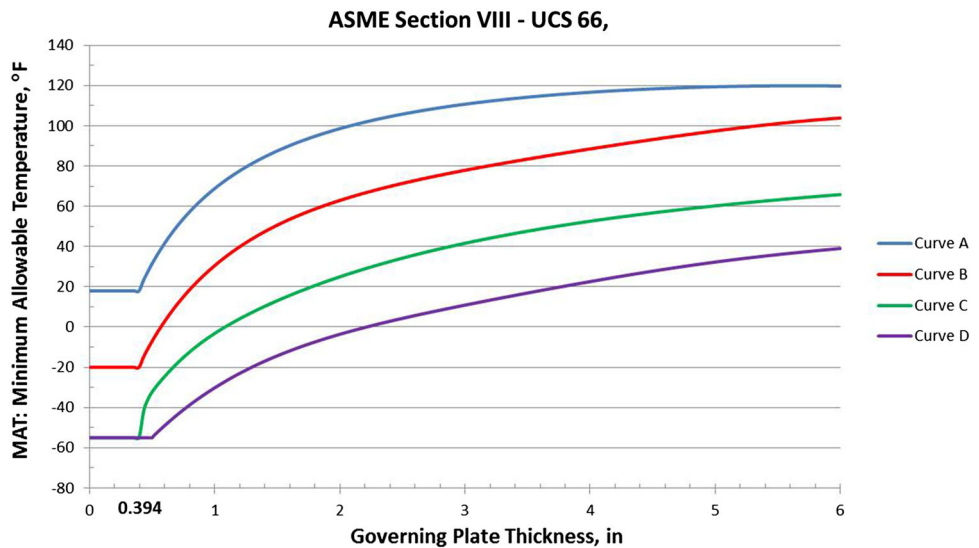
**Fig. 10** Minimal allowable temperature (MAT) based on the material thickness and grade of material [15, 16]

However, as the material thickness of the vessel increases, the allowable temperature to avoid brittle fracture also must increase, as shown in Fig. 10 [13, 14]. Curve A represents a material that has potentially poor toughness properties; while Curve D represents a material that has improved toughness. If the operating temperatures are held below that minimum allowable temperature, then there is a risk of brittle fracture. To avoid this, process controls have to be established in order to regulate the temperature, or a material upgrade may be necessary, or the vessel pressure may have to be reduced to reduce the wall stresses.

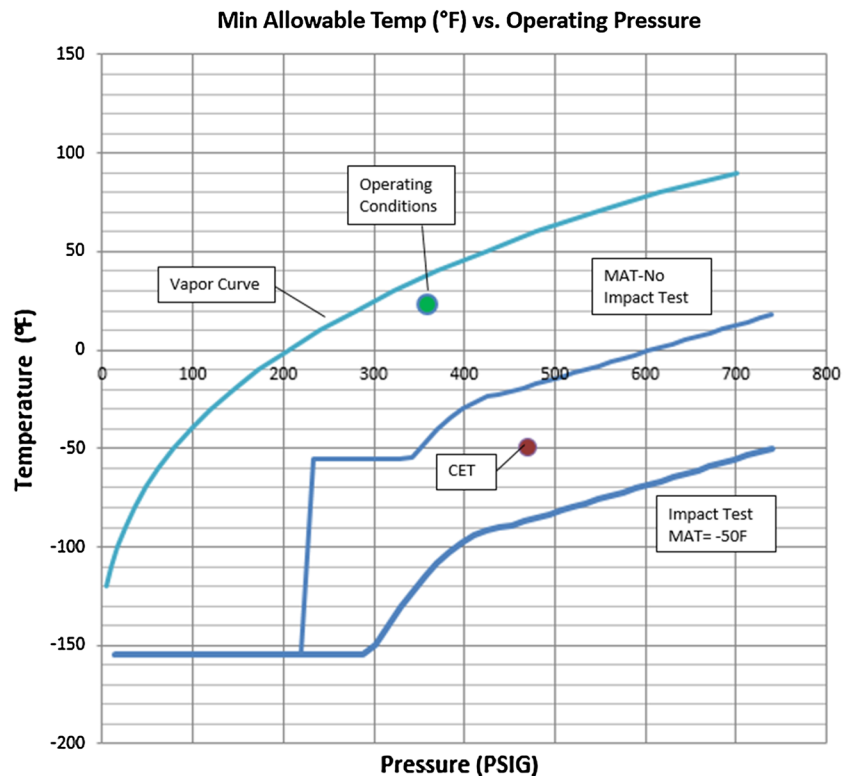
**Fig. 12** BakerRisk Software input screen showing the parameters considered for brittle fracture assessment

**Fig. 13** Plot of the MAT curve as a function of decreasing pressure compared to the CET

A cold temperature brittle fracture engineering assessment as outlined in the API 579-1/ASME FFS-1 Part 3 evaluates the safeguards in place to control pressures and temperatures required in order to avoid low temperature conditions and assess the material behavior of the equipment. Figure 12 shows a spreadsheet of parameters considered in a review.

Figure 13 shows a plot of the equipment minimum allowable temperature (MAT) as a function of pressure and stress. The assessment identifies potential scenarios for low temperature excursions and then reviews the process and equipment condition input from the plant to determine the critical exposure temperature (CET). The CET is the lowest metal temperature that the material is exposed to in the coldest scenario. The CET is derived from either the operating or atmospheric conditions at the maximum assumed combination of pressure and primary supplemental loads. The shell, head, and nozzles are assessed as shown in Fig. 14.

The CET is compared to the equipment MAT. This plot and the determination of the MAT can be generated by using a software package for cold temperature embrittlement reviews based on criteria using API 579—Fitness for Service, Part 3.

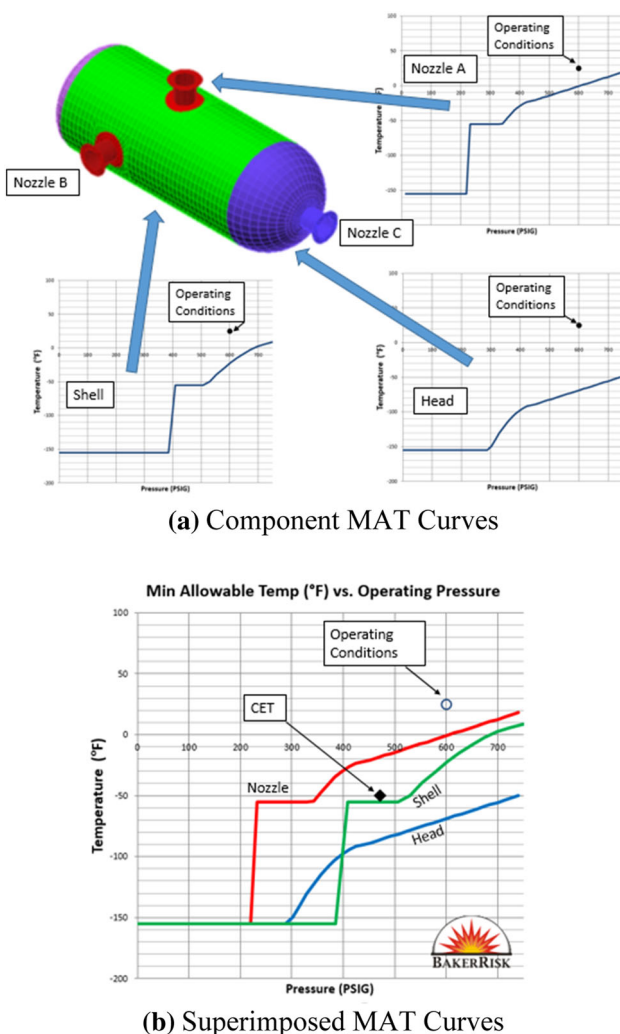
**Fig. 14** Brittle fracture review for a vessel assesses nozzles, shells, and heads made of different materials and different thicknesses. **(a)** Depicts MAT of equipment components in relation to operating conditions and **(b)** illustrates how risk for cold temperature embrittlement may develop if the temperature drops to the CET

only one of the three nozzles, Nozzle A, is represented. In this particular illustration, the shell, head, and nozzle are acceptable at the operating conditions, assuming operating conditions are above the MAT curve.

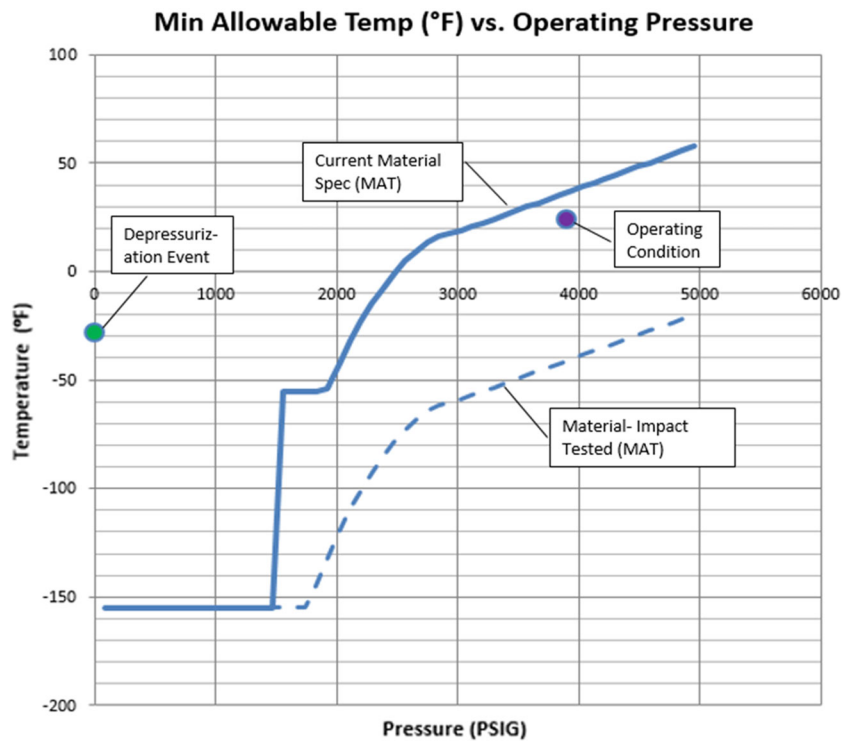
**Fig. 15** Minimum allowable temperature versus operating pressure for gas separator

A high-pressure purge gas separator was assessed for both operating and shutdown conditions. Constructed in early 1960s, the vessel has a 33-mm (1½-inch)-thick shell and heads; A106 and A234, respectively, and is stress relieved.

With design conditions of  $-4\text{ }^{\circ}\text{C}$  ( $25\text{ }^{\circ}\text{F}$ ) and maximum allowable working pressure (MAWP) of  $34\text{ MPa}$  ( $4950\text{ psig}$ ), a MAT curve was developed which identified that there may be a risk of cold temperature brittle failure at operating conditions [ $26\text{ MPa}$  ( $3900\text{ psig}$ ),  $-4\text{ }^{\circ}\text{C}$  ( $25\text{ }^{\circ}\text{F}$ )], see solid line in Fig. 15. Discussion identified that  $-33\text{ }^{\circ}\text{C}$  ( $-28\text{ }^{\circ}\text{F}$ ) was likely the coldest temperature the line would experience during a depressurization event. A review of the available documentation could not verify that Charpy impact testing was performed on the equipment. As the equipment is below the acceptable criteria of the screening Level 2 reviews, a Level 3 detailed fracture mechanics FEA assessment may be prudent. Alternatively, process controls or low temperature alarms can be implemented to stay above the curve, or the decision can be made to replace this relatively small vessel with one that is known

to have appropriate specifications and documentation (dashed line in figure).

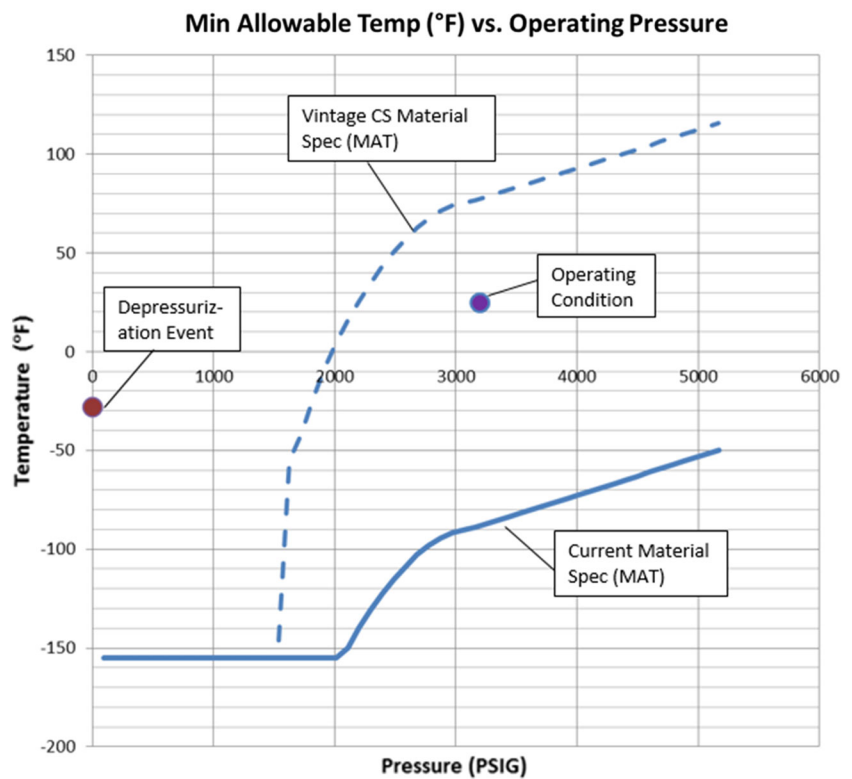
**Fig. 16** Minimum allowable temperature versus operating pressure for process separator vessel

A high-pressure separator was assessed for both operating and shutdown conditions. Constructed in the early 1960s, the vessel has  $95\text{-mm}$  ( $3\text{ }^3\text{/4}\text{-inch}$ )-thick heads with A212 Gr B (Fire Box Quality (FBQ)) per ASTM A300, which required a special treatment of a fine-grained steel with  $-46\text{ }^{\circ}\text{C}$  ( $-50\text{ }^{\circ}\text{F}$ ) guaranteed toughness properties; see solid line in Fig. 16. Standard grade A212 without special heat treatment and low toughness properties is considered to be vintage steel that historically has shown material properties susceptible to brittle failure at cold temperatures, see dashed line in figure. With design conditions of  $-33\text{ }^{\circ}\text{C}$  ( $-28\text{ }^{\circ}\text{F}$ ) and MAWP of  $35.6\text{ MPa}$  ( $5170\text{ psig}$ ), a MAT curve was developed (solid line in figure), which determined the vessel was acceptable at the operating condition and the depressurization event with the fine-grain material. This information was valuable to the facility as it gave them confidence in their vessel, knowing the possibility of the risk associated with the thick vintage steel. In this case, the fact that the material was impact tested provided the surety for low risk of cold temperature brittle fracture. Any subsequent repairs, however, could require re-evaluation.
