Revisiting (Some of) the Lasting Impacts of the Liberty Ships via a Metallurgical Analysis of Rivets from the SS “John W. Brown”

M.D. HARRIS,¹ W.J. GROGG,¹ A. AKOMA,¹ B.J. HAYES,¹
R.F. REIDY,¹ E.F. IMHOFF,² and P.C. COLLINS^{3,4}

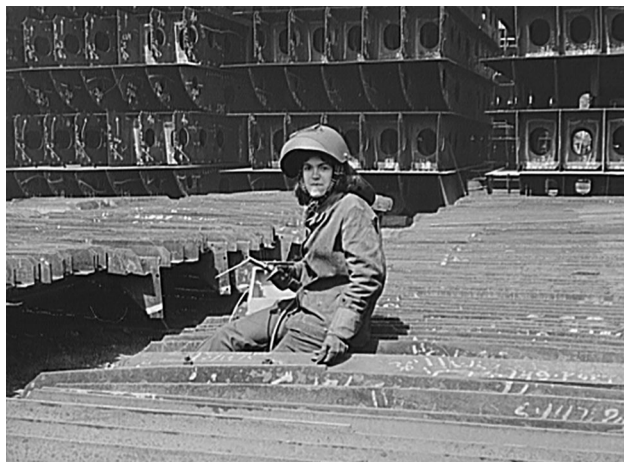
Fig. 2. An unidentified “Wendy the Welder” at the Bethlehem-Fairfield Shipyard, likely butt welding the vertical joints from Ref. 2. Original photo: Library of Congress (Arthur S. Siegel, photographer, U.S. Farm Security Administration).

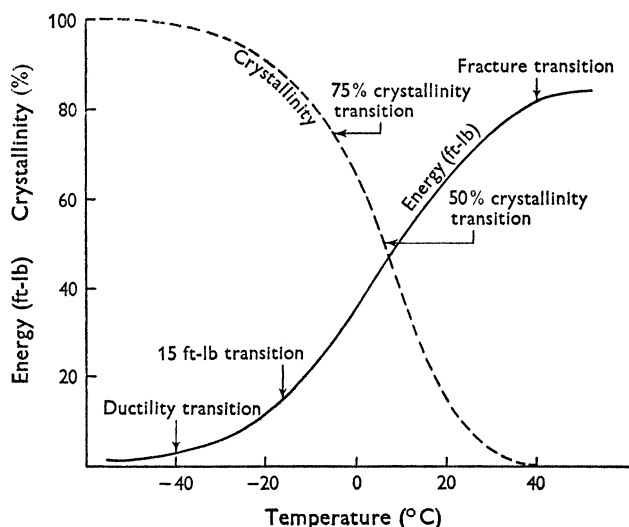
Fig. 4. Strategy proposed by Dr. C. Tipper to first understand mechanisms of the DBTT involving careful measurements of the “% Crystallinity”, which would correlate with brittle cleavage as opposed to ductile fracture.²²

The other notable effort to understand what was occurring in these materials was conducted by the British Admiralty Ship Welding Committee, which engaged Constance Tipper (*see feature article in this issue of JOM*¹⁹) to lead the metallurgical investigation. Tipper was a trail-blazing woman who was the first woman to take the Natural Sciences Tripos, in 1915, at the University of Cambridge. She then launched a distinguished career as a metallurgist and crystallographer, including conducting some of the earliest investigations of fracture surfaces using scanning electron microscopy, and making significant contributions in the area of fracture mechanics.^{20,21} The efforts of the two committees were closely aligned, sharing knowledge freely. Indeed, Tipper worked for periods of time in the Mechanics Division at the Naval Research Laboratory, invited by G.R. Irwin. While the efforts of Williams and Ellinger were seminal and encyclopedic, Tipper was able to fully unravel the story of brittle fracture.²² She developed systematic approaches to dealing with the data, and included careful analysis of both microstructure and composition, pulling together both her own data and the work of others in the field at the time. For example, she was able to show that, as opposed to simply looking at the Mn:C ratio (viewed as important), it was also necessary to consider the microstructure. Considering only composition was insufficient. For example, a poor microstructure (coarse grains, stress concentrators) may overcome the expected benefits of a ‘good’ Mn:C heat, resulting in a plate that exhibits inferior notch sensitivity. In addition, she quantified preferential cleavage planes in the α -ferrite (see Fig. 4), allowing for a simultaneous understanding of the roles of both fracture mechanics and crystal structure on this problem. Without a doubt, the rapid collection of large quantities of information by the U.S. and British governments, and the careful and methodological investigations by many, including Tipper,

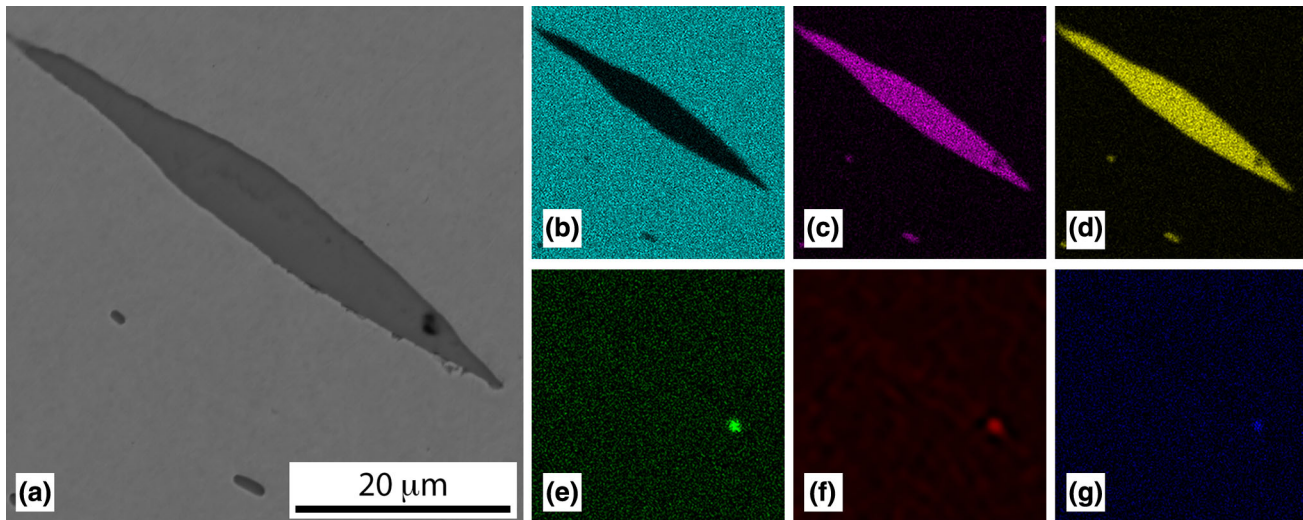
Fig. 5. Manganese sulfide inclusion with a nucleation site. (a) Back-scattered electron, (b) Fe, (c) Mn, (d) S, (e) Al, (f) O, (g) Si.

inclusions appear as faceted octahedral precipitates and are found in steels with an excess amount of aluminum.³² The MnS inclusions in both rivets are predominately type I, which begin as equiaxed structures and become elongated due to forming operations. These MnS inclusions are soft and deformable at low temperatures.³³ The backscattered scanning electron micrograph presented in Fig. 5a and the corresponding EDS maps shown in Fig. 5b–g show one of the type I MnS precipitates in the original rivet. The inclusion appears to have nucleated from a smaller oxide inclusion containing aluminum, silicon, manganese, and oxygen according to EDS mapping (see Fig. 5e–g).

Specifically, the aluminum oxide inclusions are readily observed in the original rivet (see Figs. 5 and 7). Most of the oxides in the original material

were spherical/equiaxed aluminum oxides observed to be in intimate contact with the MnS particles, most likely having served as initiation sites. The Al_2O_3 particles in the original material are fairly coarse ($\sim 5 \mu\text{m}$), and coarser than the silicides and $\text{SiO}_2\text{-MnO}$ particles that are observed in the modern rivet ($\sim 1\text{-}2 \mu\text{m}$; see Fig. 6). All oxides observed in the modern rivet contained some level of silicon. Further, no oxide was associated with the MnS particles in the modern rivets. The $\text{SiO}_2\text{-MnO}$ particles were more elongated and aligned to the rolling direction.

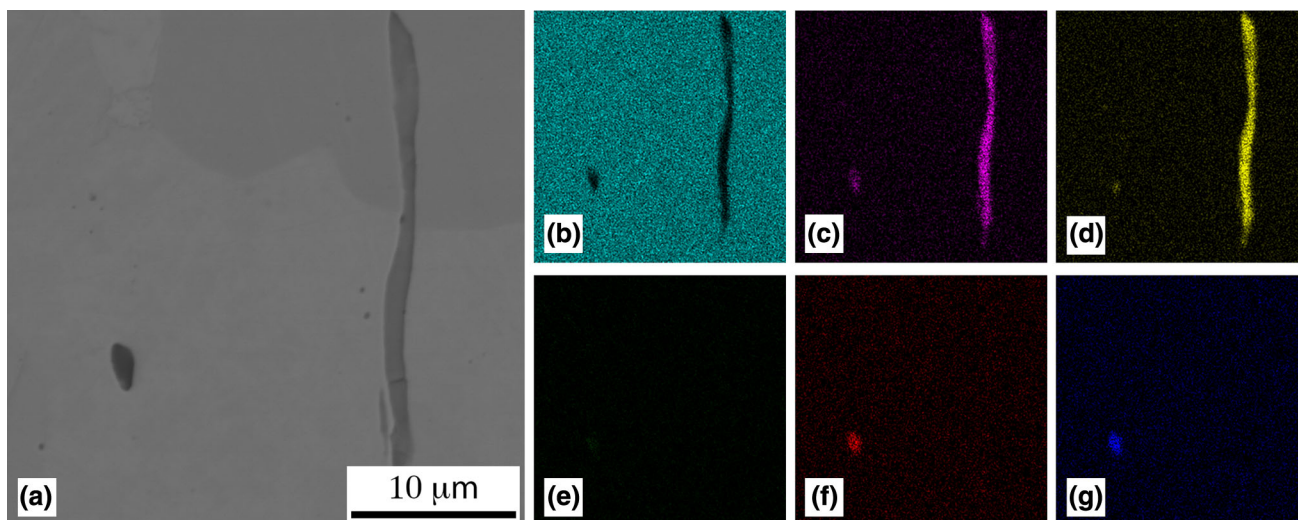
Fig. 6. Silicate and sulfide inclusion in the new rivet. (a) Back-scattered electron, (b) Fe, (c) Mn, (d) S, (e) Al, (f) O, (g) Si.

As noted above, silicon can act as a deoxidizer, and can react not only with oxygen but also with other deoxidizing elements (including Mn) to form more complex silicate inclusions. The presence of these inclusions makes the material easier to cast, although they may also coarsen the grains. As noted previously, the grain size of both steels are approximately equivalent. Specific processing conditions have reportedly led to manganese oxides reducing silicon, forming manganese silicates,³² as appears to be the case in Fig. 6.

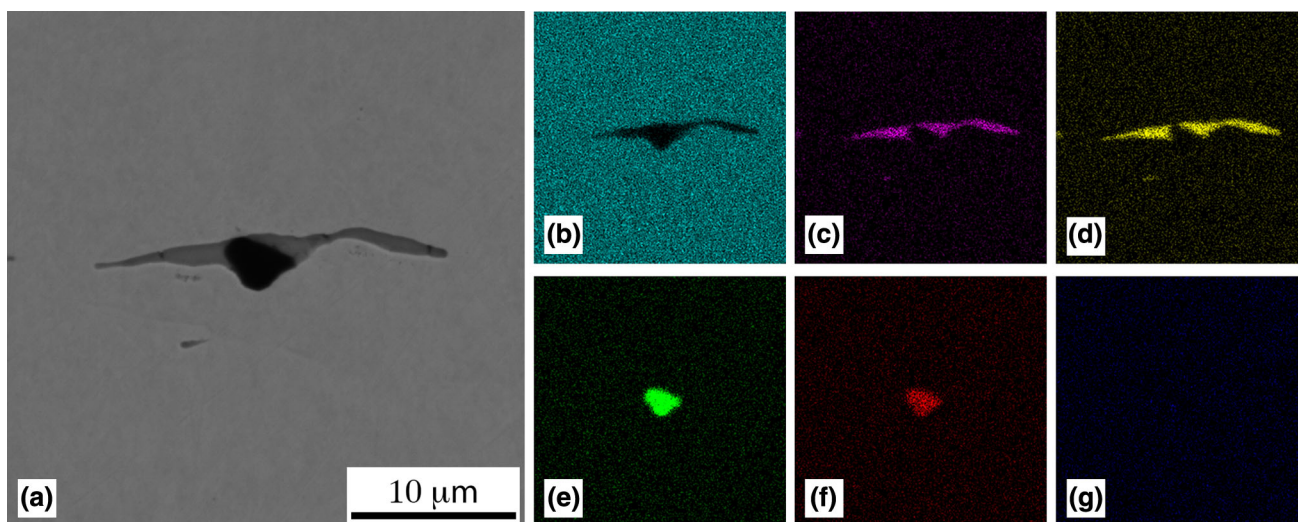
Fig. 7. Aluminum oxide inclusion acting as a nucleation site for MnS in the old rivet. (a) Back-scattered electron, (b) Fe, (c) Mn, (d) S, (e) Al, (f) O, (g) Si.
