Assessing the impact of hurricane Fiona on the coast of PEI National Park and implications for the effectiveness of beach-dune management policies

Abstract

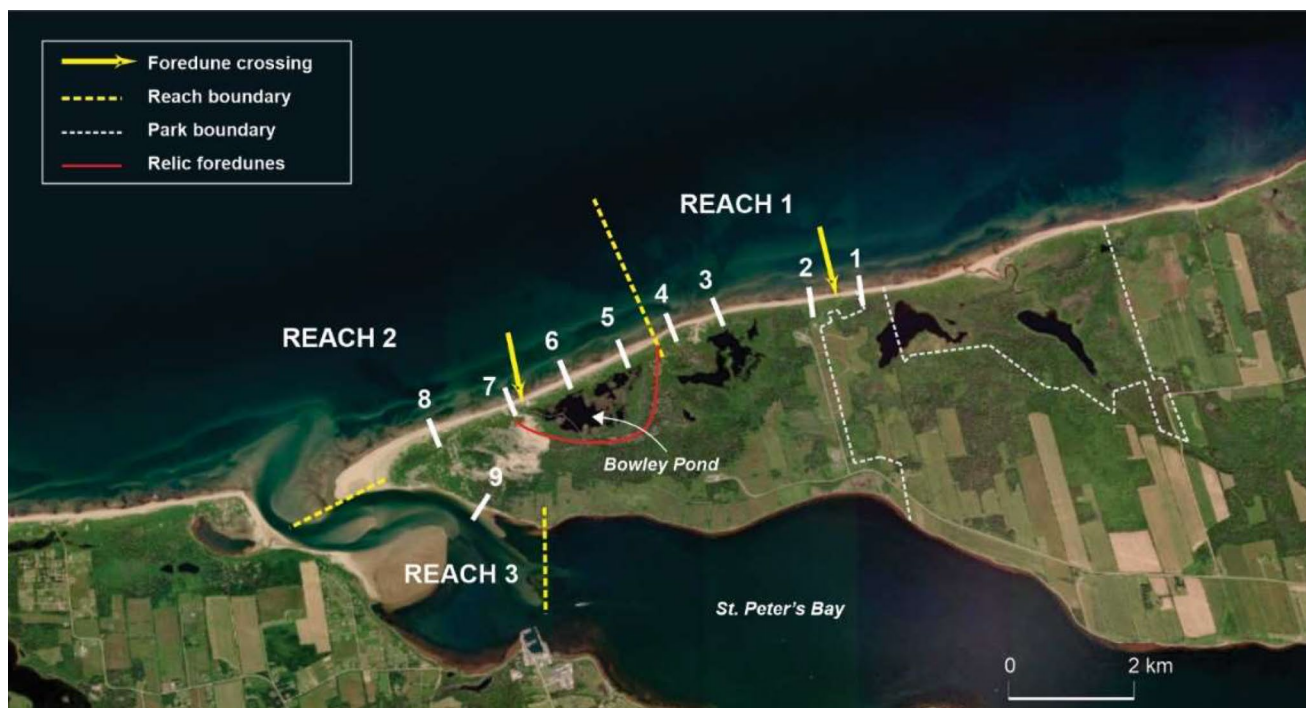
Fig. 2 Satellite image showing the shoreline at Greenwich. The locations of the 9 Lines across the beach and foredune which were monitored from 2002–2023 are shown together with the three reach boundaries and the location of the two dune crossings on the exposed beach

at Lines 1 through 9 (Ollerhead et al. 2013; Walker et al. 2017 – see Fig. 2) show a negative littoral sediment budget in the eastern Reach 1 (Lines 1–4) giving rise to shoreline retreat on the order of 10–20 m over the past 20 years. In the western Reach 2, the littoral sediment budget at Line 5 still shows a small deficit, but this decreases westward, and the littoral budget at Lines 7 and 8 appears to be neutral or slightly positive. The net foredune sediment budgets in Reach 2 are all positive. Along Reach 3 in St. Peters Bay (Line 9) there is a small positive littoral sediment budget with sand being brought into the Bay around the distal end of the Greenwich Peninsula. The beach in Reach 3 is narrow and the dynamics here reflect changes in the location of the tidal channels within the Bay as well as aeolian sediment transport from the tip of the spit. These alongshore differences in littoral and foredune sediment budgets are hypothesized to influence the response of the beach and dune system to major events such as Fiona.

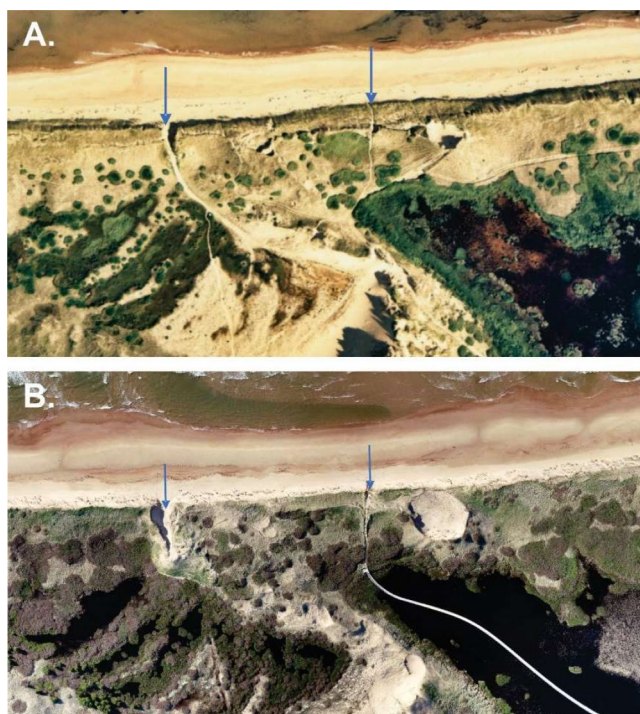
Fig. 3 Vertical aerial photographs of a section of the beach and foredune at Greenwich Dunes around the boardwalk across Bowley Pond and the beach access (marked by arrows). **A**) photograph taken in 1997 for Parks Canada showing the presence of ATV trails and pedestrian access across the foredune in several places; **B**) section cropped from an orthorectified mosaic constructed from a UAV flight on June 2, 2022. Note the increase in vegetation cover following establishment of the park and healing of access routes. The bowl blowout to the east (right) of the boardwalk access (white line across pond) has been allowed to evolve naturally (Hesp and Walker 2012)

Prior to creation of the **Greenwich Dunes** section of PEINP in 1998, uncontrolled pedestrian access to the beaches and use of ATVs and other recreational vehicles had created a series of trails and roads on the lee slopes of the foredunes and the interior dunes (Fig. 3A). The management focus for this area since incorporation into the National Park is on preservation of the natural and cultural features of the region and, while there is an extensive trail and boardwalk system, including the iconic floating boardwalk across Bowley Pond (Figs. 2 and 3B), there is no overnight camping and there are only two access points to the beach. The eastern access is along 300 m of boardwalk, and it does have limited facilities in the summer. The western access point requires a 2 km hike and has no facilities. As a result, there is little human pressure on the foredune system, and management consists only of signage that encourages the use of the trails and boardwalks. The reduction in human pressure has led to increased vegetation cover on the foredune, and to the spread of shrubs such as bayberry on the lee side of the foredune (Fig. 3B).

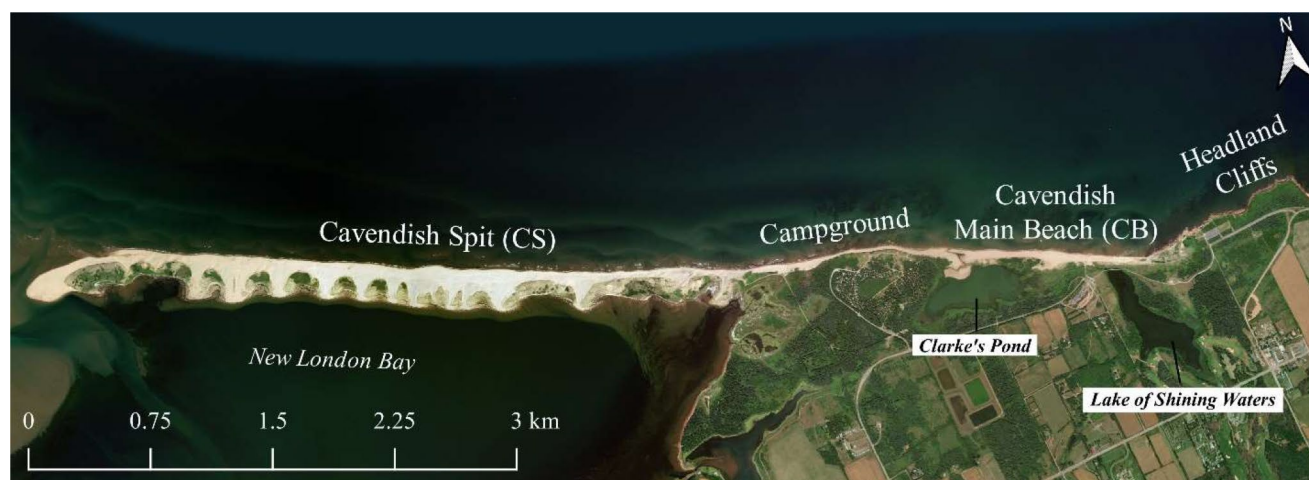
Fig. 4 Satellite image of Cavendish Beach. The eastern section is bounded by sandstone cliffs to the east and a sandstone outcrop at the beach by the main campground. A continuous foredune lies between the eastern headland to just west of the main boardwalk, followed

by low, overwashed dunes in front of Clarke’s Pond. Cavendish Spit extends westward from the campground outcrop with dunes between the washover channels decreasing in height towards the tip

The 4.4 km long Cavendish Spit extends west of the campground headland across New London Bay (Fig. 4). Cavendish Spit is characterized by large discontinuous dunes separated by washover channels that are occupied by runoff and overwash during storm events (Lunardi et al. 2023). Prominent washover fans can be observed in recent and historical imagery extending into New London Bay and are likely reflective of slow transgression due to RSLR and erosion of the headland, to which the proximal end of the spit is attached. Due to the distance of the spit from main access points such as the campground and main entrance, the distal end is less frequented by visitors. During peak summer visitation, Cavendish Spit is closed to pedestrian traffic to limit disturbance of Piping Plover nesting sites. As a result, the spit is evolving naturally without the need for active management interventions.

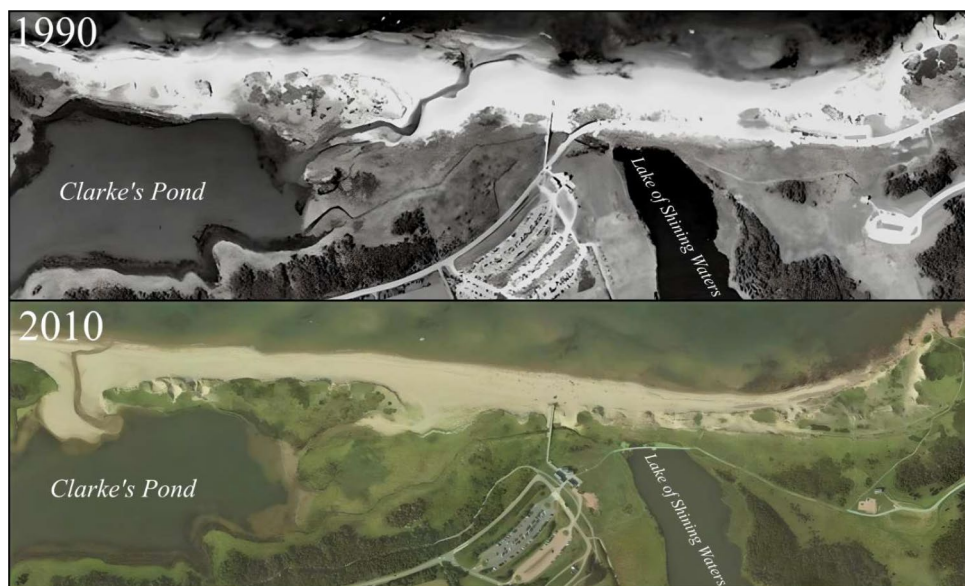
Fig. 5 Cavendish Main Beach historical imagery, east of the spit and campground. By 1990, removal of a parking lot east of the boardwalk allowed vegetation to re-establish in this area and along the main foredune. By 2010 pressure on the foredune was reduced by removing the roadway across the lee of the foredune slope and replacing it with a trail and boardwalk across the Lake of Shining Waters

In contrast, high visitor traffic at Cavendish Beach and limited restrictions in the past resulted in anthropogenic fragmentation of the vegetated foredune complex (Fig. 5). In 1990, multiple paths existed through the foredunes and, due to frequent disturbance, the foredunes both east (towards the headland) and west (towards the campground) were sparsely covered in vegetation. By 2010, as part of ongoing relocation of vehicle access and parking, the road along the lee slope of the foredune in front of Lake of Shining Waters was closed and replaced with a walkway and pedestrian bridge (Fig. 5). However, a lapse in visitor control on the beach resulted in a complete breach to the east of the primary access point in 2014 (Davidson-Arnott 2014), requiring substantial intervention to repair it. Analysis of

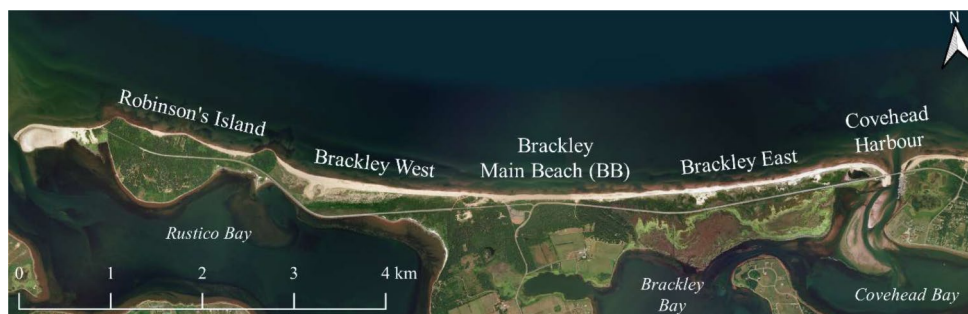
Fig. 6 Satellite image of Brackley Beach from Robinson's Island in the west to Covehead Harbour at the eastern end. The section of foredunes west of Brackley Main Beach (BB) are characterized by a large washover channel and prograding dunes of low crest elevation. BB contains a continuous foredune system ~ 4 m in height, and has the

occurs (Fig. 6). At the primary and secondary access points, management has involved moving all parking to the landward side of the highway and restricting access to the backshore and dune through the creation of boardwalks. Similar to Cavendish Beach, dune integrity has increased notably since 1990 accompanied by a reduction in blowouts resulting from human activity. Virtual fencing at the base of the dune ramp has been utilized to prevent trampling of vegetation, and fencing deployed along the road landward of the foredune promotes visitor use of the boardwalk access.

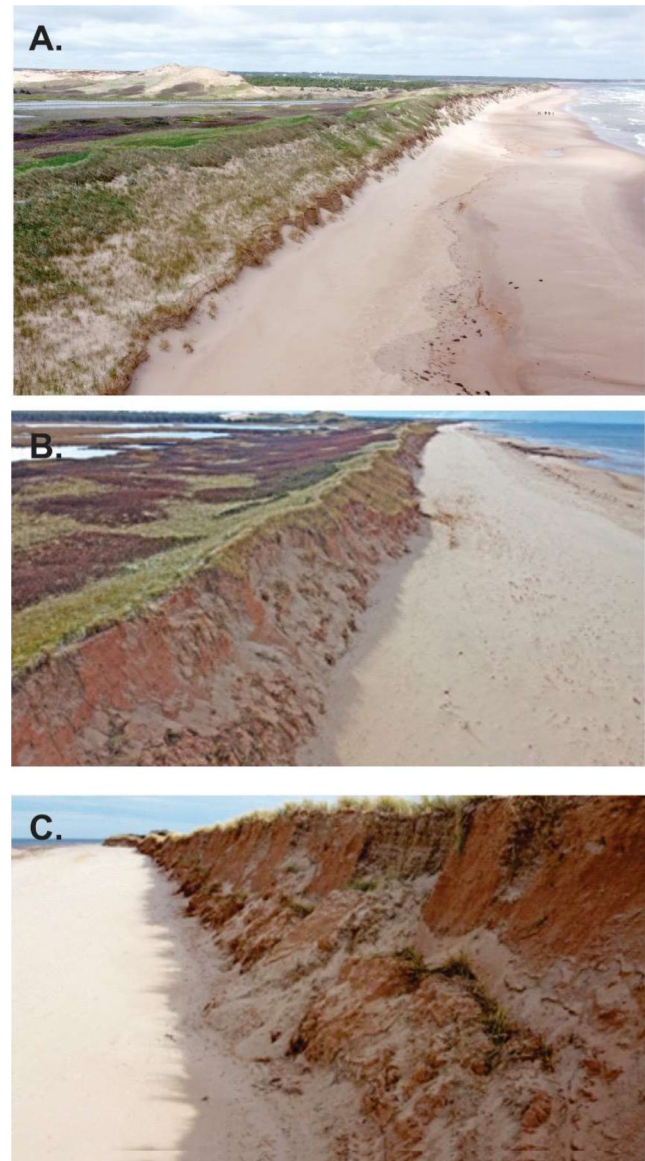
Fig. 10 Oblique UAV photos of the beach and foredune in Reach 2, Greenwich Dunes: A) view west from near Line 6 taken May 31, 2022 (i.e., before Fiona but after the January 2022 storms). Bowley Pond can be seen toward the top of the photo. Note the vegetated slump material and the developing sand ramps; view west (B) and east (C) from near Line 5 taken on October 22, 2022 (after Fiona), showing the near vertical foredune cliff and absence of dune ramps. The bright red colour is a surface coating of fine silt and clay deposited by wind-blown spray from surf bores during the storm event

The stoss slope of the foredune in Reach 2, which includes Lines 5–8 (Fig. 2), was eroded to the dune crest in most areas during Fiona, leaving a cliffed profile (Figs. 10B and C and 11). The exception was a short section around Line 6, where some of the upper stoss slope present before the event was preserved (Fig. 11B). The pre-Fiona beach profiles show the presence of a small berm near the low tide level; the post-storm beach profiles are smooth and relatively steep (Fig. 11). The dune toe elevation was higher after the storm than before due to landward migration of the toe region by erosion of the stoss slope (Conlin et al. 2023). Subsequent redevelopment of a dune ramp may lead to seaward migration of the dune toe and some decrease in elevation. Change in elevation resulting from erosion during Fiona is shown for Line 8 (Fig. 11D). Dune erosion was concentrated on the stoss slope, with the crest remaining intact and little to no deposition recorded on the lee slope. A similar pattern was recorded for the other three lines in Reach 2, except that the crest on Line 7 was eroded slightly (Fig. 11). Three different measures of horizontal retreat of the foredune due to the event, changes in the position of the crest, toe and mid-stoss, are shown in Fig. 12. In Reach 2, for all four Lines (5–8), the crest position changed < 0.5 m and so the lee slope was not affected. Horizontal recession of the mid-stoss and toe were similar, and ranged from 4 to 6 m. There was no overwash or breaching of the foredune along this section of the coast.

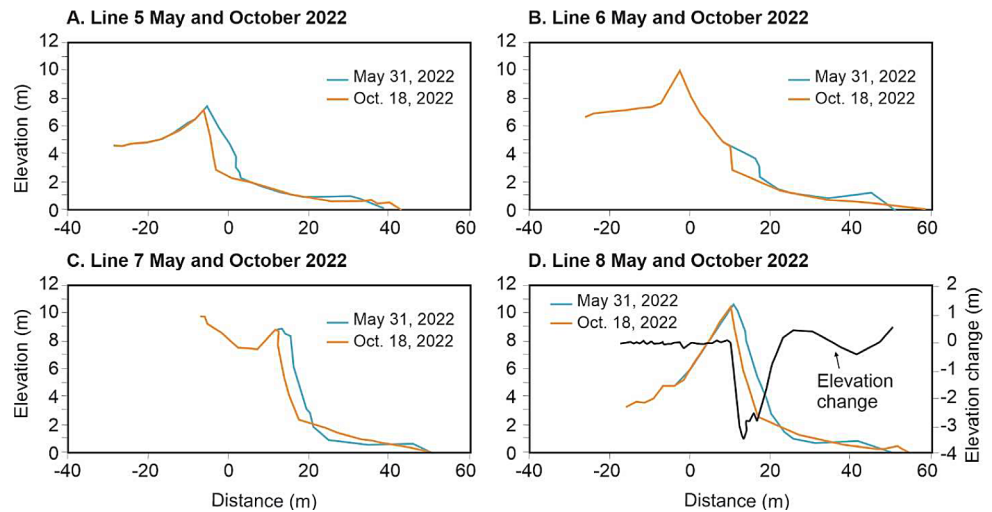
Fig. 11 Profiles of Lines 5–8 in Reach 2 surveyed on May 31 (before) and October 18, 2022 (after) Fiona. Elevation datum is CGVD2013. See Fig. 2 for locations of the lines. The elevation change along the profile is shown only for Line 8 (Panel D)

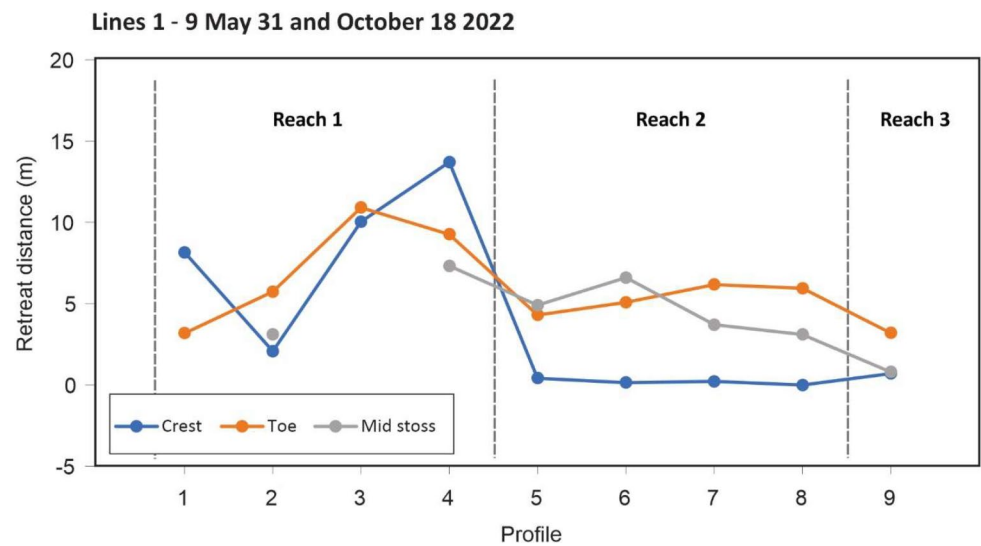
Fig. 12 Horizontal recession of the crest, toe and mid-stoss slope of the foredune at each line. There are no data for the mid-stoss for Lines 1 and 3 because the dune was eroded to bedrock and the toe values reflect the junction of the bedrock scarp with the beach. The large retreat for the crest of Line 4 reflects complete removal of the foredune and retreat to the relic dune

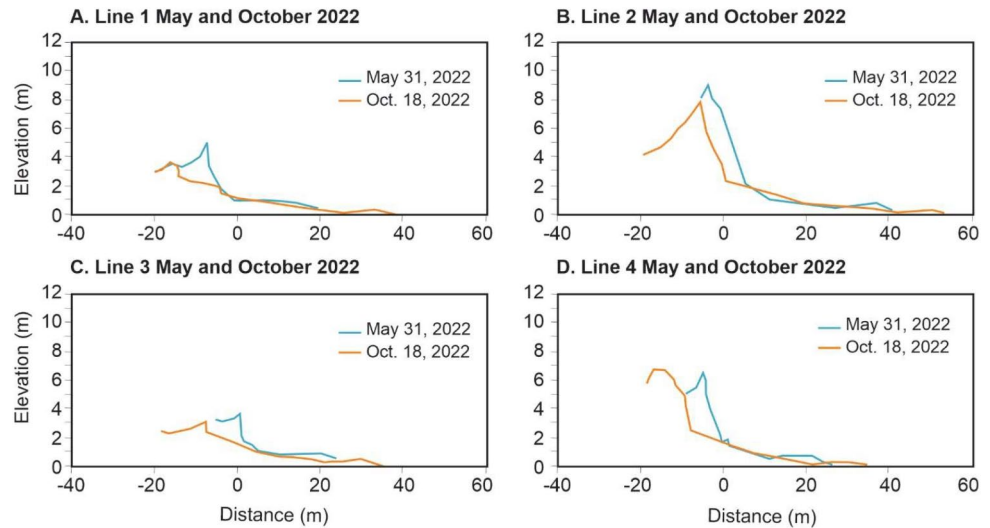
Fig. 13 Profiles of Lines 1–4 in Reach 1 surveyed on May 31 (before) and October 18, 2022 (after) Fiona. See Fig. 2 for locations of the lines

with portions of the bedrock exposed on several occasions after major winter storms. After Fiona the aeolian cover was almost completely removed (Figs. 13A and C and 14A). The position of the crest retreated about 8–10 m and at Line 3 there was a small overwash channel and fan reaching into the low area landward. At Line 2 the large foredune that developed on an older relic dune retreated about 15 m over the past 20 years and decreased in height. A reduction in height of about 1 m occurred because of Fiona along with retreat of the crest and mid-stoss of 2.5–3 m (Fig. 13B). At Line 4 the small foredune retreated about 30 m over the past 20 years. Fiona removed the existing foredune, exposing the next inland relic dune ridge (Fig. 13D) and leaving the new dune crest located nearly 15 m inland from its position in May 2022.

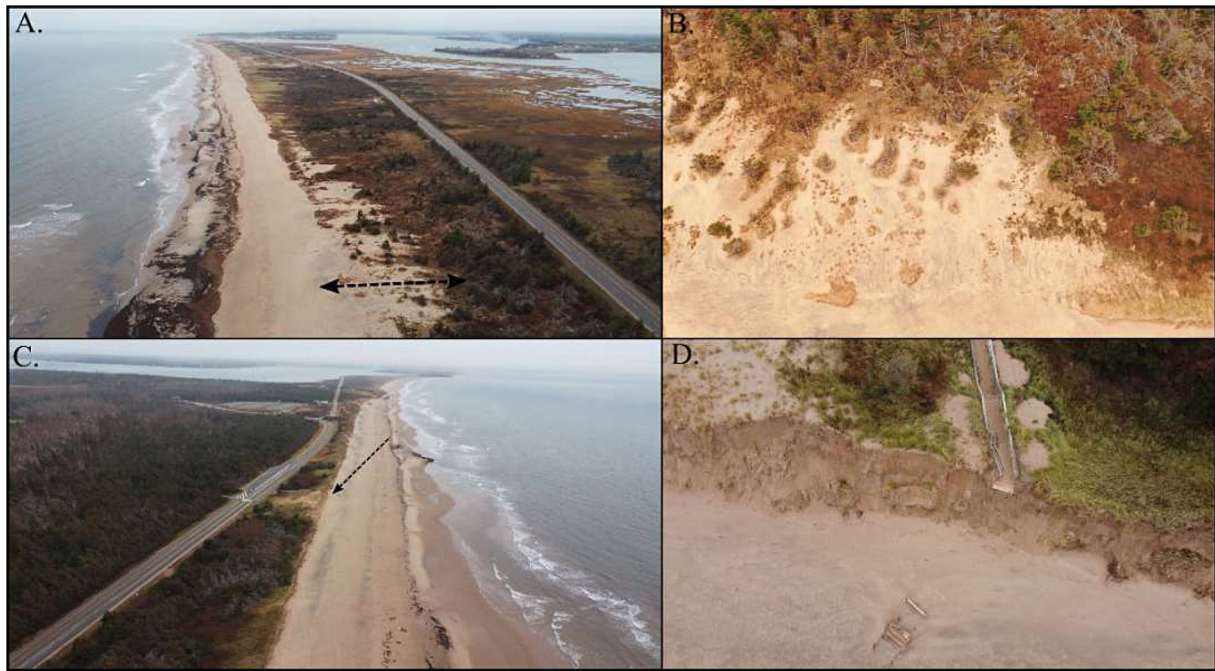
Fig. 15 Overwash penetration and crest retreat at Brackley Beach following the impacts of Fiona. Photograph A was taken above Brackley Main Beach, the arrow delineates approximately 30–40 m of overwash deposition, further depicted in image B. Image C was taken above Shaw’s Beach to the east of Brackley Main, facing west towards

the secondary and main access boardwalks. The secondary access is denoted with an arrow in image C. Above the secondary access, image D highlights damage to the boardwalk during the storm, where the entire stoss slope of the foredune and entrance stairway was removed

Following the impacts of Fiona, foredunes at Brackley averaged 5 m of crest retreat, with localized maxima of 10 m. Overwash occurred in some areas with a low pre-storm crest elevation outside of the immediate study area. These include an area east of the secondary access point (Figure 15A, B) at Brackley Main Beach (Figure 6) and at the far west end near Robinson's Island where there are prograding dunes separated by a pre-existing overwash channel. Wave action and storm surge near Robinson's Island resulted in damage to the road behind the foredunes, and restriction of vehicular access to this end of Brackley well into 2023. The high-water wrack line within isolated overwash sections was found up to 70 m inland of the foredune ridge (Figure 15). At Brackley, localized maxima of crest retreat occurred adjacent to ridge areas, such as those beside a series of blow-outs on Brackley Beach that were nearly penetrated during Fiona. In the future transgression of the foredunes will need to be monitored as they begin to encroach into limited space between the road and foredune.

The impacts of crest retreat were further reflected in damage to boardwalk infrastructure such as complete removal of the seaward staircase within the secondary access point (Fig. 15D). Prior to the onset of Fiona, lower sections of the main entrance boardwalk were removed to mitigate potential impact. Although the main entrance boardwalk structure remained intact, there was some damage to the western staircase, as shown by the almost complete removal of this piece of the boardwalk in the post-storm Coastie photographs (See Fig. 16 for location; Figs. 17-4b).

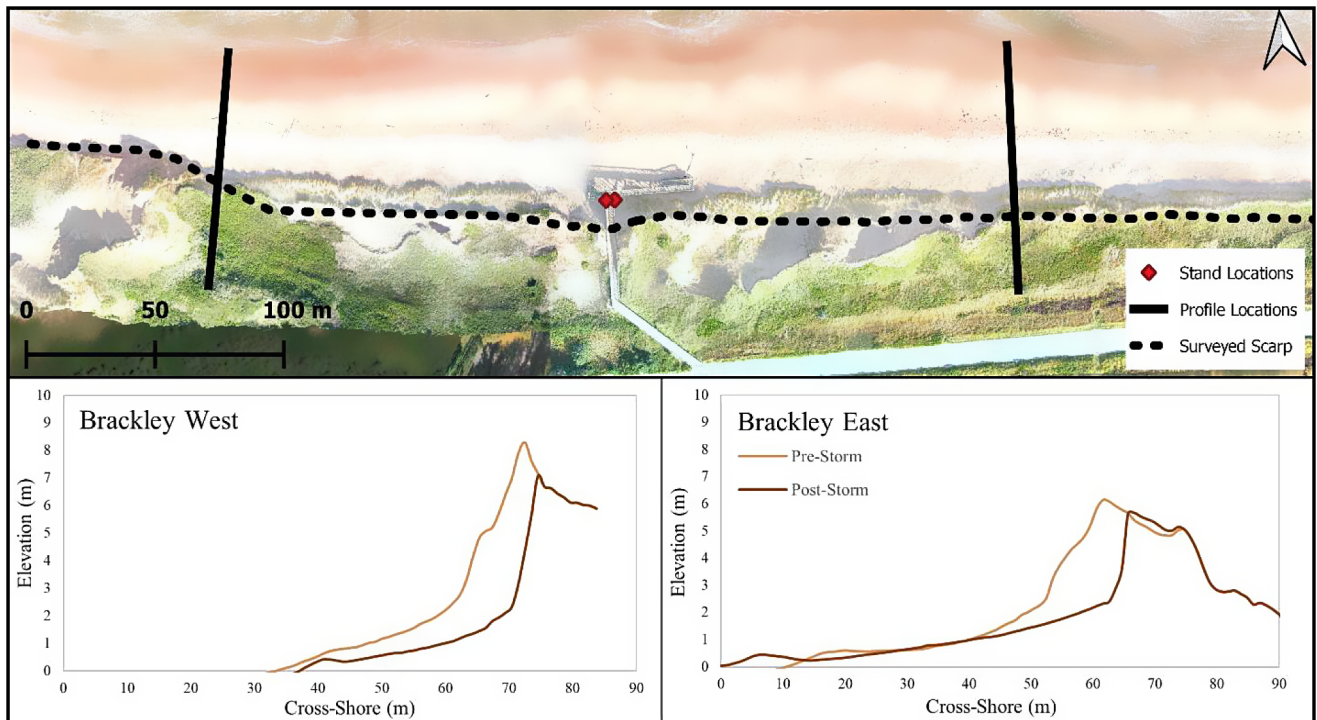
Fig. 16 Brackley West and East profile locations, in relation to the entrance boardwalk at Brackley Main Beach. The basemap consists of UAV survey imagery collected in October 2021. Note the differences in beach width and dune height between these profiles

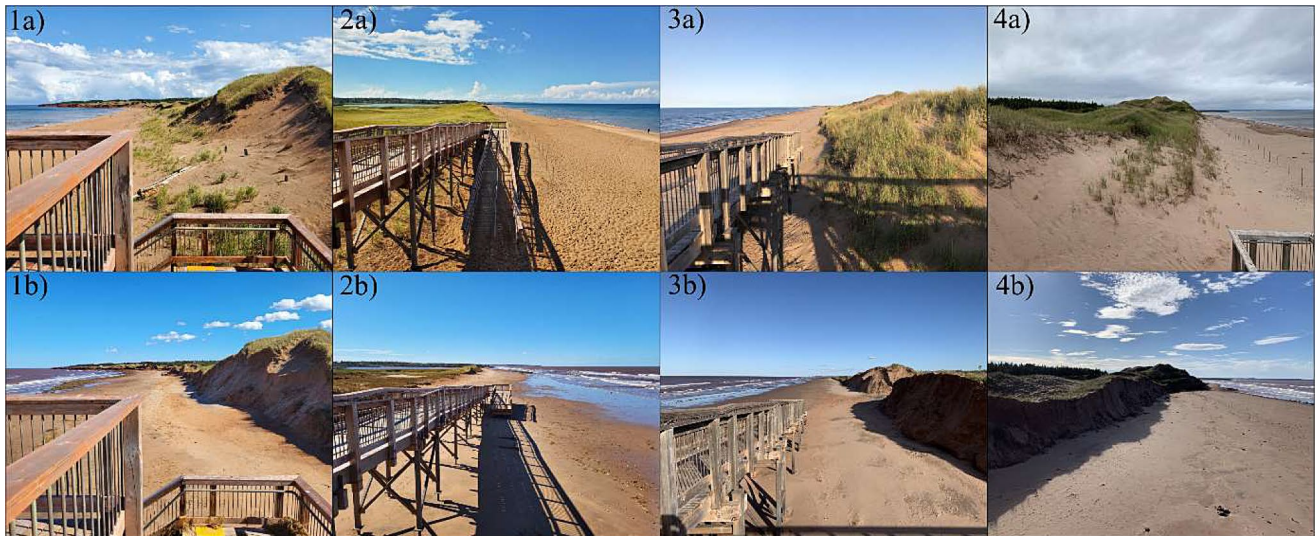
Fig. 17 Pre-Fiona (upper panels) and post-Fiona (lower panels) Coastal images at Cavendish (1) facing east from the main entrance boardwalk towards the continuous foredune section and cliffs and (2) facing

west of the main entrance boardwalk towards the lower lying dunes that were subject to overwash, (3) facing east of the Brackley boardwalk, and 4) facing west of the Brackley main entrance

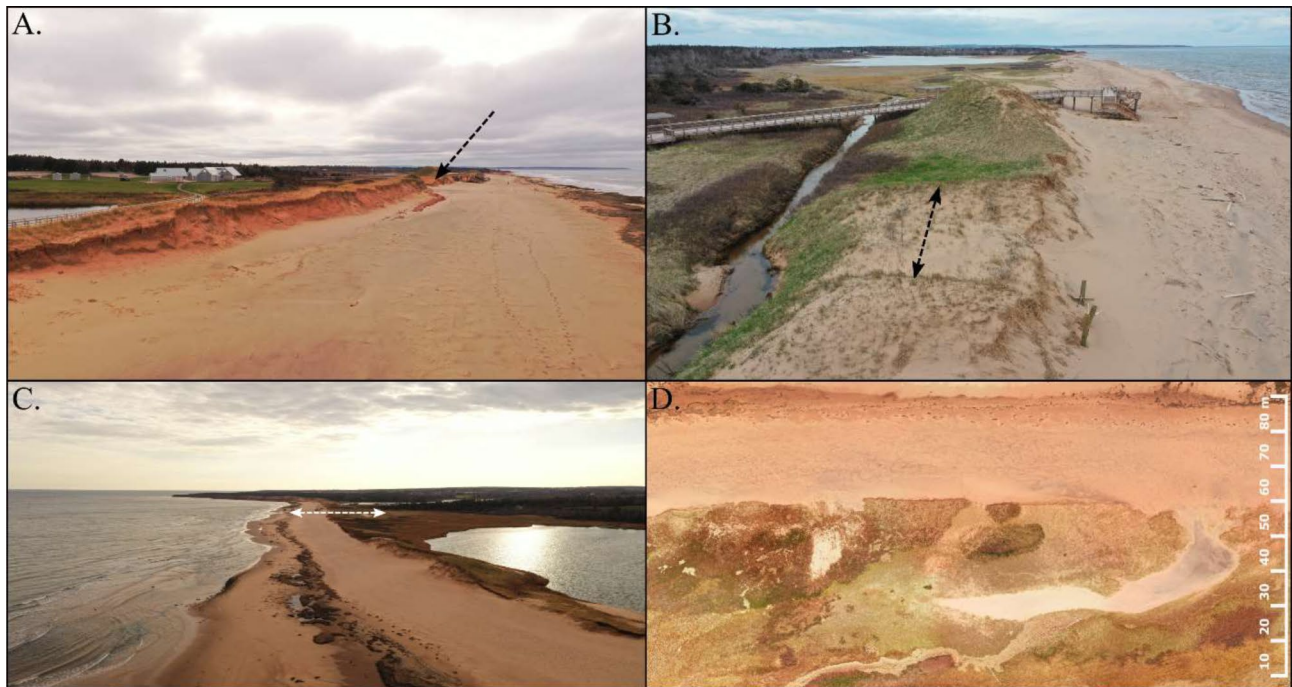
Fig. 18 Post-storm images of Cavendish Main Beach. Image A was taken from the east end, facing west towards the main entrance boardwalk, the location of which is denoted by the arrow. Image B shows the location of the previous main entrance boardwalk, the crest line of which is still recovering. Image C was taken from the west end of the

main beach, facing east toward the main entrance with Clarke’s Pond on the right (see Fig. 5 for location). A small zone of overwash west of the main access point, (marked by the white arrow in C), is shown in D. Clarke’s Pond is located off the bottom of photo D

Cavendish Beach experienced overwash and stoss slope erosion similar to that at Brackley (Fig. 18). The previous outlet to Clarke's Pond, where the foredunes have been re-establishing over the past 20 years, experienced overwash and deposition of sediment ~ 30 m into the backbarrier. This area is directly adjacent to the main entrance boardwalk, which experienced damage on the sections closer in elevation to the beach. Overwash also occurred 100–200 m west from the historical recovered outlet, where the pre-storm crest elevation was 2–3 m above the beach. Prior to the arrival of Fiona, the bottom section of the boardwalk was removed, to mitigate impacts to infrastructure. Restoration efforts at the location of the old main entrance boardwalk location were able to decrease vulnerability to this previously unstable area, which was not penetrated during Fiona (Fig. 18B).

There are several areas within PEINP where littoral sediment supply to the foredune system is insufficient to replace sediments eroded by storms, giving rise to a net neutral or negative dune sediment budget. Examples of this include portions of Reach 1 at Greenwich Dunes and the area of low dunes west of the boardwalk at Cavendish (Figs. 14 and 18C

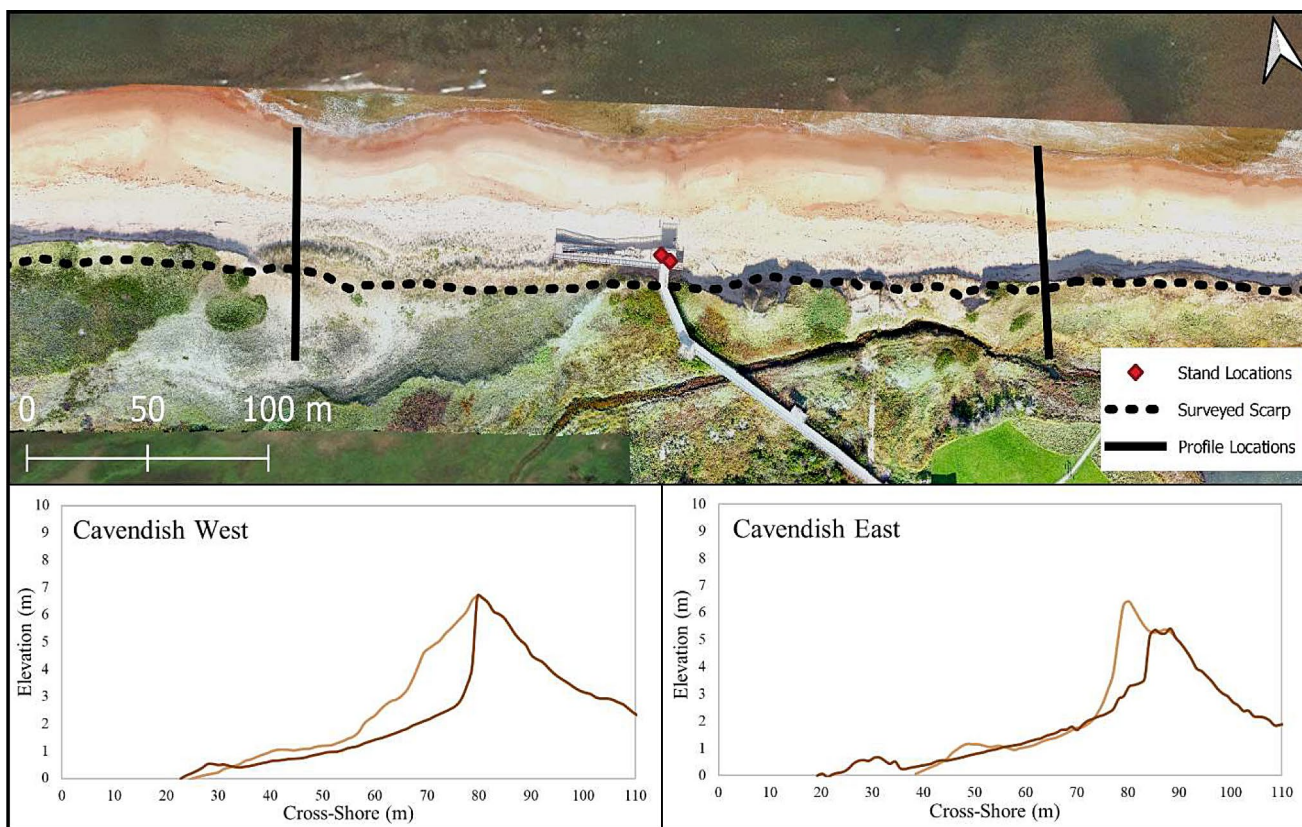
Fig. 19 Cavendish West and East profile locations, in relation to the entrance boardwalk, and pre- and post-Fiona profiles. The basemap consists of pre-storm UAV survey imagery collected in October, 2021, and Bing Virtual Earth basemap imagery

Representative Coastie profiles at Cavendish Beach, located 150 m east and west of the main entrance boardwalk, highlight pre- and post-storm morphological differences at these areas (Fig. 19). The profile east of the Coastie site experienced 5 m of crest retreat, accompanied by a 1 m

decrease in crest elevation, and 18 m^3 of volume loss. At the base of the profile, sandy bedrock was exposed, and there was limited erosion to the stoss face of the dune due to the protective bedrock. Landward of the bedrock towards the crest, the stoss slope was nearly vertical, similar to that of the Brackley Beach profiles. Aside from complete removal of the beach berm, the post-storm beach slope was very similar to the pre-storm beach slope. In comparison, the profile west of the Coastie site lost 40 m^3 of volume, but the crest position remained unchanged. The stoss slope had a gentle gradient and extended further seaward, whereas the pre-storm Cavendish East profile was steeper (Fig. 19). Therefore, volume loss is higher than the Cavendish East side, but the crest position remained intact as the beach and foredune was wider here.

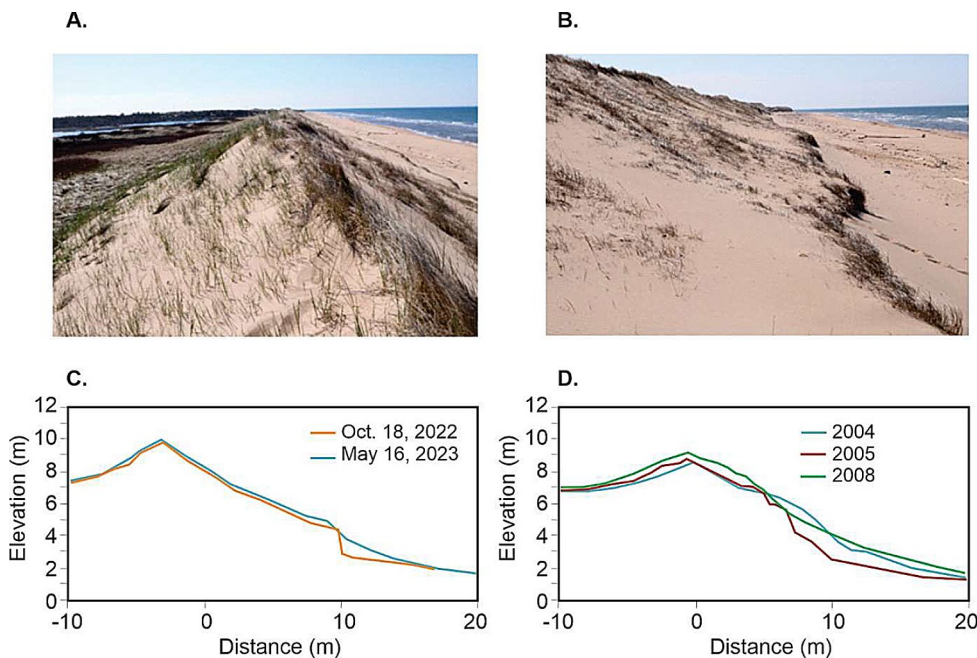
Fig. 20 Beach and foredune recovery at Line 6, Greenwich Dunes following Fiona. Photographs taken on May 16, 2023 show deposition on the crest and lee slope (A) and deposition on the dune ramp and stoss slope (B); C shows the profile surveyed October 18, 2022 and May 16, 2023 illustrating growth of the dune ramp and deposition on the foredune; D shows profiles for 2004, 2005 and 2008 following a major storm in winter 2004–2005

Recovery from the erosion associated with Fiona will vary spatially, depending on sediment availability, but at Greenwich it may only take 4–5 years assuming the area is not hit by additional high-magnitude storms. Evidence for this is based on the recovery from a storm in the winter of 2004–5 (Fig. 20D). Comparison of the 2004 and 2005 profiles (before and after the storm) shows toe erosion at this location of about 5 m and 3 m midway up the stoss slope – values that are of the same order of magnitude as that due to Fiona at this location. Profiles in 2006 and 2007 (not shown) provide evidence of rapid deposition on the beach and stoss slope and by 2008 the profile was very similar to the pre-storm condition (Fig. 20D). Subsequently, a small storm in 2009 created a small scarp at the base of the stoss slope and a much larger one in the winter of 2010–11 scarped the stoss slope nearly to the crest, thus initiating another cycle of erosion and recovery.
