Cathodic protection shielding of coated buried pipeline

Abstract During the 2000s, the concept of cathodic protection (CP) shielding was first raised in open literature and remains debated between coatings professionals. The mechanism of CP shielding, and its understanding continue to be studied for different coatings with different approaches and using various techniques. From the CP shielding factors to the assessment methods, the published literature merits a deep analysis to capture the established knowledge and identify the research gaps to further tackle the issue for reliable coated buried structures. A holistic approach to this topic seems necessary where coatings ageing, cathodic protection, electrochemistry, and transport processes should be considered. In the first part of the present review, the recent works related to the understanding of CP shielding, coatings properties were considered before discussing the mechanisms involved underneath coatings. Transport phenomena and their relationship with cathodic protection performance in the presence of chemical and microbiological processes are discussed in the second part. Finally, CP shielding assessment methods and model

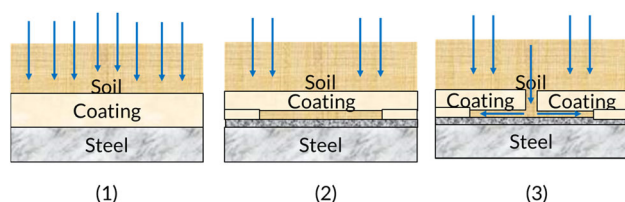
**Fig. 1: CP current permeability paths for (1): intact coating, (2): blister, (3): disbonded coating open to soil**

and the processes underneath disbonded coating. For instance, CP current permeability can be discussed considering three commonly encountered scenarios, i.e., intact coating, blisters and open coating defect (Fig. 1).

Scenarios 1 and 2 seem to be less discussed by the coatings community compared to scenario 3 which can be questionable since scenario 2 can also lead to a corrosion situation. In the third scenario (open disbonded coating), CP current permeability has two paths, i.e., soil in contact with trapped solution, and through coating. What is well established is that CP current will progress through the least resistive path. To determine this path, we should consider soil characteristics (texture, moisture level, resistivity), coating characteristics (chemistry, thickness, porosity, ageing) and trapped solution (chemistry, volume/steel surface ratio, exchange with soil). To our knowledge, this research gap is still not fully explored in open literature. On the other hand, limitations of techniques to get reliable information on these processes from field creates an additional challenge for scientists.

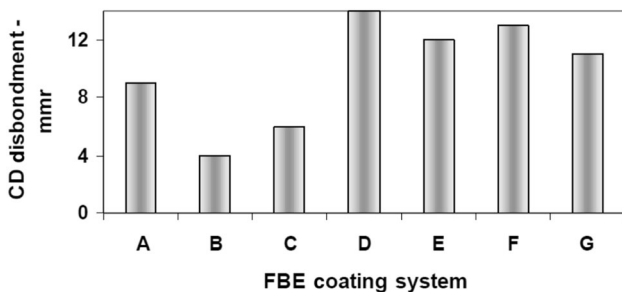
Fig. 3: Cathodic disbondment expressed as mm radius of FBE coatings from different manufacturers conducted at – 1.5 V vs Ag/AgCl in 3% NaCl at 65 °C and for 28 days²⁵

The main characteristics of FBE coatings related to the topic of CP shielding are its relatively lower thickness, optimal water absorption, resistance to cathodic disbonding, and electrical resistivity. Unfortunately, due to the variation of testing standards and conditions followed by FBE manufacturers, as well as the variation of FBE formulation it is difficult to quantify properly the main features of FBE coatings. For instance, FBE formulation variation showed a significant impact on CD as shown in Fig. 3. The

cathodic disbonding extent of FBE coating was also found to highly affect CD testing parameters such as CP potential, and temperature.²⁴ The consequence of this scattering of CD rate can be relevant when discussing disbonded region geometry where CP current progress will be affected.

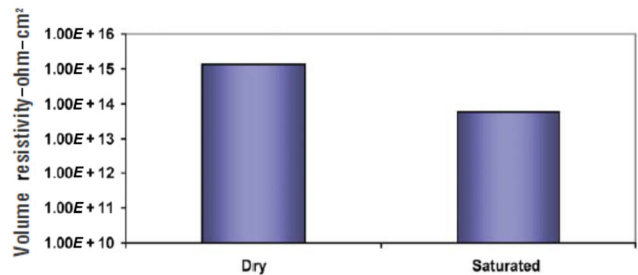
Fig. 4: FBE was saturated in a 3% NaCl solution for 40 days with and without a six-volt cathodic protection set-up¹¹

the electrolyte used, the exposure duration, the coating thickness and the FBE product. For instance, while Kehr¹¹ observed a decline of volume electrical resistance from $10^{15} \Omega \text{ cm}^2$ (dry state) to $\sim 10^{13.5} \Omega \text{ cm}^2$ after saturation in 3% NaCl for 40 days (Fig. 4), Buchanan¹² reported a more severe decline from 10^{15} to $10^9 \Omega \text{ cm}^2$ after saturation in water achieved after 500 h (20.8 days). Missing information on coating thickness and other factors makes it difficult to explain this difference between the works.

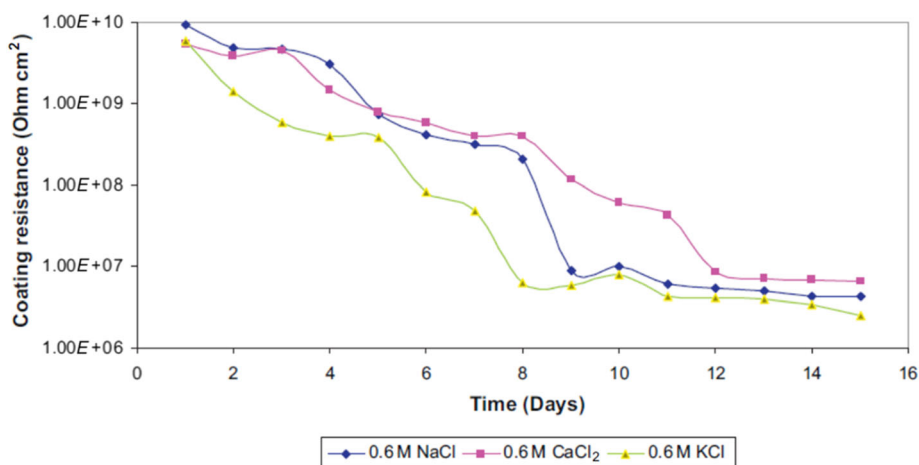
Fig. 5: Evolution of electrical resistance for a two-parts unpigmented epoxy coating in different electrolytes at ambient temperature²³

The electrolyte effects and CP potential on electrical resistance can be observed through the study conducted by Eltai et al.²⁶ Considering a commercial two parts unpigmented epoxy coating with a thickness of 50 μm , the effect of the electrolyte (0.6 M NaCl) on the coating electrical resistance was pronounced in early days of immersion but starts to become insignificant after two weeks, approaching $10^{6.5} \Omega \text{ cm}^2$ (Fig. 5). So, this highlights the effect of electrolyte saturation on the evolution of electrical resistance where a steady state can be defined depending on the coating microstructure (porosity). It is important to mention that Eltai et al.²⁶ obtained the coating electrical resistance through electrochemical impedance spectroscopy (EIS) which is based on AC small perturbation. However, most of other authors rely on the procedure based on DC current and described in EN 62631-3-1²⁷ to determine the volume electrical resistance. Therefore, it is important to check whether the measuring method influences the passing current and the obtained electrical resistance.

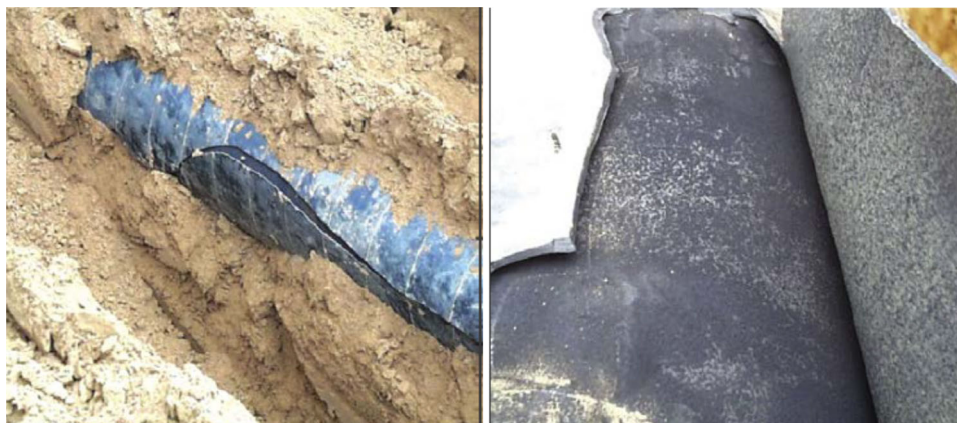
Fig. 6: Common field failures of 3LPE coating systems¹⁶

The field performance of the 3LPE coating is considered as good and limited to the cracking of the topcoat and the disbondment that occurs at two locations: primer and steel pipe or primer and topcoat. Roche et al.¹⁶ reported some cases including disbonding after 10–15 years where no significant corrosion was noticed on the pipe metal (Fig. 6). It is important to specify that disbondment cases were observed for buried pipelines operating at temperature up to 60 °C and that the longitudinal crack in PE layer was attributed to thermal ageing.³¹ The good performance

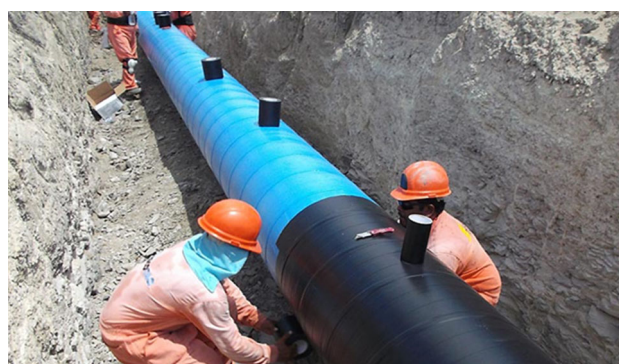
Fig. 7: Field cold applied viscoelastic tape: inner layer (blue), outer layer (black) (Color figure online)

layer for the mechanical protection (Fig. 7). The inner layer is considered self-healing with a poly-isobutene-based chemistry, as described by Doddema.³⁵ This layer is claimed to provide weathering resistance through its low water absorption and bacteria resistance. The adhesion relies on the sticky nature of the inner layer combined with the application method which can be made either by hand wrapping or using a dedicated machine.

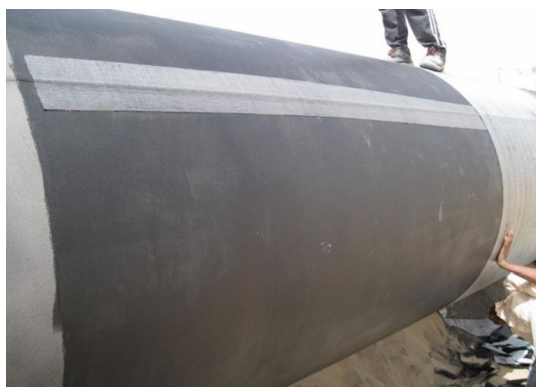
Fig. 8: Geotextile mesh backed tape applied on large diameter water pipeline

An inspection made by Meroufel³⁹ on large water pipe coated with this type of tape, showed no disbondment, a neutral pH and absence of corrosion after 5 years of service. The pipe was buried in basic and salty sandy soil (subkhas) with significant water table presence.

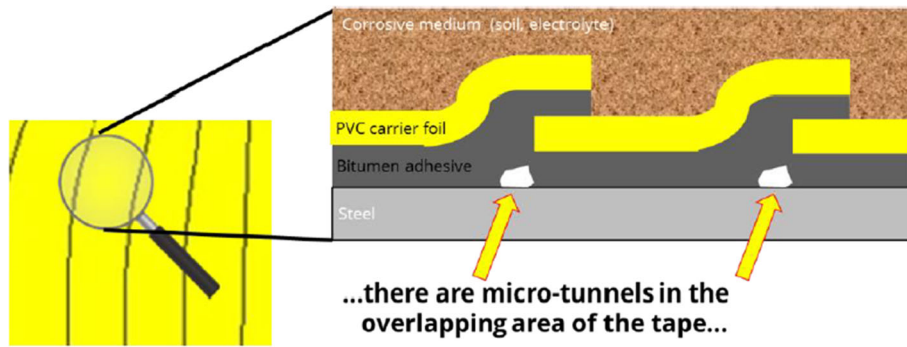
Fig. 9: Microtunnels created by field applied cold tapes

To overcome this risky area where CP current may not reach and corrosion can proceed (called spiral corrosion), some coating manufacturers have developed the concept of hose-like coating. Three-ply tape technology is a typical example of this hose-like coating where microtunnels are eliminated based on adhesive tape with butyl-rubber on the outside and inside of the tape. This forms a water/oxygen proof hose, eliminating the disbonding risk and is not affected by the soil environment changes. Therefore, coating manufacturer claim that CP is nonmandatory due to the absence of disbonding risk. Unfortunately, the lack of published articles on spiral corrosion and long-term performance, or laboratory data make it difficult to conclude on the abovementioned claims.

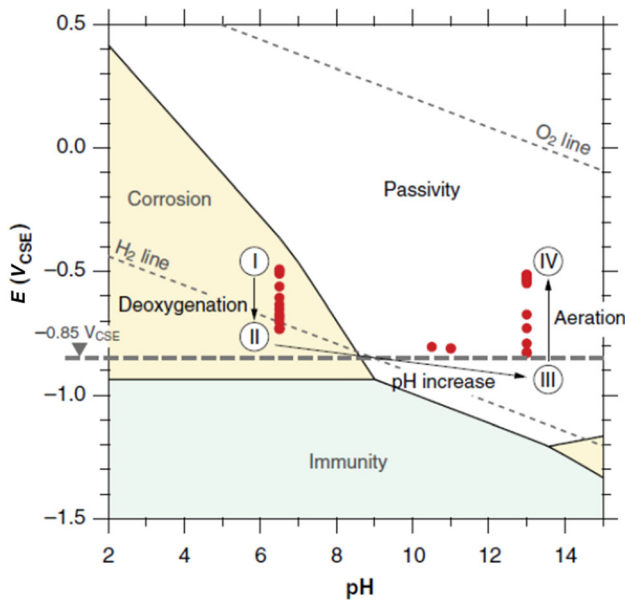
Fig. 10: The behavior of iron (red dots) on the Pourbaix diagram depending on oxygen availability⁴⁴

The impact of oxygen availability on interfacial pH was studied by Angst⁴⁴ to define the passivation level (Fig. 10). However, these experiments were done following a pure chemical experimental approach (no CP polarization) which can be different in terms of kinetics and equilibrium when compared to electrochemical-based phenomena.

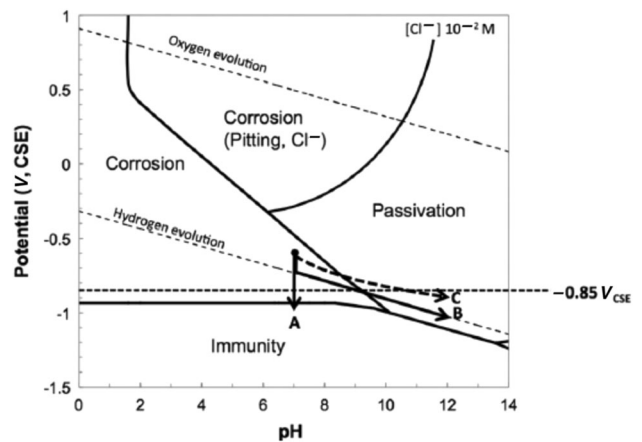
Fig. 11: Modified Pourbaix diagram considering chlorides and CO₂ roles proposed by Ackland and Dylejko⁴⁹

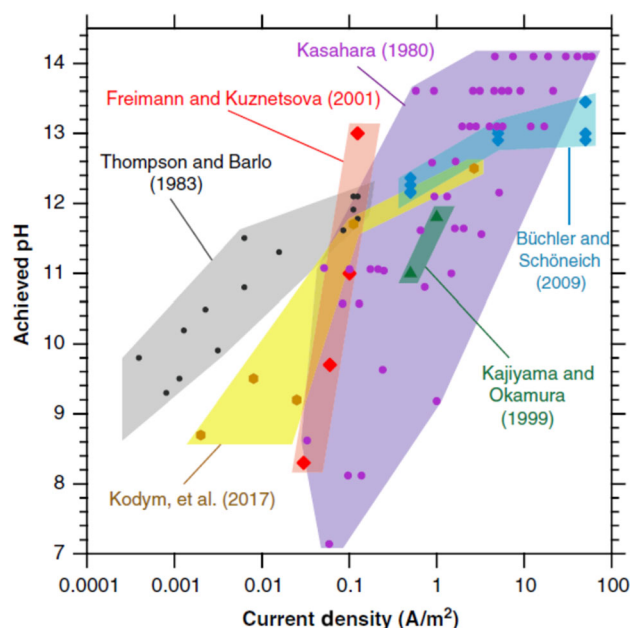
Fig. 12: Literature compilation for the relation between pH achieved at steel surface embedded in soil and the applied protection current density⁴⁴

That is why the conditions that favor concentration polarization are the subject of many studies. According to Büchler et al.,⁴³ this would happen only if the pipe were bedded in fine sand and soil or in contact with calcareous precipitate which comes from hard water. The same opinion is shared with Ackland and Dylejko.⁴⁹ Then, the extent of the concentration polarization area was found to depend not only on the ionic strength or the pH buffer capacity of the electrolyte, advection, and soil microstructure but also on the experimental time of the different studies.⁴⁴ The variation of these factors induced the difference observed in the relationship between the pH increase and the CP protection degree (current density) as shown in Fig. 12.

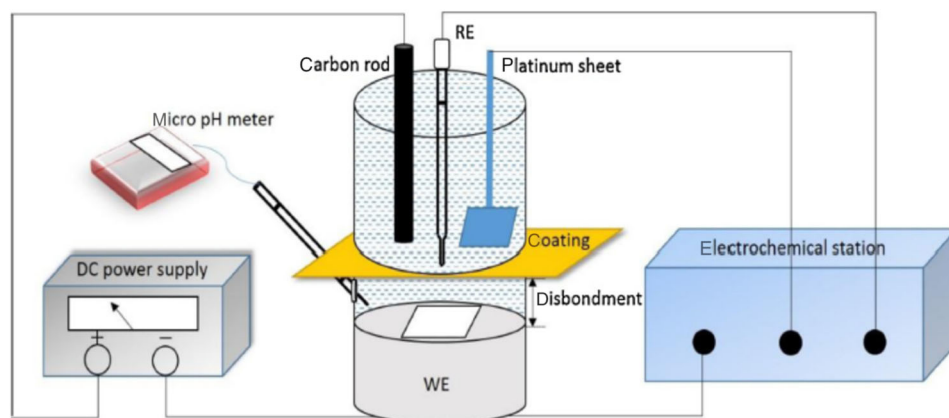
Fig. 13: Schematic diagram of the experimental setup to measure the permeability of coatings to CP³⁰

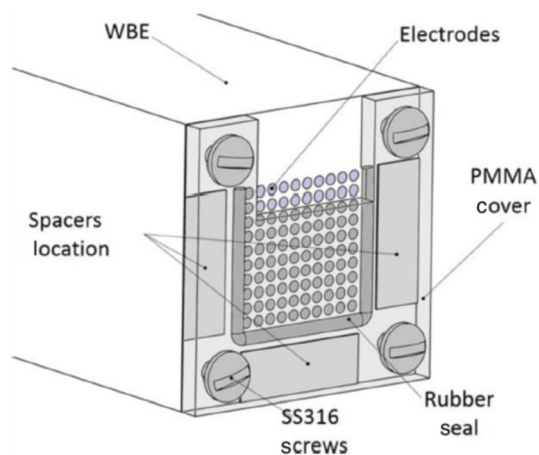
Fig. 14: Schematic illustration of differential aeration sensor (DAS)⁶²

In terms of localized corrosion in the case of CP and disbonded coating, Varela et al.⁶³ presented a differential aeration sensor (DAS) which allows for very useful electrochemical measurements (Fig. 14). For the first time, both anodic and cathodic currents were determined in the crevice area. Two different analysis methods (Faraday law and corrected currents) were used to estimate corrosion and its distribution. An improved corrosion estimation was observed in diffu-

sion control using the corrected currents method. In addition, this method allowed the estimation of corrosion patterns outside the crevice under CP. A good correlation between electrochemical calculations and surface profilometry results has been obtained.

Wang et al.⁶⁴ adopted the same sensor shown in Fig. 14 to study and visualize the effect of crevice gap geometry and water saturation level of the soil under disbonded coatings. In saturated soil, the behavior was like the one in electrolyte solutions, where crevice corrosion is mitigated by a CP-induced high pH environment and a concentration polarization mechanism. In nonsaturated soil, the crevice corrosion behavior changed significantly with coating disbondment gap size inducing a shielding condition to the CP current leading to a severe localized attack for a gap size of 1 mm. The CP current shielding condition was explained and demonstrated by the high resistivity of the nonsaturated soil.
