Polyethylene Liner Dissociation Is a Complication of the DePuy Pinnacle Cup: A Report of 23 Cases

Andrew Yun MD, Emmanuel N. Koli MD, John Moreland MD,
Richard Iorio MD, John F. Tilzey MD, J. Wesley Mesko MD,
Gwo-Chin Lee MD, Mark Froimson MD

Published online: 24 June 2015

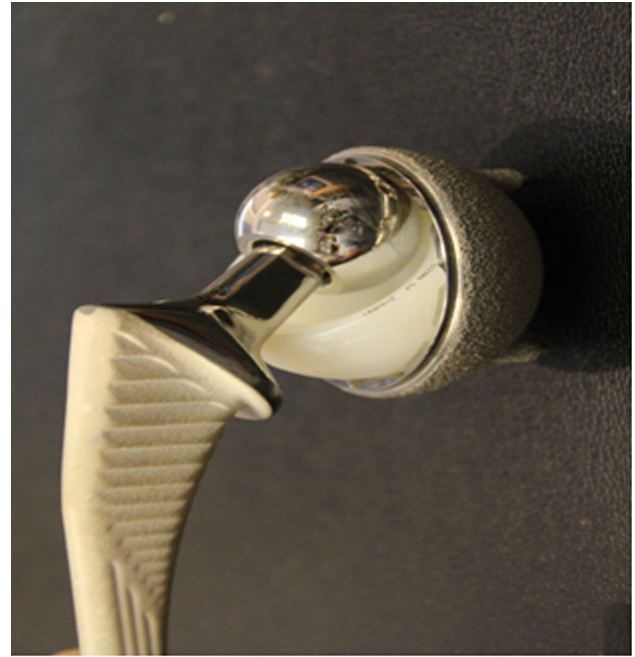
Fig. 3 Ex situ model showing direct contact of femoral head prosthesis with the inner metal shell as a result of liner subluxation.

new and sudden onset of discomfort with audible, reproducible squeaking. The mean time in situ was 48 months (range, 3–138 months). Radiographs consistently demonstrated internal subluxation of the head superiorly within the cup (Fig. 1). Intraoperative findings consistently documented well-fixed acetabular and femoral implants. However, the polyethylene liner often was found to have displaced by rotating away from its original position (Fig. 2), leaving the femoral head prosthesis in direct contact with the inner metal shell of the acetabular cup (Fig. 3).

The femoral head thus articulated with the inner metal shell to create the clunking and squeaking sensation

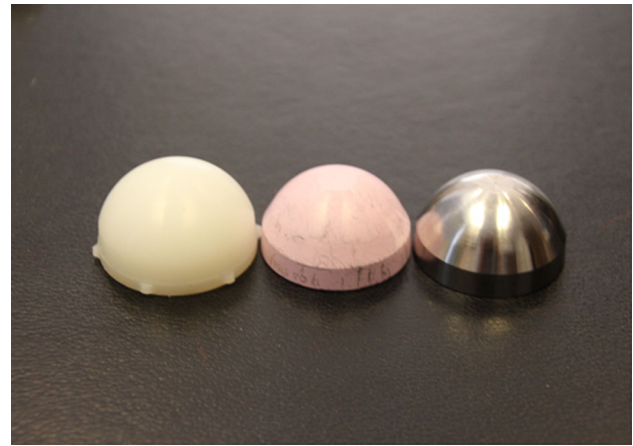
Fig. 4 A taper-lock mechanism may cause the peripheral tabs of a polyethylene liner, unlike the alternate hard bearings, to round over time.

In the early 2000 s, a series of changes to accommodate a choice of bearing modularity were made to the inner geometry of the new DePuy Pinnacle design [13]. The locking ring and rotation tabs were replaced with a taper-lock mechanism that could accept polyethylene, metal, or ceramic. The outer geometry of the liner changed from an onset design to an inset design with six peripheral locking tabs. Importantly, the nature of the polyethylene also changed. The conventional polyethylene was replaced with a highly crosslinked material irradiated to 50 kGy that improved wear but lowered mechanical strength [4, 15]. This combination of changes to cup geometry, peripheral liner shape, and material strength may be responsible for the relative weakening of the locking mechanism and the correlative increase in reported liner failures. Although a taper-lock mechanism may be sufficient for hard bearings, it may become insufficient for the mechanically softer highly crosslinked polyethylene because it rounds out over time (Fig. 4).
