HBIM for the preservation of a historic infrastructure: the Carlo III bridge of the Carolino Aqueduct

Abstract

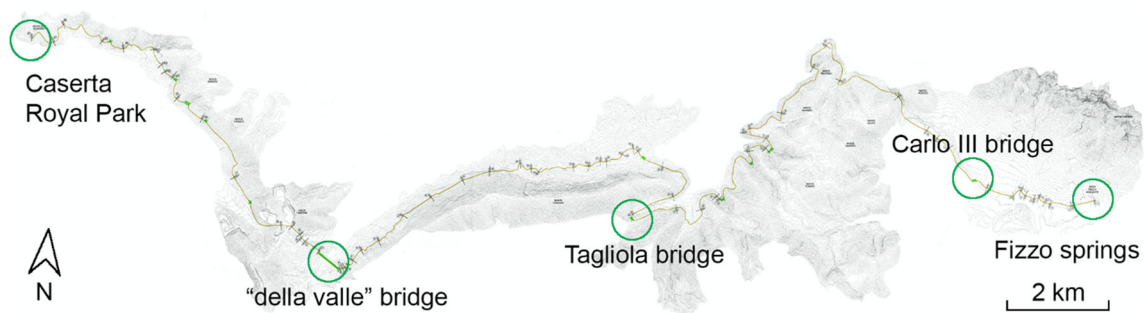
Fig. 2 The route of the Carolino aqueduct from the Fizzo springs to the Royal Park of Caserta, with the indication of the three monumental bridges

The Carolino Aqueduct is underground for 37 km and emerges in some sections only, that are the “della Valle” bridge (in the Maddaloni Valley), the Tagliola Bridge (at Durazzano) and the Carlo III bridge, which is the closest to the Fizzo springs, where the water that feeds the Royal Park and Palace is collected (Fig. 2).

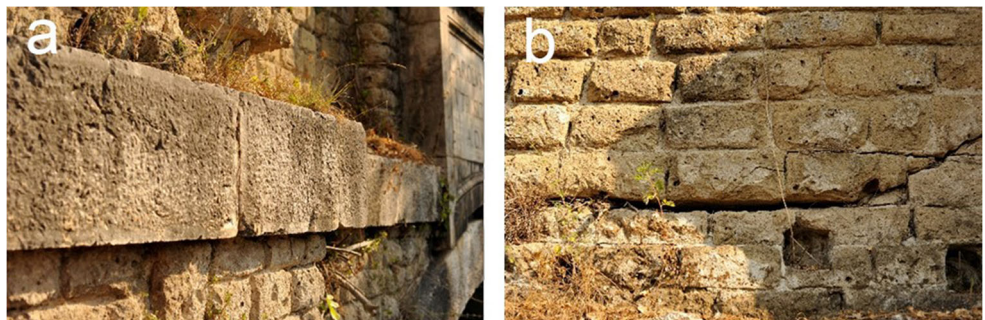
Fig. 4 The main materials of the Bridge: **a** the local limestone with the presence of a disintegration phenomenon and a superficial patina; **b** the yellow tuff, and the clear lesion on the South elevation

The bridge was built in order to cross the aqueduct over the river Isclero and without any connection with the local road network. It is about 150 m long above ground and almost 7 m high. The structure is entirely made of local yellow tuff, which is certainly extracted in the nearby quarries, while the perimeter ashlar, the plaques, some elements of the curb and the pavement are made of limestone, also local, characterized by a lighter, almost white colour (Fig. 4).

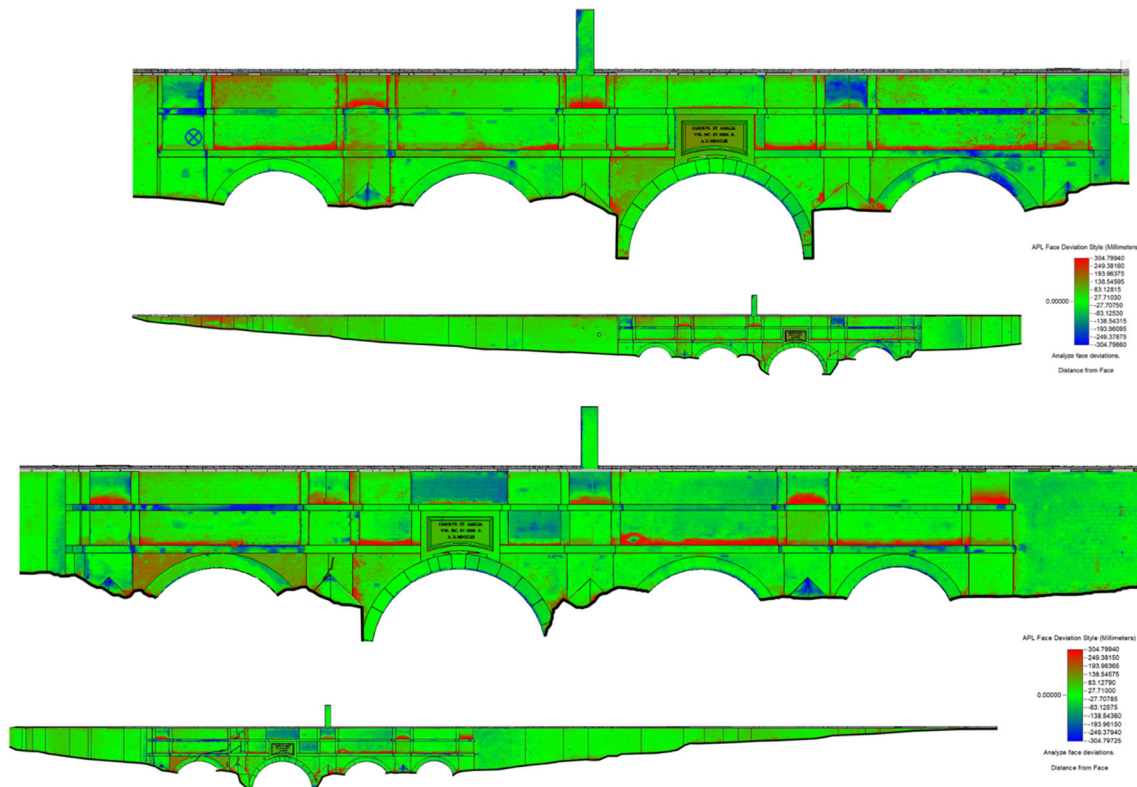
Fig. 7 Point cloud and BIM model deviation map. The diffused modelling error is about 2.7 cm, mainly related to masonry ashlars. Red areas are related to infesting vegetation (not included in the 3D model); blue areas to very irregular portions or missing parts

Due to the irregularity of the surveyed object, it was necessary to use so-called “in-place models” to represent the existing geometry as closely as possible, but without all the parametric properties of a standard family (Fig. 7).

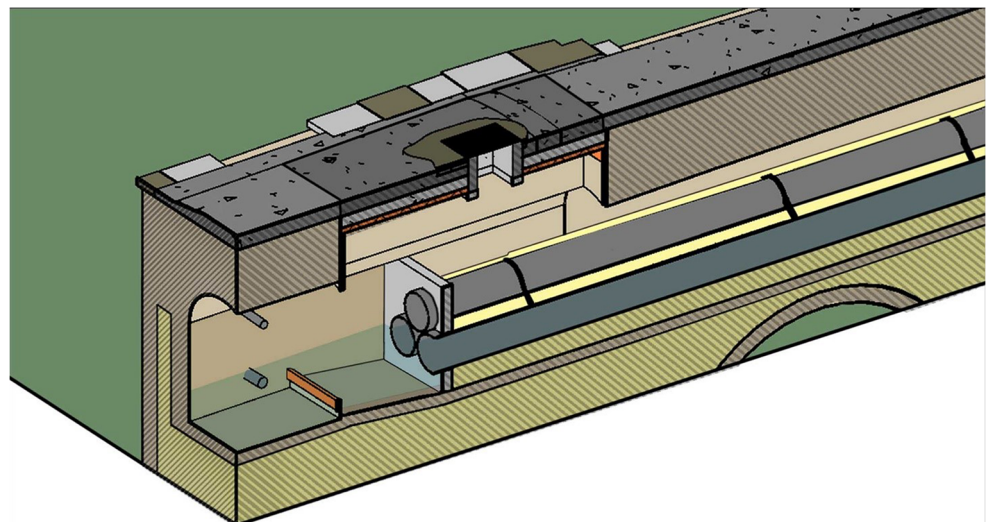
Fig. 8 The inner duct, modelled according to the currently available data

HBIM modelling also must face another issue which is not present in new constructions. Often the inner texture of a building is not completely known, so there is the risk to build a dumb model. Trying to overcome this issue, every kind of information was linked to Carlo III bridge basic components. Technical data include materials, their characteristics and processing techniques. The main materials used for building the bridge, which are Neapolitan yellow tuff and limestone, have been added to the materials library. They are linked to a brief description, an indication of the presumed origin and to informative websites. Other information includes all historic data useful to reconstruct phases and interventions, like archival or printed sources, images and also oral history, with testimonies of local people on the works occurred in last decades. Finally, in absence of other data, also the working hypotheses aroused during the research were included. As example, it was possible to inspect only a limited portion of the interior of the conduit through a manhole above the bridge in the straight

portion of the eastern side (Fig. 8). Data about dimensioning, materials and pipes have been, temporarily, extended to the entire bridge.

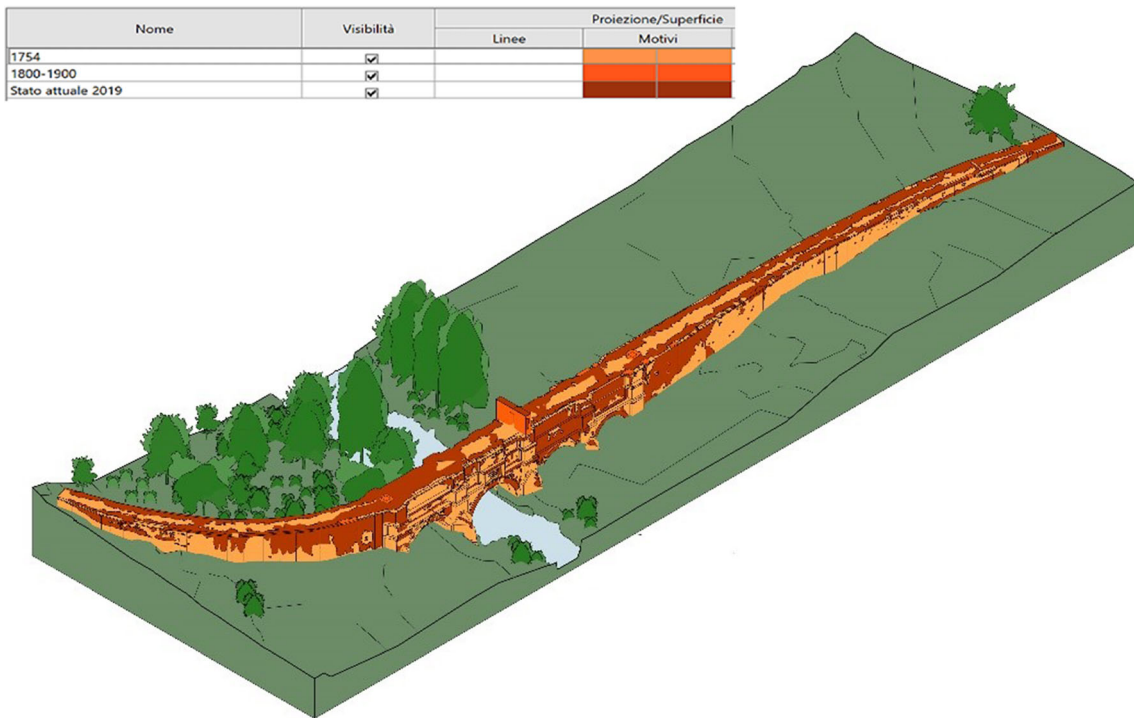
Fig. 9 Time sequence of the bridge, obtained filtering the construction phases in the HBIM model

Other information concerns the date of the interventions. All phases after the construction (about 1754) were identified and attributed to bridge elements. Cross-correlating the above-mentioned data, it is possible to create thematic maps, for showing, as example, the construction phases of the parts of the building (Fig. 9).

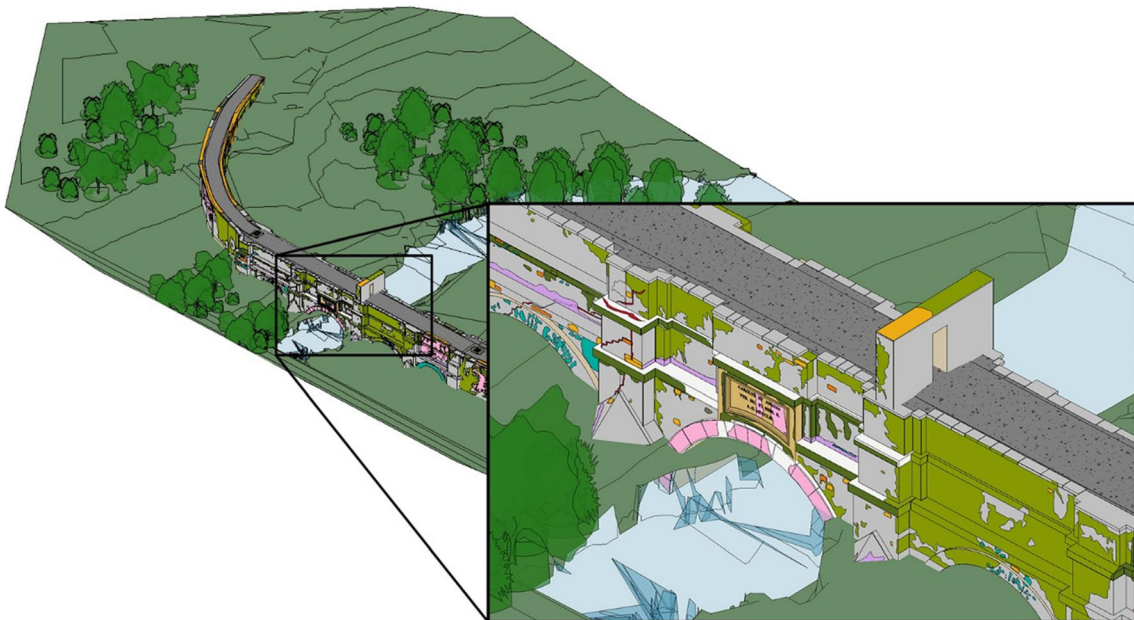
Fig. 10 Representation of decay using “in-place” models

BIM software and vectorizing the different pathologies on the flat surfaces of the model (included the parallel ones to the horizontal plane). The selected areas were modelled as millimetre-thick surfaces and classified by degradation pattern. This manual process is undoubtedly accurate but is very time-consuming (Fig. 10).

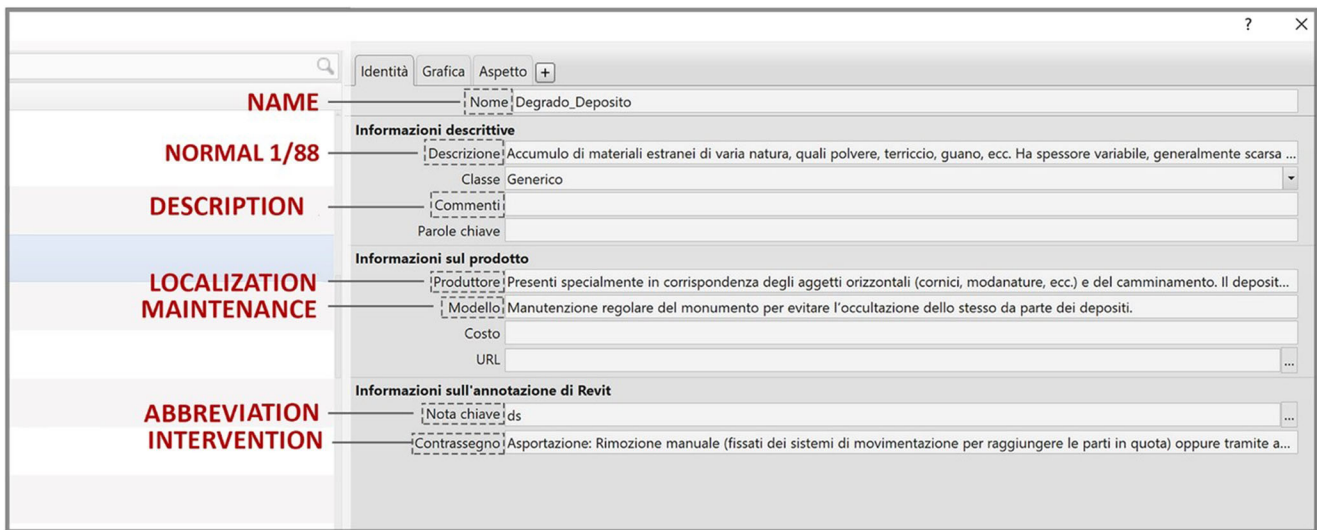
Fig. 11 Information on the decay and interventions inserted reassigning the parameters of materials in the parameters browser

All kind of information can be associated to the surfaces representing the decay: description of the pathology (according to the Italian norm UNI 11182:2006), photographic images, textual descriptions and 2D dimensioned drawings (from manual survey) to state the depth of the cracks (Fig. 11).

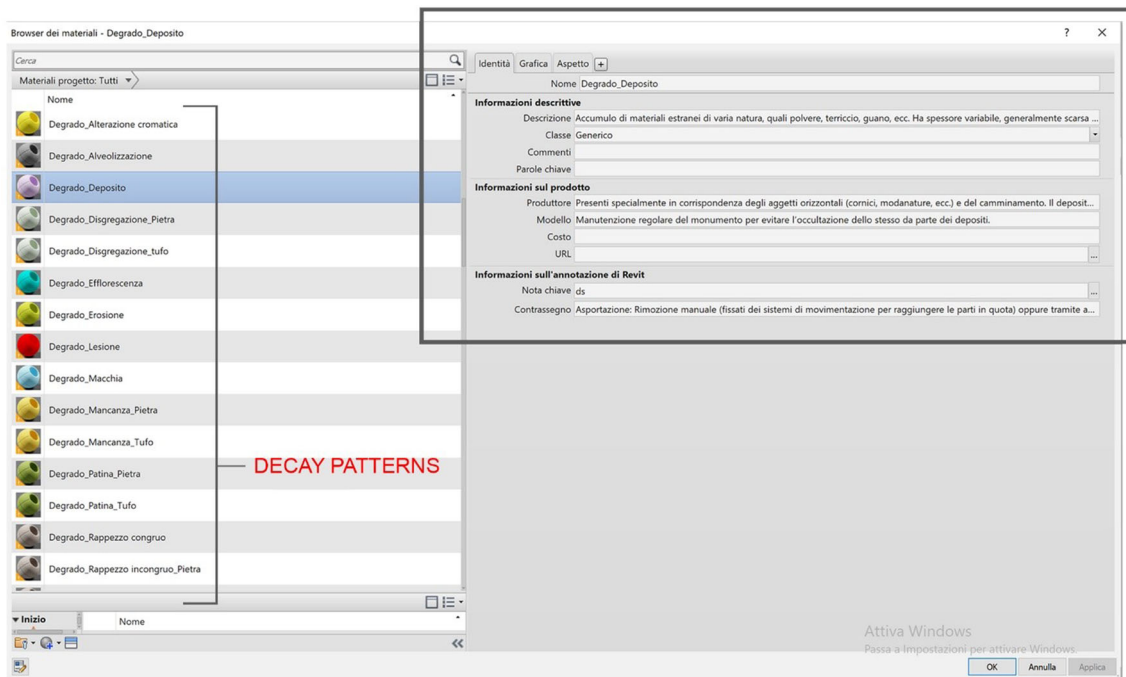
Fig. 12 A schedule with a summary of the decay patterns

In BIM, “Schedules” tool allows the data extraction. A schedule of decay patterns (Fig. 12) has been created, including the information related to the description and quantity of every kind of deterioration. When the geometry is modified, schedules are automatically updated, allowing the monitoring of the evolution of deterioration.

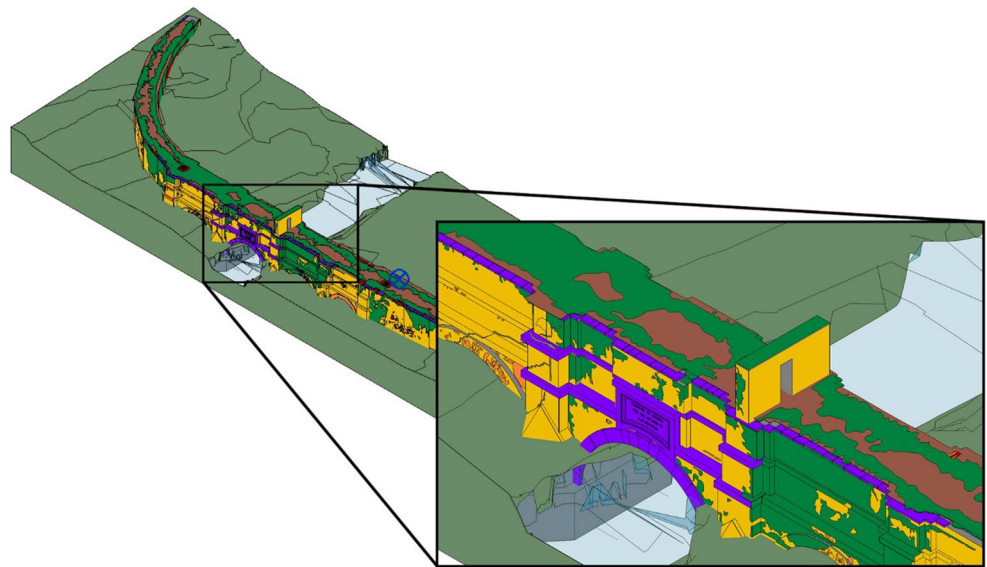
Fig. 13 Representation of interventions on the HBIM model

Once the characterization of materials, the localisation of every kind of deterioration and its quantity, is known, the conservation and structural reinforcement plan can be represented and computed on the model (Fig. 13). As described about decay representation, interventions can be attributed to

single objects or portions of surfaces, indicating the corresponding surface of the model and associating all the necessary information, e.g. name, steps, images, technical data sheets and tutorials. As for decay, it is possible to create schedules containing the quantity of the surfaces on which every intervention is required, together with detailed procedural descriptions, products to be used and other working solutions. As in the traditional restoration practice and in building sites printed drawings are still very common; it is also possible to export the 2D views in usual CAD formats or other data included in schedules for producing proper bills of quantities.
