Integration, harmonization, and processing of geomatic data for bridge health assessment: the Lastra a Signa case study

Abstract

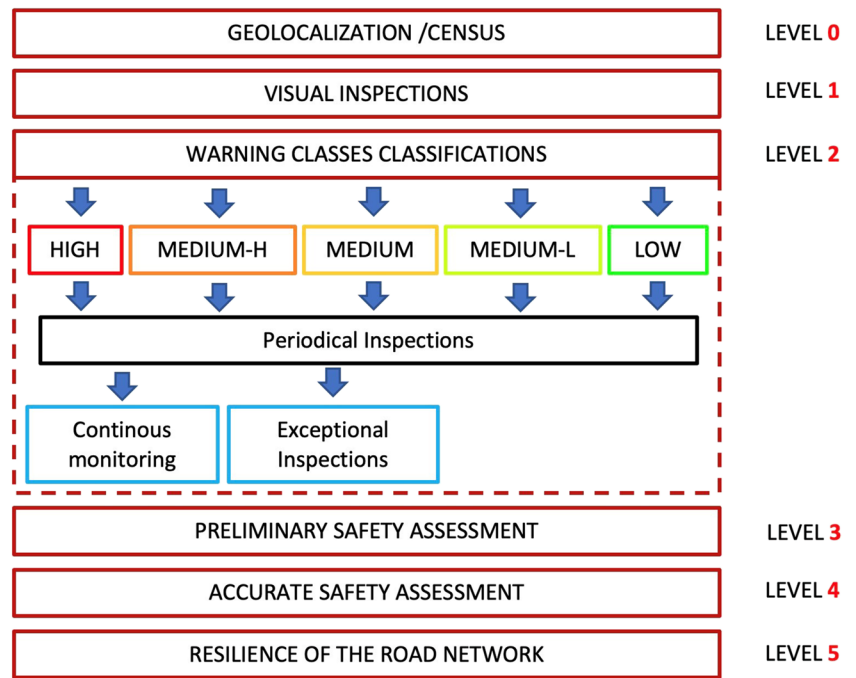
Fig. 1 Scheme of analysis levels. It describes the multi-level approach adopted by the MIT guidelines. Summarized from Ministero delle Infrastrutture e della Mobilità, 2022

that need more detailed analyses foreseen by the other levels. (Beltrami et al., 2021; Buratti et al., 2021; Zambon et al., 2017). Applying the first three levels (Fig. 1), the whole infrastructural asset can be quickly screened.

As can be seen from Fig. 1, periodical inspections and continuous monitoring are requested for level 2 warning class classification.

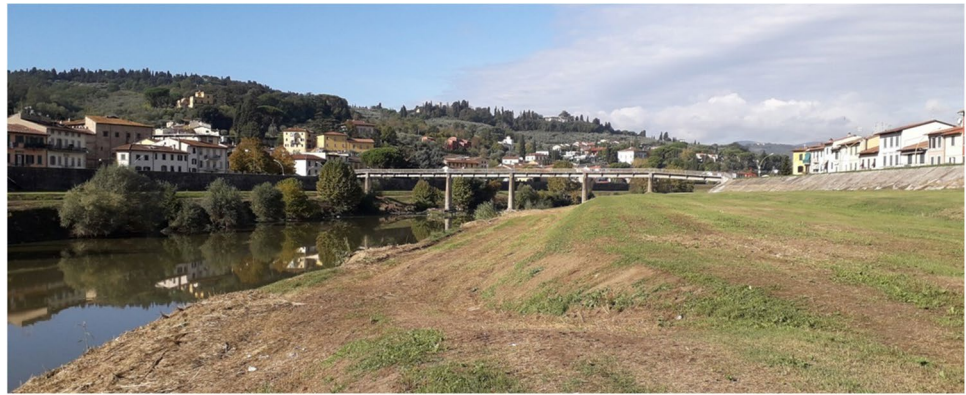
Fig. 5 Walkway, upstream view

Both were realized with reinforced concrete structures after World War II. The pedestrian walkway (Fig. 5) was built on the preexisting masonry bridge

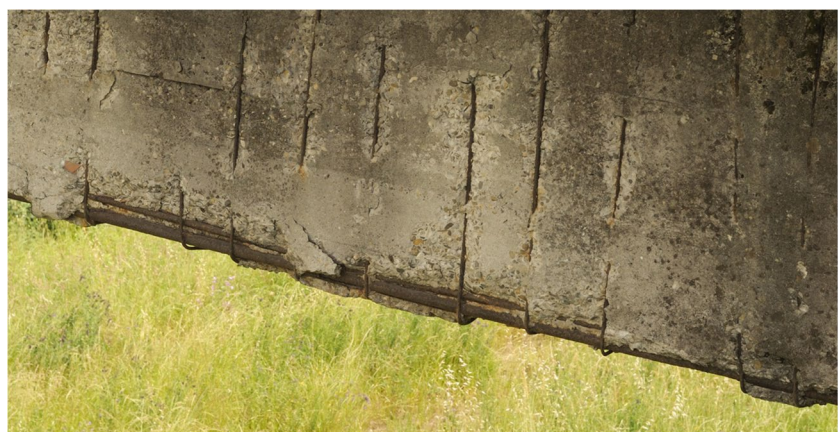
Fig. 6 Walkway, detail of concrete corrosion

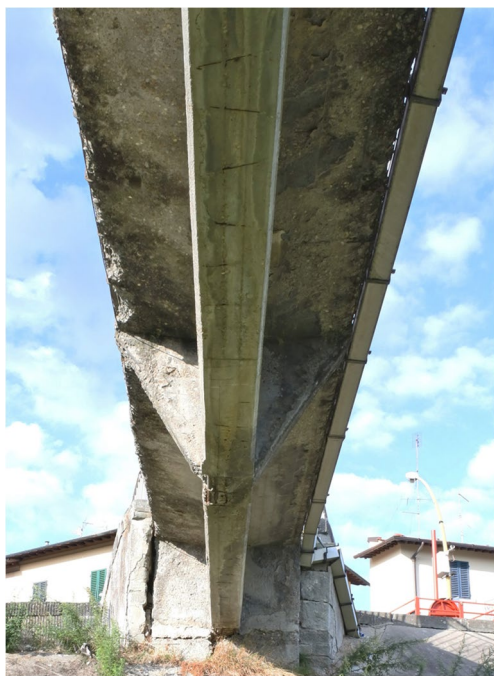
Fig. 7 Walkway, diffuse concrete corrosion

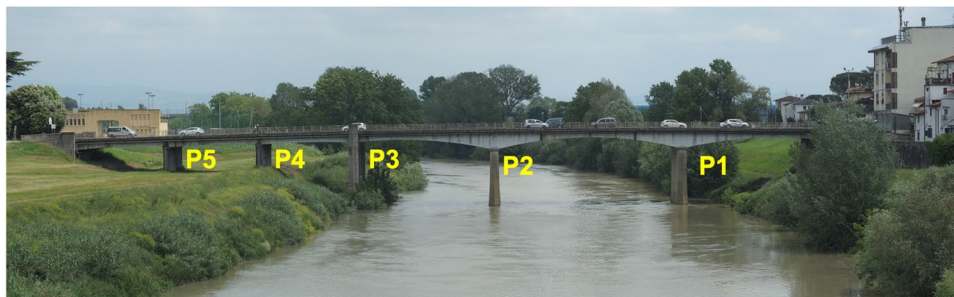
Fig. 8 Ponte sull'Arno—view from downstream

The “Ponte Nuovo sull’Arno” (Fig. 8) was blown up by the retreating Germans in 1944 and then rebuilt in 1948 near the original location of a medieval bridge (1120 AD). It has a reinforced cement concrete structure with the largest span of Gerber type; it is carried by five piles, different in shape and size, of which two (P1, P2) are entirely in the water, two on the ground (P4, P5) and one (P3) right on the riverbank. The bridge piles, like the walkway, rest on foundation plinths.

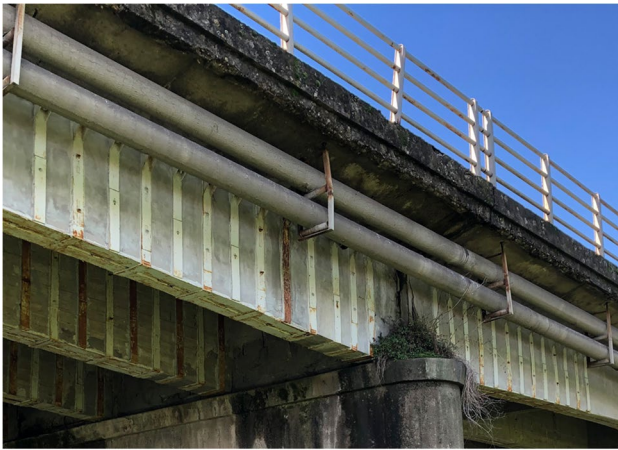
Fig. 9 Ponte sull'Arno, series of bolted steel ties

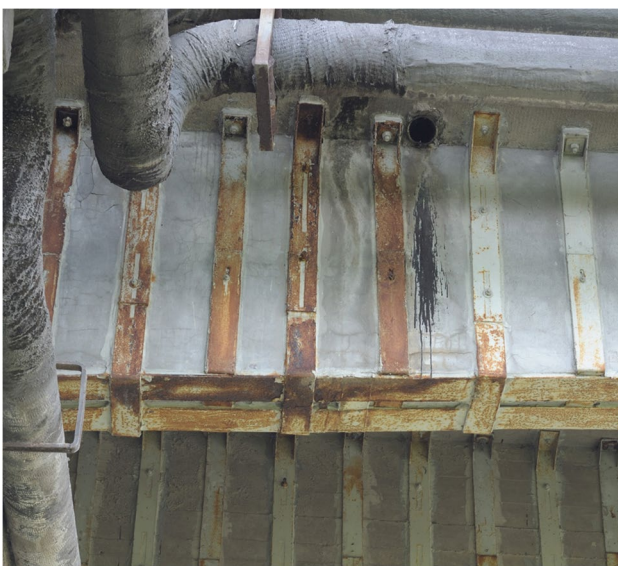
Fig. 10 Longitudinal and transversal bolted steel ties

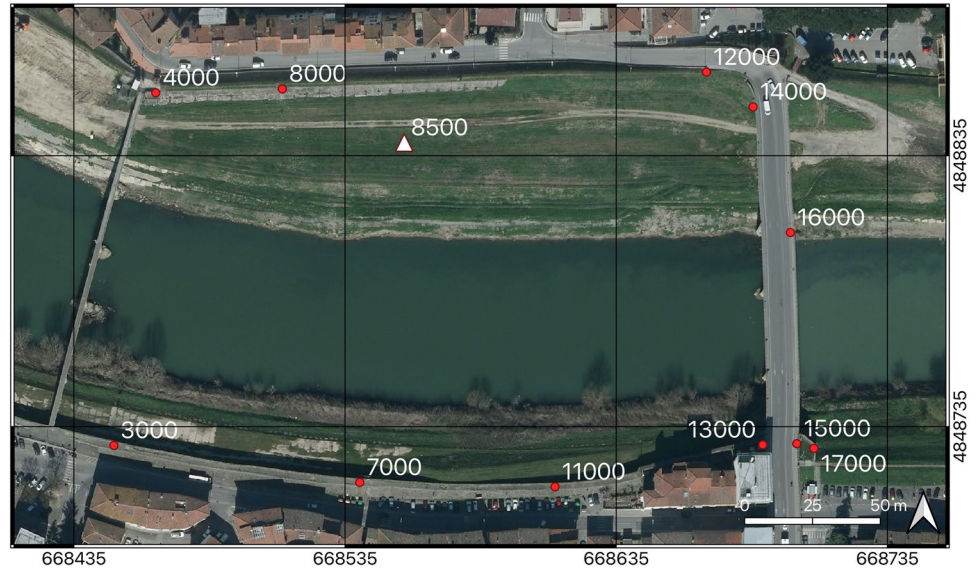
Fig. 11 Orthophoto with control network's vertexes

To this purpose, a control network (Fig. 11) has been designed to cover the entire study area. It is composed of 12 vertexes, each one firmly materialized.

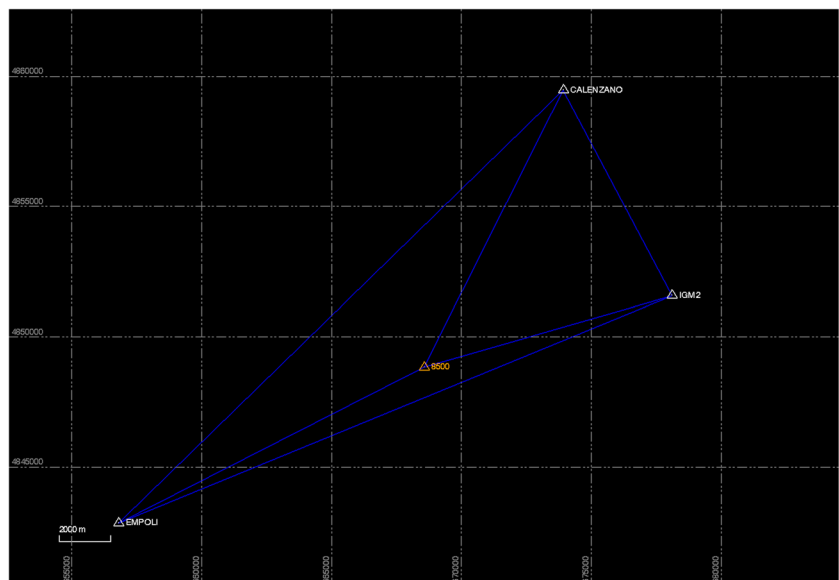
Fig. 12 View of the baselines

A vertex was fixed in a barycentric position within the survey area, and its coordinates were adjusted considering the baselines (acquired for 2 h and 25 min each) of three GNSS permanent stations (IGM2, CALA, EMNS), with a maximum length of about 13 km (Fig. 12).

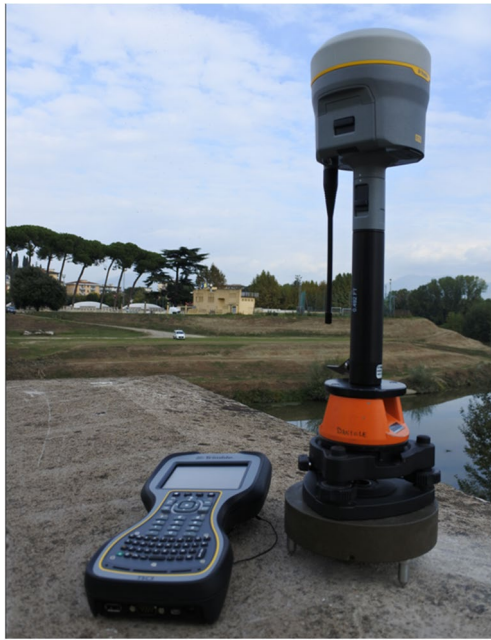
Fig. 13 GNSS measurements

To assess the results, 3D RMS on baselines can be considered (their values range from ± 1 to ± 1.4 cm). Using two GNSS Trimble R10-2 receivers with a rover acquisition time of 8 minutes, the coordinates of all the network vertexes were post-processed. The acquisition time was set considering the limited lengths of baselines between the network points and the barycenter vertex (Fig. 13).

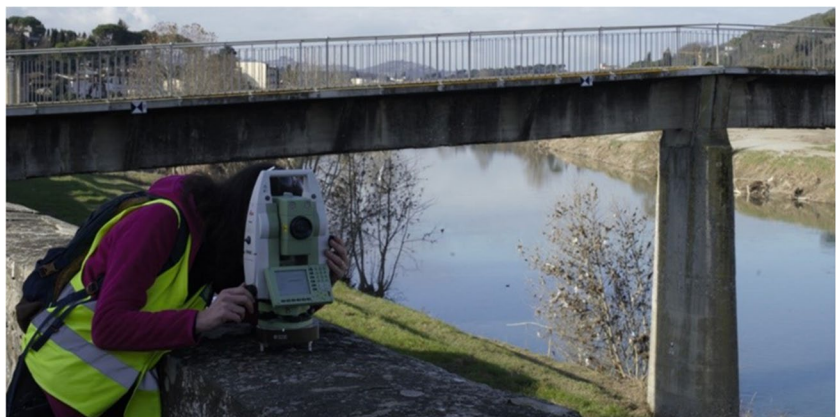
Fig. 14 TS control network measurements

To validate the results, they were compared with the coordinates obtained from the least-squares adjustment of the same control network measured by a TS Leica TCRA1202 (Fig. 14) with angular accuracy $1\sigma = \pm 0.6$

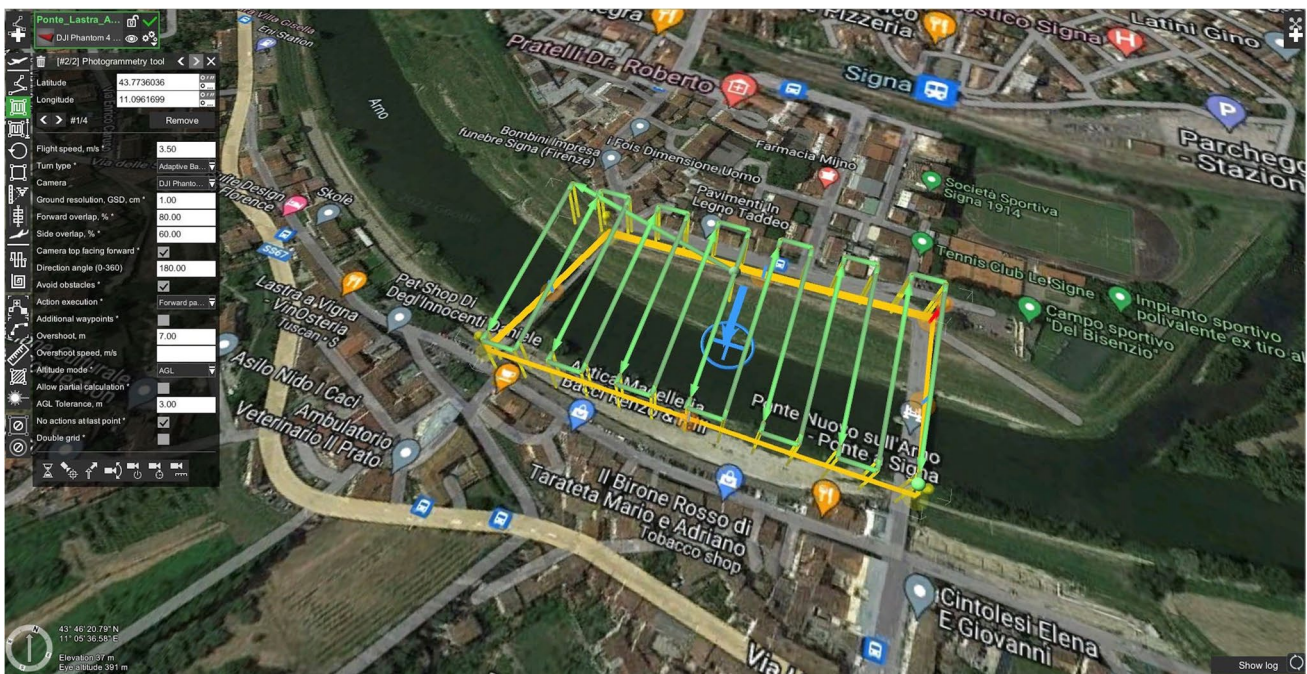
Fig. 16 Flight plan of the photogrammetric survey (UGCS software interface)

A photogrammetric survey of the area between the two bridges was performed with a DJI Phantom 4 drone. The flight plan (Fig. 16) was constrained by a tall building with a mobile phone antenna on a roof near the road bridge on the Lastra a Signa side. For this reason, it was necessary to fly at an altitude of about 35 m AGL, which corresponds to a GSD of about half a centimeter, making 13 strips in the north-south direction with 80% forward overlap and 60% side overlap. The survey was carried out with a nadir camera, taking 308 photos.

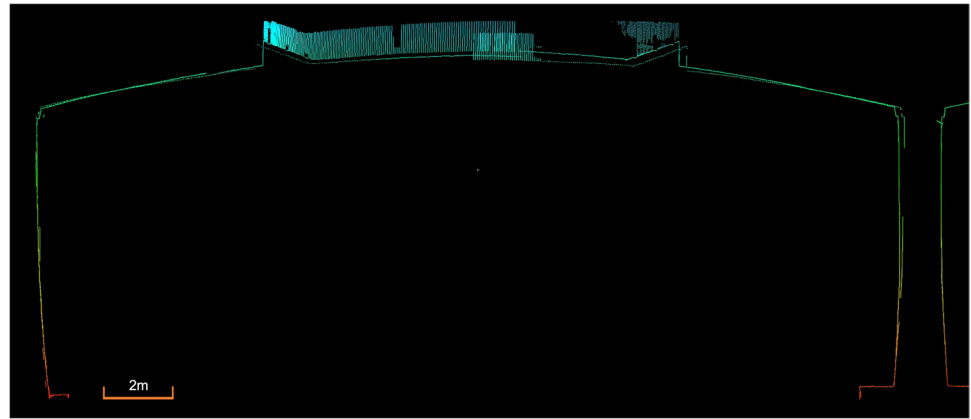
Fig. 17 Profiles from the different acquisitions: the section on the span shows a misalignment of about 30 cm

The overlap of data acquired in various acquisitions highlights critical misalignments between the different profiles (on average of the order of 15–20 cm, but with maximum values up to about 50 cm), which are negligible in

the modelling of the banks, but which prevent the correct analysis of bridge structures (Fig. 17).

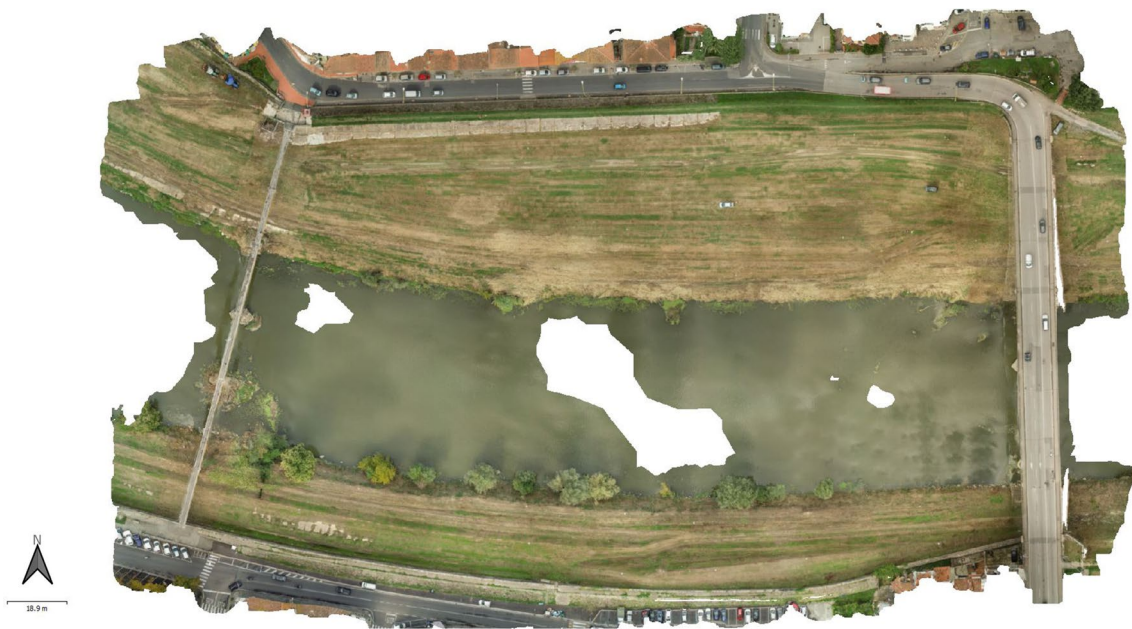
Fig. 18 Raw orthophoto of the surveyed area (300 m in length and 170 m in width)

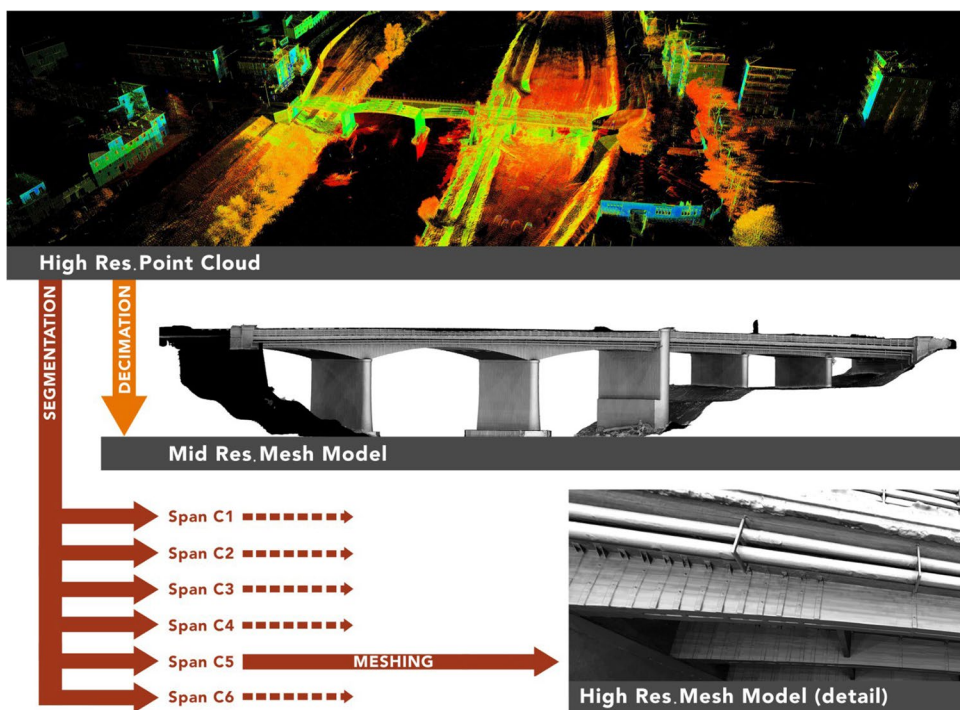
Fig. 19 Mesh models elaboration

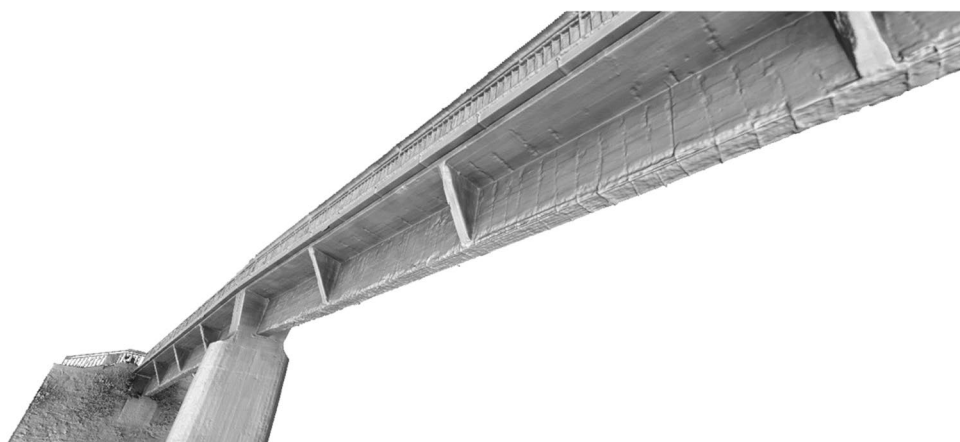
Fig. 20 Mesh model of the walkway

As the walkway is small, only one mesh model of the entire structure was created (Fig. 20). The mesh models obtained have sufficient resolution to read details such as the footprint of the formwork, the degradation of the surfaces and the beam's reinforcement ties. They can therefore be considered as digital references of the actual artefacts, on which it is possible to read highly detailed information (as in on-site visual or photographic inspections), having at the same time an overall view of the bridge structure. Several systems have been developed over time, albeit only as prototypes, allowing specialists to interact with a 3D model and annotate vector and raster information directly on the model surface, especially for managing restoration projects (Apollonio et al., 2018; Soler et al., 2017).

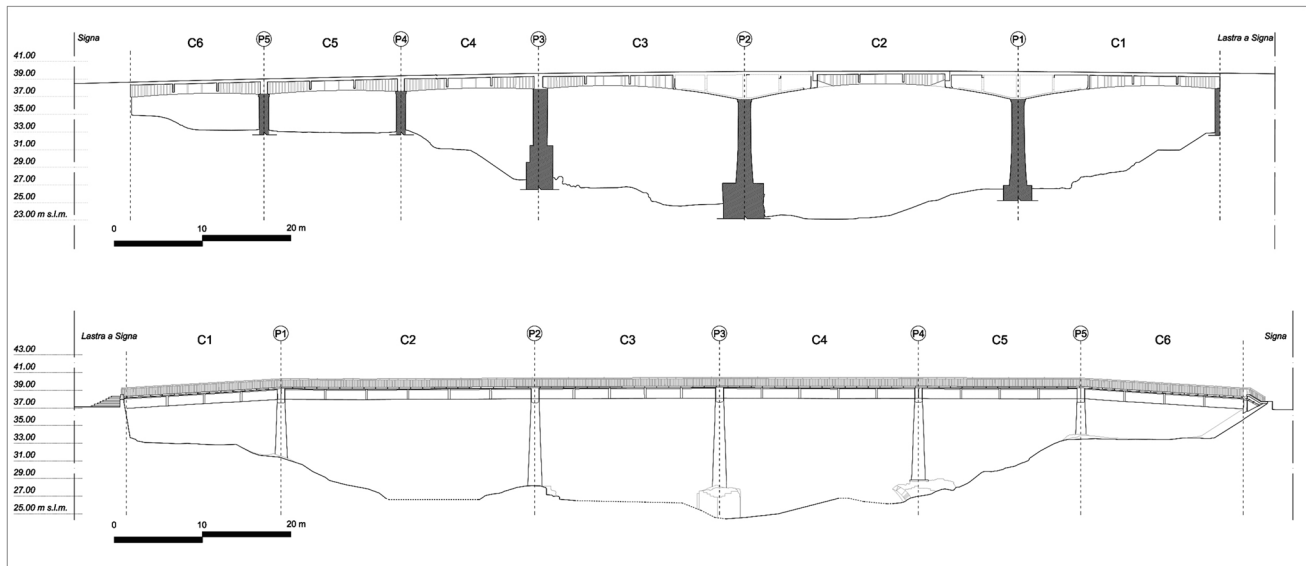
Fig. 21 Bridge longitudinal section (top) and aerial walkway Est elevation (down), original drawings in 1:100 scale

3D models offer the advantage of realistic visualization and permit interactive exploration, with pan and zoom on the details. However, design processes related to built heritage are generally still based on 2D drawings, which, although synthesizing some information, have the advantage of offering an overview and, above all, of quickly providing the necessary size information. For the bridge and the walkway, several 2D CAD drawings were plotted: a floor plan, a view of the deck from the bottom up, a plan of the pylons, elevations, and some longitudinal and cross sections (Fig. 21).

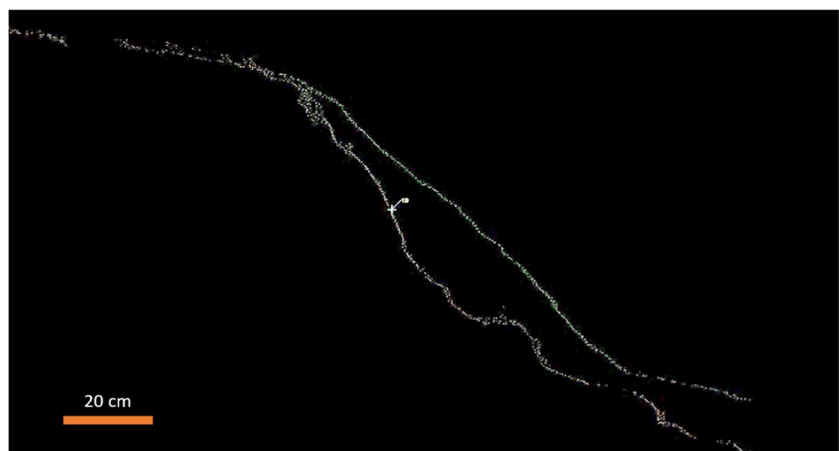
Fig. 22 Detail of riverbanks section profiles: the upper profile, acquired in October 2019 and the lower in January 2020

The processes measurements aimed at BHM according to the highest safety assessments established by Italian law require highly accurate observations to recognize even minor effects of structural stresses. However, in a dynamic situation, such as a riverbed, even macroscopic variations are evident due to phenomena of no exceptional nature. For example, a new, partial laser scanner survey campaign detects, on the banks, the erosive effects of the intervening flood (Fig. 22).

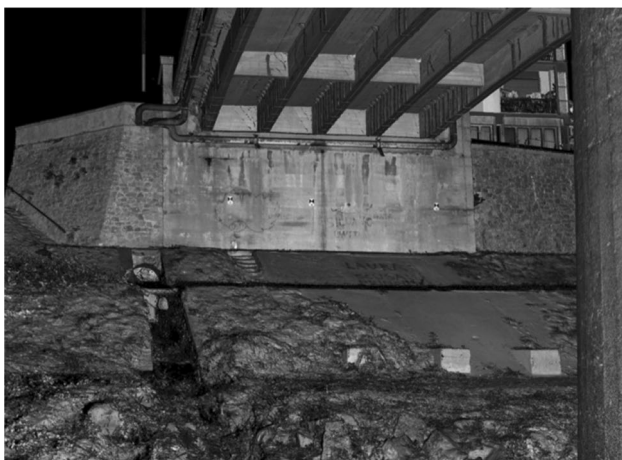
Fig. 23 TLS survey

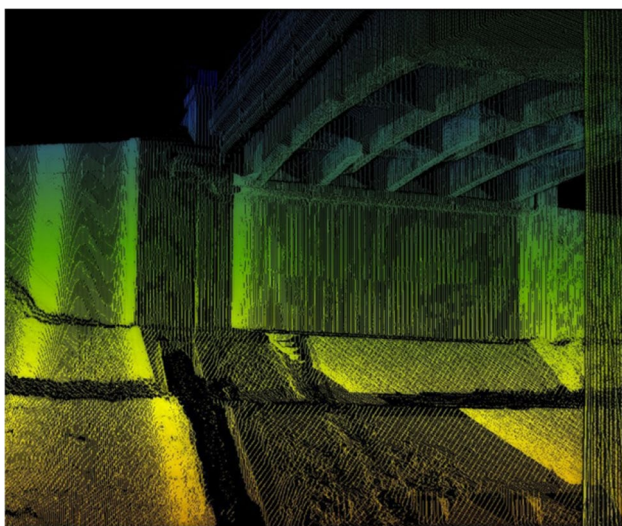
Fig. 24 Survey with profilometer mounted on the boat

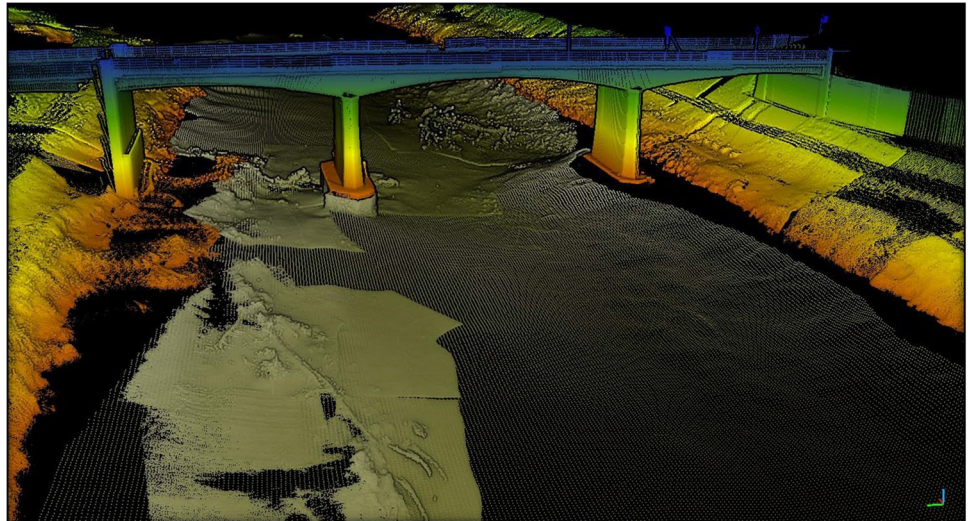
Fig. 25 Multibeam scanning of the riverbed with increased resolution in correspondence with elements of interest (from a minimum resolution of about 25 cm to a maximum of a few cm)

It allowed the assessment of the undermining that occurred at the piers' foundations (more relevant in the central pier of the bridge) and the possibility of recognizing the presence of stranded trunks on the riverbed, which are not visible from out of the water. The transport of significant vegetation constitutes a critical element in major floods, as it can obstruct the river's course.
