# Experimental archaeology and roundhouse excavated signatures: the investigation of two reconstructed Iron Age buildings at Castell Henllys, Wales

## Abstract

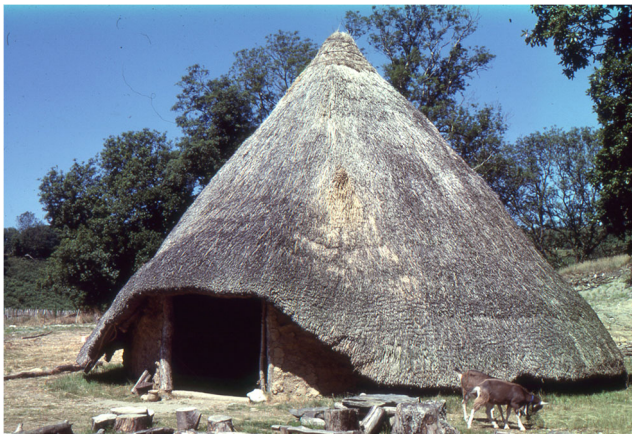
**Fig. 4** Cookhouse phase 1 from southeast, taken 1984

As the two door postholes were so massive and each held a deep-set timber upright, it was decided that the door lintel would be higher than the rest of the wall, creating an easier entry to the building and a change in angle for the roof at this point. The lack of wall plate did not create any difficulty with a raised door. The doorway faced southwest, and being larger in size, also increased natural light into the interior when the door was open (Fig. 4).

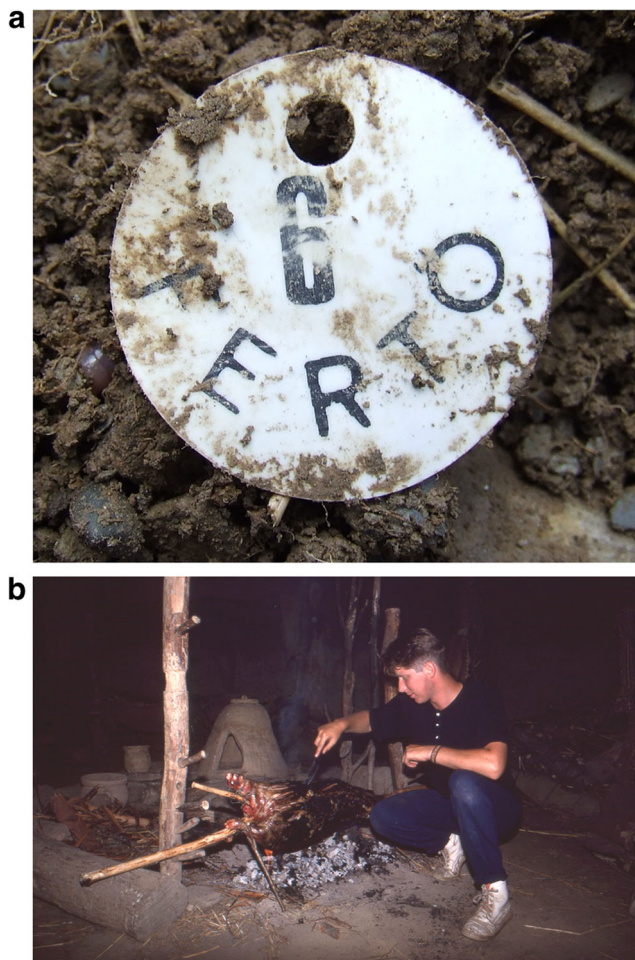
**Fig. 6** a Hungarian thatch tag from Cookhouse construction phase. b Hearth as reconstructed in Cookhouse phases 1 and 2

roughly circular hearth form without any formal edging, inspired by the excavated evidence (Fig. 6b). In phase 3 of the roundhouse reconstruction, this was replaced with a square design with upright shale slabs on the exterior and interior, creating a central space for the fire. This was not experimental in that it was not suggested by the archaeology. Its inappropriate design was rapidly demonstrated by its colonisation by rats which burrowed into the lower levels; this form of hearth left a distinctive archaeological signature, and rat skeletons were found in the burrows during the excavation following demolition. This demonstrates that this form of hearth was not used in the remote past and why. Whilst in use for a decade, there had been no infestation with the circular clay hearth set on some horizontally laid shale slabs.

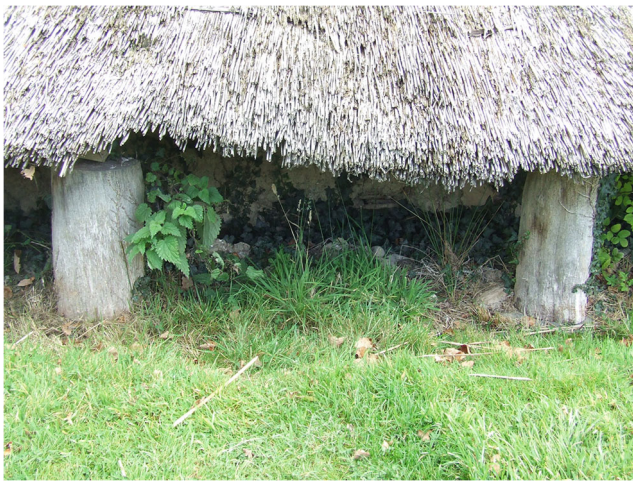
Fig. 9 Cookhouse Phase 4 wooden rafter props set on flat stones

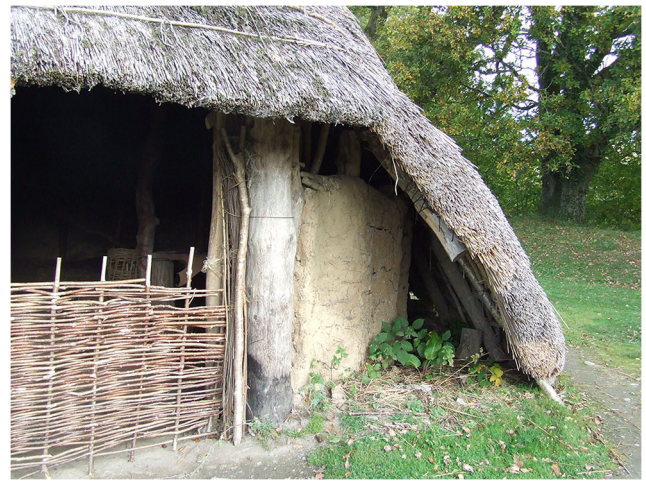
Fig. 11 Cookhouse Phase 4 rafters resting on the ground to east of doorway

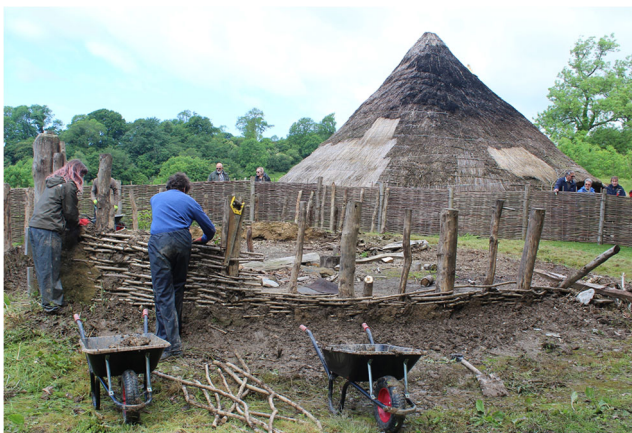
**Fig. 13** Partially standing Cookhouse wall with wattle and daub and slumped wall materials

The wall before the removal of the thatch was an intact daub wall which was structurally sound, albeit with cracks in the surface of the daub. After the thatch and rafters were taken off, parts of the walling rapidly collapsed as the rain weakened the daub. The daub initially slumped down the wall faces, exposing the already dry and weak wattle. The original upright timbers, rotted at ground level (see below), then fell over where the slumped daub was insufficient to hold these in place (Fig. 13). The wall collapse therefore created a mounded clayey deposit with high humic content along the line of the wall foundation, though with patches of wall falling, still attached to posts and wattle panels, away from the wall line. Parts of the wall were still standing when the excavation commenced, so this was carefully dismantled in the first part of the excavation. The wattle in the replacement wall section was still flexible and was in remarkably good condition, but the uprights, although intact, were already showing clear signs of rotting through at ground level. Those uprights from the original building were completely rotted through—the wall was by this stage largely a daub structure, and the timber uprights in this section was not providing any structural support, but the wall functioned perfectly well—this had not been the problematic part of the building.

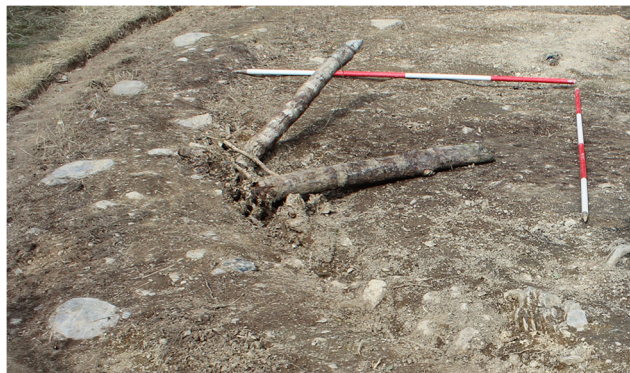
**Fig. 14** Decayed posts in postholes on the wall line of the original Cookhouse reconstruction; part below ground to the right

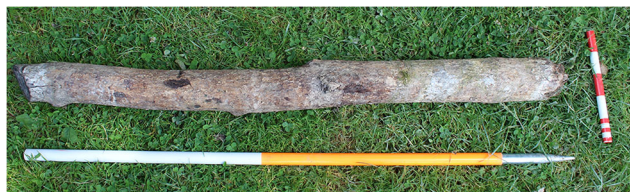
**Fig. 15** Timber removed from original Cookhouse reconstructed wall, with part below ground missing

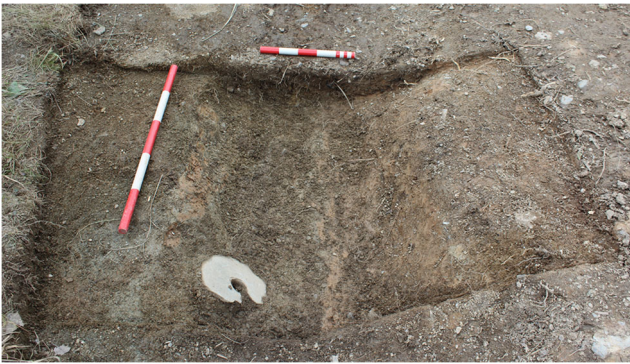
**Fig. 16** Filled up Cookhouse eaves drip gully under excavation, exposing a replica perforated stone

decayed to a humic loam), and where they were cleaned out—a process not maintained through the whole life of the roundhouse—they were not always dug on quite the same line and depth. Indeed, within the gully, some of the plastic discs were discovered that had been attached to the bundles of thatch that had to be imported from Hungary at short notice when Hugh Foster discovered that not enough local reed had been harvested to complete the roof. These had survived in the eaves drip gully fill for 35 years and represent items from the construction phase of the building. There were also other items including a replica perforated stone used as a loom weight in the reconstructions that belonged to the earliest

phase of use (Fig. 16), and evidence of visitor presence such as coins and sweet wrappers were also found, though not in large numbers because the infilling was relatively rapid.

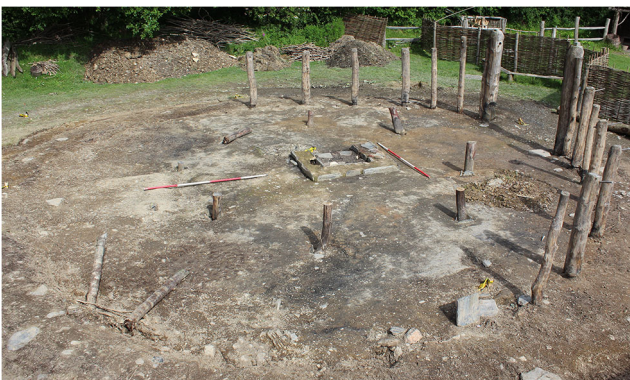
**Fig. 17** Excavation exposes the occupation deposits that accumulated within the Cookhouse roundhouse

locations over the 35 years; the leaves would decompose, and only the more recent introductions were still identifiable, but this shows how this protected micro-environment could create a distinctive deposit up to 0.03 m thick as an annular ring around the wall line (Fig. 17).

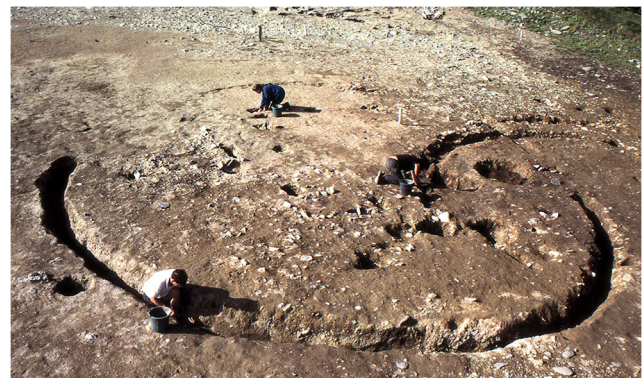
**Fig. 18** Earthwatch roundhouse under excavation, 1988

The roundhouse was therefore constructed with each upright cut to be of a length to match the location round the circumference. The timber species used for the different parts of the structure are set out in Table 1. The wall foundation trench was dug slightly deeper to take account of eroded ground surface and, in order to facilitate assembly of this unexpectedly complex design the posts were bedded slightly deeper than the wall trench, though this was not archaeologically attested. The trench was filled by a dedicated team ensuring the posts remained upright and before any wattling of the wall was possible. In the reconstruction, the wattling was completed before the wall plate was put in place as the tension in the hazel wattles made the wall extremely stable. The tops of the upright wall posts were then cut to make the pegs for the sections of wall plate to be slotted into place (Fig. 18).

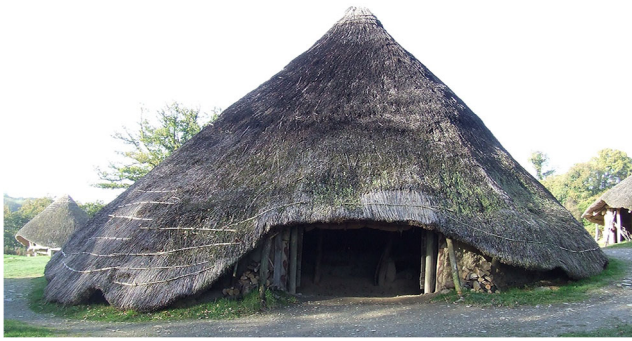
**Fig. 19** Earthwatch roundhouse doorway and asymmetrical roof profile, taken 2017

The roof of the roundhouse in plan was affected by the varied height of the wall, as it came close to the ground at all points. On the uphill side, this meant that the rafters extended only a short distance from the wall plate before they were close to the ground surface, whereas on the downhill side, they were much longer—especially as the ground was sloping away. This created a roof plan that was oval rather than circular and with an asymmetrical profile. It also meant that rafters had to be individually cut to the appropriate length for their position within the structure. The rafters began to be put in place as the daubing proceeded as this gave easier access to the wall surfaces. The long rafters on the downhill side extended a considerable distance from the wall plate and, particularly, when weighed down with thatching created a tension in the rafter timbers which was remedied by the use of angled timbers which ran from the exterior base of the wall and rested on the underside of the relevant rafter at an angle which helped support the weight of the thatch. These were wedged in after thatching, but they were no less effective for this. The door was constructed with two leaves which were set in shale pivot stones next to the door jambs. The area beneath the thatch—which appears asymmetrically in plan—also retained the trample from daubing and other debris, as had been the case with the Cookhouse (Fig. 20). A central oval hearth was surrounded by movable benching, though a practicable arrangement of the seating was soon developed which was then maintained over all the remaining phases.

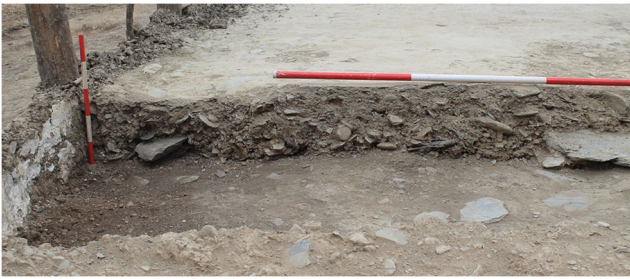
**Fig. 22** Deposits raising the Earthwatch roundhouse floor S of the central hearth and against the wall

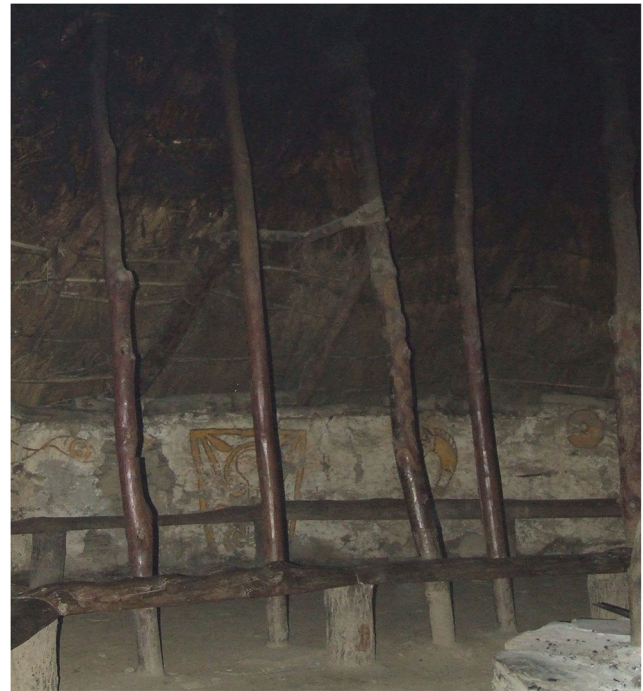
**Fig. 24** Earthwatch roundhouse interior with benches round hearth set on the raised floor which has encased the rafter prop bases and hidden their stone pads, taken 2017

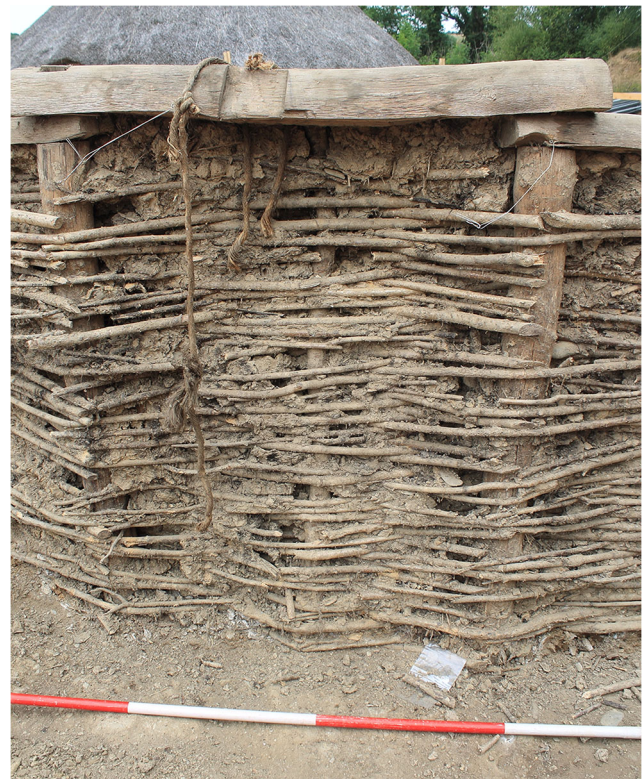
**Fig. 25** Earthwatch roundhouse wattle wall exposed after the removal of the exterior daub

The wall on the northern half had been completely dismantled and removed prior to the excavation, but the higher southern portion remained in place. As the wall had not been rebuilt at any point, it was a valuable opportunity to examine a length of intact 30-year-old walling as preserved beneath the thatched roof. It was notable how the wattle survived within the daub wall to a remarkable extent visually (Fig. 25), but it was structurally no longer effective as whilst the bark remained, the interior had been completely turned to powder by woodworms. The daub had provided the structural integrity for the building as the uprights had rotted away below ground, although the above-ground portions of the wall uprights and the wall plate remained intact, affected by woodworm to a lesser extent than had been the wattling.

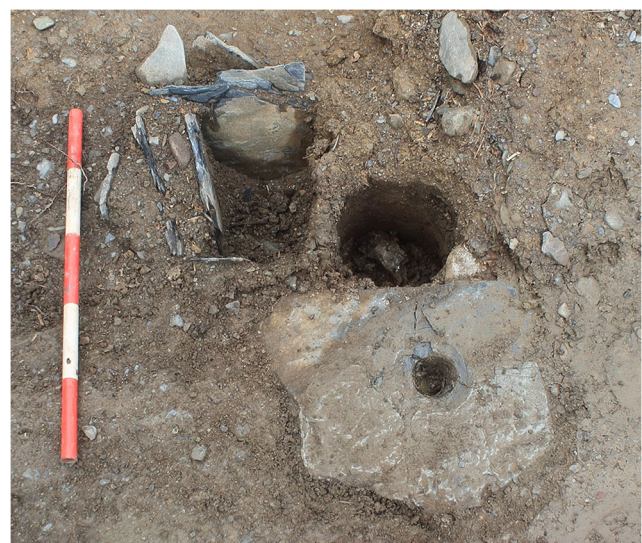
**Fig. 26** Earthwatch roundhouse pivot stone for the door with postholes for replacement door jamb supports

The doorway had experienced several different designs of door, always twin doors each affixed to a door jamb because of the door way width and also because of the slope of the ground. Opening outwards was not possible because of the overhanging thatch, and a single large door would have been wedged against the interior rising ground. The doors were set within perforated shale slabs forming pivot stones, and these survived in situ and were archaeologically recovered (Fig. 26), though one was cracked from the pressure of the door's weight and could not be retained. Over the use-life of the roundhouse, additional posts were placed adjacent to the door jambs to support the doorframe, and reused timbers were used as props, though leaving no subsoil mark. As the door was the only place where the eaves ended some distance from the

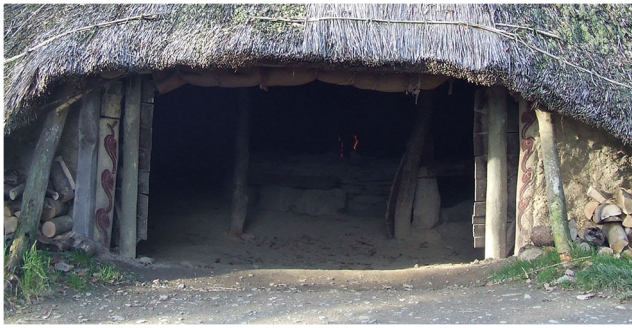
**Fig. 27** Earthwatch roundhouse doorway modifications supporting the decorated original door jambs, taken 2017; note the naturally-formed eaves drip gully across the threshold

ground, and because footfall through the entrance prevented vegetation growth, it is the only part of the perimeter of the building where a slight eaves drip gully formed without any human intervention, whilst immediately inside the doorway wear of the floor surface was substantial (Fig. 27).
