3D photogrammetry as a tool for studying erosive processes at a Roman coastal site: the case of the Roman fish-salting plant at Sobreira (Vigo, Spain)

Abstract

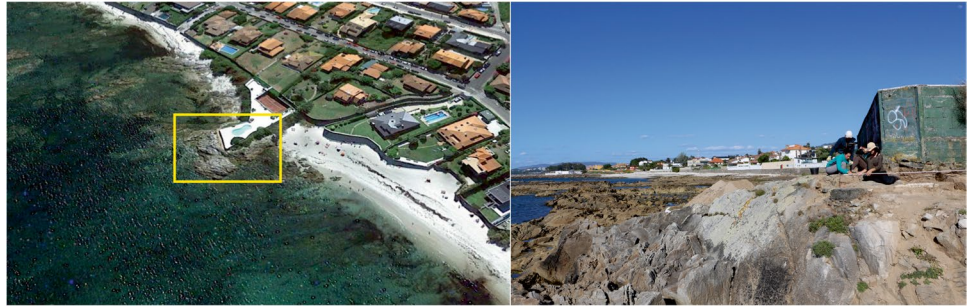
Fig. 5 Left: aerial view of the site of Sobreira (Google Earth). Right: photo taken during the archaeological works, where it is possible to see the relation between the site and the sea

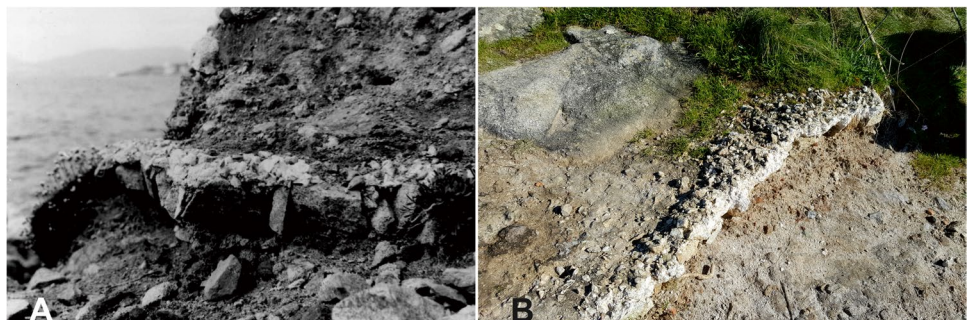
a quartz mortar pavement sitting on a layer of granite blocks laid out diagonally; these features were covered by a layer of soil, several centimetres thick (Fig. 6A). The photographs also illustrate a large wall built with

Fig. 6 **A** Mortar remains covered by a thick layer of soil in 1984 (Photo: Museo Municipal Quiñones de León, Vigo). **B** The same mortar feature in May 2016

The first visit to the site in 2016 revealed that the conditions of the site had changed considerably since its discovery, to the point that the northern sector was in danger of imminent destruction. The area located between the swimming pool and the sea had been used as a pathway, and this had severely eroded the surface. The mortar pavement, which in 1984 was still under a layer of soil (probably the mortar lining of a salting cistern), was being used as a step by beachgoers to travel from one beach to the other (Fig. 6B).

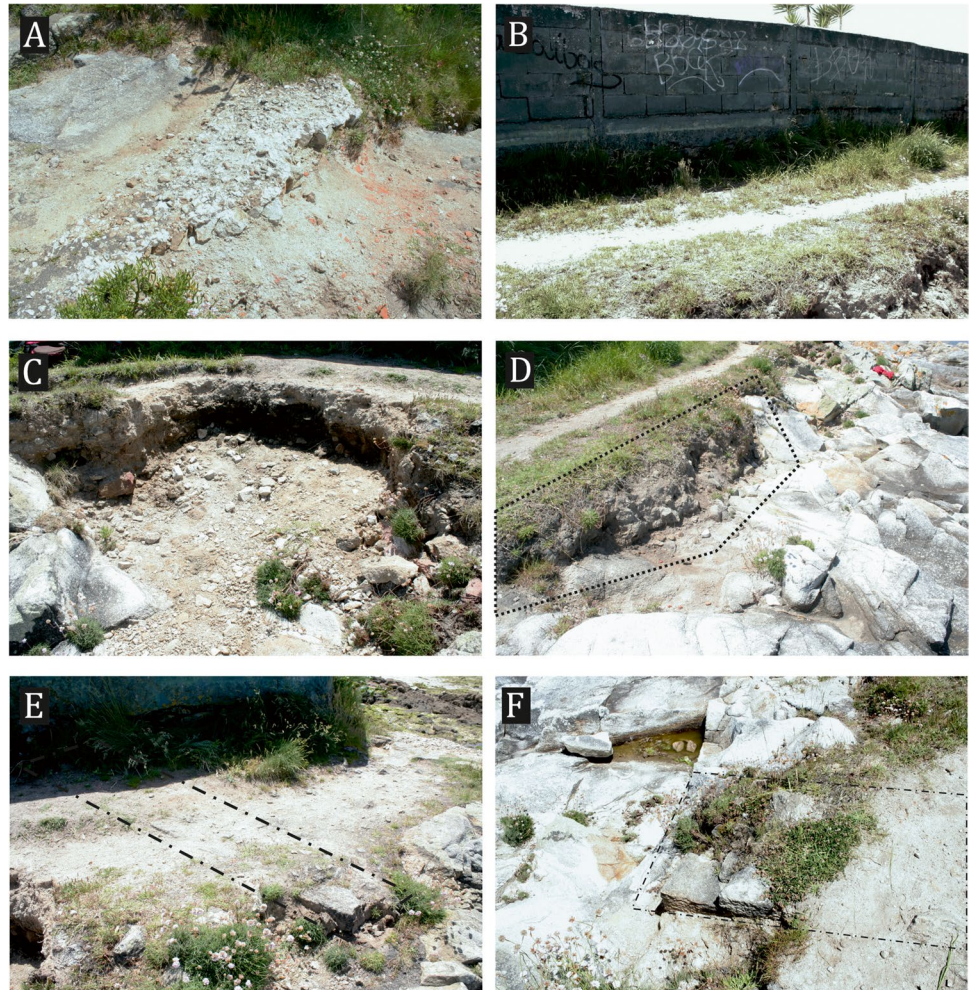
Fig. 7 Location of the affected areas, whose degradation was noticeable during the visit to the site in 2016. (A) Partially destroyed mortar; (B) presence of weeds; (C–D) loose of material in the front side of the path; (E–F) visible and exposed walls

Although some of the erosive processes affecting the site were plainly visible (Fig. 7), it was deemed necessary to monitor them, allowing us to detect less obvious processes. We were thus able to determine the exact nature of the threats and the associated erosion rates. The methodology followed consisted of taking one photogrammetric model of the site and another 1 year later, as this would theoretically allow us to measure the effects of erosive processes upon the site accurately.

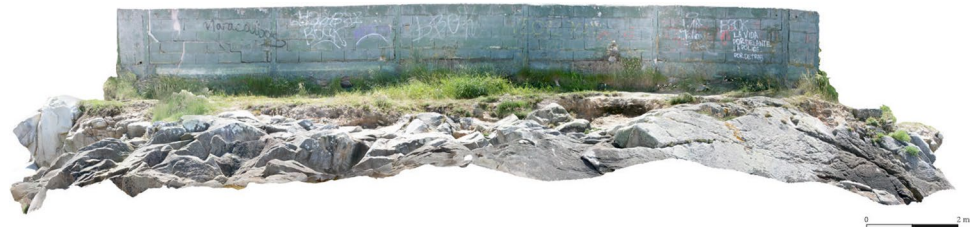
Fig. 8 Frontal view, from the north, of the first 3D model for Sobreira, which clearly illustrates the rugged nature of the terrain

Both sequences followed a linear pattern. Photographs were taken along a line with a separation interval of approximately 1 m, and a minimum overlap of 60–70%. Photographs were taken from east to west and from west to east along the pathway that crosses the promontory, resulting in a full photographic sweep of the site. Areas which were deemed to be blind spots, especially several sectors of the rocky outcrop, were photographed separately. In order to ensure that the whole site was covered, additional photographs were taken from farther away, resulting in general overviews that facilitated the assembling of different photographs to generate the final model (Fig. 8).

In both cases, the final texture applied the highest resolution settings that the equipment in use could handle (Fig. 8), to ensure a high visual quality for both models. Similarly, the models were oriented through three ground reference points—located in specific spots of the rocky outcrop and the visible structures of the factory—that worked as GCPs (Table 2). The terrestrial reference system used was ETRS89/UTM zone 29 N (EPSG: 25,829).

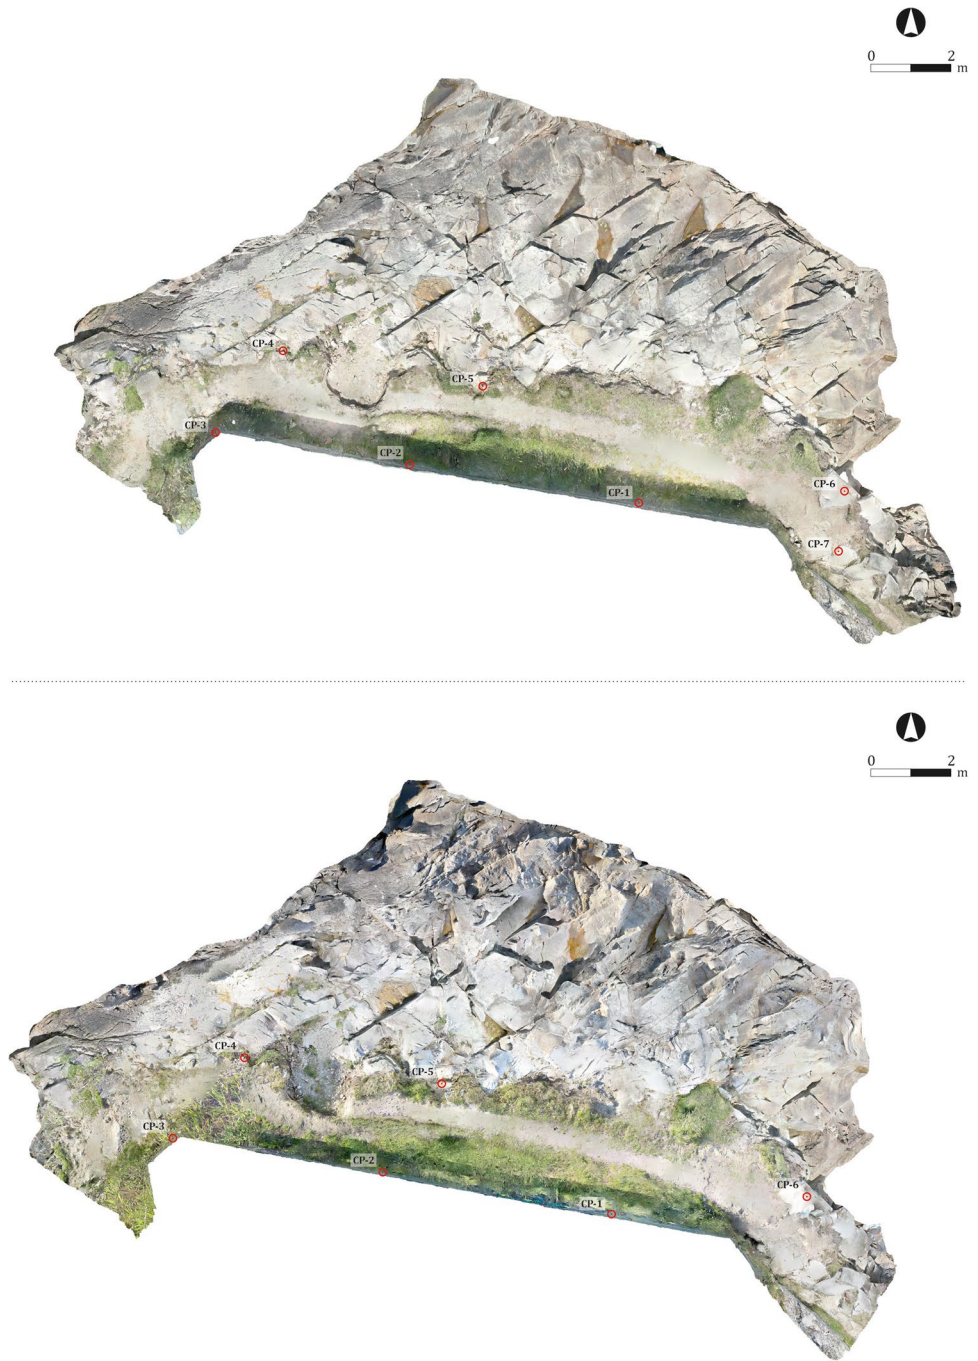
Fig. 10 Photogrammetric models of the site of Sobreira with the distribution of the GCPs. Above: 3D model realised in 2016 of the site of Sobreira; below: 3D model realised in 2017

undertaken at medium resolution (Table 1), as it was enough to create detailed and still manageable models. As illustrated by the figure (Fig. 10), some sectors—characterised by the presence of dense vegetation or flooded areas—could not be adequately modelled, leading to small errors in the final mesh. These inadequacies, however, did not hamper the comparison of the models.

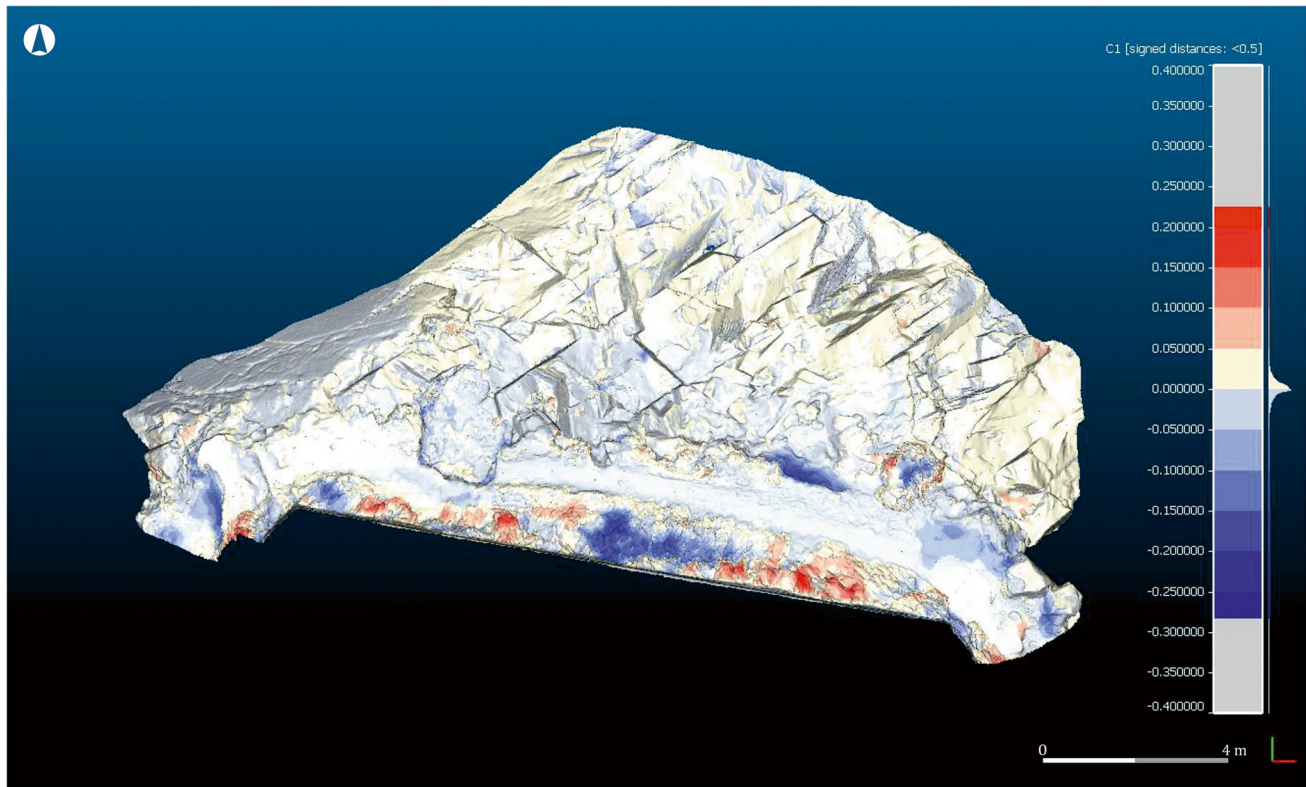
Fig. 11 Model C1, where the loose (blue) and gain (red) of material can be seen, using as base for the representation the Sequence 2 (2017)

The measure of the variations produced to the terrain by the erosion was carried out establishing a regulated distance between both meshes of less than 0.5 m, as it was verified that none of the changes exceeded this measure. This way, CloudCompare® could quantify the addition of materials up to 50 cm and the loss of ground till minus 50 cm. The results were expressed by means of a colour scale, that depicts the differences measured in metres between the ground morphology of both models. The chromatic range of this scale was limited to red-yellow-blue, where red represents areas in which there has been an addition of material, and blue those in which there has been a loss of material. The intensity of the colour expresses the intensity of the associated process. This model was designated as C1 (Fig. 11). Using the same

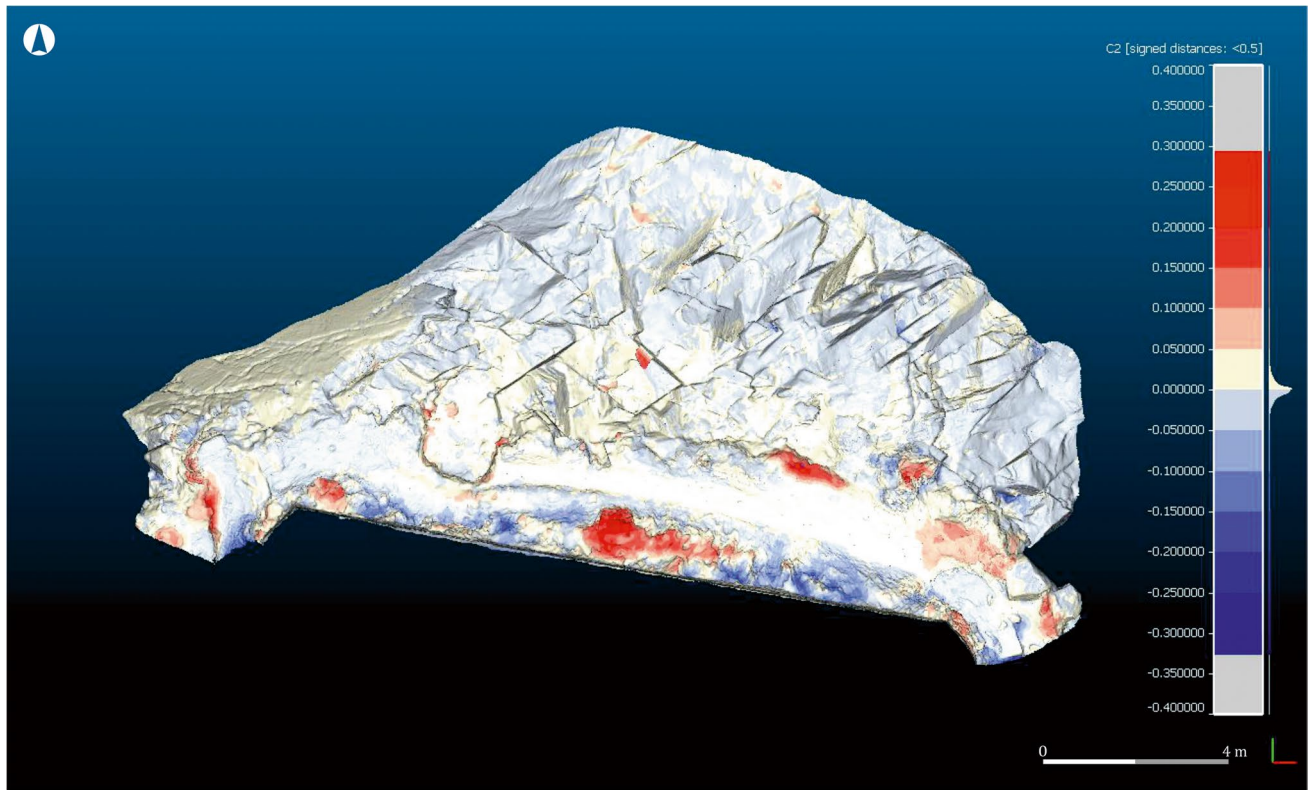
Fig. 12 Model C2, where the loose (red) and gain (blue) of material along one year can be seen, using as base for the representation the Sequence 1 (2016)

parameters of distance and chromatic scale, a second comparative model was generated, inverting the position of the sequences. As such, Sequence 2 became the base model, and Sequence 1 the comparison model. This allowed to identify some of the changes undergone by the site over the course of the year, not clearly visible in C1. This new comparison model was designated as C2 (Fig. 12).

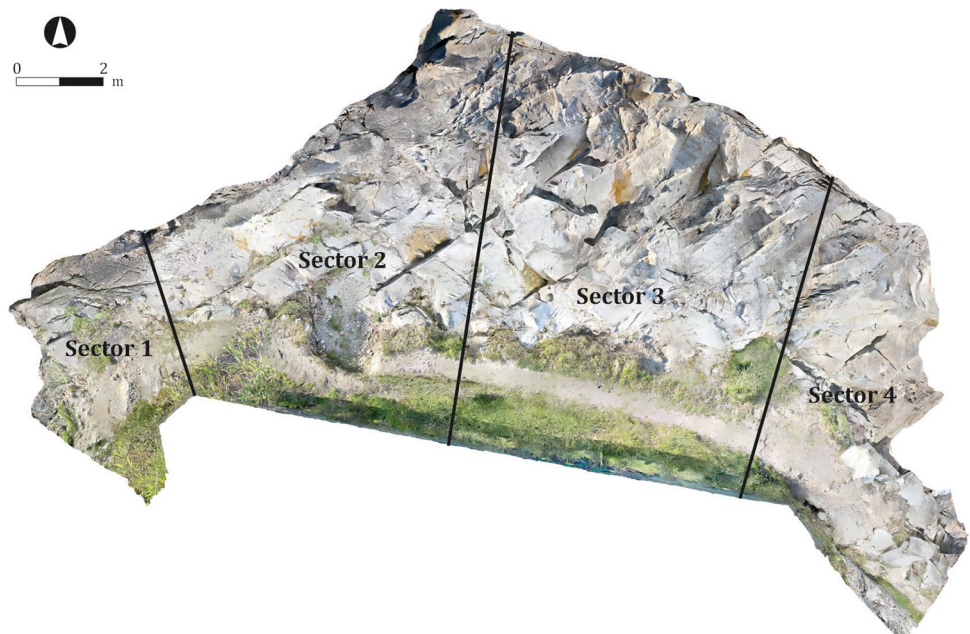
Fig. 13 Compartmentalisation of the site for its detailed analysis

The results fully confirm the initial on-the-ground observations, while also highlighting other processes that are not visible to the naked eye. Between May 2016 and May 2017, the site was affected by marine erosion as well as by other human and natural factors. A slight loss of volume on the north-eastern face of the rocks is attested (light blue), as well as at other sectors of the site, especially in the western quartz pavement, some areas of the pathway and the layer of soil that still partially cover the rocky outcrop (dark blue). The site was divided into four sectors (1–4) for more in-depth analysis. From left to right (west to east), the following situations are attested (Fig. 13):

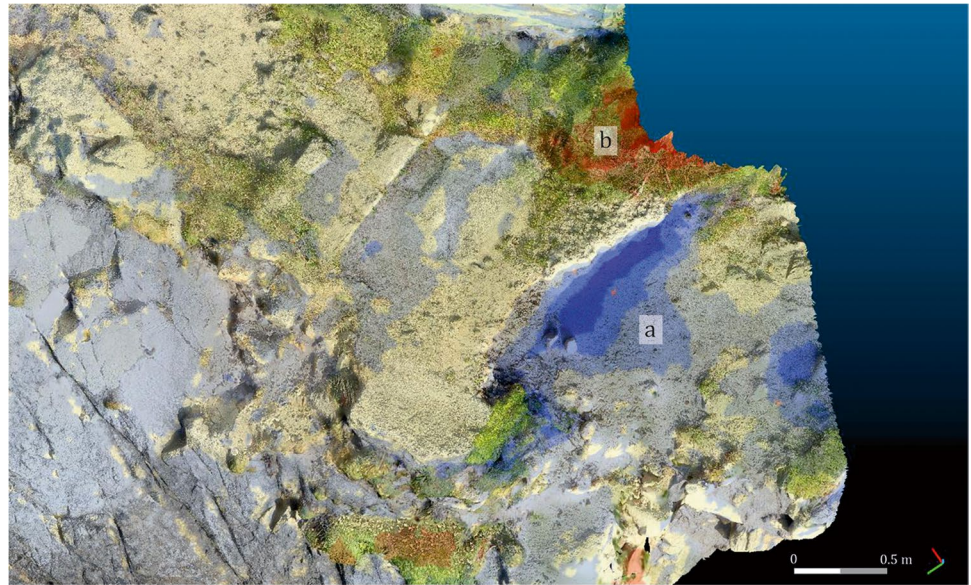
Sector 1: In this area, the Roman period fills that level out the north-western corner of the building and the quartz mortar belonging to a salting cistern have suffered severe losses (Fig. 14a). Total losses amount to 0.067 m^3 , with the mortar being especially affected: a loss of several centimetres in thickness was noted. The area is exposed to wind

erosion and, occasionally, to the direct impact of the sea, which sometimes rises to this level. However, the most important factor for this sector is the transit of humans and animals between the beaches. The steep slope also exacerbates the effects of erosion, as the mortar is used as a step. A marked increase in the volume of vegetation is also attested (Fig. 14b).

Fig. 14 Detail of the changes produced in Sector 1, using as reference the model C1. Areas with loose (a) and gain (b) of material. Oblique view from the northwest

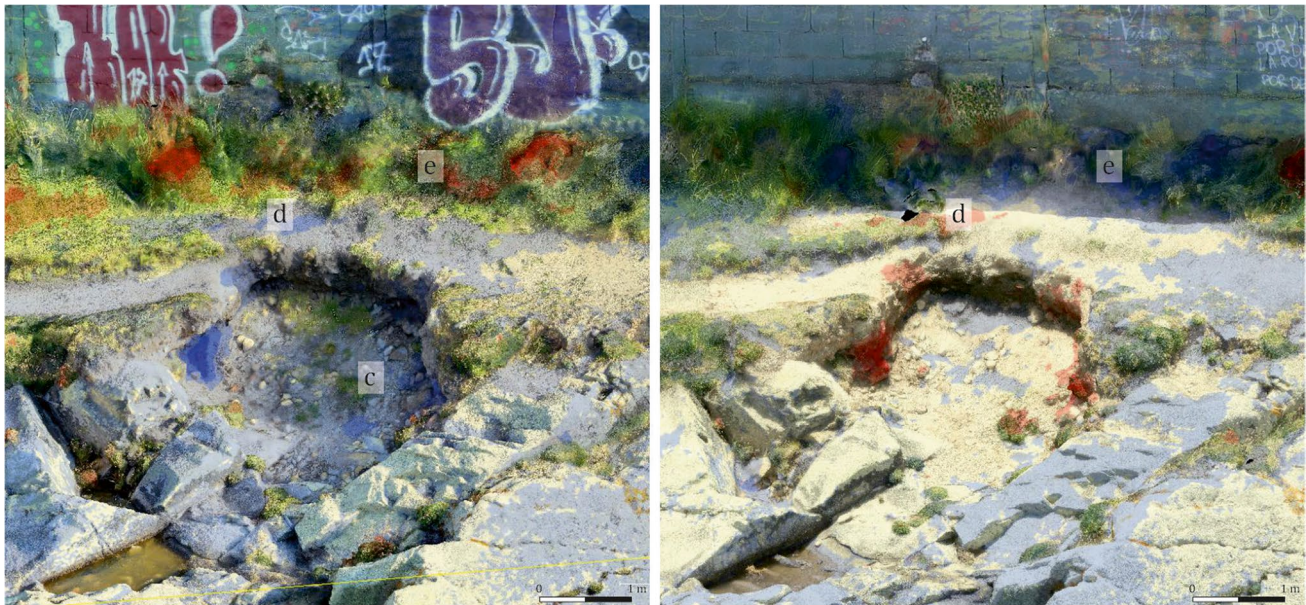
Sector 2: In this area, the topsoil that sits over the rocky promontory, covering the site, has suffered extensive losses. Especially affected is the sinkhole located in the central area of the sector, as the comparison of both models clearly reveals (Fig. 15c). The losses are severe, amounting to approximately 0.35 m^3 of soil. In addition, the area around the pathway has suffered moderate losses (Fig. 15d), owing to the decreasing width of the thoroughfare caused by the loss of material. The increase in vegetation in this sector (Fig. 15e) is remarkable, especially in the area surrounding the chalet's walls.

Fig. 15 Detail of the changes produced in Sector 2, using as reference the model C1 (left) and C2 (right). Areas with loose of material (c) and (d), area with a gain of material (e). Oblique view from the northwest

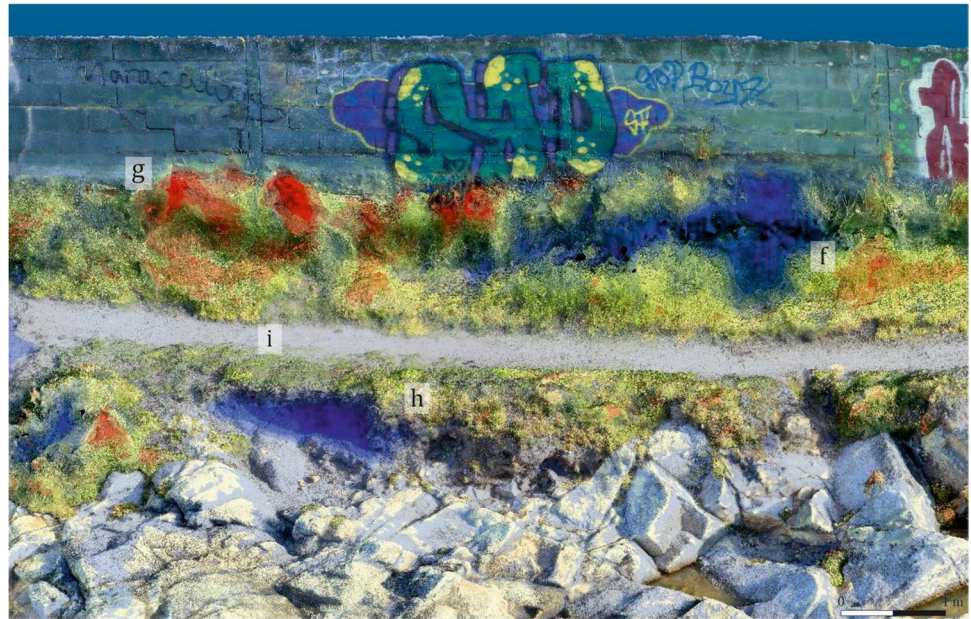
Sector 3: In this area, the sector attached to the chalet's wall has suffered considerable losses (Fig. 16f), while vegetation has proliferated to a great extent (Fig. 16g). Important losses are also detected in the sea-facing front (Fig. 16h), and moderate losses in the pathway area (Fig. 16i).

Fig. 16 Detail of the changes produced in Sector 3, using as reference the model C1. Areas with a loose of material (**f**), (**h**) and (**i**); areas with a gain of material (**g**). Frontal view from the north

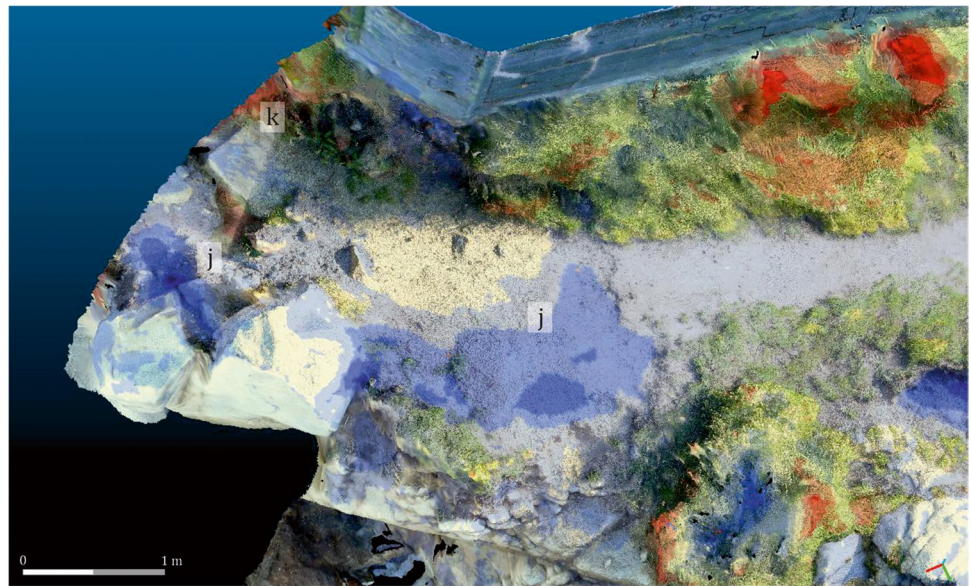
are attested in the eastern corner and the whole eastern sector more broadly (Fig. 17j), while some areas present evidence of gain (Fig. 17k), probably owing to the displacement of eroded material from the blue areas.

Afterwards, a draining channel running from the swimming pool, which operated as an added erosive agent, was detected. A considerable increase in vegetation is also attested.

Fig. 17 Detail of the changes produced in Sector 4, using as reference the model C1. Areas with a loose of material (**j**) and áreas with a gain of material (**k**). Oblique view from the northeast

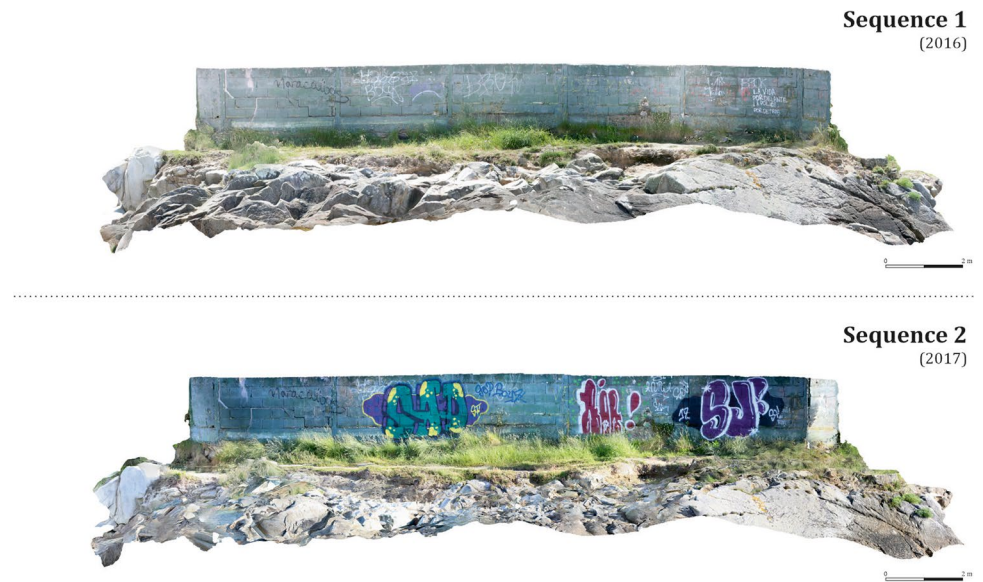
In general, a substantial increase in vegetation is detected over the whole site, especially around the perimeter wall that marks the boundaries of the private property, as well as other smaller areas scattered throughout the site. These are the areas where the sea has deposited new soil material (Fig. 10). Also clear is the generalised degradation of the most exposed areas of the rocky promontory (light blue). Finally, although this cannot be visualised using our methodology, the generation of the model also allowed us to detect an additional cause for concern: the ongoing graffitiing of

the wall surrounding the private property, as reflected in the photographic sequences (Fig. 18).

Fig. 18 Changes and anthropic aggressions suffered by the site, visible after the processing of both photogrammetric models. Frontal view of the models, from the north

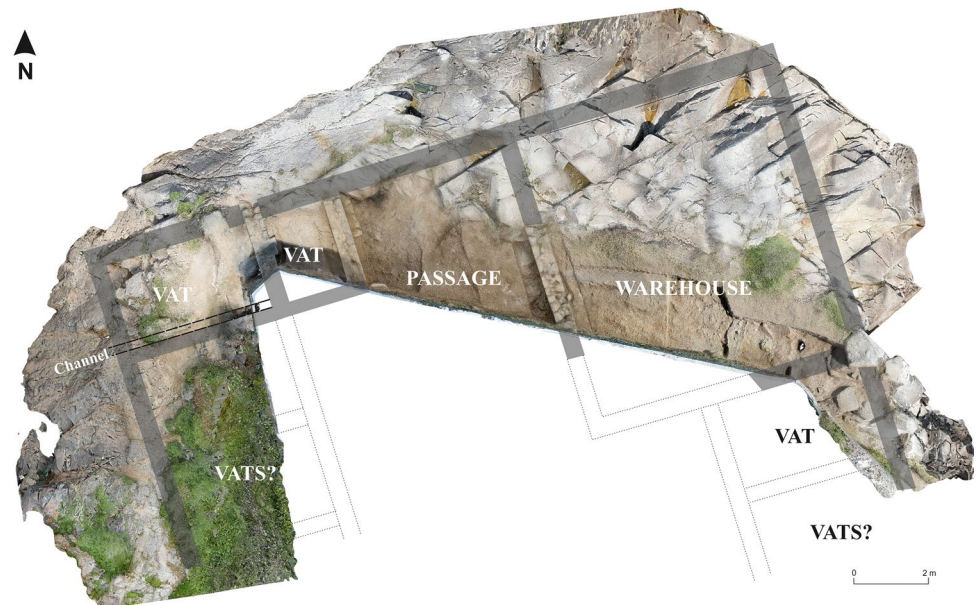
Fig. 19 Plan of the factory

The final plan of the factory shows probably only a small part of the building, being the north part destroyed by the action of the sea and the southern by the construction of a chalet's swimming pool and a tennis court (Fig. 22). However, this small part of the building suggests that it could

be a factory with a "U" shape or with a longitudinal plan. If Sobreira had a "U" shape, a common factory model in the Rias Baixas, visible for example in Bueu (Díaz García 2015; Fernández Fernández and Díaz García 2017), the vats would be located to the east and the west, with an empty central area, used as a courtyard. However, the disposition of the walls and the vats (Fig. 19) indicate that the factory had a rectangular or longitudinal plan located over the rocky outcrop, with a battery of vats on both long sides—east and west—that would finish in the western corner, attending to the presence of a small vat in the northern façade, acquiring, therefore, an "L" shape. A corridor would allow access to the vats and the north-eastern corner could be occupied by a warehouse (Fig. 19).

Given the severe threats to the fish-salting factory of Sobreira, it seemed necessary to undertake an archaeological excavation to record features and materials. This involved traditional archaeological recording methods and photogrammetry, which were used to produce detailed plans and a 3D model (Fig. 19), as well as a large number

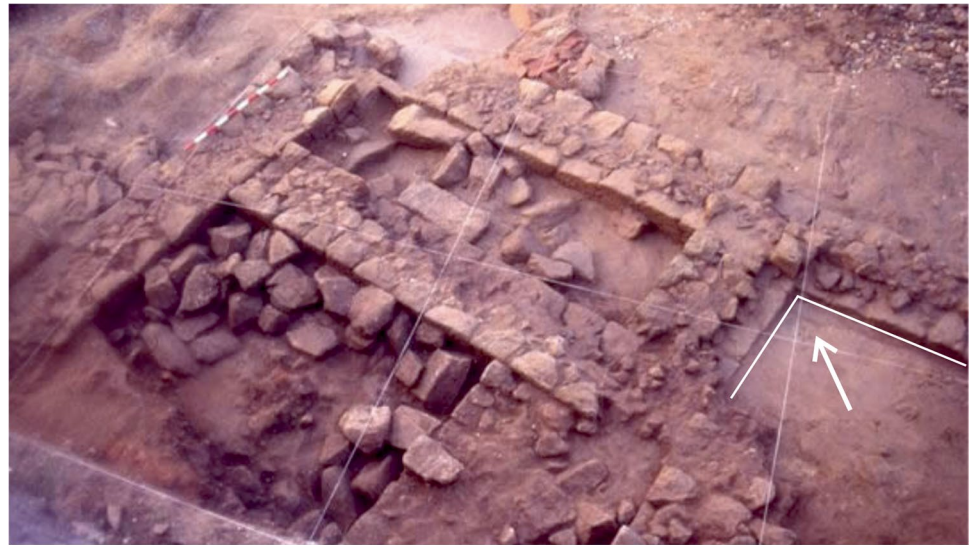
The excavation also revealed the depth of the structures and important parts of the complex, such as the aforementioned channel between the passage and the sea, as well as the presence of reinforcing walls near the vats—a type of feature also observed by us in other Galician fish-salting

Fig. 20 Reinforcement in the foundations of the walls in some fish-salting factories: O Cocho (Author: J.M. Hidalgo Cuñarro; Archive: Quiñones de Leon Museum)

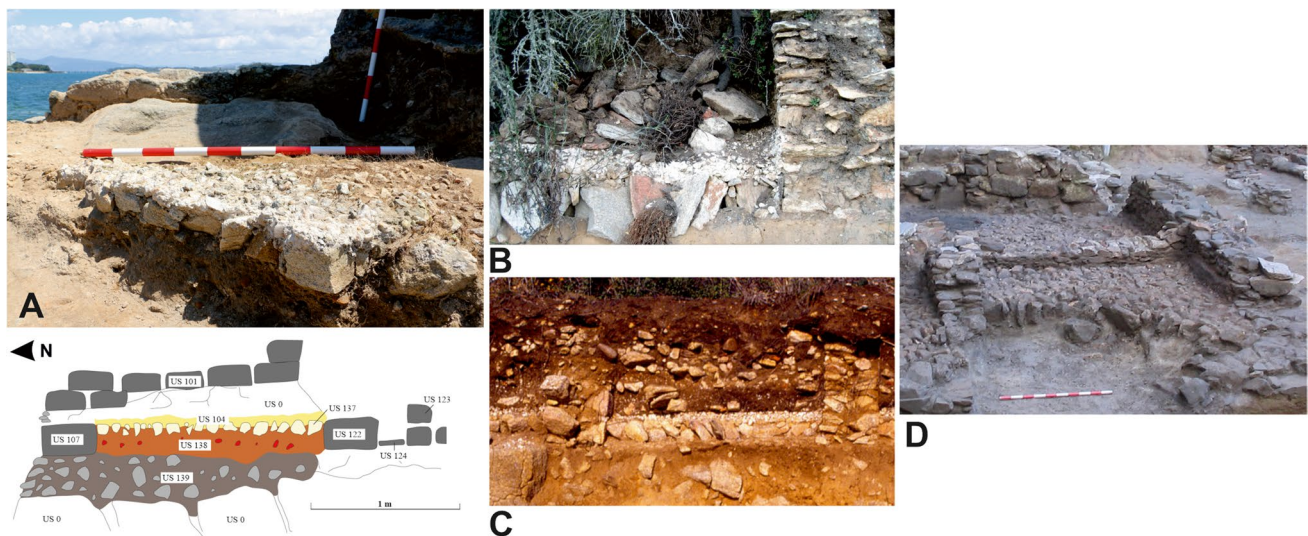
Fig. 21 Example of the construction of a vat. (A) Photo and stratigraphic cut of one of the vats from Sobreira; (B) a vat of the factory of Canexol (Ons); (C) stratigraphic cut of a vat of Cariño; (Cariño) (D) foundation with rammed stones inside a vat of Praza de Compostela (Vigo)

factories as Fiunchal, Marqués de Valladares or O Cocho (Fig. 20). The constructive system of Sobreira's vats can be found also in other factories, as O Canexol, Praza de Compostela or Cariño (Fig. 21). Once the walls were constructed, an inside foundation is created through granite blocks rammed in a diagonal axis, covering them with a limestone and quartz mortar. Finally, the walls are covered with a thin limestone mortar, completely lost in Sobreira, but still visible in other factories as Adro Vello.

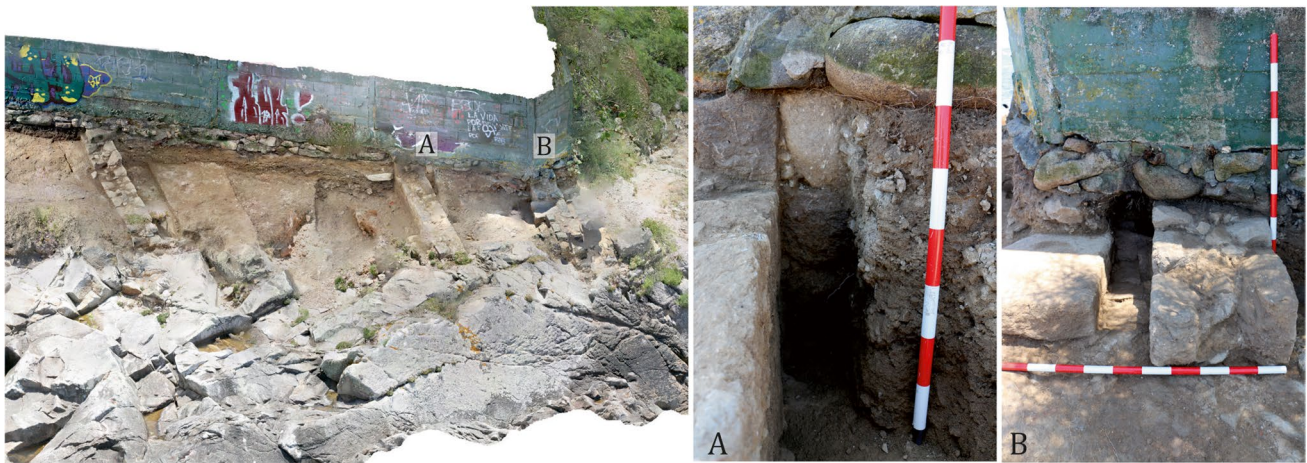
Fig. 22 Detail of the excavated area, where it is visible how the roman walls run under the enclosure of concrete slab of the swimming pool

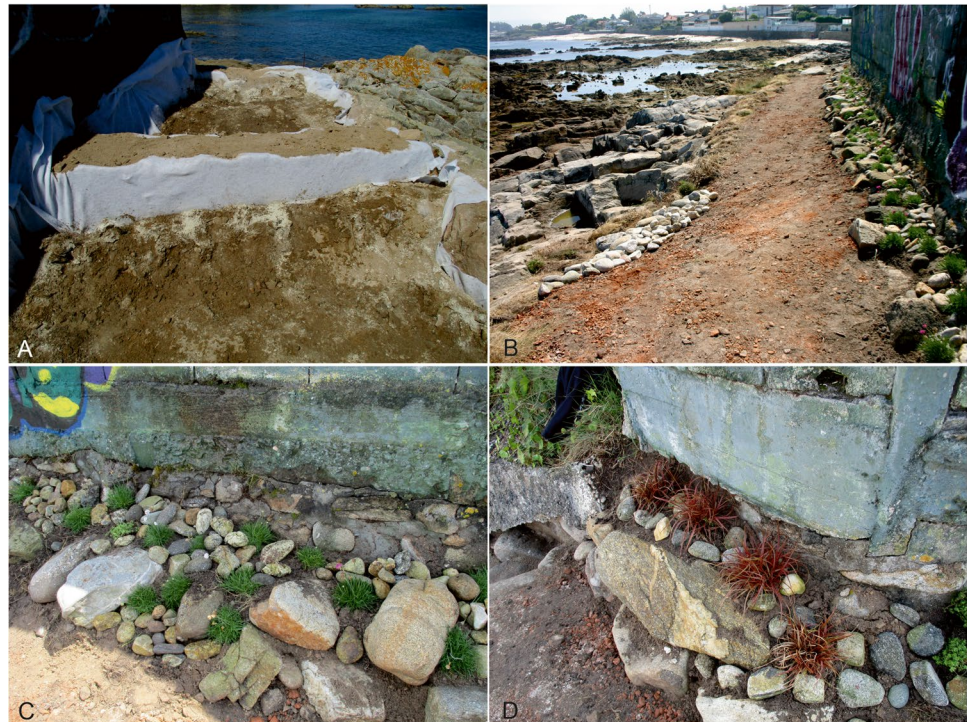
Fig. 23 **A** Construction of protective structures. **(B)** Final result after the conservation-restoration process. **(C and D)** Detail of the species *Festuca glauca* and *Uncinia rubra* used to stabilise the terrain

After the excavation, measures were adopted to address the deterioration processes and give the site as much protection as possible. Protecting the structures from marine erosion was urgent: although erosion cannot be completely halted, the construction of two small walls with stones collected on site reduces its impact upon the standing structures. Furthermore, it was necessary to undertake measures to reduce human impact, which was very intense because of the path that links the beaches. Since it was impossible to stop people from using it, the path was covered and repaved, raising it by about 30–40 cm with soil from the site, bricks—from the Roman villa of Toralla—and limestone, in the hope that this will progressively stabilise the terrain and protect the structures. Also, in order to consolidate the new path and the surrounding terrain, the edges of the path were planted with undergrowth. Currently, at both ends, the path is accessed through newly built stone and mortar steps specifically laid down to protect the quartz mortar in the western corner (Fig. 23).

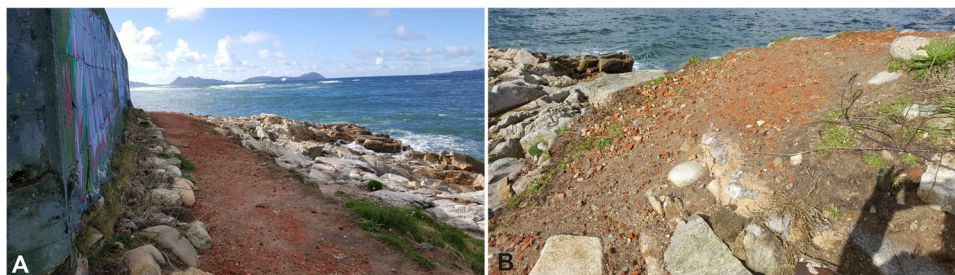
A visit to the site in March 2018, a year after works came to an end, revealed that, despite the work of the conservators, human action, and especially marine erosion, has continued to damage the site in the same areas in which their action had been attested previously. These factors, which are to a large extent inevitable, make it likely that the site will disappear in the near future. The measures that would be necessary to fully prevent this, for instance the construction of a concrete dyke, would have an enormous visual and environmental impact. It is for this reason that monitoring the site and the archaeological works undertaken as a result is so important: by monitoring carefully, we have been able to collect crucial information about the site, and the preservation measures have added a few more years to the life of this exceptional site. As the adoption of effective measures for the long-term preservation of the site is unfeasible, the 3D models will at least preserve a semblance of the site's original morphology, and the data collected will be useful in monitoring similar processes in comparable sites, in informing mitigating

Fig. 24 **A** View from the east of the intervention area, taken in March of 2018. **B** Detail of the mortar area, where the loose of material can be seen

The visit to the site, a year after the finalisation of the works, demonstrated the positive effects of the measures undertaken (Fig. 24). In addition to collecting important historical and archaeological data, the project has contributed to palliating the effects of erosion on the structures. Although the effects of erosion continue (loss of soil and of structural volume), the situation is much improved and the site will survive for years, unless weather conditions take a violent turn for the worse.
