Road safety audit on a major freeway: implementing safety improvements

Purpose The paper presents (i) the method followed in a road safety audit of Attica Freeway (“Attiki Odos”), (ii) the findings and recommendations which arose from the RSA, (iii) the improvements made by the freeway operator to improve safety, and (iv) the pilot safety treatments which were proposed with a view to broader implementation in order to mitigate similar problems at other locations.

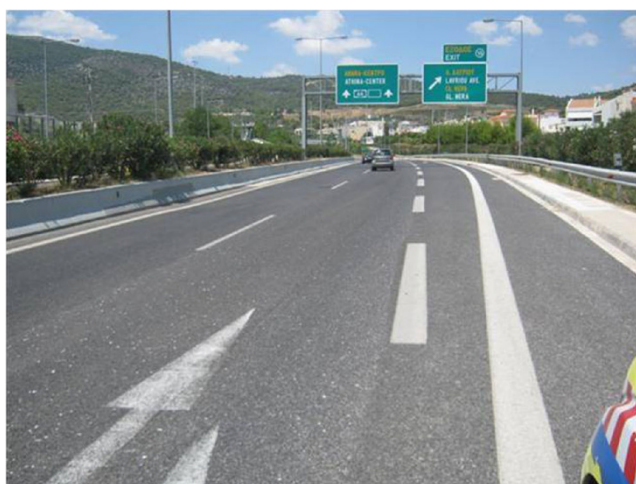
Fig. 1 Old marking

The road marking was faded at certain locations, while old markings controlling temporary traffic had not been removed effectively (Fig. 1). Improvement of road markings was recommended since ineffective markings could cause course

deviation and driver behavior problems especially in a high speed environment as a result of inadequate warning and guidance. The use of a high-quality retroreflective material effective in rain and darkness with adequate skid resistance characteristics was recommended. Priority of implementation was recommended for horizontal curves and transition points.

- Shot blasting technique was used for old markings elimination and road skid resistance improvement
- Speed limits were displayed on VMSs at tunnel entrances as well as in tunnels.
- Speed limit signs were installed in tunnels and at tunnel entrances (gantries), with special consideration to tunnels with visibility restrictions due to operating speeds exceeding the speed limit.

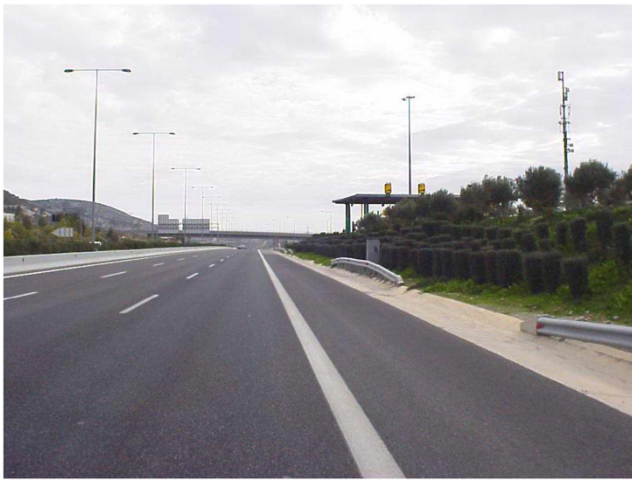
Fig. 2 Short break in guard rails

The RSA team identified locations where the roadside barrier was interrupted for a short distance. This would cause an errant vehicle entering the unprotected zone to be “trapped”, with no possibility to retain control and crash into roadside obstacles behind the barriers. In addition, there were sometimes no safety barriers in front of roadside obstacles such as lighting columns, pipes in tunnels and electrical and mechanical installations. Such features cannot be removed, while at these locations maintenance activities by technical personnel take place regularly. The team recommended the installation of restraint systems to fill the short gap between consecutive barriers – ensuring safety-barrier continuity – and in front of road equipment (Fig. 2).

The installation of a concrete barrier of appropriate height and length and special treatment of transition areas between the different types of restraint systems was recommended.

- Continuity of roadside safety barriers at locations where there are short gaps between consecutive barriers and installation of road safety barriers in front of road equipment inspected regularly by roadway personnel.
- Special treatment of concrete safety barriers in close proximity to bridge abutments, columns or walls, accompanied by appropriate transition between the various types of restraint systems and linear delineation before and after bridge structures.
- Installation of a “skirting” to road restraint systems, especially on tight curves, for guidance and protection of motorcyclists. The red and white protective system has gradually been implemented over the last three years in combination with speed limit signing.

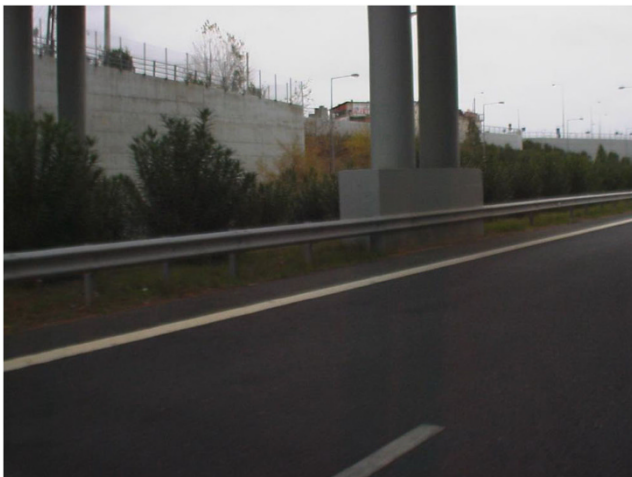
Fig. 3 Bridge column in contact with guard rail

During the RSA, the team identified some locations where bridge abutments are almost in contact with the restraint system. Similarly, there was almost no space between the safety barrier and the bridge column

(Fig. 3). In the case of a vehicle collision with the restraint systems there would be not adequate space allowing effective absorption of the kinetic energy.

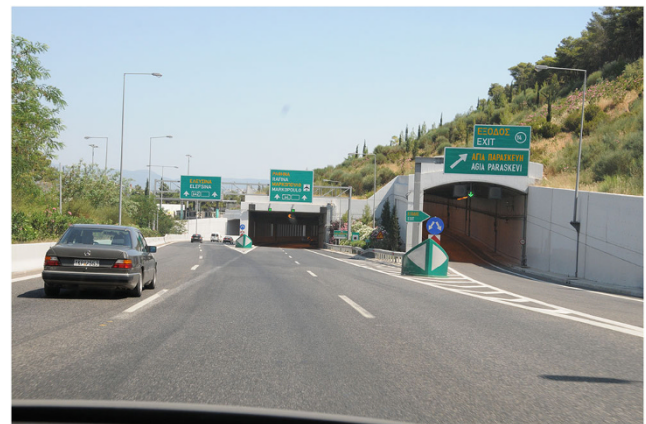
Fig. 4 Optional lane split to Eleusis and airport

A freeway split is located downstream from an entrance and a sight-restricting horizontal curve (Fig. 4).

- Improved guidance and warning of upstream freeway split with an optional lane where there is the potential of drivers' expectancy violation. Proposals include measurement of skid resistance (and improvement if necessary); elimination of old markings; installation of advance warning signs within the tunnels; installation of rumble strips before and after a sight-restricting horizontal curve; installation of speed limit signs and speed radar for speed limit enforcement; installation of a crash cushion at the split point in front of tunnel walls.

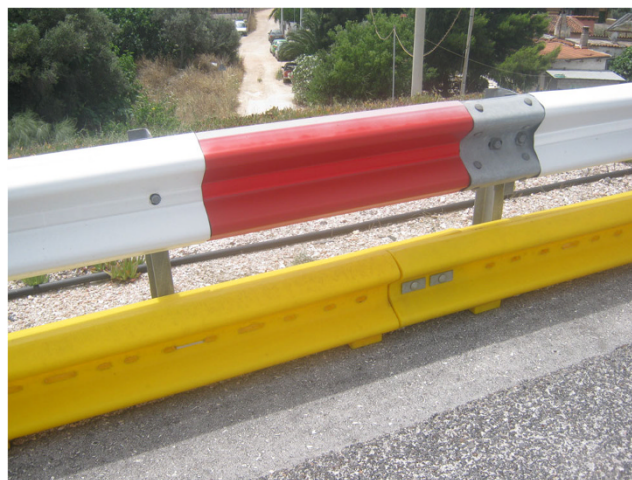
Fig. 5 Secondary rail to protect motorcyclists

Accident data revealed a significant proportion of accidents involving motorcyclists. In particular, motorcycles represent 3 % of traffic while their share in road deaths is 60 %. The RSA team recommended addition of a "skirting" to road restraint systems (Fig. 5), especially on tight curves, for guidance and protection especially for motorcyclists.

- Automatic speed cameras were installed for speed limit enforcement in 14 sites of the freeway
- A “skirting” was added to road restraint systems, especially on tight curves, for guidance and protection of motorcyclists.
