Rigorous review of electrical submersible pump failure mechanisms and their mitigation measures

Abstract

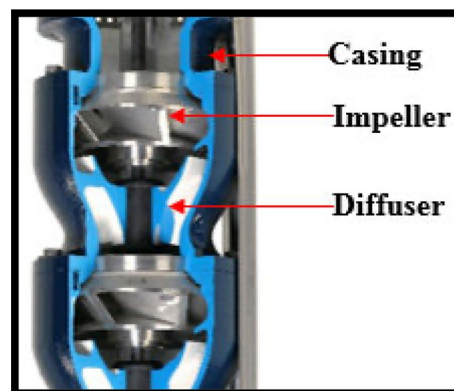
Fig. 1 ESP Main Components (Zhu and Zhang 2018)

present in the downhole assembly based on the wellbore conditions (see Fig. 1).

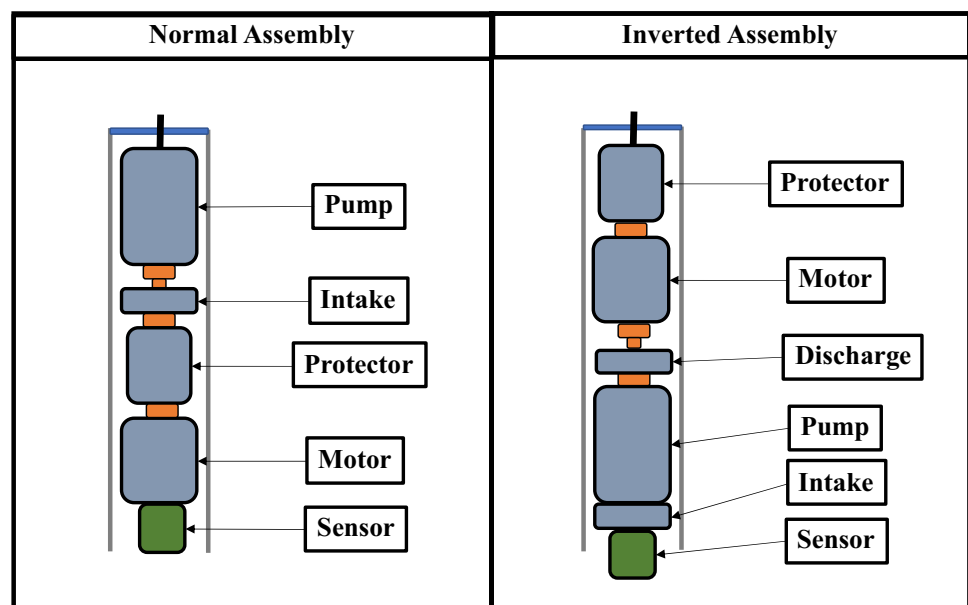
The downhole assembly can either be stacked in a normal manner or an inverted manner, as shown in Fig. 2. The main difference between both assemblies is the location of the motor and pump. In the normal assembly, the motor is located below the pump, closer to the intake. This reduces the risk of ESP failure since the pump is located in the upper

Fig. 2 Normal and Inverted ESP Assemblies

section of the string; however, it may increase the risk of motor failure and also results in the need for a prolonged electric cable to feed the motor since the motor is located near the bottom of the assembly. In the inverted assembly, the ESP is located close to the intake and the motor is placed closer to the discharge. This is beneficial in protecting the motor and also reducing the length of the electric cable. The drawback is that since the ESP is closer to the intake, there is a higher risk of gas inflow in the assembly. This can be reduced by locating the pump above the perforations; this should be incorporated in the original design.

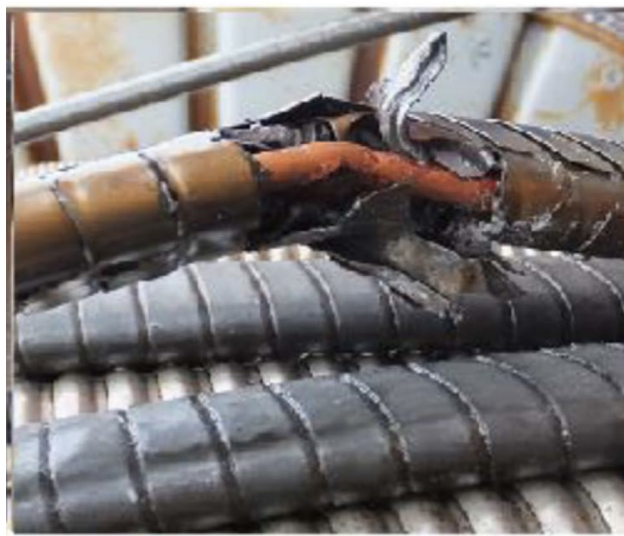
Cable insulation failure occurs due to many factors including, but not limited to, corrosion, temperature, solids and scale, and high differential pressures. An example of an ESP cable insulation failure is shown in Fig. 5.

Fig. 5 Example of ESP Assembly Cable Failure (Pastre and Fastovets, 2017)

Detection of cable insulation failure is extremely difficult since it requires visual inspection. Another method of detection includes sample analysis of the produced fluids for metal, rubber, and polymeric contamination; however, even with this analysis, it is difficult to pinpoint the failure to the cable insulation since multiple downhole components are made of similar material. Detection of cable failure is extremely simple since when the cable fails, the entire string will cease to function and so it is considered a severe failure. In order to prevent cable failure, the insulation material must be selected properly. Proper selection includes compatibility with downhole conditions, and insulation layers compatibility. Also, the cable itself should be designed with a safety factor to account for sudden surge in power requirements.

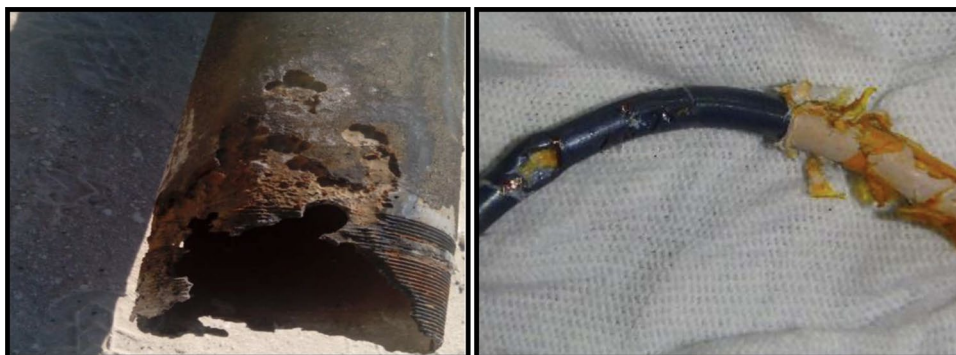
Corrosion can affect any metallic component in the downhole assembly. Although different types of corruptions exist, the main two types that can affect the downhole assembly include pitting and anodic–cathodic corrosion. Pitting is a type of corrosion that results from the exposure of the surface of the metal to the wellbore conditions. It therefore requires initiation, which comes in the form of surface erosion resulting from solid particles such as sand. Pitting can occur even in the smallest surface erosions. It then begins to expand until it causes severe failures to the metallic components. Anodic–cathodic corrosion occurs when three main components are present including an anode, a cathode, and an electrolyte. The anode and cathode represent two different metals with different potential; the electrolyte is a media that can transmit ions, in other words electricity. If the potential of the two metals is different by 0.10 to 0.15 V or larger, anodic–cathodic corrosion will take place. In this case, one of the metals will become an anode and will begin to corrode, while the cathode will not. Corrosion can cause failures in the electric components and also in the mechanical components, most of which are made of metals (Elichev et al. 2010; Kalu-Ulu and Albori 2019; Christie and Cox 2018). An example of corrosion of a metal pipe and the cable protector is shown in Fig. 6.

Fig. 6 Metallic Thread Failure and Electric Cable and Insulation Degradation Corrosion (Kalu-Ulu and Albori, 2019; Christie and Cox, 2018)

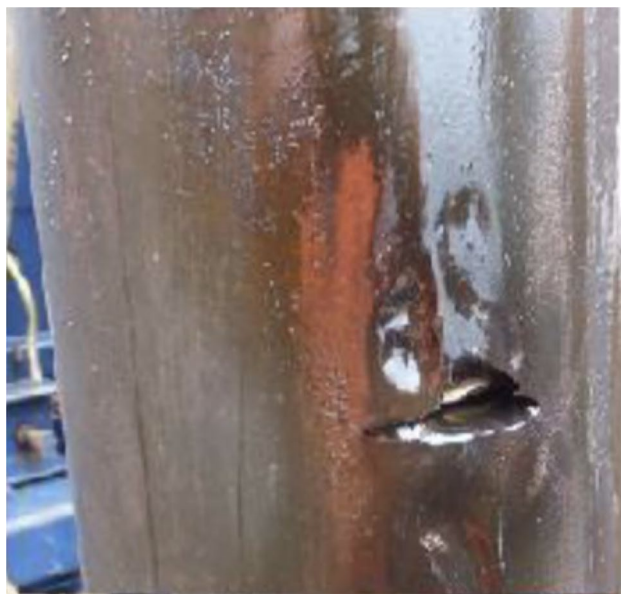
Solids in the wellbore can be classified as organic and inorganic solids. Organic deposits include solid components of the crude oil such as asphaltene and wax. These deposits can stick to the surface of the ESP assembly and result in equipment overload and failure. Inorganic deposits include sand and salt deposits from the formation water. These solids can cause equipment erosion and, with time, equipment failure (Elichev et al. 2010). Figure 7 shows an example of

Fig. 7 Metal Piping Crack due to Solids (Pastre and Fastovets, 2017)

component erosion and breakage due to solids in the production fluid.

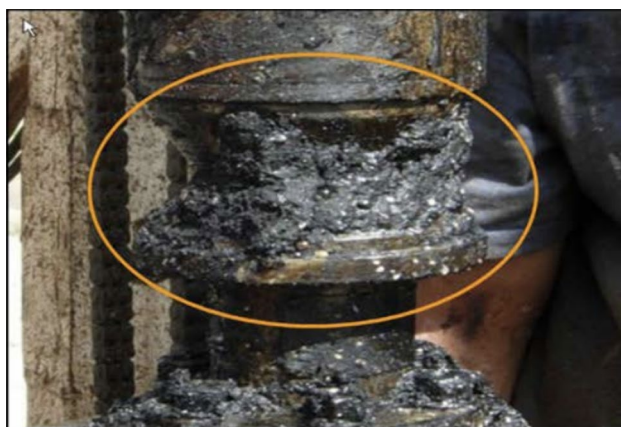
Fig. 8 Asphaltene Solid Deposit on the Surface of ESP (Jennings et al. 2020)

Detection of downhole solids and scale can be done by analyzing the produced fluids on the surface. This analysis can include compositional analysis of the crude oil to detect asphaltene and wax concentration, and analysis of the formation water to determine the most common salts that can result in scale. Asphaltene has the tendency to adsorb to the surface of the equipment and deposit on the wellbore and on the perforations (Jennings et al. 2020). This can cause severe buildups which, if not handled immediately, can result in operational failure. An example of asphaltene deposition on the surface of an ESP is shown

in Fig. 8. Wax can also form buildups on the surface of the equipment which can result in component failures. High salinity formation water must be addressed with caution especially in the presence of hydrogen sulfide and carbon dioxide to avoid further complications.

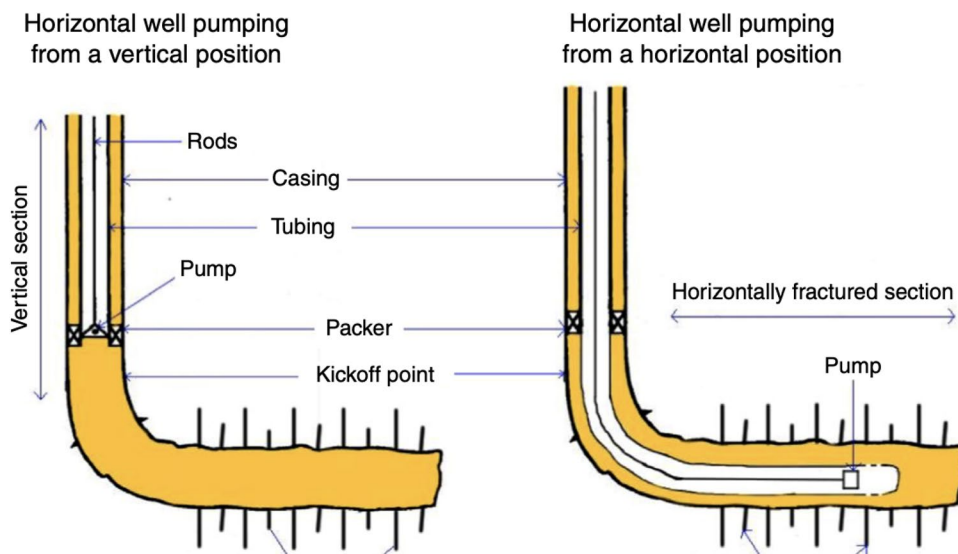
Fig. 9 ESP Application in Deviated Wells (Kolawole et al. 2020)
