# Reliability of long-term monitoring data

Peter Anderegg · Rolf Brönnimann ·  
Urs Meier

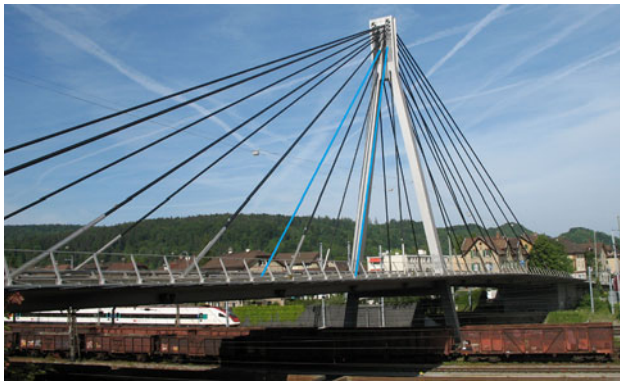
**Fig. 1** Cable-stayed bridge Storchenbrücke with the two 35-m long CFRP-cables K43 (left) and K44 (right)

This symmetric cable-stayed bridge was built in 1996 and it has been monitored since then [13]. It has a length of 120 m and is crossing 18 railway tracks. Two of the 24 cables were made of CFRP (Fig. 1), each consisting of 241 CFRP-wires, 5 mm in diameter.

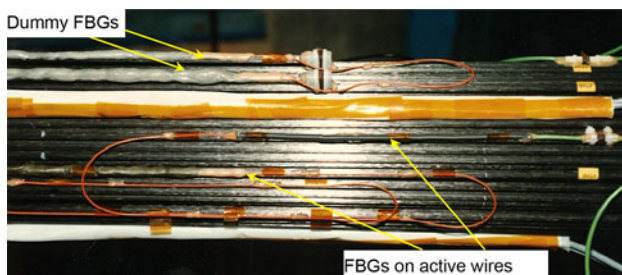
**Fig. 2** Some of the 241 CFRP-wires with attached FBG- and RSG-sensors (RSGs not seen in the figure)

To measure the wire strain, RSGs and FBGs were surface adhered to loaded wires and to unloaded dummy wires for temperature compensation (Fig. 2). Three of the FBGs were attached pre-strained on dummy wires with strains' levels around  $2,500 \mu\text{m/m}$ . Strain decay on these FBGs, e.g., due to creep or delamination, is a strong indication for the loss of long-term stability of the measurement system. As discussed in more detail below no significant difference between the drift of strained and unstrained dummies could be observed verifying its long-term stability. The FBGs and their application are described in [14] and a broader discussion of the general use of FBGs in structural health monitoring can be found e.g., in [15–19].

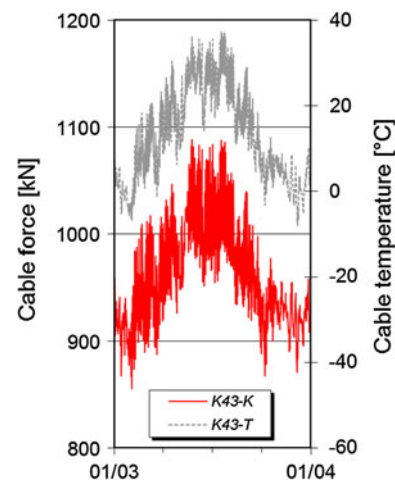
**Fig. 3** One-year-graph of a typical RSG-measurement on cable K43

CFRP is about 25 % of the pretension. Figure 3 shows 3-h mean values of the cable force obtained from the RSG-measurement of a typical year with a temperature span of approximately 45 °C. In Fig. 4, RSG- and FBG-measurements are compared for a time span of 15 years. The correlation of these two completely independent measurement systems is very good. FBG-measurements have been done at irregular intervals.

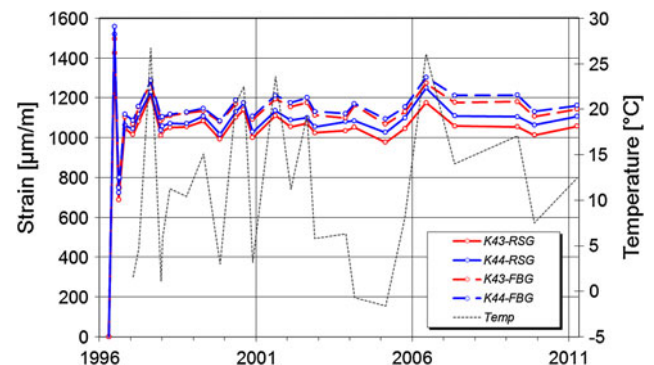
**Fig. 4** RSG (solid line) and FBG (dashed line) measurements of average strain on the CFRP-wires of cables K43 and K44 including the pretensioning phase

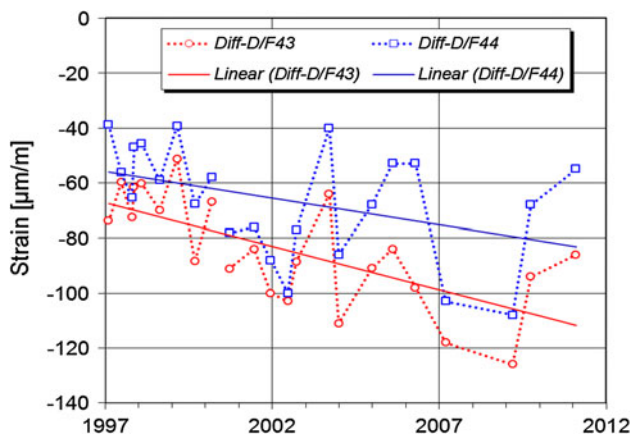
**Fig. 5** The difference between strains of RSG- and FBG-measurements (shown in Fig. 4) on cable K43 (red lines) and K44 (blue lines) resp.

Figure 5 shows the difference between the RSGs and FBGs for the two CFRP cables. The scatter can be attributed to time delay between RSG and FBG measurement and measurement uncertainties. What remains is a drift of about 3  $\mu\text{m}/\text{m}/\text{year}$ . This is mainly due to the drift of the RSGs since we can estimate the negligible long-term drift of the FBGs as follows: the measured strain change of the

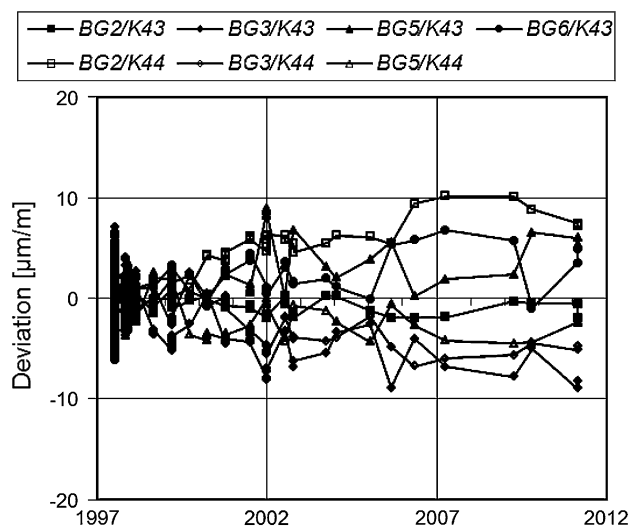
**Fig. 6** Deviation of FBGs on dummy wires from mean value (BGx/Kyy: x FBG number, yy cable number (43 or 44, resp.)

dummy FBGs should be zero in a perfect system. In a real system the values scatter and show possibly a drift. From this data, we can estimate a measurement uncertainty (one standard deviation) of about 3  $\mu\text{m}/\text{m}$  (see scatter of the seven dummy FBGs in Fig. 6). Assuming a constant drift the slope for the dummy FBG can be calculated. Over 15 years the absolute value of the slope is well below 1  $\mu\text{m}/\text{m}/\text{year}$  for each individual FBG. In addition, the signs of the slopes do not correlate with the pre-strain state of the dummies. Hence, we can state that the limit of the strain decay rate of pre-strained dummies is below this tight limit and also for the active FBGs on the cables almost no drift is expected.

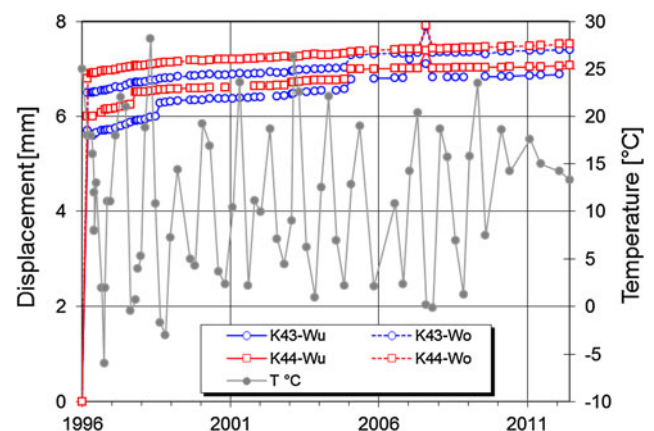
**Fig. 7** Pull-in at the top end of the cables (K43-Wo/K44-Wo) and the lower end (K43-Wu/K44-Wu) between anchorage and CFRP-wire bundle is inclusive of the pretensioning and construction phase

After the initial tensioning of the cables, only a small increase of the relative displacement between the anchorage cone and the CFRP parallel wire bundle can be observed. In contrast to the cable loads, this process is independent of the temperature and increases at about 0.1 mm per year (Fig. 7). The drift of the reference sensor in the laboratory is shown in Fig. 8. It can be interpreted as an overlay of an exponential decaying and a linear drift of about 2  $\mu\text{m}$  per year. For the long-term behavior only the linear part is essential and is below the required long-term

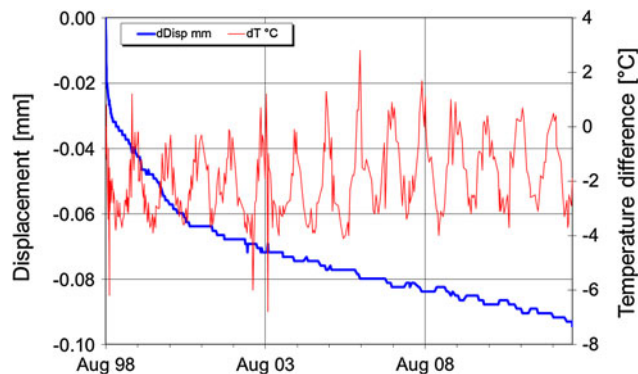
**Fig. 8** Drift of the displacement sensor under laboratory condition

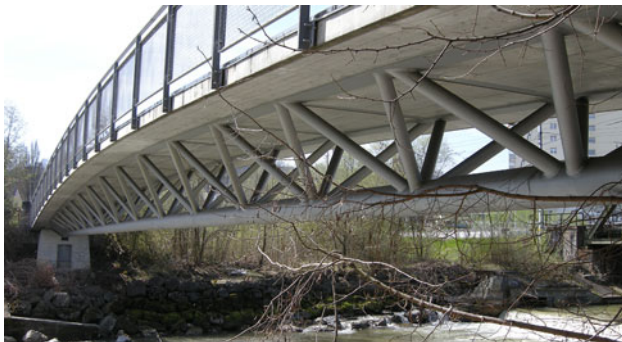
**Fig. 9** The 47-m-long steel–concrete-composite bridge with the tube containing the two CFRP-cables

This bridge is a 47-m-long steel–concrete-composite bridge for pedestrians and bicycles constructed in 1998 and monitored since then. Two CFRP-cables with 91 wires were installed under the bridge deck for pretensioning (Fig. 9). Each cable was prestressed with 2,400 kN—which corresponds to a stress level of approx. 1,350 MPa,

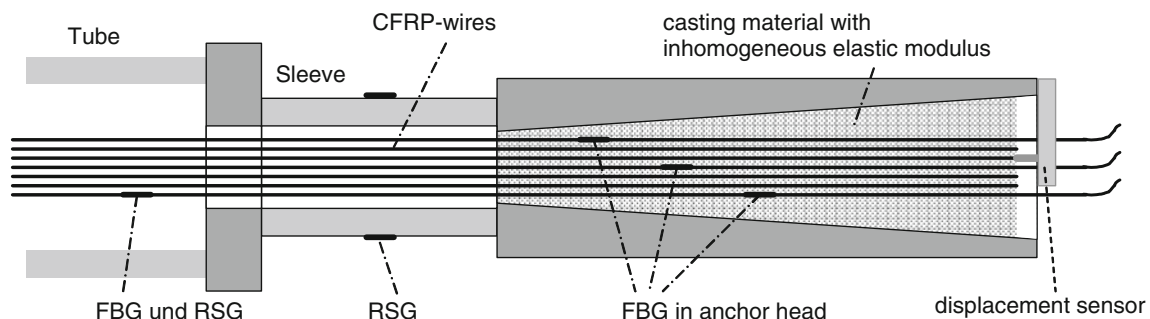
**Fig. 10** Longitudinal section of the CFRP cable anchorage with RSG and FBG sensors on the steel sleeves and the CFRP-wires—inside and outside of the anchor head

corresponding to a high strain level of about 8,500  $\mu\text{m}/\text{m}$  on the CFRP-wires. Therefore, it was of high interest to monitor the wire strains not only in the free part of the cable, but also within the anchor head. To transfer safely such high strains to the anchor head it was designed to linearly decrease the strain in the wires [1]. FBGs inside the head allowed this design to be verified (Fig. 10). To measure the strains in the wire the FBGs were directly embedded in the CFRP-wires during the industrial pultrusion process—the first application of this kind. The directly embedded FBGs allowed locating them inside the anchor, and hence to acquire the important information about axial strain distribution during the pretensioning phase and operation. In the case of this bridge, 8 of 21 FBGs failed due to high strain levels in combination with an embedding process that should be optimized. The failures occurred outside the anchor heads. Many of the RSGs initially attached on the wires in the free part of the cable failed during the pretensioning process. Therefore, additional RSGs were retrofitted on the steel anchor heads—to obtain redundant information about force variation.

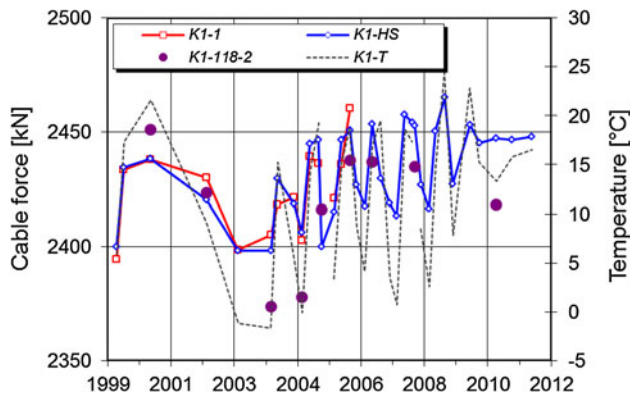
**Fig. 11** Cable force obtained from measurements with FBGs (K1-118-2) and RSGs (K1-1) and the sleeve (K1-HS) on the CFRP-wires

At the bridge Kleine Emme similar effects from the daily and seasonal temperature changes can be observed like at Storchenbrücke. The elongation of the steel tube which contains the two CFRP-cables produces a force change within a band width below 10 % of the pretension force. Figure 11 shows a comparison of the calculated forces obtained from the three different strain measuring methods with FBGs and RSGs on the CFRP-wires and RSGs on the steel sleeves. Even though these are not synchronized measurements, the strains correspond within a bandwidth of 1 % of the tensioning load.

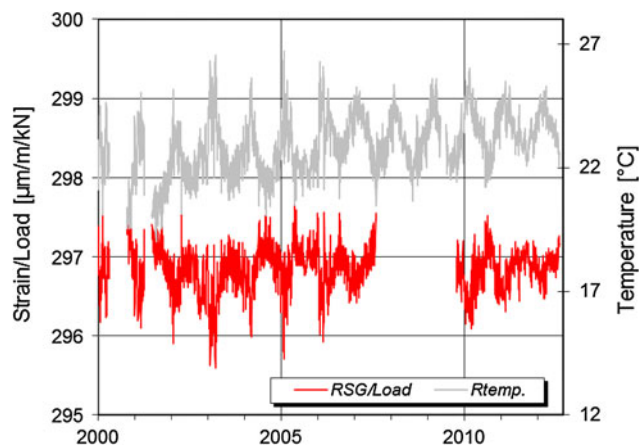
**Fig. 12** Strain to load ratio of the reference measurement on the CFRP-wire with a constant load of 32 kN

In contrast to the FBGs no information of the stability drift of the RSGs is available. Possible reasons for the higher RSG-drift were not examined further. Since the reference measurements in a testing machine with almost eight times higher strains than in the field application showed a very low drift (Fig. 12), it cannot be explained with the strain level. It is assumed that the continuous change of temperature and humidity causes the RSG drift. In respect to reliability it can be stated, that in the last 17 years none of the 14 FBGs failed, 4 of 18 RSGs failed, three RSGs simultaneously—most probably caused by a lightning.

The reference measurement with RSGs on a CFRP-wire in a testing machine under a constant load of 32 kN and unloaded dummy RSGs showed a high stability—only small residual temperature variations affected the results. Figure 12 shows the strain to load ratio: the standard deviation is 0.5  $\mu\text{m}/\text{m}/\text{kN}$ , <0.1 % of the load. This verifies the very good long-term laboratory stability of the common

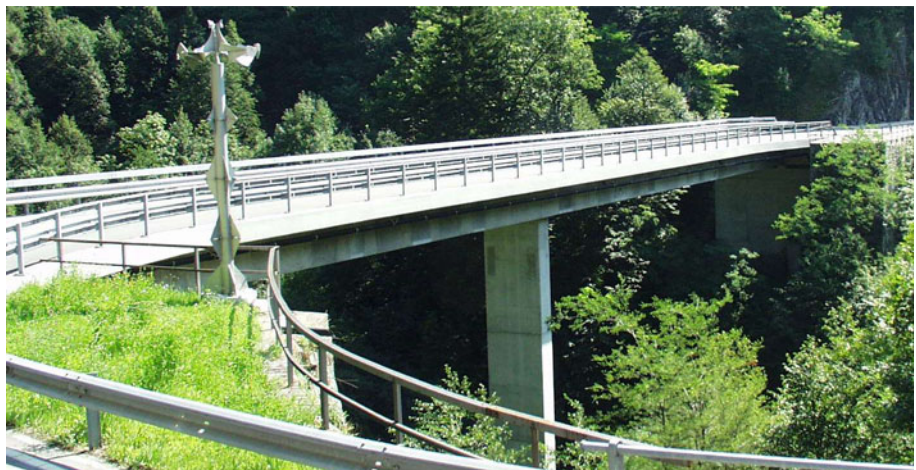
**Fig. 13** The retrofitted 70-m-long bridge sul Ri di Verdasio

During operation of this 70-m-long bridge the steel post-tensioning cables partially corroded. Therefore, the bridge was retrofitted with four additional CFRP-cables (Fig. 13). Each cable is prestressed with 600 kN, which induces very high strains in each of the 19 CFRP-wires of up to 9,500  $\mu\text{m}/\text{m}$ . Here, the eight anchor heads were equipped with RSGs and the pull-in of the CFRP wires into the head was measured with a caliper gauge (Fig. 14).

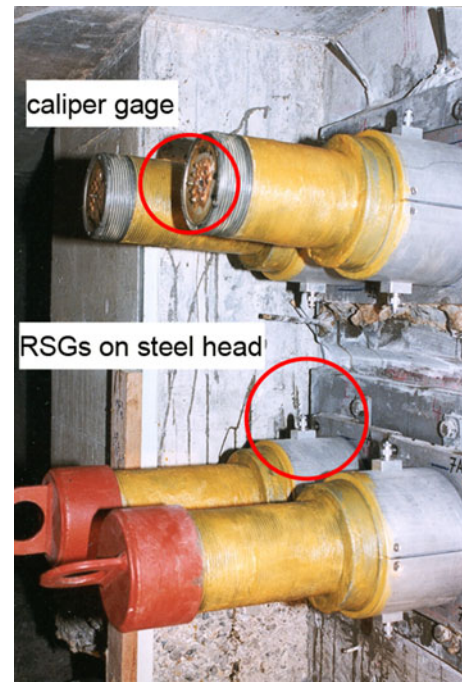
**Fig. 14** Anchorage of the four CFRP-cables where the forces and the pull-in of the CFRP-wires are measured

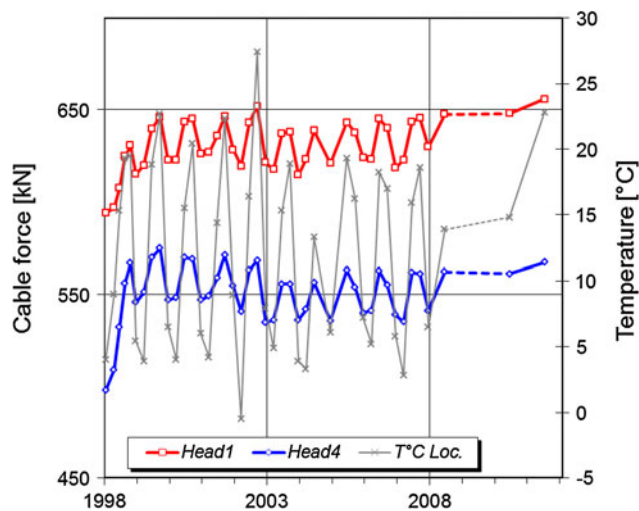
**Fig. 15** Typical data of the force measurement on both anchor heads of one CFRP-cable

machine. The scattering of this calibration shows a bandwidth of 1 % of the effective forces. This accuracy is sufficient to measure relevant changes of the pretensioning forces. Moreover, the force effects due to the seasonal temperature changes can be recorded reliably. Figure 15 shows the manual read-out of the forces for the two anchor heads of one of the four cables, while Fig. 16 shows the measurements of the pull-in of the CFRP parallel bundle into the anchorage cone. The observed increase of the forces and displacements at the beginning of the monitoring is due to the completion of the bridge with the installation of additional parts.

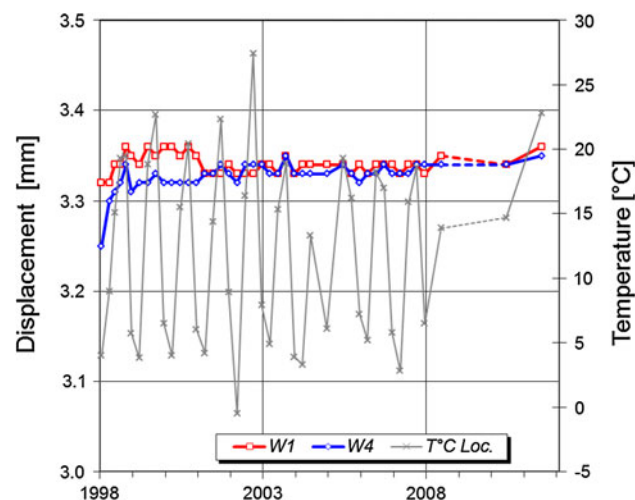
**Fig. 16** Typical data of the displacement measurement (W1 and W2) on both anchor heads of one CFRP-cable
