Implementation of a drive-by monitoring system for transport infrastructure utilising smartphone technology and GNSS

P. J. McGetrick¹ · D. Hester¹ · S. E. Taylor¹

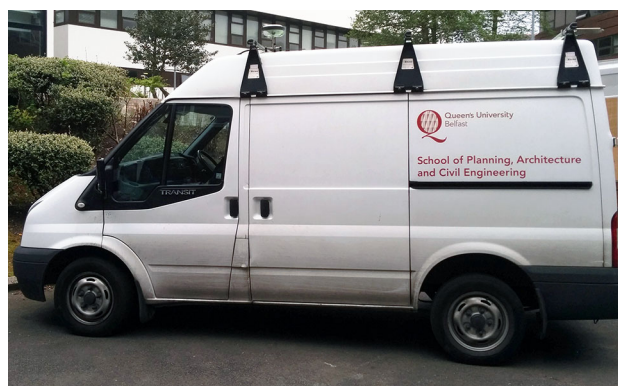
Fig. 1 Instrumented vehicle

For this field investigation, the instrumented vehicle was a Ford Transit van (Fig. 1), weighing 1600 kg and fitted with accelerometers to measure vibration and GNSS receivers to record the vehicle position in the road network. A digital camera was also used to record video footage of each vehicle test run while the average vehicle speed during

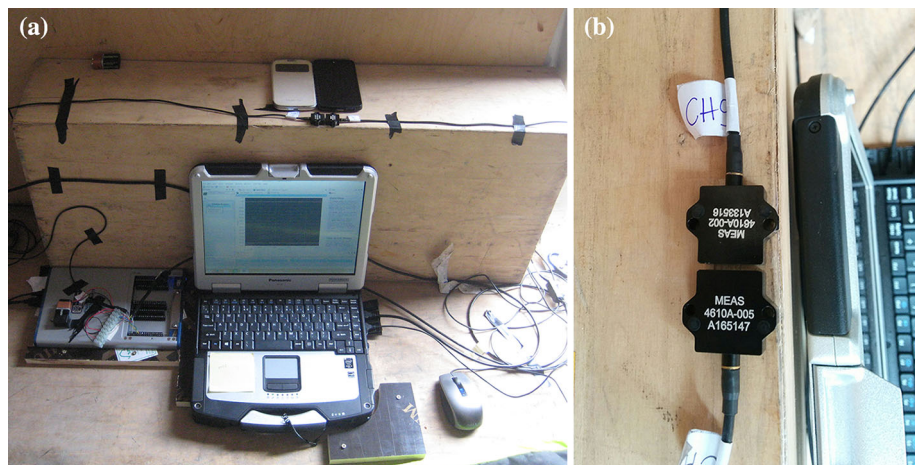
Fig. 2 a Accelerometer instrumentation setup, b uniaxial accelerometers

The overall setup of accelerometers in the vehicle is illustrated in Fig. 2, consisting of 4 accelerometers measuring vertical vibration.

Two wired uniaxial accelerometers were installed at the same location in the body of the vehicle, adhesively mounted over the left rear wheel. This location was selected based on findings of past experimental studies carried out by the authors, in which sensors mounted in the body of the vehicle over a lighter axle proved more sensitive to external excitation of the vehicle [17]. In addition, it also enabled easy access for instrumentation purposes. The installed accelerometers were ultra-low noise signal conditioned model 4610A-002 (± 2 g) and 4610A-005 (± 5 g) units by Measurement SpecialtiesTM, shown in Fig. 2b, which provide low-pass filtered output over a DC–300 Hz bandwidth. Excitation voltage was provided by a 9-V battery during testing. Both ± 2 and ± 5 g rated accelerometers were tested for comparison with smartphone sensors and to ensure any large magnitude vehicle accelerations greater than 2 g were recorded. The sampling frequency was 1000 Hz allowing potential identification of any features with frequency components between 100 Hz and 500 Hz, which would be undetected by the smartphone sensors. However, no such features were identified.

acceleration measurements; both devices were mounted over the left rear wheel with adhesive (Fig. 2a). The LG Nexus 5, retailing at €290 approximately as of summer 2016, contains a 6-axis MPU-6515 chip with integrated triaxial MEMS Gyroscope and triaxial MEMS accelerometer by InvenSense Inc., built into the device motherboard. The maximum measurement range during testing was ± 19.61 m/s², equivalent to ± 2 g, although this can be increased. As vehicle body and bridge vibration magnitudes are generally less than 2 g, this range is suitable for bridge monitoring applications. The smartphone sampling frequency was set at a maximum of 200 Hz, which is also adequate for drive-by monitoring.

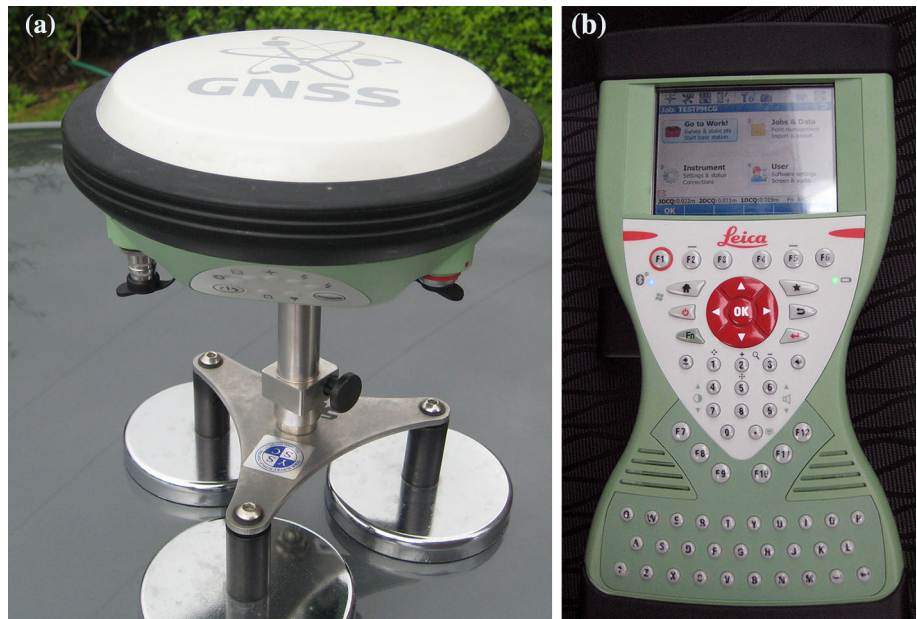
Fig. 3 **a** Leica GS14 smart antenna, **b** Leica CS15 controller

To serve as a reference for the vehicle position recorded by the Nexus 5 smartphone during testing, a survey-grade Leica Geosystems Viva GS14 GNSS smart rover antenna was used to log the vehicle location coordinates to a removable SD card throughout testing, incorporating Network Real-Time Kinematic (RTK) corrections [21] obtained via the local mobile network. The antenna was mounted magnetically on the roof of the van and operated

using a Leica Geosystems CS15 controller (see Fig. 3). Positioning errors with this system are ± 8 mm (horizontal) and ± 15 mm (vertical), respectively, for static measurements, although this is dependent upon various factors such as the number of satellites tracked, constellation geometry and observation time. Positioning error was expected to vary during testing, particularly in urban or wooded areas where satellite visibility or signal strength can be restricted, and due to the movement of the vehicle.

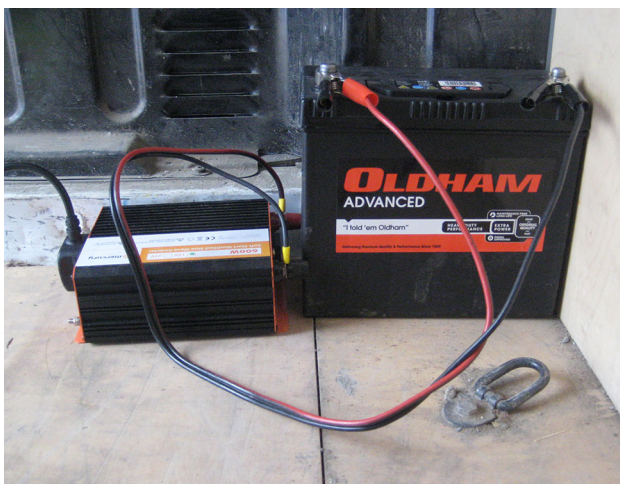
Fig. 4 Power supply for data acquisition device

power to the DAQ device was provided by a 12 V car battery placed in the rear of the vehicle, with the required output of 230Vac provided by an inverter (Fig. 4). The total cost of this DAQ setup was approximately €7000.

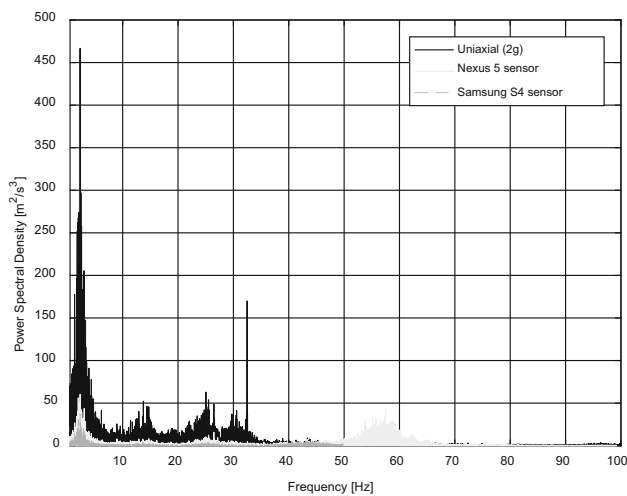
Fig. 7 Original acceleration spectra for test route 1

Although the dominant body bounce vibration mode of the vehicle at 2.3 Hz can be observed as a peak in the spectra for all sensors in Fig. 7, the smartphone peak magnitude is approximately 9 times less than that recorded by the wired sensor, indicating lower sensitivity. However, this relative magnitude difference is reflected across the whole frequency spectrum. Further vehicle-related frequencies are identified by all sensors at 14.8 and 25 Hz. A clear peak at 32.5 Hz is also observed in Fig. 7 for the wired accelerometers. This peak corresponds to the idling engine frequencies of the vehicle while it was motionless; a related peak appears in the smartphone responses but is not very significant. The relatively low sensitivity of the smartphone sensors to this frequency can also be observed in the acceleration time history during idling periods, e.g. between 500 and 560 s in Fig. 6. Lastly, a peak also occurs in the acceleration spectra close to 60 Hz for the Nexus 5 smartphone, highlighting sensitivity to electrical noise. The wired uniaxial accelerometers do not suffer from this issue as they have been designed and constructed for applications requiring low levels of output signal noise. Although most frequencies of interest for bridge

monitoring applications will fall well below this, it does raise the overall issue of smartphone sensor suitability in terms of signal quality for drive-by monitoring algorithms. For this reason, further analysis presented in the following section incorporates post-processing of all measured accelerations using a low-pass filter.

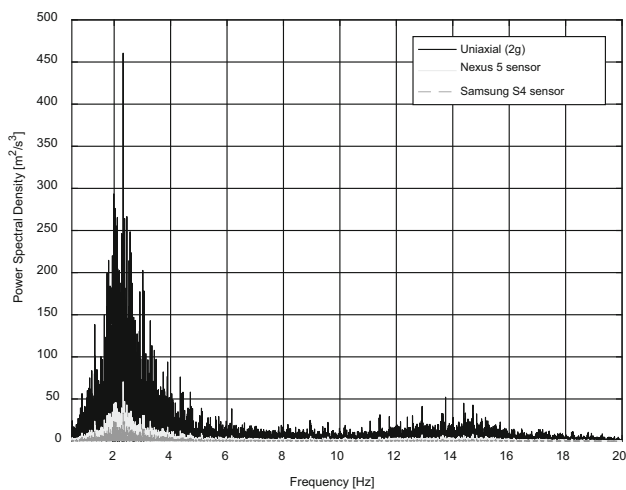
Fig. 9 Processed acceleration spectra for test route 1

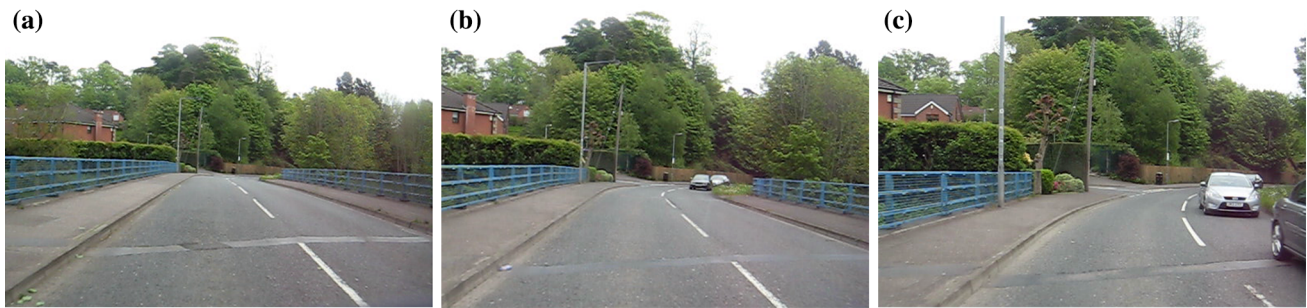
Fig. 10 Bridge expansion joints at crossing over M1 motorway on Dunmurry Lane on test route 2; **a** west entrance, **b** centre, **c** east entrance

periodic low-frequency disturbances. On inspection of video footage (Fig. 10), it can be confirmed that these correspond to the three expansion joints on the bridge, indicated by vertical dashed lines in Fig. 11. This shows that the drive-by monitoring system, at a minimum, can identify the vehicle's entry and exit to the bridge, and has potential to monitor deterioration of the expansion joint covering and/or the joint itself through analysis of the vehicle's dynamic response.

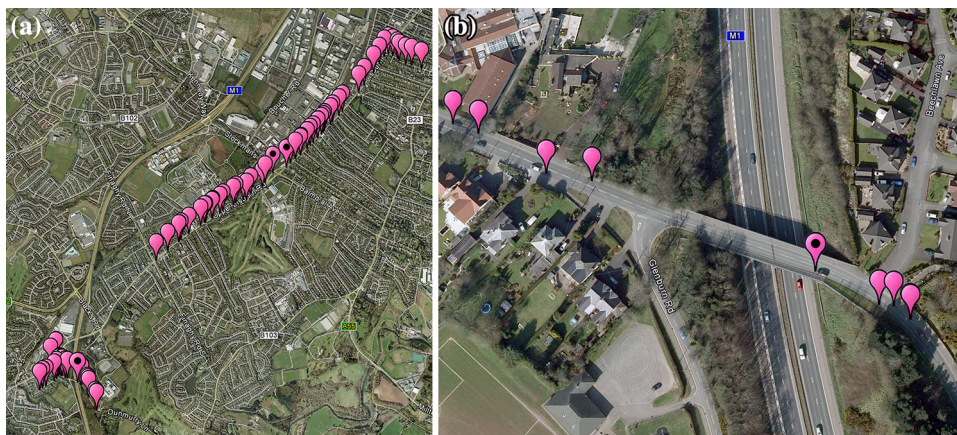
Fig. 15 Vehicle position coordinates logged using Leica GS14 on test route 2 **a** overview, **b** on bridge

The vehicle position coordinates logged by the Leica GS14 during test route 2 are shown in Fig. 15, where icons with black dots indicate two separate bridge crossings. The coordinate quality ranged 0.01–5.7 m, averaging at 0.4 m. A gap in recorded coordinates can be seen at the bottom left of this figure; this was caused by a temporary crash of the CS15 controller operating system. This can be overcome by automatically logging raw data to the GS14's internal memory, rather than manual operation as in this test. Overall, similar issues affecting accuracy were experienced as for route 1. In particular, at the M1 motorway bridge crossing (see Fig. 15 inset), overhanging trees restricted recording of location at the western entrance to the bridge (Fig. 13). In addition to raw data logging, this problem can be alleviated for GNSS systems by carrying out testing in winter rather than summer, when trees have shed their foliage. Other possible solutions include inertial navigation systems (INS), which incorporate accelerometers, gyroscopes, magnetometers and GNSS receivers, but an equivalent system for accurate vehicle tracking can be relatively expensive.

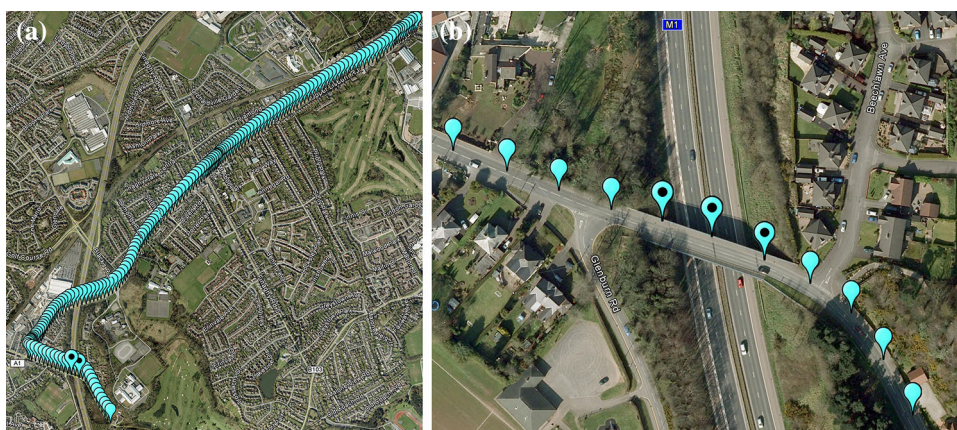
Fig. 16 Vehicle position coordinates logged using GPSEssentials smartphone application on test route 2 **a** overview, **b** on bridge

Figure 16 illustrates the vehicle position recorded by GPSEssentials during the second half test route 2, covering the gap in the Leica GS14 record. The rapid update of position and accuracy in the region of the M1 bridge crossing is particularly of note—for this application, its robustness has surpassed the Leica system. Overall it was observed that the smartphone accuracy was sufficient to identify when the vehicle was on the bridge. In terms of post-processing and visualising coordinates, GPSEssentials was very straightforward due to the output of a.kml format file; the Leica system required more user post-processing time to achieve the same output.
