# Fiber optic sensors for high-temperature measurements on composite tanks in fire

Aleksander Wosniok<sup>1</sup> · Danilo Skoczowsky<sup>1</sup> · Marcus Schukar<sup>1</sup> · Sina Pöttsch<sup>1</sup> · Samuel Pöttschke<sup>1</sup> · Simone Krüger<sup>1</sup>

## Abstract

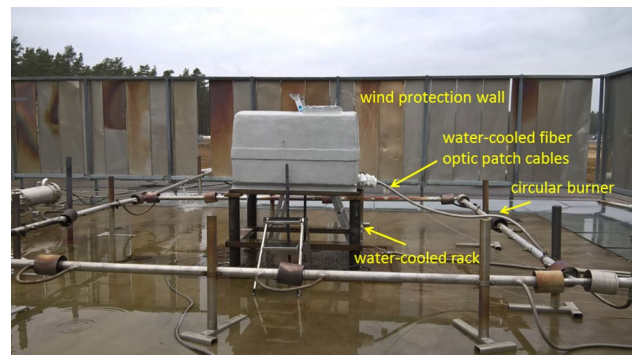
Fig. 1 GFRP tank at the test site

volume of 1.1 m<sup>3</sup> per tank. Following manufacture, an additional outside covering with fire protection coatings was carried out before placing at the test site as shown in Fig. 1.

After placing each GFRP tank to be tested for fire resistance on the water-cooled rack at the test site shown in Fig. 1, the embedded FOSs were connected to the measurement device placed outside the test site using fiber optic patch cables. For this purpose, the patch cables were directed out of the tanks over the water outlet opening located in the lower shells. Figure 1 shows the metal braiding hose enclosing water-cooled fiber optic patch cables. To ensure the best possible thermal insulation, the metal braiding hose was additionally wrapped with calcium silicate wool. The calcium silicate high-temperature insulation and the integrated water cooling inside the hose prevented not only directly the damage of the fiber optic patch cables, but mainly removed the high-gradient temperature changes deteriorating the measuring signals. The preliminary tests for determination of the cooling effects depending on the water flow rate revealed that a too strong water flow generates vibrations inside the hose. This in turn can lead to disturbances affecting the measuring signals. During the preliminary tests, an optimized water flow rate of 6.25 l/min was determined. Such a flow rate allows an artifact-free distributed temperature measurement with the required spatial resolution of 3 cm.

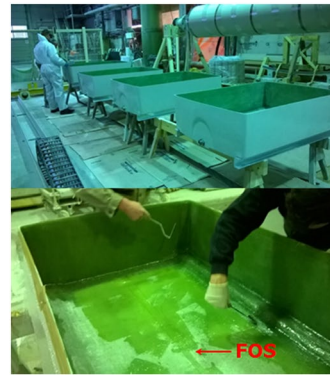
Layer structure bevor placing FOSs:		Thickness [mm]:
1.	gelcoat	0.2
2.	glass fiber mat type a	0.5
3.	glass fiber mat type b	0.8
4.	glass fiber mat type a	0.5
5.	glass fiber mat type a	0.5
6.	E-glass woven fabric	1.0
7.	glass fiber mat type b	0.8
8.	E-glass woven fabric	1.0
9.	glass fiber mat type b	0.8
Total:		6.1
Layer structure covering FOSs:		Thickness [mm]:
10.	glass fiber mat type b	0.8
11.	E-glass woven fabric	1.0
12.	glass fiber mat type b	0.8

Fig. 2 Integration of FOSs in the composite layer structure of GFRP tanks. All FOSs are located in the lower shells between the 9th and 10th layer. The used two types of glass-fiber mats differ from each other in the surface weight

To enhance comparability, all tested tanks featured the same composite layer structure shown in Fig. 2, whereas the kind of the protective coating was varied during the individual fire tests.

The layer structure of the upper shells is identical in construction to the layer structure before placing FOSs in the lower shells (see Fig. 2). The upper shells always consist of an outside gelcoat and inside 8 layers having a thickness of 6.1 cm (layers 1–9). Due to the integration of FOSs during the tank-manufacturing process, the layer construction of lower shells was extended by 3 layers, enhancing their overall thickness up to 8.7 mm (layers 1–12).

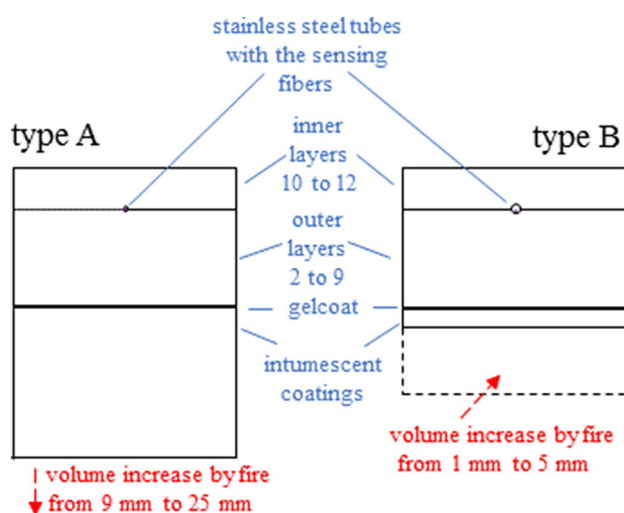
**Fig. 3** True-to-size schematic showing cross-section of the tank wall with the integrated distributed FOS and the intumescent coating of type A (left) and type B (right)

Each individual tank was always protected with only one kind of the coatings listed above. All intumescent coatings were subsequently applied onto the outside surface of the gelcoat. Figure 3 schematically shows the cross-section of the tank wall, the distributed FOS and the intumescent coatings of both type A and type B providing best fire protection properties of the tested intumescent systems (see chapter 4).

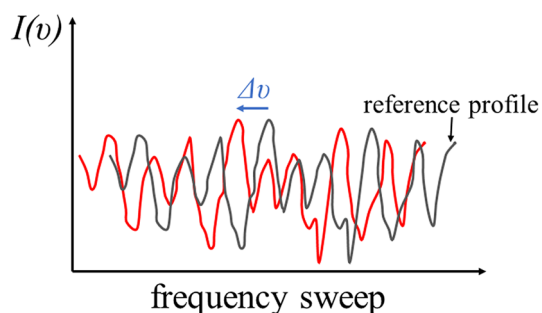
**Fig. 4** Local frequency shift of recorded Rayleigh backscattering profiles caused by temperature and strain events

sensing fiber. Therefore, this approach allows the detection of intensity profiles as a function of the swept laser frequency  $I(v)$  along the fiber under test divided into the configurable increments mentioned above. The intensity profiles  $I(v)$  varies from sensing element to sensing element, but are still stable at constant temperature and strain conditions along the sensing fiber. Such characteristic intensity fingerprints can be explained by the physical nature of the Rayleigh scattering caused by stochastic local defects and distortions as well as refractive index fluctuations along the fiber. In case of spatial changes in the external conditions affecting the sensing fiber, the characteristic intensity fingerprints are compressed or stretched leading to spatially resolved frequency shifts  $\Delta v$  of the intensity profiles  $I(v)$  as schematically shown in Fig. 4.

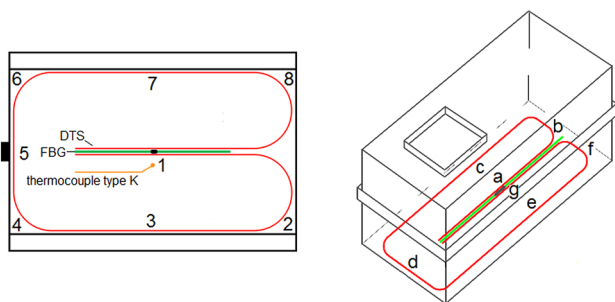
**Fig. 5** Spatial position of the FOSs in the composite structure. Dimensions of the GFRP tanks: 1.50 m long, 0.90 m high and 1.03 m wide

The application-specific designed concept of distributed fiber optic temperature sensing built on the embedment of single-mode (SM) standard glass optical fibers (GOFs) in the sandwich composite structure of lower shells according to the installation plan shown in Fig. 5. The SM GOFs equipped with high-temperature-resistant polyimide coatings were thereby mechanically decoupled by putting them in thin-walled small-diameter stainless steel tubes with the

The on-site integration of FOSs in the composite tanks was carried out by a BAM team in accordance with the layout in Fig. 5 during tank-manufacturing process at VKA GmbH in Schönbrunn, Germany. The numeration 1–8 on the left side of Fig. 5 corresponds to the selected point locations in the tank bottom that are representative for the analysis of heat-related changes in composite material while taking environmental factors such as wind direction into consideration. The numeration a–g on the right side of Fig. 5 describes various sections of distributed sensors. Due to the complex geometries and possible variance in the protective impact of the applied intumescent coatings, deviations in the measuring signal in the numbered sections are expected.

In consequence of the complex shape of the tanks, there are three groups of comparable sensing fiber sections shown in the allocation plan in Fig. 5:

- centrally located sections: a and g
- sections placed on supports: c and e
- unsupported sections: b, f and d.

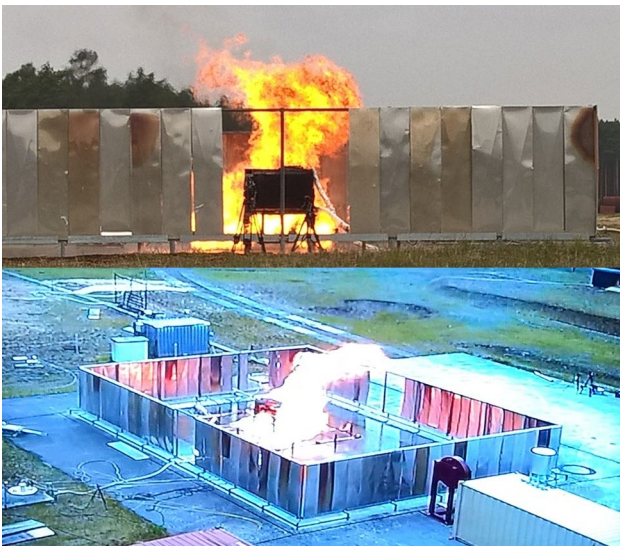
**Fig. 6** GFRP tank under fully developed fire

The suitability of the fire protection systems listed in Sect. 2.2 was investigated under fully developed fire as shown in Fig. 6. The fire temperature at the outside surface of the tested tanks averaged 950 °C [2]. To ensure the flame

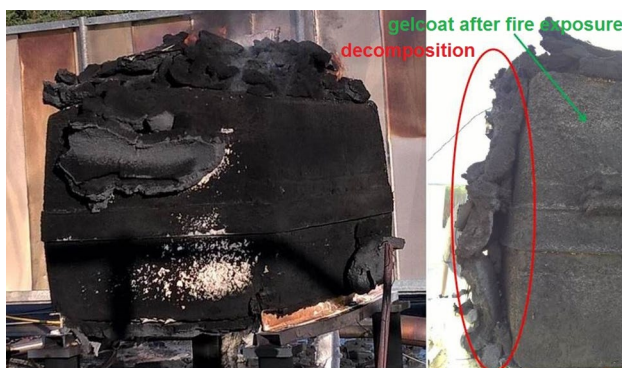
**Fig. 7** Heat-related decomposition of the fire protective thermoplastic foil applied on the outer tank surface

The visual inspection of the tanks after flame treatment yielded a satisfactory protective function of the two intumescent coatings A and B. On the other hand, due to the heat-related decomposition of the fire protective thermoplastic foil, shown in Fig. 7, the use of such fire protective materials cannot be recommended in this particular application. The effect of this intumescent thermoplastic foil is, therefore, not further considered below. In general, due to the strong decomposition and the associated malfunction of the thermoplastic foil, the temperature measured by the FOSs constantly exceeded the value of 120 °C after about 7 min of the start of the fire test. Such a temperature increase was

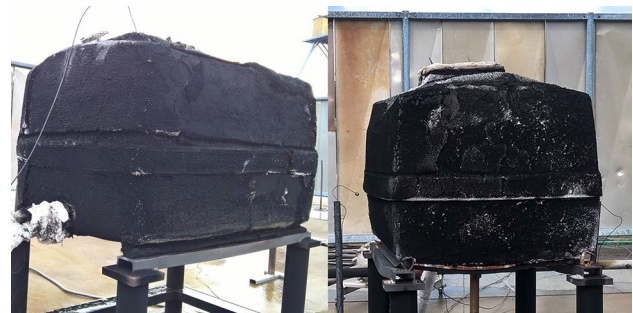
**Fig. 8** Inspection after fire tests—GFRP tanks with a protective coating of type A (left) and type B (right)

For the sake of completeness, Fig. 8 documents the results of the visual inspection for the remaining tanks protected by the intumescent coatings. The two GFRP tanks have met the requirements of leakproofness defined by ADR.

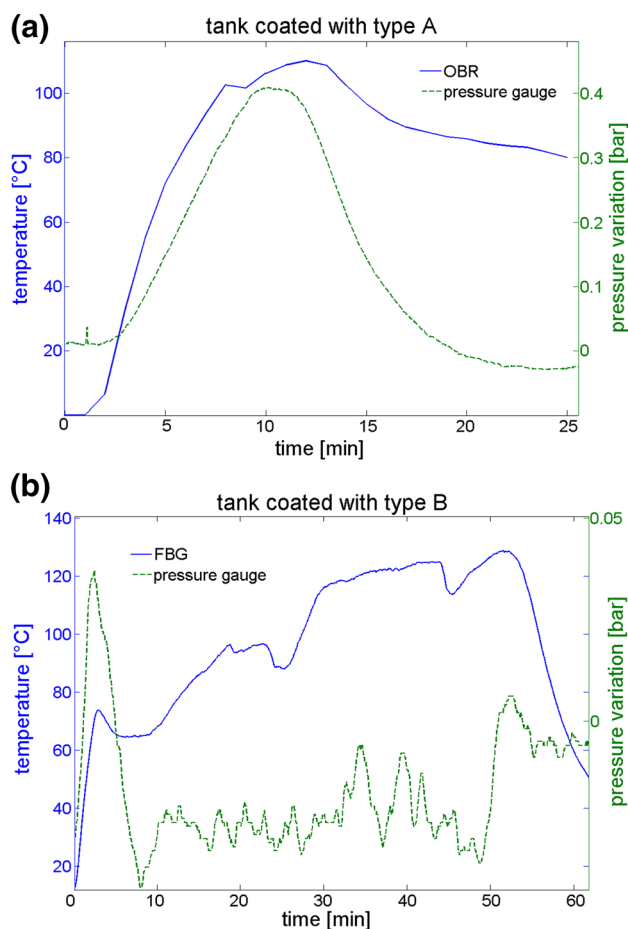
**Fig. 10** Temperature development vs. pressure inside the tank with (a) intumescent coating of type A and (b) intumescent coating of type B

In contrast to the temperature drops shown in Fig. 9b and described above, also a clear temperature peak was measured after the first few minutes of the fire test. As presented in Fig. 10, the temperature peaks generally correlated in time to the overpressure peaks measured by standard pressure gauge placed inside each tank. Due to

the different overpressure levels obtained during the individual fire tests, differing reasons for the observed reduction in pressure can be supposed in the two cases presented in Fig. 10. In the case (a), a buckle of the sealing system of the tank lid can be assumed. Since the sealing action was diminished in advance of the remaining fire tests, the reasons for the detected reduction in pressure cannot be clearly identified for the case (b). However, the fact is that from a physical point of view, the reduction in pressure can result in the temperature decrease. Furthermore, the assumption of different reasons for the pressure decrease is further reinforced by measurements presented in Fig. 11.

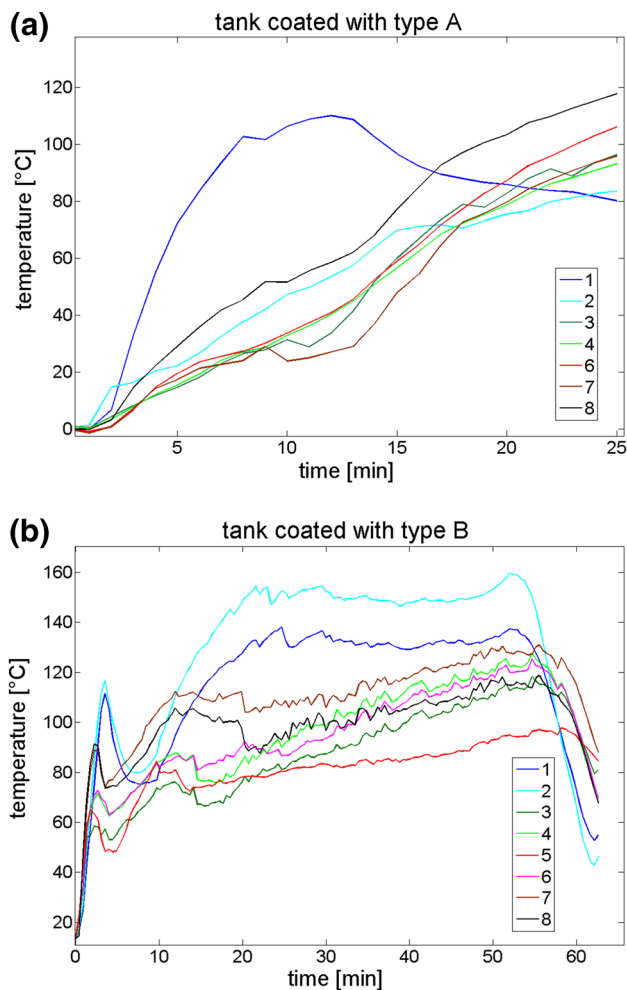
**Fig. 11** Position-related temperature differences in the tank bottom coated with (a) type A and (b) type B measured by OBR

The upper diagram in Fig. 11 (case a) proves that the distinctive temperature peak was observed only at the central position 1, whereas the lower diagram (case b) reflects the independence of the measurement point position for the occurrence of the temperature peak.

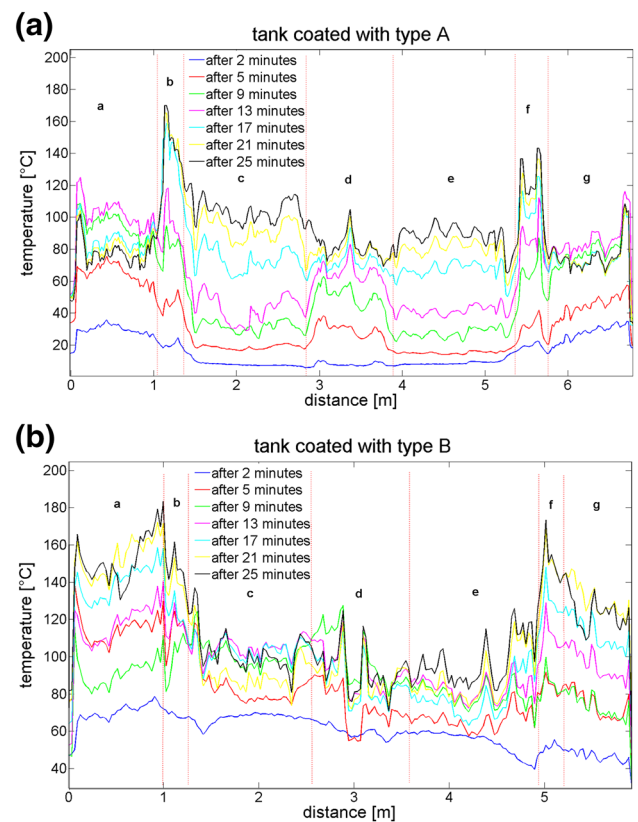
**Fig. 12** Temporal development of temperature distribution in the tank bottom coated with (a) type A and (b) type B

The results of the distributed measurements presented in Fig. 12 provide spatially resolved information about the temperature development over time in the tank bottom along the whole sensing fiber. The diagram in Fig. 12 can thereby

The measurement data presented in Fig. 12a prove similar temperature increase with time in sections c and e. The temperature development in sections a and g of the tank coated with type A provides evidence for the unexpected temperature decrease initiated in the 13th minute after the start of the fire test. This behavior can be explained by the viscous softening of the matrix at the area of the highest weight-related deformation causing water ingress with its cooling effect.

In contrast to the section-wise similarity of temperature development described above, an important discrepancy in the temperature behavior in sections b and f compared to d can be identified. Furthermore, the signal increase observed in b and f can be explained by friction-related strain cross-sensitivity in the both sections caused by critical bending of the tube including the sensing fiber. As presented in Fig. 12a, the temperature distribution recorded 25 min after the beginning of the fire test on the tank coated with type A shows the maximum temperature value in the section b exceeding the remaining temperature values by about 70 °C. Under the assumption of a certain behavioral comparability of the temperature development in the sections b, f and d, such a signal enhancement in the range of 70 °C cannot correspond to a real temperature increase. It can, therefore, be considered that the excessive spectral frequency shifts measured by the OBR system are caused both by the fire-related temperature gradients and by an additional friction-related strain increase. Applying the knowledge about the temperature and strain coefficients of the OBR-based sensor determined during the preliminary laboratory tests, the temperature change of 1 °C can correspondingly be treated as a strain change of 8.776  $\mu\text{m}/\text{m}$ . In this way, the unexpected signal peak in the section b thus represents the friction-related strain increase

up to 600  $\mu\text{m}/\text{m}$  and not the 70 °C rise in temperature shown in Fig. 12a.

By choosing stainless steel tubes with an inner diameter of 0.45 mm instead of 0.20 mm, the friction-related strain cross-sensitivity has been suppressed in the subsequent fire tests as clearly presented in Fig. 12b. Here, the use of the new design of temperature sensors based on the larger diameter of the stainless steel tubes used in the tank coated with type B resulted in a significant decrease of the measuring signals recorded in the sections b and f.
