Microstructural Analysis of Ballistic Tests on Welded Armor Steel Joints

Abstract The deformation and fracture behavior of welded joints made from quenched and tempered steel closely conforming to AISI 4340 were investigated. Due to weld thermal cycles and under matching fillers, the welded armor steel joints showed poor ballistic performance compared with the base metal (BM). The problems encountered in the past were reduced by depositing a soft austenitic stainless-steel buttering layer in between the BM and the hardfaced layer. This method showed enhancement in ballistic performance and good weld integrity. In this investigation, an attempt is made to investigate the microstructure after ballistic testing on the weld metal zone consisting of the hardfaced interlayer. The results reveal the microstructural characteristics before and after ballistic testing of armor steel welds fabricated using the shielded metal arc welding (SMAW) process.

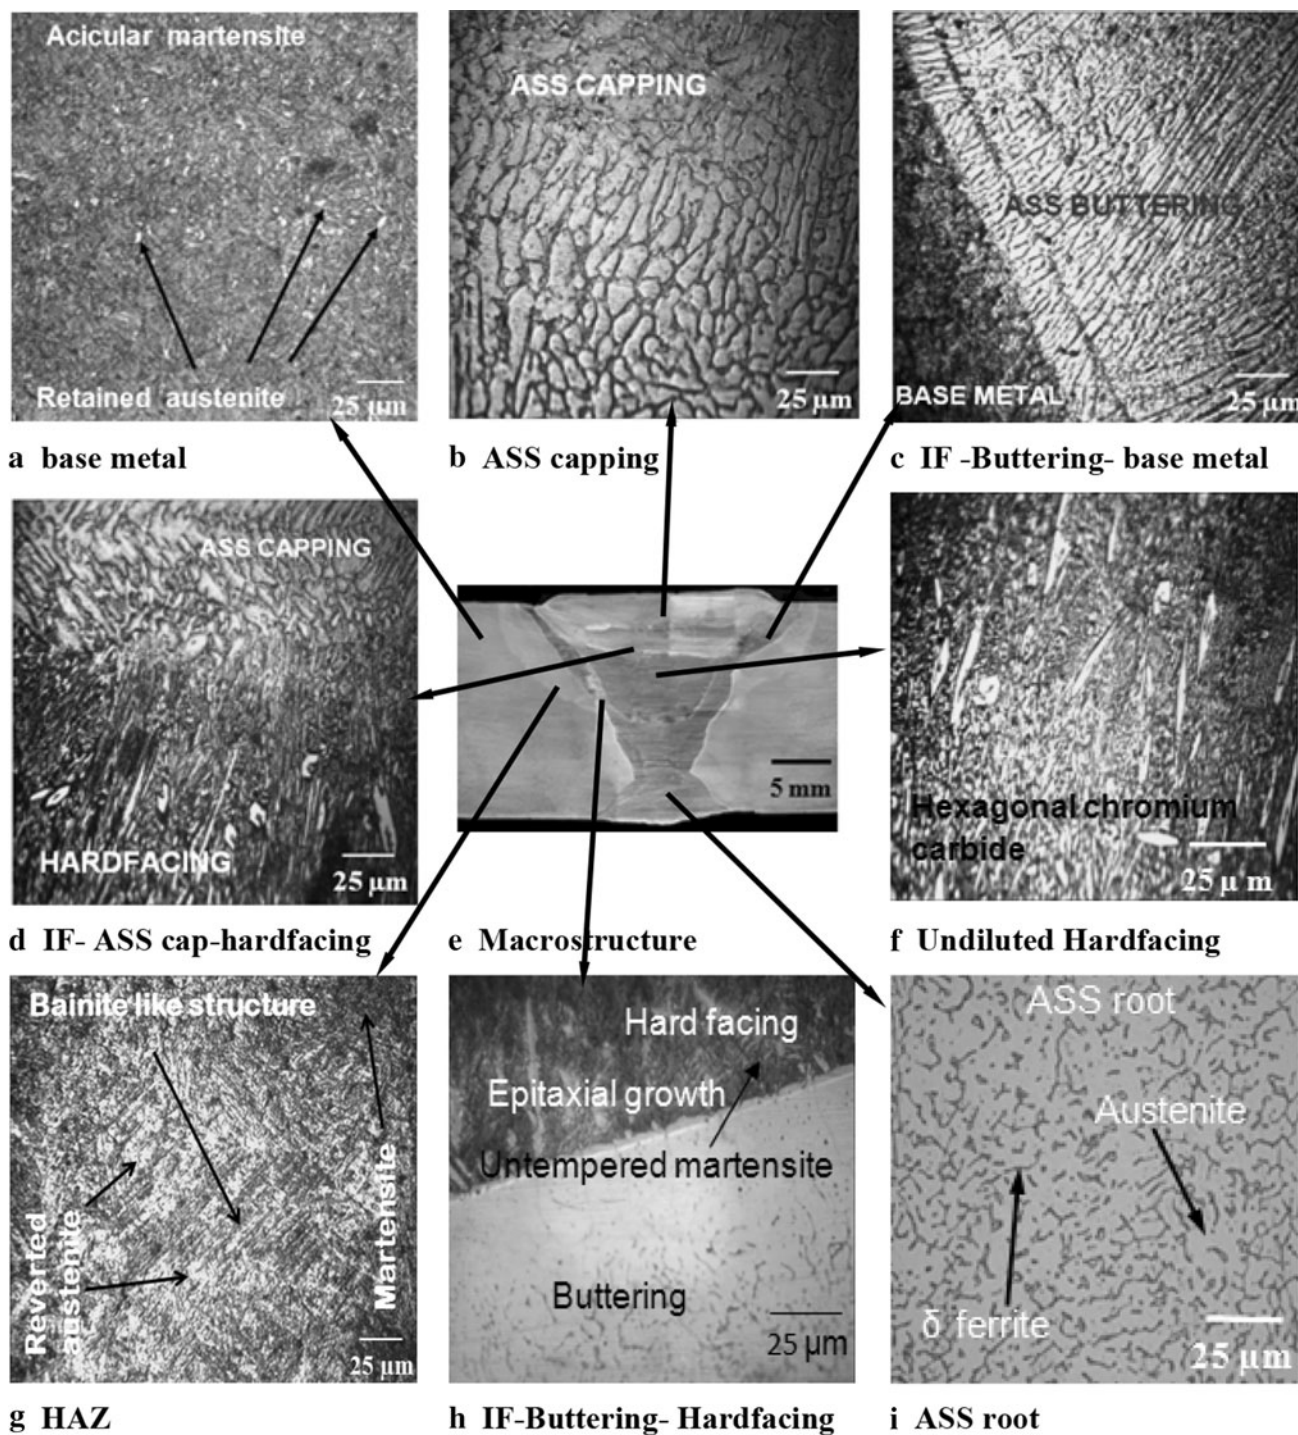
Light micrographs of various locations before ballistic testing are shown in Fig. 2. The microstructure of the BM (Fig. 2a) consists of acicular martensite with fine needles of lath martensite, in addition to some retained austenite [20]. The image analysis result revealed the presence of 97.2 % martensite and 2.7 % retained austenite in the BM microstructure. The microstructures of various locations of the multilayered joint are presented in Fig. 2(b–i). The undiluted weld metal microstructure in the SS buttering and SS capping (Fig. 2b) contains grain boundary δ -ferrite in a plain austenitic matrix. The weld interface (IF) region of the SS buttering and BM (Fig. 2c) contains a continuous epitaxial growth of austenite. The weld interface region of hardfacing and SS capping (Fig. 2d) shows an epitaxial growth of δ -ferrite in austenitic matrix. Figure 2(e) presents the macrostructure of the welded joint and shows the different layers/regions of the joint. From this macrograph, it is clear that the joint has very good integrity and complete fusion at all interfaces was achieved. The HAZ is also visible in the macrostructure. The undiluted hardfaced region (Fig. 2f) contains homogeneous cast-like structure and is composed of hard phase precipitates of hexagonal chromium carbides of different sizes on softer austenitic matrix [21]. Large spine-like

carbides are clearly visible in the microstructure of the hardfaced layers in the joints. The HAZ microstructure (Fig. 2g) clearly depicts the presence of coarse martensite near the FL and toward the BM side; it contains uniformly distributed martensite along with low-temperature products such as bainite [22]. The weld interface region of SS buttering and hardfacing (Fig. 2h) reveals fine continuous epitaxial growth of austenitic matrix and hexagonal carbides. The interface region between buttering layer and BM, and between buttering layers and hardfacing, has similar morphology. The interface microstructure of the sandwiched joint has a smaller portion of unmixed zone near to the periphery of the fusion boundary along with a softened layer of untempered martensite structure. Figure 2(i) shows the SS root microstructure, which clearly depicts the presence of vermicular δ -ferrite dispersed in a massive austenite matrix.

Fig. 2 Optical micrographs of BM and weld metal at various locations

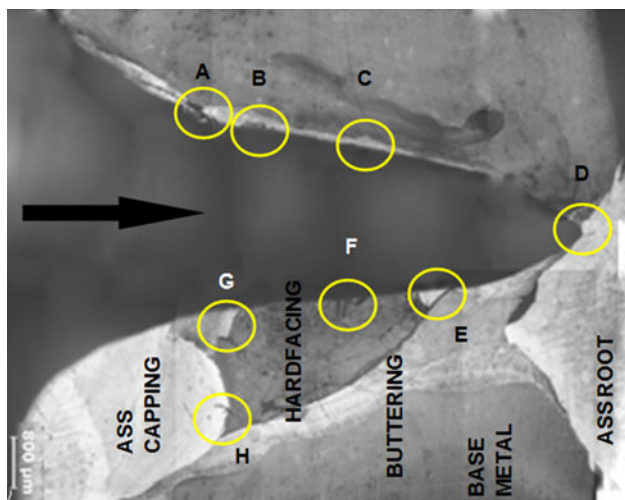
Figure 3 shows the microstructure of the material surrounding the projectile path in the through-thickness direction of the target plate at the WCL location. Microstructural features of encircled locations are discussed in the following paragraphs.

Fig. 3 Microstructure of through-thickness cross section (arrow indicates bullet direction)

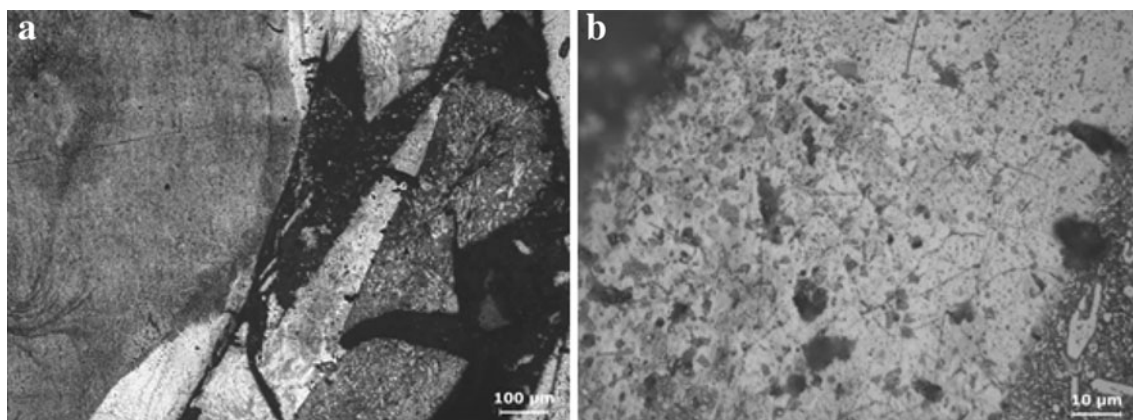
Figure 4(a, b) shows the microstructural features of location “A” at different magnifications. This location corresponds to the interface between the BM and SS buttering layer. Figure 4(a) reveals a number of small fragmentations of the layer. Though it is disintegrated into a number of pieces, in the middle (Fig. 4a) there is a part which shows the integrity of the fusion between buttering layer and hardfaced layer. The micrograph clearly shows that the crack exists only in the high-hardness hardfaced layer and in the low-hardness buttering layer, but not in the interface between the buttering layer and BM. This suggests that the joint integrity is enhanced by the buttering layer. A blunted crack at the interface between SS buttering and hardfacing is visible in Fig. 4(b). In the same micrograph, the hardfaced layer consists of a number of microcracks. At higher magnification, the interface region between SS buttering layer and hardfacing layer shows few microvoids (Fig. 4b). Figure 4(b) reveals the presence of a number of very fine microcracks in the SS buttering layer also. However, good bonding between hardfaced layer and buttering layer is clearly visible in the same micrograph. This suggests that the soft and tough buttering layer was

able to absorb some of the impact energy by cracking on its own in the presence of the hardfaced layer.

Fig. 4 Microstructural features of location “A” labeled in Fig. 3 (a) at 100× magnification (b) at 1000× magnification

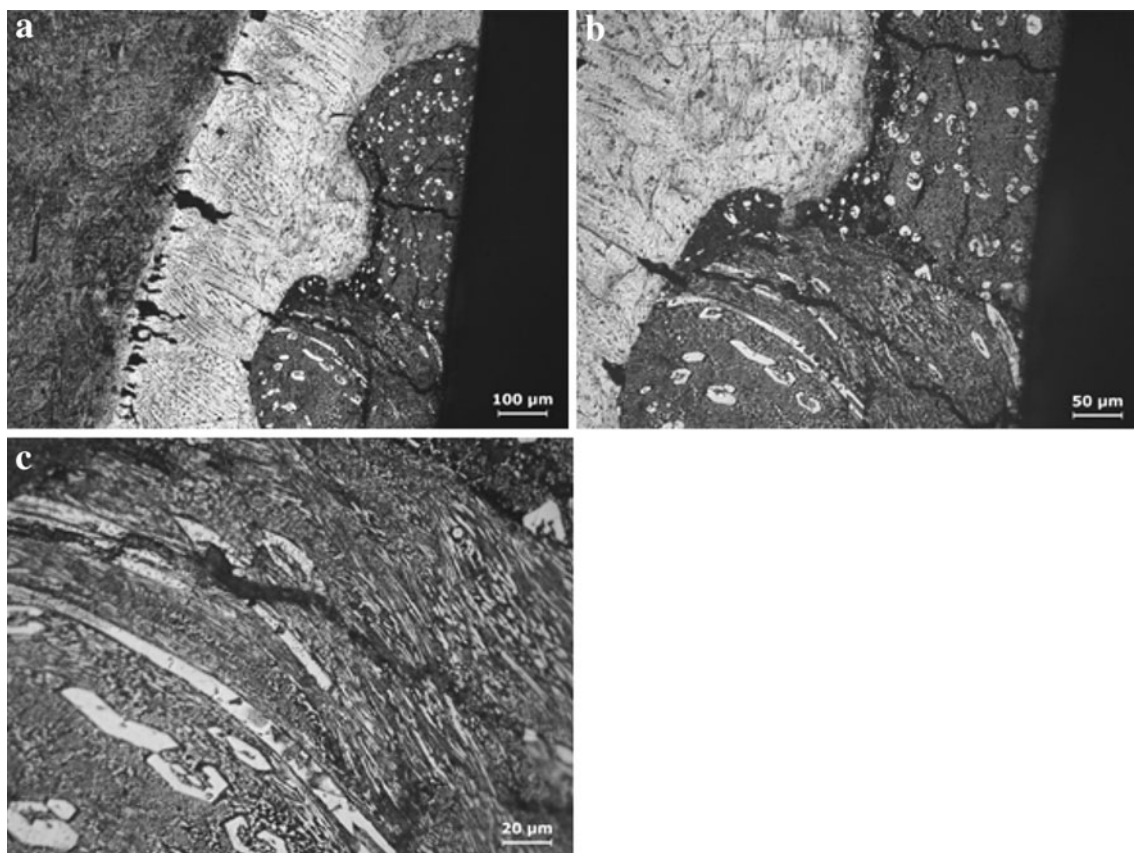
Figure 5 shows the microstructure after ballistic impact at location “B” in Fig. 3. Figure 5(a) shows the presence of cracks in the hardfaced layer both parallel and normal to the bullet trajectory. When the projectile hits the hard layer directly, it proceeds off-beam and tends to produce more

cracks in the hard layer [23]. This might lead to fragmentation and separation from the subsequent layers. These cracks presented in the hardfaced layer are arrested at the interface between the hardfacing and buttering layer, and this is clearly visible in Fig. 5(a). At the interface between the buttering layer and hardfacing layer (Fig. 5a), the presence of some small microvoids is clearly visible.

These microvoids are not presented in the direction parallel to the bullet trajectory. This suggests that the separation of buttering layer and hardfacing layer after impact is still prevented due to the presence of the soft austenitic buttering layer. Cracks both parallel and normal to the direction of the projectile trajectory are clearly visible in Fig. 5(b). In the same microstructure, the presence of hexagonal chromium carbides is also observed.

Figure 5(b) reveals the presence of transgranular failure of hexagonal chromium carbides in the horizontal crack path. In addition, the presence of gross plastic deformation (elongated chromium carbide) is also observed in the same figure (Fig. 5c). Figure 5(c) reveals the crack path, which shows transgranular failure of high-hardness hexagonal chromium carbide. The hard layer of high-carbon, high-chromium carbide alloy absorbs the ballistic impact energy by forming high-density cracks. The distribution and shape of these cracks seem to be dependent on the distance from

the impact point. They vary in amount from one location to another in a given target specimen and a given layer. This suggests that the failure of the hardfaced layer could be caused after considerable plastic deformation of chromium carbides and that the failure can be considered as plastic flow led rupture [24, 25].

Fig. 5 Microstructural features of location “B” labeled in Fig. 3 (a) at 100× magnification (b) at 200× magnification (c) at 500× magnification

there is no evidence of separation of the buttering layer and hardfacing layer (Figs. 5b, 6(b, c)). These results again exemplify the joint integrity between these two layers after the ballistic impact. The highly distorted microstructure of δ -ferrite in a plain austenite matrix is clearly visible in Fig. 6(f). The presence of massive austenite and dispersed δ -ferrite in the austenitic matrix is clearly visible instead of the grain boundary δ -ferrite present in the austenitic matrix as seen in Fig. 2(b). This could be attributed to the solid-state material flow of the austenitic buttering layer in between the bullet and BM. This microstructure appears

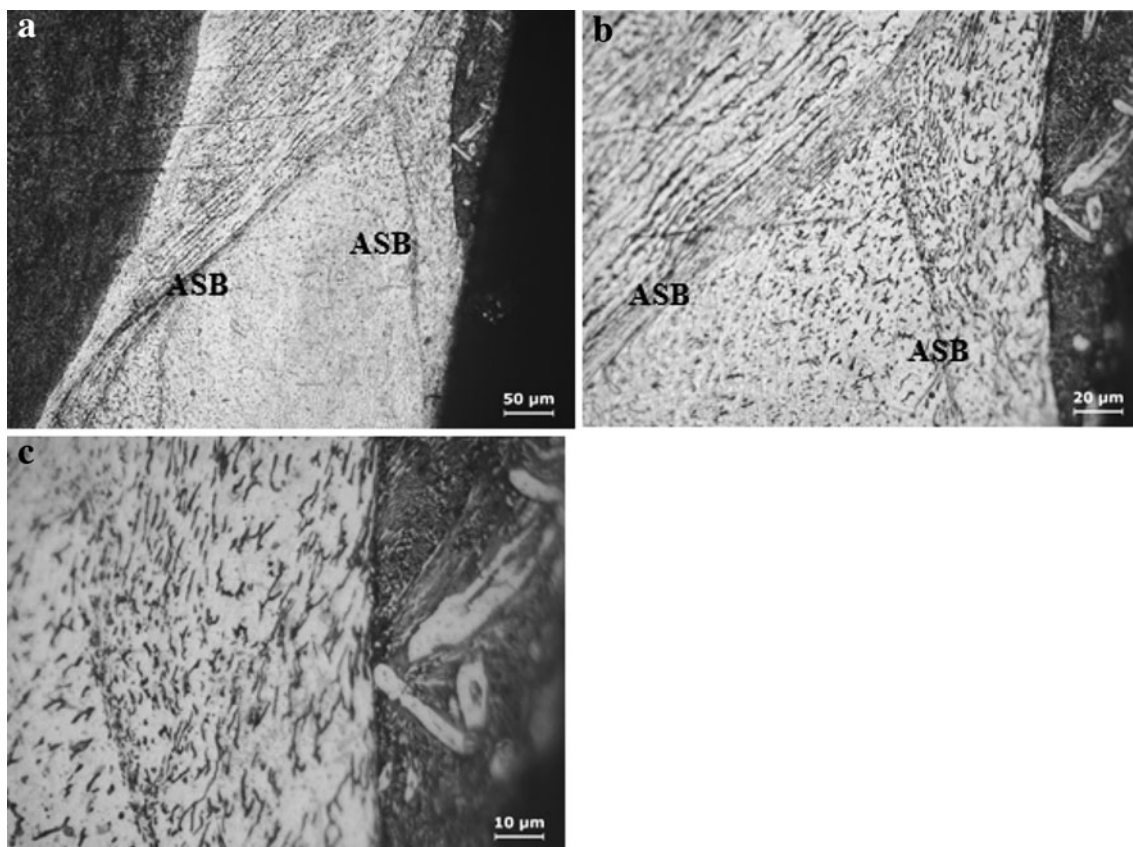
Figure 6 shows the microstructural features of location “C” labeled in Fig. 3. In this figure, the deformation of the SS buttering layer is clearly visible (Fig. 6a), being composed of solid-state flow of austenitic buttering layer in between the bullet and BM, as observed by Pizana et al. [25]. The solid-state flow is clearly visible in Fig. 6(b, c). Figure 6 shows the presence of adiabatic shear bands (ASBs). The solid-state flow could be produced when material from the head section near the target–projectile interface is transported. Thus, the shear bands facilitate the high-strain-rate deformation experienced in this region [25].

Fig. 6 Microstructural features of location “C” labeled in Fig. 3 (a) at 200× magnification (b) at 500× magnification (c) at 1000× magnification

From Fig. 6, it is very clear that, at the time of bullet travel through the weld layers, there is a considerable amount of plastic flow of weld metal. A schematic illustration of the material flow is presented in Fig. 15. The material flow in this case is outward, opposite to the bullet direction, and perpendicular to the target surface because of the presence of very high-hardness BM next to the soft SS buttering layer; this could be the reason for the arrest of the material flow in the direction perpendicular to the bullet penetration and parallel to the target surface. The highly distorted grain boundary δ -ferrite is clearly visible in Fig. 6(b, c). This shows the capability of the austenite matrix present in the buttering layer against the high-strain-rate deformation, which is assisted by the distortion of δ -ferrite present in the grain boundaries of this layer. Though solid-state material flow occurred in the adjacent region (SS buttering layer),

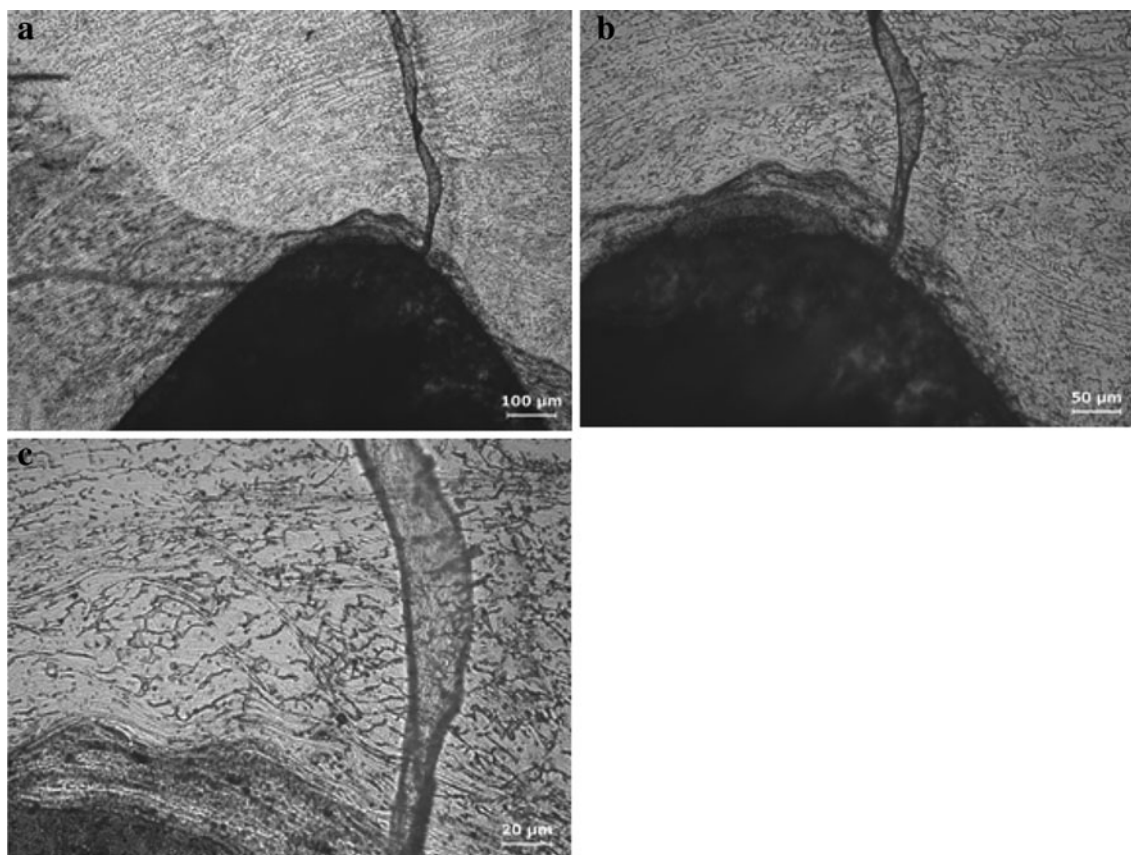
Figure 7 shows the microstructural features of location “D” labeled in Fig. 3. Figure 7(a) shows the target–bullet interfacial microstructure (where the nose of the bullet was stopped). At the root of the joint, the presence of skeletal δ -ferrite in the austenitic matrix is clearly visible in the micrograph. A part of the hardfaced layer jammed at the interface between the target and projectile is also evident in the same micrograph. In Fig. 7(b), an anomalous pattern of skeletal δ -ferrite in the austenitic matrix in the immediate vicinity of the target–projectile interface is also visible.

Fig. 7 Microstructural features of location “D” labeled in Fig. 3 (a) at 100× magnification (b) at 200× magnification (c) at 500× magnification

bullet interface (Fig. 7c), while the other locations possess strongly distorted microstructure (Figs. 6, 7). Again the absence of adiabatic shear band in this region in Fig. 7 can be ascribed to this lower available impact energy reduced by the other (SS capping front and hardfacing) layers.

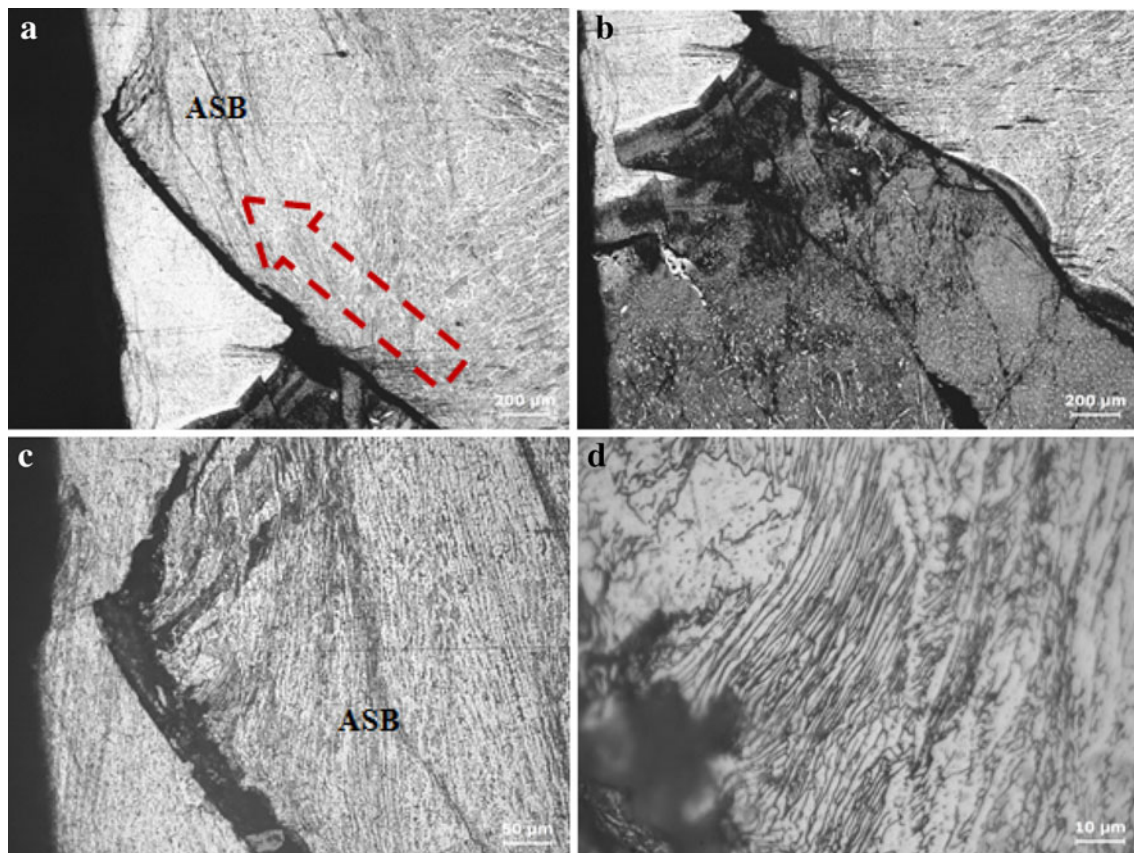
Figure 8 shows the microstructural features of location “E” labeled in Fig. 3. This location corresponds to the interface between the hardfacing and SS root layer. The microstructure (Fig. 8a) clearly shows the presence of hanging of buttering layer and hardfaced layer. In Fig. 8(a), the arrow indicates the plausible crack propagation direction starting from the hardfaced layer and propagating toward the soft SS layer. In Fig. 8(b), ASBs are observed, and adjacent to the ASBs, cracks are also seen. Figure 8(a, b)

reveals the presence of a crack in both the buttering and the hardfaced layers after ballistic impact. In Fig. 8(c, d), the presence of elongated austenitic grains is clearly visible from the micrographs. This shows that these layers have undergone considerable deformation before crack initiation and separation of layers.

Fig. 8 Microstructural features of location “E” labeled in Fig. 3 (a) at 50× magnification (b) at 50× magnification (c) at 200× magnification (d) at 1000× magnification

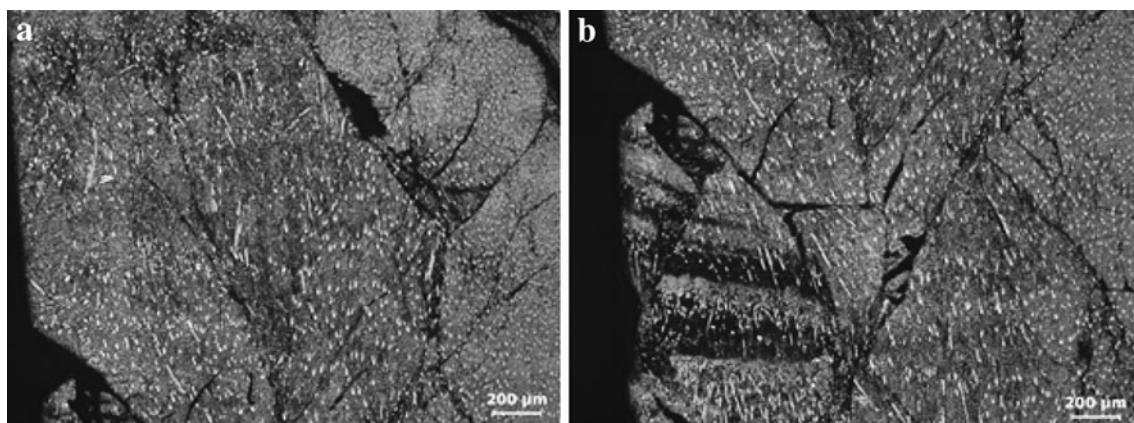
Figure 9 shows the microstructural transformation after ballistic impact at location “F” (different locations of hardfaced region alone) labeled in Fig. 3. From Fig. 9(a, b), it is evident that numerous cracks were generated during the ballistic impact in orientations both parallel and normal to the bullet trajectory. The distribution and shape of the cracks depend on the distance from the impact point. They vary in number from one location to another in a given target specimen and a given layer. However, in Fig. 2(b), it is apparent that no such cracks are presented in the hardfaced layer. This suggests that the cracks are generated during the ballistic impact only.

Fig. 9 Microstructural features of location “F” labeled in Fig. 3 (a) at 50× magnification (b) at 50× magnification

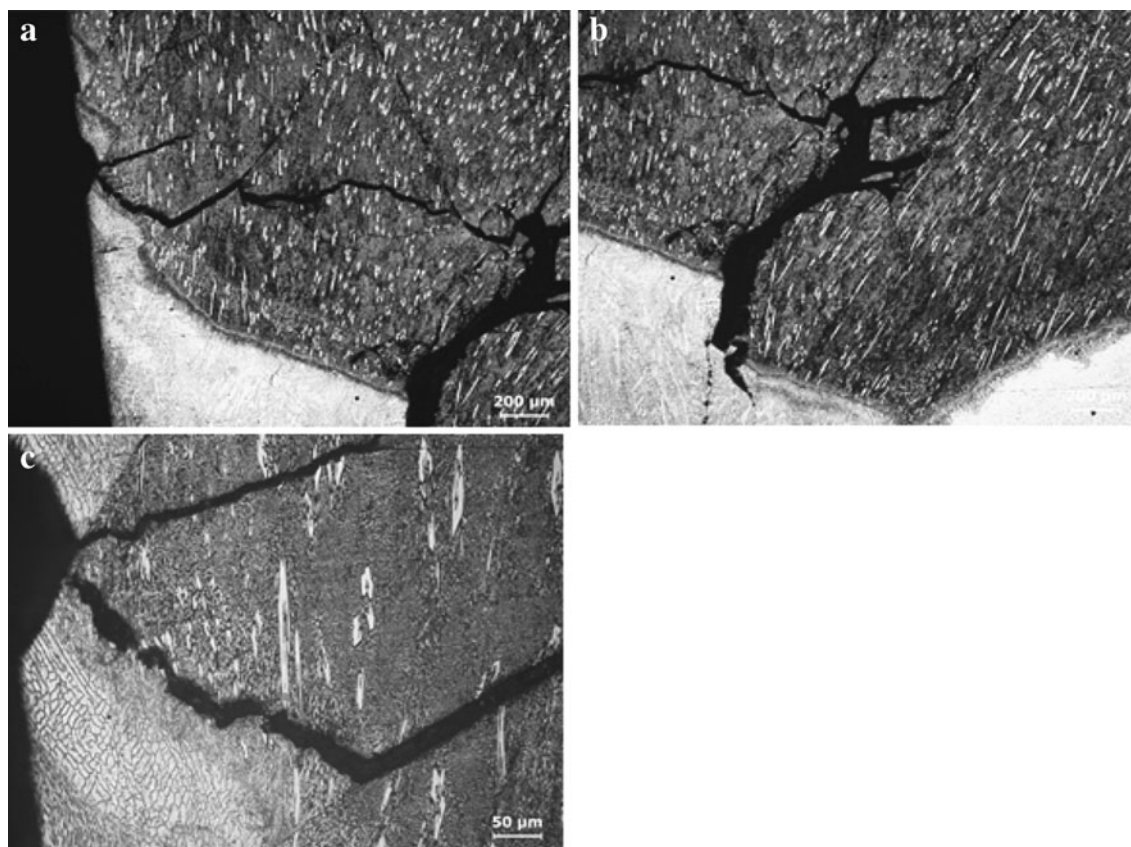
Figure 10 reveals the microstructural features of location “G” (interface between SS cap and hardfaced region). In Fig. 10(a, b), cracks are present in multiple directions. In Fig. 10(b), crack arrest in the SS capping layer is observed. In Fig. 10(c), the presence of cracking in the interface between the SS capping front layer and hardfaced

interlayer is clearly visible. It is significant that the crack is not in the soft front layer but instead is presented in the hardfaced middle layer in the radial direction (normal to the bullet trajectory). This can be ascribed to the fact that the austenite matrix might have played a role in retarding fast crack propagation as it is a ductile phase. In Fig. 10(c), the needle-like chromium carbides are broken due to the long cracks.

Fig. 10 Microstructural features of location “G” labeled in Fig. 3 (a) at 50× magnification (b) at 50× magnification (c) at 200× magnification

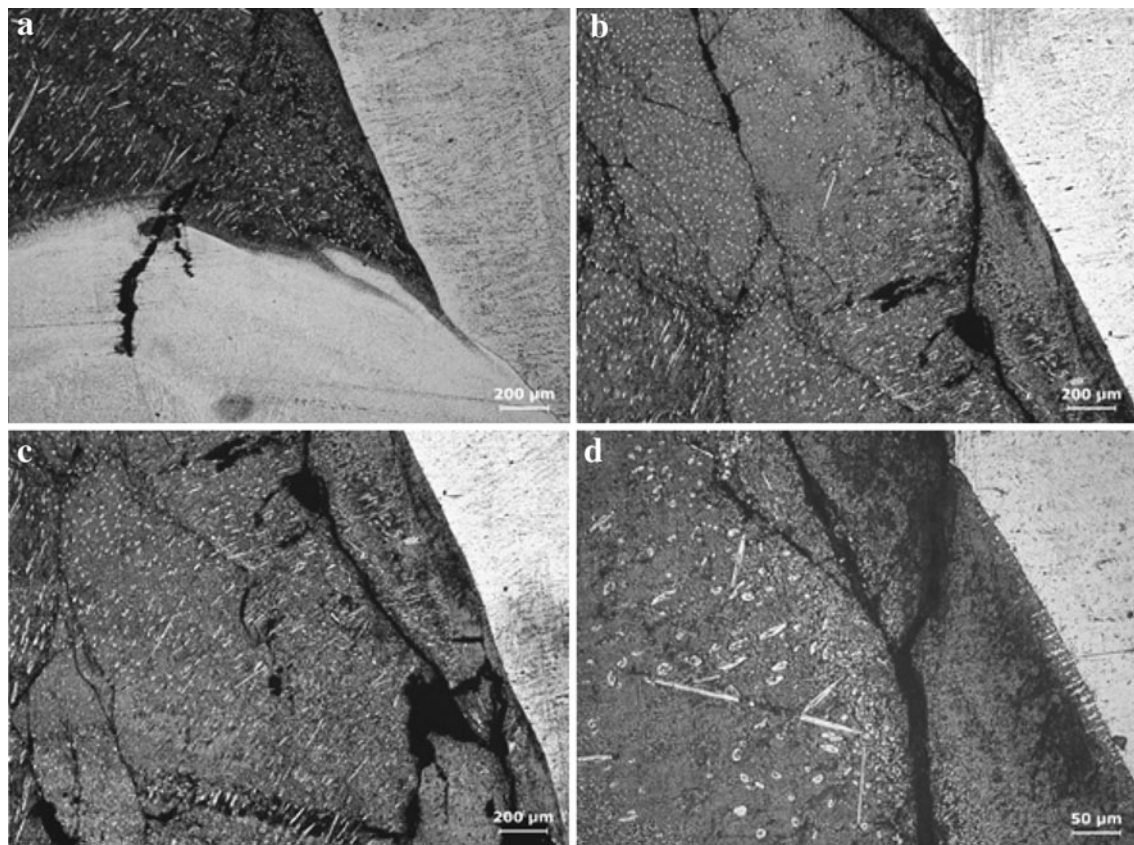
Figure 11 reveals the microstructural features of location “H” labeled in Fig. 3 (the interface between SS capping/buttering layer and hardfaced region). In Fig. 11(a), the interfaces (interface between buttering/hardfacing and hardfacing/SS capping) are clearly visible. The presence of cracks is observed only in the SS capping front layer but not in the SS buttering layer. This can be ascribed to the dilution effect of the SS capping layer with the hardfaced layer and also the impact intensity on the front layer. This impact intensity is comparatively lower in the SS buttering layer, and also the available microstructure in this zone (buttering layer) possesses higher toughness as compared with the chromium carbide microstructure in the hardfaced layer. Figure 11(b–d) depicts a number of microcracks and pull-out of some parts of the hardfaced layer. However, these cracks are completely arrested in the interface

between the SS buttering layer and hardfacing, because these cracks are blunted by the austenite microstructure.

Fig. 11 Microstructural features of location “H” labeled in Fig. 3 (a) at 50× magnification (b) at 50× magnification (c) at 50× magnification (d) at 200× magnification

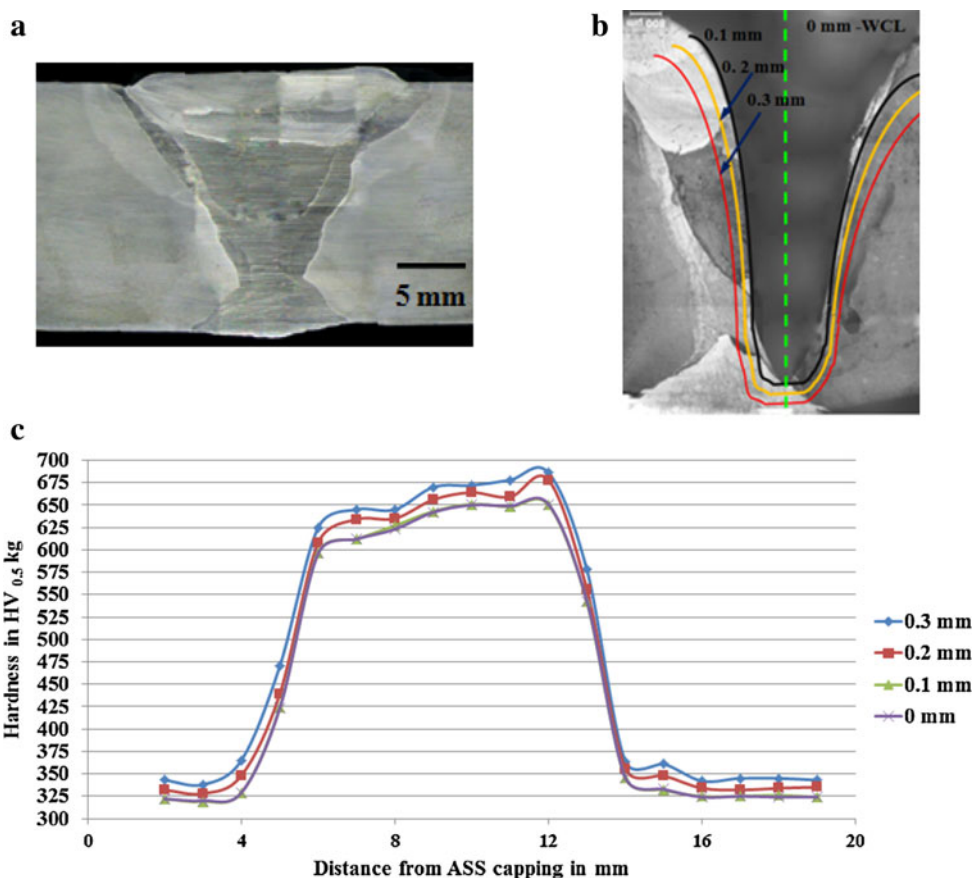
Microhardness measurements were taken along the WCL to identify the hardness profile in the through-thickness direction of the target plate. Similarly, hardness measurements were performed as per the scheme illustrated in Fig. 12(a) to identify the hardness alteration after the ballistic test at three different radial distances from the lip of the unaffected area after projectile travel. For comparative analysis, the hardness profile along the WCL before and after impact is presented in a single graph (Fig. 12c). In this graph, the hardness curve labeled “0 mm” is the hardness profile along the WCL before impact and the hardness profile along 0.4 mm from the lip of the bullet trajectory after impact. Similarly, the hardness curves of 0.1, 0.2, and 0.3 mm are the hardness profiles after ballistic impact at 0.1, 0.2, and 0.3 mm, respectively, from the lip of the bullet trajectory. From these curves, it is observed that a smaller increase in hardness was observed within the localized area (Fig. 12b) that covered with adiabatic shear band as seen in Figs. 6 and 8. A similar increase in

microhardness has been observed by Solberg et al. [26] in the through-thickness direction, irrespective of weld layers. These hardness values are just above the hardness measured in the virgin material (0 mm, hardness along WCL) far from the shear zone.

Fig. 12 Hardness test results. (a) Macrostructure of the joint before impact. (b) Microstructure of the joint after impact and schematic illustration of hardness measurement map. (c) Hardness profile along the weld center line at different locations of the joint before and after impact

The hardness is markedly increased within the localized area (Fig. 12) that covered with adiabatic shear band as seen in Figs. 6 and 8. A similar increase in microhardness was observed by Solberg et al. [26] in the through-thickness direction, irrespective of weld layers. These hardness values are just above the hardness measured in the virgin material (0 mm, hardness along WCL) far from the shear

zone. This indicates that there is no possible phase transformation, and the increase in hardness could be due to deformation-induced microstructure changes (Figs. 5–11) and work-hardening effect [28]. Even though no microstructural changes were discovered for undiluted hardfaced layers, a small increase in hardness was detected due to the deformation-induced hardening of this zone by the ballistic impact. Even these zones before impact possess a very high hardness, resulting in the generation of numerous cracks in both directions. This prevents adiabatic shear band formation in this zone.

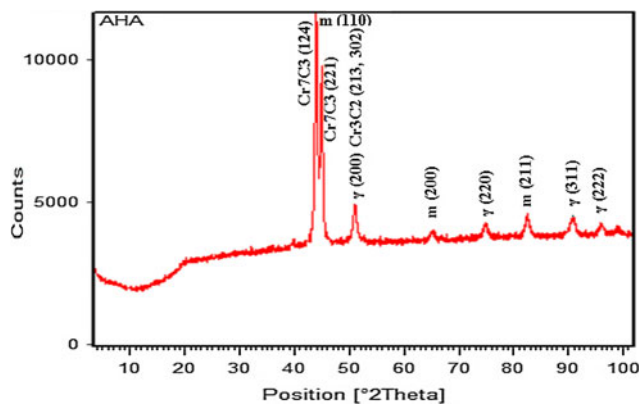
Comparing the XRD patterns from the two examination locations (Fig. 13), the only difference is the presence of chromium carbide peaks in the section containing both weld metal and BM. The XRD results confirm the presence of austenitic and martensitic peaks in both cases. In addition to the austenitic and martensitic peaks, the presence of Cr_7C_3 and Cr_3C_2 is also confirmed through this XRD analysis in this section. The main peaks of the specimen reveal four phases: face-centered cubic (γ), body-centered cubic (m), hexagonal (Cr_7C_3), and orthorhombic crystal structure (Cr_2C_3). As the hard chromium carbide peaks are observed at high intensity, these results indicate that these phases are more dominant in these layers. The presence of austenitic phases reflects the presence of retained austenite in these regions.

Fig. 13 XRD pattern for weld metal/base metal

possessing very high hardness can be beneficial to resist the ballistic impact. XRD analysis confirmed the presence of hexagonal (Cr_7C_3) and orthorhombic crystal structure (Cr_2C_3). The projectile penetration resistance of various armor materials is dependent on their hardness. Adequate toughness is called for, to avoid cracking tendency and consequent disintegration of the material. Generally, the harder the material, the better its resistance to projectile penetration [17, 18]. It was expected that the soft austenitic capping front layer would no longer offer resistance to projectile penetration. The capping front layer allows the bullet to puncture the front layer; when the bullet reaches the hardfaced layers, the hardfacing offers maximum resistance to penetration.

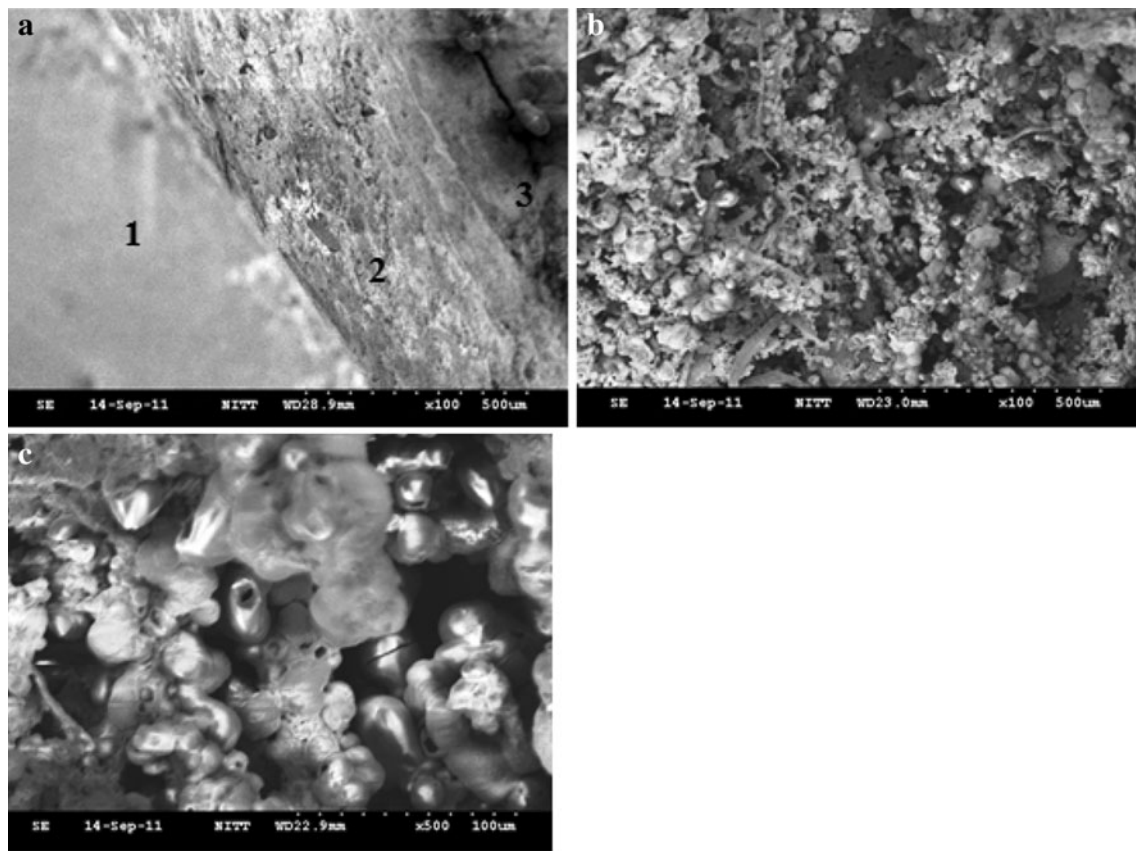
The samples exhibit a fibrous fracture surface showing three distinct zones, as shown in Fig. 14. Zones marked 1, 2, and 3 represent the fracture surface of the bulk material and that of the sheared regions, respectively. The transitional deformed band between the bulk material and 1.5 mm depth from the lip of the broken area is shown in zone 2. The appearance of shear bands depended on the distance from the initiation point. Near the edge of the plate in the fractured surface, the shear lips of the broken plate were smooth with very fine dimples. Zone 3 is the large curved surface representing the conical shell of the transformed adiabatic shear band that formed during the combined action of plastic deformation and adiabatic heating along the narrow heat wave paths [12, 13]. Two fracture modes are observed in this zone: ductile shear fracture mode showing highly elongated dimples (Fig. 14b) and knobby fracture mode (Fig. 14c), which suggests partial melting of the grain boundary within the shear bands [27]. This can be ascribed to the high velocity of the projectile; the heat generated in some slip planes does not have enough time to dissipate completely. This local heating prevents homogeneous deformation and thus promotes the

knobby type of fracture mode at this location. The dimples are narrower and more elongated. Both dimpled and knobby fracture occurred along ASB in these specimens, and the transition between ductile shear fracture and knobby fracture modes is clearly visible on the fracture surface.

Fig. 14 Fracture surface of bullet path

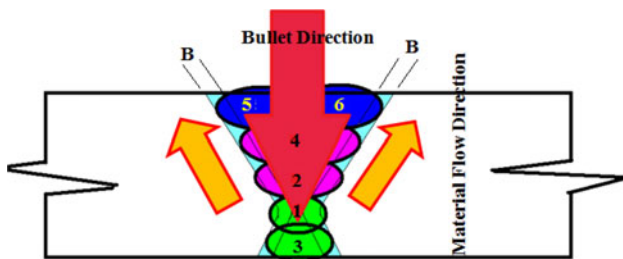
Fig. 15 Schematic illustration shows the probable solid state flow of material at the time of impact (1-6 sequence of deposition; layers 1, 3, 5 & 6 represents the ASS weld, layers 2 and 4 are hardfacing and ‘B’ is ASS buttering layer.)
