Alkali–Silica Reactions: An Overview. Part I

Isabel Fernandes · Maarten A. T. M. Broekmans

Abstract Concrete is one of the most widely used building materials since the nineteenth century. The manufacture of concrete includes the binder (cement), aggregates, water and possible additives. Although very versatile and durable, in the early 1900s, it was recognized that concrete can deteriorate and in consequence, compromise the durability and good functioning of the structures. From the many different damage mechanisms that can originate the deterioration of concrete, alkali–silica reaction (ASR) is the one that involves the aggregates. Aggregates constitute about three-quarter of the volume of concrete, and therefore their physical and chemical properties need to be correctly assessed before their use in concrete. Since the 1940s, considerable research has been developed to determine which components of the rocks and minerals contribute to the chemical reaction involved in this process of deterioration. However, a lot still remains to be understood. In the present article, an introduction to the subject is made, focusing mainly on the mechanisms and on the manifestations of the ASR

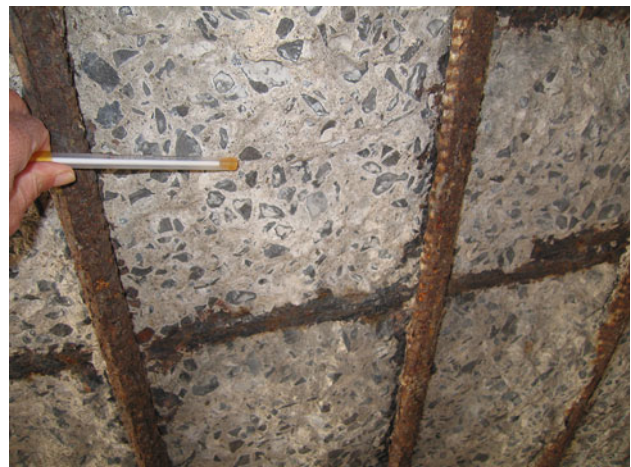
Fig. 1 Corrosion of the steel bars and spalling of the concrete in a viaduct

The use of steel (e.g. pre-/post-tensioned, traditional reinforcement) in concrete structures has the primary function to enhance tensile strength, allowing much larger spans than would be possible with nonreinforced concrete. Corrosion of steel reinforcement has several consequences. Corrosion-induced cracking, spalling, delamination and bleeding do decay the aesthetic aspect of a structure, giving it a 'poorly maintained' appearance (Fig. 1). However, far more important than cosmetic appearance is the reduction

of the cross-sectional area of the steel and concomitant reduction of load-bearing capacity [9, 21].

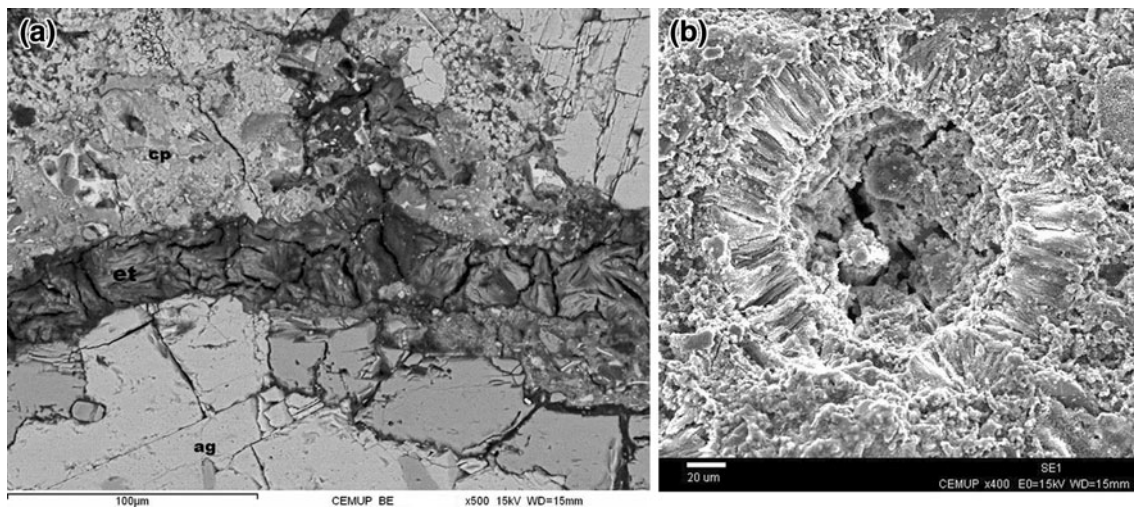
Fig. 2 Images of ettringite crystals obtained by scanning electron microscope (SEM): (a) ettringite in cracks inside concrete, between the aggregate (ag) and the cement paste (cp) in a polished thin section; (b) ettringite inside a void in a fragment of concrete

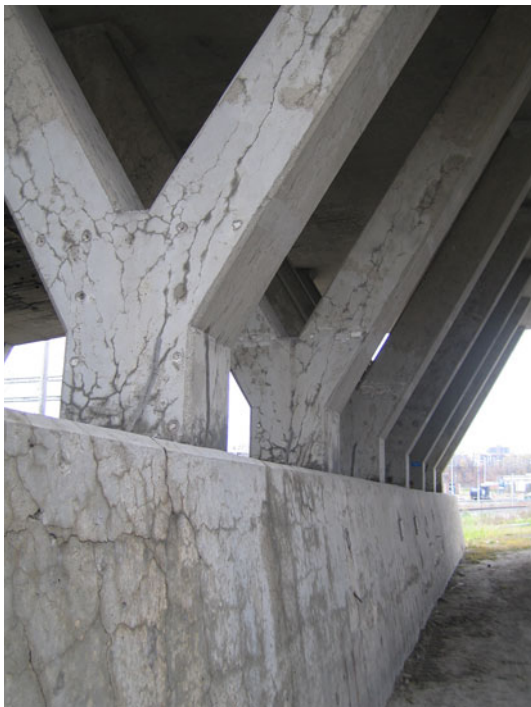
Fig. 3 Du Vallon–Charest highway interchange viaduct, in Quebec city, Canada, recently demolished because of ASR

Although no structure is known to have collapsed because of the occurrence of ASR (at least in published documentation), there are some structures that have been demolished and replaced by new ones because the structural integrity revealed that safe operation had been severely compromised. There are examples from different locations around the world, such as the Charrest viaduct in Quebec, Canada (Fig. 3), Alto Ceira dam, in Portugal and some viaducts in the Netherlands and Belgium [59].

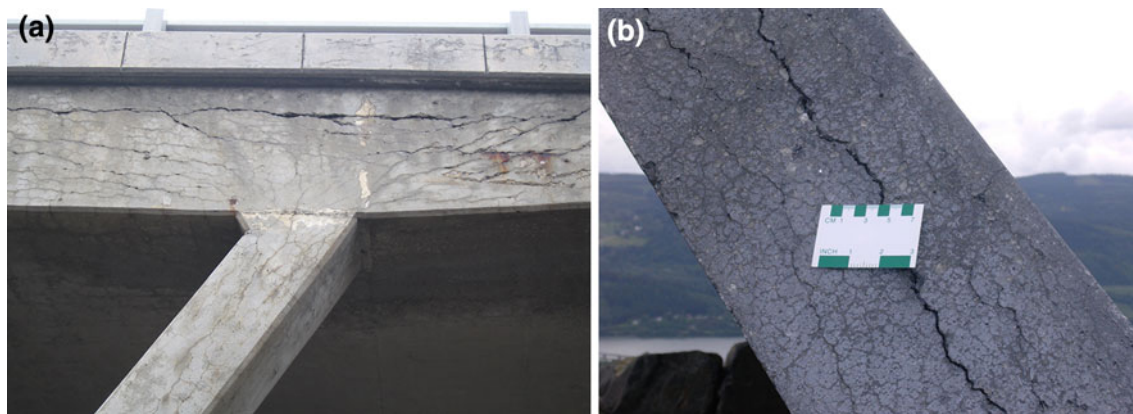
Fig. 4 Pattern of the cracks related to ASR. In both structures (a, b), the major cracks reflect the underlying steel reinforcement. Cracks tend to develop longitudinally parallel to the direction of dominant restraint

The cracks which originate from ASR are a consequence of swelling from the uptake of water by ASR gel. This cracking is characterized by a network of fine cracks joined up in polygonal shapes and confined by larger cracks in a pattern that resembles the limits in a map and is named ‘map cracking’. This random distribution occurs in unrestrained concrete [16, 53, 61]. Because the least restraint occurs in a direction perpendicular to the surface, the cracks tend to align subparallel to the surface [15]. These cracks usually do not go deeper than 25–50 mm of the exposed surface, seldom exceeding depths >100 mm in massive structures [16, 17, 61]. In reinforced concrete, the cracks often reflect the pattern of the underlying steel (Fig. 4) and seldom go below the level of the reinforcement. In heavily reinforced, or prestressed beams and columns, or where there is longitudinal compressive stress in the structural element, cracks will tend to be orientated along the stress direction, i.e. along the length of the member and may extend along its entire length.

In concrete structures, cracking develops mainly in areas where the concrete has a permanent supply of moisture, such as close to the waterline in piers, from the soil behind retaining walls, beneath pavement slabs, or by wick action in piers or columns [16]. In pavements, ASR cracks are usually perpendicular to transverse joints, and parallel to

free edges along the roadside where there is less restraint. In gravity dams, expansion is less restrained in the upward direction, and cracking is mainly horizontal.

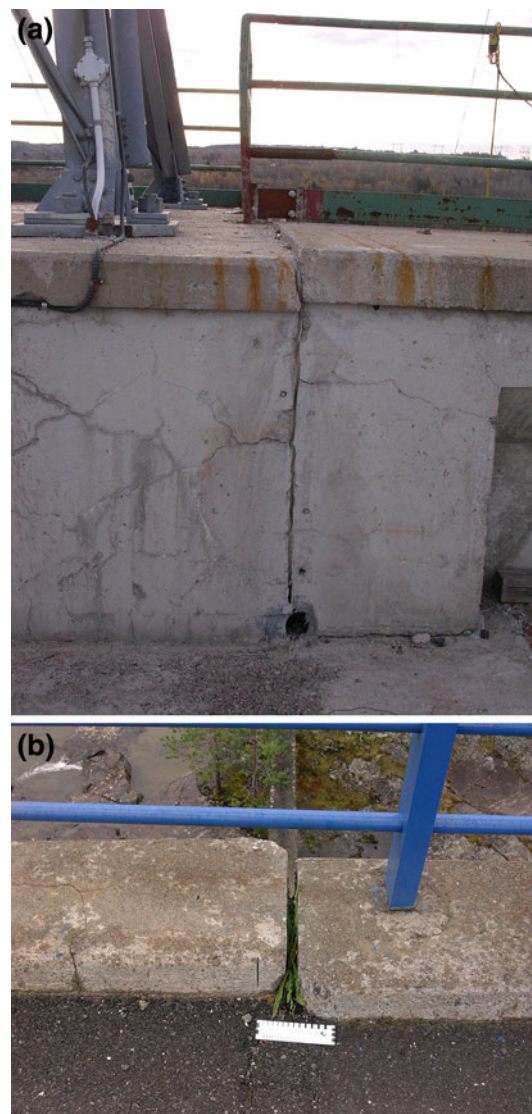
Fig. 5 Misalignment in the crest of two different concrete dams (a, b)

Significant movements in the structure can sometimes occur because of loading, shrinkage, variable expansions, displacements and deformations (such as deflection and bulging) at different scales between parts of a structure. ASR is a potentially expansive mechanism, so that significant movements in the structure can sometimes occur [60]. A record should be made of any differential movement, such as the closing of joints, the relative displacement of adjacent concrete sections (Fig. 5), excessive deflection, and the twisting or bulging of originally flat surfaces. The volume increase may lead to malfunctioning of the structures as occurs in some spillway gates in damaged concrete dams [15].

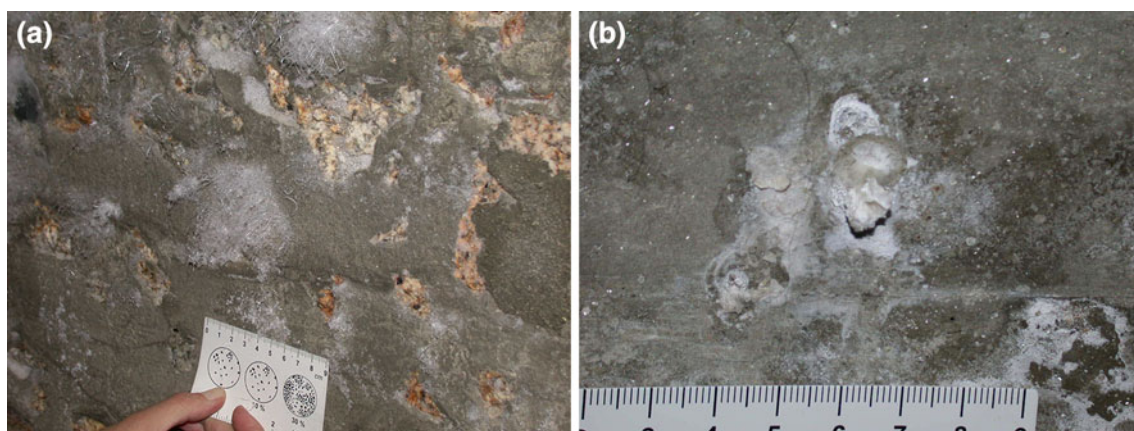
Fig. 6 Interior wall in two different dams. **(a)** Needle crystals of trona forming efflorescence (*white fluffy patches*); **(b)** exudation of carbonated alkali–silica gel (*white droplet*)

Efflorescence is due to the transport of fluids through concrete and evaporation at the surface with the consequent deposition of salts from the solution. The most common efflorescence is formed by calcite, brucite (magnesium hydroxide), gypsum and trona. The extent, location and quantity of efflorescence should be recorded, and the colour, texture, dampness and hardness of the deposit described [16, 60]. Samples should be collected for

chemical analysis in the laboratory to determine if ASR gel is present (Fig. 6).

Exudations of alkali–silica gel reflect the fact that there is enough moisture to transport the gel to the surface [62]. The exuded gel is usually transparent but it can be white, yellowish, or colourless, and viscous, fluid, waxy, rubbery, or hard. It carbonates very easily and becomes white to yellowish, and therefore difficult to distinguish from calcium carbonate deposits, which are quite common in concrete surfaces. The presence of alkali–silica gel on the surface of the concrete indicates the presence of ASR, but it does not mean that the reaction is deleterious [60].

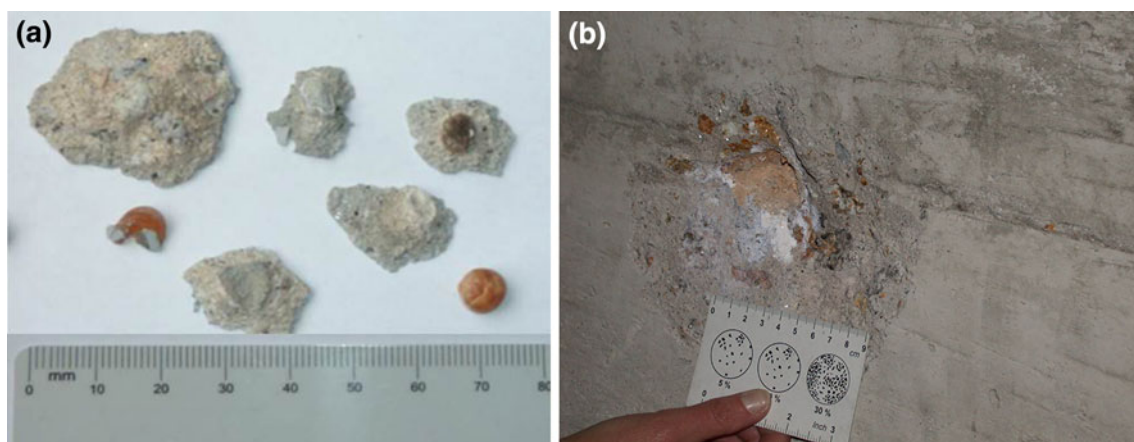
Fig. 7 Examples of pop-outs: **(a)** conical fragments from a pavement; **(b)** depression left on the wall of a concrete dam after the detachment of a pop-out

The term pop-out is applied to designate small conical fragments (Fig. 7a) which detach from the surface of the concrete because of expansion of individual aggregate particles close to an exposed concrete surface. The process leaves a shallow depression (Fig. 7b). Pop-outs can originate from ASR but also, for example, by the expansion of individual frost-susceptible water-saturated aggregate particles lying near the surface [15, 16, 60, 61]. Pop-outs can also be caused by a poor bond between the cement paste and dusty coarse aggregate particles. The number, size, and location of pop-outs should be recorded, and the nature of the aggregate exposed in the base of the pit should be identified, as these data provide valuable information about the quality of aggregates in a concrete. The confirmation of the occurrence of ASR can be made if ASR gel is present partially replacing the reactive aggregate particle. Pop-outs are a cosmetic issue but usually do not affect the serviceability or durability of the concrete.
