# Evaluation of the Compatibility of Repair Materials for Concrete Structures

**Abstract:** This study evaluates the compatibility of repair materials for concrete bridge decks. A new compatibility test set-up was designed and tested based on the concrete bridge deck cracking and delamination mechanism theory. The repair materials used in this study include lab formulated inorganic nano-aluminum silicates and commercially available organic two-part epoxy systems. Two different lab test-setups are proposed in this study: a prototype and a full-scale test. The developed test procedures were effective in communicating results in terms of compatibility of material properties, performance and quality. The prototype beams test can successfully serve as a small scale screening test providing insights on materials selection for the full-scale beam tests. The full-scale beams demonstrated the compatibility of the repaired system by providing data on authentic field conditions. Based on the observations it can be concluded that the proposed test setup is effective in examining the concrete bridge deck repair materials performance and selection, and compatibility in terms of mechanical prope

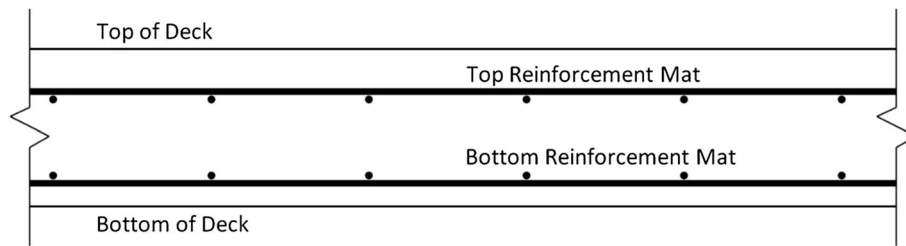
Fig. 1 Typical reinforcement placement in bridge deck.

bridge deck is usually anywhere from 8 inches to 12 inches thick but can be greater if required. Usually the deck features two layers of reinforcement called mats and consists of two sets of bars located perpendicular to each other for transverse and longitudinal flexural loads near the outer edge of the concrete as shown in Fig. 1.

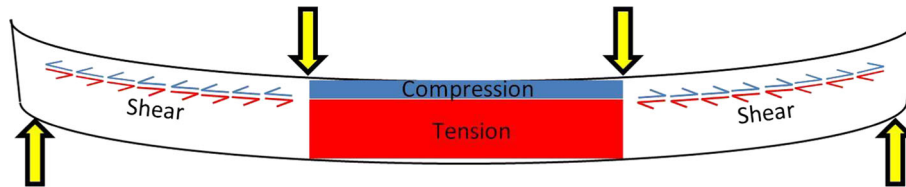
Fig. 2 Internal stress distribution in third-point bending.

When concrete is loaded in flexure, small flexural cracks form as a result of the transfer of tensile forces from the concrete to the steel reinforcement. In addition, when loads are applied to the superstructure, the opposing tensile and compression stresses from the ensuing flexural forces provide shear loads at or near the neutral axis (see Fig. 2). Since the strength of concrete and steel are different the neutral axis is not located at the mid-point as would be the case in a homogenous material but rather can be located at approximately 1/5 the thickness of the deck. This location often corresponds to the location of one of the two reinforcing mats described above. Most concrete decks are cast continuously across the supporting girders and therefore the compression and tensile inducing shear zones of the deck alternate with respect to the girder spacing. The zones located at the top surface of the bridge deck are where the maximum stresses can occur—“compressive” shear stresses near the deck supports and “tensile” shear stresses at the midsection.

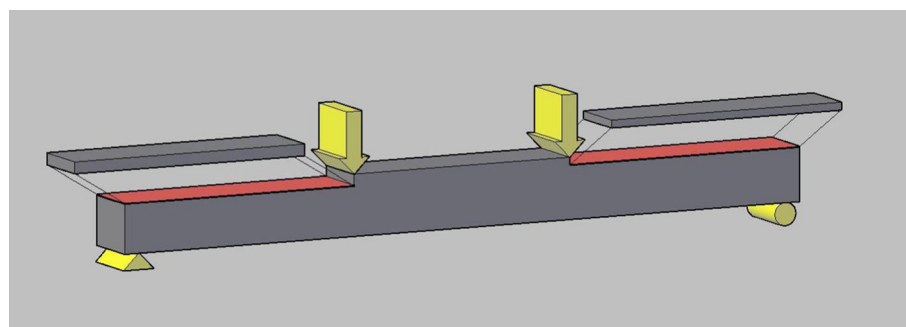
Fig. 3 Diagram of compatibility beam.

Therefore, the main stresses acting on the concrete causing delaminations, spalling, and eventually loss of the concrete cover and potholes, are tensile forces from corroding steel reinforcement and/or shear forces resulting from the opposing compressive and tensile stresses inherent in flexural loading. This analysis is used to design a test set-up for finding how effective the concrete repair is and determine repair material compatibility with concrete. A beam is designed with notches at either end at the compressive reinforcement (top mat) layer (see Fig. 3). Then blocks are formed to fill the notches to the size of a rectangular beam after being fixed to the notched beam using the repair material.

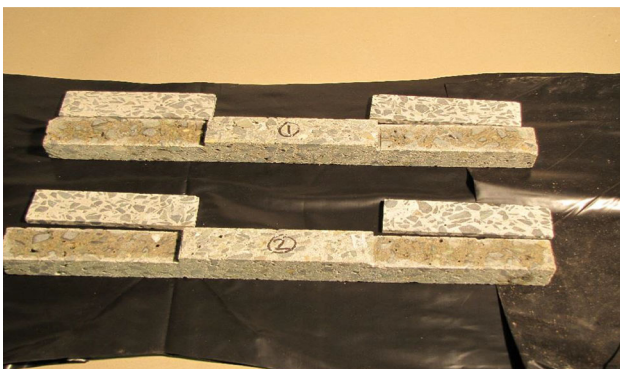
**Fig. 4** Prototype beams.

In order to test compatibility between the repair materials and concrete, small-scale (prototype) beams samples were prepared and cast. The small beam specimens were helpful in verifying some assumptions and the observations from their testing and test results helped in designing representative full-scale beams and avoiding problems during the test itself. The dimensions were scaled from the proposed full-scale samples with the length fixed at 14 inches. The concrete in the flexural samples was tested with a compressive strength of 5500 psi. The dimensions for the width and depth were 1-1/8 inch. The notches were 5/16 inch and 1/4 inch for the approximate neutral axis. Length of the notch was set

at L/3 and was equal to 4.75 inches including the 1 inch overhang at the end as shown in Fig. 4. Since the beams were created from existing concrete without internal tensile reinforcement, the beams were strengthened using carbon fibers after the notches were repaired with the specified repair materials as shown in Fig. 5. Two tows of 35 k Zoltec Panex fibers were fixed to the bottom of the beams using a typical 2-part epoxy for bonding carbon fibers to concrete beams.

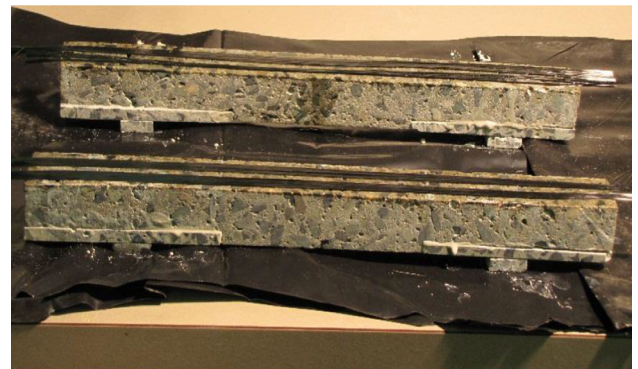
**Fig. 5** Completed prototype beams.

The beams were notched and then repaired using selected inorganic and organic repair compounds. Two similar inorganic materials compounds (inorganic 1 and inorganic 2) were formulated based on silica/alumina ratio as specified in Sect. 2.1. Similarly for the organic materials, two epoxy systems (epoxy 1 and epoxy 2) were used (Matthew 2013).

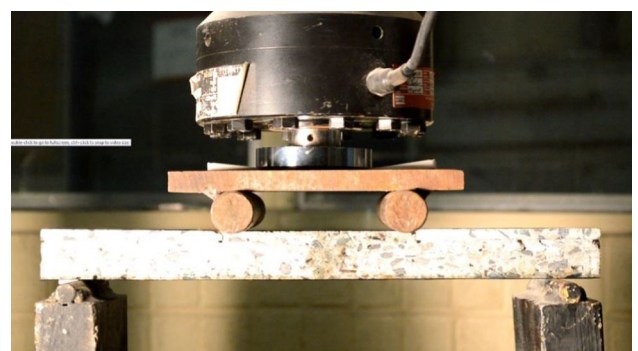
**Fig. 6** Prototype beam test.

After the repaired beams were allowed to cure at room temperature for at least one week they were tested using MTS Sintech 10/GL load testing machine with 10 kip load capacity as shown in Fig. 6.

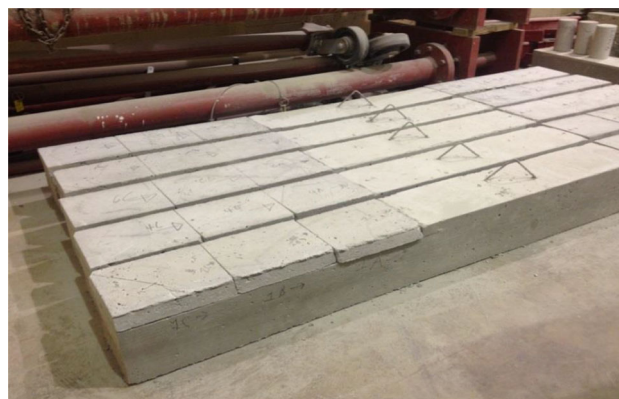
Fig. 9 Notched full-scale beams.

Five full-scale beams are cast in that two beams used as control beams, one repaired with the inorganic repair

material, one repaired with epoxy, and one used as contingency plan beam against beam damage (see Fig. 9). The organic and inorganic materials for the full-scale study were selected based on their performance in prototype testing (Sect. 4.1). The two control beams are a full-sized 8 inch square beam without notches and a notched beam to give the expected upper and lower bounds on the load–deflection curve.

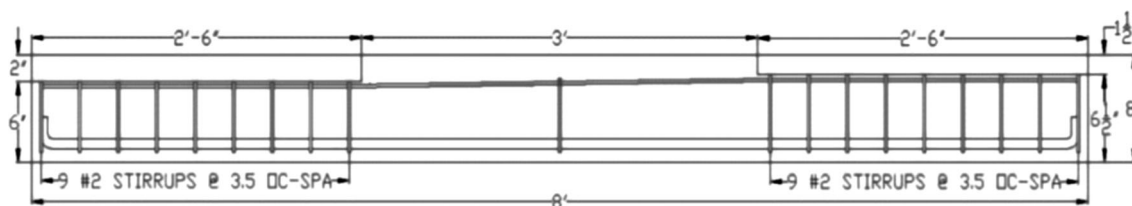
Fig. 7 Full-scale beam elevation dimensions.

length beams and is a common bridge girder spacing. The depth of the beam, 8 inches, was chosen as a common bridge deck thickness and the width was kept at 8 inches to give a depth to width ratio of 1. In addition, the thickness satisfies target neutral axis calculations by placing the axis between 1 and 1/2 to 2 inches (approximately 1/5–1/4 the depth of the beam). This also explains the choice of the notch depth at 1–1/2 on one side and 2 inches on the other so that the full range of the neutral axis can be affected and maximum shear can be applied to the repair. The full-scale beam elevation dimensions are shown in Fig. 7.

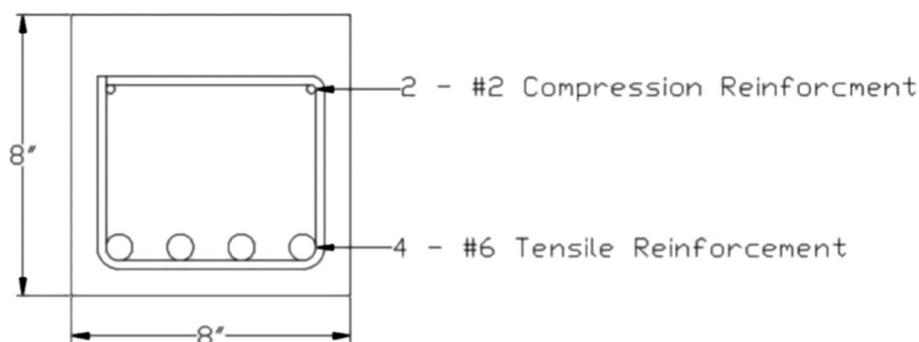
Fig. 8 Full-scale beam cross-section dimensions.

As for tensile reinforcement, four #6 bars were used to create an over-reinforced design as shown in Fig. 8, to insure the beam will reach maximum shear in the neutral axis. In an over-reinforced beam, the ultimate failure occurs in the compression zone. The maximum load of the beam was found to be at 19.17 kip in each load point (third point bending) for a total of 38.34 kip. However, since the beam is not to be tested destructively and to represent normal bridge loading condition which include respective factors of safety of the inherent error in the load and material resistance, the beam is only loaded to approximately 60% of the ultimate load corresponding to two point loads of 11.5 kip spaced at one-third the length of the beam or 23.0 kip total. This load also satisfies the cracking load which is found to be 1.61 kip, meaning that the reinforcement will be loaded during the test. Minimum shear reinforcement in the critical areas of the beam is provided using #2 stirrups spaced at  $d/2 = 3-1/2$  inches over the outside one-third of the span. The concrete shear resistance is sufficient in the center third of the beam simplifying the design and construction of the beam. Minimum concrete cover of 3/4 inch is supplied in all directions around the reinforcing steel.

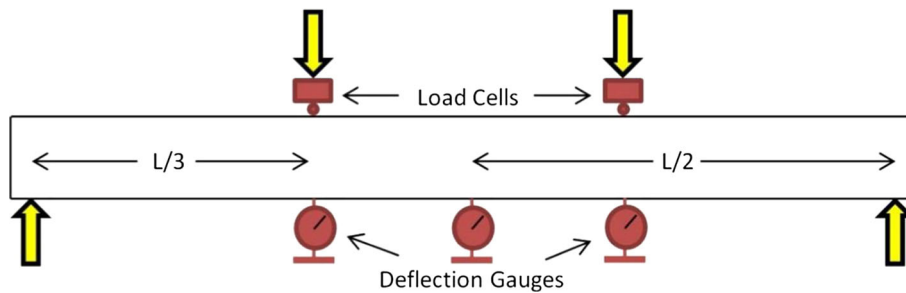
Fig. 10 Instrumentation set-up.

The data collection system used in this study gathered data points that includes the loads and deflection at the midpoint and at each load point to create a load–deflection profile for each beam (see Fig. 10). These data were used to determine the effective stiffness of each beam and allow for easy comparison to check for effectiveness of repair. In addition to the loads and deflection, lines were drawn on the side surfaces of the repaired beams crossing over the repair plane so that the shear movement can be monitored. Initially, the

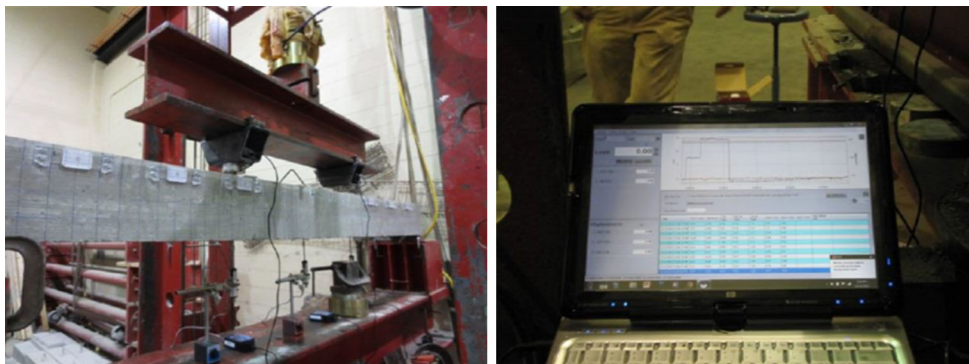
Fig. 11 Full-scale beam test instrumentation.

use of crack monitoring equipment was specified but the dimensions of the notches would not allow for installation of the gauges (Fig. 11).

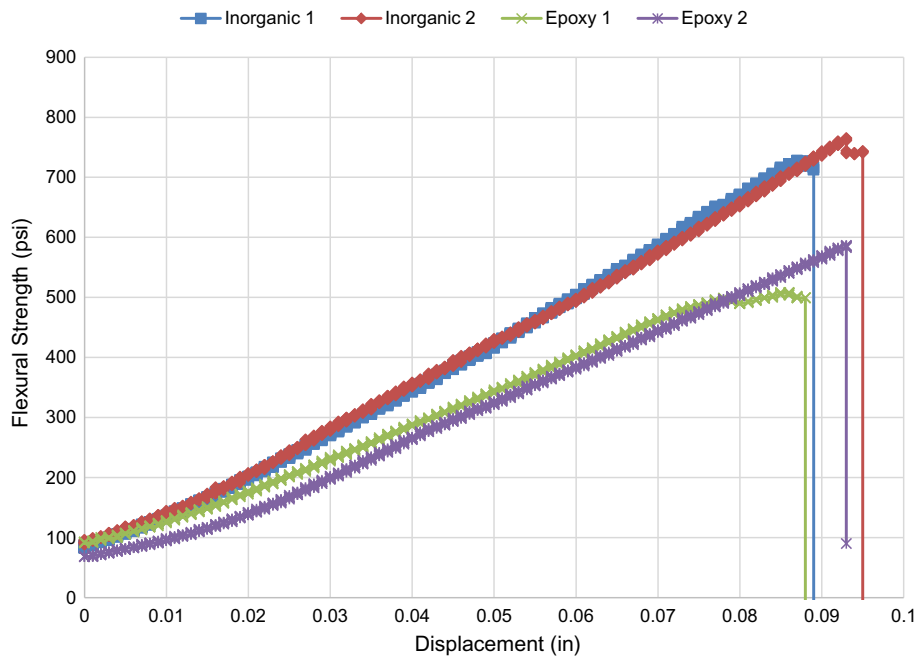
Fig. 12 Prototype beam results.

From Fig. 12, it can be observed that the stiffness is greater in the inorganic repaired beam and the loads are higher in the same beams. Both of these outcomes were predicted in theory. Recall that if the repair material was more compatible with concrete, then it would behave as a single homogeneous beam and offer the same stiffness and

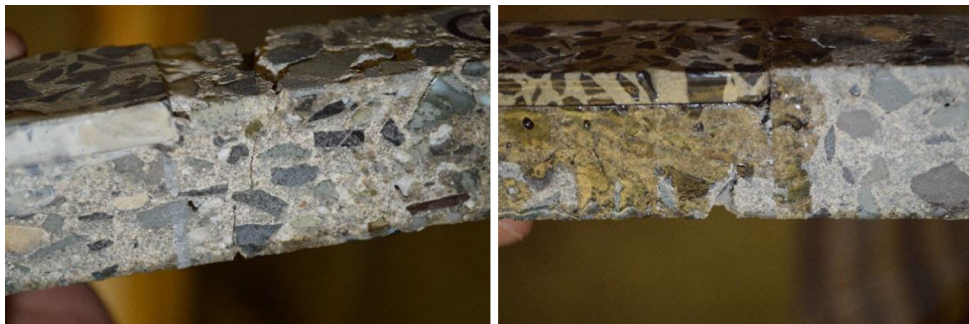
Fig. 13 Prototype failures; inorganic (left), organic (right).

All beams were failed at similar strain due to debonding of the carbon fibers as predicted. The beams repaired with the inorganic material failed at an average of 747 psi and the beams repaired with the epoxy failed at an average of 547 psi. The average deflections were 0.0913 inches. Both inorganic repair beams fracture point occurred in the middle third of the beam as most third-point loading test usually do. The epoxy repaired beams fracture point was located at the load point or outside of the middle third of the span as shown below in Fig. 13. (Notches were added outside of the middle third of the span on either side).

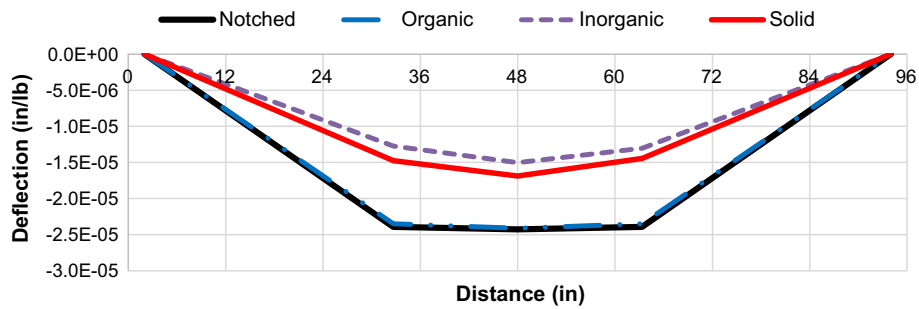
Fig. 14 Full-scale beam curvature comparison.

showed similar stiffness to the solid beam. The repaired organic epoxy beam behaved just like the notched beam that had not been repaired at all. The curvature (shown in Fig. 14) shows that the notched and epoxy repaired beams had internal hinges in at the load points at  $L/3$ . The solid and aluminosilicate repaired beams had an even curvature all across the span.

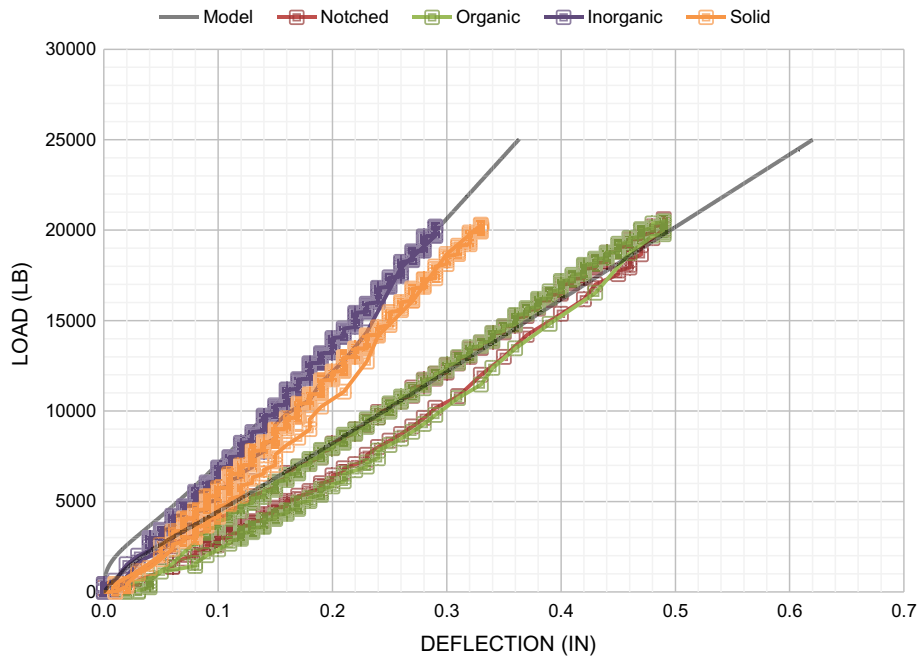
Fig. 15 Full-scale beam comparison.

In addition, the load/deflection graphs show a similar trend (Fig. 15). Both the notched and epoxy repaired beams showed lower stiffness with increased deflection over the same loading. The inorganic repaired and solid beams exhibited higher stiffnesses. A model of a solid beam was also generated using the cracked moment of inertia (Matthew 2013) and the inorganic repaired and solid beams followed closely to the model with slight deviations due to imperfections in the cast beams.

Both of these results clearly show that the epoxy repaired beam did not benefit from the repair. The beam had the same load and deflection reaction as the beam that was completely notched without repair of any type. The beam repaired with the inorganic polymer showed the same stiffness as the calculated model and slightly higher stiffness than the actual

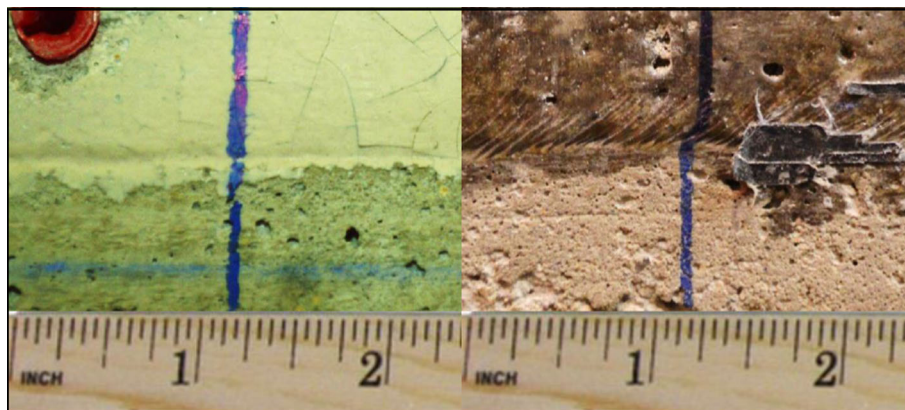
Fig. 16 Shear movement comparison; inorganic (*left*), organic (*right*).

solid unnotched beam. Of course, this is due to imperfections in the beam but the point is still poignantly made, that the inorganic epoxy allows the internal forces to transfer across the repair plane and include the compression block in the resolution of the moment arm in the flexural strength of the beam. Figure 16 illustrate the shifting of the blocks with

respect to the beam. The flexibility of the organic epoxy is evident in the offset of the detection lines across the horizontal crack. The inorganic repaired beam does not have any apparent movement and indicates that the repair of the concrete using the inorganic epoxy will be able to provide stress transfer and concrete compatibility for the structural

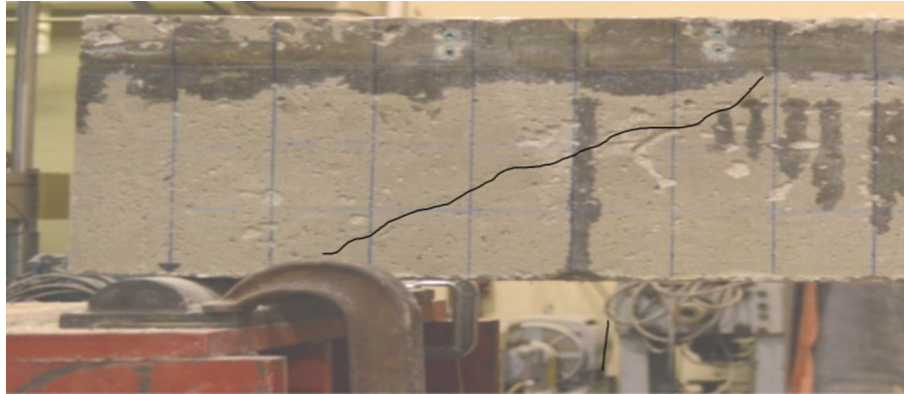
**Fig. 17** Shear crack in epoxy repaired beam.

In addition to the experimental evidence of the incompatibility of the epoxy repair system and the concrete, both the notched and epoxy repaired beams featured shear cracking in the outside third of the beam. This indicated that the minimum shear reinforcement set by the ACI 318 code requirement of half the distance from the extreme compression fiber to the centroid of the tensile reinforcement was too large (ACI (American Concrete Institute) 2011). In essence, the actual extreme compression fiber was not the top of the block in the case of the epoxy repaired beam, but the top of the notch as seen in Fig. 17.
