Evaluation and upgrading web-gap distortion retrofits in steel girder bridges

Abstract

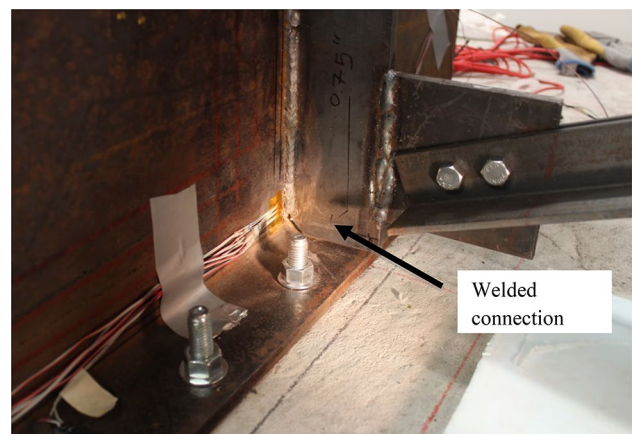
Fig. 5 Control beam

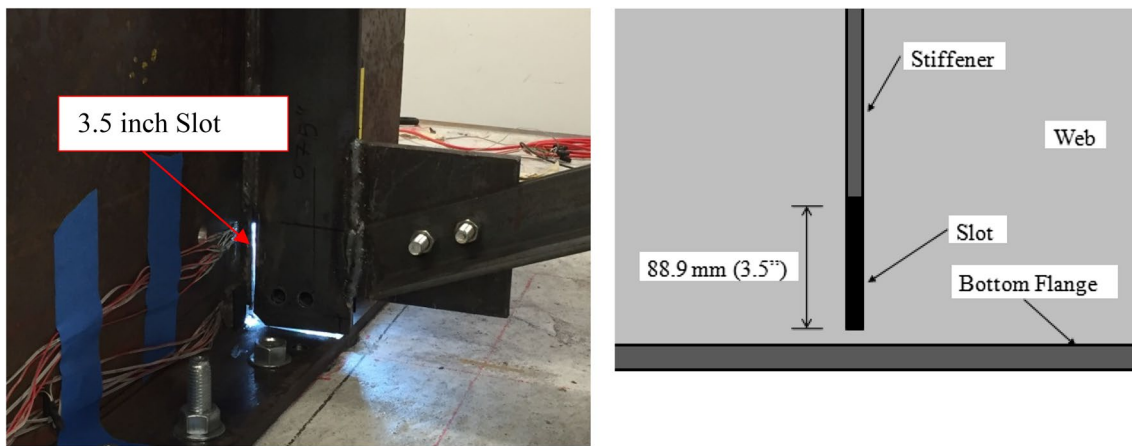
Fig. 7 Slot retrofit

The proposed retrofit technique consisted of a slot and an angle section connecting the disconnected part of the CP to the web. These retrofit measures intended to reduce stress levels by softening the web-gap region as well as distributing lateral forces, transferred by cross-frames, over a wider area of the web (slot-angle retrofit). This technique could be implemented to upgrade the existing slot repairs that failed to sufficiently fix distortion-induced fatigue cracking in the web-gap region. The Lexington Avenue Bridge in Lexington, KY, would be a good candidate for this repair strategy

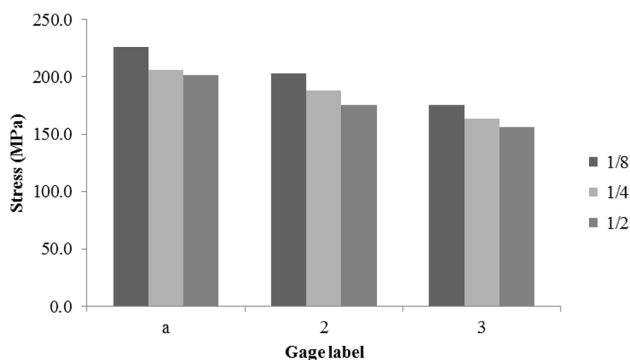
Fig. 11 Stresses for top-angle retrofitted beams due to 20.3 mm (0.8 in.) displacement

To investigate the effect of the steel angle rigidity on the stress reduction in the web-gap region and susceptibility to distortion-induced fatigue damage, three different angle sections with a length of 50.8 mm (2 in.) were used to retrofit the beam. The three top-angle sections were $L2 \times 2 \times 1/8$, $L2 \times 2 \times 1/4$, and $L2 \times 2 \times 1/2$. Figure 11 demonstrates the variation of the stresses in the web-gap region retrofitted with different angle sections and subjected to an equal displacement of 20.3 mm (0.8 in.) at the end of the diaphragm. There is only a small difference between stresses (ranging 3–8%) in the web-gap region of the retrofitted beams, as shown in Fig. 11.

loading. However, when the beams are subjected to a similar deflection, there is only a minor change in stress, as shown in Fig. 11.

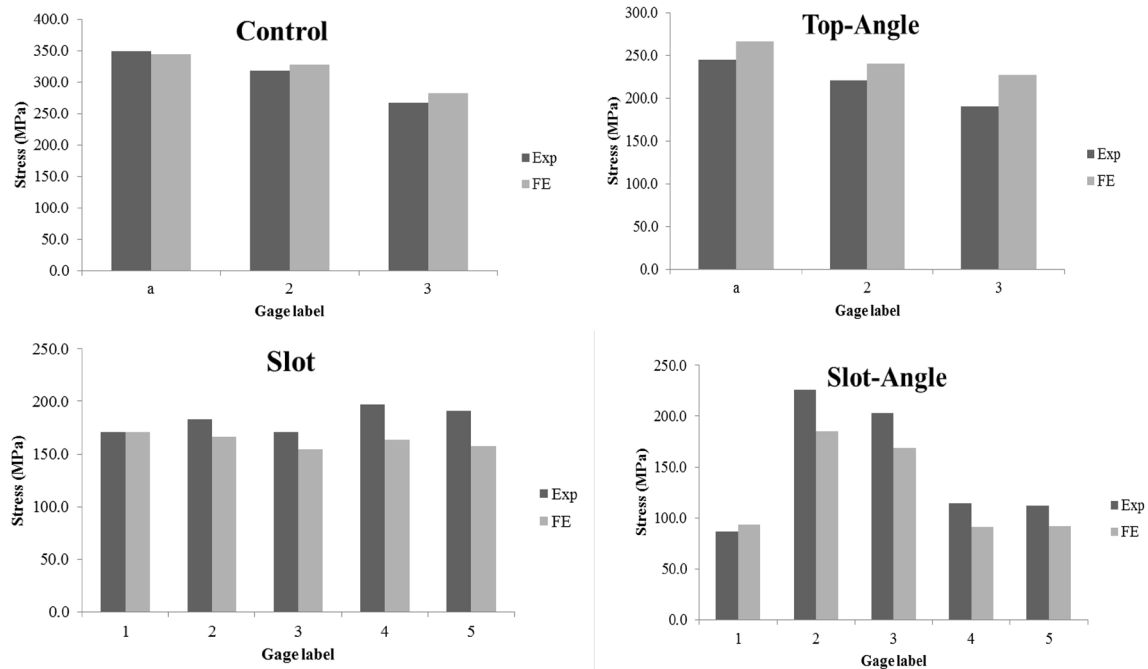
Fig. 13 Comparison between principal stresses from experimental test and FEA

The principal stresses at the locations corresponding to the attached strain gages in the lab test were determined and compared with the experimental results, as shown in Fig. 13. The results from the FEA are slightly higher than results from the lab test for the control beam and the retrofitted top-angle beam. For most of the readings from the gages attached to the retrofitted slot specimens, as well as slot-angle specimens, the corresponding stresses are moderately higher than those readings from the FEA. The percent difference between the experimental results and FEA results vary between 1 and 23%.

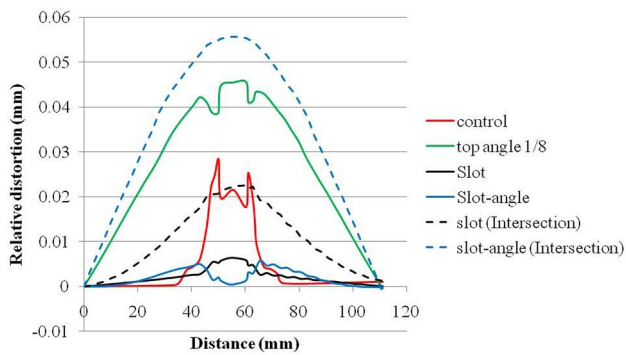
Fig. 16 Web-gap relative distortion along a 114-mm (4.5-in.) line

Figure 16 demonstrates the relative distortion of the web in the web-gap region for all tested beams distortion in the web-gap region of beam when the cross-frame diaphragm is subjected to 20.3 mm (0.8 in.) deflection. The original line was used for measuring the distortion of control beam and top-angle specimens, while the distortion for slot repair

beam slot angle one was measure along the new line, shown in Fig. 16.

The control beam experienced a sudden increase in distortion at the CP–web intersection and exceeded 0.025 mm (0.001 in.). The retrofit options changed the distortion rate in the web-gap region. As shown in Fig. 16, where the localized distortion is more evenly distributed over a wider area when a retrofit measure is adopted. The top-angle method led to an increase in the web-gap out-of-plane displacement. However, the sudden increase for the control beam changed to a gradual increase in the web-gap distortion. Implementing slot and slot-angle retrofit options limited the distortion to a lower level. When the original lines at the CP–web intersection (solid lines), are considered as the reference for evaluating the results. The distortion for slot-angle exceeds 0.051 mm (0.002 in.) at the new CP–web intersection. However, the new web-gap region is more flexible than the original one to absorb the extra distortion.
