Challenges to Quality Control in Bored Cast-In-Situ Piling in Growing Urban Environment

D. V. Karandikar¹

Keywords Bored piles · Quality control · Urban environment · Rotary auger rigs

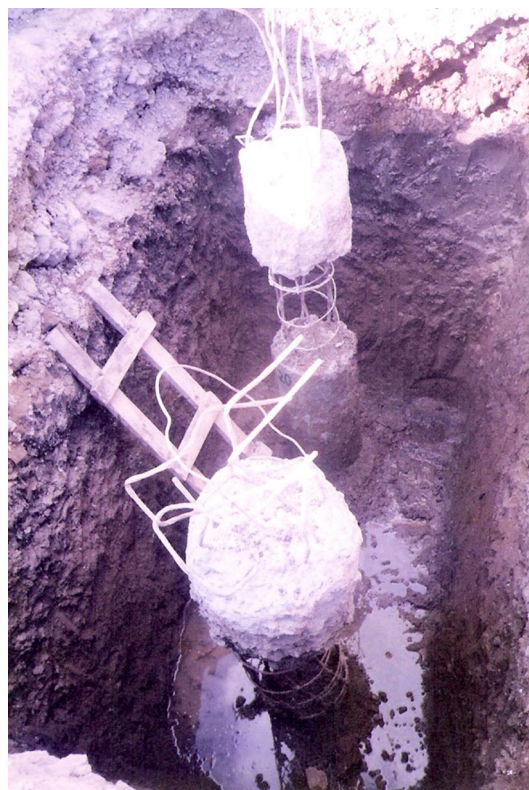
Fig. 1 Necking and bulging defects in bored cast-in-situ piles

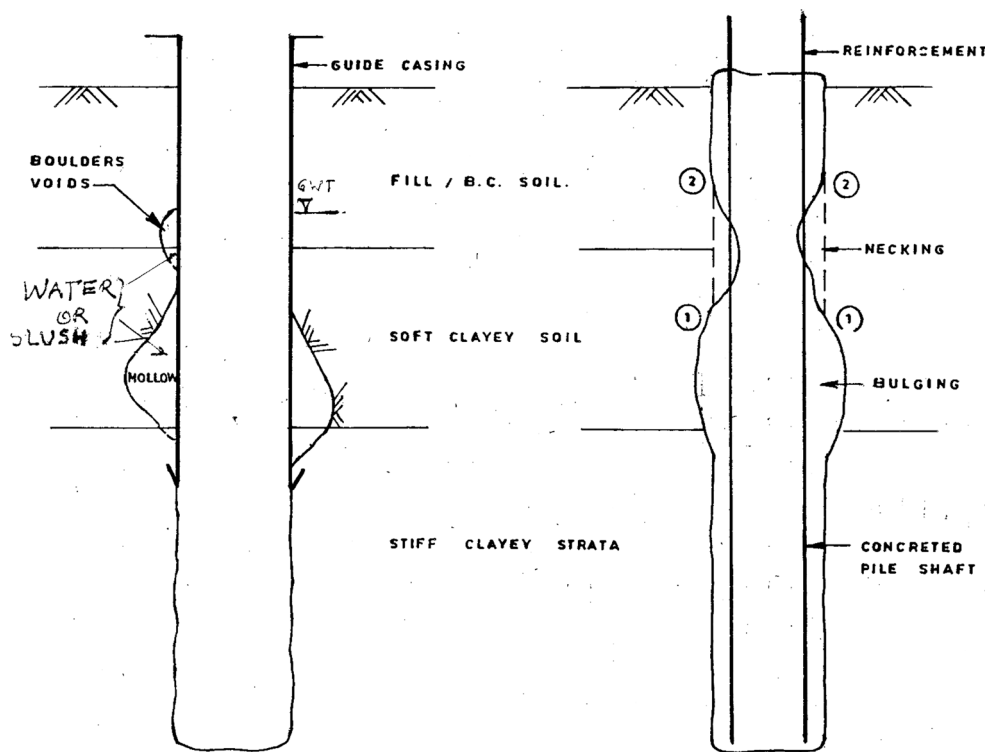
Fig. 2 Piles with severe shaft integrity problem with loss of concrete in pile shafts

PROBLEMS IN PILES IN FILL / BOULDERY STRATA.

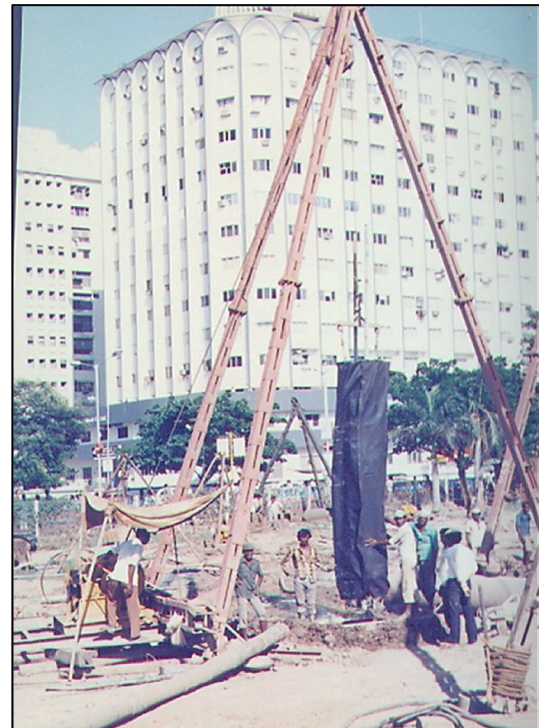
Fig. 7 Geofabric pile liner with bituminous slip coating

Permanent pile liners, going up to the start of rock socket, made from woven or non-woven polypropylene can be very effectively used to ensure pile shaft integrity, particularly in bouldery fill or in very soft clays. The liners are wound around the reinforcement cages and the cages are lowered in the pile bores stabilized either by bentonite slurry or by temporary M.S. liners. The alternative of using permanent M.S. liners in such situations becomes costly. Apart from economy, geofabric liners increase the pile concrete durability in aggressive environment. The liners however have to be properly designed to withstand fluid concrete pressure and have toughness to prevent their puncturing in bouldery zone. Figures 6, 7 and 8 show typical arrangement for use of fabric liner. With LDPE melt coat on the outer surface of these liners, negative skin friction can be virtually eliminated in soft clays. Geofabric liners have been successfully used in bored piles installed in soft clays in Uran, Nhava Sheva, Navi Mumbai and in bouldery strata of Eksar, Borivali.

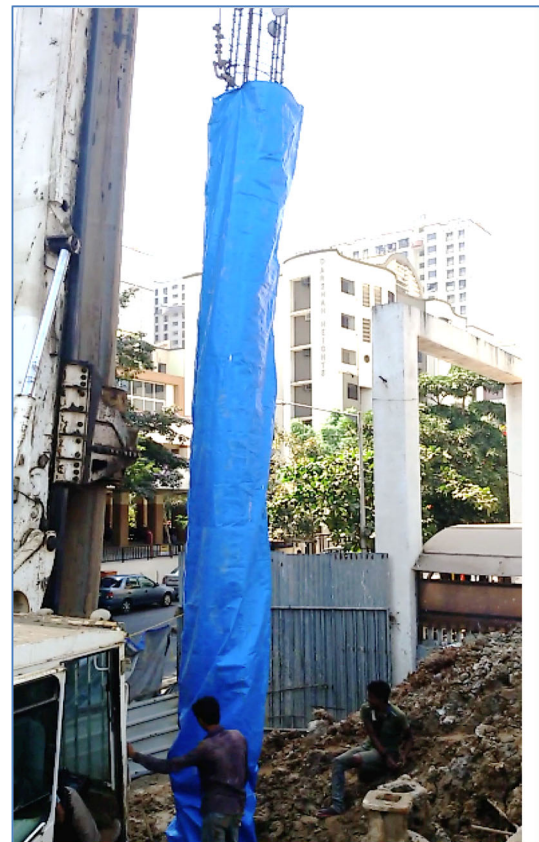
Fig. 8 Geofabric pile liner with LDPE melt coating

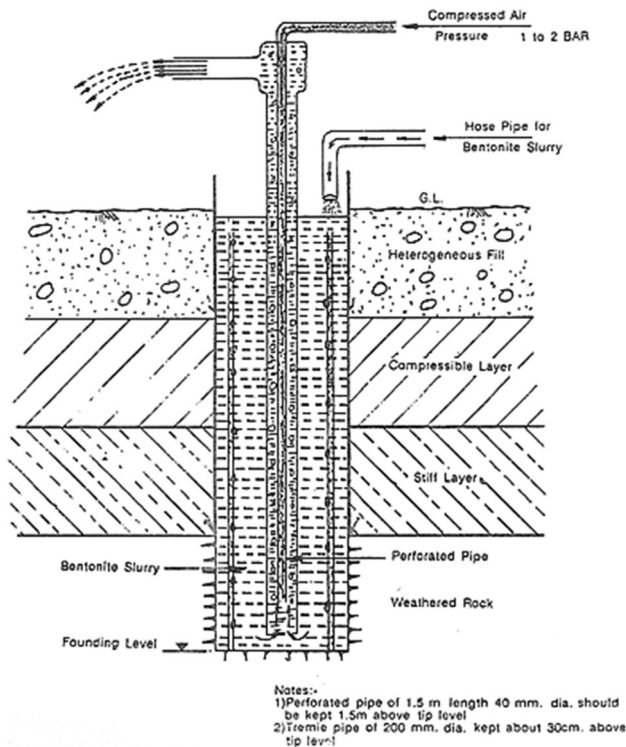
Fig. 9 Airlift cleaning arrangement of pile tip

Compressed airlift flushing method suggested by Datye [1] as illustrated in Fig. 9 is very convenient and should be encouraged. Its use at one of the sites can be seen in Fig. 10.

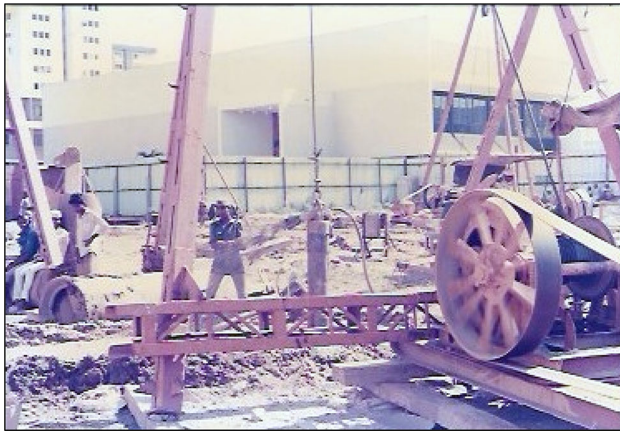
Fig. 10 Airlift cleaning of pile tip

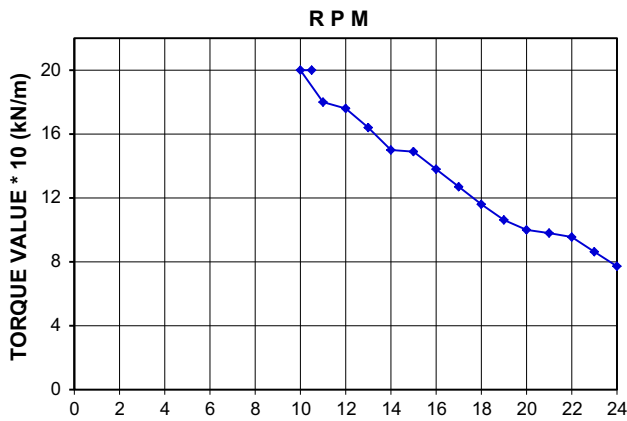
Fig. 13 Typical Torque-RPM diagram of 180 kN m capacity rotary auger rig

As the resistance to rock cutting increases, RPM decreases and Kelly bar pressure is required to be increased, increasing the Torque. This is reflected in Torque-RPM curve, typically shown in Figs. 13 and 14. Piling manufacturers can furnish Torque-RPM curve specific to the machine used. Some contractors install torque meters on the control panels of hydraulic rigs to measure the torque. Based on borelog and rock quality data, manufacturers can suggest the most suitable rig to be used. It is seen from the Chisel Energy and PPR data of the same site at same depth, that PPR values tends to be 3–5 times larger than chisel Energy values. Both these methods are mainly recommended for deciding pile termination during execution. PPR should not be used to compute pile capacity.

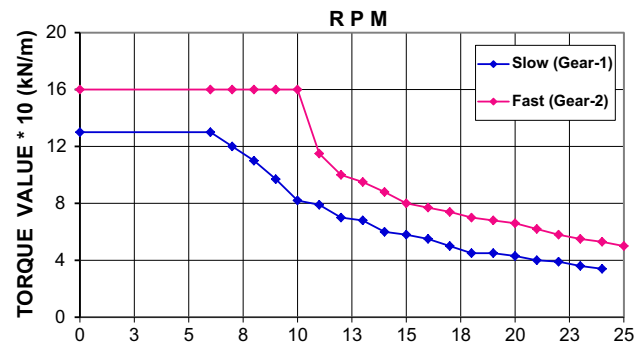
Fig. 14 Typical Torque-RPM Diagram of 130 kN m capacity rotary auger rig

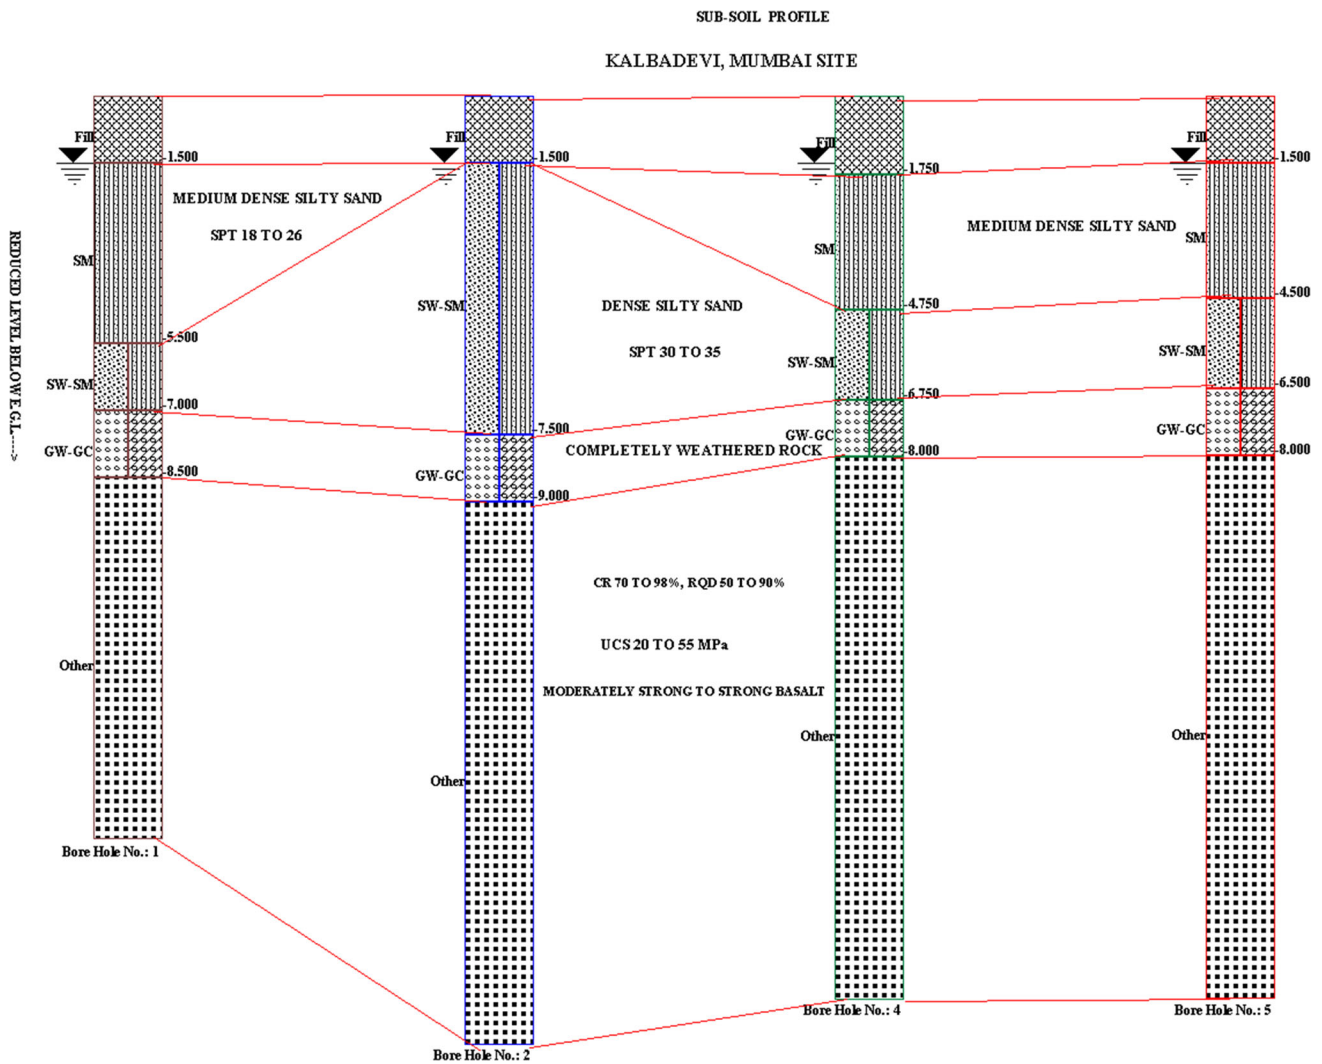
Fig. 16 Subsurface profile Kalbadevi site, Mumbai

Similar problems were observed at Kalbadevi site also (Fig. 16), (Refer Tables 6 and 7). The required safe pile capacities for 600 and 750 mm dia. piles were 1600 and 2800 kN respectively. The dynamic pile load test data, (PDA), however showed that safe capacities were only to the extent of 500–1000 kN (See Table 6). Due to high loads on a smaller foot-print of building, pile layout was congested and it became difficult to plan and install new remedial piles of 4000 kN safe vertical capacity, in the spaces between the defective piles. All new piles were installed with M.S. liners and pile tip zones were meticulously cleaned by polymer fluid.

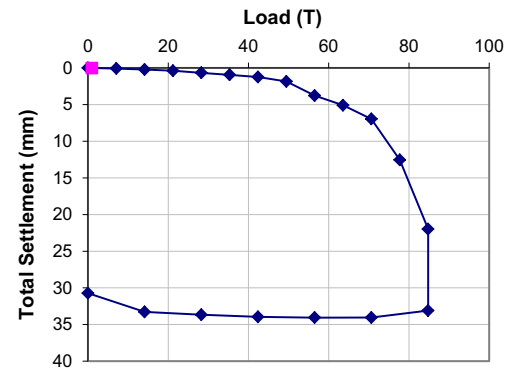
MICRO PILE LOAD TEST AT VILE PARLE , MICROPILES SUPPORTING BUILDING EXTENSION

Fig. 18 Typical micro-pile load test data. 300 mm dia, 40 T design capacity, 8.5 m long with 2 m socket in rock

but for 800 kN it increased to 15 mm and at 850 kN it failed with settlement reaching 33 mm. Factor of safety of 2.5 was not met. Typical load settlement curve of micro-pile test is enclosed (Fig. 18). Allowing very high loads on micro-piles is definitely risky.

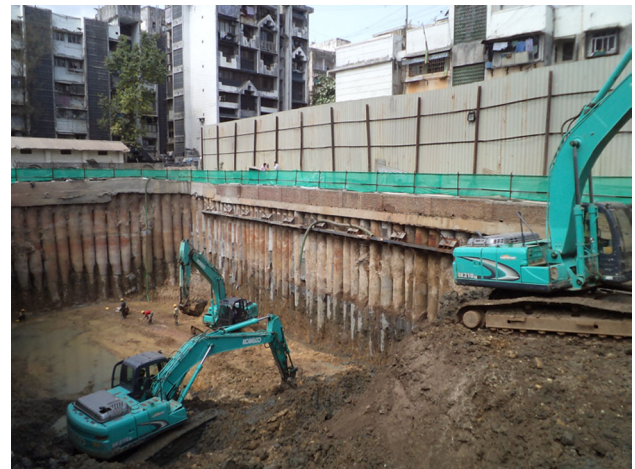
Fig. 19 Properly designed shoring piles with anchors

footings. The scheme has to be discussed with neighbours for their concurrence and for ensuring safety of their building. If adjoining building is on piles, then anchors have to be avoided. Large diameter piles can then be installed without anchors on ‘stand alone’ design. To avoid the anchors, diaphragm wall and ‘Top Down Construction’ may also be planned with supports given by basement floor slabs (Figs. 19, 20, 21, 22).

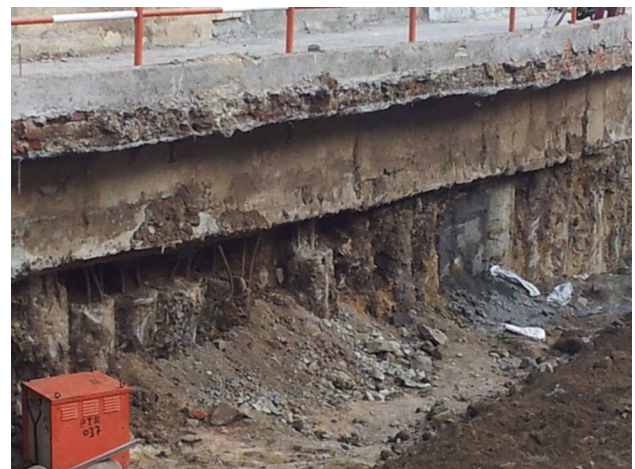
Fig. 20 Defect in shoring piles near tie beam

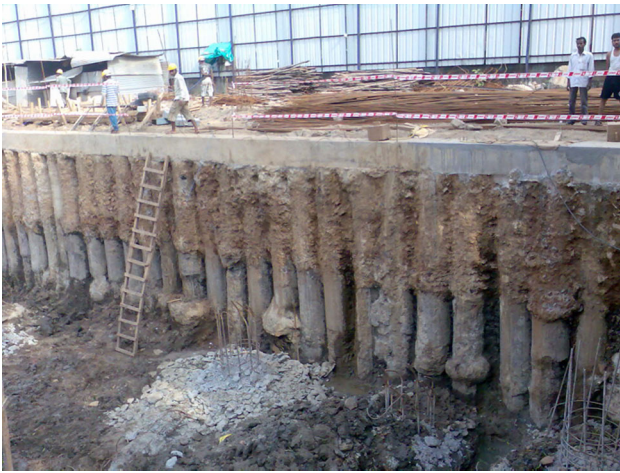
Fig. 21 Defects at tips of shoring piles

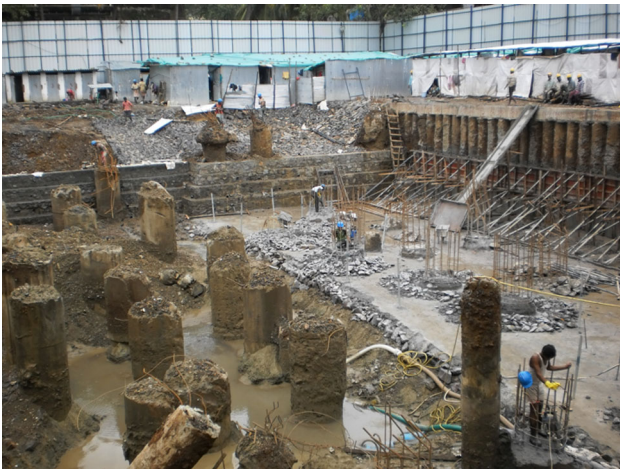
Fig. 22 Rubble wall and shoring piles without anchors for single basement in Andheri site
