# Fatigue and burst tests of full-scale girth welded pipeline sections for safe operations

A. Y. Dakhel<sup>1</sup> · M. Gáspár<sup>1</sup> · Zs. Koncsik<sup>1</sup> · J. Lukács<sup>1</sup>

Received: 16 September 2022 / Accepted: 14 February 2023 / Published online: 25 February 2023  
© The Author(s) 2023

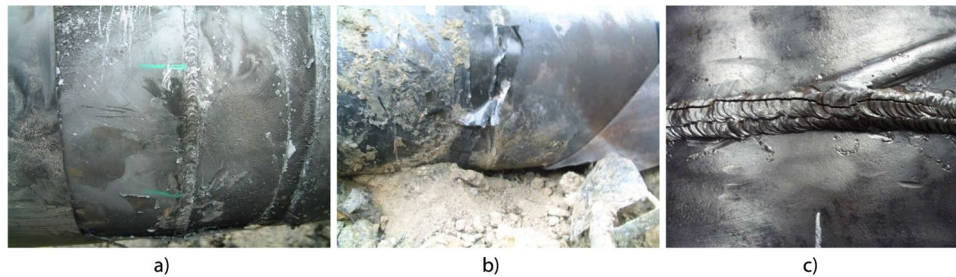
**Fig. 1** Damaged areas of girth welds on Hungarian pipelines: **a** HU1: DN400, crack in a repaired girth weld; **b** HU2: DN600, repair and cyclic loads caused crack in a repaired girth weld; **c** HU3: DN800,

geometrical irregularities and cyclic loads caused crack, initiated in the meeting point of a girth weld and spiral weld

The damaged areas of  $HU_i$  ( $i = 1, 2, 3$ ) failure cases are shown in Fig. 1.

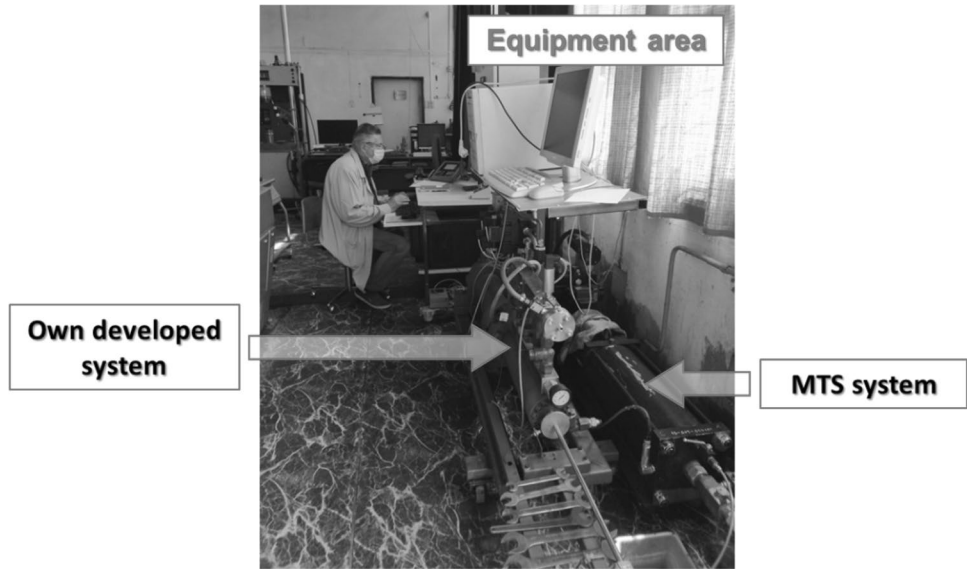
**Fig. 4** The hydraulic cylinders of the two testing systems: MTS (black) and own developed (grey)

The tested pipe sections are located in a pit outside the laboratory building; all other components of the systems are located inside. Figure 4 shows the hydraulic cylinders of the two systems.

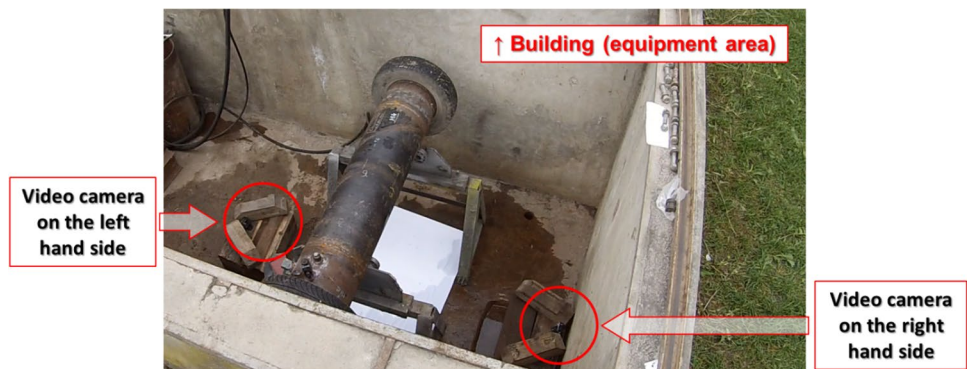
**Fig. 5** The testing pit with a DN300 pipeline section (FSPS2) and the two cameras under the pipeline section

Three video cameras are used for recording of the burst process, two recorded of the process from under (from the left and from the right) and the third one from above. The image from the video camera on the column recording the burst test from above can be seen in Fig. 5.

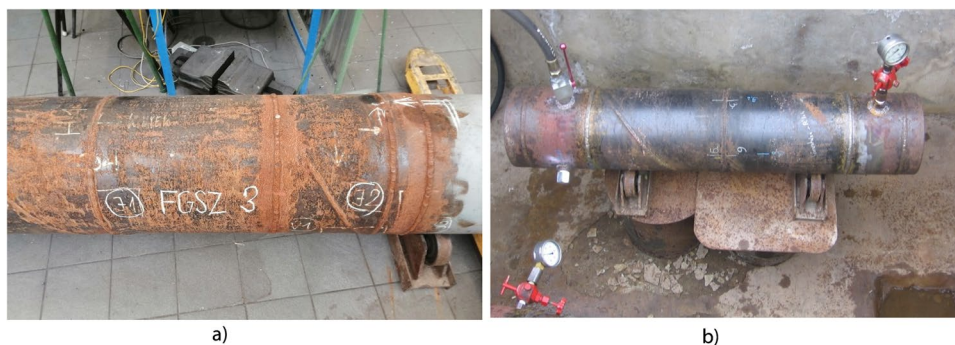
**Fig. 6** Full-scale pipeline sections: **a** cut DN350 pipe with the two tested girth welds before the formation of the pipeline section FSPS4; **b** FSPS3 DN300 pipeline section before the beginning of the fatigue test

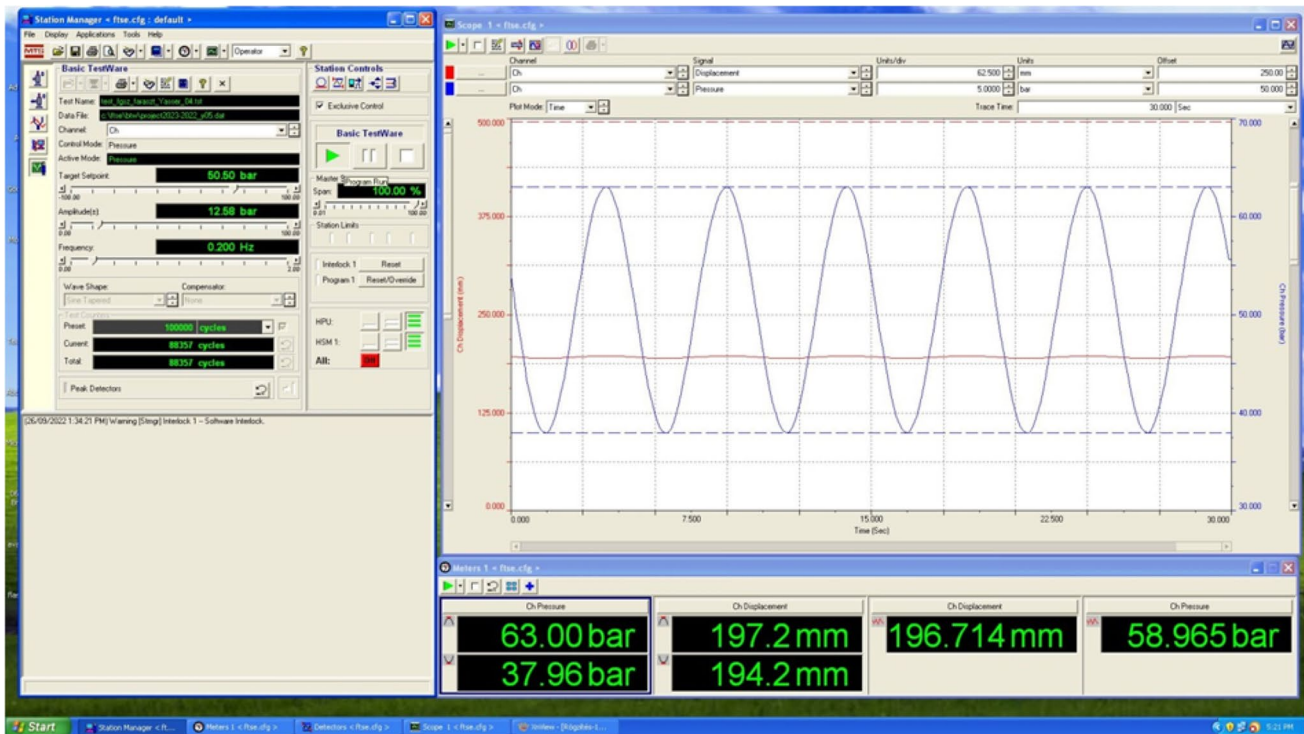
Fig. 7 The screen of the MTS control system illustrating the sinusoidal type programmed internal pressure (blue function)

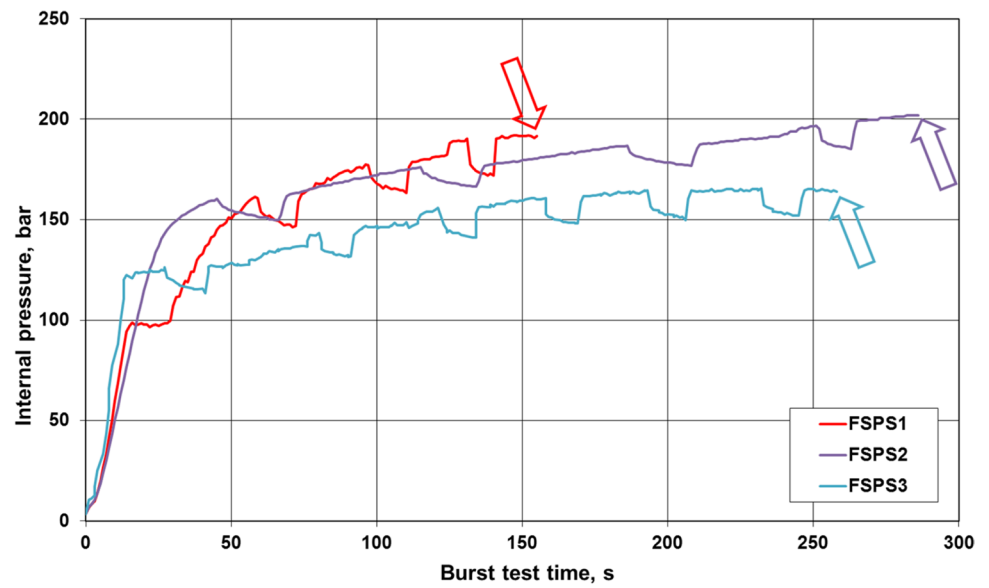
**Fig. 8** Internal pressure vs. burst test time diagrams during the burst tests of the FSPS<sub>*i*</sub> (*i* = 1, 2, 3) DN300 pipe sections, including indicated burst points with arrows

Figure 8 illustrates the internal pressure vs. burst test time diagrams of the investigated DN300 pipeline sections (FSPSi,  $i = 1, 2, 3$ ), where the arrows indicate the burst points. The average pressure growth rate values in the first stage, between 0 bar and approximately 60 bar, of the tests are 6.0 bar/s, 5.3 bar/s, and 8.2 bar/s, respectively. All three average pressure growth rate values can be evaluated as quasi-static values, and the greatest value cannot be considered as dynamic impact. Other characteristics of the diagrams are the same; the tines-like changes of the diagrams demonstrate the volume expansions of the sections. During the tines-like changes shown in the diagrams in Fig. 8 and in similar figures further on, the system draws water from the water

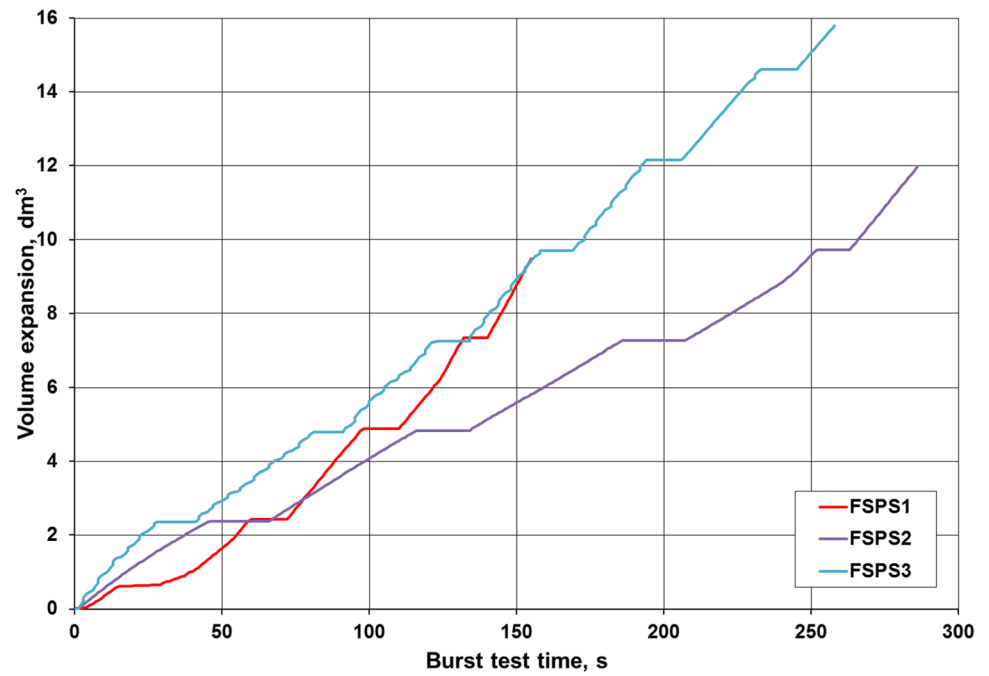
**Fig. 9** Volume expansion vs. burst test time diagrams during the burst tests of the FSPS<sub>*i*</sub> (*i* = 1, 2, 3) DN300 pipe sections

Figure 9 shows the volume expansion of the FSPS $i$  ( $i = 1, 2, 3$ ) pipe sections during their burst tests. The stairs of the curves are important characteristics of the tests and the testing system; the horizontal stages belong to the water intakes from the external water system to the testing system, which is the result of the elastic–plastic deformation (expansion) due to an increase in internal pressure.

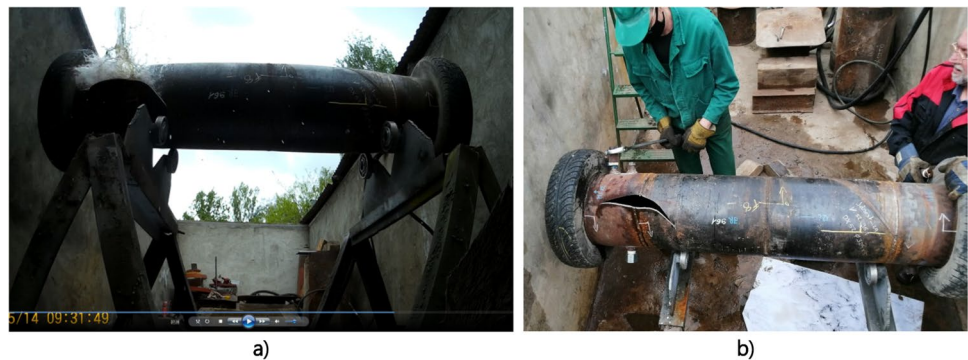
**Fig. 10** The burst test of the FSPS2 DN300 pipeline section: **a** end of the burst test (recorded from under); **b** the pipe section after the test

Figure 10 shows the FSPS2 pipeline section during and after its burst tests, which clearly demonstrates that the failure did not take place in the girth weld located in the middle of the section. The load-bearing capacity of the assembly girth weld was lower than that of the tested girth weld.

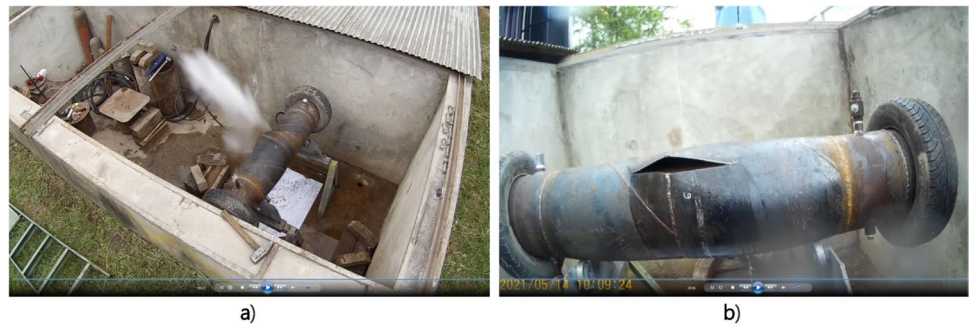
**Fig. 11** The burst test of the FSPS3 DN300 pipe section: **a** end of the burst test (recorded from above); **b** the pipeline section after the test

Figure 11 shows the FSPS3 pipeline section during and after its burst tests, which clearly demonstrates that the failure take place in the girth weld located in the middle of the section.

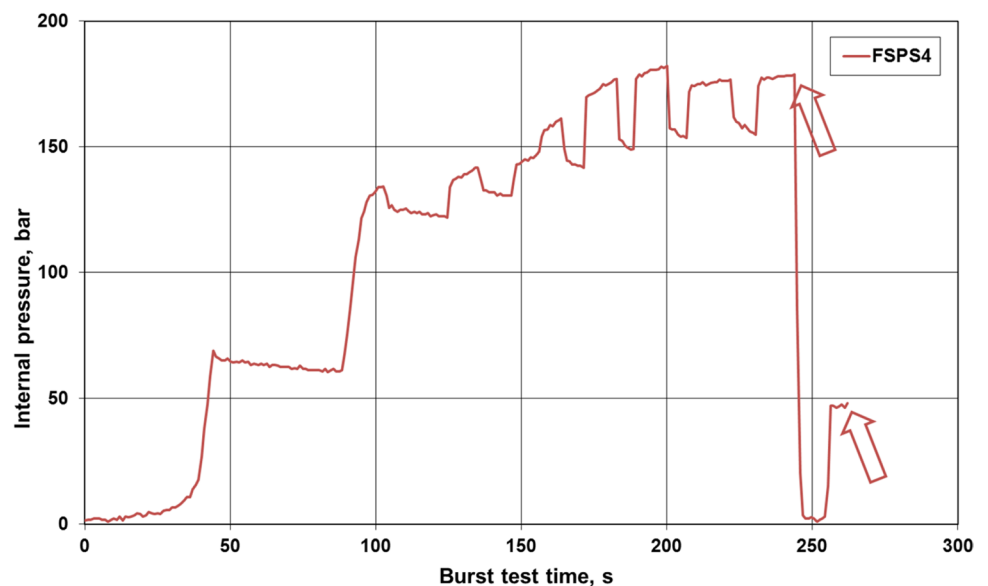
**Fig. 12** Internal pressure vs. burst test time diagrams during the burst tests of the FSPS4 DN350 pipe section, including indicated burst points with arrows

Figure 12 illustrates the internal pressure vs. burst test time diagrams of the investigated DN350 pipeline section (FSPS4), containing two test girth welds. For both girth welds containing unacceptable welding discontinuities, a slight leakage was detected, which resulted in a pressure drop and water intake from the water supply network. The leakage continued during the water intake, water was drawn, and as the pressure increased, one of the seams continued to leak, but the other one ruptured. Due to the fact that both girth welds were damaged during the burst test, the nature of the diagram is different from the previously known cases. The two arrows this time belong to the beginning of the two damages. The pressure growth rate value was quasi-static in this case, too.

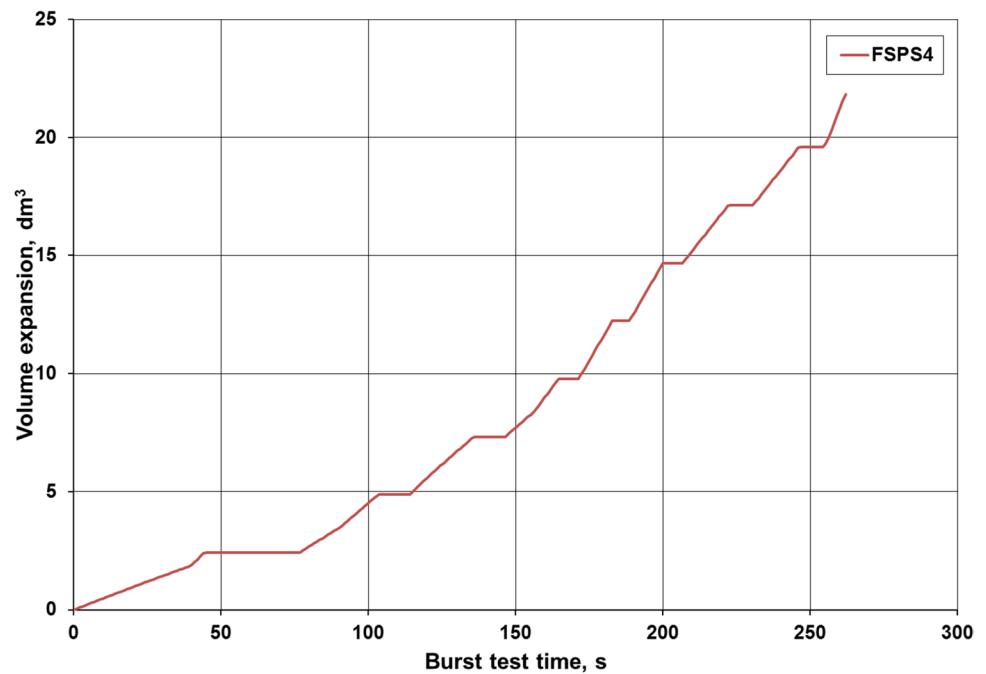
**Fig. 13** Volume expansion vs. burst test time diagrams during the burst tests of the FSPS4 DN350 pipe section

Figure 13 shows the volume expansion of the FSPS4 pipe section during its burst test; furthermore, Fig. 14 shows the pipe section after the burst test, in which water is still trickling from one of the damaged girth welds. It is also possible to observe the different plastic deformation characteristics of the pipe section areas between the individual girth welds.

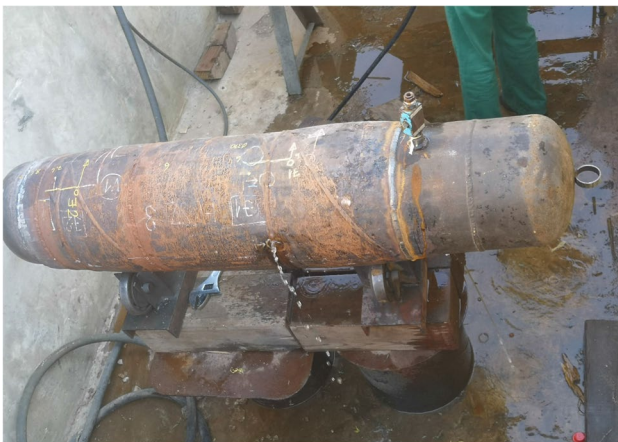
**Fig. 14** The FSPS4 DN350 pipe section after the burst test

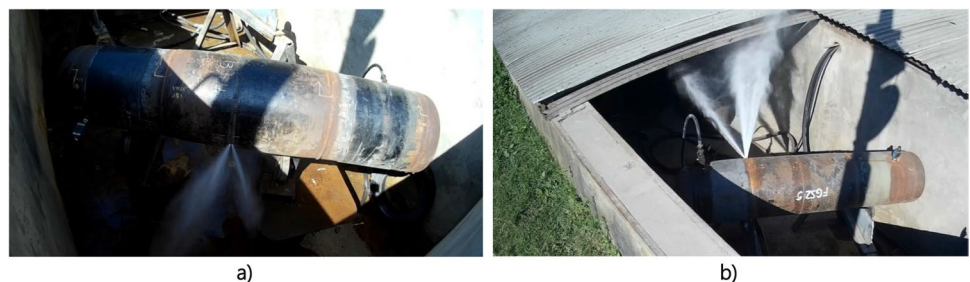
**Fig. 15** **a** End of the burst test of the FSPS5 DN400 pipeline section (recorded from above); **b** end of the burst test of the FSPS6 DN400 pipeline section (recorded from above)

Figure 15 introduces the DN400 (FSPS $i$ ,  $i = 5, 6$ ) pipeline sections at the end of their burst tests. Identical as for FSPS2 DN300 pipeline section, the damage of FSPS6 DN400 pipeline section occurred in assembly girth weld.

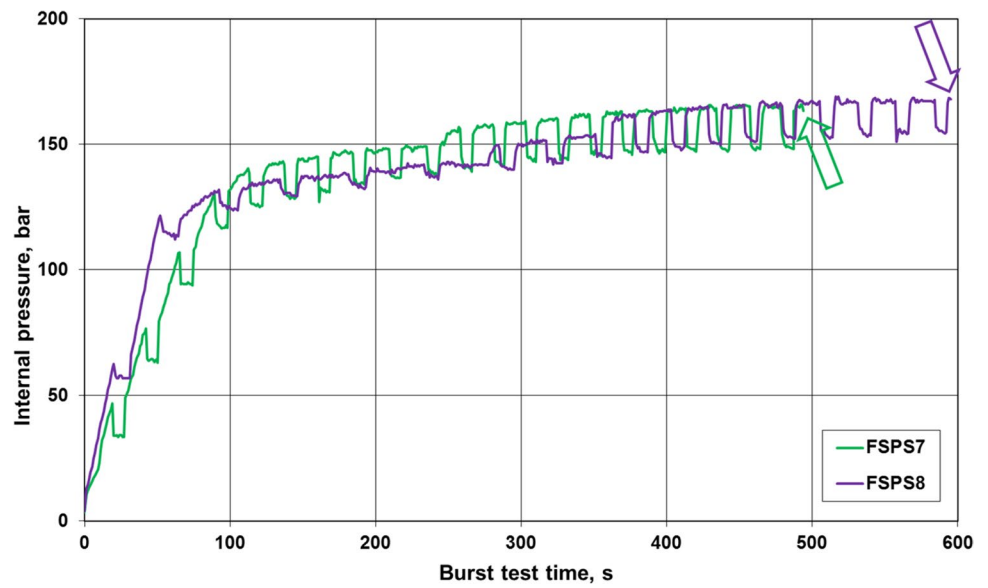
**Fig. 16** Internal pressure vs. burst test time diagrams during the burst tests of the FSPSi ( $i=7, 8$ ) DN600 pipe sections, including indicated burst points with arrows

Figure 16 illustrates the internal pressure vs. burst test time diagrams of the investigated DN600 pipeline sections (FSPS $i$ ,  $i = 7, 8$ ), where the arrows indicate the burst points in these cases, too. The average pressure growth rate values in the first stage are 1.8 bar/s and 1.9 bar/s, respectively; hence, these values can be evaluated as quasi-static values, and those cannot consider as dynamic impact. The characteristics of the diagrams are the same; the several times-like changes of the diagrams demonstrate the large-scale volume expansions of the sections.

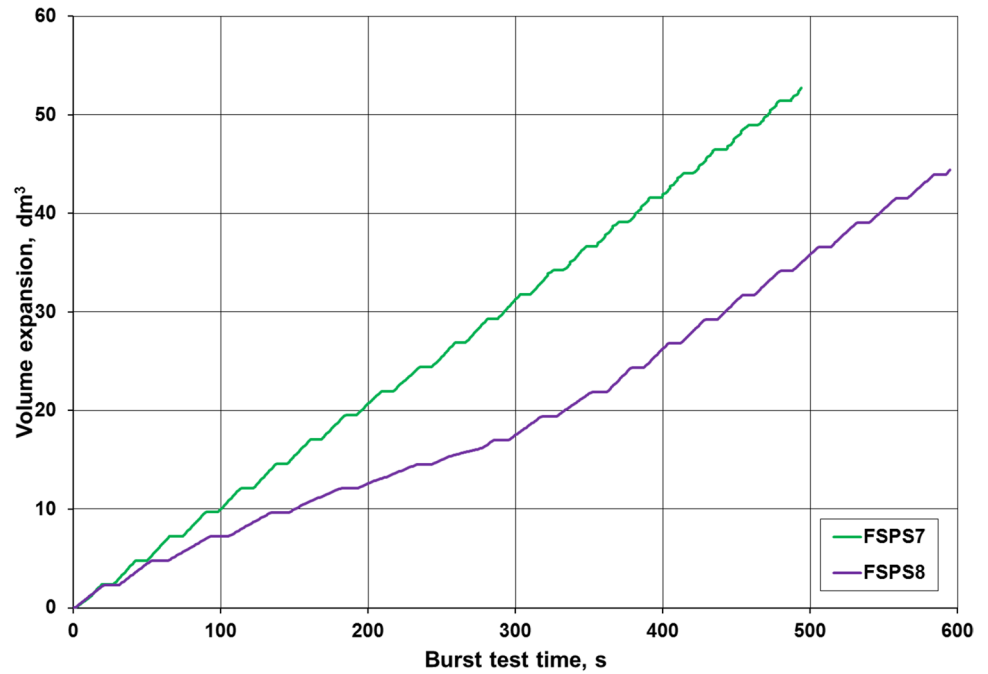
**Fig. 17** Volume expansion vs. burst test time diagrams during the burst tests of the FSPSi ( $i=7, 8$ ) DN600 pipe sections

Figure 17 shows the volume expansion of the FSPS $i$  ( $i = 7, 8$ ) pipe sections during their burst tests. The volume expansion values can be compared with the relevant values of the DN300 (FSPS $i$ ,  $i = 1, 2, 3$ ) and DN350 (FSPS4) pipeline sections (see Figs. 9 and 13, respectively).

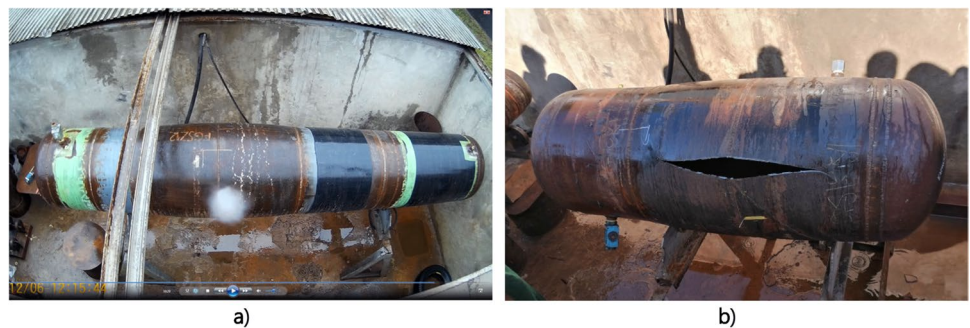
**Fig. 18** The burst test of the DN600 pipeline sections: **a** end of the burst test (recorded from above) of the FSPS7 pipeline section; **b** the FSPS8 pipeline section after the test

The end of the burst test of pipeline section FSPS7 can be seen in Fig. 18a; furthermore, the FSPS8 pipeline section after the burst test can be studied in Fig. 18b. Both pipeline damaged in the middle girth weld of the section.

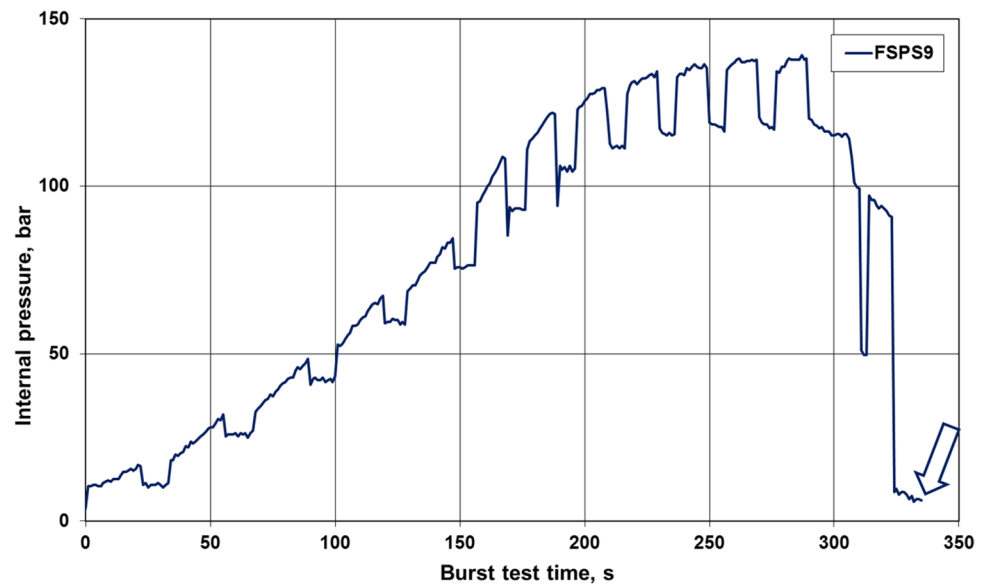
**Fig. 19** Internal pressure vs. burst test time diagrams during the burst tests of the FSPS9 DN800 pipe section, including indicated burst points with arrow

Figure 19 illustrates the internal pressure vs. burst test time diagram of the investigated DN800 pipeline

section (FSPS9). Forasmuch as the damage has happened in the welded fitting, the arrow indicates the leakage point in this case. The damage process started with a slight leakage accompanied by a pressure drop. During this time, the system drew water from the water supply network on two times, the leakage continued and the rupture occurred.

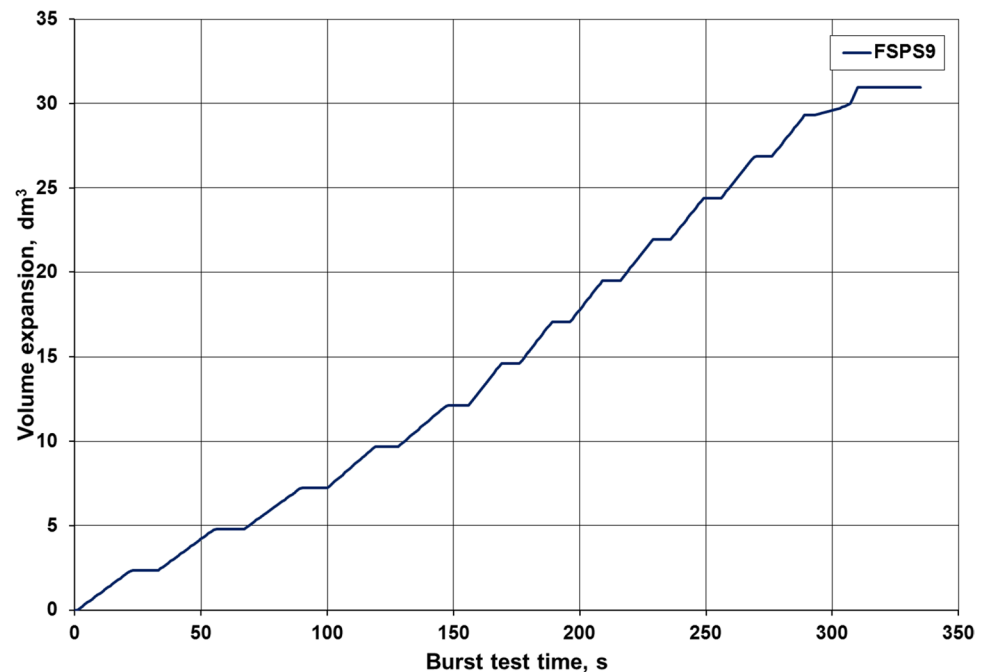
**Fig. 20** Volume expansion vs. burst test time diagrams during the burst tests of the FSPS9 DN800 pipe section

Figure 20 shows the volume expansion of the FSPS9 pipe sections during their burst tests. Given the location of the damage and comparing the characteristics of the internal pressure vs. burst test time and the volume expansion vs. burst test time diagrams with previous cases,

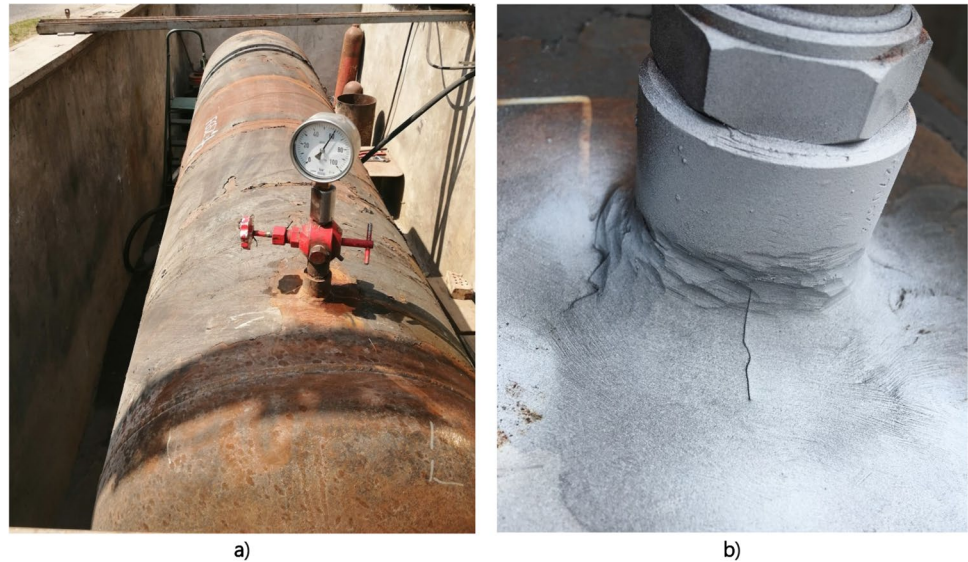
**Fig. 21** **a** The DN800 pipeline section FSPS9 during its fatigue test; **b** the location of the damage in DN25 fitting after the penetrant testing (PT)

The pipeline section FSPS9 during its fatigue test can be seen in Fig. 21a, and the location of the damage after the penetrant testing (PT) can be studied in Fig. 21b.
