Defect detection in freight railcar tapered-roller bearings using vibration techniques

Constantine Tarawneh¹ · Joseph Montalvo¹ · Brent Wilson²

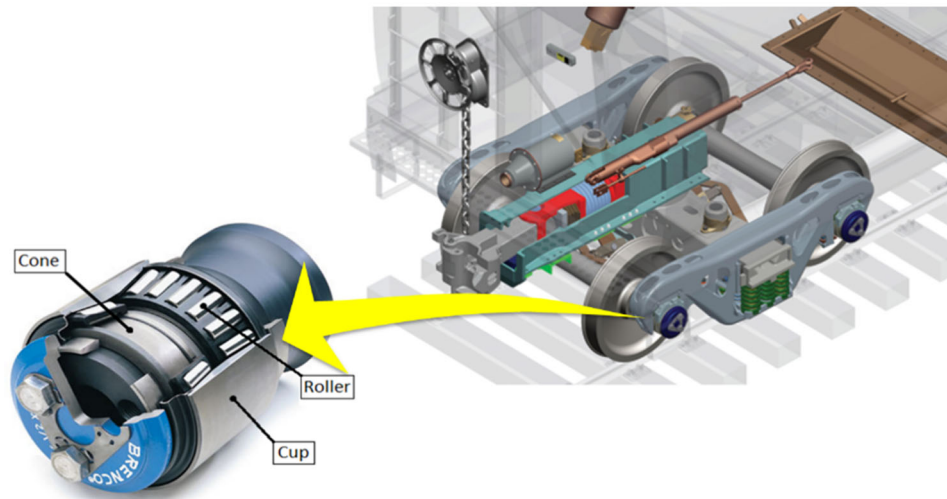
Fig. 1 Fundamental components of a typical tapered-roller bearing used in freight railcars [1]

The tapered-roller bearing typically used in freight railcar service has three distinct fundamental components: rollers, inner rings (cones), and outer ring (cup). These components, shown in Fig. 1, allow for near-frictionless operation under heavy loads and high speeds. However, when one of these components develops a defect, the operational effectiveness is compromised, which may lead to increased frictional heating depending on the size and location of the initiated defect.

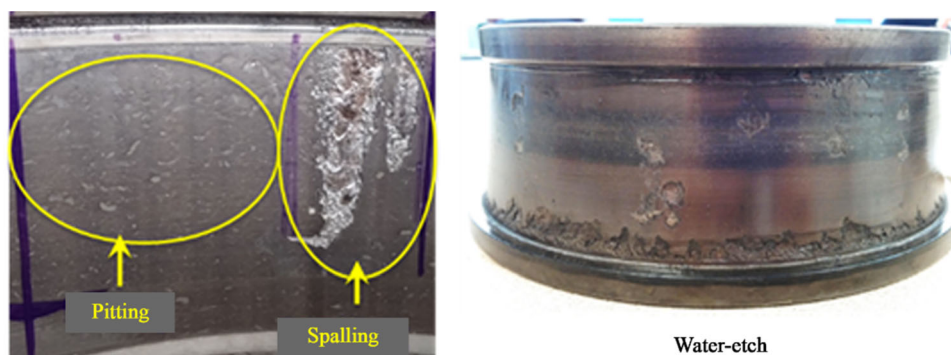
Fig. 2 Example of a localized defect (left) and distributed defect (right)

The defects can be categorized into one of three general categories: a geometric defect, a localized defect, or a distributed defect. A geometric defect is when one or more of the fundamental components of the bearing are out of tolerance because of inconsistencies in the manufacturing processes. A bearing can also develop a geometric defect through improper reconditioning or prolonged usage. Two examples of localized defects that include pits, cracks, or spalls on a single component of the bearing are illustrated in Fig. 2 (left). A distributed defect is when multiple bearing components have localized defects or a single component with multiple defects that are distributed throughout its surface such as a water-etch defect, pictured in Fig. 2 (right). Water-etch is the consequence of water entering the bearing through an orifice or broken seal and degrading the grease. This grease degradation leads to increased metal-to-metal friction, which in turn causes the rolling surfaces of the bearing components to wear away at

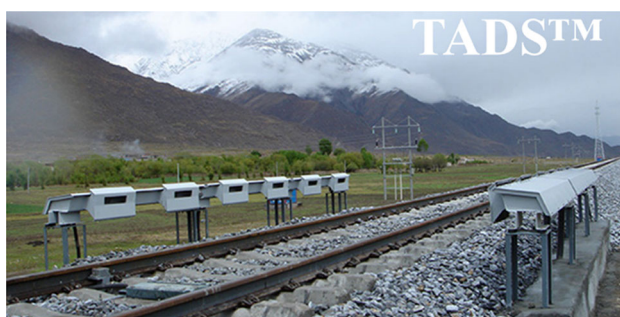
Fig. 3 Photograph of a TADSTM site [2]

TADSTM, pictured in Fig. 3, uses wayside microphones to detect high-risk defects in bearings and alert the conductor as the train passes by the system. A “growler” is an example of a high-risk defect in which spalls occupy about 90% of the bearing component’s rolling surface. The system is proficient in determining end-of-life bearings but fails to identify bearings with defects at their early stages of development. Moreover, there are less than 20 systems in service throughout the USA and Canada, and TADSTM is not proficient in detecting inner ring (cone) defects [3, 4]. The latter facts suggest that many bearings may spend their entire service life without passing through a TADSTM station, and many other bearings with relatively small defects will go undetected as they pass through TADSTM.

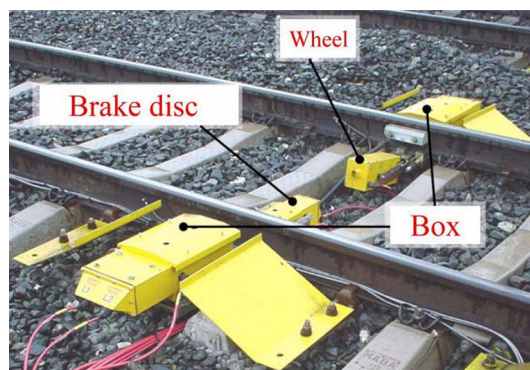
Fig. 4 Example of an HBD site [5]

HBDs, shown in Fig. 4, are the most utilized bearing condition monitoring systems in operation in North

America with over 6000 in use [3]. They are usually placed 40-rail km (25 mi) apart, with some positioned 64-rail km (40 mi) apart on rail lines with less traffic. HBDs use non-contact infrared sensors to measure the temperature radiated from the bearings, wheels, axles, and brakes as they roll over the detector. The HBD will alert the train operator of any bearings running at temperatures greater than 94.4 °C (170 °F) above ambient conditions or any bearings operating at a temperature greater than 52.8 °C (95 °F) above the temperature of the bearing that shares the same axle [6].

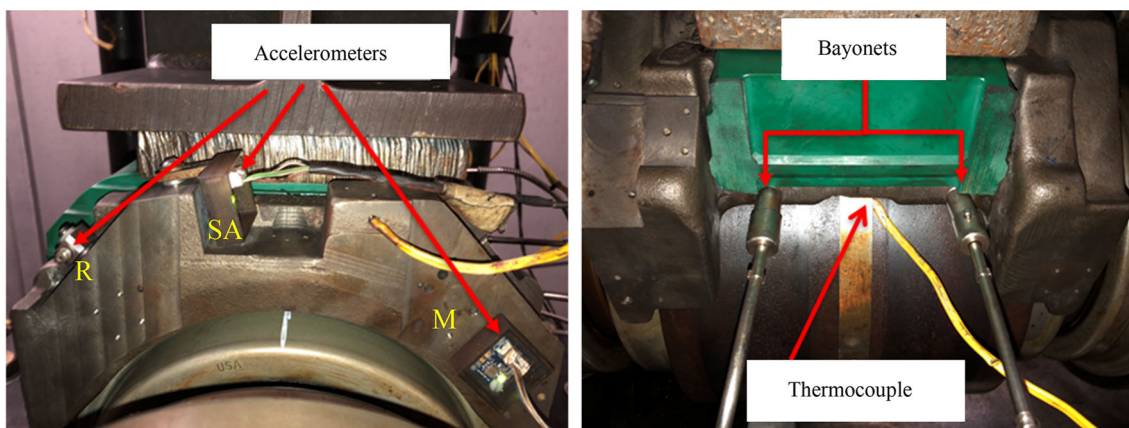
Fig. 6 Wired version of the onboard condition monitoring system showing accelerometer locations on the machined bearing adapter (left) as well as thermocouple locations (right)

To replicate field service conditions, only data collected from the middle two bearings (B2 and B3) were used for this study since they are both top loaded. Thus, the middle two bearing adapters were machined to accept two customized 70 g ADI ADXL001-70BEZ accelerometers (placed in the outboard smart adapter (SA) and mote (M) locations), one 500 g PCB 355B02 accelerometer (placed in the outboard radial (R) location), two K-type bayonet thermocouples, and one regular K-type thermocouple aligned with the two bayonet thermocouples and placed midway along the bearing cup width, held tightly by a hose clamp. Figure 6 shows the SA, M and R location of the accelerometers on the modified bearing adapter (left) as well as the thermocouple locations (right).

Note that the sensors pictured in Fig. 6 are part of the initial wired version of the onboard condition monitoring system that was used to develop and optimize the wireless version pictured in Fig. 7. The wireless onboard condition monitoring system has been extensively validated and proven to produce identical results to those obtained by the wired version shown in Fig. 6.

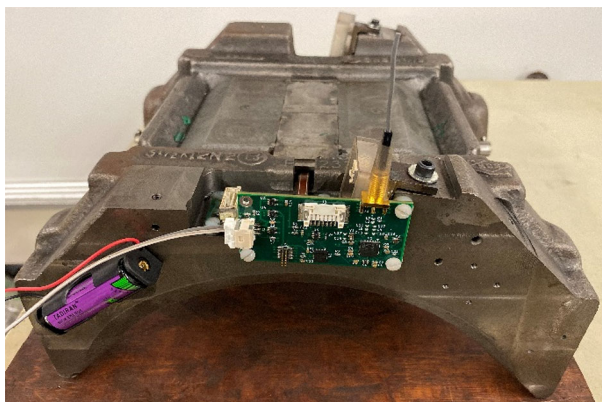
Fig. 7 A picture of the wireless onboard condition monitoring system powered by a battery pack and affixed to the bearing adapter

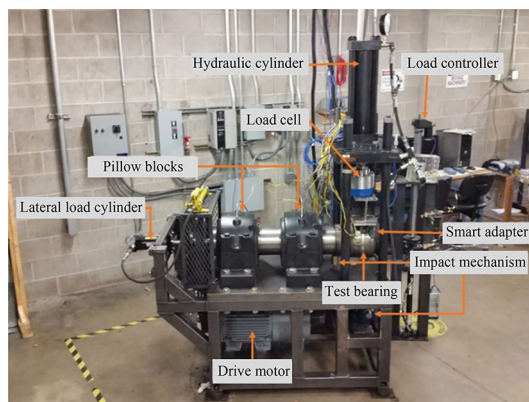
Fig. 8 Single bearing test rig (SBT)

The SBT, depicted in Fig. 8, accommodates a single railroad tapered-roller bearing (classes E, F, G, or K) in a cantilever setup, which closely mimics the bearing loading conditions on freight railcars. An AdapterPlus™ bearing adapter was specially machined to accept four 70 g ADI

ADXL accelerometers (placed in SA and M locations at the inboard and outboard sides of the bearing), one 500 g PCB accelerometer (placed in the R location on the outboard side), and four K-type bayonet thermocouples (two inboard and two outboard). In addition to the four thermocouples affixed to the bearing adapter, there are seven K-type thermocouples placed equidistantly around the circumference of the bearing cup and held in place tightly via a hose clamp, as shown in Fig. 9.

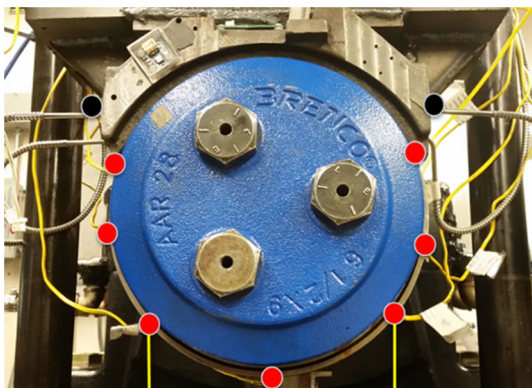
Fig. 9 Placement of thermocouples on the railroad bearing (red dots represent the locations of the regular K-type thermocouples and black dots represent the locations of the bayonet K-type thermocouples)

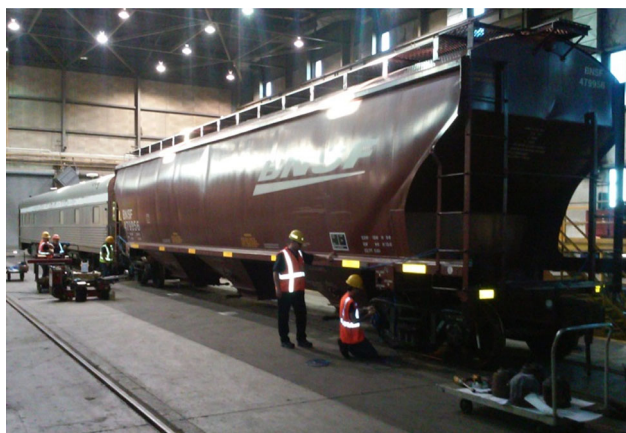
Fig. 10 A picture of the business car and the freight railcar being instrumented for the field test at the Transportation Technology Center, Inc. (TTCI)

In 2015, the UTCRS research team, in collaboration with Amsted Rail Engineers, conducted a proof of concept field test at the Transportation Technology Center, Inc. (TTCI) in Pueblo, Colorado. The primary objective of the field test was to validate the accuracy and reliability of the onboard accelerometer-based condition monitoring system in detecting defective bearings. A locomotive towing a business car and an instrumented freight railcar (empty 1 day and fully loaded the second day) along different TTCI tracks at speeds ranging from 48 to 105 km/h (30–65 mph) provided the field test data for this study. The data acquisition system was set up in the business car. Figure 10 is a picture of the business car, and the freight railcar as the UTCRS research team was completing the instrumentation in preparation for the field test at TTCI.

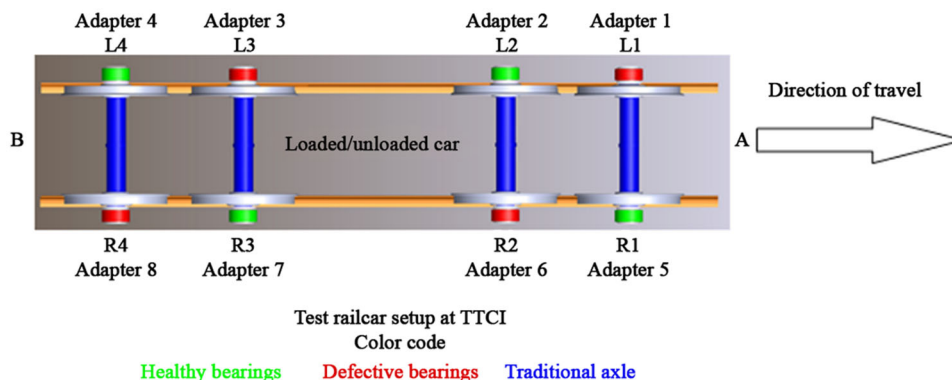
Fig. 11 Schematic diagram describing the test freight railcar setup at TTCI

Figure 11 provides the locations of the healthy and defective bearings on the instrumented freight railcar. Table 3 displays the conditions of the bearings along with their defect sizes. All defects were placed on the inboard raceway, whereas all the sensors were placed on the outboard side of the bearing adapter. This provides a worst-case scenario where the defect is the furthest away from the sensors.

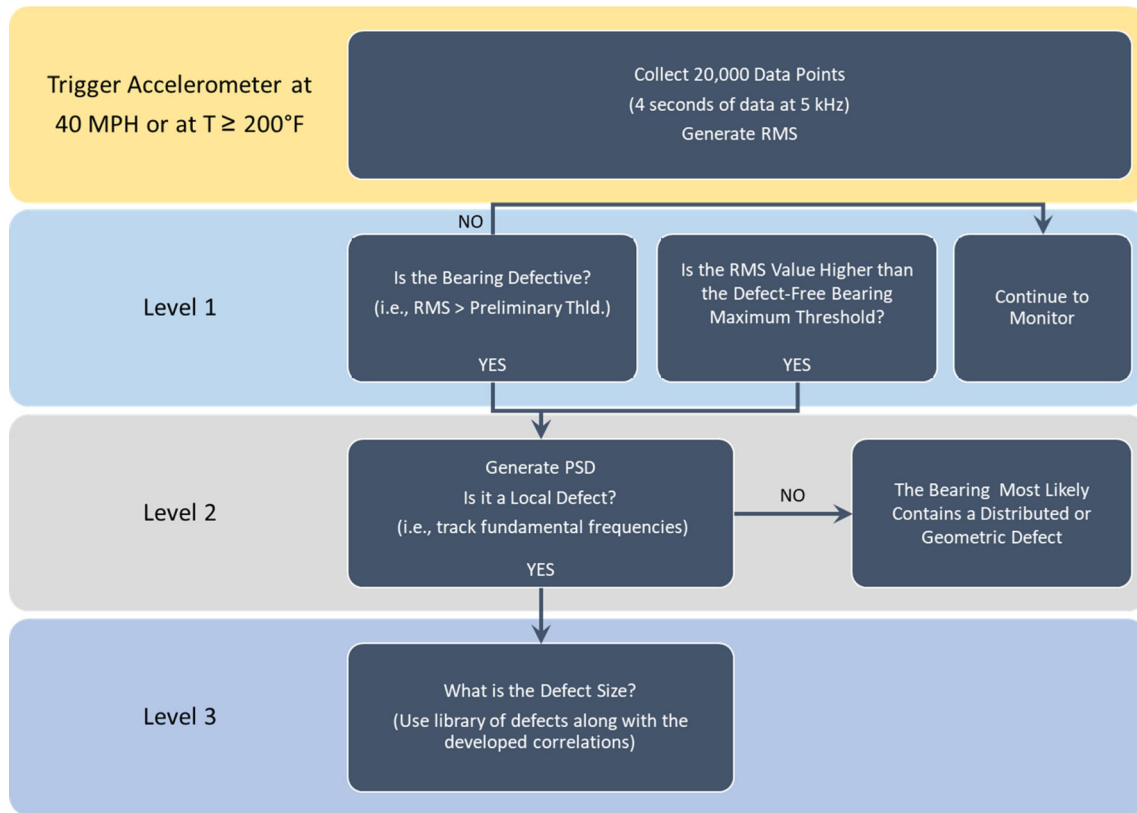
Fig. 12 Flowchart of the proposed algorithm [16]

Based on the laboratory testing, a field implementation version of the bearing defect detection algorithm was developed to identify the presence of raceway defects at the early stages of their initiation while also determining the defect location and estimating its size. The temperature sensor of the wireless condition monitoring module and a GPS chip installed in the central computing unit record the bearing operating temperature and the train traveling speed, respectively. Currently, the algorithm is set to trigger when the train is operating at speeds of at least 64 km/h (40 mph) or the bearing operating temperature is above 93 °C (200 °F). Note that these thresholds can be adjusted as needed through programming. Once the algorithm is triggered, the accelerometer embedded within the onboard sensor module collects 4-s of vibration data at a sampling rate of 5 kHz (20,000 data points). The onboard sensor modules are affixed to the bearing adapter, and there are eight modules mounted per freight railcar (one for each bearing). The root-mean-square (RMS) of the vibration data is calculated and a single g-value is output. Figure 12

provides a brief description of each level within the algorithm.

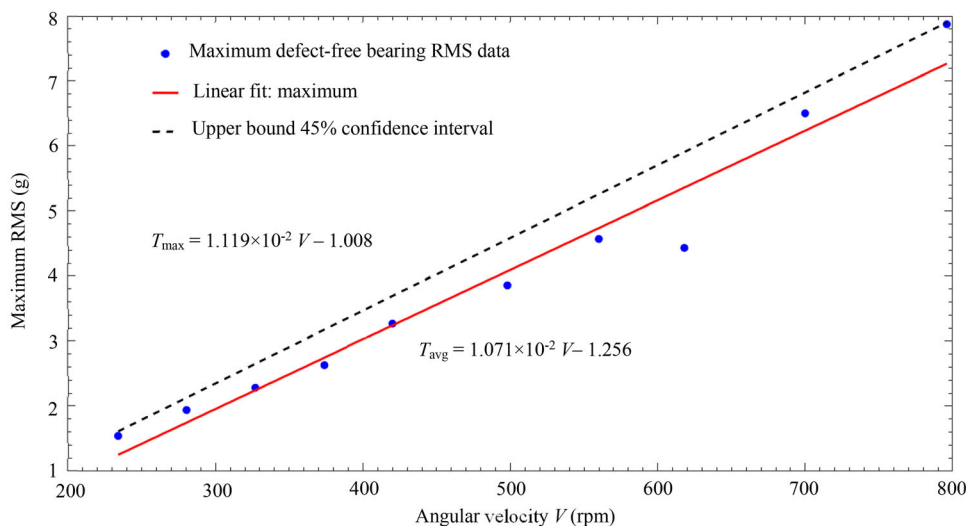
Fig. 13 Plot of maximum defect-free bearing RMS values versus angular velocity

Maximum threshold (T_{max}) was developed so that all bearings with an RMS value above it are flagged as defective. The T_{max} is based on a correlation between the maximum defect-free bearing RMS values for each speed data set versus the speed (V). The upper bound of the 45% CI, plotted in Fig. 13, provided the most conservative threshold for which no defect-free bearings would be mis-categorized as defective. Equation (2) gives T_{max} as a function of train/axle speed V :

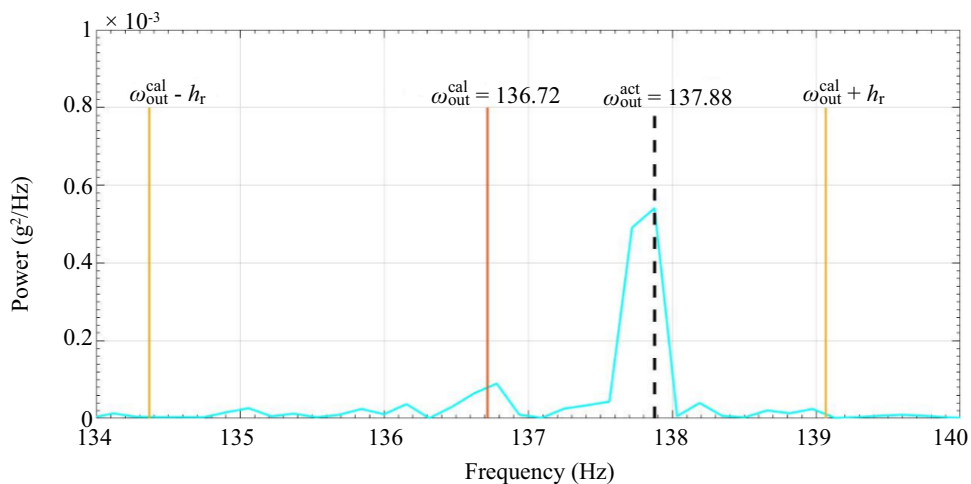
Fig. 15 Example of using the hunting ranges to determine the actual fundamental defect frequency

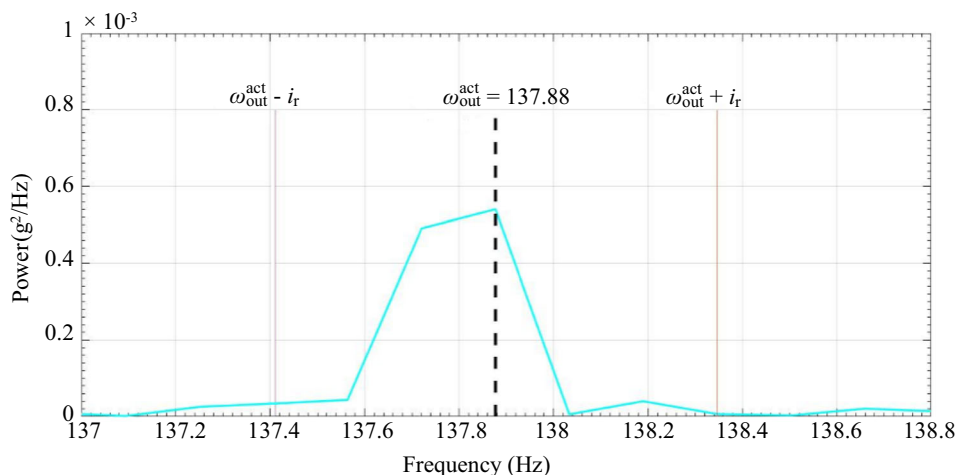
Fig. 16 Example of using the integration ranges to calculate the normalized defect energy for each fundamental defect frequency

These defect frequencies and harmonics are then used to calculate the normalized defect energy (NDE) for each bearing in order to categorize the defect [17]. The NDE is computed by taking the square of the sum of areas under a specific defect frequency (cup, cone, or roller) and its harmonics within the PSD divided by the total amount of harmonics within a specified frequency range. However, laboratory and field testing have shown that the calculated frequencies were slightly shifted from the actual frequencies, causing improper NDE calculations. These shifts can be caused by the slight differences in tolerances of the components as well as any speed variations or component slipping. A hunting range (h_r) was incorporated to mitigate these shifts in the fundamental frequencies. The hunting range is a function of the resolution (rs) of the spectrum and varies with the rotational speed of the axle (ω_o). The resolution is calculated by dividing the sampling frequency

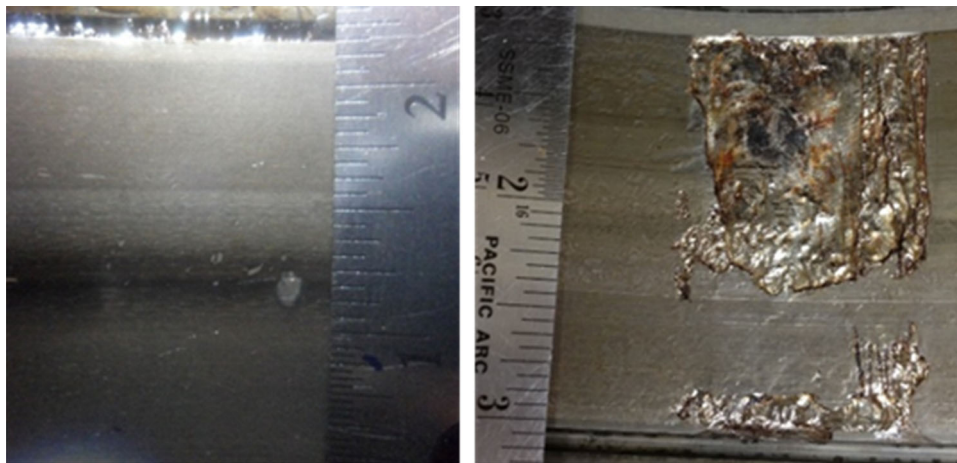
Fig. 17 Initial pitting on cup raceway (left) and resulting cup spall (right) (ruler is in inches)

In laboratory Experiment 200, a class K bearing with a pitted inboard cup (outer ring) raceway was run in the B2 position on the 4BT (refer to Fig. 5). The initial defect, pictured in Fig. 17 (left), propagated throughout the experiment to a final size of 8.98 cm^2 (1.39 in^2), as shown in Fig. 17 (right).

The final defect size of 8.98 cm^2 corresponds to approximately 2.4% of the 367.28 cm^2 (56.93 in^2) total area of one cup raceway in a class K bearing. To accelerate the testing and simulate a worst-case scenario, the region of the pit on the cup was placed directly under the full load path and the bearing was run at 137 km/h (85 mph) and 110% of full load representing an overloaded railcar.

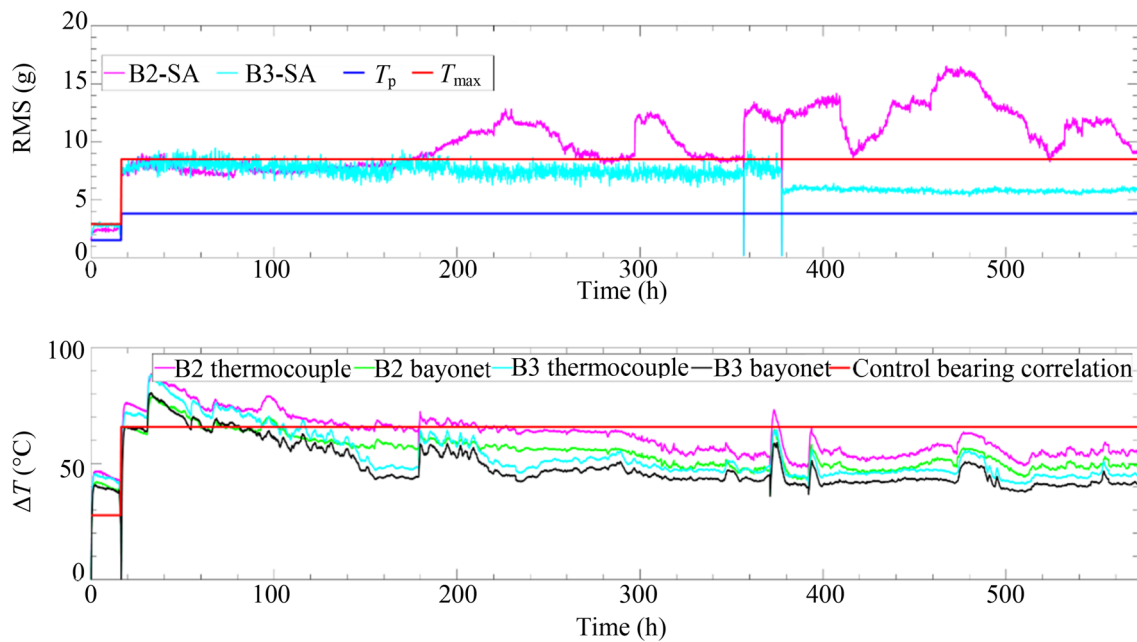
Fig. 18 Vibration and temperature profiles for bearing 2 (B2) and bearing 3 (B3) during Experiment 200

Figure 18 depicts the vibration and temperature profiles for bearing 2 (B2) and bearing 3 (B3) throughout Experiment 200. The control bearing correlation in Fig. 18 refers to a previous study for which the average operating temperatures above ambient (ΔT) for healthy (defect-free) bearings at several speeds for empty and fully loaded railcars were acquired [7]. Note that bearings tend to operate at temperatures above the control bearing threshold regardless of bearing health at the beginning of experiments as the freshly packed grease breaks in. The ambient temperature was held at $20 \text{ }^\circ\text{C}$ ($68 \text{ }^\circ\text{F}$). Tables 5 and 6 provide the average values of the final 2 h of each loading condition during the experiment.

Initially, the vibration levels within B2 were slightly below the T_{max} . After the 150-h mark, B2 vibration levels started to increase reaching levels that are noticeably above the T_{max} , signifying a defective bearing. This fluctuation in vibration levels is indicative of defect growth. As the defect grows, metal debris from the cup raceway is circulated throughout the bearing during operation. This causes an increase in roller misalignment and is represented by an increase in vibration. However, as the debris gets crushed by the rotating rollers, the vibration levels start to decline. This cycle repeats itself every time the defect deteriorates. Since the vibration levels within B2 exceeded the T_{max} at

137 km/h (85 mph), B2 proceeds to Level 2 analysis. The vibration levels within B3 remained above the T_p but below the T_{max} . Upon teardown and visual inspection, B3 did not have any visible defects and was determined to be healthy.

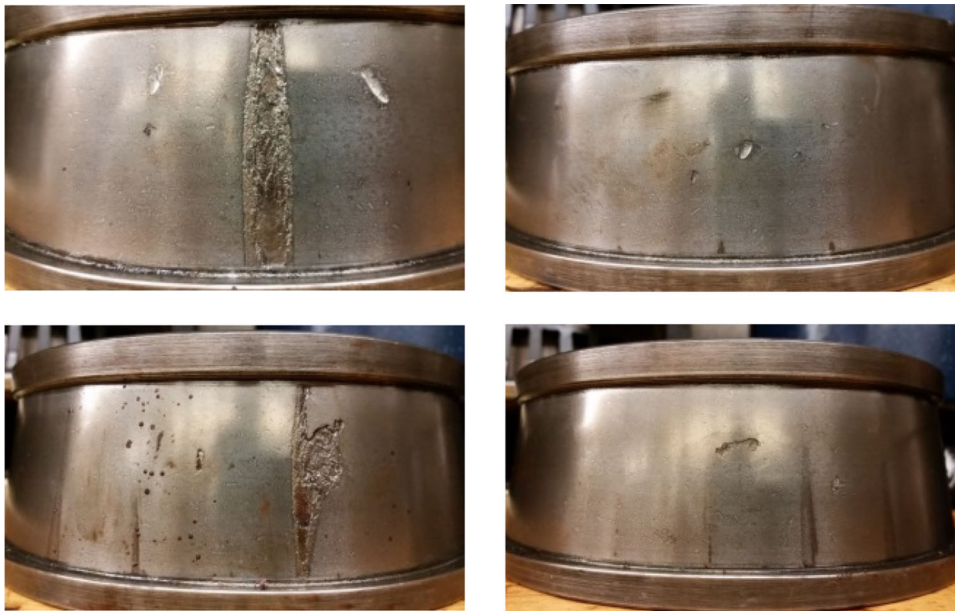
Fig. 19 Photographs of L1 bearing cone defect (refer to Fig. 11 and Table 3)
