Effect of Soil Grain Size Distribution on the Mechanical Damage of Nonwoven Geotextiles Under Repeated Loading

Abstract Installation processes (which induce mechanical damage) may cause undesirable changes on the properties of geosynthetics, affecting their performance. This work evaluates the effect of mechanical damage on the short-term tensile behaviour of two nonwoven geotextiles (with different masses per unit area). The geotextiles were damaged in laboratory using a standardised procedure and an artificial aggregate (*corundum*) and eight other soils. The damage induced was characterized using wide-width tensile tests. Results showed reductions of the tensile strength of both geotextiles, which depended on the grain size distribution and uniformity of the soils and on the mass per unit area of the geotextiles. The reduction in tensile strength provoked by *corundum* was higher than the decreases caused by most of the other soils. The mechanical damage tests also led to a reduction of elongation at maximum load and an increase of stiffness.

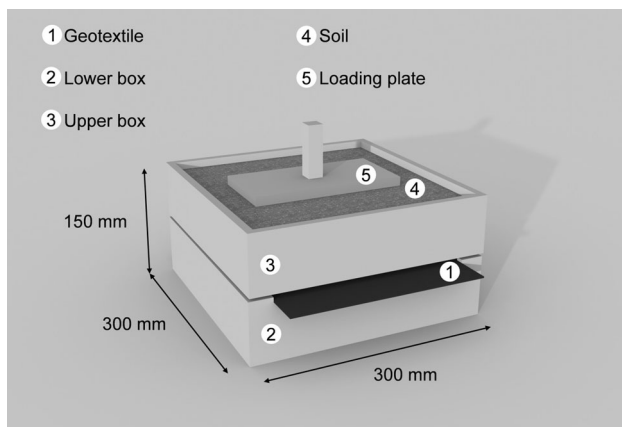
Fig. 1 Schematic representation of the equipment used in the mechanical damage tests

The mechanical damage tests were performed in a laboratory prototype equipment following the specifications of EN ISO 10722 [11]. The equipment was formed by a container (Fig. 1) divided into a lower and an upper box (rigid metal boxes where the geotextile and the soil were placed), a loading plate and a compression machine (full description of the equipment can be found in Lopes and Lopes [17]).

The mechanical damage tests were carried out according to EN ISO 10722 [11]: each specimen of geotextile (250 mm wide and 500 mm long) was placed between two layers of a synthetic aggregate of sintered aluminium oxide (*corundum*) and submitted to repeated loading. Additional tests were performed using other soils. The layer placed under the specimen consisted in two sublayers (each 37.5 mm high) compacted by a flat plate loaded to a pressure of 200 ± 2 kPa, during 60 s, over the whole area of the test container. The layer placed over the specimen consisted in loose soil with 75 mm high. Each specimen was subjected to dynamic loading (ranging between 5 ± 0.5 and 500 ± 10 kPa) at a frequency of 1 Hz and for 200 cycles. Finished the loading, the test was stopped and the specimen was removed carefully from the test container, avoiding additional damage.

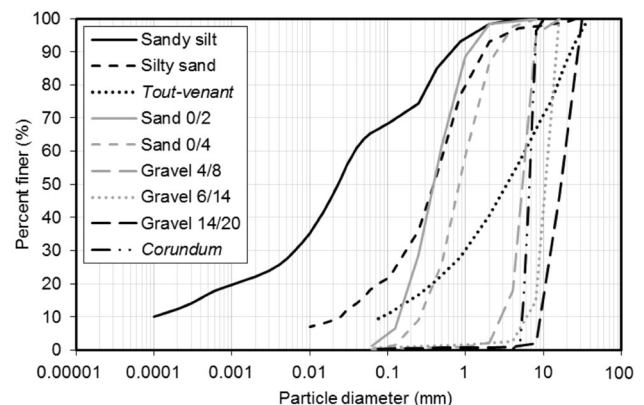
Fig. 2 Grain size distribution of the soils

The grain size distributions of the soils (evaluated according to ISO/TS 17892-4 [18]) are presented in Fig. 2. The main parameters for the characterisation of the grain size distributions (such as: D_x —effective x % grain size, D_{max} —maximum particle size, C_U —coefficient of uniformity, C_C —coefficient of curvature) can be found in Table 2.

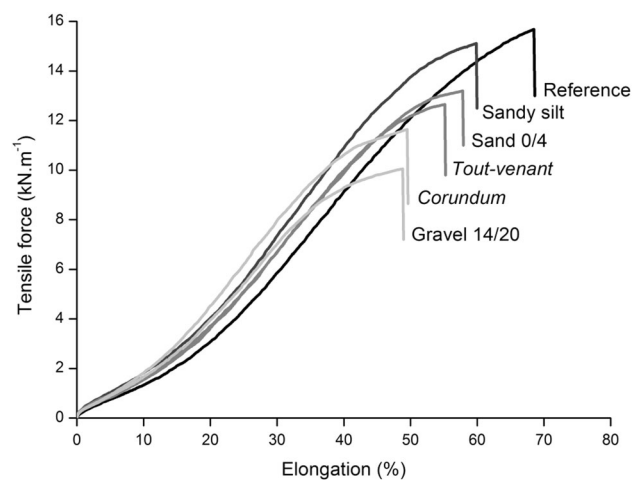
Fig. 3 Mean curves “tensile force–elongation” obtained for geotextile G250 before and after some mechanical damage tests

The tensile properties of geotextile G250 after the mechanical damage tests are presented in Table 3. Figure 3 includes mean curves tensile force–elongation for the reference sample and after mechanical damage with some of the soils considered. The curves omitted were very similar to the ones presented and were removed to make the figure easier to understand.

The tensile strength of geotextile G250 decreased after the mechanical damage tests (from 16.00 kN m^{-1} for the undamaged sample to $10.68\text{--}15.57 \text{ kN m}^{-1}$ after damage, depending on the soil used). Similarly, the elongation at maximum load was reduced from 70.4 % for the reference sample to 48.4–60.8 % after mechanical damage. The steeper slopes of the non-elastic region of the mean curves tensile force-elongation showed an increase in stiffness after the mechanical damage tests. The same consequence was observed for the curves not included in Fig. 3.

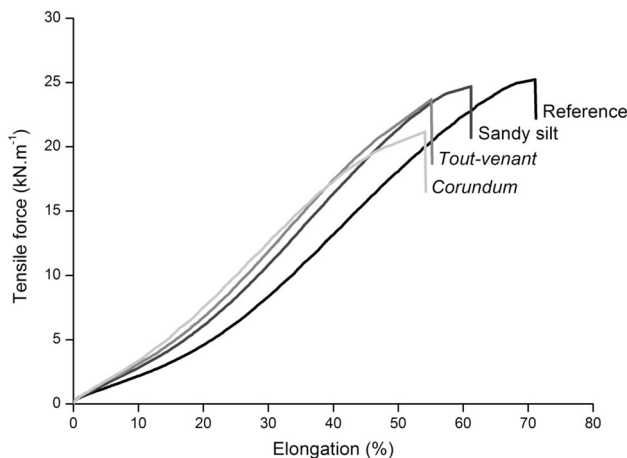
Fig. 4 Mean curves “tensile force–elongation” obtained for geotextile G400 before and after some mechanical damage tests

25.56 to 21.35–25.08 kN m⁻¹) and the elongation at maximum load (reduction from 70.9 to 50.5–61.1 %) tended to decrease. Figure 4 shows some mean curves tensile force-elongation obtained for geotextile G400 (certain curves were omitted for clarification purposes). These curves showed an increase in stiffness after the mechanical damage tests (this increase also occurred for the samples damaged with the soils omitted in Fig. 4).

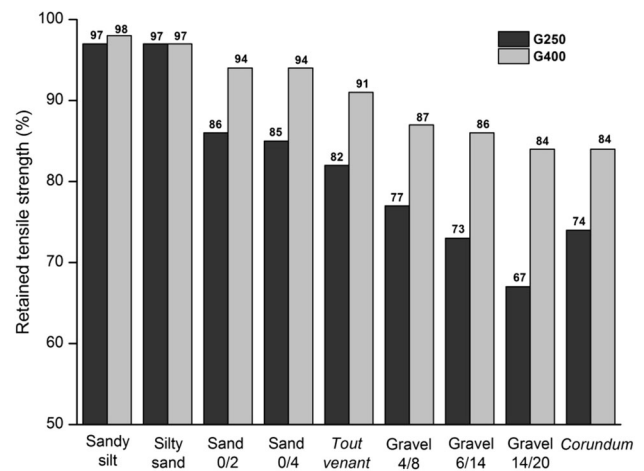
Fig. 5 Retained tensile strength of geotextiles G250 and G400 after the mechanical damage tests

The evolution of the tensile properties (after the mechanical damage tests) had a similar behaviour in geotextiles G250 and G400 (this way, the main conclusions withdrawn for geotextile G250 in “Geotextile G250” section are also valid for geotextile G400). However, and with exception for the finest soils (where no relevant changes occurred), the reductions in tensile strength were less pronounced for geotextile G400 (Fig. 5). The higher mass per unit area (and thickness) was responsible for the better resistance of geotextile G400 against mechanical damage.

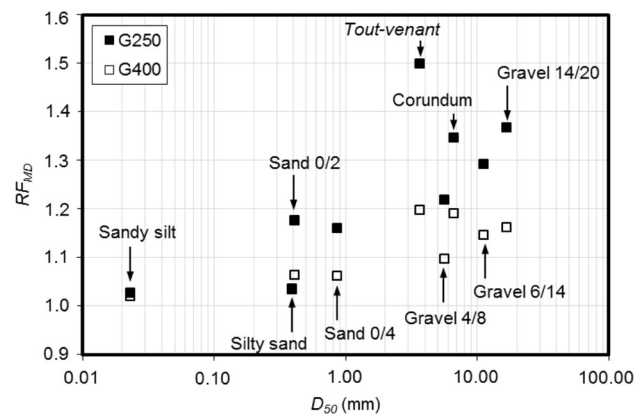
Fig. 6 Variation of RF_{MD} with the D_{50} of the soils for geotextiles G250 and G400

The reduction factors presented in this paper were determined from mechanical damage laboratory tests and thus should not be used for design. Nevertheless, they can be useful to compare the influence of the type of soil and the mass per unit area on the damage suffered by the geotextiles. Figure 6 illustrates the variation of RF_{MD} with the D_{50} of the soils used in the mechanical damage tests for geotextiles G250 and G400.

Geotextiles of the same product family with different values of mass per unit area have different robustness. Higher robustness resulted in lower values for the reduction factor, RF_{MD} . Generally, the soils with higher values of D_{50} led to larger reduction factors. However, as the soils used

were quite different, there are other factors to be considered. The uniformity of the soils also played an important role on the changes observed after the mechanical damage tests. Soils with wider range of particle sizes seemed to be less aggressive.
