The strength of aged glass

Kyriaki Corinna Datsiou · Mauro Overend

Abstract Glass is known for its excellent durability, but the strength of glass is very sensitive to the characteristics of its surface, which is known to accumulate damage during its service life. There is however, a lack of strength data on weathered or aged glass, particularly on thermally or chemically treated glass. In this study a carefully calibrated sand trickling test is used to produce surface damage equivalent to erosive action of 20 years of natural weathering on different types of glass: soda-lime-silica annealed, soda-lime-silica fully toughened and aluminosilicate chemically toughened. The soda-lime-silica glass specimens are tested destructively in their as-received and artificially aged form in a conventional coaxial double ring set-up, while the alumino-silicate chemically toughened specimens are tested in an improved coaxial double ring set-up. Fractography is subsequently used to identify and measure the critical flaw size on each specimen. The strength data are analysed statistically and the design strengths for each glass type are obtained. It is found that all glasses suffer a loss in streng

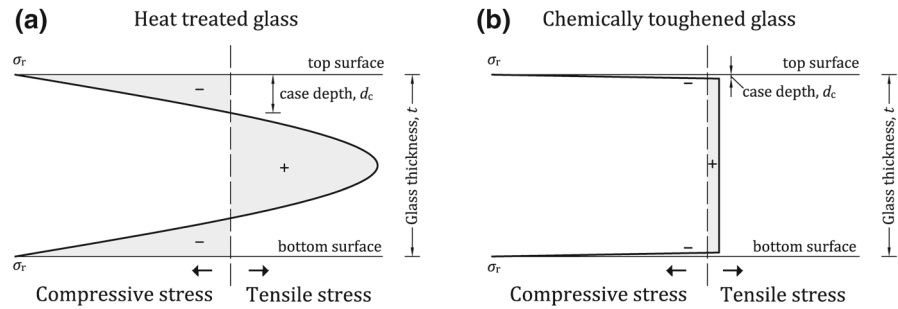
Fig. 1 Residual stress profile through the glass thickness for: **a** heat treated and; **b** chemically toughened glass

Contemporary architectural trends frequently require glass to bear higher loads than those typically imposed on a traditional infill panel. This need is currently addressed with the use of high strength glass in the form of heat treated or chemically toughened glass. High strength glass is produced with toughening procedures that introduce an advantageous residual stress profile through the thickness of the glass, which is characterized by tensile stress in the core and compressive stress at the surfaces (as shown in Fig. 1).

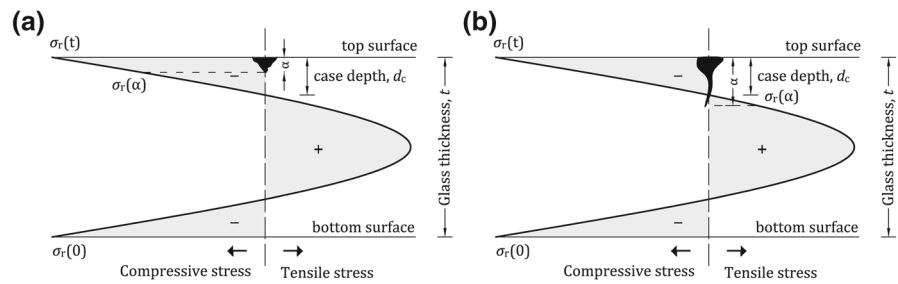
Fig. 2 Flaw in fully toughened glass: **a** $\alpha \leq d_c : |\sigma_r(\alpha)| < |\sigma_r(t)|$ and; **b** $\alpha > d_c : \sigma_r(\alpha) > 0$

Fig. 2a). The residual compressive stress is ineffective when the flaw depth exceeds the case depth ($\sigma_r(\alpha) > 0$, Fig. 2b). In this case, the flaw is expected to grow under the influence of the residual tensile stress $\sigma_r(\alpha)$ at the flaw tip and the stress arising from the external loads until the stress intensity factor at the flaw tip reaches a critical value and fracture occurs.

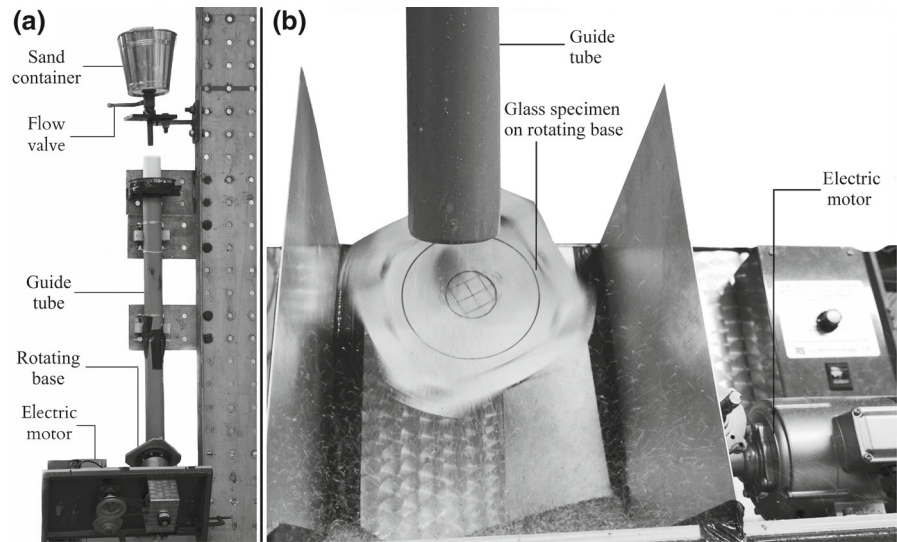
Fig. 3 Artificial ageing of glass with falling abrasive method: **a** whole set-up and; **b** glass specimen abrasion

A falling abrasive method ([Fig. 3](#)) is used in this study for the artificial ageing of glass. The method involves dropping of abrasive medium (of specific mass, M , grain size range, GSR) from a controlled drop height, H , on a single glass specimen that is fixed on an inclined rotating base (45° to the floor). After abrasion and prior to their destructive testing, the glass specimens are stored for a specific amount of time, t_c in specific conditions (temperature, T and humidity, RH). Further details on the method are available in [DIN 52348 \(1985\)](#) and [Datsiou and Overend \(2017\)](#).

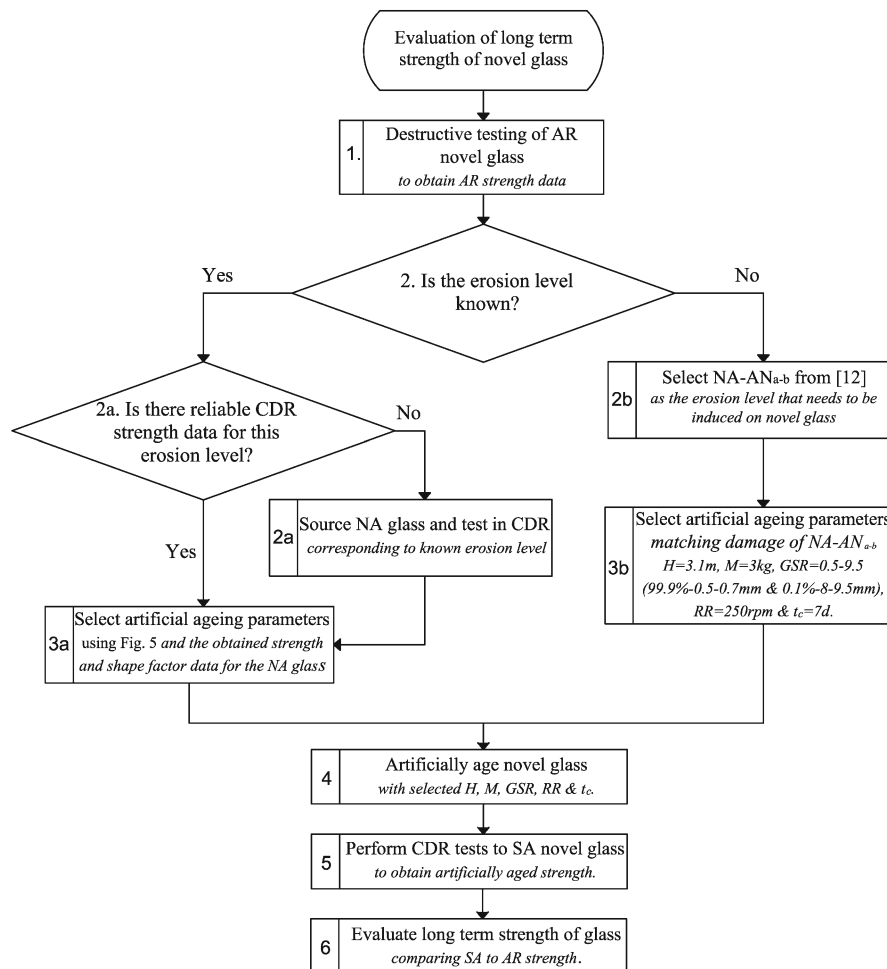
Fig. 4 Procedure for the evaluation of durability of novel glass

The authors' previous research in [Datsiou and Overend \(2017\)](#) showed that artificial ageing of glass with the falling abrasive method has the potential to produce similar Weibull parameters and therefore, similar levels of damage to those found in naturally aged glass. These results are condensed in this section into a procedure for the assessment of the strength of aged glass ([Fig. 4](#)):

Step 1 *Destructive testing of as-received glass:* Perform coaxial double ring (CDR) tests to obtain fracture strength data of the as-received glass. Fit a 2-parameter Weibull distribution to the data (as shown in [Datsiou and Overend 2017](#)) to obtain strength results at low $P_f = 0.008$ complying with the recommendations of [ASTM E1300-12A \(2012\)](#) or mean $P_f = 0.50$ probabilities of failure.

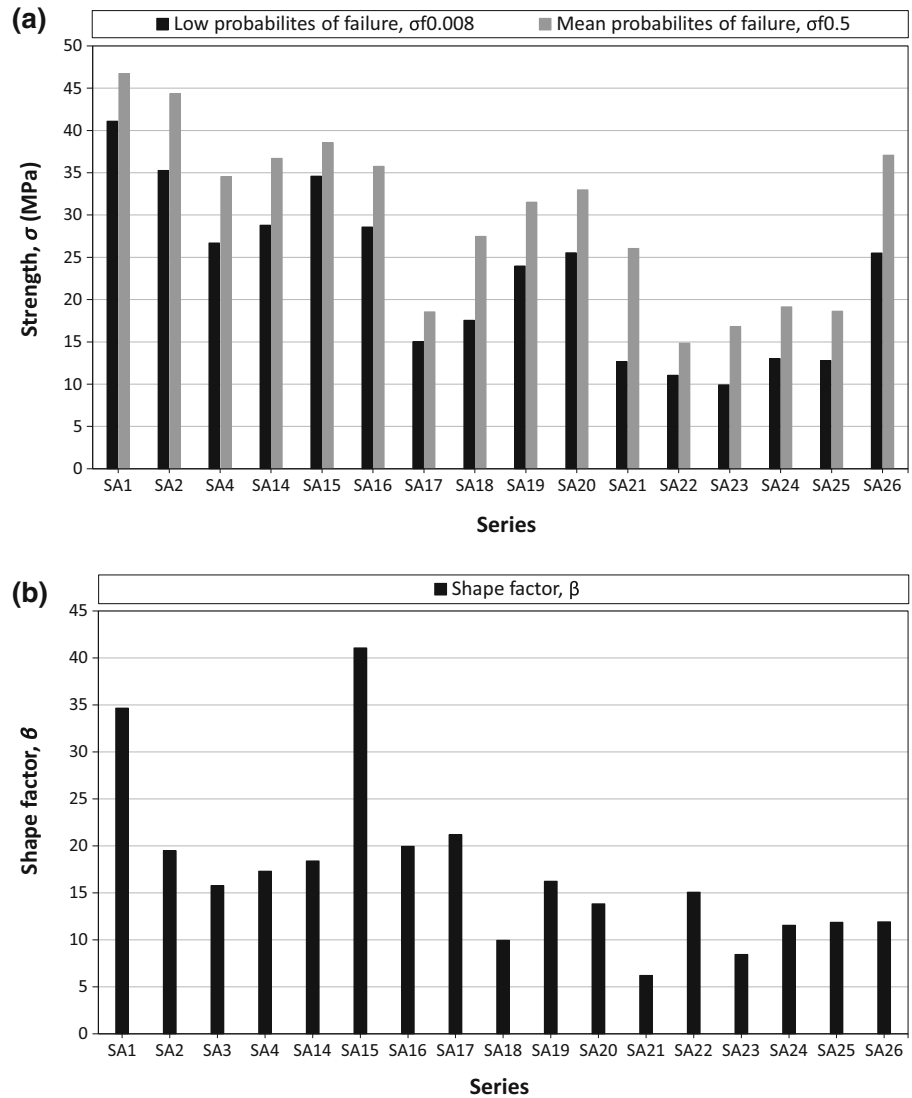
Fig. 5 Artificially aged annealed glass: **a** strengths at $P_f = 0.008$ and $P_f = 0.50$ probabilities of failure and; **b** shape factor of the Weibull distribution (Table 1)

- (3a) *Known erosion level*: Refer to Fig. 5a–b to match the design or mean strength of naturally aged glass and the shape factor of the Weibull distribution obtained in step 2 with the strength of one of the artificially aged series in Datsiou and Overend (2017). Subsequently, refer to Table 1 to obtain the ageing parameters that were used for the selected artificially aged series.

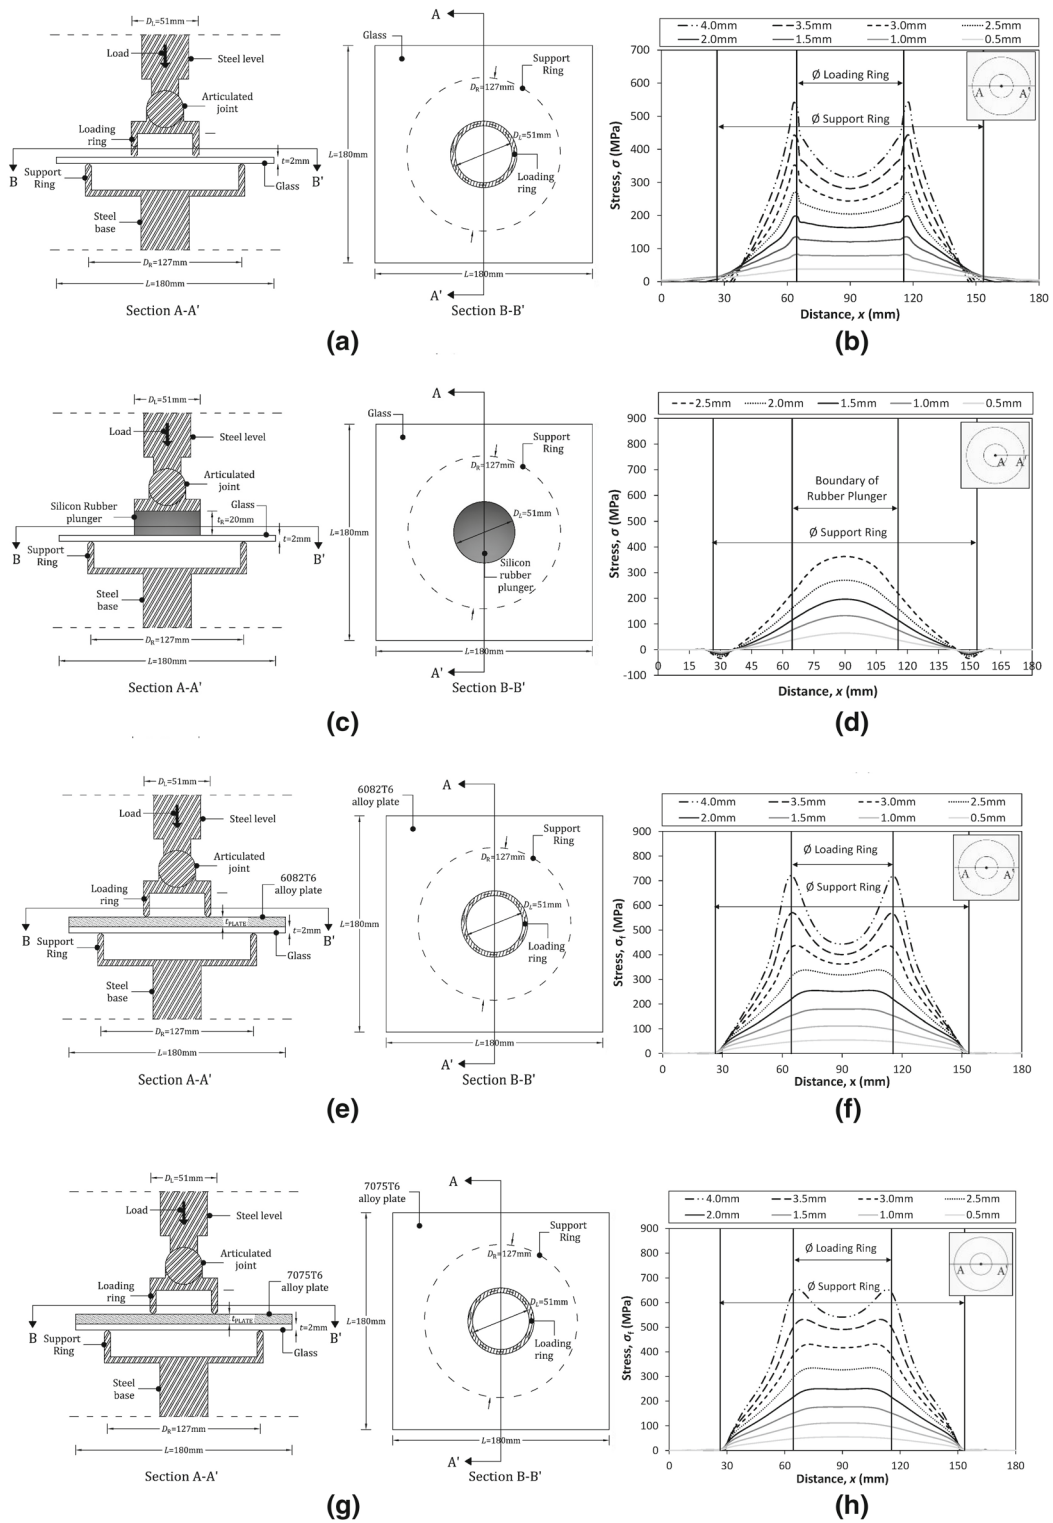
Fig. 6 Set-up and max. principal stress along section A-A' for: **a, b** conventional CDR; **c, d** Set-up A: rubber plunger; **e, f** Set-up B: 6082T6 aluminium plate and; **g, h** Set-up B: 7075T6 aluminium plate

Annealed and fully toughened glass A coaxial double ring set-up (Fig. 6a) with a diameter of $D_L = 51$ mm for the loading and $D_S = 127$ mm for the support ring was used for the annealed and fully toughened glass. Fast stress rates of 20 MPa/s (13.6 mm/min) and 70 MPa/s (20 mm/min) were chosen for annealed and

Set-up A—silicone rubber plunger: Previous research suggests that application of a uniformly distributed load with a silicon rubber plunger over the loading ring area (Fig. 6c), can be used to create a uniform equibiaxial stress field for the destructive testing of thin photovoltaic panels (Blaumeiser and Schneider 2016). However, further numerical investigation of this set-up by the authors (details available in Datsiou 2017) for a Shore Hardness 60°, silicon rubber, shows that an almost uniform surface stress is only achieved for relatively low applied displacements, $\delta_{\text{applied}} < 0.75$ mm (corresponding to $\sigma_f < 100$ MPa, Fig. 6d) and a glass thickness of 2 mm. Other limitations of this set-up are: (i) excessive distortion of the rubber elements causing numerical convergence problems which require a computationally inefficient high density mesh; (ii) defining the rubber material properties is not trivial and requires very careful material characterization and; (iii) uncertainties associated with fitting a material model (Ogden, Yeoh, Mooney Rivlin etc) to describe the rubber stress - strain data.

Set-up B—use of spreader plates: An alternative variation of a CDR set-up is investigated here. This involves introducing an additional plate above the glass specimen in the CDR set-up (Fig. 6e, g). The additional plate increases the bending stiffness of the un-bonded unit and reduces the ratio of applied displacement over the specimen's thickness, $\delta_{\text{applied}}/t$. This is expected to reduce excessive development of radial stress concentrations below the boundaries of the loading ring.

The experimental and numerical results validate the initial assumption that an equibiaxial stress field can be created within the area of the loading ring up to an applied total of $P = 36$ kN (Figs. 7b, 6f) for the 6082T6 alloy. However, as the applied

load/displacement exceeds $P = 36$ kN / $\delta_{\text{applied,D}} \approx 2.2$ mm, the 6082T6 alloy plate reaches its ultimate tensile strength. This increases the load sharing factor of glass and results in stress concentrations underneath the loading ring. The Grade 7075T6 aluminium plate reaches its maximum tensile capacity at a higher applied displacement, $\delta_{\text{applied}} \approx 3.1$ mm and thereby, suppresses significant stress concentrations ($(\sigma_{\text{max}} - \sigma_E) / \sigma_E > 10\%$) up to an applied displacement of $\delta_{\text{applied}} = 3.5$ mm (Fig. 6h).

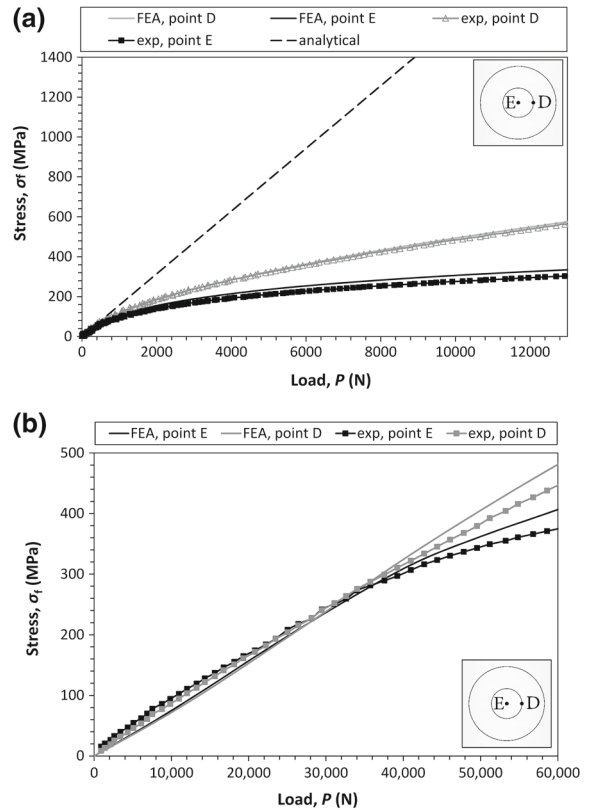
Fig. 7 Max principal stress for chemically toughened glass at points E and D for: **a** conventional CDR and; **b** Set-up B

Aluminium ($E_A = 70$ GPa and $\nu_A = 0.30$) was chosen for the additional plate to suit the material properties of glass ($E_G = 70$ GPa and $\nu_G = 0.23$) and in particular, a medium strength and a high strength alloy conforming to Grades 6082T6 and 7075T6 respectively (BS EN 485-2:2013 2013 and BS EN 573-3:2013 2013). This set-up was investigated numerically (details available in Datsiou 2017) for an additional $180 \times 180 \times 4.75$ mm aluminium plate (stress and plastic strain data available in Boller and Seeger (1987) for Grades 6082T6 and 7075T6). The model was validated with experimental strain gauge data for a 4.75 mm thick, 6082T6 Grade aluminium plate and a 2 mm thick glass plate (Fig. 7b).

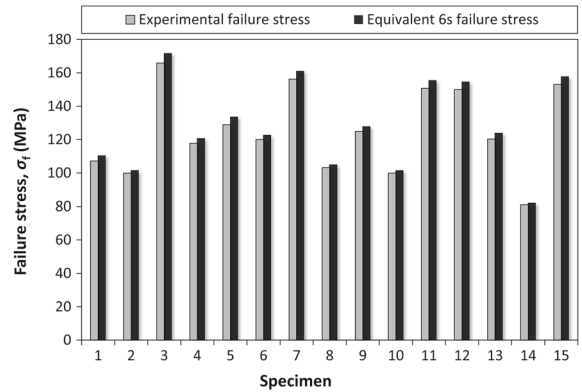
Fig. 8 Experimental and 6s equivalent failure stress for annealed as-received glass

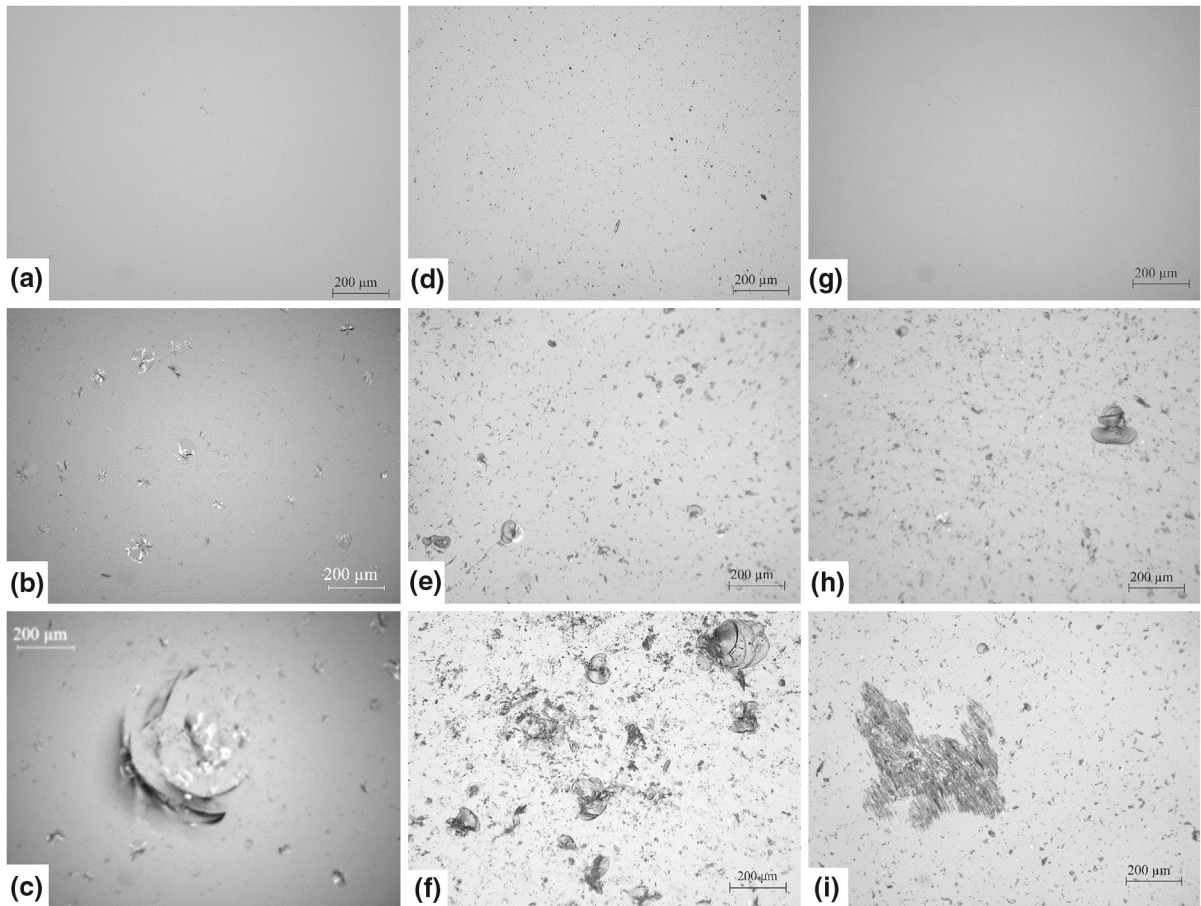
Fig. 9 Micrographs of as-received, sand abraded-sand impacts and sand abraded-gravel impact of: **a–c** annealed; **d–f** fully toughened and **g–i** chemically toughened glass

Micrographs of the surface were obtained prior and after the artificial ageing for the three types of glass (Fig. 9). The surface of as-received annealed (Fig. 9a)

and chemically toughened glass (Fig. 9g) are almost defect free at a magnification level of $100\times$ whilst as-received fully toughened glass has multiple digs on its surface (Fig. 9d) which were potentially introduced during manufacture and/or transportation of the glass.

Artificial ageing with sand abrasion results in digs and some lateral cracks in annealed, fully toughened and chemically toughened glass (Fig. 9b, e, h respectively). Flaws induced by impact of sand grains are similar in all types of glass (Fig. 9b, e, h). However, the flaws induced by the larger gravel particularly on the annealed and fully toughened glass differ from those in the chemically toughened glass as follows: (a) digs surrounded by lateral cracks that intersect with the glass surface are found in fully toughened and annealed glass. However, these flaws are larger in annealed (Fig. 9c) than fully toughened glass (Fig. 9f)

and; (b) gravel impacts do not form digs in chemically toughened glass but result in abrasive damage (Fig. 9i).

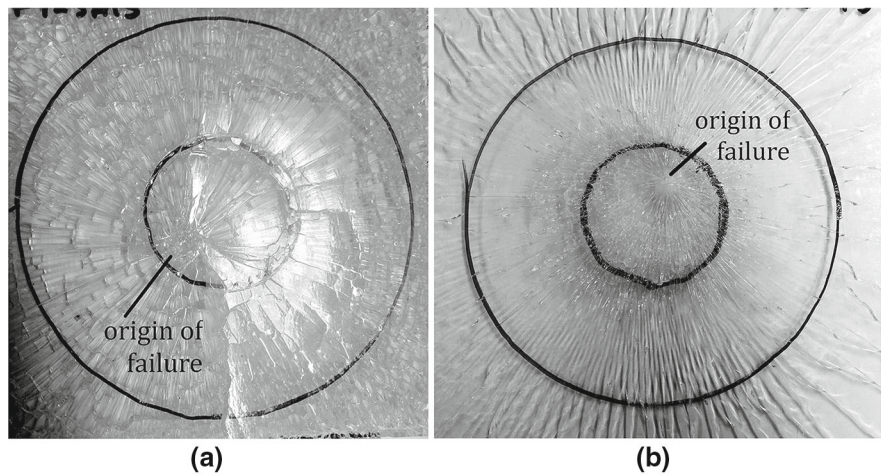
Fig. 11 Fragmentation of sand abraded: **a** fully toughened and; **b** chemically toughened glass

compression, increase the elastic energy that is stored within the specimen. This energy is released upon fracture and is dissipated in opening new crack surfaces, resulting in a very dense fragmentation pattern (Fig. 11b). Therefore, post-fracture microscopy was only possible for the few chemically toughened glass specimens that failed at the “lower” stress tail of the Weibull distribution and thereby resulted in “larger” fragments. Specimens that fail at the lower stresses do so because they have relatively deeper flaws on their surface and therefore, post-fracture microscopy in those specimens is biased because it will only reveal the upper range (maximum depth) of critical flaws.

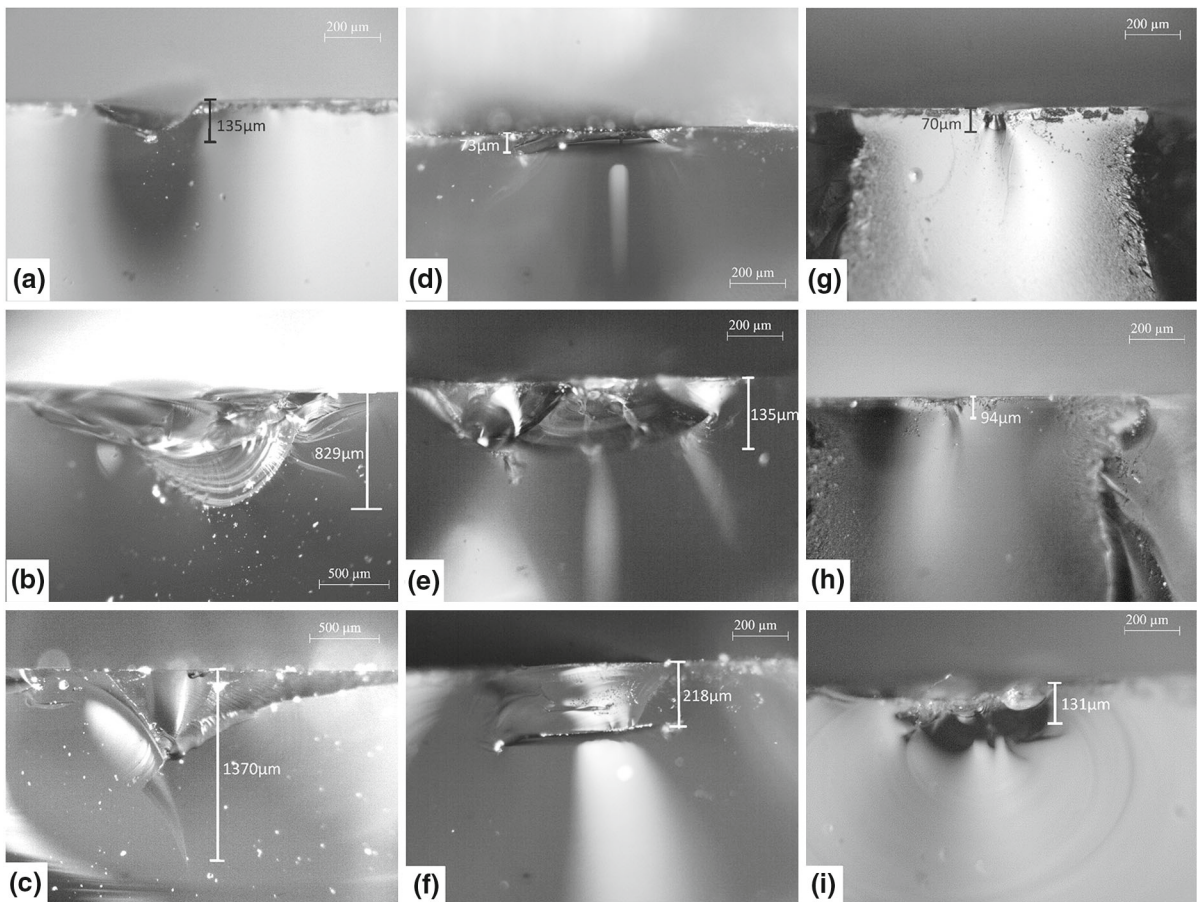
Fig. 12 Critical flaws (of max, average and min depths) in sand abraded: **a–c** annealed; **d–f** fully toughened and; **g–i** chemically toughened glass

Optical microscopy reveals average critical flaw depths after sand abrasion of $472 \mu\text{m}$ ($132 \leq \alpha \leq 1370 \mu\text{m}$) in annealed glass, $127 \mu\text{m}$ ($72 \leq \alpha \leq 218 \mu\text{m}$) for fully toughened glass and $96 \mu\text{m}$ ($71 \leq \alpha \leq 132 \mu\text{m}$) for chemically toughened. Typical micrographs of the critical flaws are shown in Fig. 12a–i, representing the largest, average and smallest flaw for each type of glass revealed with the optical microscope.

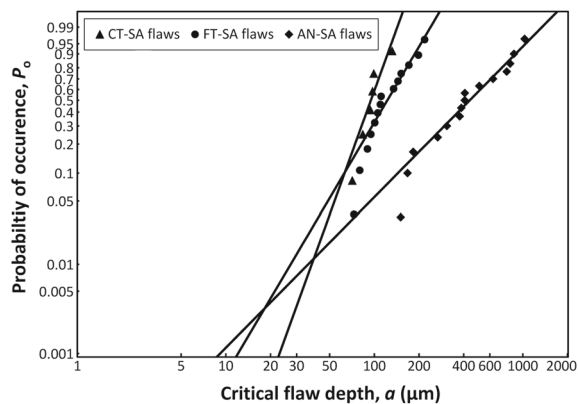
Fig. 13 CDFs for critical flaw depths for annealed, fully toughened and chemically toughened, sand abraded glass

Statistical analysis of the flaw depths followed by fitting the data to a 2-parameter Weibull distribution (Fig. 13) producing acceptable goodness-of-fit. Larger critical flaws were therefore, found for annealed, followed by fully toughened and then chemically toughened glass. This implies that the degree of toughening/amount of residual surface stress has an effect on the critical flaw depth for the same artificial ageing procedure and thereby, the abrasive resistance of glass. In particular, higher residual surface stress results in smaller flaw depths under the same ageing conditions.
