Wrecked All Over the Place: The Identification of Disarticulated Context-Free Ship Remains from the Gold Coast in Queensland, Australia

Wendy van Duivenvoorde · Lauren Davison · Mark Polzer · Mick de Ruyter · Kurt Bennett · David Nutley · Paddy Waterson

Keywords shipwreck identification · colonial shipbuilding · *Coolangatta* · *Heroine* · Australia

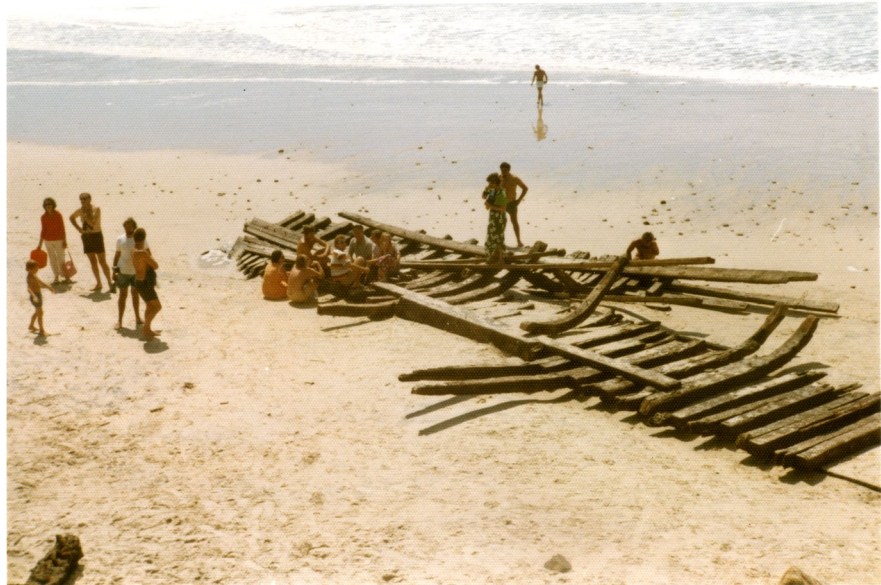
Fig. 2 Shipwreck on North Kirra Beach. (Photo by unknown photographer [possibly B. Stafford], 1970s, courtesy of the Tweed Regional Museum, TH192-11T.)

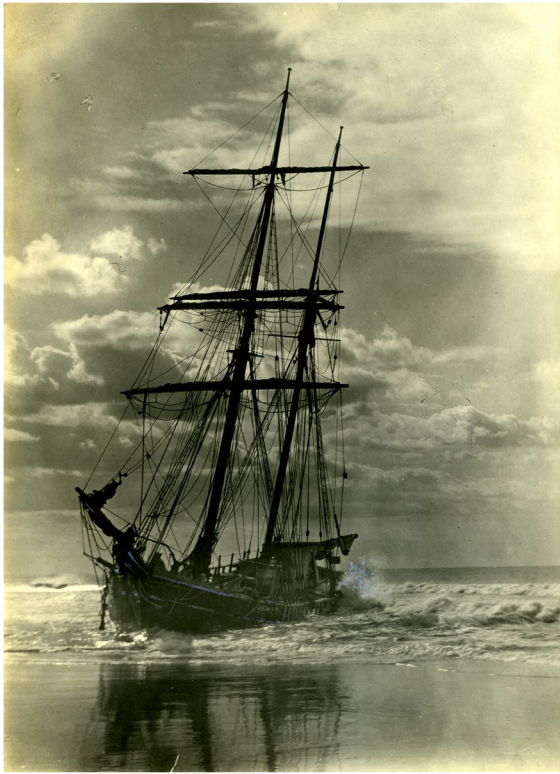
Fig. 3 *Heroine* beached on Sunday, 25 July 1897. (Photo by F. J. Davey, 1897; courtesy of the Tweed Regional Museum, TH10-40.)

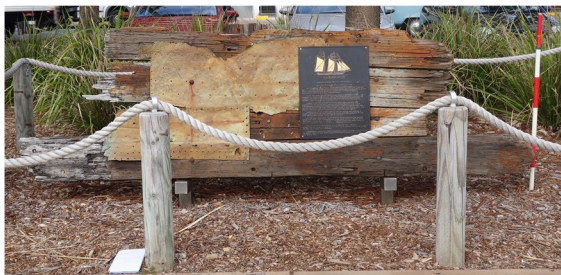
Fig. 5 Hull remains displayed at QEP on Marine Parade in Coolangatta (display is upside down). (Photo by Lauren Davison, 2014.)

The best-preserved intact portion of the ship’s hull at QEP contains the highest proportion of planking still connected. This includes three hull planks and a wale (Figs. 5, 15). Planks range in length from 99.5 (GCHHS P9) to 348.9 cm (GCCC P1) and from 17.5 to 31.5 cm wide (Table 3). Thickness varies from 5.9 to 6.5 cm in the hull planking while the wale is 10.1 cm thick. The planking is still fastened to frames and the planks themselves are separated by small spaces. This may be due to the deterioration of the timber.

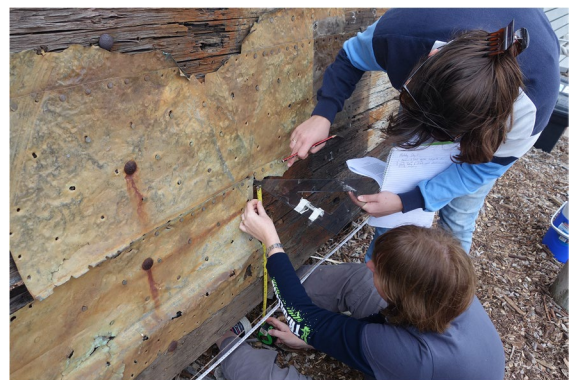
Fig. 6 Lauren Davison and Peta Fray recording hull remains at QEP using baseline-offset measurements. (Photo by Mark Polzer, 2014.)

Two individual frames and an intact section containing frames, outer planking, ceiling, and a caprail were recorded at the Tugun depot. A small intact section of hull, with frames, planking, and a wale, was recorded at QEP (Figs. 5, 6). A sculpture at the GCHHS, relocated from Coolangatta airport when the runway was extended (Department of Environment and Science, Queensland 2014, pers. comm.), included 10 timber elements—planking and frames—from Shipwreck X (Figs. 7, 8). The recording team first photographed the artwork in detail before disassembling it, which allowed them to access the ship

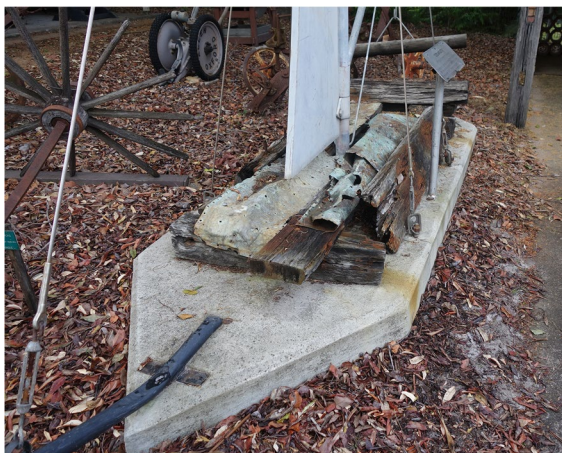
Fig. 7 Sculpture made of loose ship timbers and sheathing from Shipwreck X, GCHHS, Surfers Paradise. (Photo by Wendy van Duivenvoorde, 2014.)

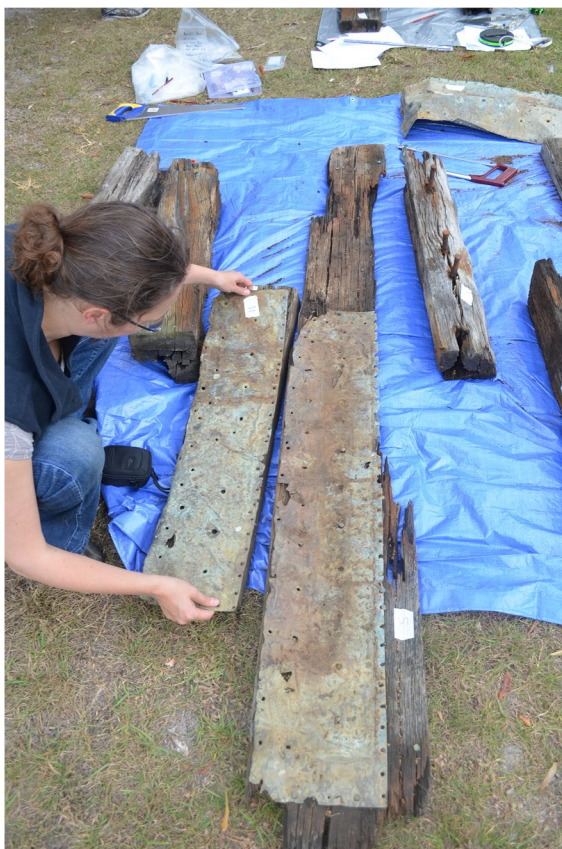
Fig. 8 Timbers from the sculpture ready for recording, GCHHS, Surfers Paradise. (Photo by Kate Greenwood, 2014.)

components for recording and then reassemble the installation to its initial form.

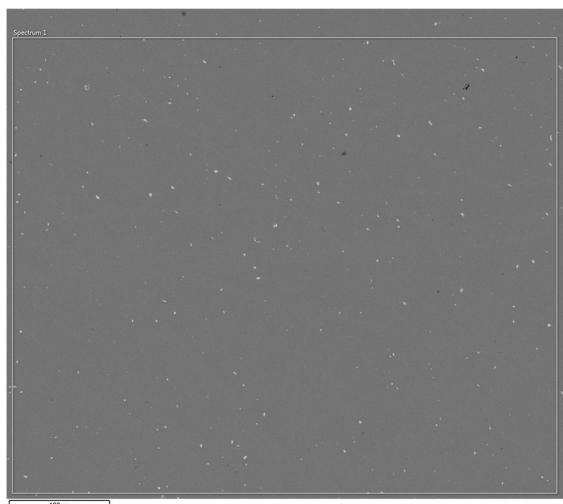
Fig. 9 Micrograph showing sheathing area analyzed (with the white-lined box labeled Spectrum 1) (Sample 3). White specs in micrographs are lead inclusions. (Micrograph by Wendy van Duivenvoorde, 2021.)

The application of the FEI Quanta 450 with SDD EDS detector provides a semiquantitative analytical method of elemental composition by area or spot testing. The area or spot sizes analyzed for the samples prepared in this study measured approximately 300 × 300 μm to 3 × 3 mm (Figs. 9, 10, 11). This

corrosion (Fig. 9). The time of analysis per sample was automated—the Quanta 450 takes about 10 sec. to get a reliable elemental composition.

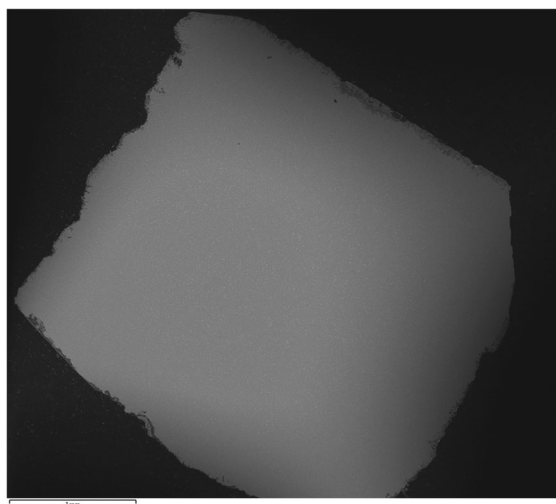
Fig. 11 Micrograph showing cross section of tack shaft (Sample 2). (Micrograph by Wendy van Duivenvoorde, 2021.)

sheathing tacks were analyzed in their entirety. Such fasteners, when embedded in resin, display the entire cross-sectional surface of their shafts (in this case these sections measure ca. 3×3 mm) (Fig. 11), and it is possible to capture this entire area for elemental determination—the areas chosen for analyses display solid metal and are relatively free of any surface

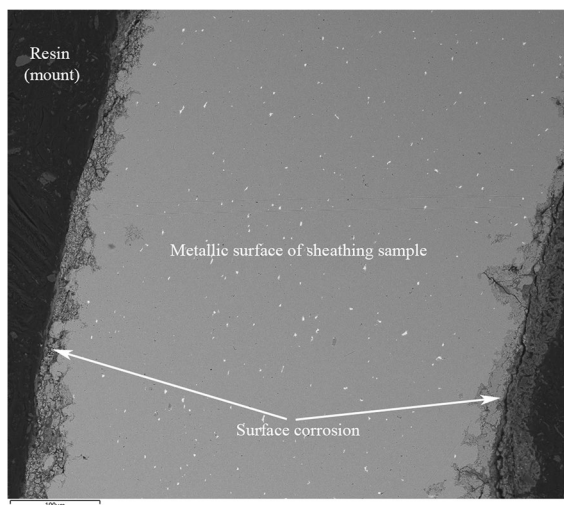
Fig. 10 Micrograph showing cross section of sheathing fragment (Sample 7), showing surface corrosion on the edges and metallic surface of the sample. (Micrograph by Wendy van Duivenvoorde, 2021.)

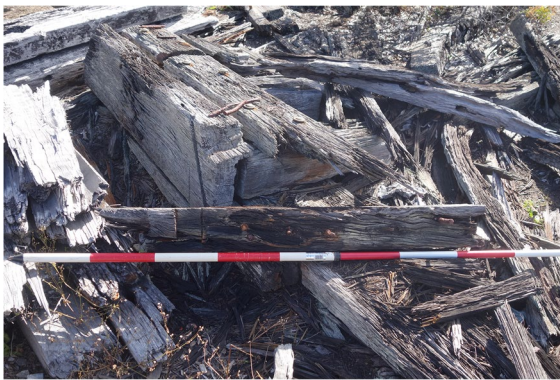
Fig. 12 Ship timbers at GCCC depot. (Photo by Lauren Davison, 2014.)

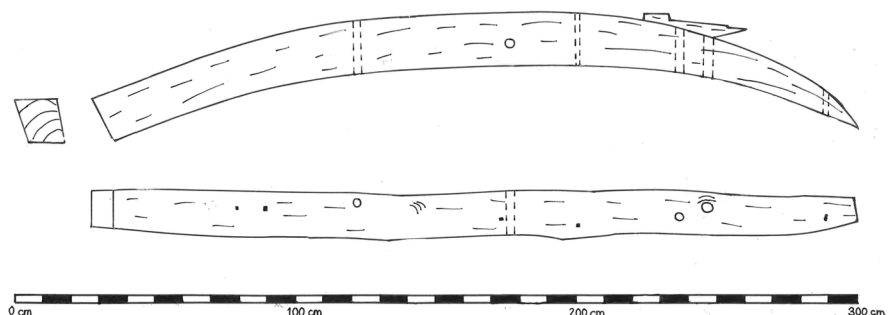
Fig. 13 Schematic drawing of GCCC F2. (Drawing by Lauren Davison and Wendy van Duivenvoorde, 2022.)

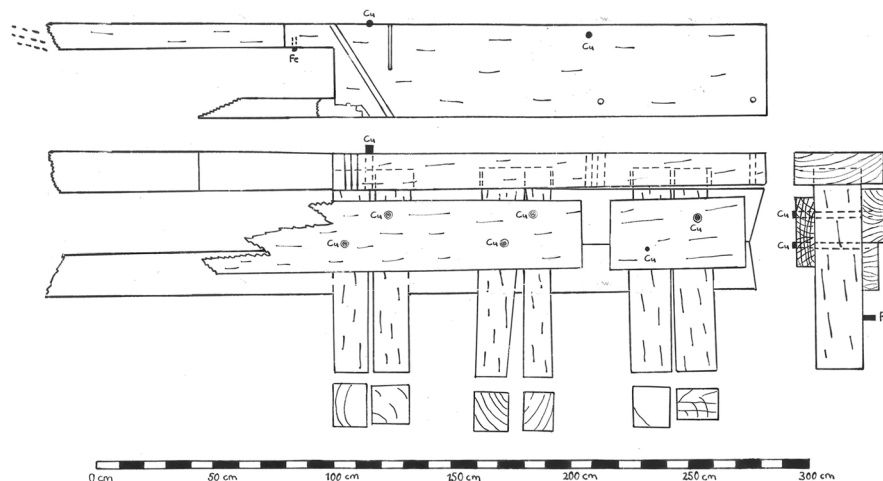
Fig. 14 Schematic drawing of intact section with double framing, two hull planks, one ceiling plank, and caprail at GCCC depot. (Drawing by Lauren Davison, Brad Guadagnin, and Wendy van Duivenvoorde, 2022.)

The ceiling plank is 230 cm long by 29.2 cm wide by 7.7 cm thick and attached to the frames using copper alloy bolts approximately 3 cm in diameter with circular washers ranging between 4.5 and 4.8 cm in diameter. A rectangular section, 10.1 cm wide, is missing from the ceiling plank above a fastener hole in the caprail. This may indicate the local souveniring of metal fastenings mentioned in newspaper accounts

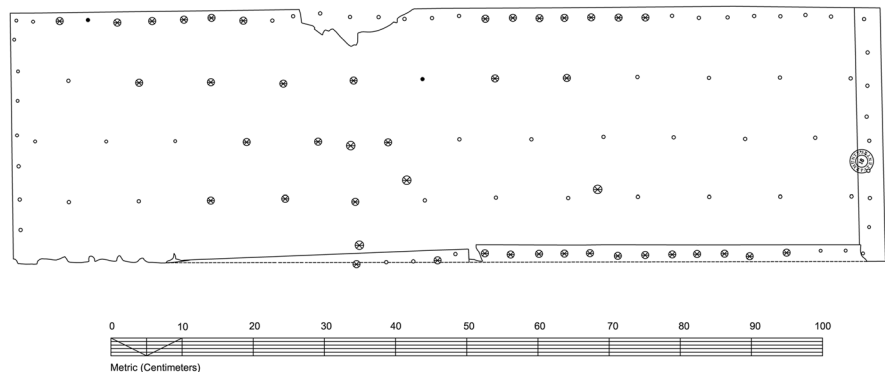
Fig. 15 Illustration of intact Muntz-metal sheet on ship’s remains on display at QEP in Coolangatta. (Drawing by Mark Polzer, Dana Gilmore, and Wendy van Duivenvoorde, 2022.)

The complete sheet of Muntz-metal from Shipwreck X has the standard British dimensions of 48 × 14 in. typically seen in colonial-built vessels in the Americas and Australia (Ronnberg 1980:128;

Villalobos 2020:95). The sheet was mechanically punched with three rows of nails in a diagonal pattern at 60°, requiring 36 tacks, each row was spaced 8.5 cm apart, and holes were spaced 10 cm from center to center. The other fragments of sheathing from Shipwreck X also have three rows of mechanically punched holes for the sheathing tacks,

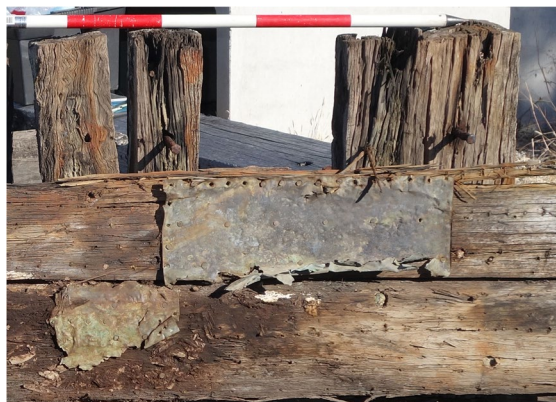
Fig. 16 Detail of intact section showing double framing, two hull planks, and preserved Muntz-metal sheets at GCCC depot (remains are photographed upside down; the caprail is attached to the bottom of this assembly and not visible in photo). (Photo by Lauren Davison, 2014.)

Fourteen complete or fragmentary sheets of Muntz's metal patented sheathing survive on the remains of Shipwreck X. The remnants of three sheets were observed at the GCCC depot, two still attached to the hull planking (Fig. 16). The third piece was found detached below the ship remains and was fragmented into three segments when moved. The GCHHS contained three sections of sheathing still attached to the timbers, two loose sheets, and a flag constructed from a third fragment (Figs. 7, 8, 17). QEP has five sheets attached to the hull planking—one complete sheet and four fragments (Figs. 5, 15). The complete sheet of Muntz-metal sheathing (QEP S1) is 122 cm (48 in.) long and 35 cm (14 in.) wide. The sheathing fragments measure between 26.7 and 127.2 cm in length and they vary in width from 6 to 35.5 cm. Their thicknesses range from 0.05 to 0.2 cm.

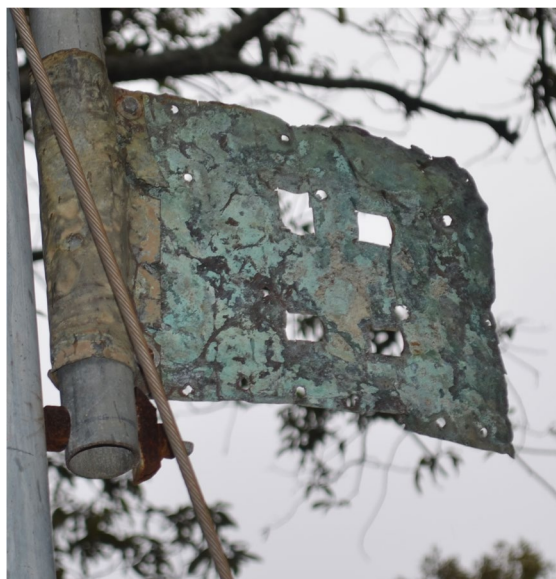
Fig. 17 Muntz-metal sheet turned into a flag on the sculpture from Shipwreck X, GCHHS, Surfers Paradise. (Photo by Kate Greenwood, 2014.)

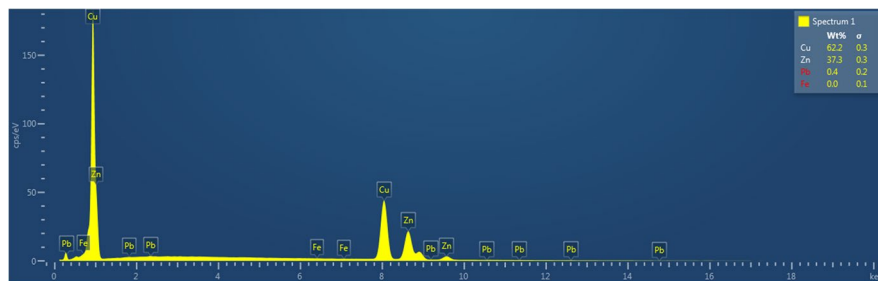
Fig. 18 Spectrum 1 of Shipwreck X, Sample 1 including all trace elements. (Graph by Wendy van Duivenvoorde, 2021.)

The Muntz-metal sheathing from Shipwreck X is an alloy of approximately 62–63 wt% copper, 37–38 wt% zinc (Table 4). The tacks that fastened the sheathing to the hull contain a slightly different alloy. The concentration of copper in the tacks is significantly higher at 81–83 wt%, there is much less zinc at only 15–16 wt%, and there is 3 wt% tin

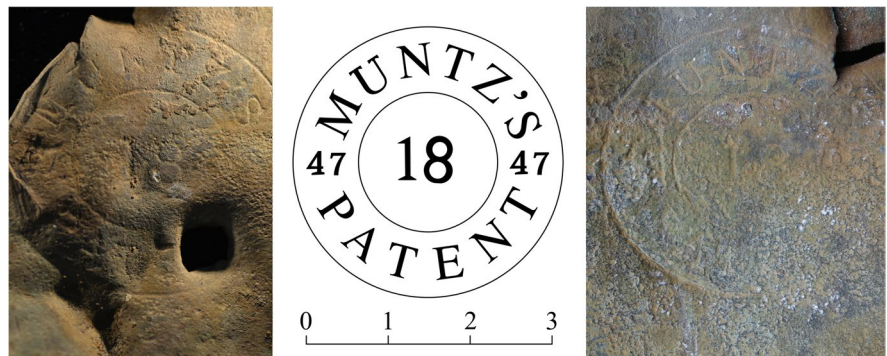
Fig. 19 Muntz’s patent stamps on ship’s hull sheets from QEP (left) and hull plank at GCHHS (P5), Surfers Paradise (right). Scale is in centimeters. (Photos and drawing by Lauren Davison [left] and Wendy van Duivenvoorde [middle, right].)

Investigators observed five Muntz’s patent stamps on the sheathing, two at QEP and three at the GCHHS. All are located near the edges of the sheathing and

The Muntz patent stamps found on Shipwreck X’s sheathing are closest in appearance to the one found on *Edwin Fox*. The only difference is the small unidentified number on its side, which reads “45” for *Edwin Fox* and “47” for Shipwreck X (Bennett, this issue). The sheathing found on *Edwin Fox* today could date to 1869 when the ship was remetaled “from its wales down” during repairs in London, or to 1885 when its yellow metal sheathing was repaired and the vessel converted to a meat freezer in Dunedin, New Zealand (Costley 2014:97,148; Bennett 2021:274).
