High-Voltage Safety Improvement Design for Electric Vehicle in Rear Impact

Abstract

High voltage safety is very important for electric vehicles, how to ensure the passengers' safety in traffic accidents is an important research subject. This paper describes a study of the high-voltage safety of an electric vehicle under rear impact conditions to ensure that it is in accordance with Chinese regulations. The high-voltage safety has been analyzed and optimized from several perspectives and includes the development of a high-voltage cutoff strategy, assessment of the integrity of the high-voltage components after the crash, the layout of the high-voltage and low-voltage cables, and the crashworthiness of the structure. This study resolved the high-voltage safety problems that were found in the design phase and thus ensured that the vehicle not only meets the requirements of the Chinese regulations, but also meets the high-voltage safety requirements of US Federal Motor Vehicle Safety Standard (FMVSS) 305 for 80 km/h rear impact.

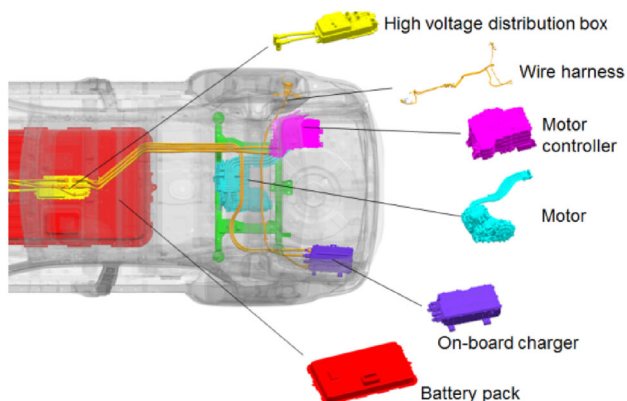
The rear part of a typical electric vehicle body is equipped with a large number of high-voltage (HV) components, including the battery pack, the HV distribution box, the wire harness, the motor controller, the motor, and the on-board charger. Figure 1 shows the HV parts contained in the rear space of vehicle A. Vehicle A is a midsize sport utility vehicle (SUV) with five seats.

Fig. 1 HV parts in the rear space of vehicle A

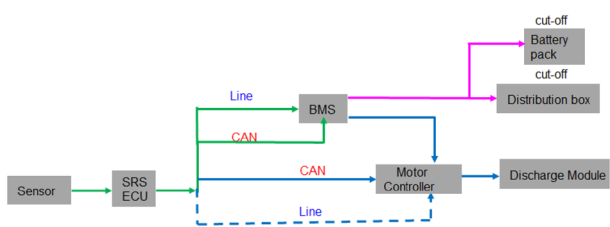
When the rear impact occurs, the impact sensor transmits an impact alarm signal to the SRS ECU through a hard line. After the SRS ECU receives the impact signal, it determines whether the impact signal reaches the required threshold; if the answer is yes, then the SRS ECU sends an alarm sig-

Fig. 3 Schematic illustrating HV cutoff and discharge theory

nal to the battery management system (BMS) and the motor controller.

The SRS ECU can send the alarm signal to the front motor controller in two forms, via a pulse width modulation (PWM) signal and using the controller area network (CAN); however, the alarm signal is sent to the motor controllers in CAN form only. When the front and rear motor controllers receive their cutoff signals from the BMS, they would cut off the high-voltage supplied by the battery pack. In addition, at the time when they received their impact signals from SRS ECU, they would also reduce their own operating voltages immediately.

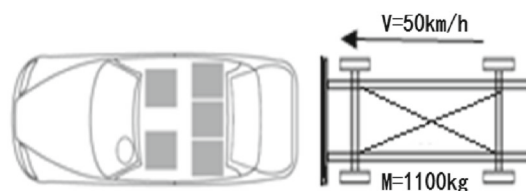
Fig. 5 50 km/h rear impact test conditions

To provide a more in-depth understanding of the cutoff behavior of the HV parts and the discharge performance of the vehicle under actual impact conditions, three rear impact tests were arranged. In these tests, vehicle A was subject to 50 km/h and 80 km/h rear impacts, while vehicle B was subject to a 50 km/h rear impact. The 50 km/h rear impact preparation and tests were carried out with reference to the GB 20072 standard, and the 80 km/h rear impact preparation and test were carried out with reference to FMVSS 305. The tests are illustrated schematically in Figs. 5 and 6.

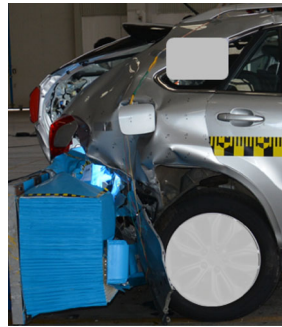
After the impact tests, the complete resulting deformations of the three vehicles were as shown in Figs. 7, 8 and 9.

Fig. 9 Vehicle B: 50 km/h rear impact

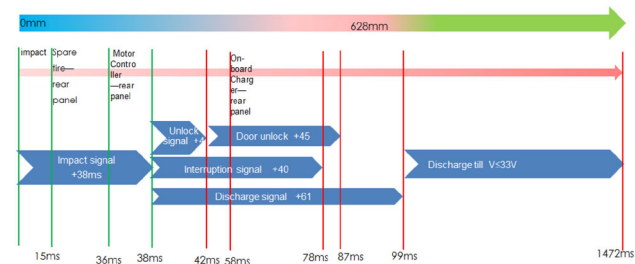
After analysis of the signals from the three tests, the deformations of each vehicle with respect to the signal time were obtained; the results corresponding to Figs. 7, 8 and 9 are shown in Figs. 10, 11 and 12, respectively.

Fig. 11 80 km/h rear impact results for vehicle A

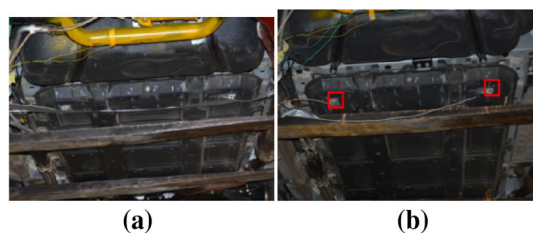
Fig. 13 States of the battery pack **a** pretest and **b** posttest

The maximum body (B pillar) acceleration was approximately 18 g and that of the battery pack was 18.9 g, so the battery pack showed almost no extrusion deformation. The states of the battery pack before and after the test are shown in Fig. 13, in which the red boxes indicate the acceleration sensors. The acceleration curves of the battery pack are shown in Fig. 14.

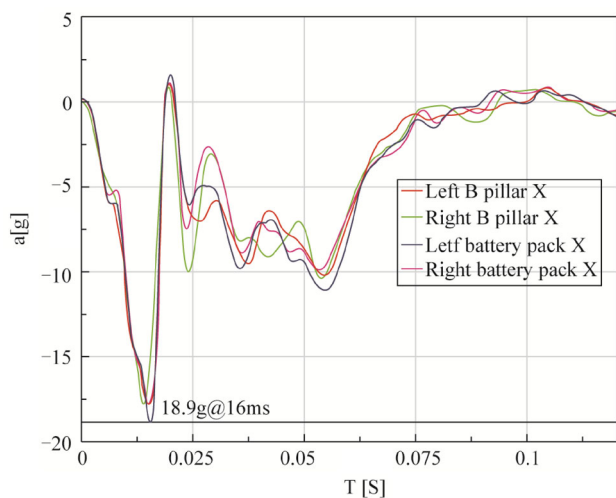
Fig. 14 Battery pack acceleration characteristics

values mentioned above from representing the impact acceleration of a single point, accelerometer sensors were placed on both sides of the battery pack during the test. However, the actual test results showed that the accelerations on the two sides were not very different. Because the battery pack was not squeezed, the accelerations of the ends of the battery pack were basically the same as the acceleration of the entire vehicle.

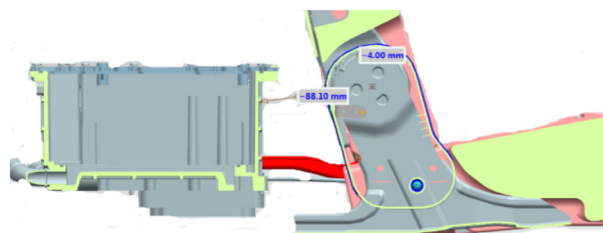
The motor controller was located between the rear panel and the seat, and the space between the motor controller and the rear panel was very small, as was the space between the motor controller and the seat. After the impact, the motor controller struck the hinged plate of seat and as a result, a hole was formed in the motor controller housing. If the housing shell fragments dropped onto the internal copper wires, this could

Fig. 15 Relative positions of motor controller and seat

cause an HV leakage and represent a fire risk. The relative positions of the motor controller and the seat are shown in Fig. 15. The simulation of the contact area between the motor controller and the hinged plate of the seat is illustrated in Fig. 16. The results of testing of the contact area between the motor controller and the hinged plate of the seat are shown in Fig. 17.

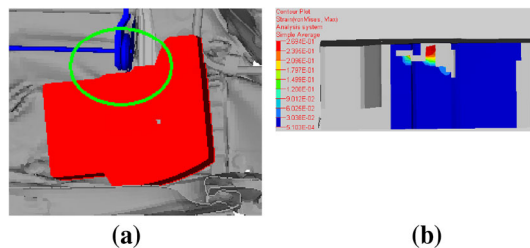
Fig. 16 Simulation of contact area between motor controller and seat

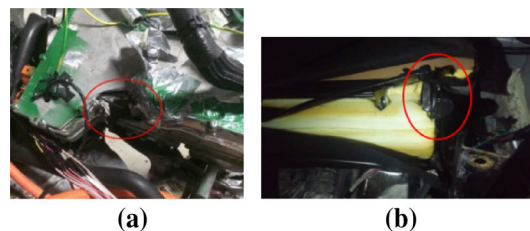
Fig. 17 Results of testing of the contact area between motor controller and seat. **a** Damaged area of motor controller. **b** Hinged plate of seat

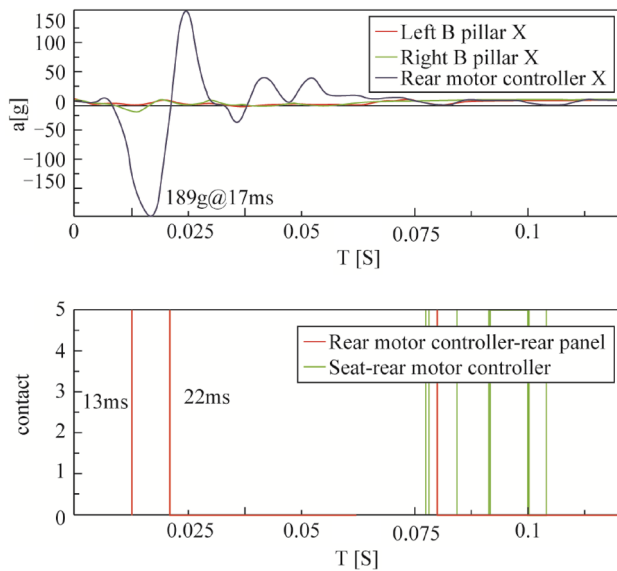
The maximum body (B pillar) acceleration was approximately 18 g, while that of the motor controller was 198 g, as shown in Fig. 18. The acceleration of the motor controller was approximately 10 times that of the body. This showed that the motor controller was pressed severely by the rear panel and the seat. At a time of approximately 13 ms, the rear panel of the body started to make contact with the motor controller, and the motor controller then contacted the seat at approximately 22 ms. The contact time curve is shown in Fig. 18 in the form of a voltage signal curve; initially, the voltage was 0 V, but when the motor controller made contact with another part of the vehicle, the voltage rose.

Analysis of the damage area contact time curve and the acceleration curve indicated that, at the time of 22 ms, the motor controller made contact with the hinged plate of the

Fig. 18 Acceleration and contact time results of the motor controller

seat; at this moment, the velocity of the motor controller reached a maximum, and the motor controller started to be pressed strongly by both the rear panel and the seat. At the time of approximately 30 ms, the acceleration changed to 0 because the housing was damaged by the formation of a hole, as indicated by Fig. 19, which shows a voltage signal curve where the voltage was initially 0 V and then rose when the motor controller made contact with another part of the vehicle.

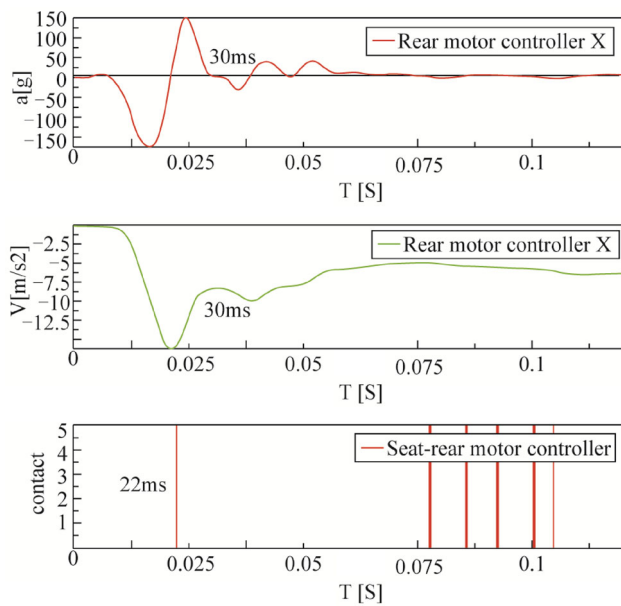
Fig. 19 Time characteristic showing when the motor controller was damaged

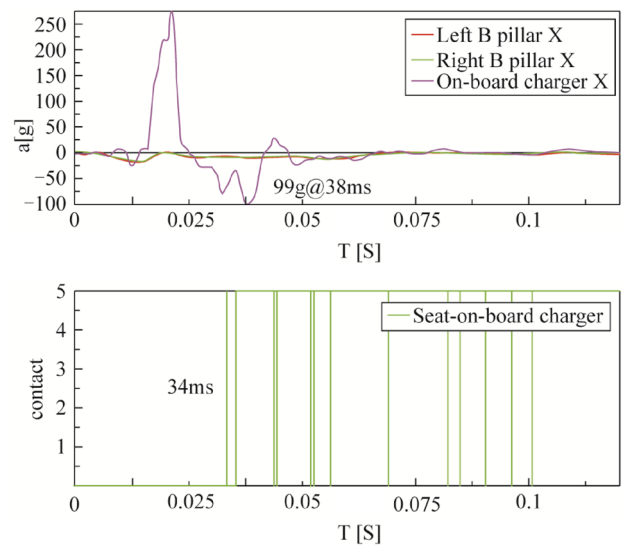
The on-board charger is packaged within the left side of the luggage compartment and is located between the rear panel and seat; the spaces between the on-board charger and the rear panel and between the on-board charger and the seat were both very small. The curve shown in Fig. 20 indicated that the on-board charger started to make contact with the seat at approximately 34 ms. After the crash, the on-board charger was struck severely by the hinged plate of the seat, but was not damaged. The maximum on-board charger acceleration was 99 g, which was much larger than the body acceleration of 18 g, indicating that the on-board charger was struck violently during the impact. The contact time between the on-board charger and the seat and the on-board charger acceleration are shown in Fig. 20 in the form of a voltage signal curve, where the voltage was initially 0 V, but the voltage rose when the motor controller made contact with another part of the vehicle. The state of the on-board charger after testing is shown in Fig. 21a, and the simulated state of the charger is shown in Fig. 21b.

Fig. 20 On-board charger acceleration and contact time

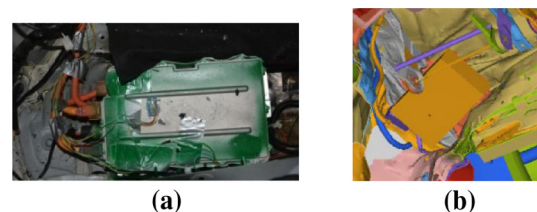
Fig. 21 On-board charger posttest and simulated states. a On-board charger after testing. b On-board charger simulation

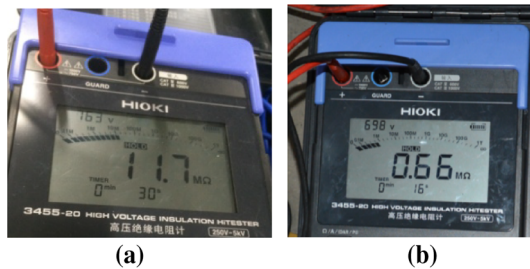
The HV electric leakage was monitored before and after the test. The resistance results are shown in Fig. 22, and the pretest and posttest insulation resistance values are listed in Table 5. Figure 22 shows the resistance values that were measured between the electric chassis and the HV storage/charger.

Fig. 22 Resistance measurement results. **a** Resistance measured pretest. **b** Resistance measured posttest

Before the test was performed, the voltage was 763 V, and the resistance was 11.7 MΩ; after the test, the voltage changed to 698 V, and the insulation resistance dropped to 0.66 MΩ. The insulation resistance thus varies greatly before and after the test, which indicates that there may be a serious leakage.

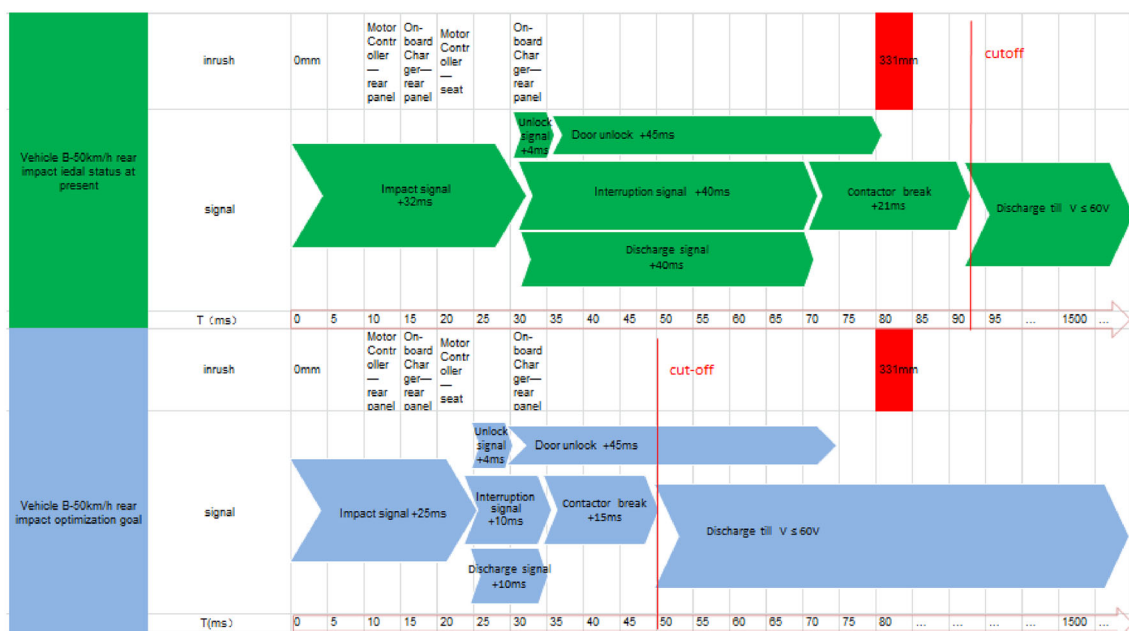
HV cutoff control signals, ideal conditions were obtained that indicated that the best time for the HV cutoff level in the ideal state was 93 ms. However, by this time, the invasion of the car body had already reached the maximum distance of 331 mm, and the motor controller had already broken at 30 ms. Therefore, in the ideal state, the HV cutoff control signal could not meet the safety requirements and it is thus necessary to optimize the HV cutoff control signal.

After the preliminary analysis and theoretical calculations were combined with the optimal design for the body structure, it was determined that if the main contactor broke at 50 ms or so, it may then meet the HV safety requirements. To realize the target value of the 50 ms cutoff, the signal processing logic requirements for each of the modules were as shown below:

Fig. 23 Control signal transmission times

1. Shorten the impact signal time;
2. Optimize the CAN message processing time;
3. Shorten the impact signal processing time;
4. Optimize the contactor breaking time;
5. Add a line for control signal transmission.

The ideal state of the HV cutoff control signal transmission time and the optimized signal transmission time is shown in Fig. 23.

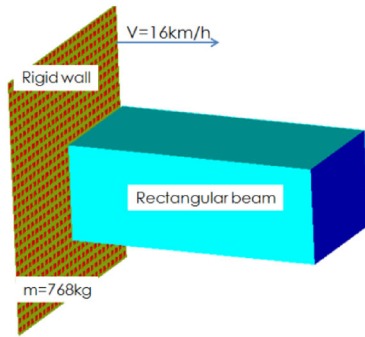
Fig. 24 Simple CAE crash model

To verify the accuracy of the above theoretical deduction, a simplified numerical simulation was performed [15, 16]. A rigid barrier with a mass of 768 kg crushed a rectangular beam at a speed of 16 km/h. The sectional parameters of the rectangular section beams were 60 × 80 mm, the material thickness was 1.65 mm, and the length was 160 mm. The different material parameters used for the rectangular section beams are listed in Table 7. The simple computer-aided engineering (CAE) crash model is shown in Fig. 24.

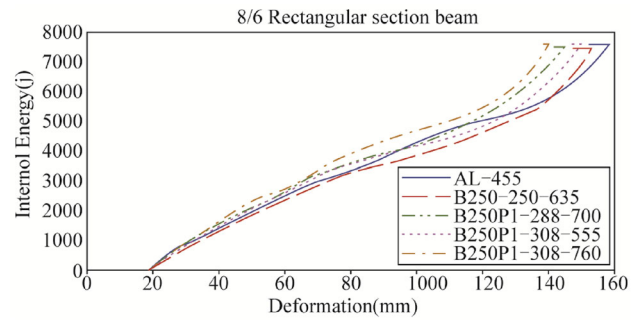
The relationships between the energy absorption and the deformation of the rectangular beams made from the different materials are shown in Fig. 25. The stroke utilization ratio (S_{te}) values of the rectangular beams composed of the different materials are listed in Table 8.

Figure 25 indicates that the kinetic energy of the rigid barrier was basically transformed into the internal energy of the rectangular section beam. The S_{te} results listed in Table 8 reflect the amount of cross section deformation that occurs in the different materials when they absorb the same energy. The

Fig. 25 Internal energy and deformation of the rectangular beams

overall trend for the stroke utilization ratio of these materials with the same cross section is as follows: higher material strength corresponds to a lower stroke utilization ratio [17]. These results proved that, because both E_k and A remain unchanged, when σ_{\max} is increased, then S will decrease accordingly.

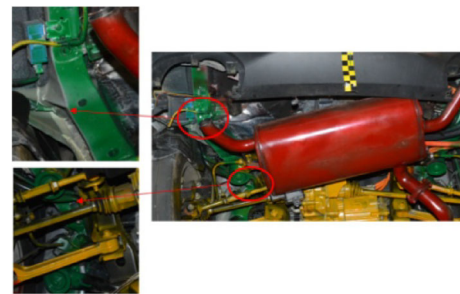
Fig. 26 Posttest deformation of rear longitudinal beam

The deformation results from vehicle testing and simulations were compared and analyzed, and an optimization scheme was proposed. The test and simulation results for the deformation of the rear longitudinal beam are shown in Figs. 26 and 27, respectively. Comparison of the test and simulation results showed that two regions in the rear longitudinal beam were relatively weak, and the deformation in these regions was obvious. The structures of these regions must therefore be optimized. The rear longitudinal beam was thus optimized based on the theoretical analysis and a simplification of the simulation results.

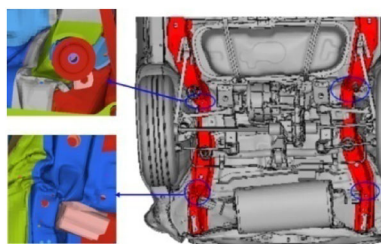
Fig. 27 Deformation of rear longitudinal beam determined by simulation

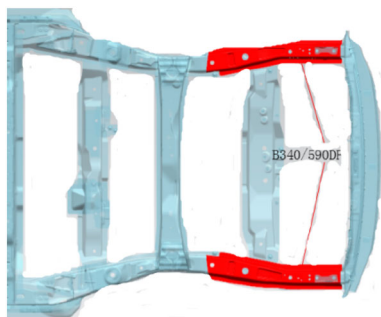
Fig. 28 Structural optimization of rear longitudinal beam

The optimization of the rear longitudinal beam involved changing the material from B250 to B340, which could effectively improve the energy absorption ability of the rear longitudinal beam; the optimization is illustrated in Fig. 28.

The test and simulation analysis results for vehicle deformation before and after the optimization of the longitudinal beam are listed in Table 9. The results show that after the material was changed from B250 to B340, the deformation of the vehicle body decreased significantly.

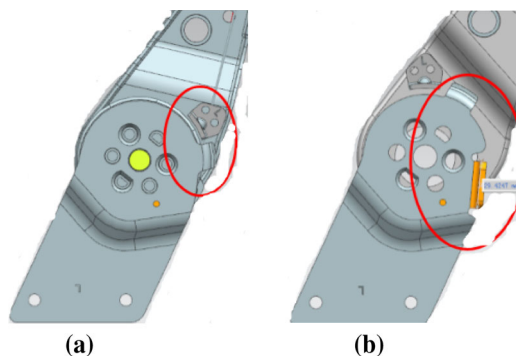
Because the motor controller was pushed by both the rear panel and the hinged plate of the seat, and the resulting stress was beyond the allowable stresses of both the structure and the material, the housing of the motor controller was damaged and a hole was formed. Here, the design of the hinged plate of the seat was improved by moving the limiting block forward, while the hinged plate outward (*Y* direction) flang-

Fig. 29 Optimization of hinged plate structure. **a** Hinged plate before optimization. **b** Hinged plate after optimization

ing was increased to 15 mm, with flanging in the *Z* direction to increase the length to 30 mm. The hinged plate structures before and after optimization are shown in Fig. 29.

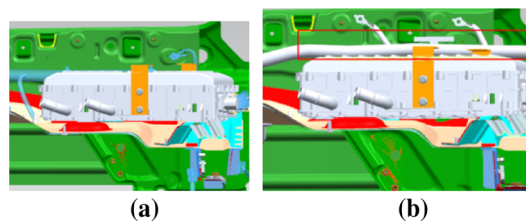
Fig. 34 Positioning of low-voltage wire. a Old position of low-voltage wire. b New position of low-voltage wire

Because the low-voltage wire was arranged along the rear panel and was fully coincident with the on-board charger in the Z direction, if a serious rear impact occurred, then the low-voltage wire risked being compressed or even ruptured by the back panel and the on-board charger. Therefore, it was necessary to rearrange the low-voltage wire positioning. Analysis showed that moving the low-voltage wire up in the Z direction by 25 mm can effectively avoid the failure risk. The old and new positions of the low-voltage wire are shown in Fig. 34.
