# Flexural performance of wire mesh and geotextile-strengthened reinforced concrete beam

## Abstract

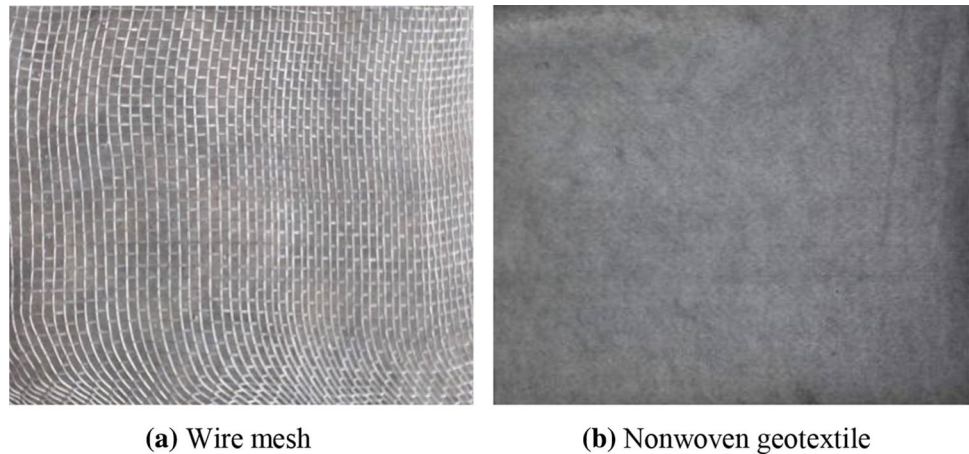
**Fig. 1** Strengthening materials

Nonwoven polypropylene geotextile fabric with pressurized thickness of 1.55 mm was used for strengthening. These geotextiles have maximum 35% elongation and 700 N grab tensile strength. Woven wire mesh was constructed using 1.5-mm-diameter galvanized iron wire with 3 mm square openings. Wire mesh and geotextiles are shown in Fig. 1a, b respectively. RCB strengthening was performed after 28 days of curing of the prepared specimen for flexural testing. Geotextile and wire mesh were applied in three different configurations. The first

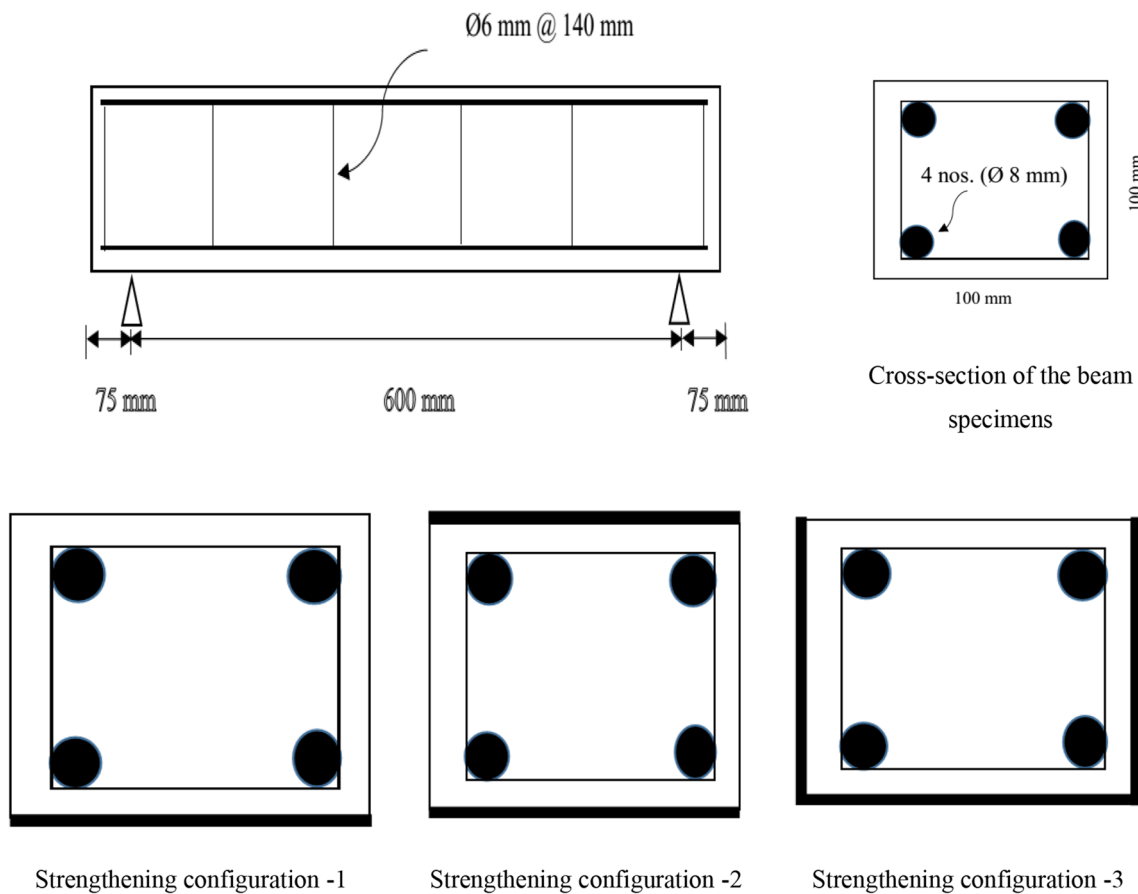
Fig. 2 Strengthening configuration of RCBs

strengthening was performed by applying geotextile or wire mesh along the tension face of the beams using a 10-mm-thick mortar. This mortar was prepared using Portland cement and very fine sand with proportion of 1:2. The second strengthening was performed in tension and compression faces, and the third strengthening was conducted by U-wrapping the beam by the strengthening material. Generally beams were failed due to the flexural and shear cracks under point loadings, where the flexural cracks seen within maximum moment region and propagates towards the upper fibers and the some of the shear cracks started form top of the beam and propagates towards bottom diagonally. For this reason these configurations were selected. Though the second strengthening scheme is not very practical, but in some cases during casting of new beams and the open compression face of beam can be strengthened by using this technique. Specifically, the second scheme was just used for comparison the effectiveness. All the strengthening configurations are shown in Fig. 2.

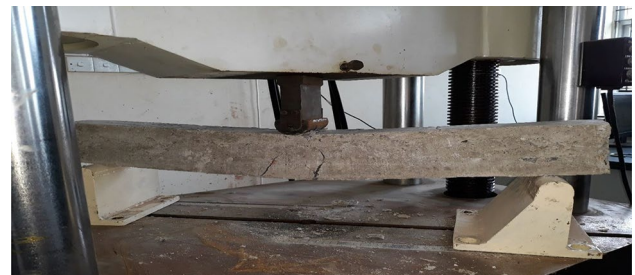
Fig. 4 Increased and widened flexural cracks with load in RCBs

RCB showed ductile behavior under bending action up to a certain limit of deflection. When steel started to yield, cracks started to become visible from the bottom of the beam under one point bending load. Tensile flexural cracks in concrete widen with the increase of load, and the beam could be deflected up to failure in concrete. All the RCBs failed in concrete crushing with steel yield. The cracking patterns and failure of RCB are shown in Figs. 3 and 4. These beams' failure mode can be defined as the flexural failure and showed a good shear resistance. Therefore, flexural strength should be improved to increase the ultimate load capacity under bending action. The flexural strength of the conventional RCB before strengthening was 20.565 MPa (Table 2). The deflection of the beam under point load was 4–5 mm under ultimate loading condition. Wide distribution cracks were found in the load–deflection curve, as shown in Fig. 5. The load–deflection curve clearly showed that the beams underwent wide deflection after concrete crushing because the steel yielded rapidly after ultimate load without load increment. The confinement of concrete with ductile material may enhance the flexural performance of these beams.

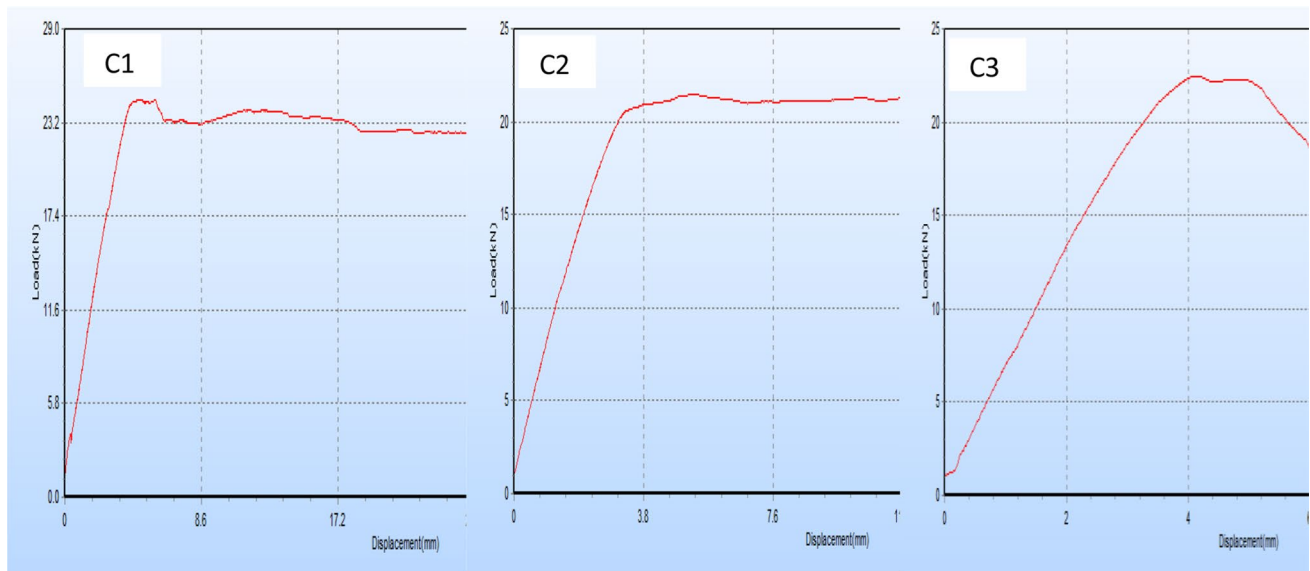
**Fig. 5** Load–deflection curve of control RCBs

Beam type	Specimen ID	Ultimate load (kN)	Ultimate deflection at mid span (mm)	Flexural strength (MPa)	Average flexural strength (MPa)
Control beam	C1	24.6	4.3	22.14	20.565
	C2	21.48	5.32	19.332	
	C3	22.47	4.2	20.223

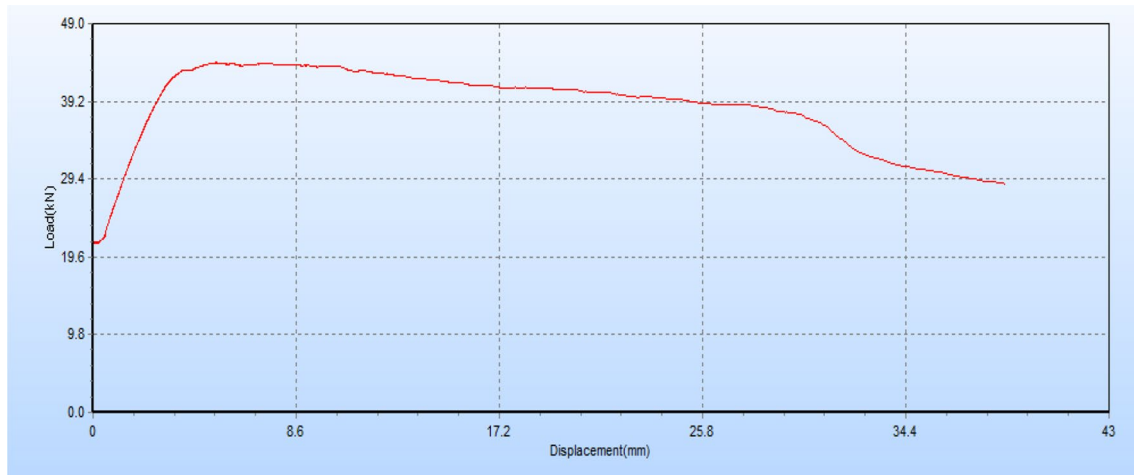
**Fig. 6** Load–deflection curve of W1-type beam

action compared with the two side bonding techniques. Comparison of the control RCBs shows that the wire mesh in the tension face of the beam could resist nearly 80% more load at same deflection level at the beam midpoint. Meanwhile, U-wrapping strengthening could enhance the flexural strength two times more than the control beams. Initially, W1-type beams could resist more vertical deflection than the control beams but failure mode observed as the control beams. As shown in Fig. 6, W1-type beams started to deflect after the load reached at 20 kN;

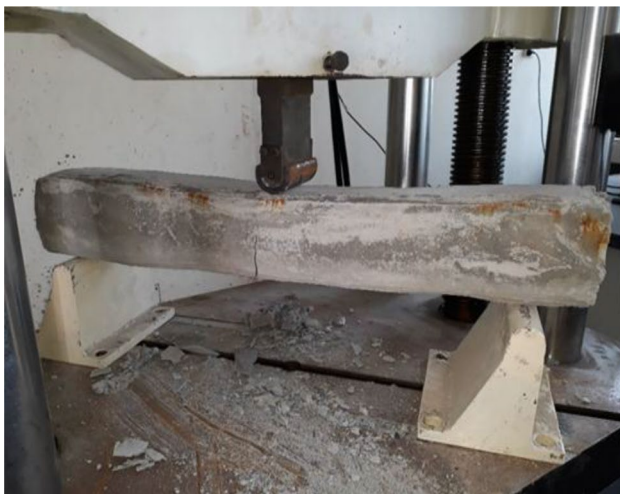
**Fig. 7** Failure mode of W1-type beam

subsequently, minimum deflection was found at peak load also. Failure mode in W1-type and W3-type beam is shown in Fig. 7 and Fig. 8 respectively, in which the post-cracking behavior of the control and the W1-type beams are comparable. Having an extremely thin layer of wire mesh and mortar resulted in failure before concrete cracking reach the ultimate limit and widening of the cracks after fracture in wire mesh occurred. Moreover, yielding of main steel rapidly progressed toward concrete failure. The ductility and ultimate strength of these beams increased with the wire diameter and mortar thickness. However, this result may sometimes cause a negative influence in strengthening performance because premature debonding may arise

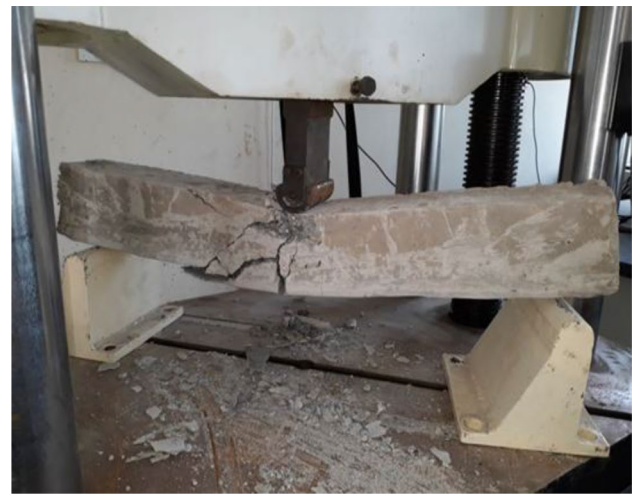
**Fig. 8** Crack pattern in W3-type beam

Meanwhile, in terms of the performance of U-wrapped beams, it was showed a complicated failure mode. Initial flexural cracks were developed at early-stage load, and rapid widening of cracks was evident with the increase of beam deflection. Near-failure debonding started from the top compression face and propagated toward the support. However, one part of the compression face still had a grip in bonding, and no cracks or

signs of debonding were evident up to failure, as shown in Figs. 8 and 10. Therefore, debonding is less dependent on loading condition but highly dependent in bond strength with concrete. Debonding could have started from the weak point and propagated toward the high adverse stressed zone. All the flexural cracks widened immediately after fracture occurred in the wire mesh. Fracture of the wire mesh is comparable to brittle failure in this experiment because of the low thickness of the composite layer. Post-failure deflection of the control and W3-type beams were comparable, and both beams were deflected rapidly with the same load after failure due to steel yielding, as shown in Fig. 11. Therefore, the experimental results confirmed that RCB strengthening using wire mesh is advantageous.

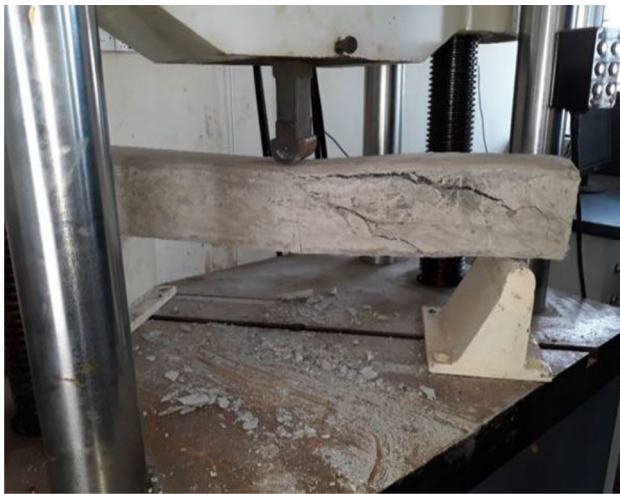
Fig. 9 Debonding failure in W2-type beam

from excessive mortar thickness and improper curing [9]. High-strength mortar can reduce the concrete crack width and limit the deflection and strength capacity, thereby requiring further investigation. In W2-type specimen, force directly applied to the wire mesh layer along the top of beam, which creates a compression in the layer and caused debonding in the compression face. The failure of W2-type specimens in debonding is shown in Fig. 9. When the wire mesh layer started to debond from the compression face of the beam, diagonal cracks sometimes initiated and reached toward the bottom of the beam. This phenomenon may be caused by the porous concrete structure, which may lower the concrete strength; consequently

a low bonding with reinforcing steel and strengthening layer. However, most of the beams failed in debonding before flexural cracks widened. Nevertheless, these beams could carry slightly better load than the control specimen before failure in debonding occurred. For example, one of the W2-type specimen failed at 24.37 kN load at a deflection of 10 mm before debonding occurred.

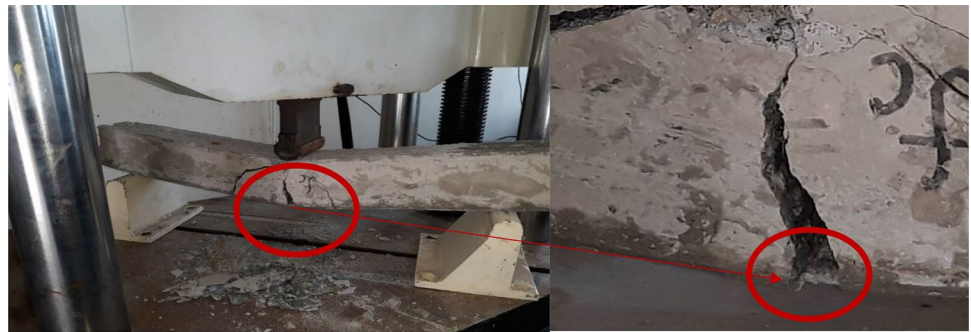
**Fig. 12** Failure pattern of G1 type beam

Nonwoven geotextile-reinforced beams are highly ductile in nature. Geotextile bonding with concrete can sufficiently resist debonding up to concrete crushing. Geotextile strengthened-beam could resist extensive vertical deflection without fracture. High deformability of polypropylene fibers may enhance this behavior. The deformability of this fabric is higher than 30% [21]. A 0–91% increase in ultimate load carrying capacity was found in the experiment, which depended on the arrangement of strengthened layers (Table 4). A slight increase in strength was found in G1-type beam compared with the control beams. However, high deflection in the beam was found for this load. In Fig. 12, after cracks in concrete widened and reached failure, geotextile fabric had still not torn. Therefore, this ductile nature of geotextile could provide grip on concrete even after crushing occurs under loads. Similar results were found after testing G2-type beams. Failure of G2-type beams occurred at an average of 43.71 kN load when deflection of the beam was 12 mm; nevertheless, geotextile did not crack or fracture. This advantageous nature of nonwoven geotextile can decrease the scattering of concrete when crushed under service load.

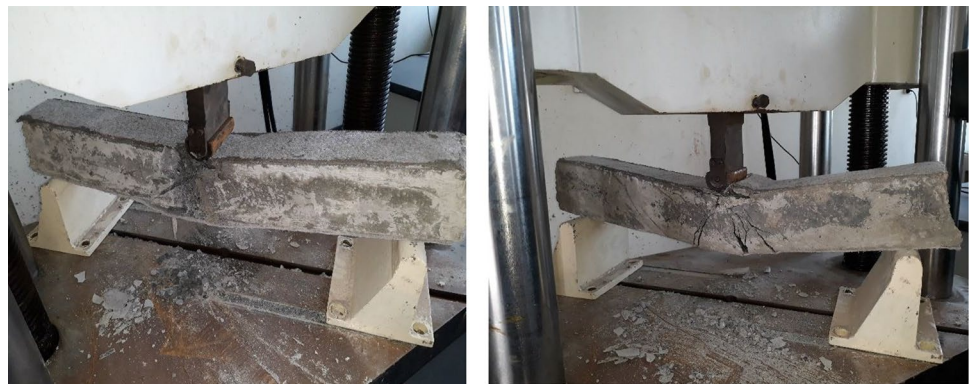
**Fig. 13** Failure pattern of G2 type beam

Meanwhile, G2-type beams were found as most effective in terms of strength gaining properties. However, the analysis of the failure mode of G2-type beams showed that geotextile fabric under load was delaminated from concrete due to slippage (Fig. 13). This result may be caused by the absence of compression capacity of geotextile. The disappointing matter resulted from G3-type beams. These beams failed at a lower load in comparison with G2-type beams but had higher capacity than control beams. The average flexural strength of G3-type strengthened beams was 33.498 MPa. One of the G3-type beams failed in concrete crushing and showed tearing of the geotextile

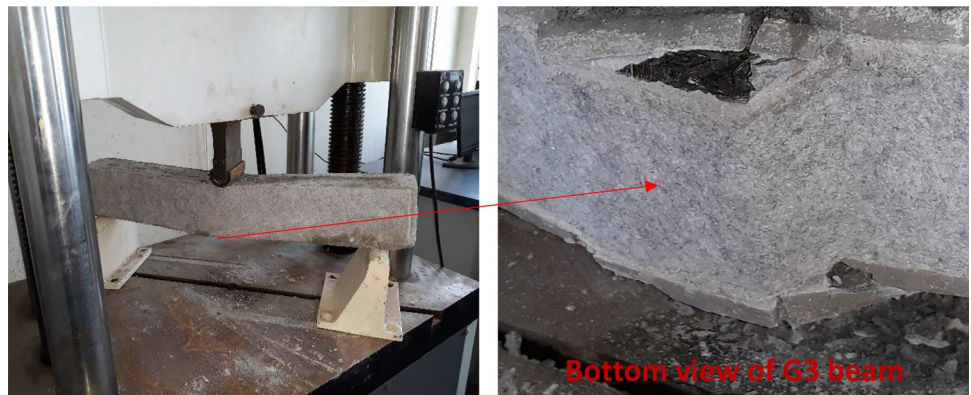
**Fig. 14** Deflection pattern of G3 type beam

fabric along the bottom edges of the beam below the load point. The bonding between concrete and geotextile was assumed to be sufficient in this case. When cracks in

concrete widened with load, geotextile extended up to its limit and tore along the most deflected section (Fig. 14). This occurrence was due to low fabric strength along the

tear line. Nevertheless, the geotextile along the soffit of the beam did not crack even when the beam failed.

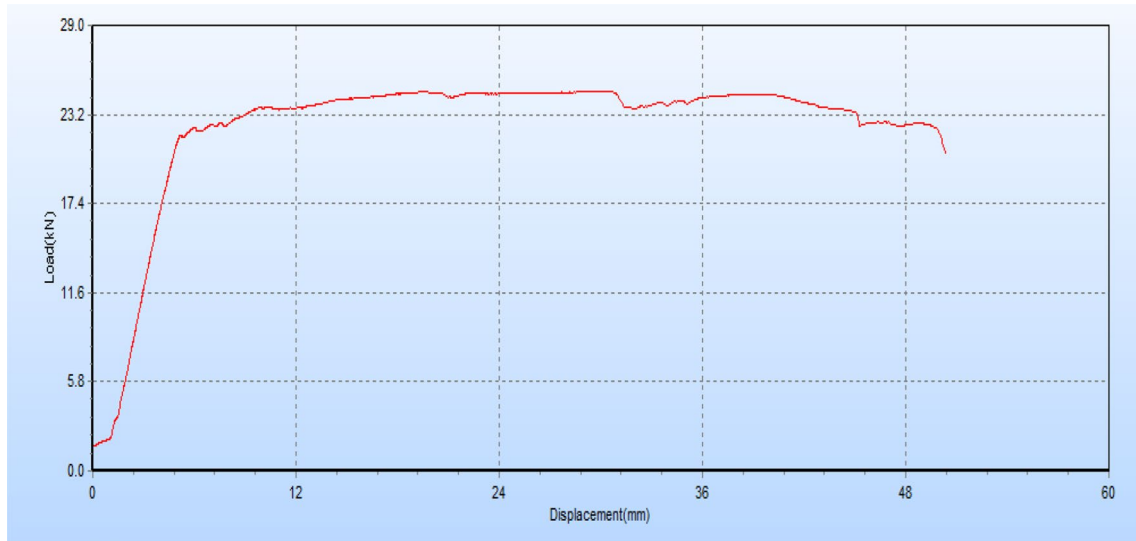
Fig. 15 Load–deflection curve of G1-type beam

and deflection carrying capacity. Wire mesh-strengthened beams were stiffer than those strengthened by geotextile in this experiment. Geotextile-strengthened beam could deflect more than 3–4 times from wire mesh strengthened beam before failure, as shown in Figs. 15, 16 and 17. Therefore, the failure mode of geotextile-strengthened beams could be considered ductile flexural failure, whereas control and wire mesh-strengthened beams' failure was found stiffer and less ductile. Among all the beams, a similarity was observed as their concrete crushed with steel yielding mode. Strength gain was considerably higher in wire
