Case Study

Seismic assessment of existing gravity load-designed RC framed building: a case study from Warangal, India

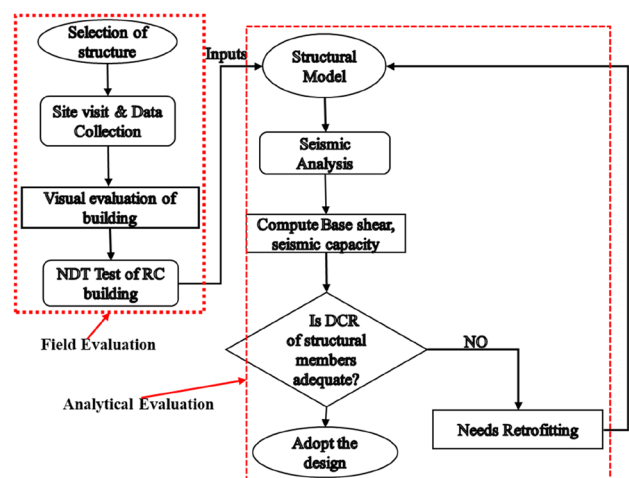
Fig. 1 Methodology of the study

the loads and remain stable. Seismic vulnerability of a structure is usually expressed as a relationship between intensity measure (spectral displacement, spectral velocity or spectral acceleration) and damage measure (various damage states, viz., slight, moderate, extensive and collapse) [5–9]. The overall methodology for seismic resistance assessment evaluation of existing RC building adopted in this work to withstand seismic loads pertaining to zone III requirements is depicted in Fig. 1.

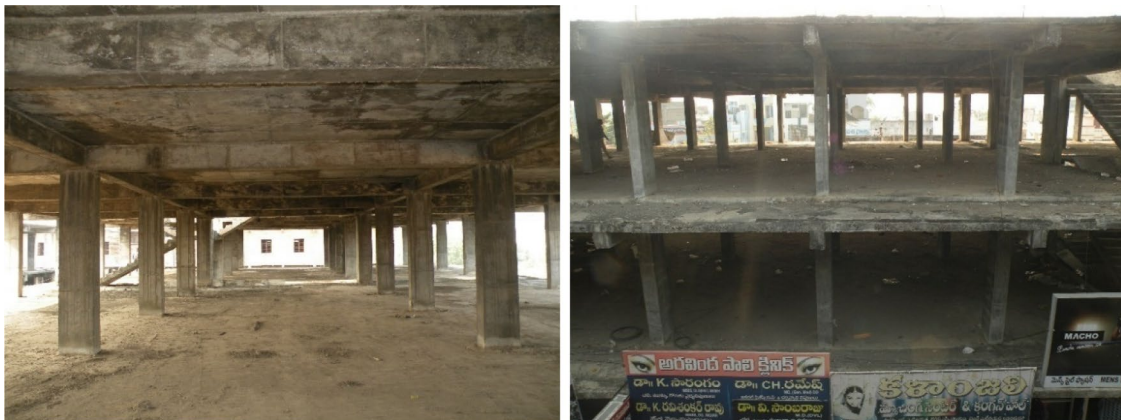
Fig. 2 Photographs of the existing RC frame building

A G+3 story RC building situated in Warangal city, Telangana state, India, as shown in Fig. 2 is selected to understand the seismic resistance capability. The total height of the existing building configuration is 12.8 m with floor height as 3.2 m each for all the stories (G+3). The structural floor plan for the selected building configuration is depicted in Fig. 3. The floor area comprises of $57.2 \text{ m} \times 17.6 \text{ m}$ and consists of five categories of beam sections and six categories of column sections as given in Table 1. This building has been designed and constructed as a gravity load-designed building as per BIS 456 [20], without seismic provisions and is proposed to be extended vertically from existing G+3 to G+5 configuration.

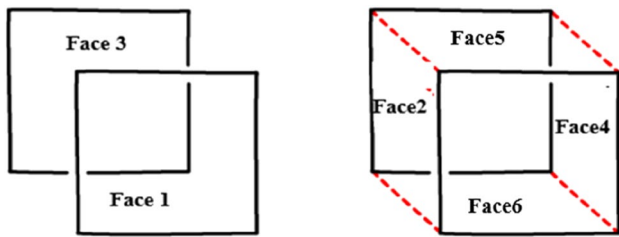
Fig. 4 Schematic representing nondestructive test pattern

The structural model is developed using SAP2000 software [21], for the structural floor plan shown in Fig. 3, and the component details are given in Table 1 prepared as per the structural drawings provided during the field visit. Material properties are updated after visual inspection and nondestructive rebound hammer test performed on all the structural components. Around 1000 data points comprising of all the structural components including beams, columns and slabs have been recorded using rebound hammer to ascertain the compressive strength of the structural components as depicted in schematic shown in Fig. 4 (beams: on Face 1, Face 3, Face 6; columns: on Face 1, Face 2, Face 3 and Face 4; and slabs).

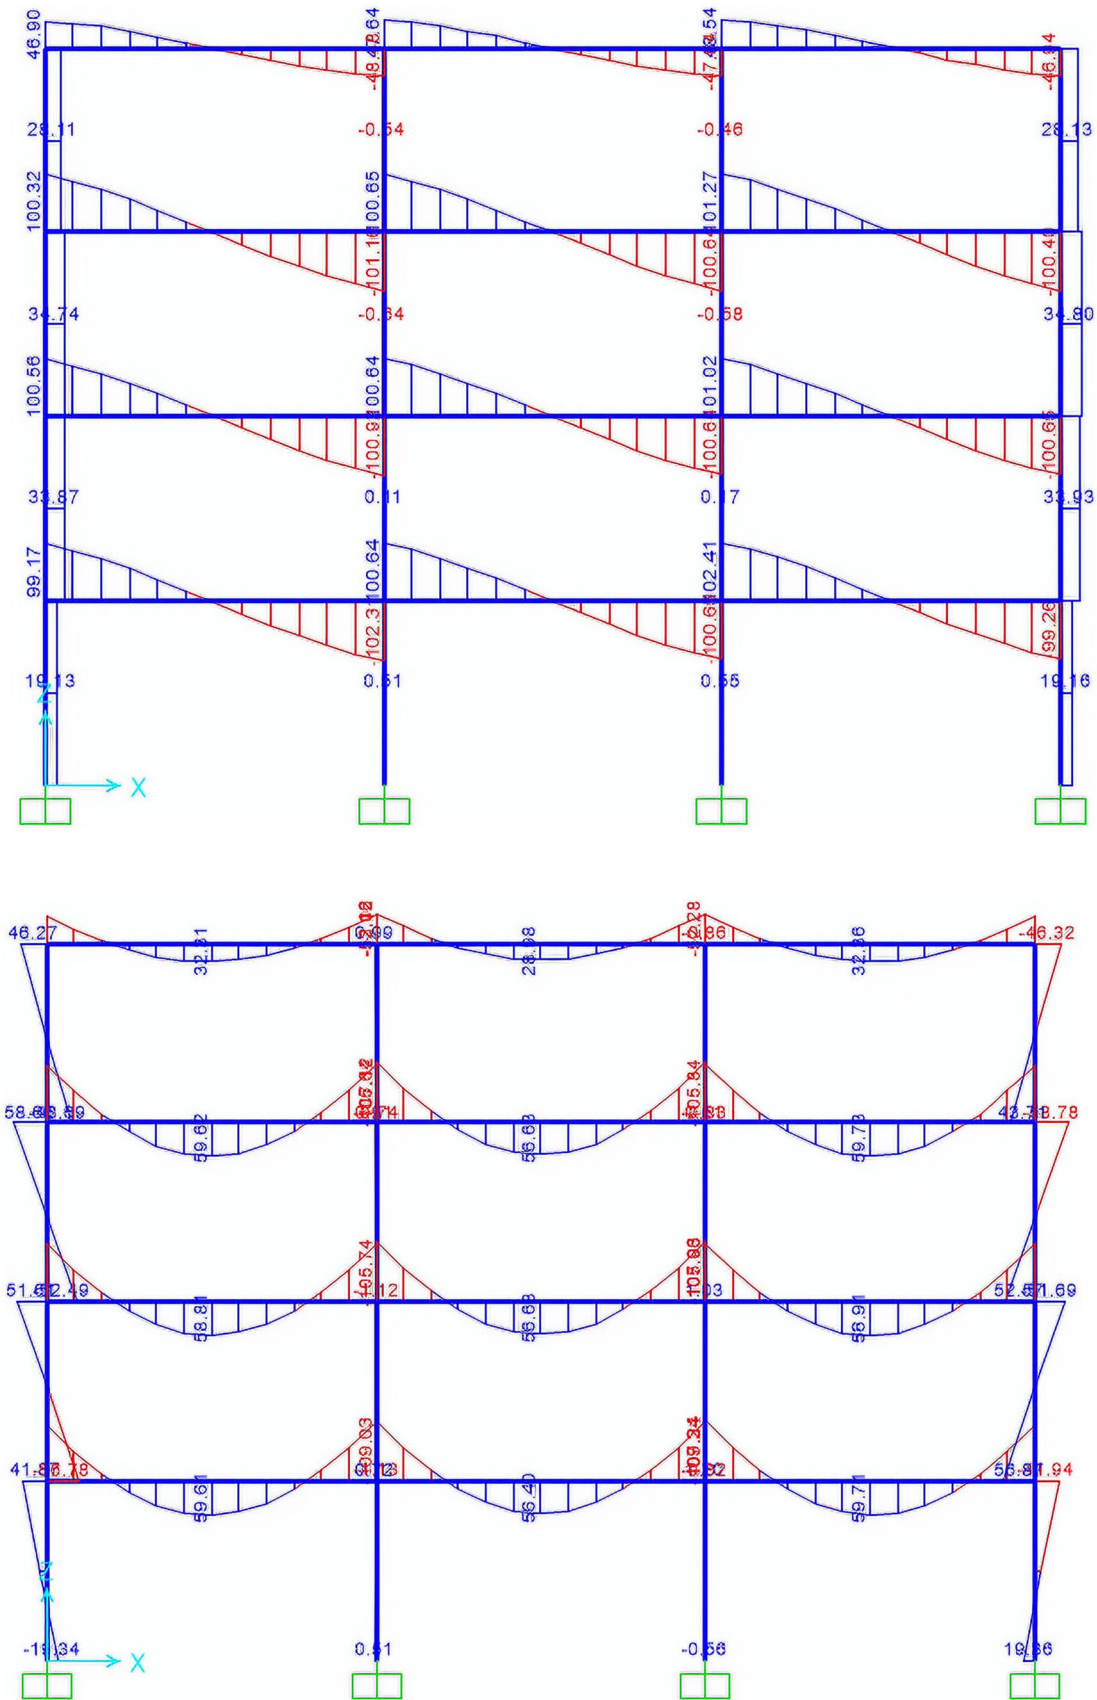
Fig. 7 SFD and BMD of a typical frame in G+3 building for load combination (1.5(DL + EQ)) for zone III

The results corresponding to the outcome of the response spectrum analysis performed on the existing building G+3 building model is shown in Fig. 7. The legend in Fig. 8 describes different damage states of plastic hinges (i.e., IO: immediate occupancy, LS: life safety, CP: collapse prevention, C: collapse) with appropriate labels and colors, as per

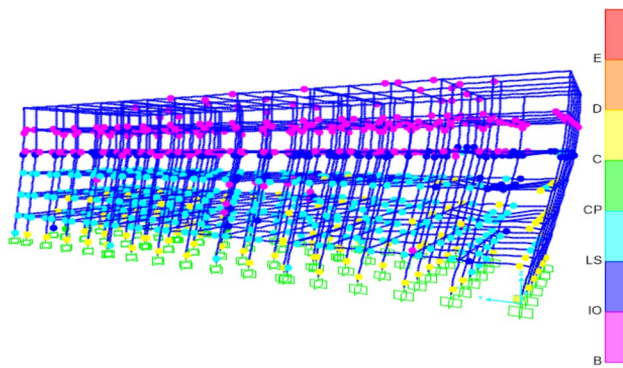
Fig. 8 Plastic hinge formation in the G+3 building model for zone III seismic load

FEMA 356 [22]. It can be observed from the plastic hinge formulation that certain components are in the collapse (C) limit state in Fig. 8. The DCR contour plot indicating the stress levels (0: unstressed to 1: fully stressed) also confirms this observation, as shown in Fig. 9 for load combination 1.5(DL + EQ) in zone III. The components have DCR greater than one which indicates the failure of the member. The total number of components indicated as failed or in collapse limit state for the existing structure and needs retrofiting are presented in Table 3. Further, seismic analysis is again repeated for G+5 storied building considering a load combination of 1.5(DL + EQ) zone III medium soil profile to ascertain its seismic resistance capability of withstanding the additional two stories on the existing structure.

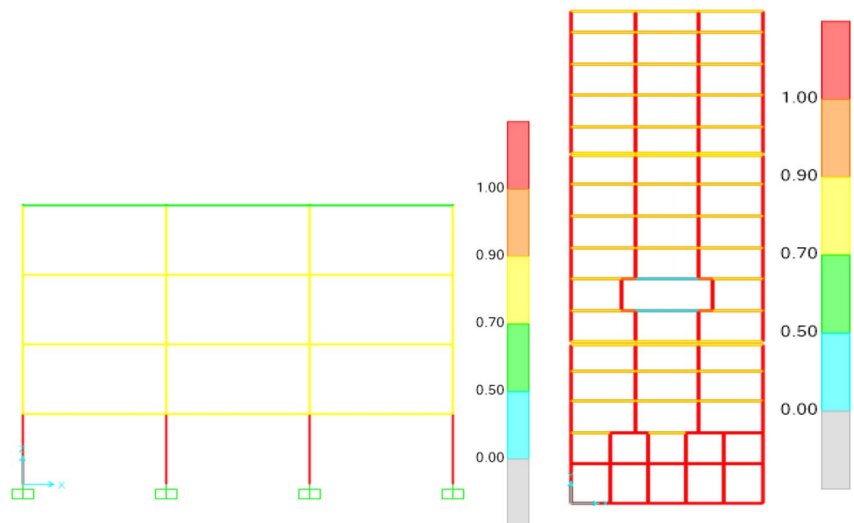
Fig. 9 DCR contour for G+3 building for zone III seismic load in **a** elevation, **b** plan

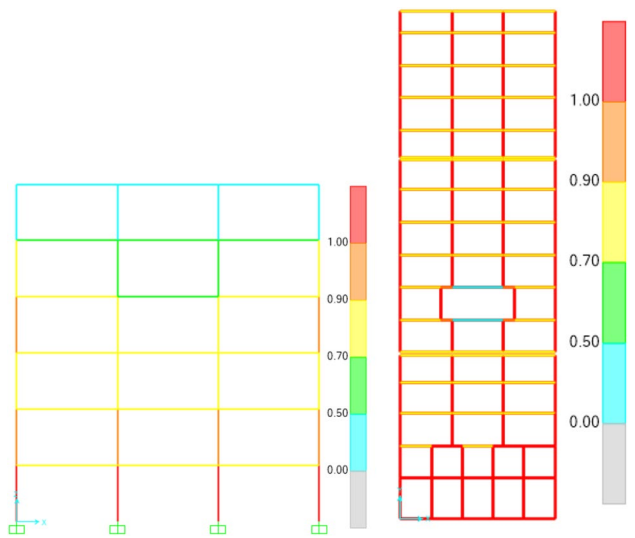
Fig. 11 DCR contour for G+5 building for zone III seismic load before strengthening existing G+3 configuration in **a** elevation, **b** plan

These results are confirmed by checking the DCR ratios of the structural components which can be seen from the results shown in Figs. 10 and 11 (indicating the stress levels (0: unstressed to 1: fully stressed)). From the results, it can be concluded that the structural components that need strengthening/retrofitting to withstand for seismic zone III requirements are present only in the existing G+3 structure. Therefore, the extended portion from G+3 to G+5 appears meeting the design requirements and the existing design shown in Table 1 can be adopted after strengthening the G+3 building.

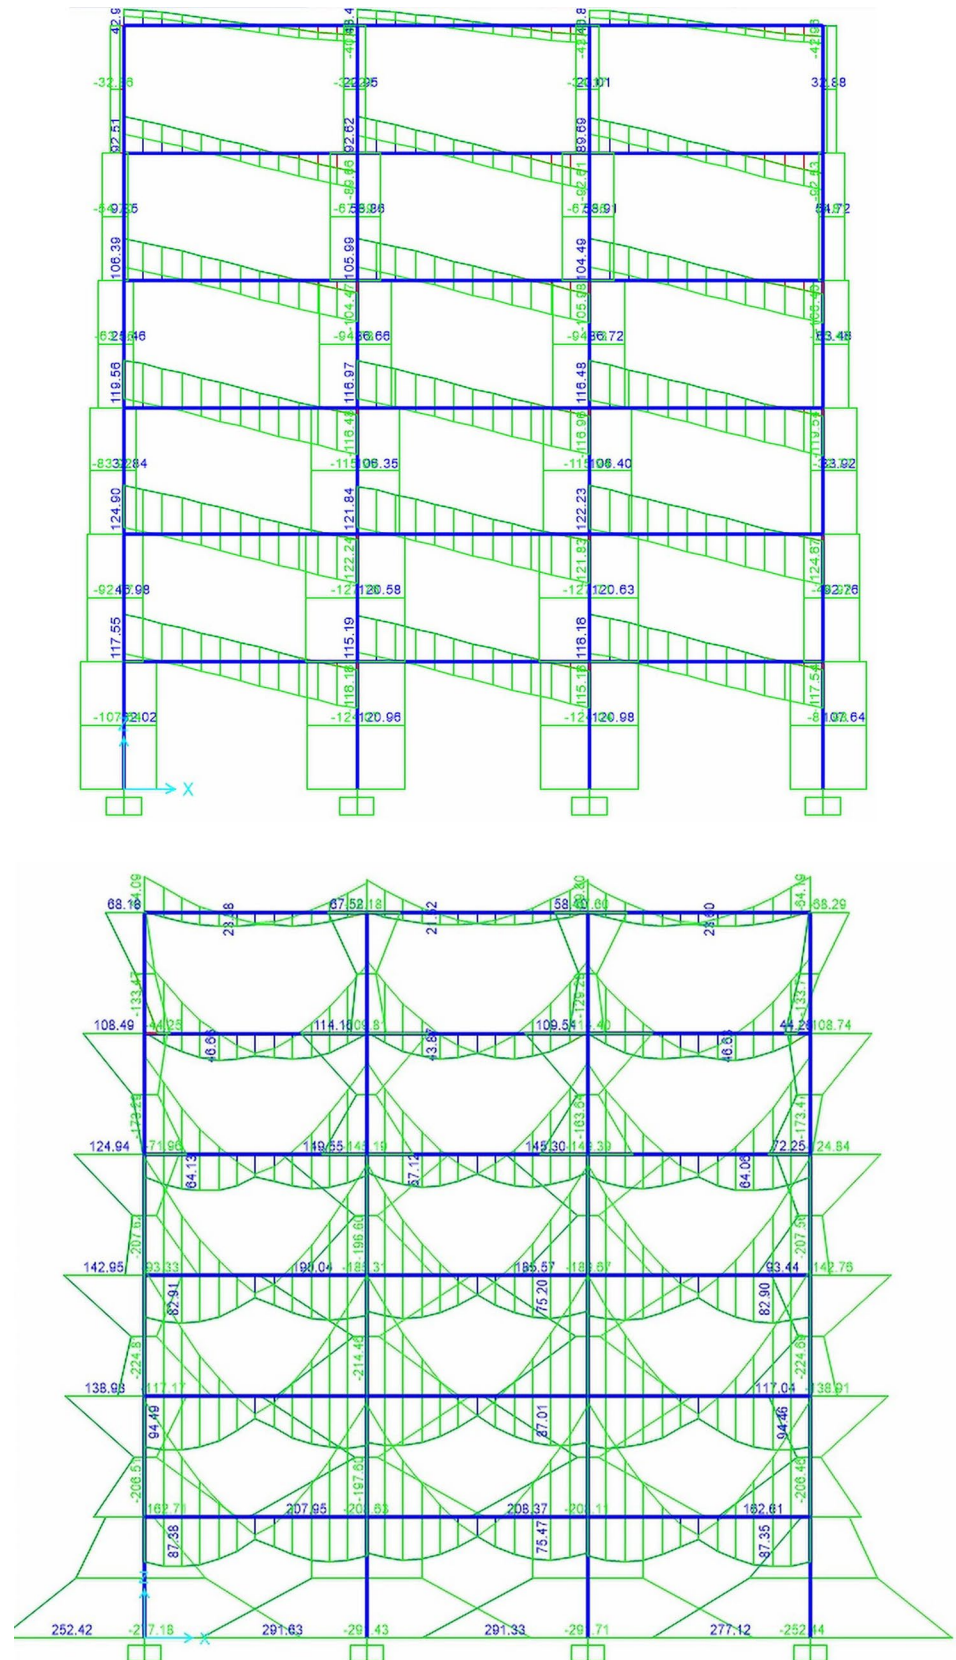
Fig. 13 SFD and BMD of a typical frame in G+5 building after strengthening under load combination 1.5(DL + EQ) for zone III

Seismic analysis is repeated on this new configuration (G+5) for zone III medium soil profile, and seismic resistance capability of the structural components is confirmed by checking the DCR ratios of the structural components. From the results shown in Figs. 13 and 14 (indicating the stress levels (0: unstressed to 1: fully stressed)), it can be observed that the capacity of the building components has enhanced from collapse limit state (C) to life safety limit state (LS) due to strengthening of the existing RC building.

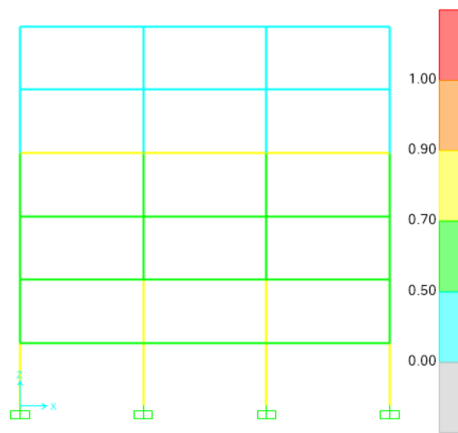
Fig. 14 DCR contour for G+5 building for zone III seismic load after strengthening existing G+3 configuration
