# An experimental approach to the influence of partial rebar corrosion and concrete degradation on behavior of FRP-strengthened RC beams

M. Abbasi<sup>1</sup> · H. Naderpour<sup>1</sup>

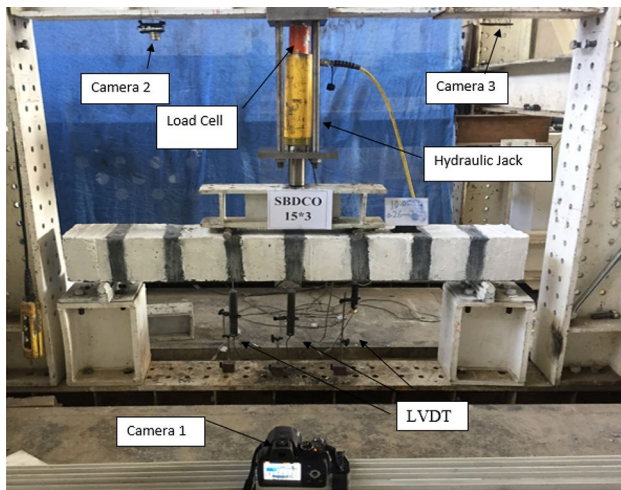
**Fig. 1** Details of the test setup and location of cameras and LVDTs

In this study, eight full-scale RC beams were manufactured and tested. All the specimens had 2100 mm length and a square surface (250 mm × 250 mm). Since the study purpose was to examine the fracture of the beams with internal damage and to detect the crack spread pattern, the specimens were allowed (based on ACI 318) to experience bending cracks. Moreover, a control specimen, with no concrete or rebar damage, was utilized to compare the results of the rehabilitated beams. The amount of the used rebar was 1.23%. The size of steel reinforcements was  $\phi 10@200$  mm. In accordance with the rebar layout, the span to effective depth ratio ( $a/d$ ) of the beams was equal to 2.65. The specimens were procured and then tested by a hydraulic jack using a four-point loading. The

area between the two-point loads had a constant moment and zero shear. In this area, the beam behavior under pure bending could be evaluated. In the area between each load point and the closest support, the combined effect of bending and shear loads can be examined. Static and uniform loads were applied. According to Fig. 1, the middle-point displacement and force can be transferred to the data logger device by LVDT<sup>3</sup> and the load cell, respectively. Further, the experimental displacement in the middle of RC beams reinforced with FRP was determined. Using the load–displacement diagrams from the tests, the beam displacements were determined in different load levels and bearing capacities of the beams reinforced with FRP. Moreover, the observations were recorded in each stage, and the crack spread pattern was illustrated to determine the beam failure mechanism.

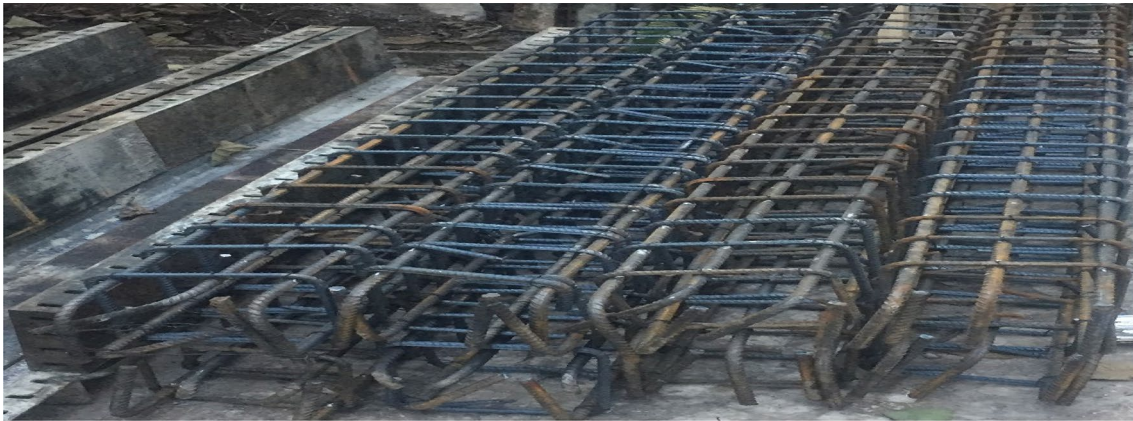
**Fig. 2** Corrosion method of rebar

The manufactured beams were divided into two categories based on their damage type: beams with concrete damage and beams with rebar damage. Rebar damage includes two 25 mm corruptions and a decrease in the rebar diameter by half (7 mm) of the length of the bottom rebars. The beams were reinforced with FRP strips. According to the beam perimeter (100 mm), some extra strip lengths were considered for the overlaps (150 mm) in order to maintain the necessary connection and strength. The FRP width is 80 mm, and it is located 200 mm on either side of the middle point. In the case of concrete damage, special foams with different widths and depths were utilized in order to simulate the damage. All the posed damages are shown in Table 1.

were considered for the overlaps (150 mm) in order to maintain the necessary connection and strength. The FRP width is 80 mm, and it is located 200 mm on either side of the middle point. According to Fig. 2, seven FRP strips are installed on each beam. One failure in BDRA samples and two failures in BDRS samples were located in one-third of the effective span of the fixed-end beam with a distance of 60 cm from the two head supports. It is machined accurately and evenly using a turning tool such that to cause failure. The reinforcement's diameter is reduced from 14 to 7 mm (Fig. 3).

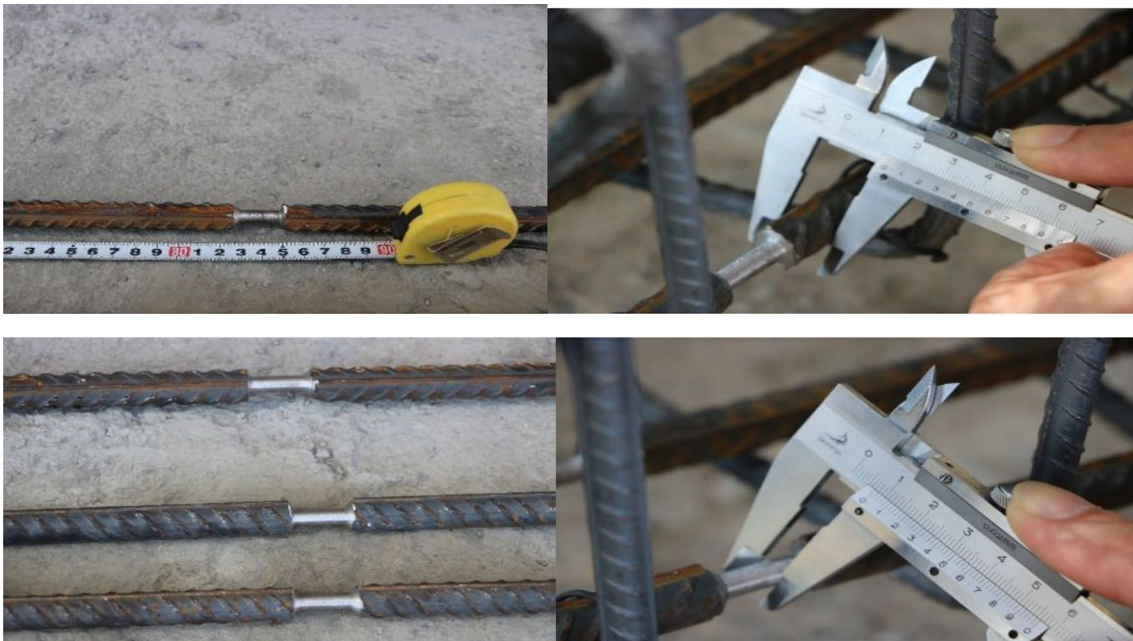
**Fig. 3** Longitudinal and transverse rebars and their layout

In order to reinforce the concrete and manufacture the RC beams, 10-mm and 14-mm rebars were used. The 10-mm rebars were used for internal reinforcements, and 14-mm rebars were utilized for longitudinal reinforcements. The rebar layout is shown in Fig. 2. Rebar yielding strength was measured according to ISO 6982-1 as such three specimens with 75-cm length were selected and used for uniaxial tension test.

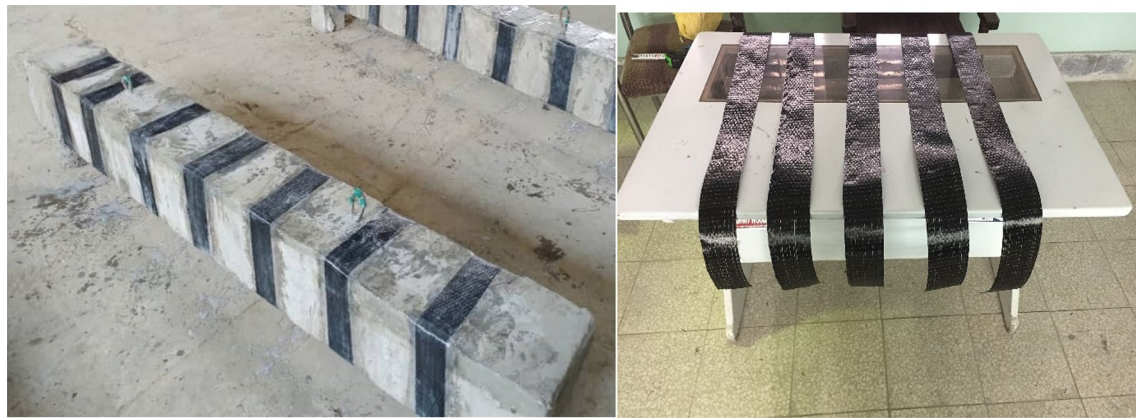
**Fig. 4** FRP strips preparation

2. FRP strips with 8-mm width and 110-mm length were provided.
3. A combination of adhesive and resin, with a ratio of 1 to 3, was prepared. This proportion would result in maximum strength.
4. Seven FRP stripes were installed on the RC beam, 72 h before testing the specimens.

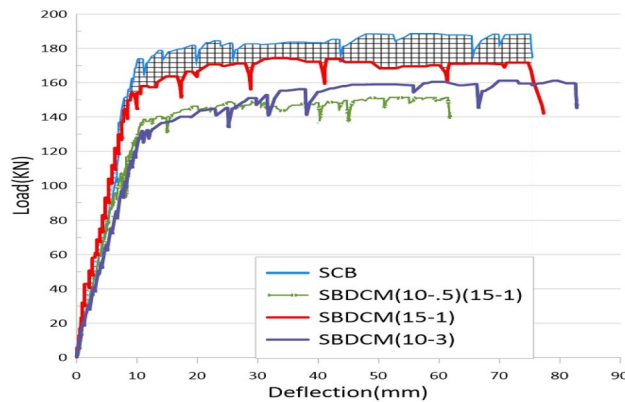
**Fig. 6** Load-displacement diagrams of specimens having degradation in the middle

The following diagram shows the force–displacement of the control beam, specimens with damage in the middle point, and specimens with different concrete damages. According to Fig. 5, the beam with two damages has the least deflection and bearing capacity among all the beam specimens. When comparing the beams with damage in the same location, it was revealed that the beam with less damage width has the highest bearing capacity.

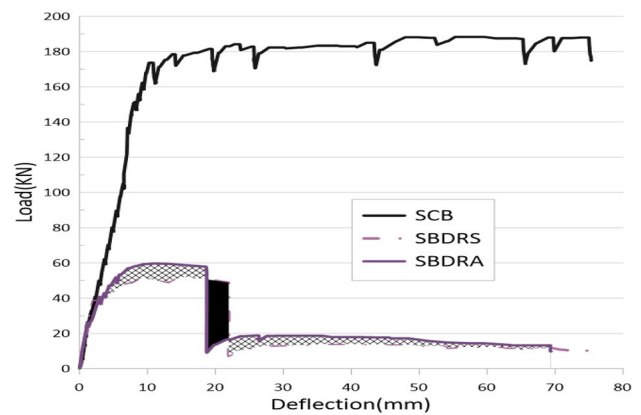
**Fig. 7** Load-displacement diagrams of specimens having corroded rebars

In Fig. 6, the control concrete beam is compared with specimens having two types of rebar damage. It can be noticed that the exerted force and absorbed energy are

significantly different in these specimens. The specimen with symmetric rebar damage has lower energy absorption, and its bearing capacity is decreased by 7%. As can be seen, despite the weakness and crack in the concrete, the load-carrying capacity of the control and damaged beams is similar due to the use of CFRP. In another research, the use of reinforcement has increased the load-carrying capacity and compensated for the defect in concrete.

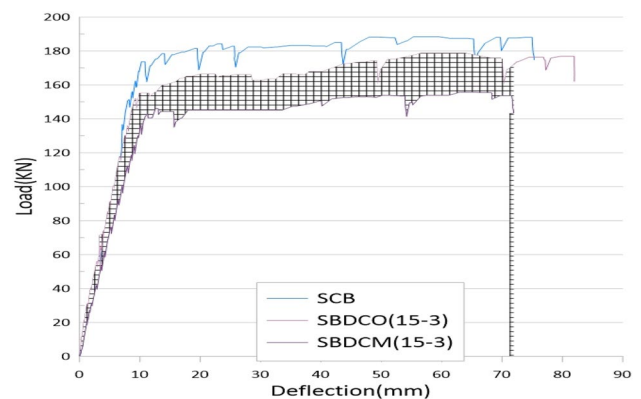
**Fig. 8** Load-displacement diagrams in specimens having the same damage

In Fig. 7, the control specimen is compared with the two other specimens having similar damages. In one specimen, damage is located in the middle, and damage in the other ones is located in the 1/3 point of the beam span. It can be mentioned that the latter endured more force and displacement and has more energy absorption rate. The control specimen has identical reinforcement and

thus similar displacement. Its bearing capacity, however, increased 14% and compared with the specimen with middle span damage.

In Fig. 8, the control beam is compared with the specimens with central damage and with different widths and heights. It can be observed that the damage width is much more effective than the other variables. The specimens with greater damage width and lower height show more displacement under the less force.

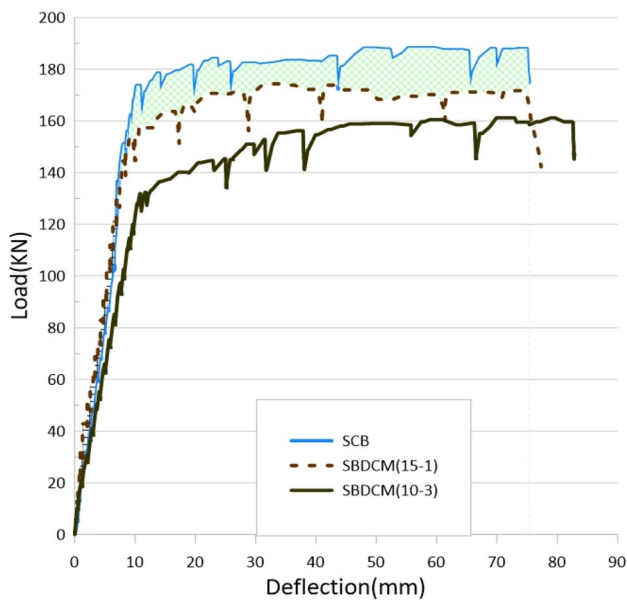
**Fig. 9** Load–deflection of specimens with different damage widths and heights

In Fig. 9, the blank sample was compared with center-damaged samples with different widths and heights. As shown in the figure, the effect of damage is higher in the width than in the height. However, samples containing damage with larger width and smaller height exhibit smaller displacement for a smaller force.

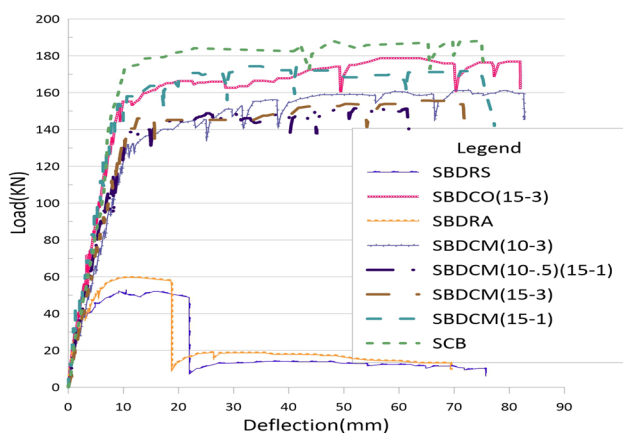
**Fig. 10** Comparison of load–displacement for all specimens

According to Fig. 10, damage in the rebar has a great impact on reducing the bearing capacity. Also, this sample has less bearing capacity compared to other samples that have damage in concrete. The SCB sample has the highest

load capacity and then damage in one-third of the opening as expected. However, despite the use of CFRP, the bearing capacity of all samples is very close to each other and this can be considered as a very important point in strengthening the beams. Notably, the bearing capacity of all samples is very close to each other despite the use of CFRP. This can be considered a very important point in strengthening the beams.

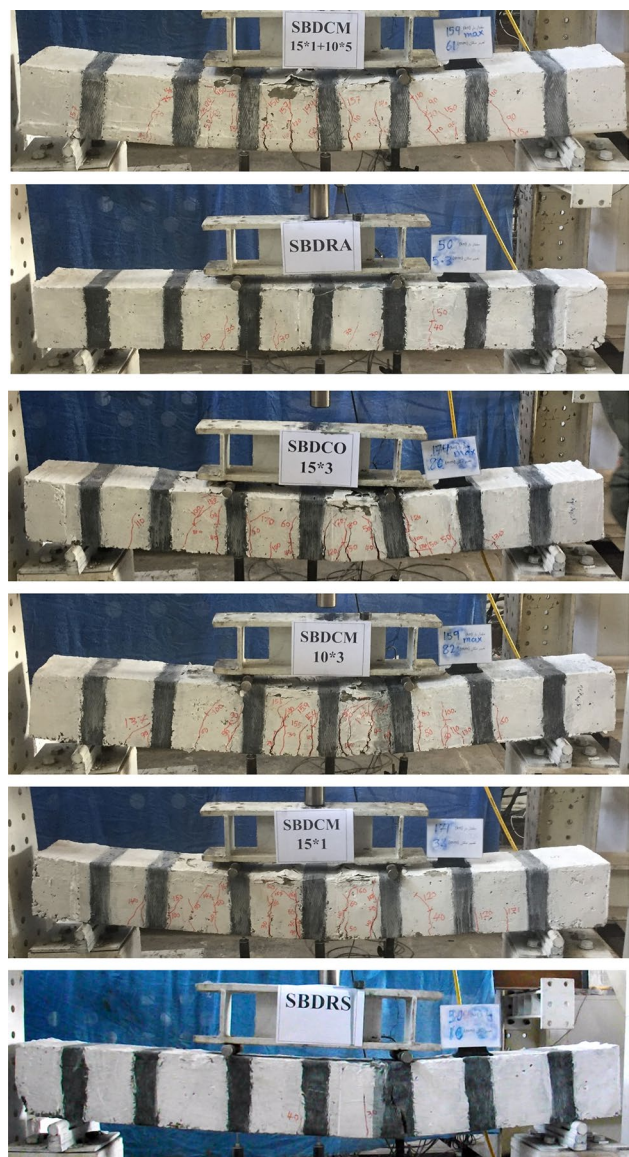
**Fig. 11** Crack spread pattern of specimens corresponding to the fracture moment

Figure 11 shows the post-failure states for RC beams. As can be seen, the specimens have bending cracks, and the cracks are centered at the vertical direction. These cracks

start from the bottom of the beam and spread upward. In the control specimen, the cracks are fully distributed. Getting away from the beam center would result in an increase in the crack angles. If the load increases, cracks will develop. Eventually, when the transverse rebars yield, the beam will reach its maximum loading capacity. In SBDCM 15\*1 specimen, since the damage is located in the middle, the cracks are vertical and placed in the middle. With getting away from the middle point, cracks incline, and the crack concentration is in the vicinity of the damage region (Fig. 11) [31]. In the specimens with rebar damage, specimen fractures from the rebar damage region occur quickly. Moreover, in the SBDRS specimen, since FRP is used in the rebar damage region, composite fractures occurred (Fig. 12).

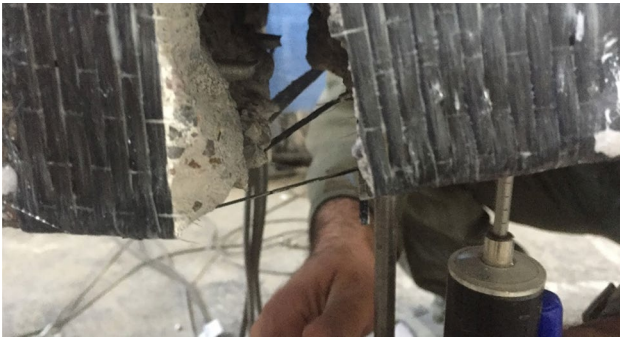
Fig. 12 Rebar failure pattern in SBDRS

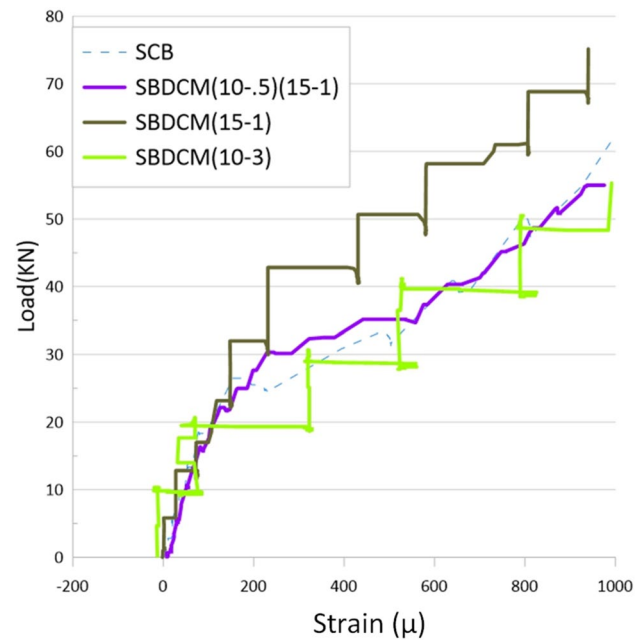
Fig. 13 Load–strain curves for three specimens compared to those of the control beam

As shown in Figs. 13 and 14, under similar loading conditions, the specimen with greater heights experience more strain in comparison with the other similar specimens. The comparison of the specimens with the control specimen indicated that the control beam demonstrates fewer rebar strains since the concrete can help the rebar in this regard.

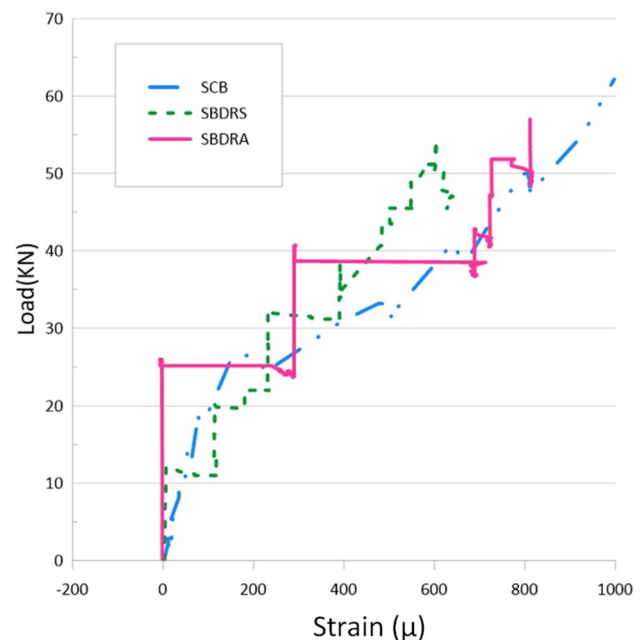
Fig. 14 Load–strain curves for two specimens compared to those of the control beam

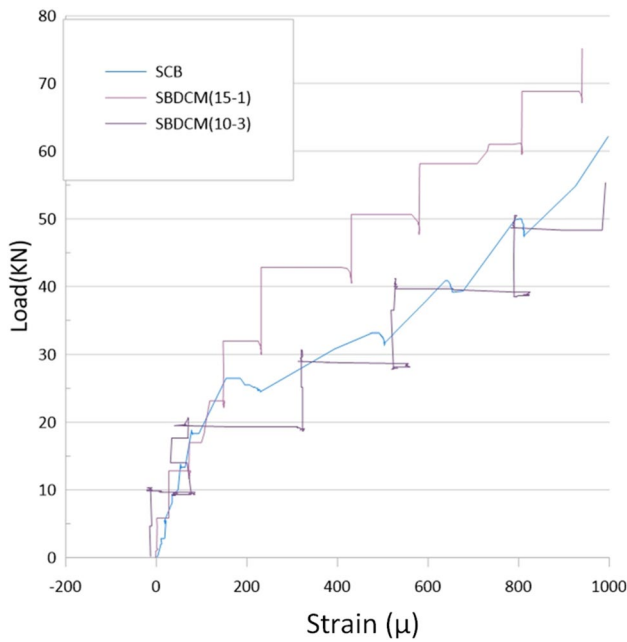
**Fig. 15** Load–strain curves for two specimens compared to those of the control beam

In Fig. 15, the damaged specimens are compared with the control specimen. As presented, the damaged beam experiences less strain under similar loading conditions. It might be attributed to the role of the rebar. In addition to the existing failures, the main load is also applied to the rebar; therefore, it reaches the control specimen strain at a higher load level. The diagram path does not change much, and there is no obvious difference with the samples containing concrete damage. The reason is that comparing

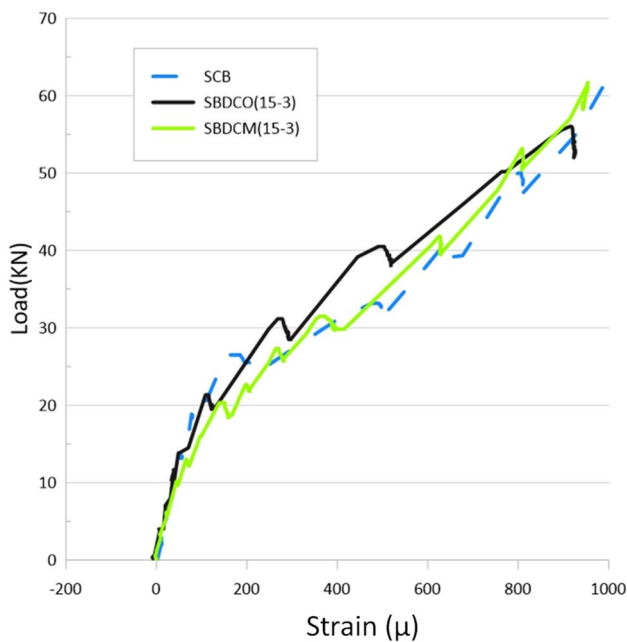
**Fig. 16** Load–strain curves for two specimens compared to those of the control beam

the damaged samples with the control sample shows the same shear reinforcement is used in all samples (Figs. 13, 14, 15, 16). In particular, Fig. 16 shows that the SBDCM (15-3) & SBDCO (15-3) samples overlap with the SCB sample.
