Archaeoseismological study of the Cherichira aqueduct bridge, Kairouan, Tunisia

Abstract

Keywords Archaeoseismology · Cherichira aqueduct · Kairouan · Historic earthquake · Flash flood · Laser scan · Dating · Synthetic seismogram

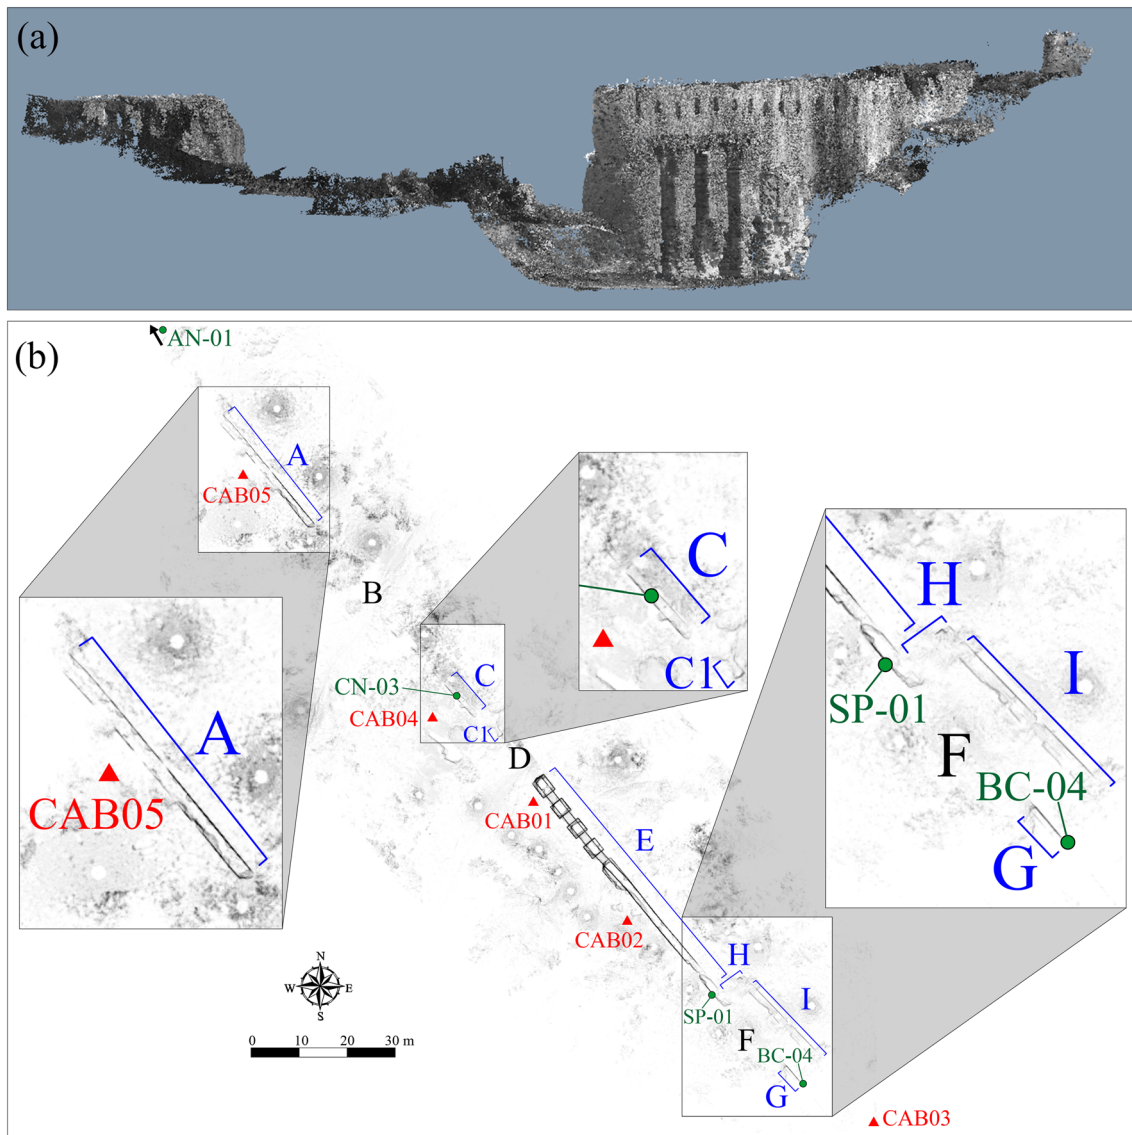
Fig. 4 **a** Perspective view from NW to the CAB 3D scan model. Total length of the model is 180 m. **b** Overview map of the scanned Cherichira aqueduct. Individual sections are marked with blue capital letters starting from NW; black letters indicate the gaps between sections. An arrow on the top left points towards a small pool about

100 m outside the map area. Three zoom-windows show more details; the scale bar applies to the main map; the labeled red triangles mark positions of HVSR measurements and the labeled green dots give locations of C14-dating samples

In the following, the explored part of the CAB is divided into nine sections labeled A to I from NW to SE, where B, D, and F are gaps without major visible remains of the original construction (Figs. 4 and 5). The height of the ruins aboveground in section A increases from NW to SE from 1.5 m to 4.3 m due to sloping terrain. Section C shows severe damage, and the remaining height aboveground is about 2 m. Some 5 m south of section C, a small fraction (C1) extrudes from the slope within the gap labeled D; however, the elevation of C and C1 differs by at least 4 m from rest of the bridge. In the neighborhood of C and C1, several large debris piles are visible within the bushes, including remains of a water channel. The best-preserved part of the bridge in section E has a maximum remaining height above the (current) ground of 11.1 m. Towards the SE, the height decreases as dictated by the natural slope to about 2.7 m. Section G rises to 2.2 m aboveground and then descends in section I to about 1.1 m. Section H was heavily overgrown by shrubs, and the estimated existing height is 1.4 m. Table 1 summarizes the dimensions of the sections.

Section A (Figs. 4b and 5a) is the most northern of the examined area of the CAB. It is roughly 30 m long, the

Section B is the more than 40-m-long gap between sections A and C (Figs. 4b and 5b). While it contains some rubble and heavily degraded parts of the aqueduct, the vegetation prevented a more thorough study of this section.

Section F is the gap between the southern end of the bridge, section E and section G (Fig. 4b). Here, the trend of the aqueduct structure is well visible on the ground surface; however, the structure is leveled to the ground with no rising wall remains.

Section G (Fig. 4b) shows two distinct differences to the rest of the ruins of the CAB: (1) the wall is wider (~2.0 m) compared to the other sections, and the canal with ~0.8 m width is larger. The elevation of the canal does not fit the elevation of all other sections, e.g. the water channel in section

Section H constitutes a short deviation and connection between section E and I with a trend nearly perpendicular to the other two sections (Fig. 4b). Section I then continues with a common trend (N131°E), but about 5.5 m further east along a line connecting the bridge (section E) and section G (Fig. 9a–d). Section I shows heavy damage; in particular, segments of the western side of the water canal broke away and were shifted westward by ~ 0.22 m, but are still in place (Fig. 9c and d). Three cracks cut through the whole canal causing warping, a damage pattern that could well be of seismic origin.

Measurements of ambient noise at five locations (CAB01–CAB05, Fig. 4b) were made to determine horizontal to vertical component spectral ratios (HVSR); these can give some basic ideas of the frequency of ground amplifications due to soft surface layers (e.g. Mucciarelli and Gallipoli 2001; Lunedei and Malischewsky 2015). Measuring procedure and results are given in the electronic supplements (Fig. S1). Except for an impedance contrast correlated to the base of the sediment fill in the wadi center, no indications for major site effects were found.

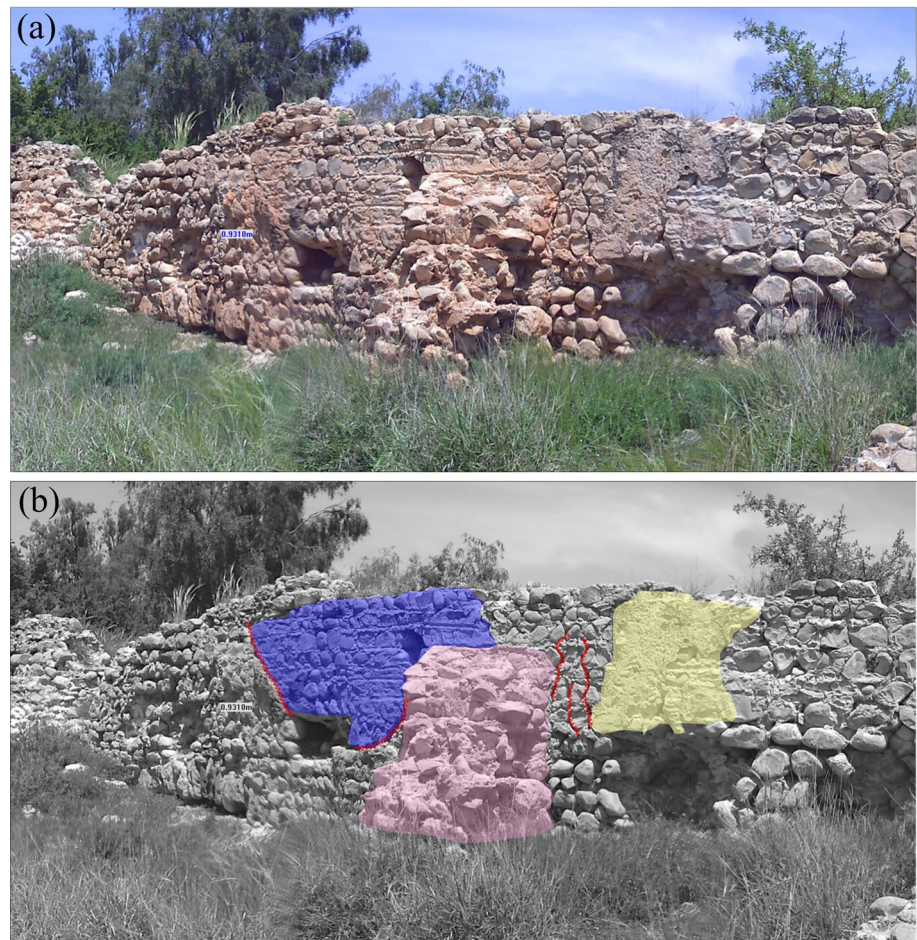
Fig. 6 View from west to section C. **a** Colored 3D scan, **b** same view as in (a) with a buttress shaded red, tufa deposits in yellow and a segment of the wall with trowel lines in blue. Red lines mark major cracks in the wall

with a 6.15-m-wide gap in between; no evidence exists for a masonry bond to the wall they support, a sign which could indicate a later addition to give the canal support. Later, the buttresses collapsed together with the canal. In Fig. 6a and b, one of the buttresses is indicated by the red shading. Another sign of repair is a part of section C which shows clear trowel lines on both sides of the wall, filling a stretch of at least 3 m length and minimum 1 m height. This type of construction has not been found anywhere else along the scanned section of the CAB and could be attributed to a repair, possibly together with the buttress construction. Further indicated in Fig. 6b are major cracks, some of which trend along the edge of the inserted part with the trowel lines and one with tufa deposits on the outside of the wall.

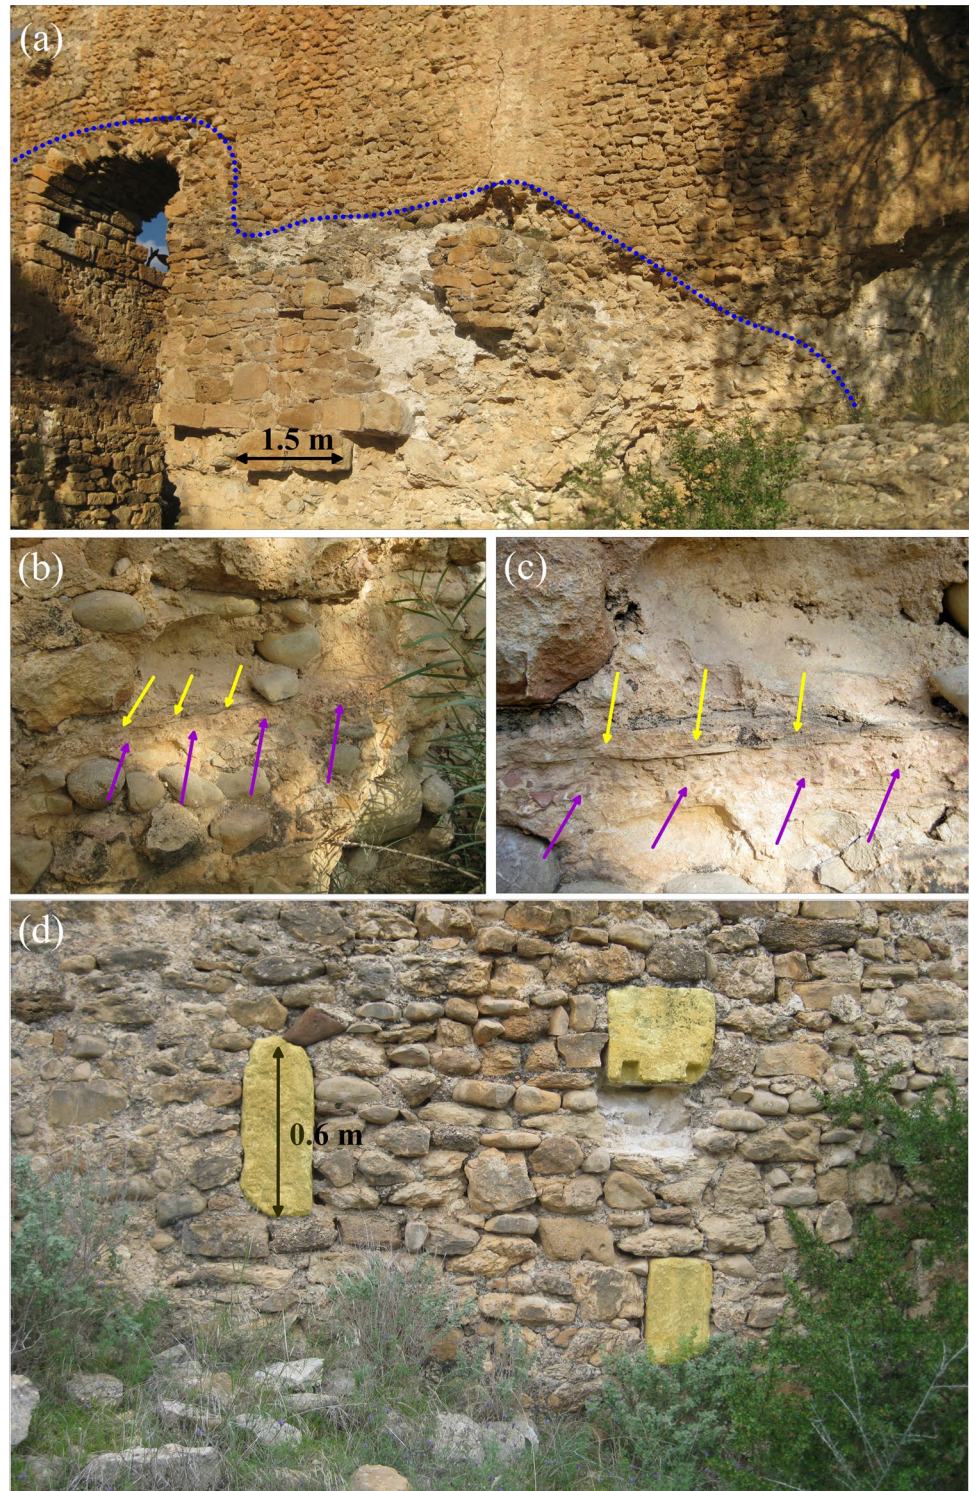
Fig. 8 **a** Photo of the western side of section E of the CAB with the most southern arch at the left side. The dotted blue line shows the border between the 3.0-m wide substructure and the narrower 1.5-m wide wall on top. The photos in **(b)** and **(c)** show some spolia visible in the parts, where the outer shell of the wall broke off. Pink and yellow arrows point to remain of water tight canal lining (*opus signinum*) and attached tufa deposits, respectively. The photo in **(d)** was taken on the opposite (eastern) site of the bridge; the yellow shade indicates three large blocks used as spolia (photo K.-G. Hinzen)

and c). On the eastern side of the bridge, some large worked ashlars, probably of Roman origin, are found within the outer shell of the wall which is otherwise

made from crude stones (Fig. 8d). In the river bed, south of the bridge, we also found a large fragment of a Roman column.

bridge the Aghlabid builders used as much of the Roman construction as possible. Spolia in the form of large blocks (Fig. 8c) and ruins from a former water canal, probably of Roman origin, indicate that such material must have been still existing in the vicinity of the structure in the ninth century AD when the aqueduct was retrofitted, also a sign of the decay or destruction of the original Roman bridge; however, this earlier deterioration process is outside the scope of this study.

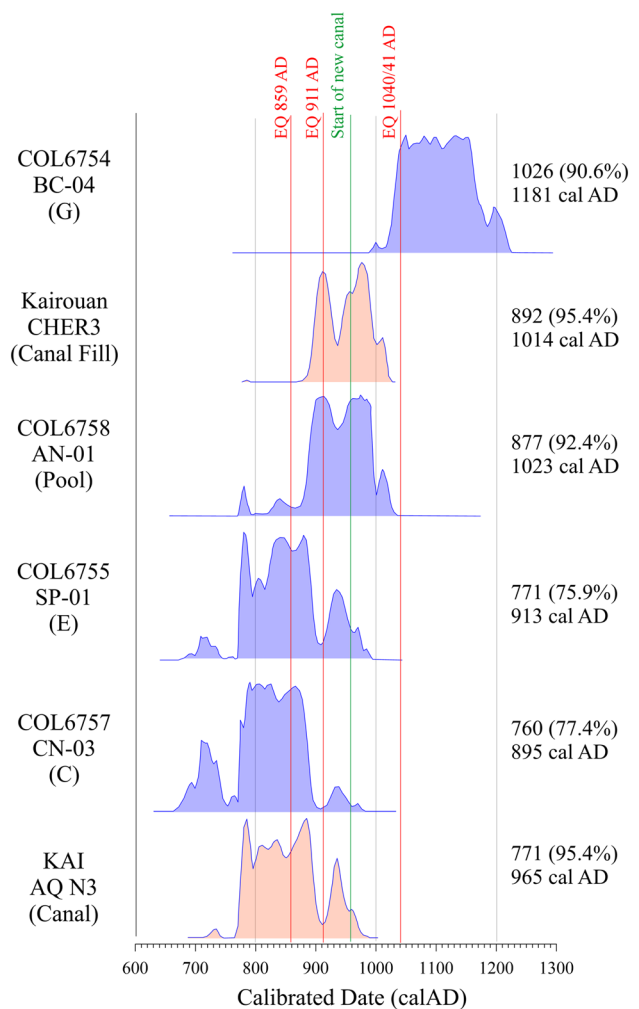
Fig. 12 Results of C14 radiocarbon dating of samples from the CAB. Name of sample and location of sampling (in brackets) is given on the left side and in Fig. 5b. The two red shaded curves are from Bahrouni et al. (2020a, 2020b) the blue shades one from this study. Dates on the right side give the 2σ uncertainty range; the historically documented time of three earthquakes (Ambraseys 2009; Kharrat et al. 2019; Bahrouni et al. 2020a, b) and the inferred start of construction of the new canal are indicated by red and green lines, respectively

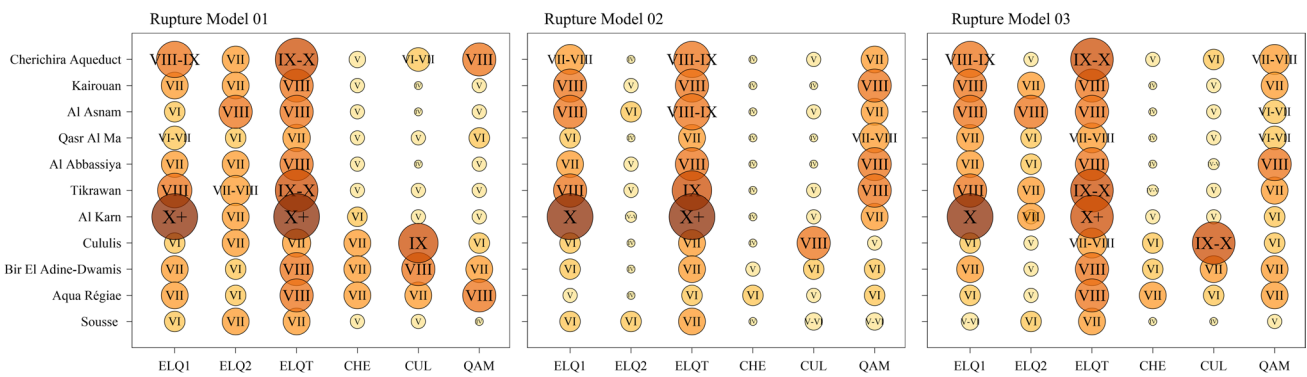
Fig. 20 Summary of the estimated MM intensities for 11 sites (names on the left axis) and the 18 earthquake scenarios; the rupture models and the related directivity are given above the graphs and as in Fig. 16; circle size scales with the intensities given in Roman numerals

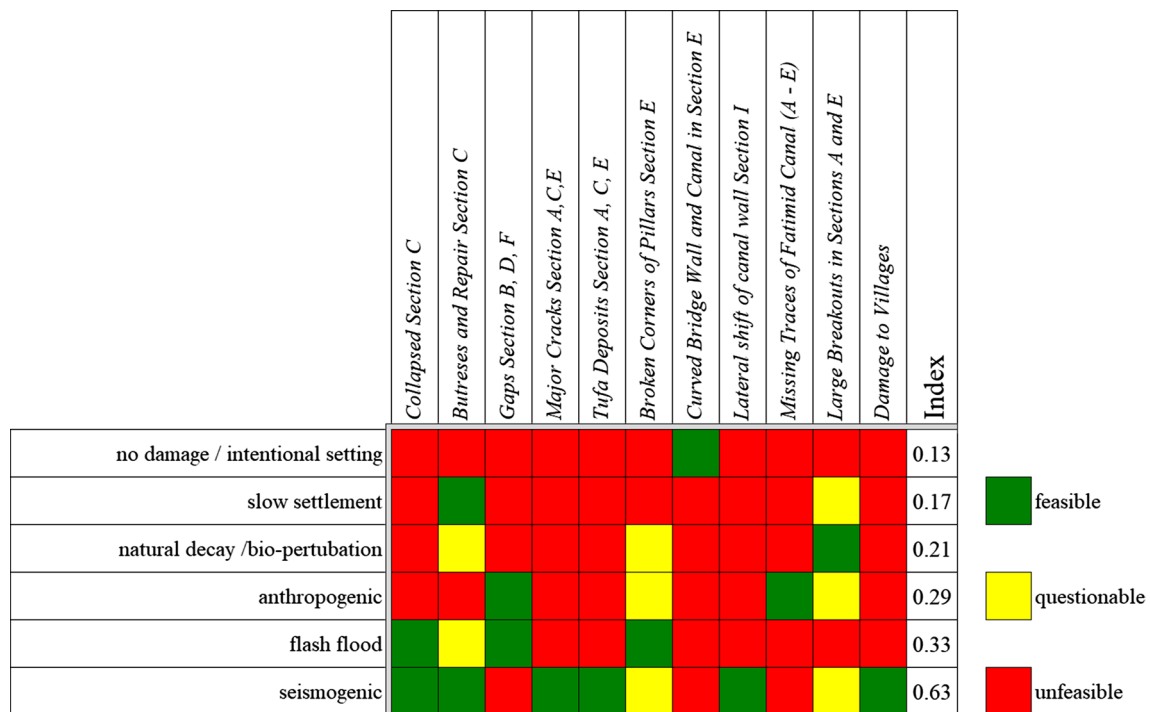
Fig. 21 Plausibility matrix linking six potential causes of damage (rows) with 11 observations or damage descriptions of the CAB and its surrounding. The index is a measure of plausibility of a single cause in terms of all observations and damage descriptions (Hinzen et al. 2012)

Most but not all observations of damage at the CAB can be related to earthquake ground motions. Figure 21 summarizes the plausibility of observed damage and potential cause for the CAB in the form a matrix (Galadini et al. 2006; Hinzen et al. 2012) categorizing the damage/cause relation simply feasible, questionable, or unfeasible. Plausibility is then quantified by a number between 0 and 1 (Hinzen et al. 2012), meaning that none or all of the observations can be explained by a particular cause, respectively. Six causes are linked to 11 observations which have been discussed above with the highest score of 63% possibility assigned to a seismogenic origin.
