Fatigue damage development in 10CrMo9-10 steel for power plant pipes in as-received state and after 280,000 h of exploitation

Mateusz Kopec^{1,2} · Adam Brodecki¹ · Zbigniew L. Kowalewski¹

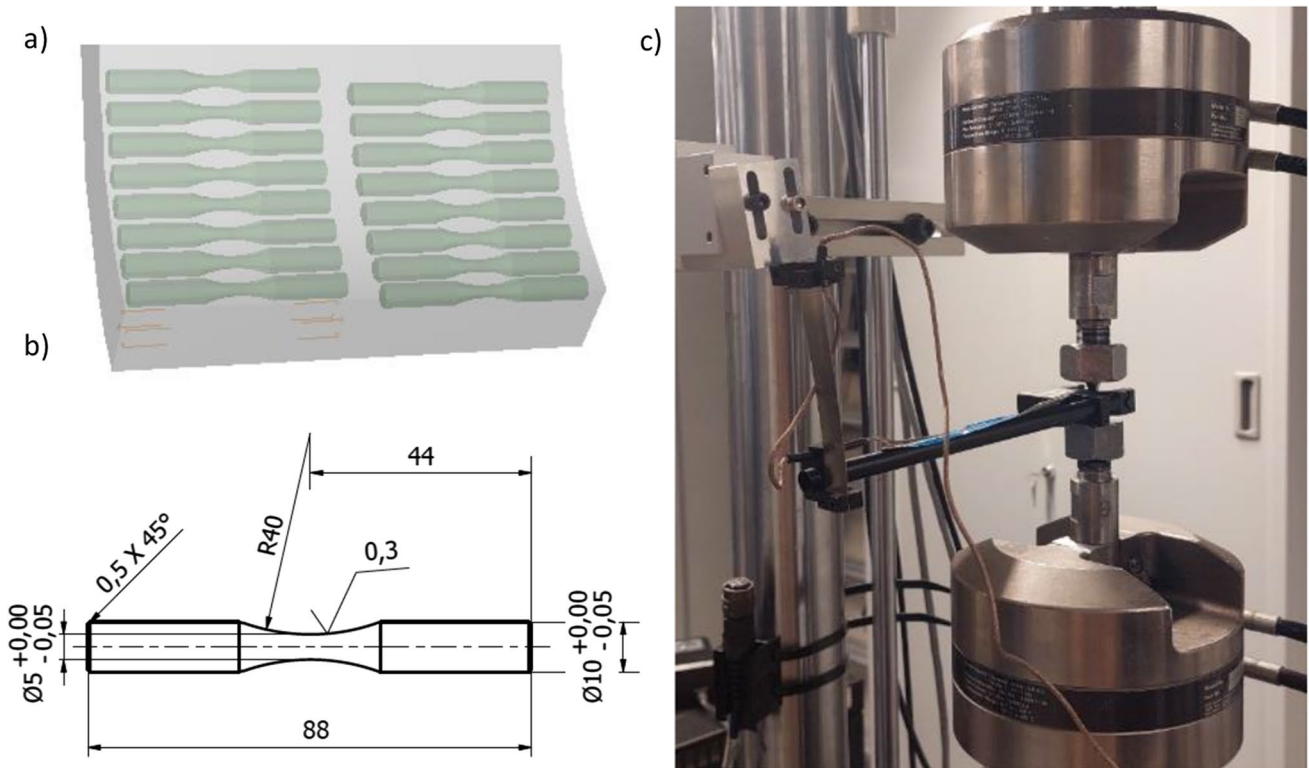
Fig. 1 Specimens' distribution in a pipe section (a), engineering drawing of the specimen (b), and general view of the experimental setup (c)

The hourglass specimens were extracted (wire-cut and machined) from two types of 10H2M steel pipelines as presented in Fig. 1a. Three specimens per condition were used to guarantee the reliability of the results obtained. The geometry of specimens for both standard tensile and fatigue tests is shown in Fig. 1b. They were machined in a computer numerical control (CNC) lathe machine using the same programme to ensure a surface finish and repeatability of the subsequent tests. A total number of 60 specimens were machined from two pipelines (30 specimens from each). Uniaxial tensile tests were performed at a strain rate equal to $2 \times 10^{-4} \text{ s}^{-1}$. The range of fatigue loads was established on the basis of yield strength $R_{0.2}$ determined from the uniaxial tensile test. The fatigue tests were performed in the range of stress amplitude from ± 250 MPa to ± 400 MPa using the MTS 858 testing machine, as shown in Fig. 1c. The fatigue tests were force controlled with zero mean value and constant stress amplitude with a frequency of 20 Hz. During the entire loading process, an MTS extensometer was used to monitor a diameter change in the specimen gauge length. The axial strain was calculated on the basis of transversal strain and Poisson's ratio. The fracture surface observation was performed using a JEOL field emission gun scanning electron microscope (SEM) operated at 20 kV. The qualitative chemical composition analysis was performed using Quanta 3D FEG field emission scanning electron microscope (SEM) operated at 20 kV with EDS detector.

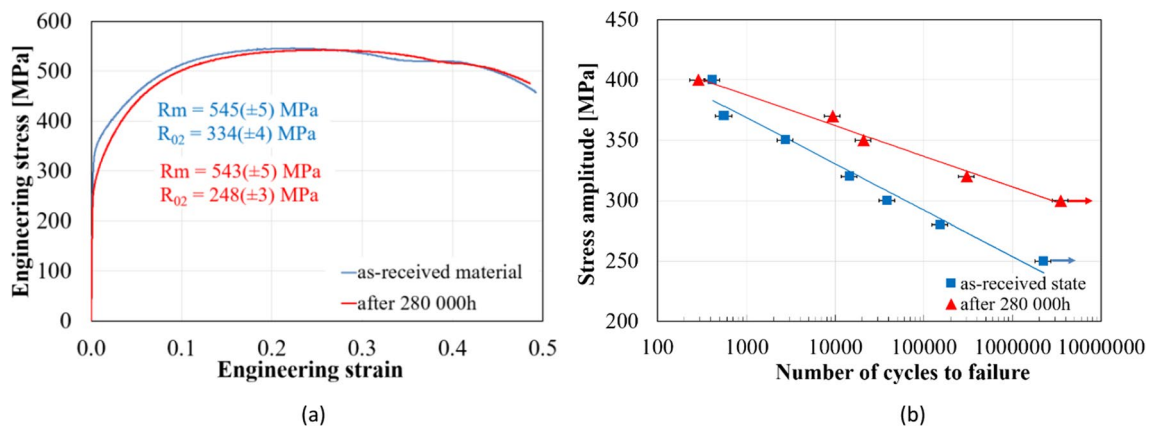
Fig. 2 Representative tensile curves for 10H2M steel in the as-received state and after exploitation (a); S–N curves for the steel in the as-received state and after exploitation (b)

The representative strength characteristics of 10H2M steel in the as-received state and after the operation are shown in Fig. 2a. The reliability of the tensile test results was confirmed by testing five specimens accordingly. The average values of parameters determined from these tests are presented in Table 2. Interestingly, the results of tensile tests exhibited a significant decrease in yield point of about 86 MPa for the steel subjected to long-term operation. However, the ultimate tensile strength and ductility remained at a similar level. Nevertheless, both these parameters were still

Subsequent comparative fatigue tests performed to elaborate the S–N curves for both states of the steel in question revealed that due to exploitation, a significant decrease of fatigue lifetime was observed for the entire range of stress amplitudes considered. One should highlight a considerable drop of the number of cycles to failure for the exploited steel

in comparison to the same material tested in the as-received state under the same stress amplitude (Fig. 2b). Such tendency can be observed for majority of stress amplitude magnitudes taken into account.

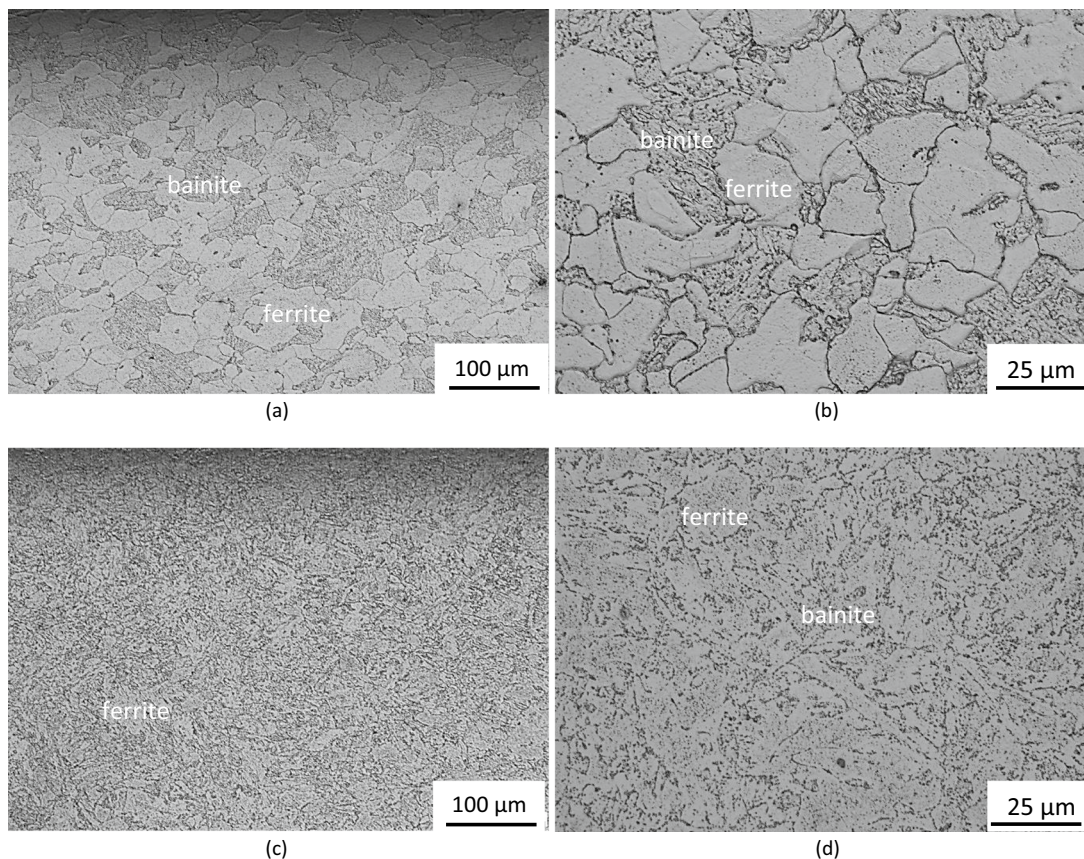
Fig. 3 Microstructure of 10H2M steel in the as-received state (a–b) and after exploitation (c–d)

The high-temperature, time-intensive exploitation for 280,000 h at 540 °C and the internal pressure of 2.9 MPa led to the significant degradation of the 10H2M steel microstructure, as shown in Fig. 3. The microstructure of 10H2M steel in the as-received (normalized and tempered) state consisted of the typical ferritic–bainitic microstructure [11] in which packets of lath or plate-shaped ferrite, associated with carbide particles, could be observed (Fig. 3a–b). On the other hand, the exploited material was characterized by degraded bainite, a small amount of ferrite and precipitated carbides concentrated at the grain boundaries [8] (Fig. 3c–d).

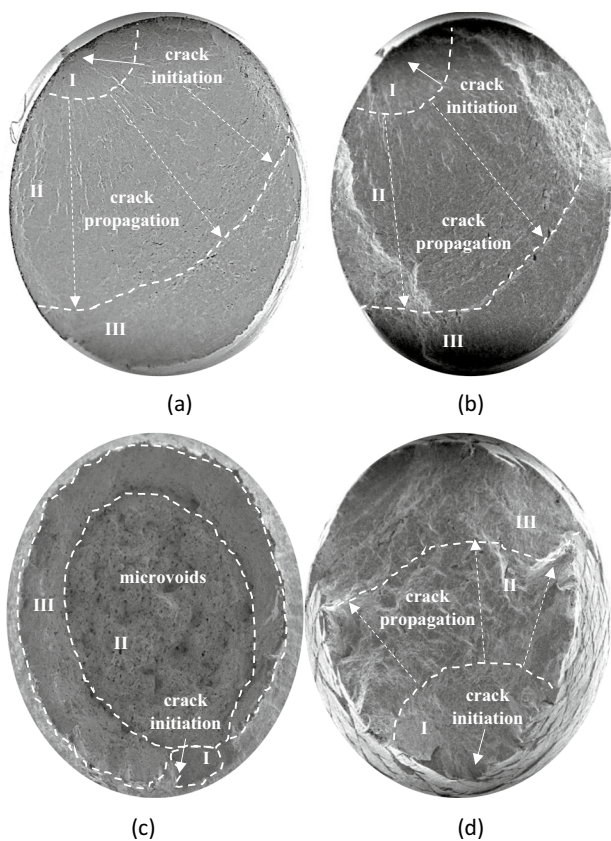
Fig. 4 Fracture surface of the as-received (a) and exploited (b) specimen after testing at the stress amplitude of ± 320 MPa; the fracture surface of the as-received (c) and exploited (d) specimen after testing at the stress amplitude of ± 400 MPa

After fatigue tests, a fracture analysis was performed. Characteristic fracture surface morphologies observed for almost all steel specimens included: crack initiation area surrounded by radial streaks along the crack propagation

direction and a relatively flat surface (marked as I in Fig. 4), propagation area with microvoids and dimples (marked as II in Fig. 4), and instantaneous fracture area (marked as III) [13]. The crack initiation areas were mainly found at the edge of the specimen so in the areas, where the stress concentration occurs due to sub-surface defects or non-metallic inclusions [14]. The propagation area characterized by microvoids consisted also the secondary cracks, which were formed due to connecting pores. Subsequent cleavage steps parallel to the direction of crack propagation form the so-called “river patterns” [13]. On the other hand, the ductile fracture surface of a greater contribution of the fine morphological cavities in the form of craters and non-metallic inclusions was observed for the as-received material after testing at stress amplitude of 400 MPa.

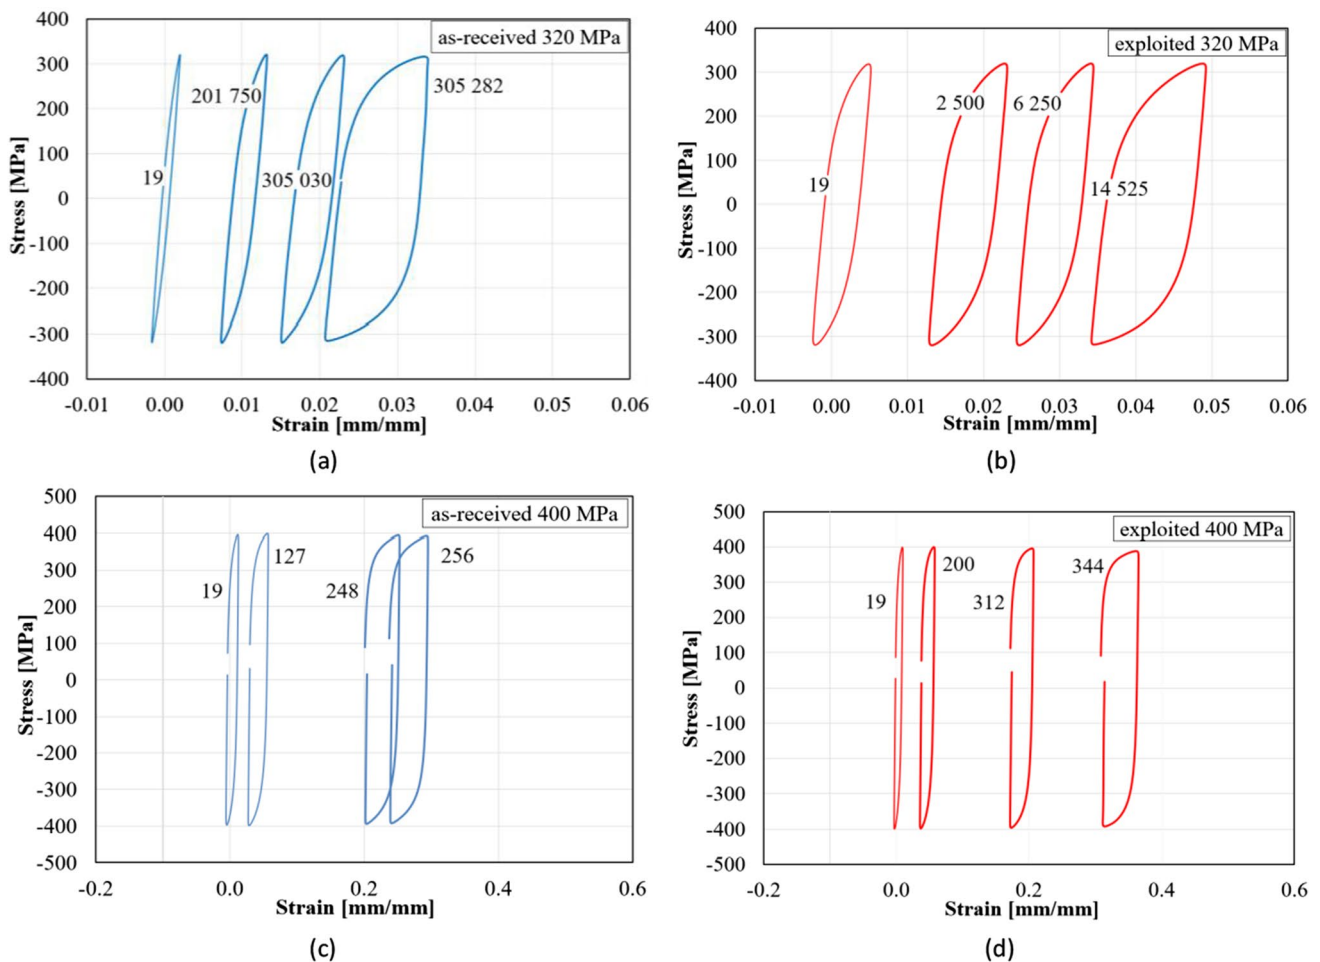
Fig. 5 Fatigue development in the selected cycles for the steel in the as-received state (a, c); steel after exploitation for 280 000 h (b, d) at the amplitude of ±320 MPa and ±400 MPa

The quantitative assessment of the fatigue damage development was performed based on the mechanical response of 10H2M steel registered in successive cycles for all levels of constant stress amplitude. The representative graphs were presented for the as-received and exploited material subjected to limit stress amplitudes between ± 320 MPa and ± 400 MPa to reveal both the effect of stress amplitude and the state of development of damage mechanism in the steel tested (Fig. 5).

strain in subsequent cycles, while for the cyclic plasticity, considerable changes of the hysteresis loop width are observed [17]. Similarly to X10CrMoVNb9-1 (high-temperature resistant, martensitic high-chromium–molybdenum–alloyed power engineering steel) [7], 10H2M steel exhibited a combination of both mechanisms (Fig. 5). It should be emphasised, however, that for the as-received material subjected to the stress amplitude of ± 320 MPa, ratcheting is the dominating mechanism, since the width of hysteresis loop changes slightly up to 200,000 cycles (Fig. 5a). On the other hand, a considerable change in the width was observed for the exploited steel. The 19th loop registered for that state was significantly wider than the 200,000th one for the as-received material (Fig. 5b). Similar behaviour was observed for both states of steel subjected to fatigue loading at the stress amplitude of 400 MPa. The combination of ratcheting and cyclic plasticity mechanisms led to the increase of the hysteresis loop width and its simultaneous shift (Fig. 5c–d).

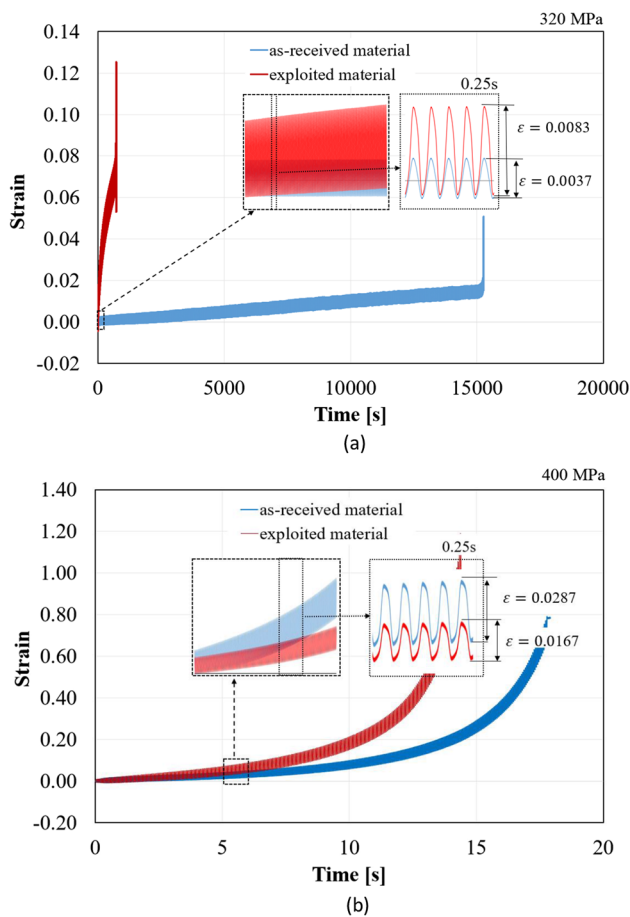
Fig. 6 Strain–time characteristics evolution of the 10H2M steel specimens subjected to the stress amplitude of ± 320 MPa (a) and ± 400 MPa (b)

It should be mentioned that the 10H2M steel was subjected to fatigue testing slightly above the yield stress level, and thus, the high plastic deformation was induced at the initial cycles. Therefore, the analysis of fatigue response was treated in terms of strain versus time (Fig. 6) and number of cycles to failure (Fig. 8). It is easy to notice that the material subjected to fatigue at the same stress amplitude was characterized by a different strain response which was dependent on its state. The strain response of the exploited material subjected to fatigue at both stress amplitudes considered (320 MPa and 400 MPa) was found as two times higher than that for the as-received state obtained. Interestingly, the effect of long-time exploitation was more prominent under a higher stress amplitude, i.e., 400 MPa, under which the strain signal registered for the material subjected to 280,000 h of work was 220% higher than that for the as-received one.

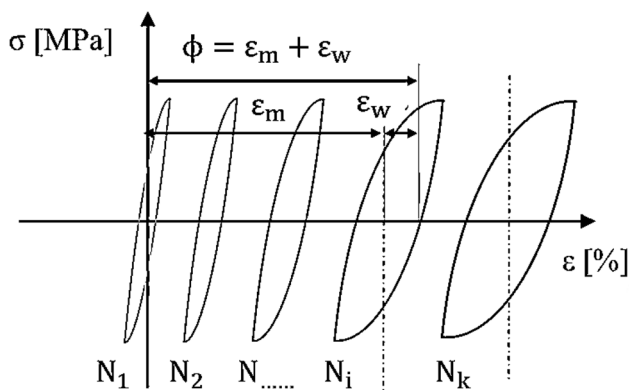
Fig. 7 Hysteresis loop evolution in subsequent fatigue cycles for 10H2M steel in both (as-received and exploited) conditions

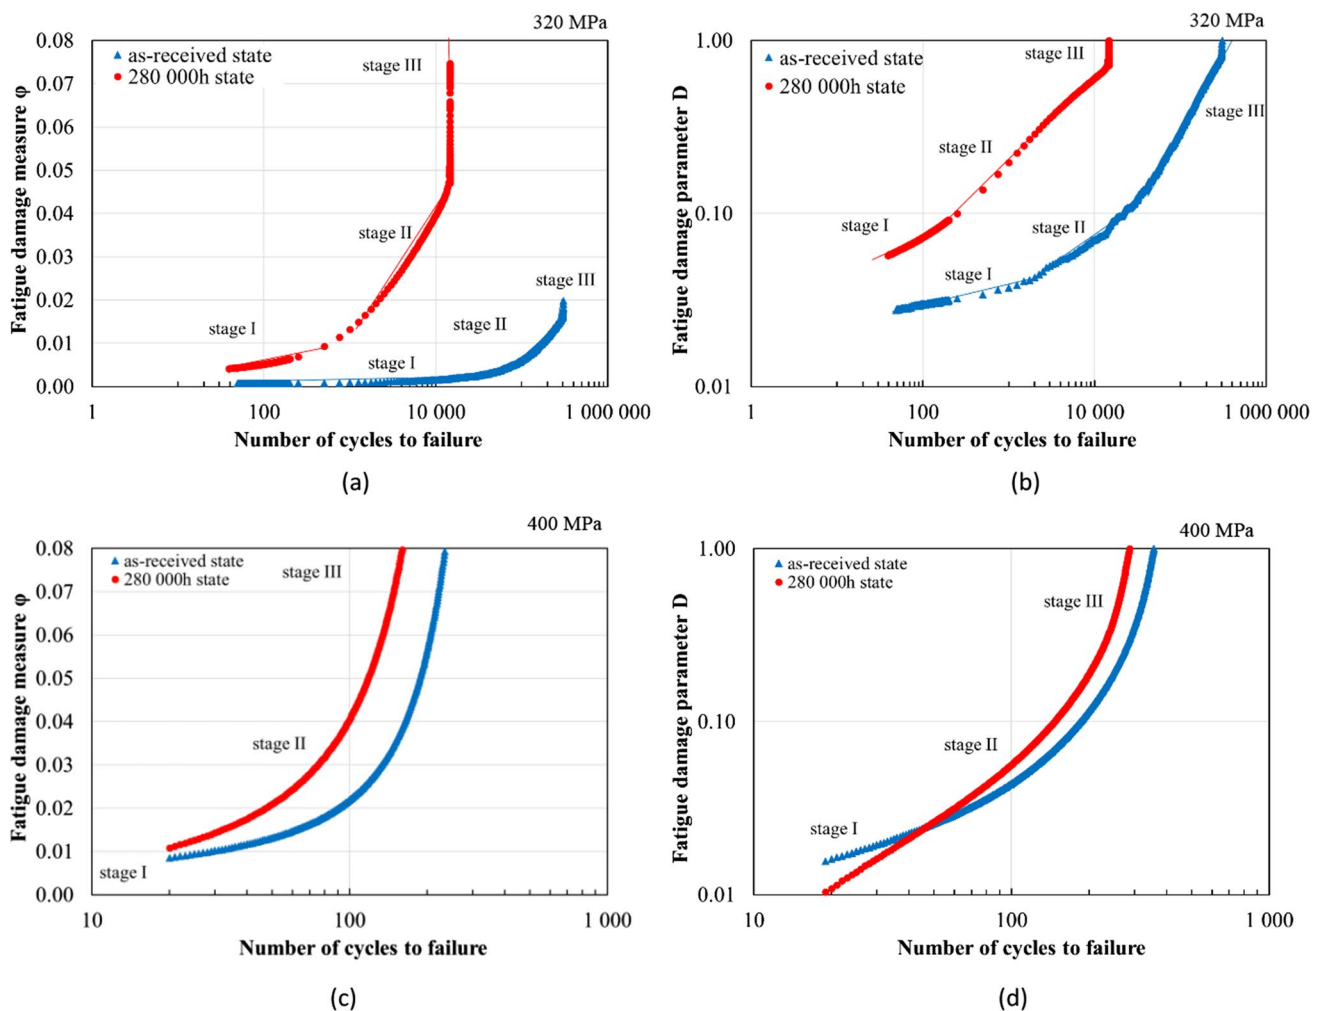
Fig. 8 Development of the fatigue damage for stress amplitude of ± 320 MPa and ± 400 MPa expressed by fatigue damage measure ϕ variations as a function of the number of cycles (a, c), and evolution of the fatigue damage parameter D (b, d)

The accelerated dynamics of fatigue damage development could be clearly observed for the exploited steel by comparing an evolution of the fatigue damage measure and fatigue damage parameter as a function of the number of cycles to failure (Fig. 8). Both states of 10H2M steel exhibited significantly different dynamics, since the damage of exploited steel occurred much earlier than in the case of as-received material. Based on the fatigue damage measure (Fig. 8a, c), it could be demonstrated that the exploited steel was characterized by notably greater dynamics of damage development, since the growth of φ parameter observed up to 10 000 cycles indicates the simultaneous increase of hysteresis loop width. Such behaviour was not observed for the as-received material, which means that the ratcheting was the dominant deformation mechanism in this case. Such significant differences were not observed for the stress amplitude of ± 400 MPa (Fig. 8b, d); however, the damage dynamics for exploited material were still more pronounced.

One could find that the character of curve slope is more steady for the as-received material and the degradation rate is permanently growing from near zero values reflecting its undeformed state. On the other hand, the exploited material just at the beginning of deformation exhibits higher values of both fatigue damage measure and fatigue damage parameter. Such characteristic feature well corresponds to its changed internal state.

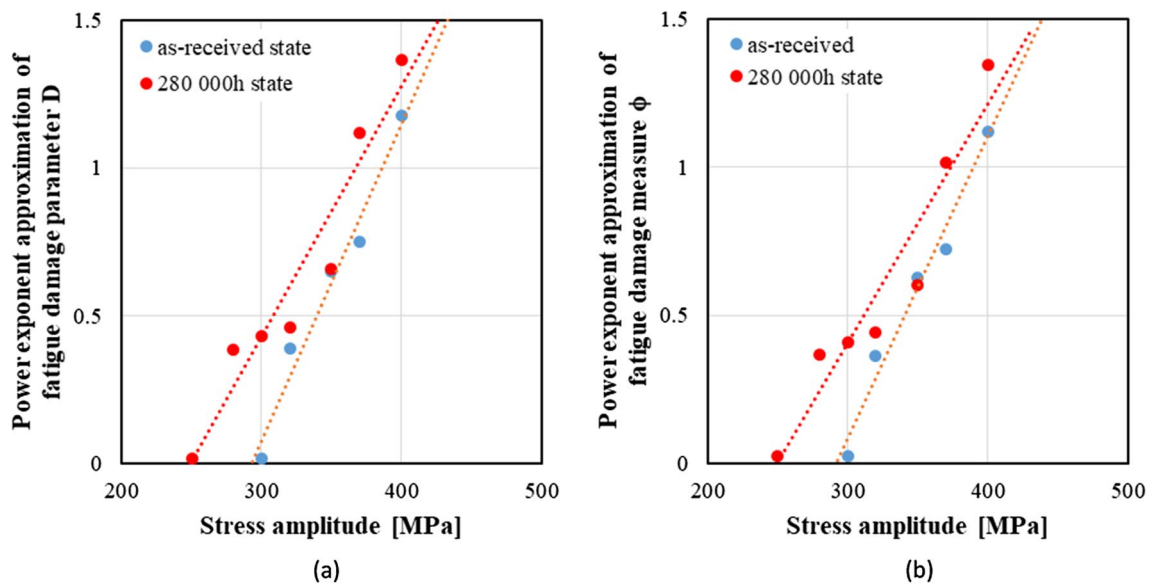
Fig. 9 Determination of the cyclic stress amplitude limit on the basis of power exponent approximation in the case of fatigue damage measure φ (a) and fatigue damage parameter D (b)

Finally, the determination of fatigue stress amplitude limit was performed by approximation of exponential curves obtained by fatigue damage measure, φ , and fatigue damage parameter D correlation for each stress amplitude (Fig. 9). First, Eqs. 1 and 4 were used to determine both parameters φ and D for each stress amplitude. The evolution of these parameters in individual cycles enabled for approximation of these exponential curves. Subsequently, the exponent values of functions describing each curve were compared on the graph as a function of stress amplitude values for both states of the material tested. Finally, a linear trend line was used to predict the fatigue stress amplitude limit. Such limit, according to the Polish Standards [19], represents stress amplitude

that enables carrying out 10^7 loading cycles. In the method presented here, the fatigue stress amplitude limit value corresponds to the intersection point of the line representing an approximation of the experimental results with the x-axis. Such determined value was equal to 245 MPa for the steel exploited for 280,000 h, and 293 MPa for the material in the as-received state. One should highlight a good agreement between these results and those obtained from the S–N curves (250 MPa for the steel exploited for 280 000 h, 300 MPa for the material in the as-received state) (Fig. 9, Table 3).
