Identification, prevention, and treatment of *Legionella* in bath facility water systems in South Korea

June Hae Lee¹, Sejin Lee² and Myoung-Souk Yeo^{2*}

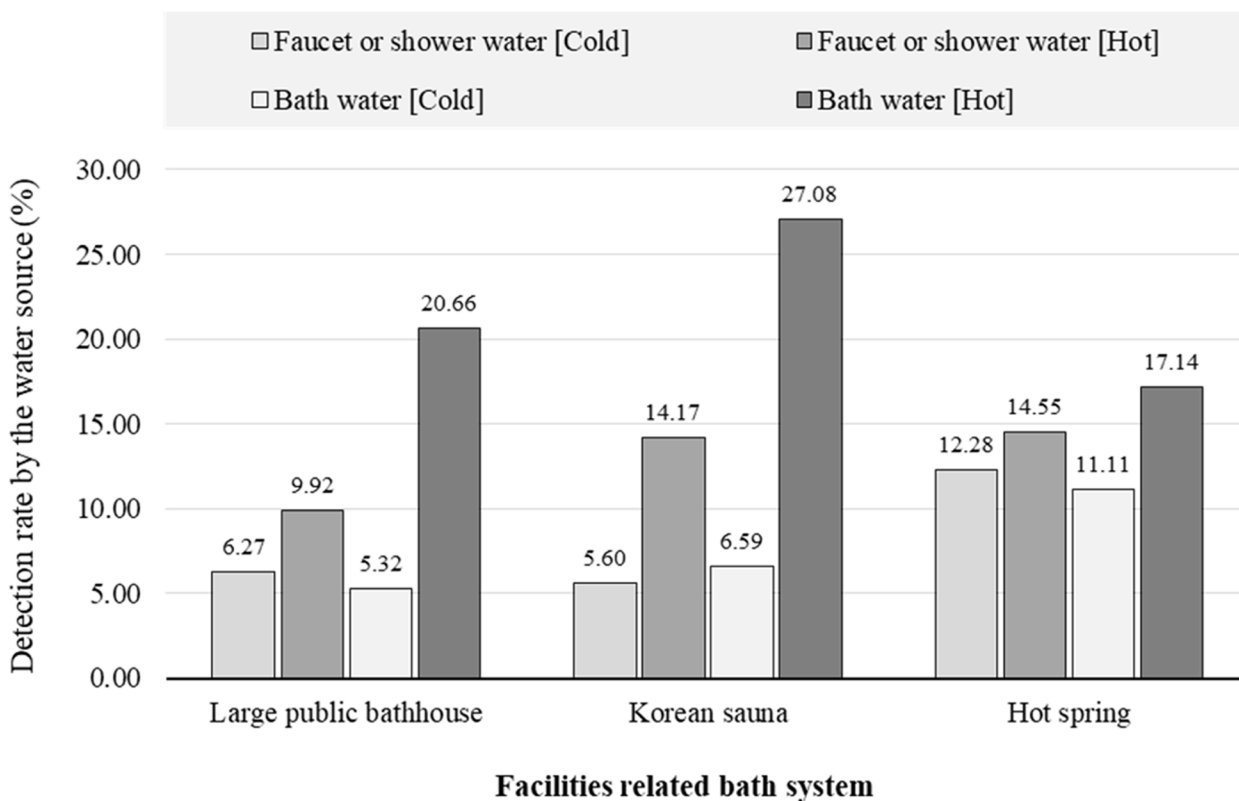
Fig. 1 *Legionella* detection related to bath systems

The water specimen from the hot bathtub had a high *Legionella* detection rate among all bath facilities, including large public bathhouses, Korean saunas, and hot springs, as shown in Fig. 1. Although there were fewer water samples from the bathtub than from the faucet or shower, the positive detection rate of bath water was 14.20%, while that from the faucet or shower was 9.06%, as shown in Table 2. Moreover, *Legionella* detection was higher in the hot water system than in the cold water system. The *Legionella* detection rate in hot water from both the faucet and bathtub was 16.02%, whereas the cold water detection rate was 6.48%. Therefore, the *Legionella* detection rate average was 21.79% for hot bathtub water from large public bathhouses (20.66%), Korean saunas (27.08%), and hot springs (17.14%).

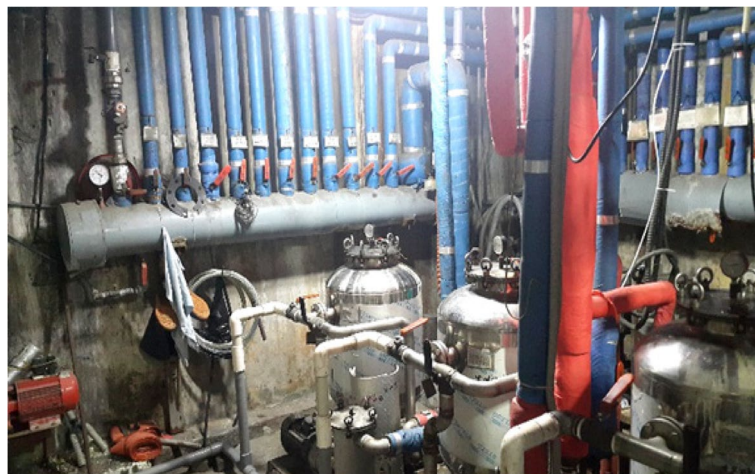
Fig. 3 Sand filter and supply pipes for bathtub water in the basement machine room

from the human body. As illustrated in Fig. 3, the system recycled hot water for hot water bathtubs by filtering suspended matter through a sand filter.

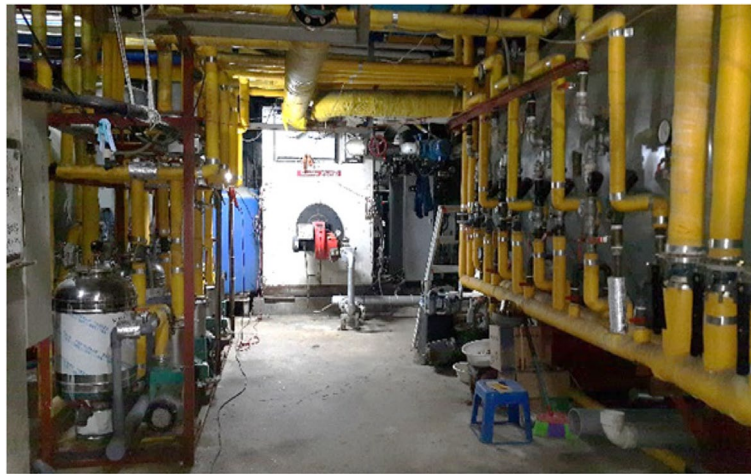
Fig. 4 Machine room of Bathhouse B

Regular specimen inspections at Bathhouse B revealed the presence of *Legionella* bacteria at 28,000 CFU/L in the hot water bathtub and 32,000 CFU/L in the hot water faucet. The building had two basement levels and four above-ground levels. The second basement floor consisted of a machine room (Fig. 4), and the spaces from the first basement to the third floor were used as a bathhouse

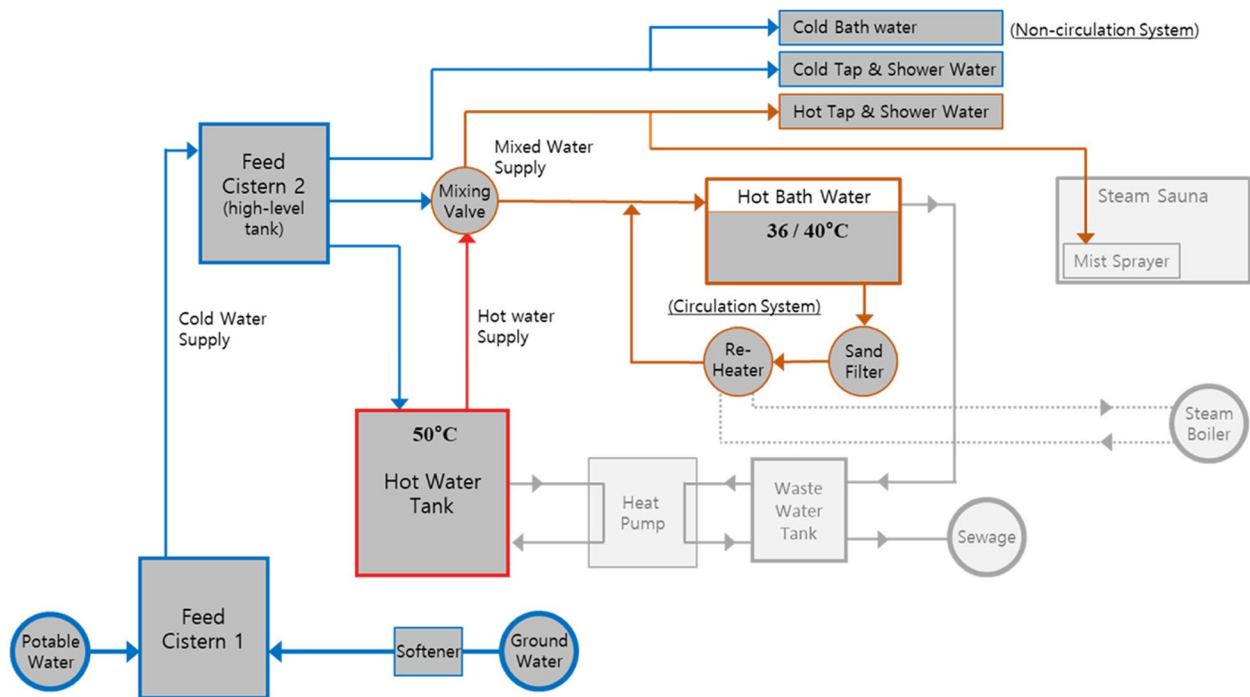
Fig. 5 Schematic diagram of the water system in Bathhouse B

and sauna. The fourth floor above the ground, as well as the rooftop, were used as the residence of the owner. As shown in Fig. 5, the facility was equipped with a system in which portable water was mixed with groundwater and stored in a feed cistern no. 1, from which water was sent to an elevated feed cistern no. 2 located on the roof of the building in order to supply water to each use point.

The risk of *Legionella* detection from the hot water faucet may have increased because of internal contamination in the pipe or a temperature drop by the time it reached hot water at the faucet. The bacteria may have grown because of contamination in the pipe supplied by

the mixing valve; the supply temperature from the hot water tank was maintained at 50°C and was mixed with the potable water supply from feed cistern no. 2.

As in the case of Bathhouse A, the water temperature and sand filter in the hot water bathtub circulation system promoted the growth of *Legionella*. The temperature of the hot water circulating in the hot water bathtub ranged between 33°C and 40°C, and a sand filter captured the microorganisms to provide bacteria with nutrients. The re-heater on the water circulation system, which was

heated by a steam boiler, was primarily used to adjust the temperature of the circulation hot water bathtub during winter. When the re-heater was not in use, the hot water was replenished via an auxiliary hot water pipe connected to a hot water tank.

Temperature control was essential for the hot water supply of the water system. *Legionella* bacteria were detected in the hot water faucets of Bathhouse B (Table 4). Guidelines suggest that the supply temperature of hot-water systems should be maintained within the range of 55–60°C and below 20°C. The hot water tank was operated at a temperature of approximately 50°C; however, the temperature had decreased by the time the hot water reached the faucet. In addition, hot water at a temperature of 50°C was mixed with the potable water supply, and internal contamination in the pipe may have increased the risk of detection from the hot water faucet. Therefore, it is necessary to shorten the pipeline after mixing points for hot and cold water and to maintain a water system temperature above 50°C and below 20°C.
