Characteristics and emergency mitigation of the 2018 Laochang landslide in Tianquan County, Sichuan Province, China

Zhuo Chen^{1,2}, Danqing Song³✉ & Lihu Dong⁴

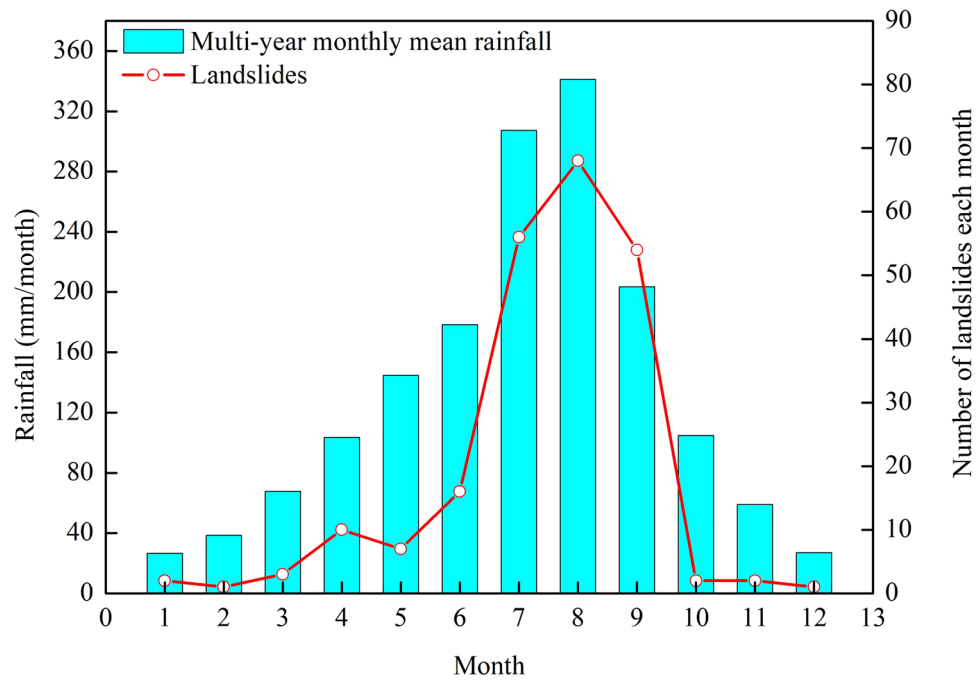
Figure 1. Graph showing the monthly distribution of the landslides and rainfall in the period 1971–2018 in Tianquan County.

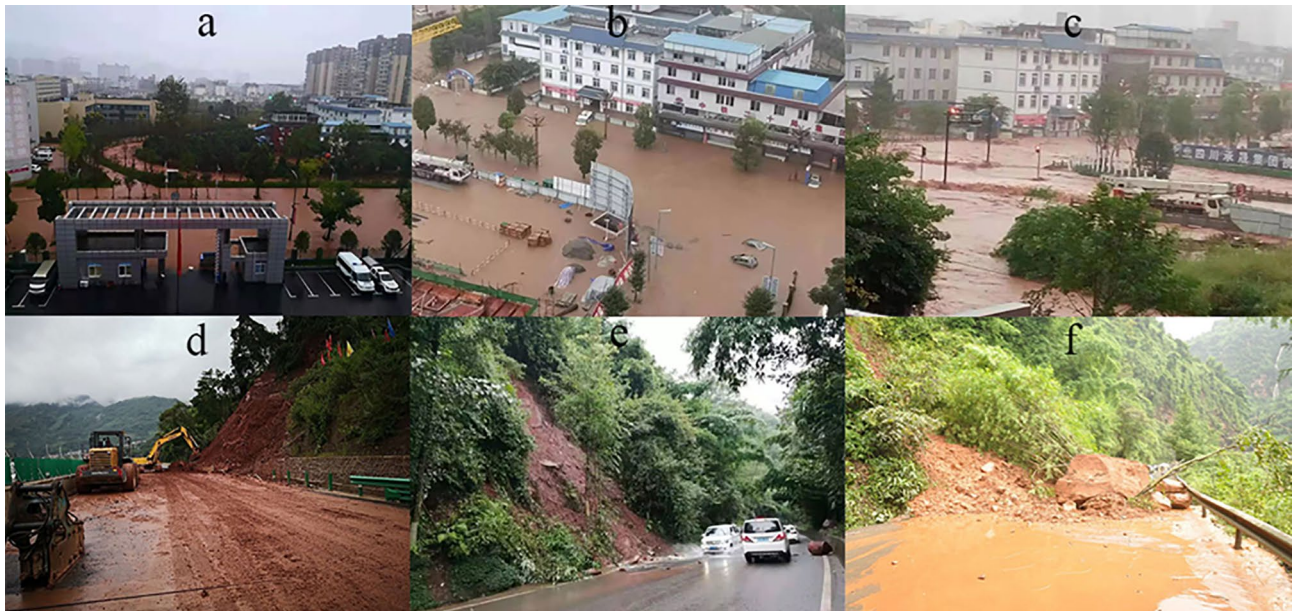
Figure 2. Photos of the rainfall-triggered flood and landslides in Tianquan County. (a–c) flood; (d–f) landslides.

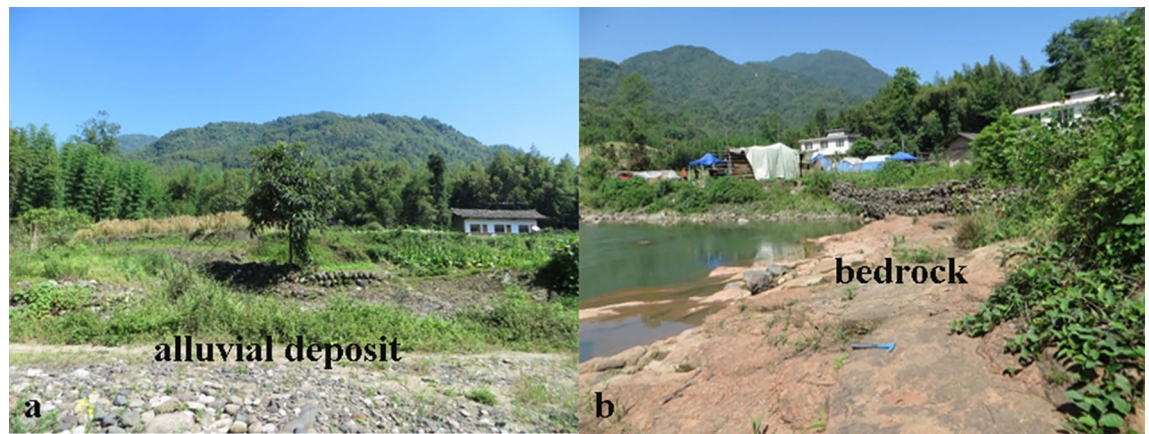
Figure 3. Bedrock and alluvial deposits of the study area.

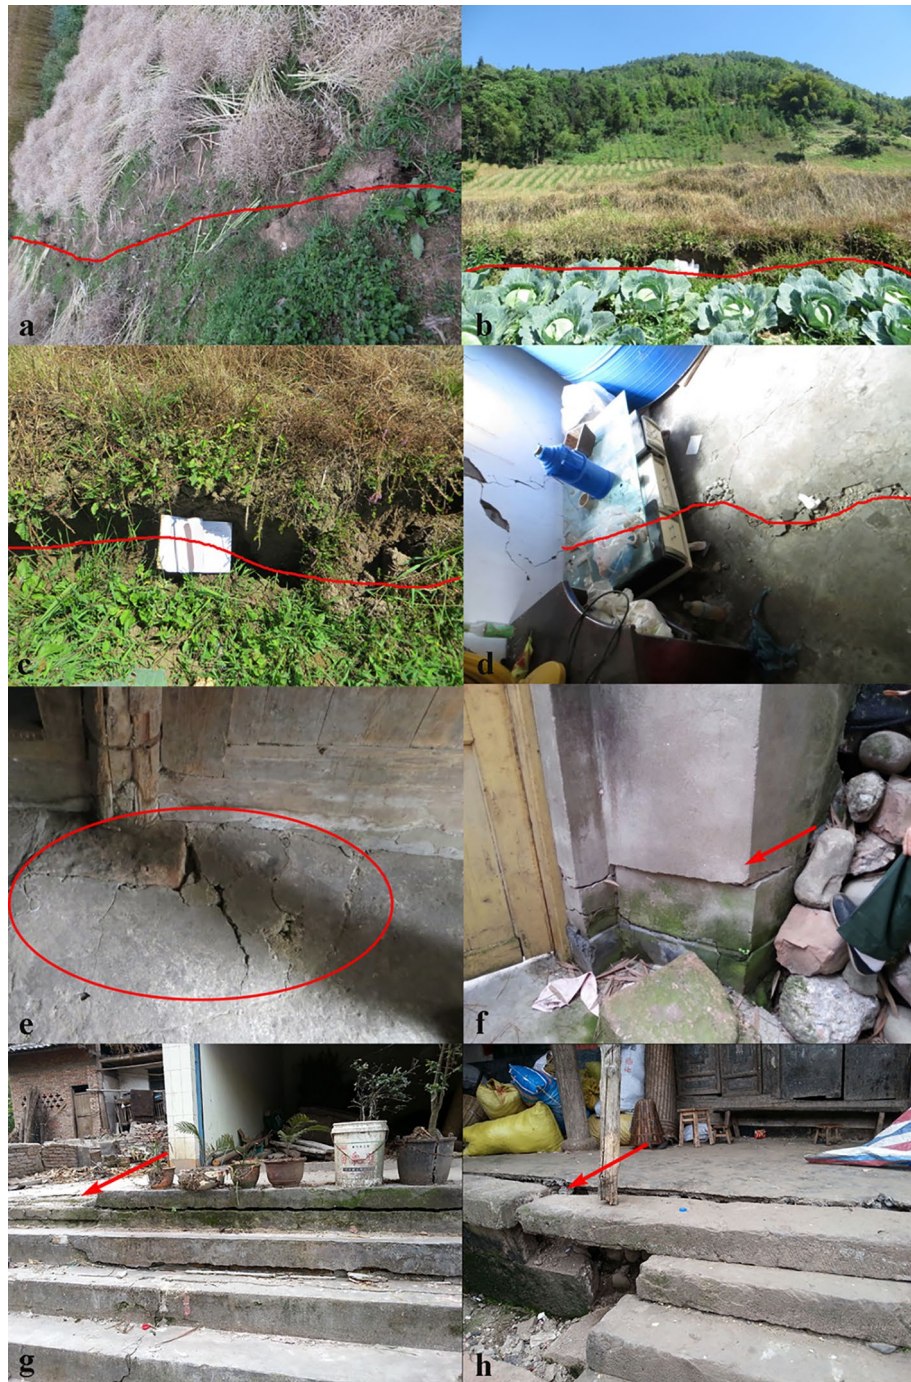
Macroscopic deformations, including cracks, minor scarps, bulges, and dislocations, have been observed within the landslide body (Fig. 5). Detailed site investigations revealed five cracks developed on the landslide surface. These cracks have widths of 7–30 cm, lengths of 15–63 m, vertical displacements of 12–50 cm, and observed depths of 30–80 cm, and they cause damage to several houses. The Wenchuan earthquake exerted a very intense impact in the landslide area, and four cracks (crack 1, crack 2, crack 3 and crack 5) developed on the landslide surface were caused by this earthquake (oral information from the local residents). According to the local residents, the Lushan earthquake enlarged these cracks. The extruding mass movement produced bulging cracks at the landslide toe (Fig. 5e). Severe structural damage was observed, resulting in the tilt of some houses (Fig. 5f–h).

Figure 5. Macroscopic deformations have been observed within the landslides body. (a) Crack C1. (b) Crack C2. (c) Crack C3. (d) Crack C5. The locations of bulges and dislocations are shown in Fig. 4.

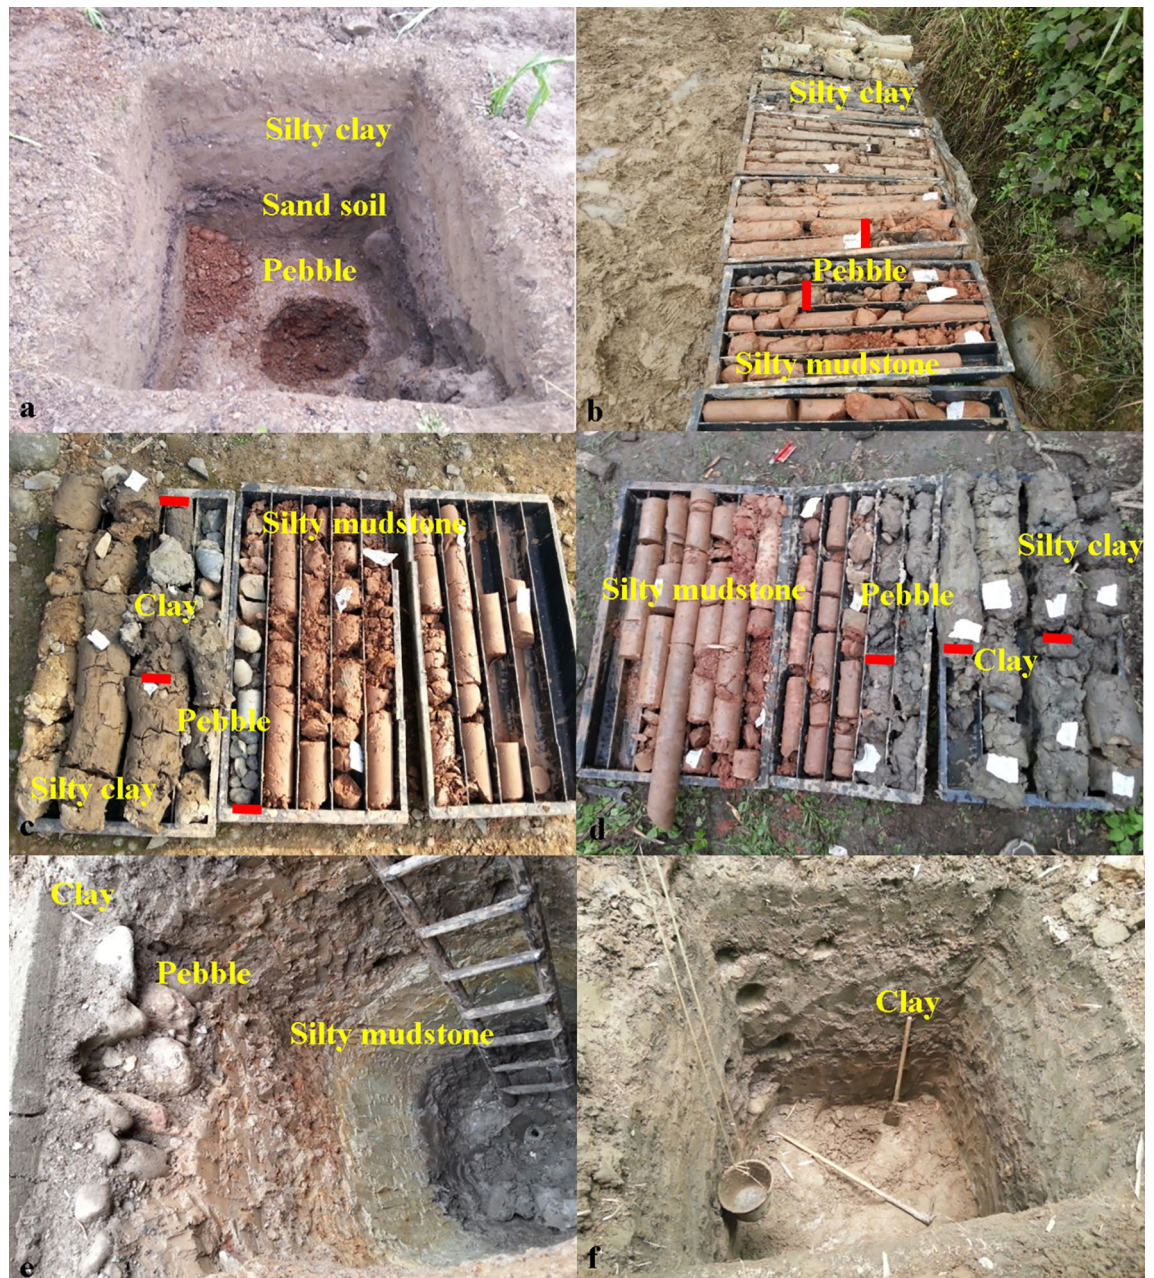
The geological structure of the landslide and the potential slip surface is obtained through boreholes and exploratory trenches, as shown in Figs. 6 and 7. Figure 4 shows the locations of the boreholes and the exploratory trenches. The landslide structure from bottom to top is pebble, silty clay, silty clay with rubble, respectively. According to the result of boreholes and the exploratory trenches, the location of the slip surface was confirmed (Figs. 7 and 8). The slip surface has a depth of approximately 3.8–15.8 m and is located at the interface between the superficial deposits and the underlying bedrock. The sliding zone is about 0.6–0.9 m thick, which is mainly composed of clay and small gravels.

Figure 6. Lithological stratigraphic logs of boreholes and exploratory trenches. (a) TC-9. (b) B03. (c) B05. (d) B06. (e) TC-4. (f) TC-7.

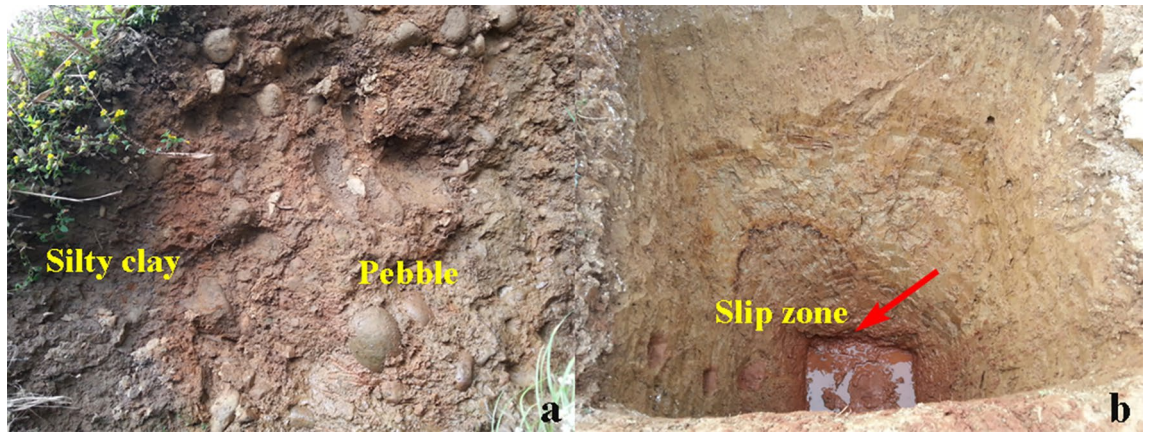
Figure 7. The structure of the sliding mass and the slip zone of the landslide exposed by exploratory trench.

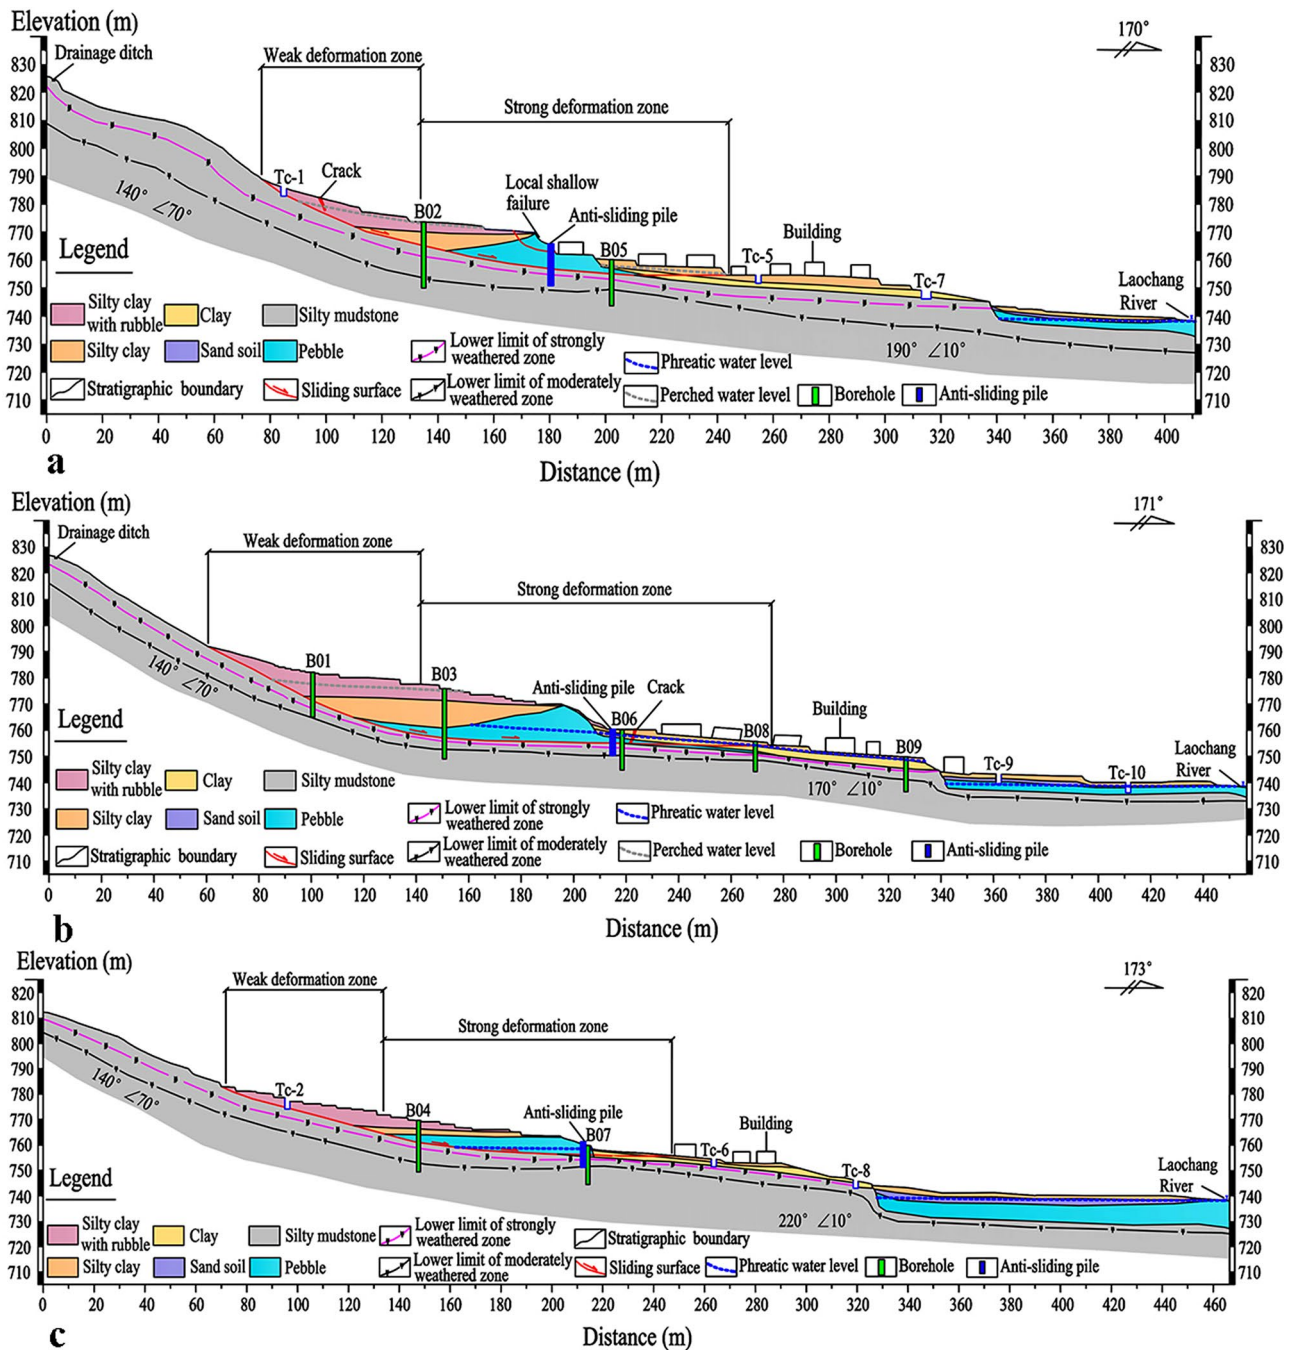
Figure 8 shows the landslide structure and the groundwater level in the landslide body. The groundwater in the landslide area mainly includes two types: the perched water and the phreatic water. The perched water is mainly found in the silty clay with rubble, and the phreatic water is found primarily in the contact zone between the silty mudstone and the overlying pebble. Tensile cracks observed on the landslide surface provide a preferential flow path for the rainwater infiltration. Continuous rainfall led to increased groundwater and thus decreased the effective stress in the slope. In addition, a significant amount of irrigation water in spring and summer

Figure 8. Longitudinal geological profiles: (a) 1–1', (b) 2–2', (c) 3–3' (Fig. 4).

Three cross-sections, including 1-1', 2-2', and 3-3', are used in the stability analysis of the Laochang landslide. The average water table heights of the three sections are 2.54 m, 5.07 m, and 2.67 m, respectively. The peak ground acceleration (PGA) of 0.15 g is used for pseudo-static analysis. The physical and mechanical parameters obtained from laboratory tests are listed in Table 2. The safety factors of the Laochang landslide were calculated under three scenarios (Table 3), indicating that the landslide without an anti-sliding pile would become unstable under both strong rainfall and earthquake conditions.

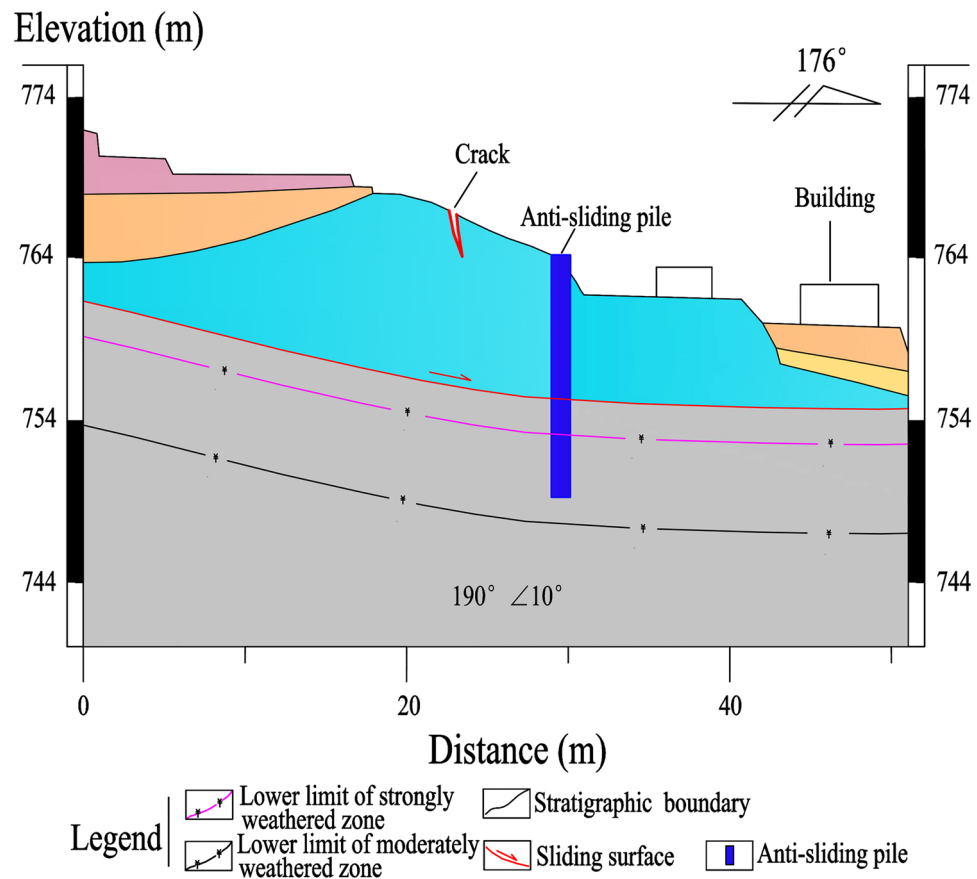
Figure 9. Longitudinal geological profile 4–4' (Fig. 4).

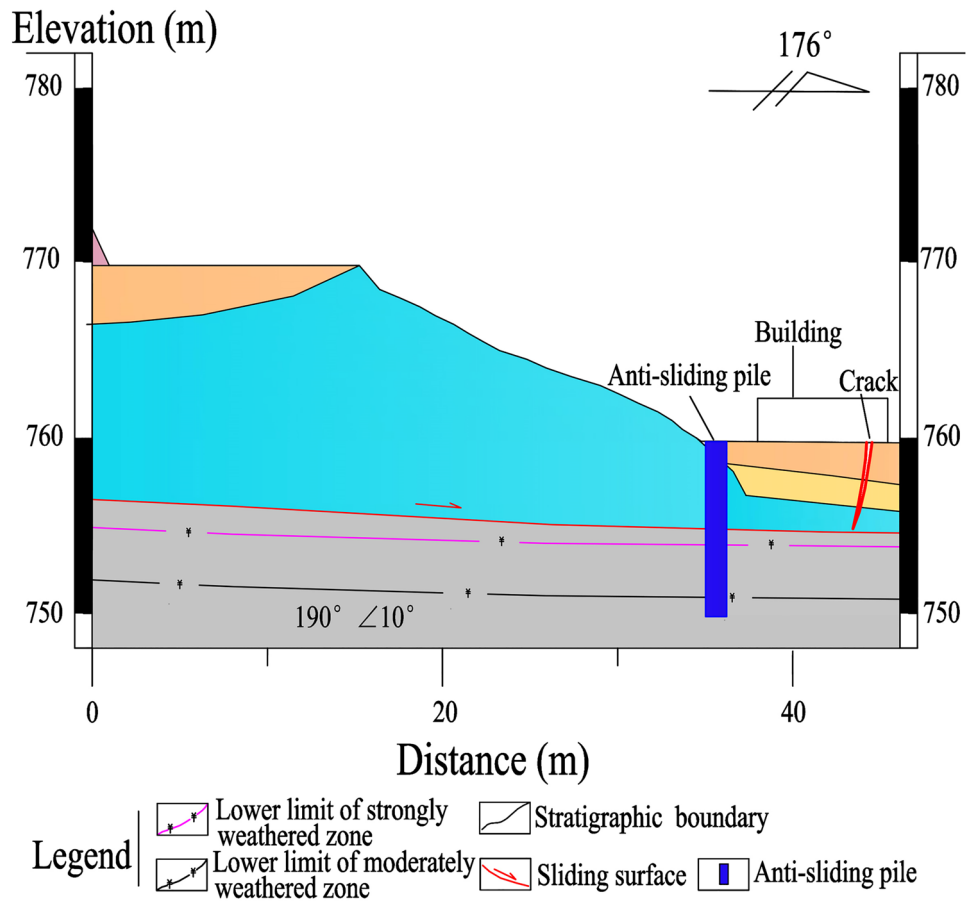
Figure 10. Longitudinal geological profile 5–5' (Fig. 4).

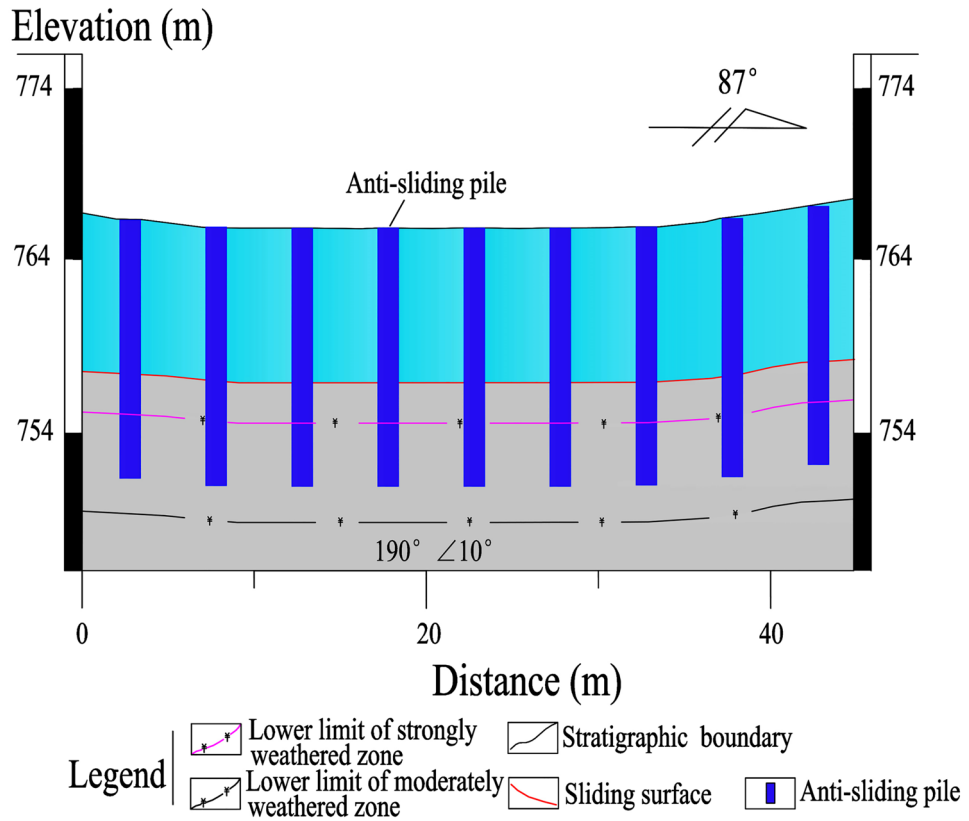
Figure 11. Longitudinal geological profile 6-6' (Fig. 4).

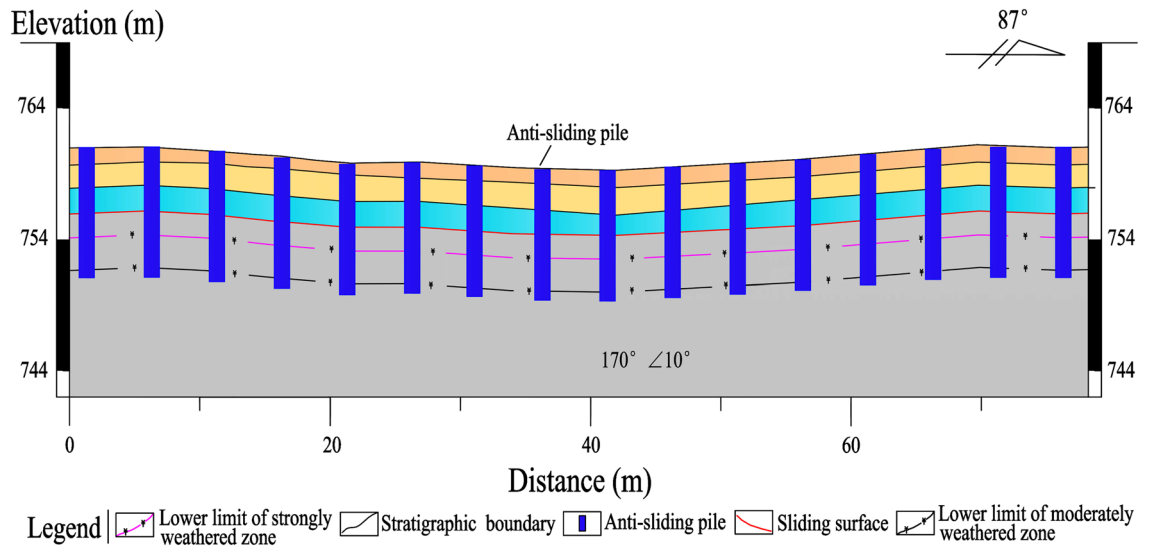
Figure 12. Longitudinal geological profile 7-7' (Fig. 4).

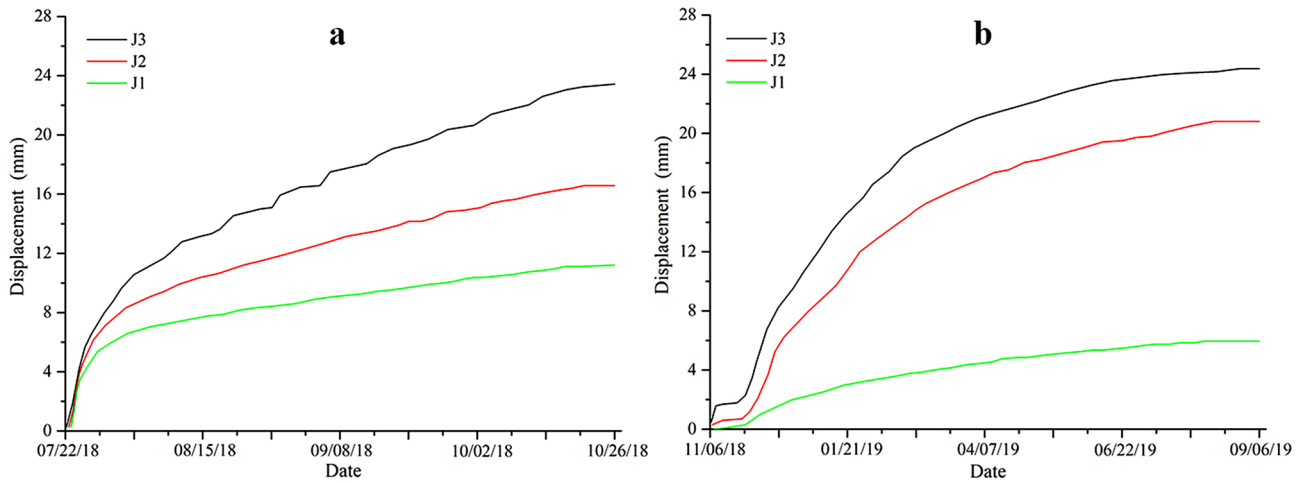
Figure 13 shows that anti-sliding piles significantly reduced the rates of surface displacement. For the monitoring point J3, the rate of surface displacement after construction was 0.079 mm/day, in contrast to 0.244 mm/day before the construction of anti-sliding piles. For the monitoring point J2, the rate of surface displacement after the construction of anti-sliding piles was 0.068 mm/day, compared with 0.173 mm/day before construction. Before the construction of anti-sliding piles, surface displacement increased rapidly during the rainy season. After the construction of anti-sliding piles, no significant, sudden increased displacement was observed during the rainy season. The displacement curves were relatively flat and the rates of surface displacement were also small. This indicated that anti-sliding piles had a remarkable effect on slope stability. From Fig. 13b, the displacement curves of the two monitoring points (J2 and J3) increased rapidly from November 2018 to January 2019. The main reason for this increase was the disturbance of the engineering construction between the two rows of the anti-slide piles.

Figure 13. Surface displacement monitoring result: (a) before the construction of anti-sliding piles; (b) after the construction of anti-sliding piles (Fig. 4).

A total of 25 anti-sliding piles, with a rectangular cross-section of 1.2 × 1.5 m and a length of 10–15 m, are constructed in the middle-lower section of the Laochang landslide (Figs. 9, 10, 11, 12). The center distance between the two adjacent piles is 5.0 m, and the embedment depth of each pile into the bedrock is 4.5–6.5 m. The Laochang landslide with anti-sliding piles would become stable under rainstorm or earthquake conditions (Table 3).
