Historical, architectonic and structural investigations of the Bell Tower of Santa Maria del Carmine Church

Detailed historical and architectonical investigation was performed on the Bell Tower of Santa Maria del Carmine Church in Naples. Geometrical and material surveys and destructive and nondestructive tests were performed *in situ* to evaluate the level of damage, the sequence of changes in the structures and the stress distribution due to static loads. Experimental dynamic characterisation of the Bell Tower was conducted and the environmental effects of vibrations due to wind, traffic and the ringing of the Towers’ bells were considered. Linear static and dynamic analyses were developed to compare experimental with analytical results in terms of stress level for vertical loads and dynamic behaviour.

Journal of Building Appraisal (2007) **3**, 155–179. doi:10.1057/palgrave.jba.2950068

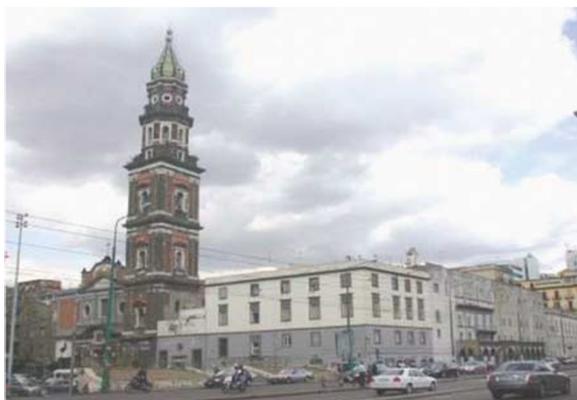
Figure 1: The complex of Santa Maria of Carmine

The Santa Maria del Carmine Church complex (Figure 1) is located at the extreme periphery of the ancient city of Naples in Italy. The Bell Tower is now 68 m tall (with an

The 17th century structure rises out of the 14th century basement of the old Tower where remainders of the original configuration can still be seen. At present, the first two levels are surrounded by adjacent buildings (the church of Santa Maria del Carmine, the congregation building and the monastery, see Figures 1–3), while the upper storeys are free on each side.

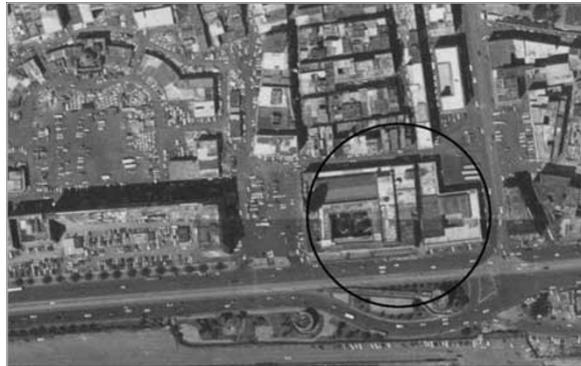
Figure 2: Aerial view of the complex

The Bell Tower is not an isolated structure but rather is part of a building system (Figures 2 and 3) that has experienced architectural and structural modifications over the centuries. The Bell Tower is joined between two other buildings, the Church of the Carmine the Major on the northern side, up to a height of about 19 m, and the Congregation of ‘S. Maria dell’ Angelo’ on the southern side, up to a height of about 16 m, as shown in Figure 1. The western side of the Tower faces the main square and is completely open while the eastern side borders the cloister of the Church. Historical surveys revealed that the Congregation was built after the Bell Tower and without any structural connection with the pre-existing walls. Although the church and the Bell Tower are now joined, originally they were separated as depicted in an engraving by Petrini (Celano and Chiarini, 1974) and in Antonio Joli’s painting (National Motor Museum, Beulieu, England) dating, respectively, from the 18th and 17th centuries, and which

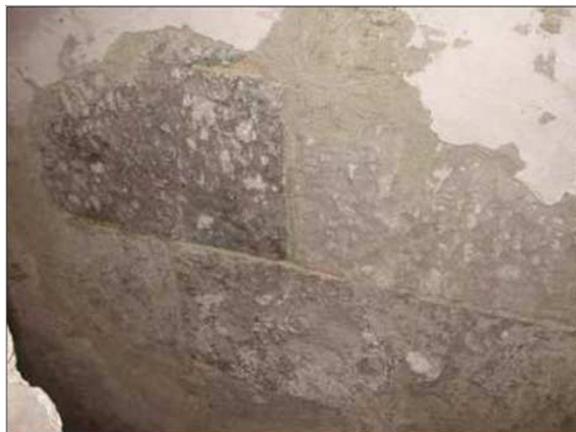
The analysis revealed that the Tower comprises faced masonry of tuff up to 41.4 m with an external basement of piperno for the first 7.5 m and an internal covering in peperino, while the walls of the upper levels are made of full clay bricks masonry but with some openings closed off with tuff block curtains. Tuff is a natural volcanic stone typical of the Naples area and has a characteristic yellow colour and is used widely as a construction material in Southern Italy due to its excellent mechanical properties under compression and low weight, while piperno and peperino are volcanic lapideous dark stones generally used as internal and external wall coverings. The peperino covering the backup tuff wall (Figure 9) is constructed of well-squared and aligned rectangular-shaped stones approximately 20 cm thick and with thin mortar joints of 1.5 cm. This texture is typical of the 14th century base structure architecture and confirms the hypothesis that the 17th century structure was built atop the 14th century buildings.

Figure 9: Peperino cover stones

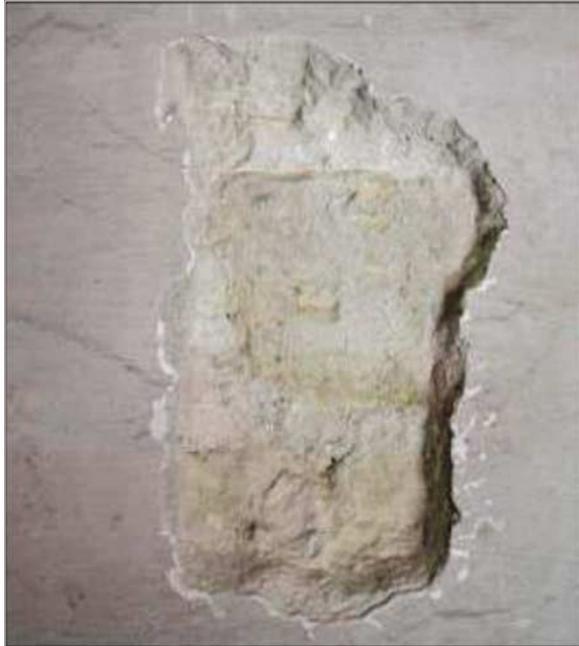
The levels having a rectangular layout (0–41.4 m) and built with a faced tuff masonry show a wall texture (Figure 10) characterised by roughly squared tuff stones with a regular shape and with thick mortar joints of about 3 cm. Stone dimensions are 16×23 cm alternated with 20 cm×20 cm stones. The levels higher than 40 m are characterised by an octagonal planimetric layout with walls covered by red and yellow clay bricks (Figure 11) and which probably also forms the internal texture.

Figure 10: Tuff wall texture

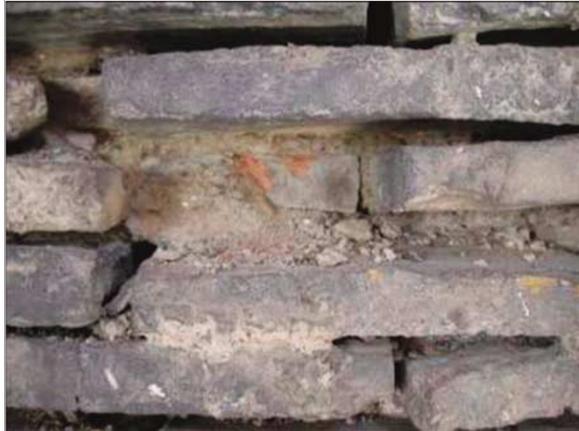
Figure 11: Clay bricks wall texture

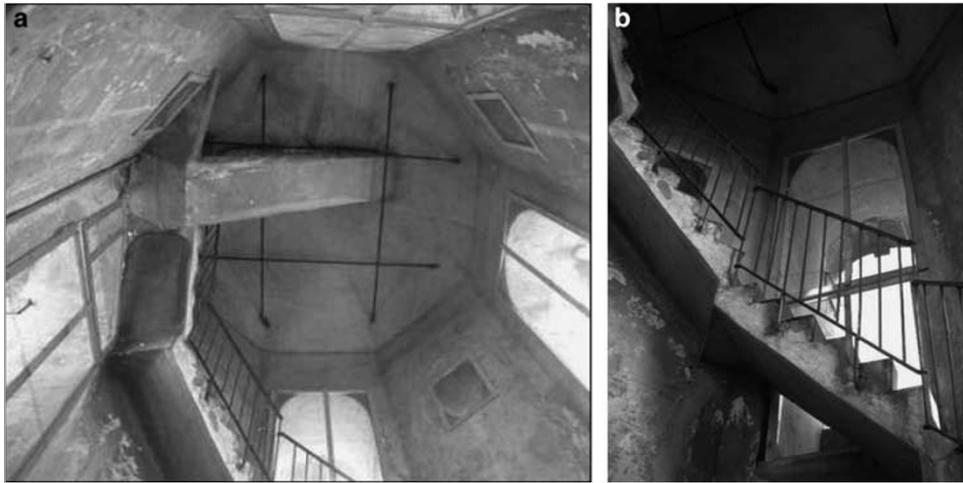
During the 1970s, several internal steel chains were added and RC injections were conducted in numerous areas corresponding particularly to the connections of the RC stairs in the masonry walls and in the corners. After the earthquake of 1980, mortar injections, reinforced with steel bars, were realised in the corners of most floors under the fourth level to improve the connections between walls and to improve the monolithic behaviour of the whole structure. These interventions are documented in the archives of the local superintendence as mandatory due to the increasing risk of

Figure 12: (a–b) View of the RC stairs

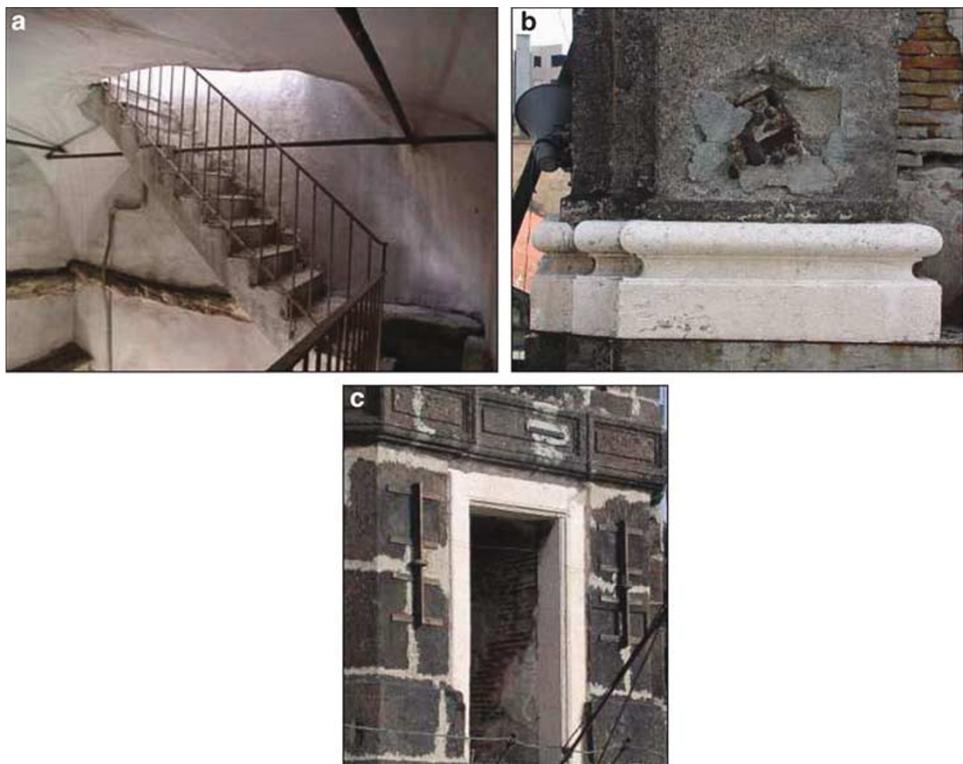
More recent interventions in the 1970s and 1980s consisted of adding extra steel supporting chains and bars to the existing ones, some of which in the upper levels date back to the end of the 19th century, while the strands and the bars through the stairs (Figure 13a) were added in the 1920s and 1930s before the construction of the RC stairs 20 years later. For the strands, only the anchoring plates are visible from the outside (Figure 13b) since the cables run through the walls, while the steel bars (diameter 30–50 mm) are visible from the inside of the Bell Tower and whose anchoring systems are generally made of external vertical or semi-horizontal bars (Figure 13c).

Figure 13: Particulars of chains (a) chains passing in the RC stairs; (b) anchorage of strand and (c) anchorage of bars

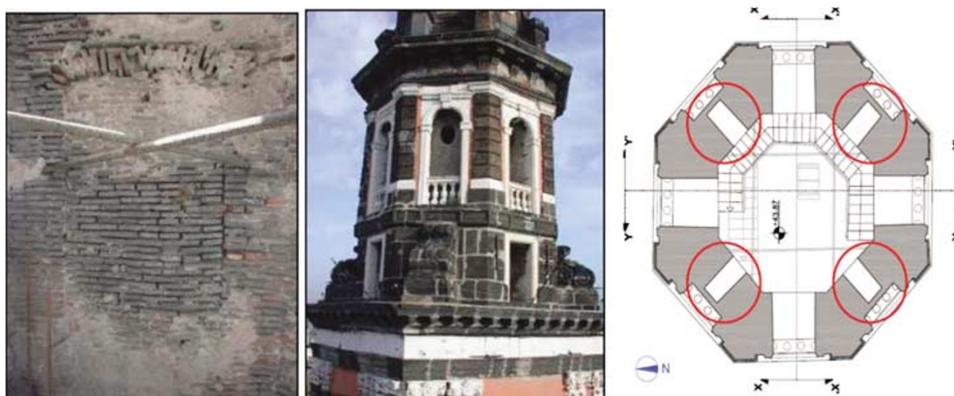
damage from earthquakes and are simply classified as ‘highest urgency’ interventions but without any documented record of the actual damage that had occurred. Visual assessment of corrosion of the reinforcing steel strands and bars, which is worsened by proximity of the Tower to the sea, suggests that these previous interventions are no longer fully effective. This suggestion is reinforced with evidence that the upper levels of the Tower are more deformable and is confirmed by the fact that at the upper levels, beyond 40m, where the Tower is octagonal and slender, some openings have been filled in by tuff curtains (Figure 14) to try to improve stiffness. At the fifth floor (+41.4m level), cracks were identified at the interfaces between new and old materials (tuff/clay bricks) where the original openings have been closed.

Figure 14: Inside and outside view of closed openings

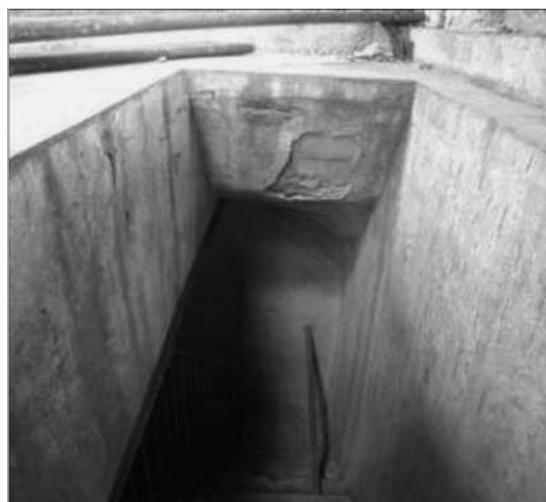
The materials used for the floors of the six storeys now vary. In some cases the original wooden floor or masonry vaults were partially removed and modified, probably for structural and functional reasons; at the third level the floor is totally made by an RC slab, while at the other levels RC slabs were fixed on the original vaults (Figure 15). Partial remains of the 15th century vault are visible at level +13.2m (Figure 16) and a wooden beam truss is still present at the level of bells. In most cases the thickness of lateral masonry walls were increased by tuff or concrete addition (Figure 15).

Figure 15: RC slab

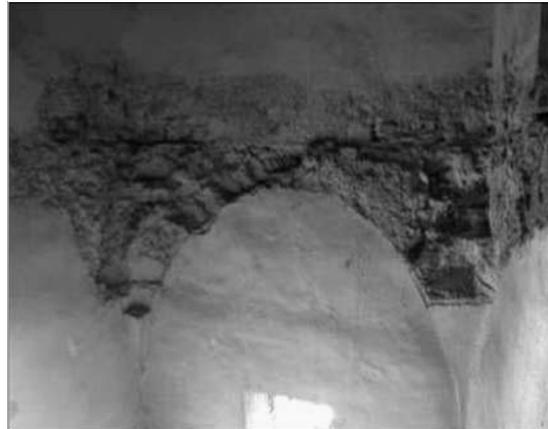
Figure 16: Remains of the demolished vault

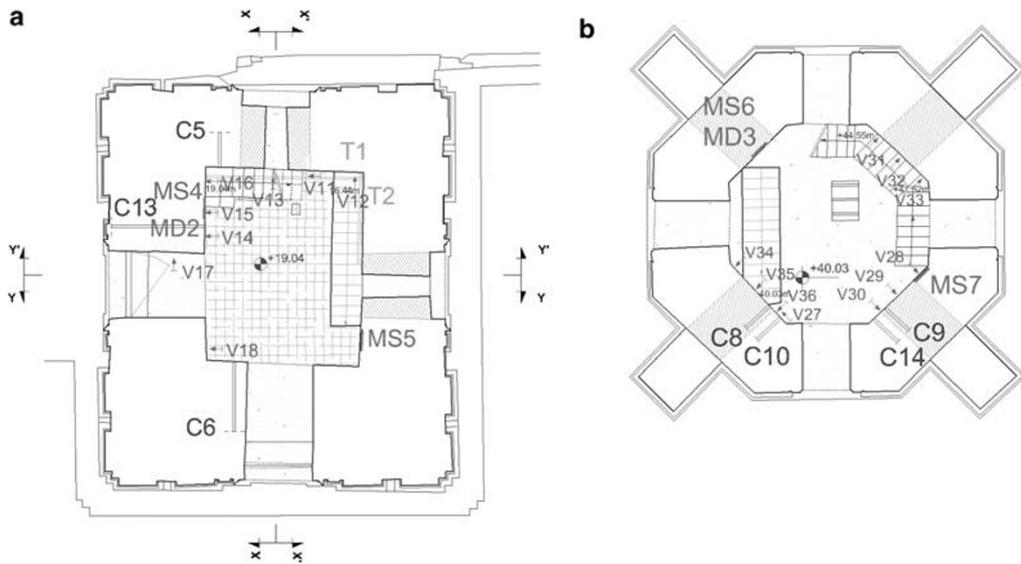
Figure 17: Location of *in situ* tests (a) plan +19.00m and (b) plan +40.00m

Three double flat-jack tests were performed in correspondence with three single flat-jack tests (at 8.7, 19 and 40 m), the location of two of which are shown as ‘MD’ in Figure 17. A typical stress–strain relationship obtained by double flat-jack tests is reported in Figure 18 for the faced tuff masonry until the occurrence of local failure happened. The compressive strength given by the three double flat-jacks is reported in Table 2, together with the elastic modulus E , and is calculated on the basis of the stress–strain relationship as secant modulus between 0 and a stress equal to 1/3 of the strength. The elastic modulus given by the flat-jack MD2 was anomalous, probably because it was taken from a nonhomogeneous masonry section while the flat-jack test at MD3 gave a value of elastic modulus similar to tuff, which was expected as the test was performed on a tuff curtain closing an original opening of the clay brick wall.

Therefore, by knowing the density and Poisson’s ratio (ρ and ν , respectively) of the investigated material, the dynamic elastic modulus can be evaluated. Measurements were performed by direct, indirect and semi-direct transmission, according to the positions of the source and receiving points (on the opposite sides of the wall, on the same surface of the investigated wall or on adjacent, often orthogonal, walls). When waves intersect a discontinuity (micro-cracks, voids and change of materials), the distance between the source and the receiver increases with respect to the geometric one because the wave avoids the discontinuity so that the speed reduces. About 60 measurements were performed in different points of the Tower with an instrumented hammer. Some examples of wave source location with the corresponding transmission directions are indicated as V in Figure 17.

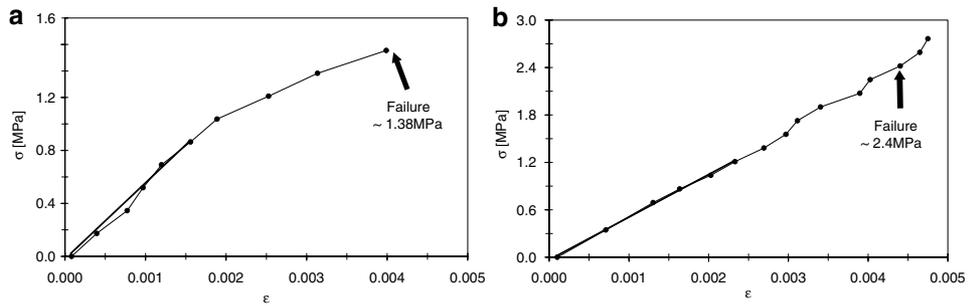
Figure 18: Stress–strain relationship (a) faced tuff (MD1) and (b) clay bricks/tuff (MD3)

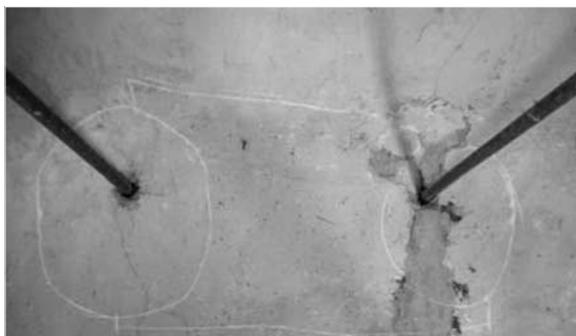
Considering the corrosion of some steel chains, tests were performed by measuring the strain levels of the steel by vibration sources in order to evaluate their effectiveness. Twenty-two chains were monitored by strain measurement and they showed that most of them bear tensile stresses varying between 27 and 99 MPa, and that eight of the chains are practically unloaded. Some chains have evident problems of corrosion, which, in some cases, has led to a local failure of the anchorage (Figure 19).

Figure 19: Damage of anchorage of steel chain

For the examined case of the Bell Tower of Santa Maria del Carmine, the analyses was very complex because of the complicated geometry, the variety of materials, the presence of past modifications and restoration interventions as well as for the structural effects of surrounding structures, but all of these data were needed in order to develop a reliable model of the structural behaviour of the Tower. The results of *in situ* tests and the linear static analysis performed by a simple finite element model showed that the Tower is under a low level of stress for vertical loads. The experimental dynamic behaviour of the Tower has been compared with the results of the numerical linear dynamic analysis and showed minor effects of surrounding buildings in the presence of environmental dynamic sources. A nonlinear static analysis is in progress assuming a nonlinear behaviour for materials to evaluate the displacement capacity of the Tower that will be compared with the design displacement demand evaluated according to national seismic codes. Furthermore, studies about the effectiveness of connections between walls are in progress to consider the reliability of out-of-plane local failure mechanisms, which should be avoided by improving the monolithic behaviour of the Tower by substituting or adding new chains.

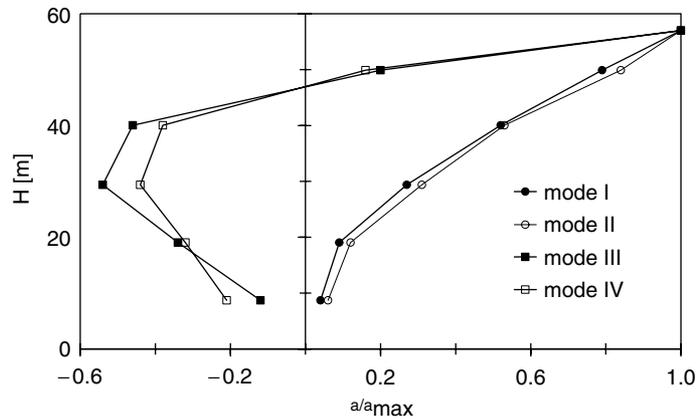
In Figure 20, the first four modal shapes of the Tower in terms of acceleration normalised with respect to the maximum that was measured in the Tower (7th level at 57 m) are depicted. For each direction the first and second modal shapes show no change of curvature along the Tower, while for the 3rd and 4th modal shapes there is a point of curvature inversion. All the shapes are similar to the dynamic behaviour of a cantilever.

Figure 20: Experimental normalised modal shapes

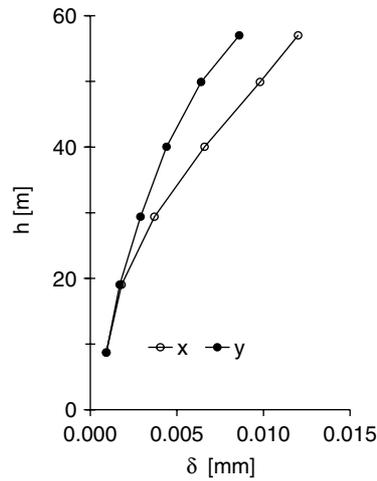
Figure 21: Distribution of mean displacement

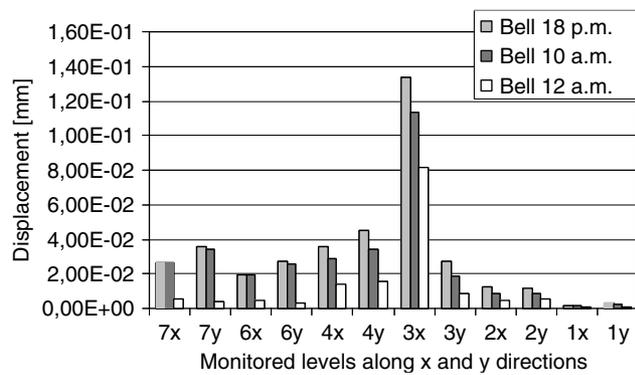
Relevant peaks were also recorded when the bells rang (for 2–3 min with different intensity according to the hours), and although the effects were strongest on the level where bells are positioned (fourth level, +30 m) and on the adjacent ones, a global effect on the entire Tower was however observed. In Figure 22, the maximum displacements registered when bells rang is reported for three time intervals at the six monitored levels. The maximum effect was observed when bells rang at 06.00pm and the displacement at the bell level had increased by about 35 times compared to normal conditions.

Figure 22: Effects of bells at various levels for different hours during the day (10.00am, 12.00am and 06.00pm)

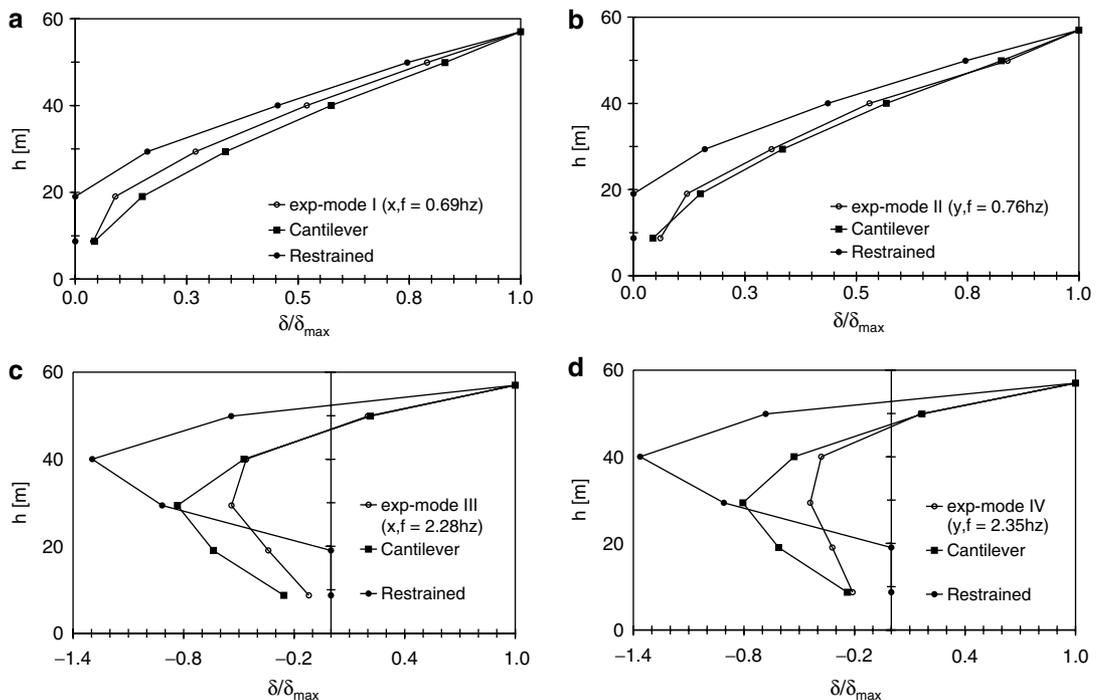
In Figure 24, the deformation modal shapes corresponding to the first four modal shapes for both configurations are compared with the experimental ones. The comparisons between experimental and numerical results show that in terms of values of natural frequencies the behaviour of the Tower is proximal to the fixed restrained configuration, while the experimental modal shapes are very similar to the behaviour of a cantilever reproduced by configuration A.

Figure 24: Modal shape for several configurations: (a) Mode I; (b) Mode II; (c) Mode III and (d) Mode IV
