Maintenance survey of cultural properties in Ile-Ife, Nigeria

Journal of Building Appraisal (2009) **4**, 255–268. doi:10.1057/jba.2009.3

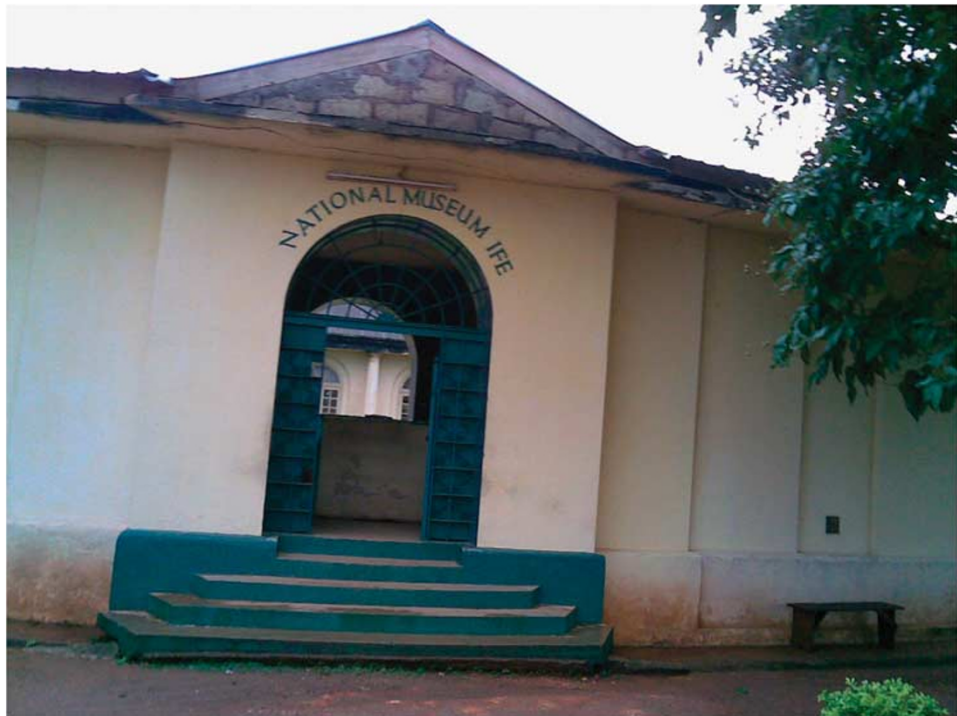
The National Museum, which was the first in south-western Nigeria, was established in 1954. The Museum was donated by the late Oba Adesoji Aderemi. It was designed to cater for two categories of objects. These are archaeological and ethnographical objects. Archaeological objects refer to those objects dug out of the ground such as human remains and metal objects. Ethnographical objects are objects like leather bags, traditional weavings like clothes and wood. There are four structures within the premises of the Museum, which are constructed with burnt bricks, wooden doors and louver windows. Figures 1 and 2 show the existing state of the National Museum.

Figure 1: Front view of the National Museum, Ile- Ife.

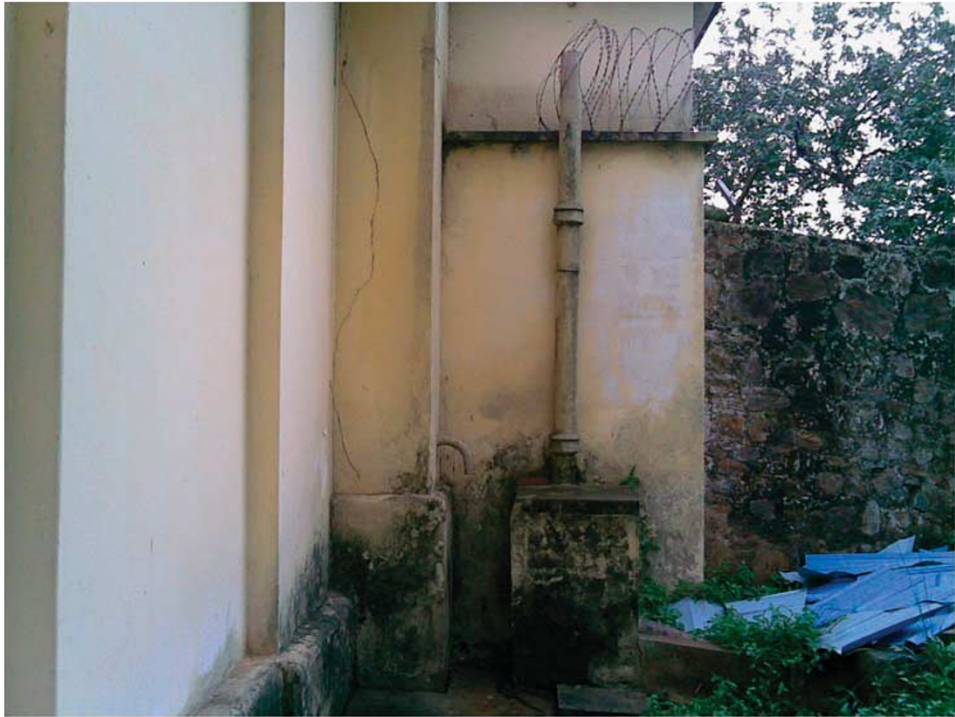
Figure 2: Deterioration – Cracks and moss growth on National Museum wall.

Table 5: Physical defects observed in the National Museum building, Ile-Ife

<i>Elemental/components</i>	<i>Observed defects</i>	<i>Possible causes of defects</i>	<i>Proposed remedial actions</i>
Walls	Cracking Termite attract Discolorations	Environmental factors Biological factors Environmental factors	Patching and repairs Fumigation of the building Renovation works
Concrete ceiling	Cracking Spalling Reduced strength Dampness	Poor construction Environmental factors Moisture movement	Renovation of the building Renovation of the building Renovation of the building
Floors	Cracking Collapse of floor Dampness Screed failure Terrazzo failure	Environmental factor Consolidation of sub-soil Moisture movement High traffic intensity	Renovation of the building Re-flooring of affected parts Re-screeding and re-lay of terrazzo finish
Beams and columns	Cracking	Environmental factor	Patching and repairs
Roof	Termite attack on fascia board	Biological factor	Fumigation/replacement
Landscape	Plant growth	Environmental factor	Flooring of the surrounding with concrete or laying of interlocking tiles

Finishes	Discoloration and flaking of paint	Environmental factor Solar radiation.	Re-painting and decoration of the buildings

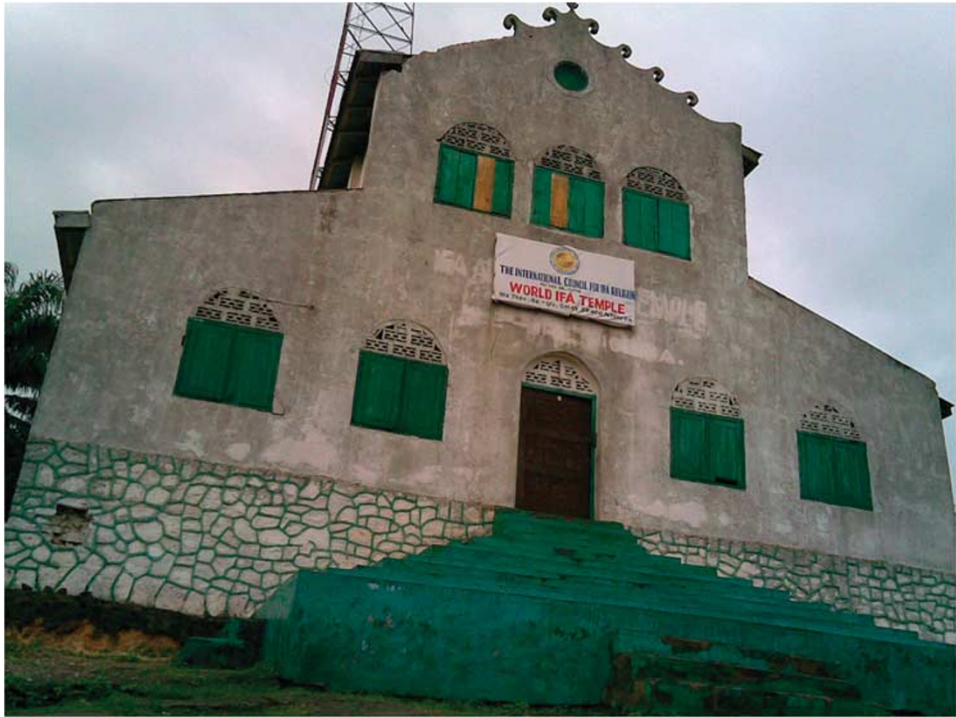
The Ifa temple is located at Oke Itase, Oke Agboniregun, Ile-Ife. The place is not occupied by anybody. Ifa temple has also been in existence for centuries till date. Ifa temple is also very popular in south west part of Nigeria. The building is constructed with burnt mud, made of wooden panel doors and small wooden windows. It has a pit toilet constructed with corrugated iron sheets. Figure 3 shows the state of the Ifa temple and surrounding elements.

Figure 3: World Ifa temple – Deteriorating external works.

Table 6: Physical defects observed in Ifa temple building Ile-Ife

<i>Elemental/components</i>	<i>Observed defects</i>	<i>Possible causes of defects</i>	<i>Proposed remedial actions</i>
Walls	Cracking Dampness Discoloration	Environmental factor Moisture movement Environmental factor	Patching and repairs Renovation of the building.
Roof	Sagging Leaking	Failure of timber trusses Environmental factor	Complete renovation
Doors and windows	Warping Rots	Environmental factor Environmental factor	Complete renovation Complete renovation
External floor	Collapse of floor Cracks Dampness Plant growth	Consolidation of hardcore Environmental factors Moisture movement Environmental factor	Complete renovation Complete renovation Complete renovation Complete renovation
Finishes	Discoloration and flaking	Environmental factor Solar radiation.	Complete renovation Complete renovation

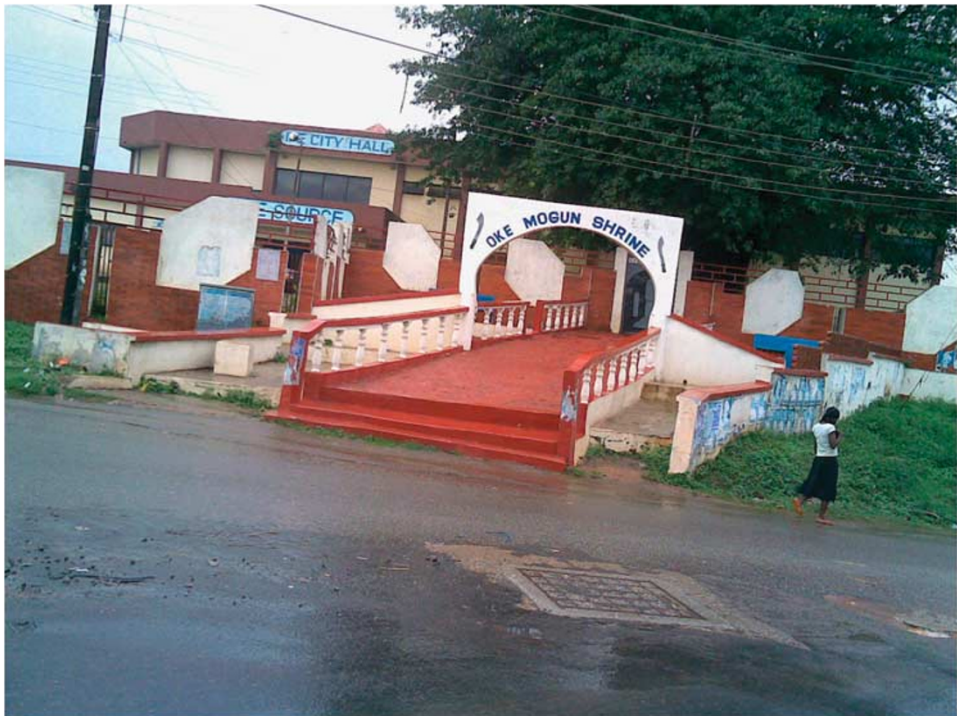
Oke-Mogun shrine is located at Oke-Mogun in Ile-Ife. This shrine has also been in existence for centuries and is very popular in Yoruba land. It is owned by the Ife community. The shrine is fenced with a gate and has no building within but marked by two trees located at the centre of the compound. Figure 4 shows the Oke-Mogun shrine compound and its inner courts.

Figure 4: The Adjoung Oke-Mogun shrine.
