Incessant building collapse: A case of a hotel in Akure, Nigeria

Journal of Building Appraisal (2011) 6, 241–248. doi:10.1057/jba.2011.1

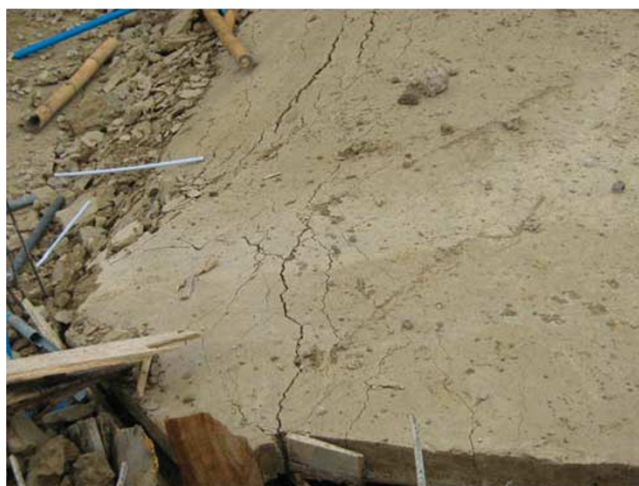
Figure 1: Concrete slab full of cracks and disintegrating from steel reinforcement.

The collapsed hotel building is located after Oba-Ile Housing Estate, on the way to Oba town in Akure, Nigeria (Figures 1–5 show different views of the collapsed hotel). It was observed that substandard materials were used in the construction of the hotel building. The quality and quantity of cement used in the construction was very poor. The concrete mix was not evenly distributed. From observation, one could easily assert that the concrete was mixed manually, which made the non-even distribution of the cement, sand and coarse aggregate possible. The reinforcement steel bars used in the construction of this building had low area of steel in the beams, columns and floor slabs,

which eventually gave rise to cracks that led to the collapse of the structure under the massive weight of the dead loads.

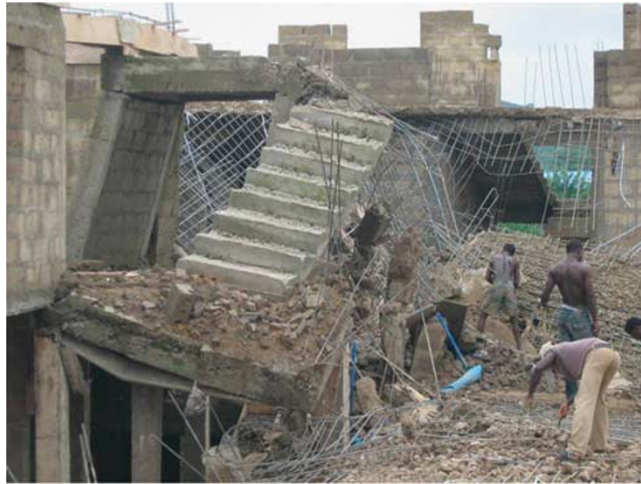
Figure 2: The hotel under construction that collapsed along Oba-Ile road, Akure, showing the wreckage.

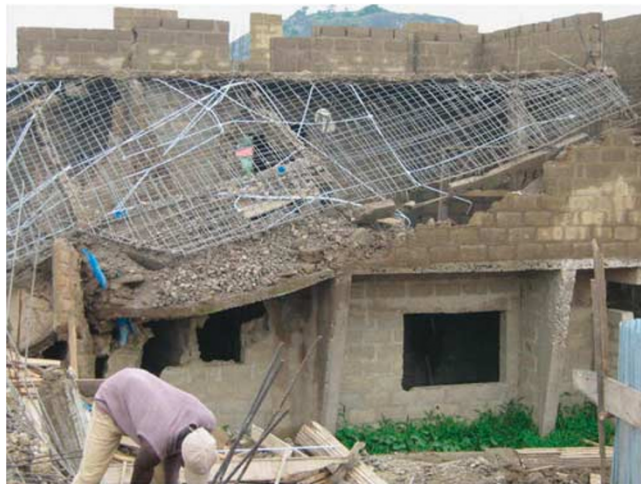
Figure 3: Structural failure: As a result of substandard materials used.

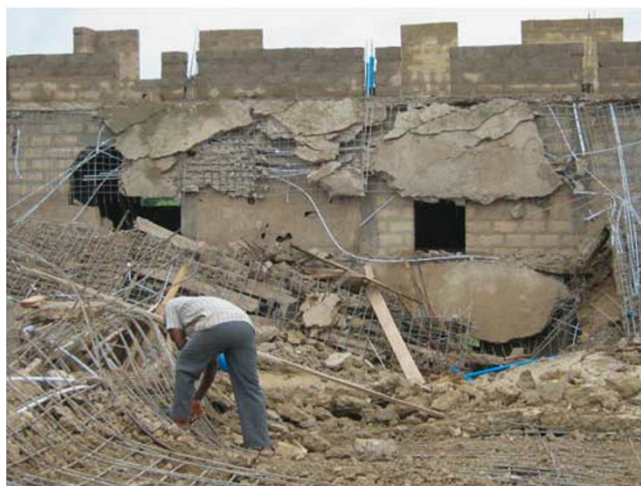
Figure 4: Another view of the collapsed hotel building.

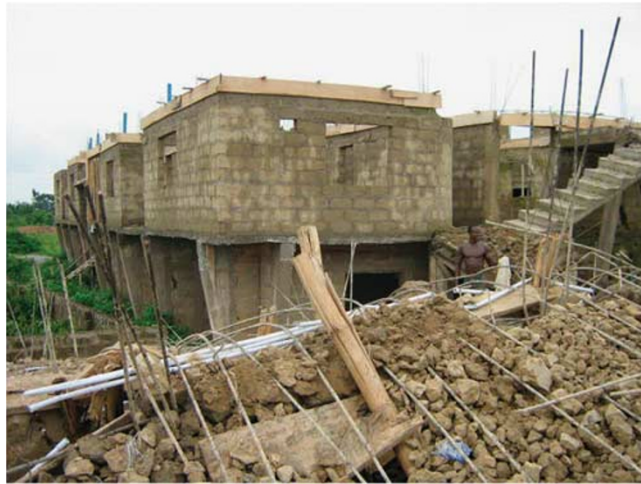
Figure 5: Clearing debris on the collapsed hotel building site.
